**Re: Cameron Hills Gas Pipeline and Gathering System approved under National Energy Board
Orders XO-P097-02-2002 and EPO-01-2002, respectively**

The following is a summary of the inspection of the Cameron Hills Pipeline and Gathering System right-of-ways (ROW) that was conducted by Darren Unrau and Brian Anderson of Paramount Resources Ltd ("Paramount") on May 28 and 29, 2002. Also provided is information on the location of the issues, a description of the issue, and the proposed corrective measures that will be pursued by Paramount.

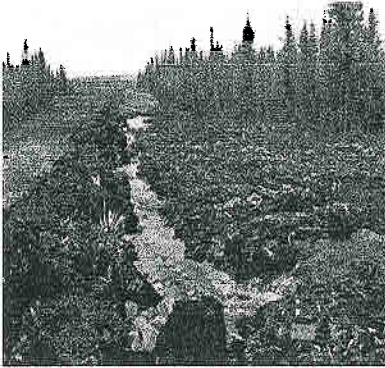
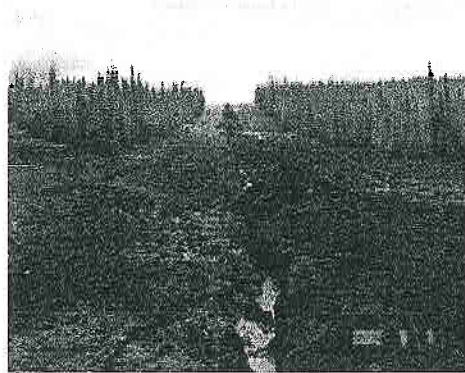
Issue – Area A is located at 60° 05' 22"N and 117° 30' 09"W, approximately 1.5 km south of the Cameron River bridge. The muskeg to the east of the ROW is naturally draining, and water is entering the ROW. This water is flowing down the ditch line, then across the ROW and back again. There is minor erosion and scouring of the trench ditch at this location.

Additional Mitigation Required - The water needs to be diverted back into the muskeg and allowed to flow downhill into a natural drainage channel that flows away from the ROW. A permanent diversion berm constructed at this location would be expected to correct this issue.

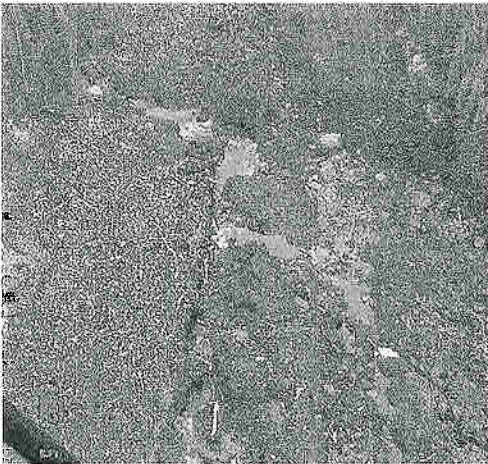
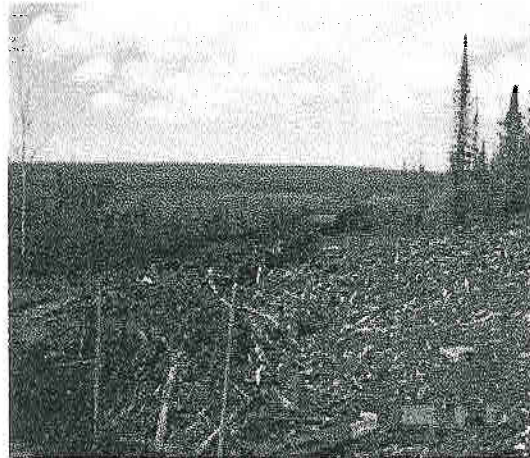
Issue – Area B is located at 60° 05' 26"N and 117° 30' 09"W, approximately 200 m north of Area A. Water that flows naturally along the east side of the ROW has turned to the west at this location to enter the ROW and flows down the ditch line for approximately 200 metres. At this point the waterflow exits the ditchline and flows to the west, out of the ROW and into a muskeg area. The water has caused erosion and removed much of the roach material, exposing the pipe in a few places. The eroded silt has been deposited at the edge of the ROW.

Action Taken - On June 1, 2002, a work crew with hand tools attended this location. The location where the water was entering the ROW and subsequently flowing into the trench was the focus of the remedial work. A barrier (i.e., silt fence), supported by available soil, was constructed to block the water from entering the trench and resulted in the water being diverted across the ROW. The water then flows down the ROW for approximately 30 metres before exiting to the west into the natural channel.

Additional Mitigation Required - To address this issue, the construction of a permanent ditch block, a permanent diversion berm directly below the ditch block, and backfilling the exposed trench would be required.

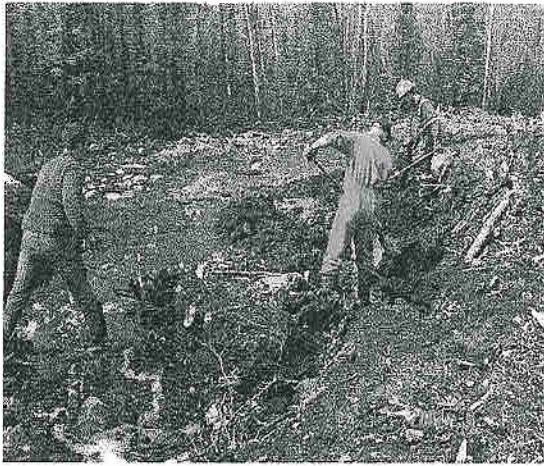
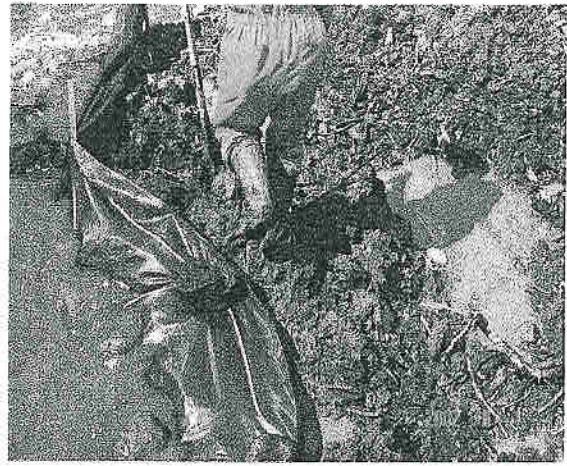
Diverting water from entering the trench.

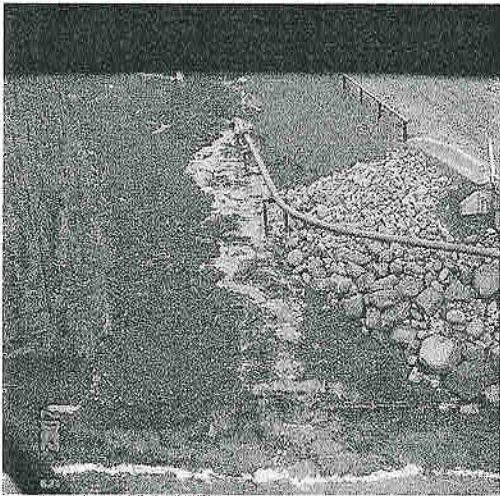
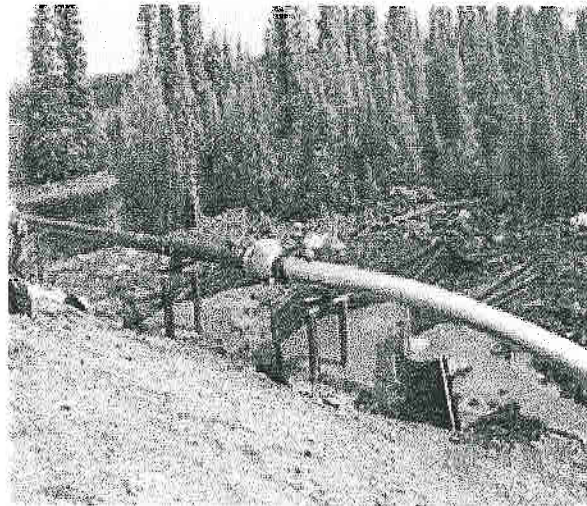
Area D

Issue - This issue is located at 60° 06' 19"N and 117° 30' 03"W, where the pipeline exits the trench before going up and onto the vehicle bridge on the south side of the Cameron River. Water is flowing out of the pipeline trench, with the sources being the issue locations noted above. In addition, a small amount of water is flowing from the temporary workspace area east of the ROW and joins the water from the pipeline trench where they both flow approximately 30 metres and into the Cameron River. This has resulted in an erosion channel being cut into the riverbank.

Action Taken - On June 1, 2002, a crew with hand tools worked on this site. A barrier fence was installed to divert the water that was flowing from the temporary workspace area. The water was diverted to an adjacent area with undisturbed brush where sediments would be filtered out naturally before entering the Cameron River. Three silt fences were erected where the water was flowing out of the pipeline trench. This resulted in the water being slowed down and pooling before it entered the river. It is anticipated that the additional work that was completed uphill of this location will limit the amount of water that will flow down the pipe. Frozen ground conditions at the time of the remedial action prevented a diversion ditch from being dug to divert the flow off the ROW before entering the river.

Additional Mitigation Required - Additional mitigative measures would be required and include installing additional silt fences, along with fiber matting, to prevent continued erosion at the riverbank. This will be completed at the earliest opportunity. A permanent ditch block and diversion berm may be required at the point where the water is flowing out of the trench line, in conjunction with the diversion of the small waterflows that are currently entering the pipeline trench up the hill (i.e., Areas B and C). Disturbed areas will be seeded with the approved mixture once the area has been stabilized. There were four foam ditch blocks put into the trench during the initial pipeline construction along this slope, but they failed to arrest the erosion.

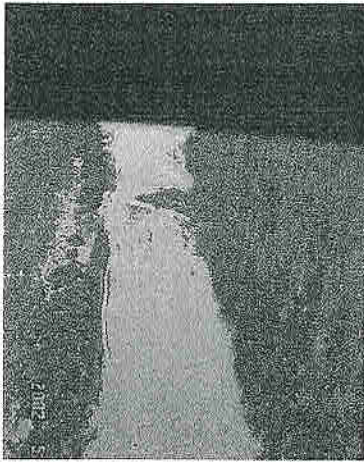
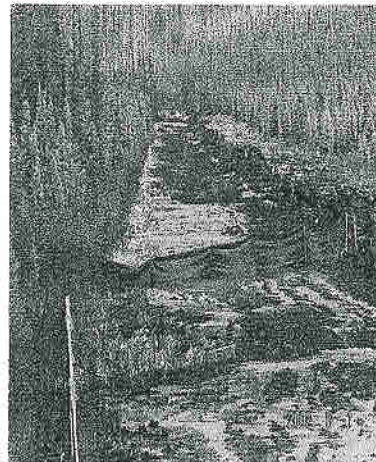
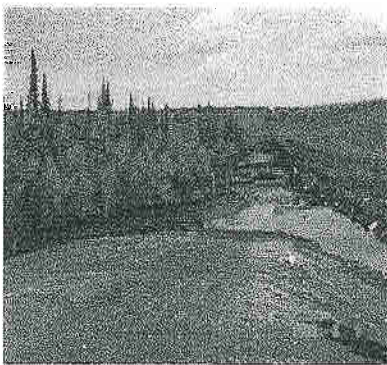
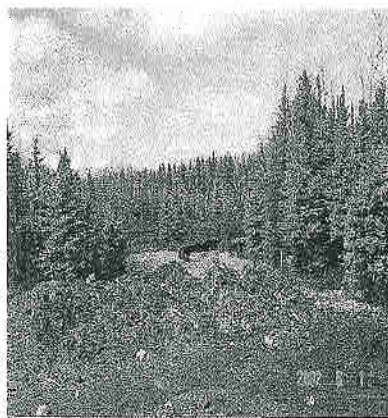
Area E

Issue - This area is located at 60° 06' 19"N and 117° 30' 03"W, approximately 500 metres north of the Cameron River bridge. Water is entering the ROW from the muskeg to the west, flows down the ROW to the base of the hill. At this point the hill water joins water flows that are originating from a muskeg area to the east, and crosses the ROW. The water then flows to the west approximately 50 metres before entering the Cameron River.

Action Taken - The work crew installed a diversion fence that directed the majority of this water back into the muskeg area which drains naturally into the Cameron River, approximately 200 metres to the west. Two silt fences were erected to slow and pool the water before entering the river. Additional silt fences should be installed at this location as required.

Additional Mitigation Required - Additional measures should include the construction of a permanent diversion berm to divert any future water from flowing down the trench at this location. The construction of permanent diversion berms to prevent water from entering the Cameron River is also required. The disturbed areas will be seeded with the approved mixture once the area is stabilized.

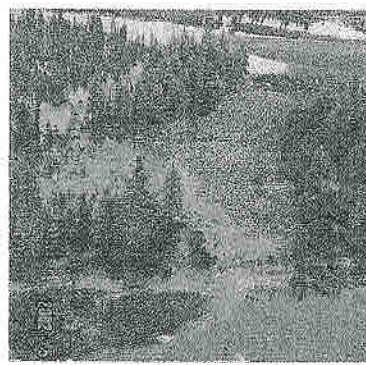
Water entering the Cameron River

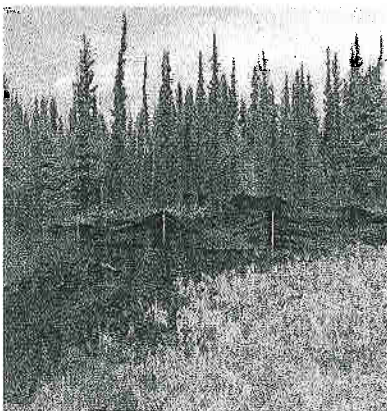
Installed silt fences

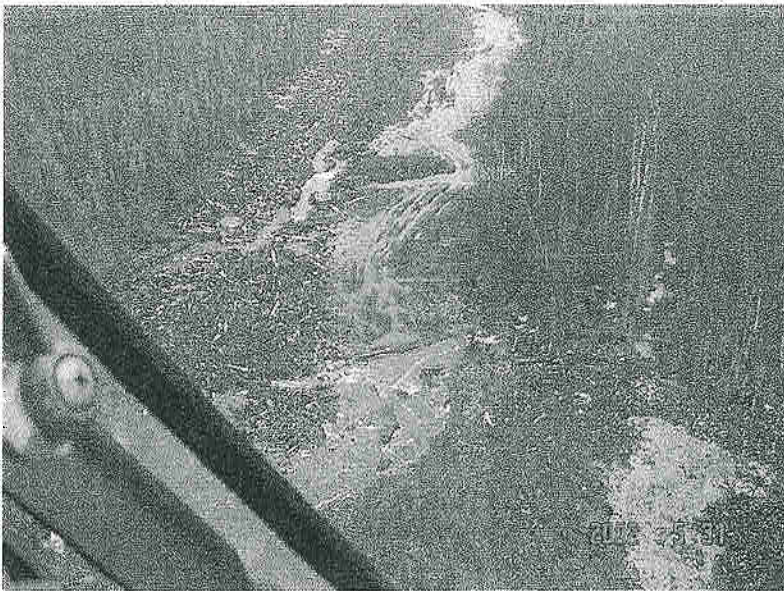
Area F

Issue - At 60° 05' 41"N and 117° 30' 10"W, approximately 1 kilometre north of the Cameron River, a small water flow crosses the ROW. This drainage has two distinct channels as it enters the ROW. The main channel flows across the ROW in its natural channel. The second channel flows on the ROW and has eroded a channel into the trench and then down the trench towards the Cameron River bridge.

Action Taken - On June 1, 2002, a crew with hand tools diverted the one channel to prevent water from entering the trench. The trench, from this point down towards the Cameron River bridge for approximately 300 metres, has eroded in places, with exposed pipe at a couple locations. Water is also entering the trench from seismic lines and the muskeg on the east side of the ROW.

Additional Mitigation Required - Additional mitigative measures required would include construction of a permanent ditch block directly below the drainage to prevent future water from flowing down the trench. The exposed pipe and the scoured trench line will need to be backfilled. The small waterflows entering the trench along this area will also have to be addressed by diverting them from entering the ROW or by constructing crossings across the ROW which prevents water flow from travelling down the trench. Disturbed areas will be seeded with the approved mixture once the area is stabilized.

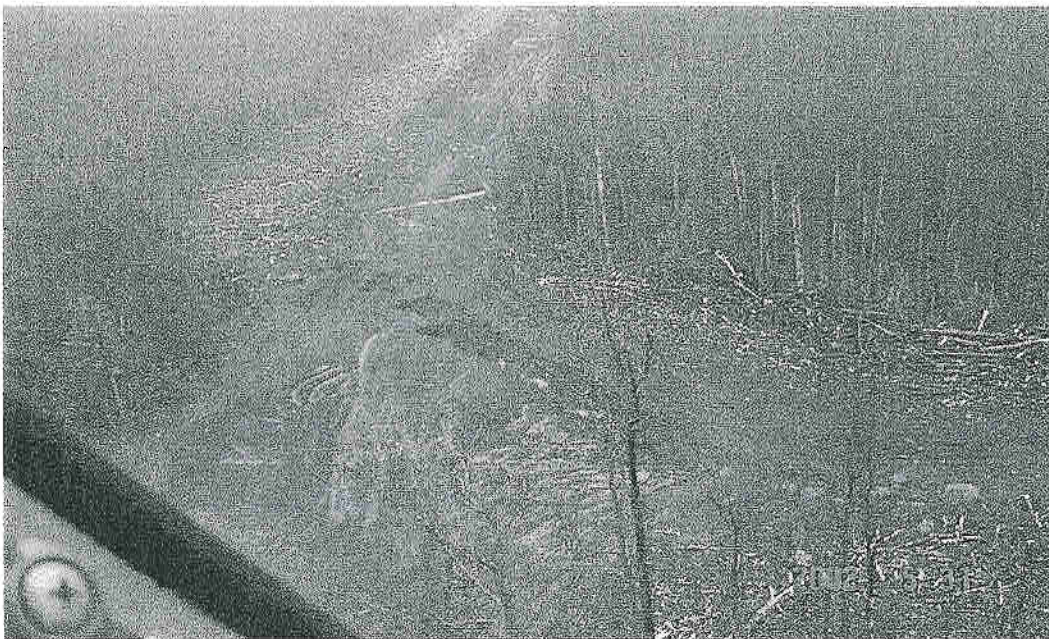
Area G

Issue - At 60° 07' 08"N and 117° 30' 06"W, at the very top of the hill where the pipeline turns west towards well B-08, the trench exhibits subsidence for approximately 50 metres, where the pipeline crossed the winter road.

Additional Mitigation Required - Backfilling would be required at this location to correct this issue. Disturbed areas will be seeded with the approved mixture once the area is stabilized.

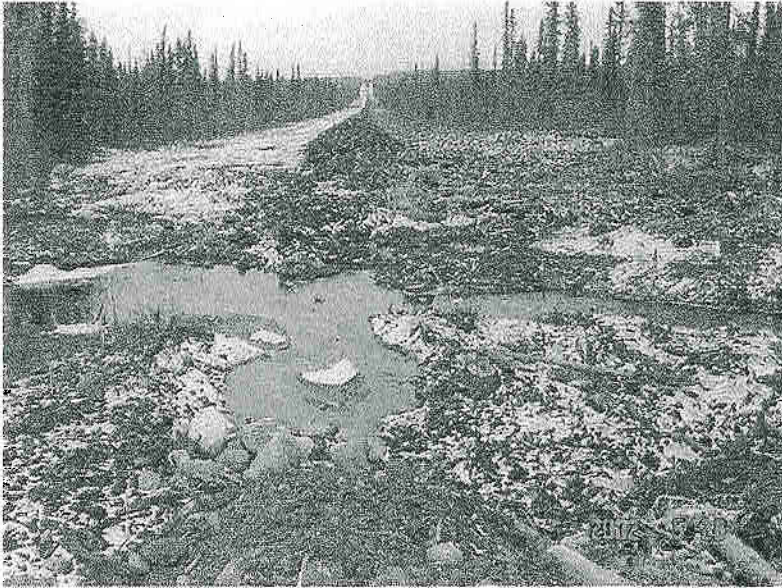
Area H

Issue - At creek crossing GSC 20, located at 60° 09' 22"N and 117° 37' 00"W, water is flowing out of a muskeg to the east and enters the ROW above the creek. This water is then flowing down the pipeline and into the creek. During the initial pipeline construction, a spring was noted at the base of the hill when the trench was being excavated. A foam ditch block was constructed, and a diversion berm was installed to divert the water from the trench. Neither of these has arrested the erosion.

Additional Mitigation Required - Permanent mitigative measures include diversion of the small drainages over the trench and installing a permanent ditch block and diversion berm to prevent water from flowing down the trench line. Disturbed areas will be seeded with the approved mixture once the area is stabilized.

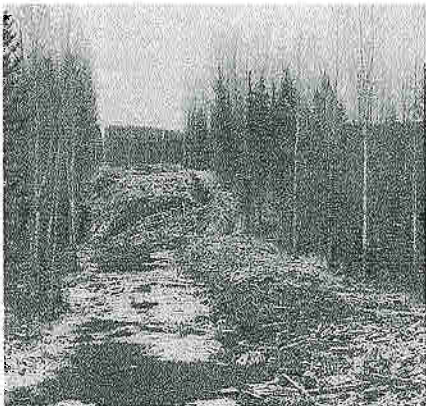
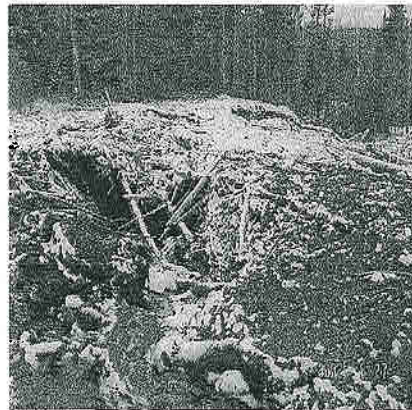
Area I

Issue - This area is located at 60° 09' 23"N and 117° 37' 56"W, which is east of the Cameron River quad bridge near C-50. To the east of this location, water is draining from the muskeg on the south side of the ROW and enters the ROW. The water then crosses the trench and flows to the southwest along the north side of the ROW before entering the ditch at the top of the hill that leads down to the river. The water then flows along the trench, which has resulted in erosion of portions of the hill. At the base of the hill the water enters a natural drainage which parallels the river for approximately 50 metres before entering the Cameron River. Eroded material has been deposited in this drainage area prior to reaching the Cameron River.

Action Taken - Initial mitigative measure conducted, included the construction of two temporary berms along the ROW to divert the water into the adjacent timber. Also, two silt fences were established in the drainage at the base of the hill to slow and pool water before entering the river.

Additional Mitigation Required - Additional measures required would be the construction of a permanent ditch block at the location where the water enters the ROW and a permanent diversion berm to direct the water down the natural channel. Also, the hill will need to be re-contoured to a stable condition, and seeded with the approved mixture.

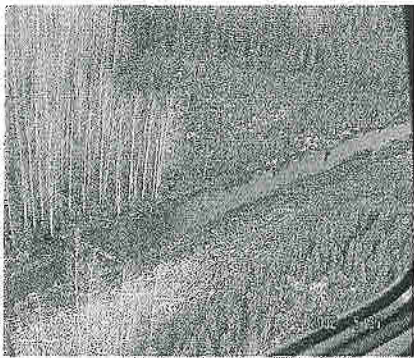
Water flowing towards Cameron River

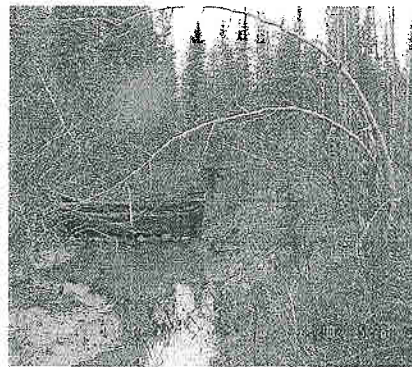
Silt fences installed below hill

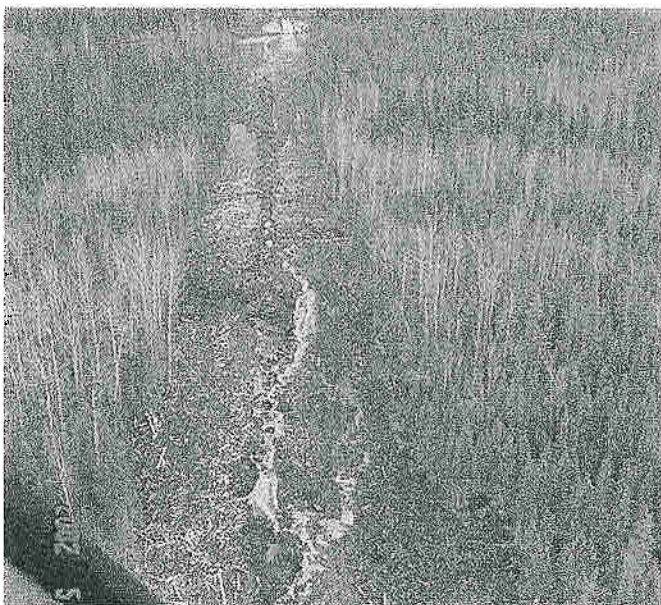
Area J

Issue - This area is located at creek crossing GSC 24 (A-73 quad bridge) at 60° 11' 42"N and 117° 42' 52"W. On the north hill (i.e., south-facing slope) before the bridge there is water entering the ROW from the east. This water then flows along the trench for approximately 100 metres before exiting and flowing off the ROW to the west. Limited erosion has resulted at this location.

Additional Mitigation Required - Additional work required would be to establish a permanent diversion berm to direct this water across the ROW and into the vegetated, stable areas adjacent to the ROW. Once stabilized the area would be seeded with the approved mixture.
