NEB Files: 3400-P097-1 & 2620-D-4-7

Re: Cameron Hills Gas Pipeline approved under National Energy Board Order XO-P097-02-2002 as amended

**Environmental Assessment and Remediation Plan
For the Erosion Issues at the Paramount Resources Ltd.
Cameron Hills Gathering System and Transborder Pipeline**

August 7, 2002

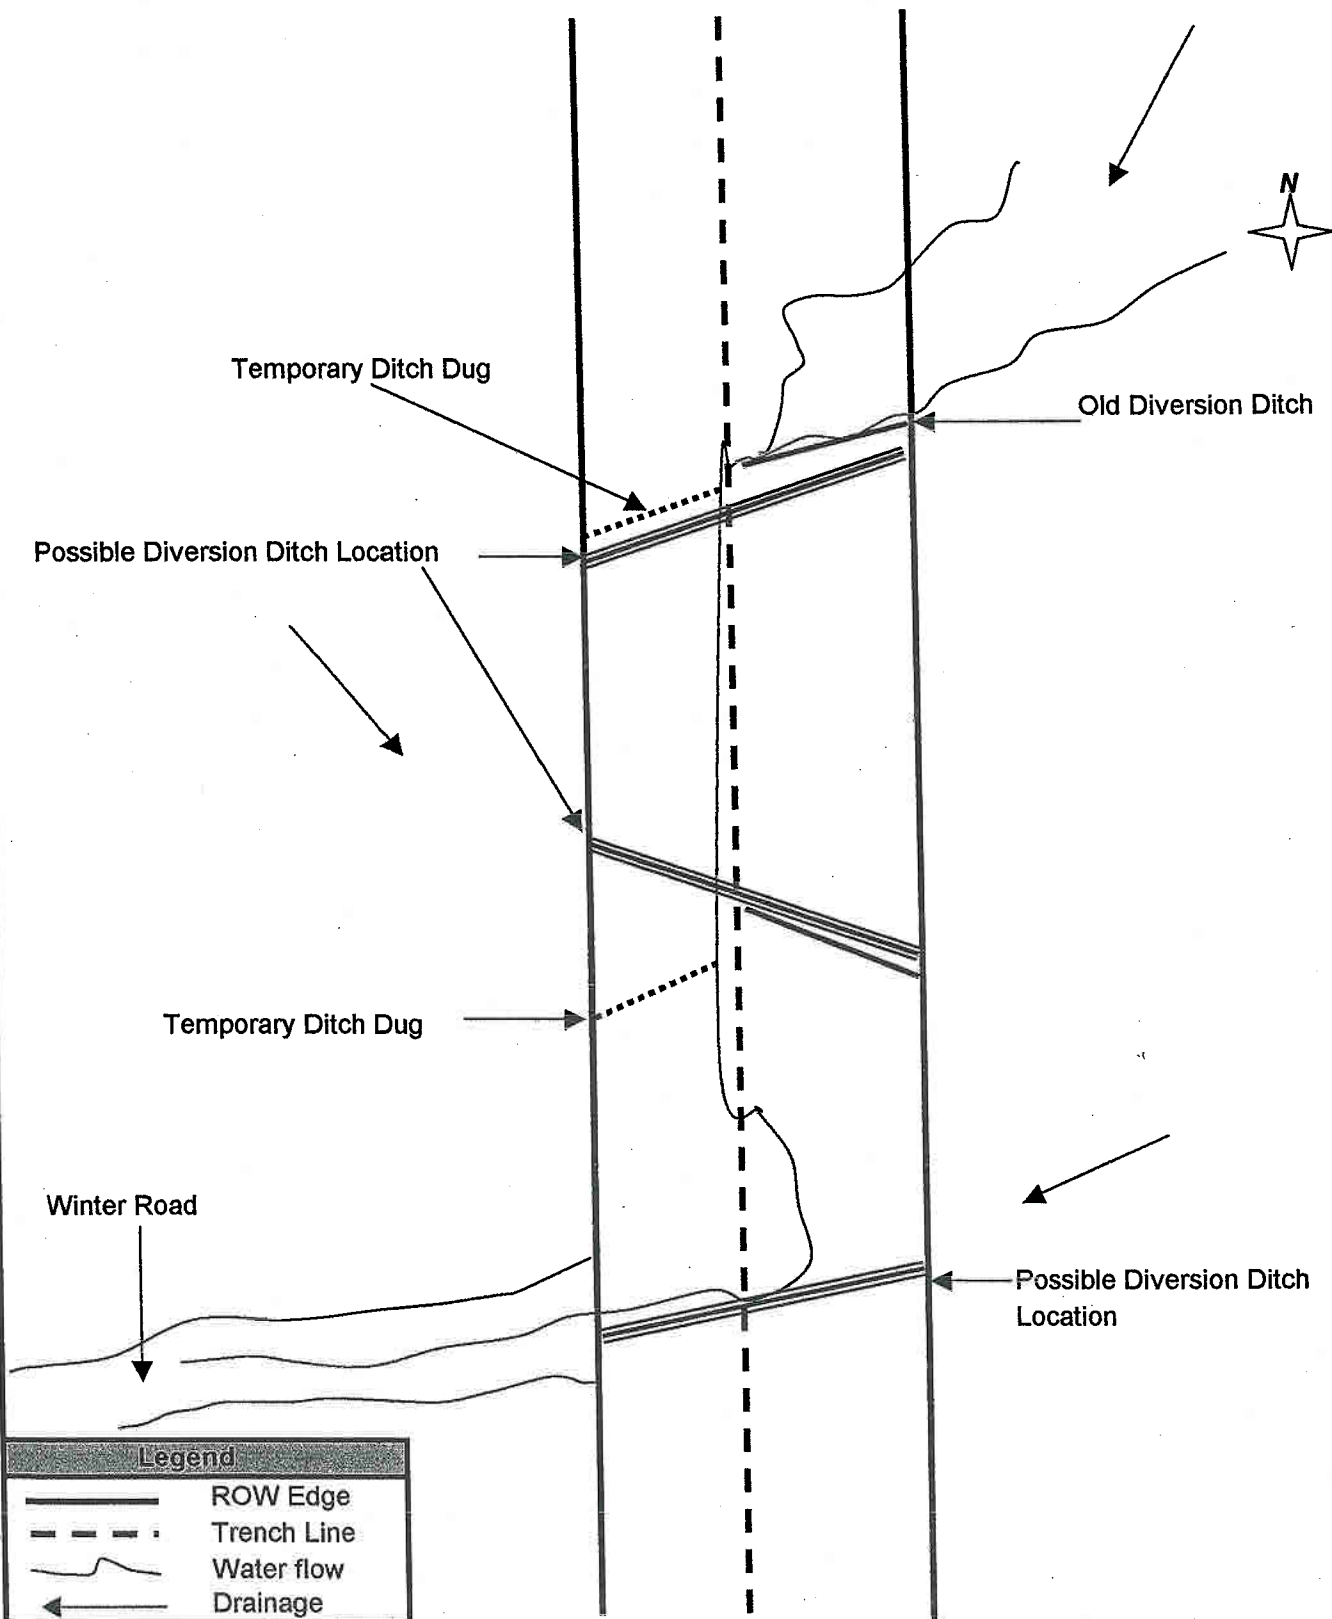
**Figure 4: Area 3
Transborder Pipe Line
Cameron Hills, NWT**

Issue: Water was entering the ROW from a muskeg drainage located east of the ROW. The water entered the trench, flowed along roach and the trench to the south for approximately 250 metres (Figure 4). At this point the water exited the trench and flowed off the ROW. Further down gradient to the south, an old diversion ditch brought water onto the ROW and to the trench. Still further down gradient there was an old diversion ditch that could have taken water from the trench and off the ROW, but it had been blocked by roach material. Minimal erosion has occurred at this location, but some ditch cover has been removed from a ten metre section of the ROW where the water exited the trench.

existing trenches or adding new ones. A short section of the trench at the bottom of the slope will be backfilled as required to repair the eroded ditch (Figure 4). If natural revegetation is not occurring at this location, the area will be seeded with the approved seed mixture and fertilized

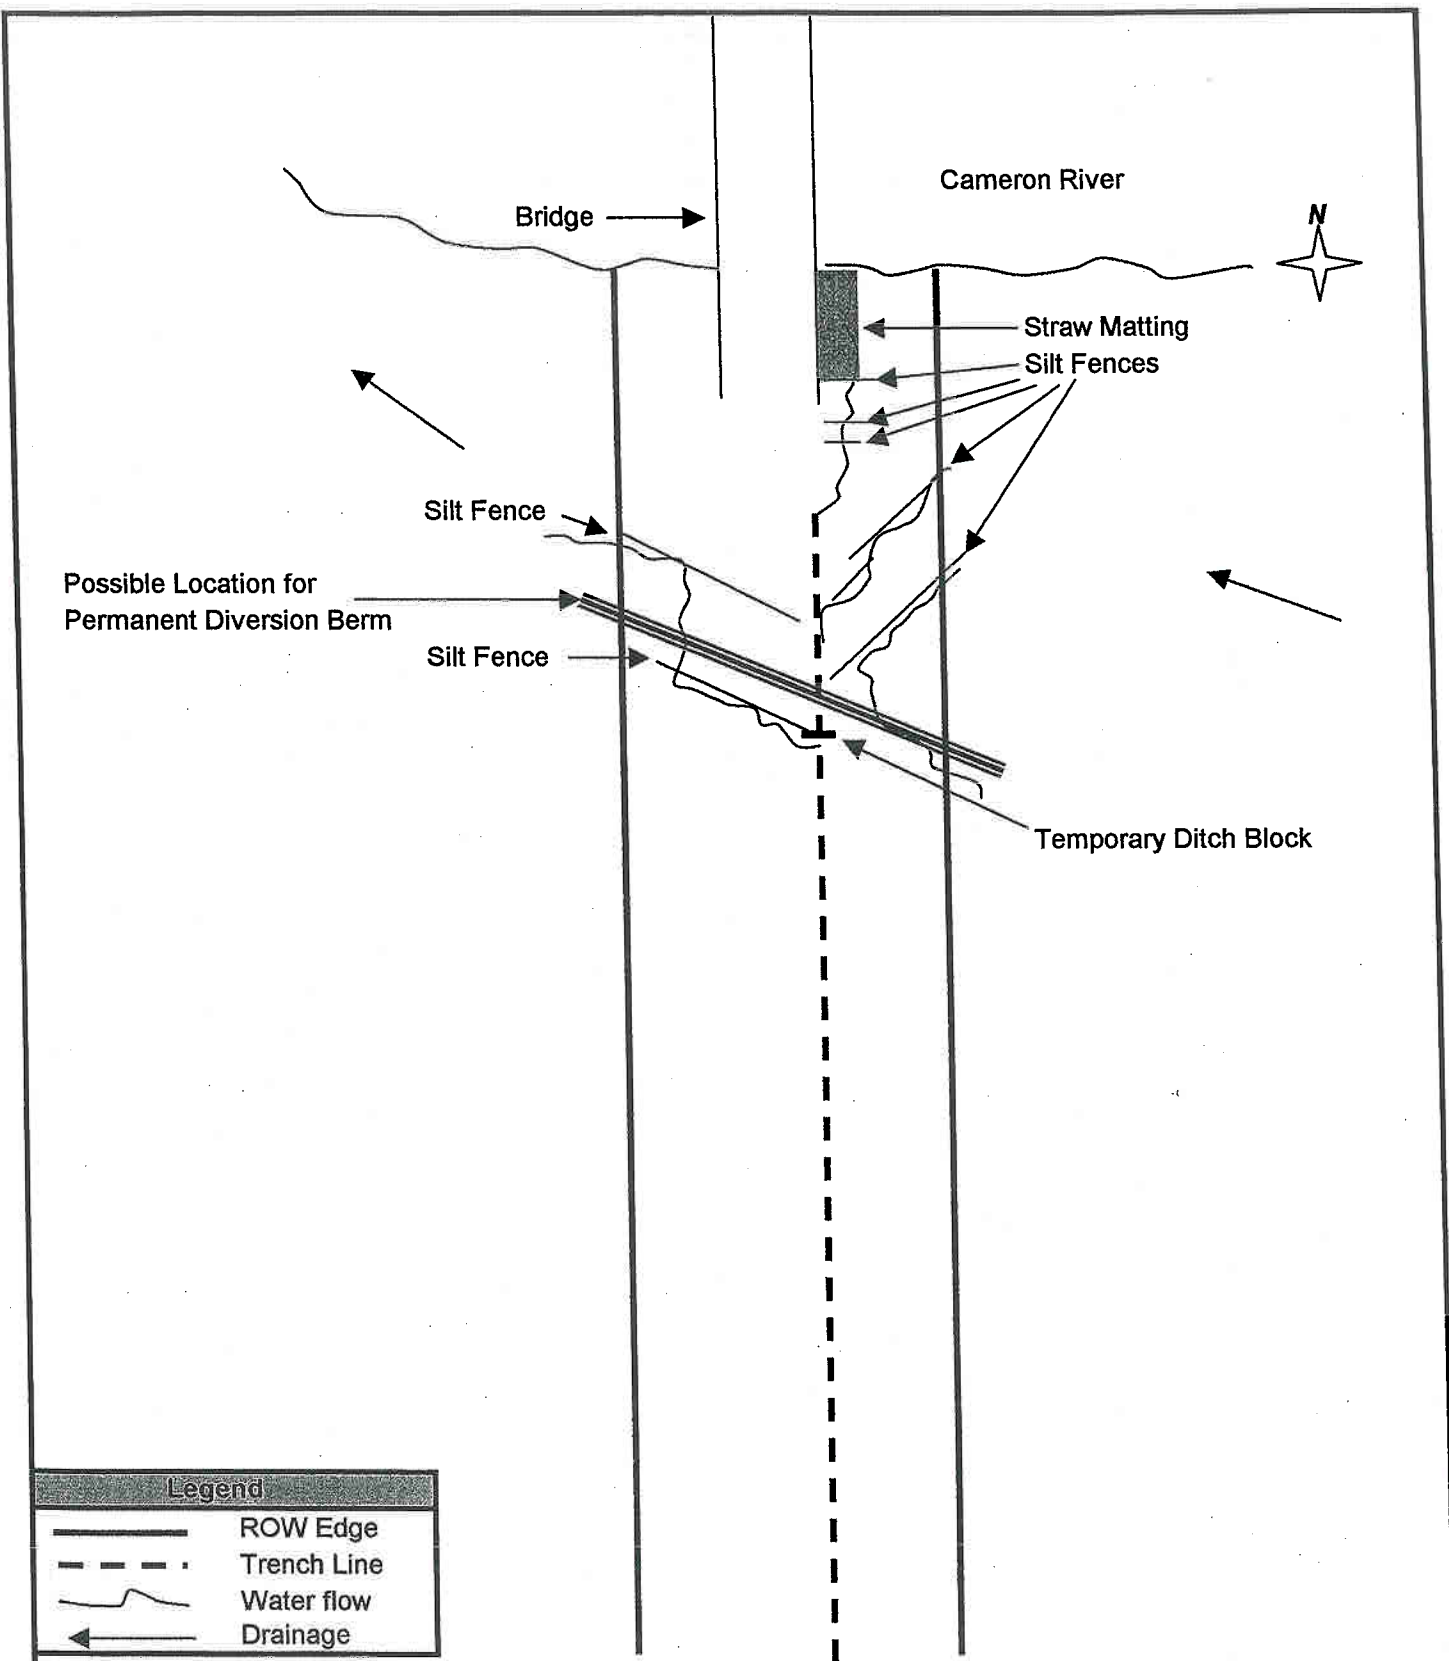
Figure 9: Area D
Gathering System Pipe Line
Cameron Hills, NWT

Issue: Water was flowing from the point where the pipeline exits the ground and goes up onto the vehicle bridge. From here, the water flowed down the slope and into the Cameron River. Limited erosion has occurred between the water exit point from the trench and the bank of the Cameron River.

Temporary Work Completed: Three silt fences were initially erected between the Cameron River and the point where the water exited the pipeline ditch. Two additional silt fences were installed to direct the flowing water on the ROW into stable, vegetated areas adjacent to the ROW. Sandbags were then used to construct a temporary ditch block at the up slope location where water also exited the ditch. Two silt fences were erected to divert this water to the west and off the ROW. A silt fence was also established on the east side of the ROW to divert any additional water to the standing timber adjacent to the ROW. Straw matting was laid down and secured, from the most northerly silt fence and extended to the edge of the Cameron River to provide additional protection for the river bank.

Proposed Long Term Remediation: The temporary work that was completed will be monitored and maintained. A permanent ditch block will be installed directly above this area and permanent diversion berms constructed to divert water off the ROW (Figure 9). The surface erosion located to the east of the vehicle bridge approach will be repaired. The ROW and approach leading down to the river will be stabilized by seeding with the approved seed mixture and fertilized.

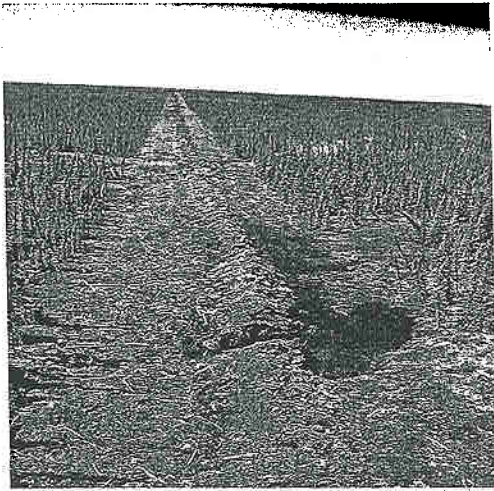
Area 1, facing south

Issue: This is a muskeg area which is relatively flat that drains from east to west. Water was entering the ROW from two seasonal drainages located approximately 100 metres apart. Water flow in both drainages was to the west. The water from the south drainage entered the ROW and then flowed through an opening constructed in the roach, across and then off the ROW to the west. Minimal erosion was noted at the south drainage crossing area. The water flow in the north drainage entered the ROW and was blocked by the roach, which forced the water to enter the trench. The water then flowed to the south within the trench and eventually exited the trench at the south drainage crossing. Erosion concerns and loss of ditch cover were determined to be minimal at this location.

Temporary Work Completed: The roach was opened up with hand tools to allow the majority of the water at the north drainage to cross the trench and exit the ROW in a temporary shallow trench. No work was completed on the south drainage.

Proposed Long Term Remediation: This area will be monitored over the course of the summer and the settlement in the trench will be evaluated. Paramount proposes to construct a permanent crossing for the north drainage to reestablish the natural channel with a drainage ditch/berm (see

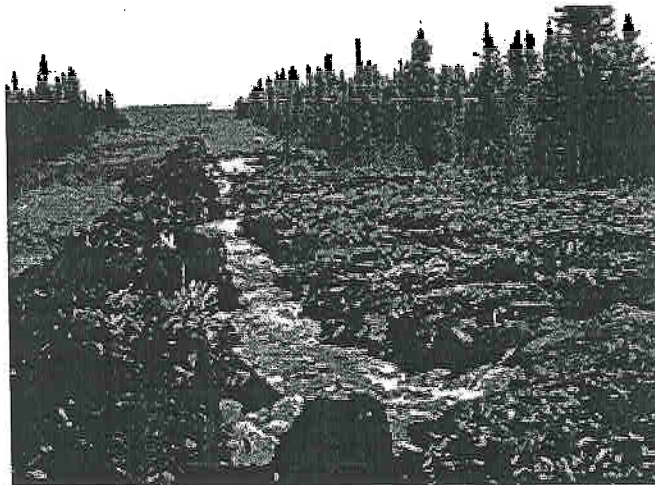
Area A, facing north

Issue: A small, seasonal drainage was flowing onto the ROW from the east (Figure 6). The drainage flowed next to the ditch line for approximately 150 metres, at which point the water flowed over the roach and then back again, all within the natural channel. The drainage then flowed off the ROW to the east, still within its natural channel.

Proposed Long Term Remediation: The area will be monitored during the 2002 summer to ensure that the water does not enter the ditch and remove additional ditch cover. The area will be evaluated when the ditch cover has settled to determine if additional work is required. Construction of a permanent diversion trench/berm over the entire ROW may be required. Areas disturbed by remedial construction will be seeded with the approved seed mixture and fertilized as appropriate to promote stability.

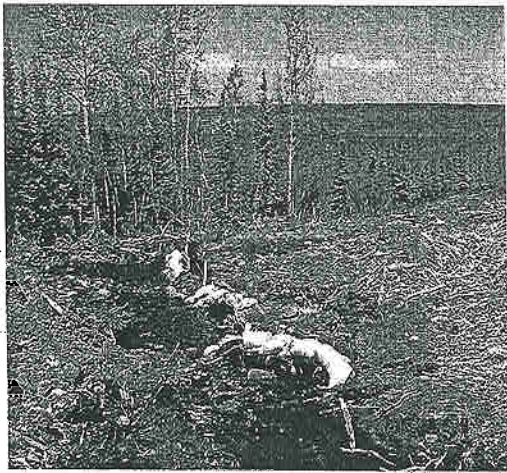
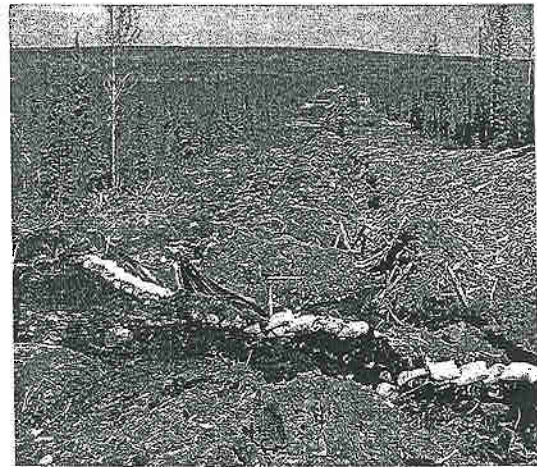
Issue: The GSC-16 drainage enters the ROW from the east within its natural channel (Figure 7). The water failed to cross the roach where a water diversion break was installed, but instead, followed the roach for a short distance and entered the trench. The water flow caused extensive erosion for approximately 200 metres, removing the majority of ditch cover and exposed portions of the pipe. The water then exited the trench and entered a muskeg on the west side of the ROW. The eroded soil was deposited in this area.

Temporary Work Completed: Initially, the water from GSC-16 was prevented from entering the trench by using local material and diverted on the ROW where it flowed down the slope approximately 30 metres and exited off the ROW into the surrounding timber. Later, sand bags were flown in and the ditch plug was strengthened and a temporary diversion berm was constructed to maintain GSC-16 within its natural channel and prevent water from entering the trench.

Proposed Long Term Remediation: The temporary work completed will be monitored to ensure that the ditch plug remains in place. The need for additional sand bags to create a more permanent plug will be evaluated when the remaining material in the trench settles. To ensure diversion of the water off the ROW, a permanent diversion trench/berm will be constructed to

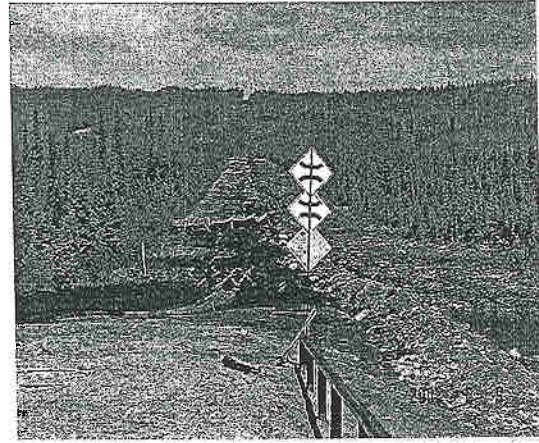
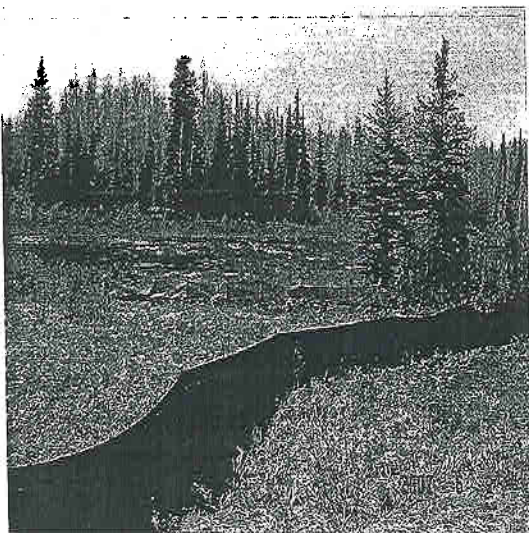
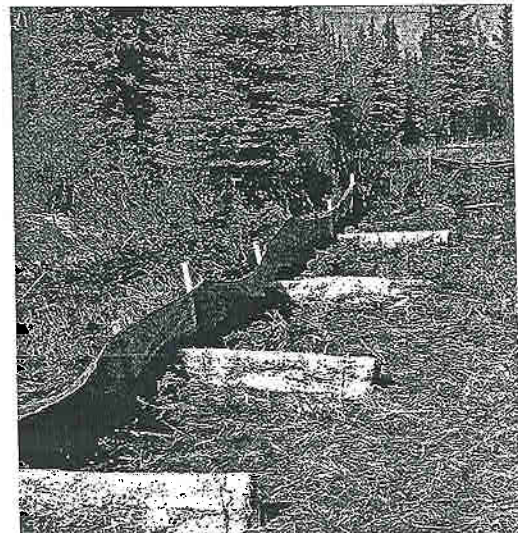
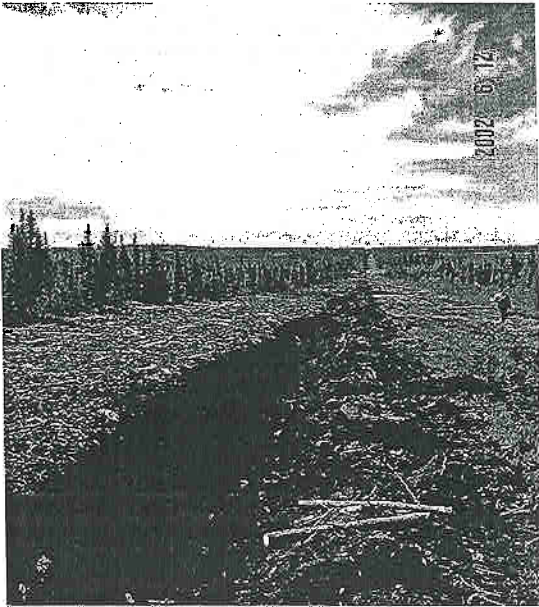
Issues: Water from a drainage area (GSC-29) entered the ROW from the west. There were also several small muskeg drainages bringing water from the east onto the ROW and subsequently into the ditch. Erosion has resulted in removing a substantial amount of the ditch cover and exposed the pipe in places. The eroded soil was carried down slope to a point where the water left the trench and off the ROW to the west (Figure 10). The majority of the soil was deposited in a muskeg area, near the bank of the Cameron River. In addition, there are two old diversion berms which brought water onto the ROW and into the trench.

Temporary Work Completed: Initially silt fences were installed up slope to intercept the water that was entering the ROW from the west, and down slope at the location where water was exiting the eroded trench and flowing toward the Cameron River. The up slope fence resulted in the majority of the water being directed off the ROW, to the west and into a muskeg area. A second silt fence was installed up slope to help divert water off the ROW. Two silt fences were installed at the down slope location where the water left the trench and flowed toward the Cameron River. An additional silt fence was installed at the down slope location to provide additional protection from runoff potentially entering the Cameron River.

Proposed Long Term Remediation: The temporary measures will be monitored and maintained. A permanent ditch plug and diversion berms will be installed on the slope. The eroded soils at the base of the slope will be stabilized by seeding and fertilizing. The exposed pipe and the eroded trench will be backfilled, seeded and fertilized (Figure 10).

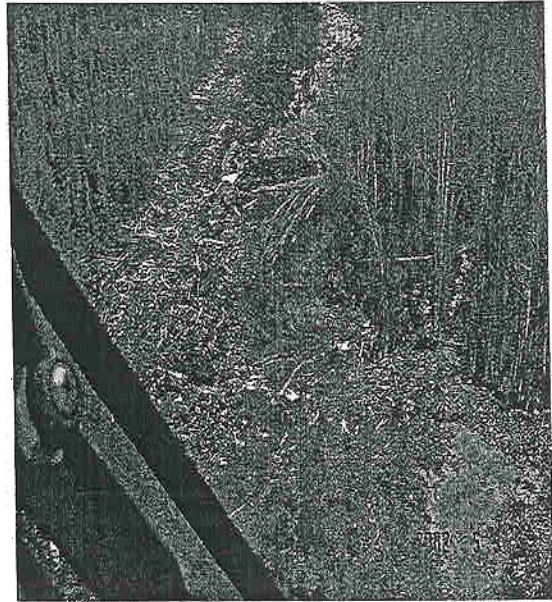
Area F, facing southeast

Issue: GSC-29 consisted of two small drainage channels that entered the ROW from the north at this location (Figure 11). One of the channels entered the ditch and flowed down the ditch line a short distance before exiting the trench. The water then flowed along the ROW to the southwest, to a point where an old diversion berm diverted the water back into the trench. From here, the water flowed down towards Area E causing erosion and the removal of some of the ditch cover.

Temporary Work Carried Out: The one creek channel was diverted above the ROW, which eliminated the downstream problems from continuing.

Long Term Remediation Plans: The temporary creek diversion will be monitored and maintained over the 2002 summer. This diversion will be made permanent by adding sand bags. The diversion berm constructed in March, 2002 will be evaluated, and a determination will be made as to whether or not the berm needs to be expanded or additional berms installed. The eroded trench will be backfilled and the repaired areas seeded with the approved seed mixture and fertilized.

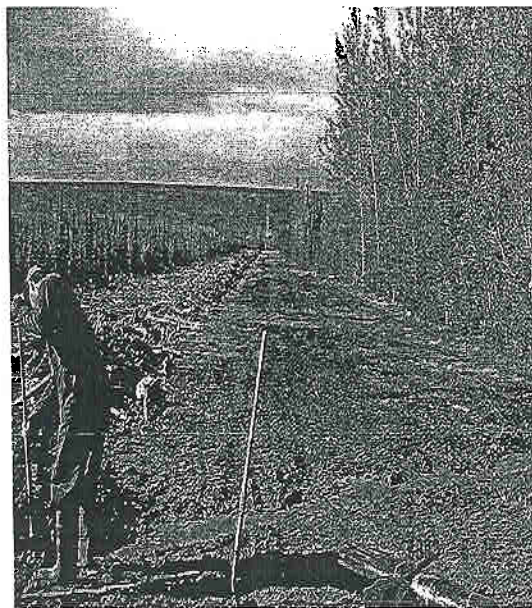
Area G, facing south

Issues: At the top of the hill where the ROW turns west there has been significant settling of the ditch and water entered the ditch from the north. Further down the slope, towards GSC-29, two old diversion berms directed water into the trench. Diversion berms constructed in March did not extend across the entire ROW.

Temporary Work Completed: Water was diverted from the ditch where it came to surface at two locations (Figure 12).

Proposed Long Term Remediation: The ditch area that has extensive settling and erosion will be backfilled. Paramount will determine if water has been (or still is) moving along the bottom of the ditch for most of the length of this slope. If water is moving along the bottom of the trench, ditch plugs and associated diversion berms will be installed along the slope as appropriate. The existing diversion berms will be extended across the entire ROW (Figure 12). The need for diversion ditches and/or berms to be located near the top of the slope to prevent water from entering the ditch will be determined, and constructed if deemed appropriate. After stabilization efforts have been completed, all disturbed or eroded areas will be seeded with the approved seed mixture and fertilized.

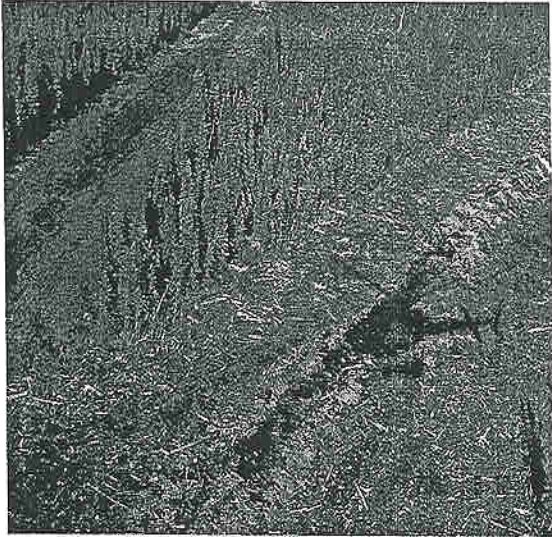
Area GG, facing east

Issue: There is runoff water from a small, intermittent drainage that entered the ROW from the north, and water has entered the trench and flowed down the ROW and onto the lease. The trench has settled in this area.

Proposed Long Term Remediation: The eroded ditch will be repaired and a permanent diversion berm will be constructed to permanently prevent the drainage from entering the ditch (Figure 13). Repaired areas within the ROW and lease will be seeded with the approved seed mixture and fertilized.

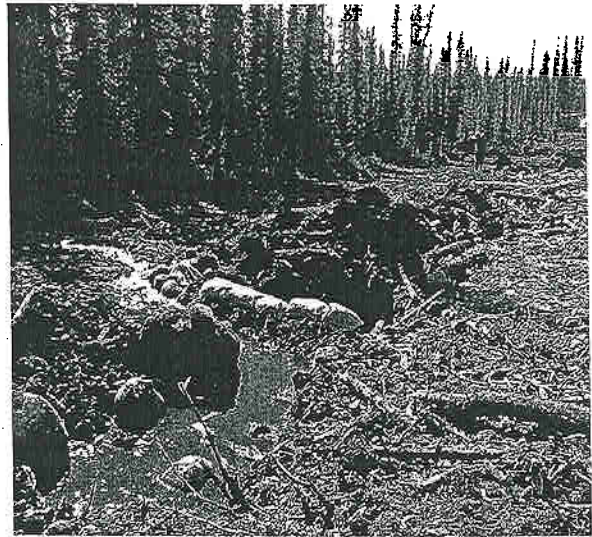
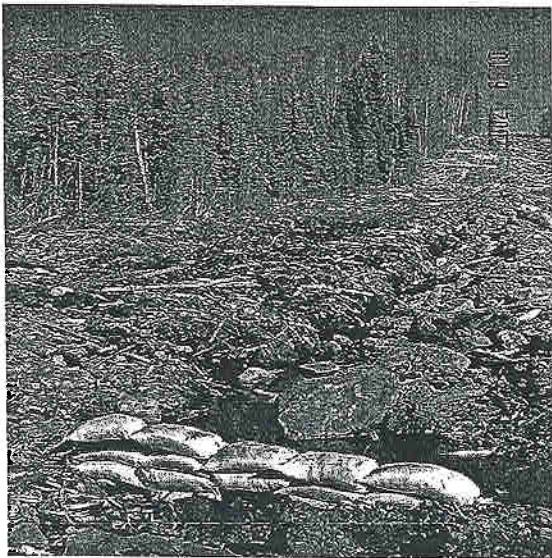
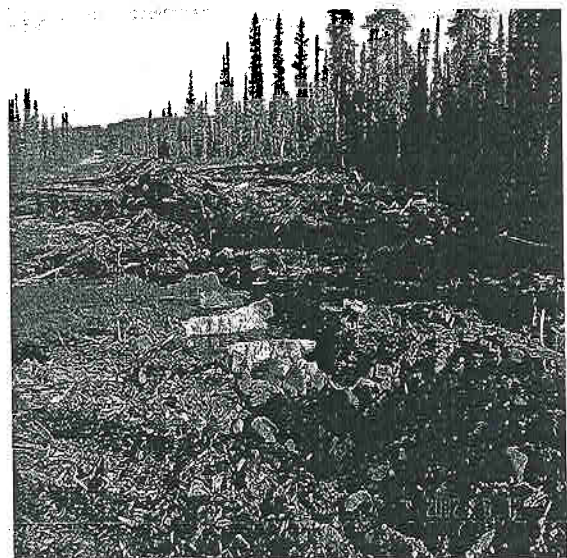
Issues: Water entered the ROW from a spring at the base of the hill and from surface runoff from the east along the length of the slope. The water entered the ditch and flowed down the slope for approximately 300 metres and into the GSC-20 drainage, causing silt to enter the drainage. At the top of the slope, a diversion ditch allowed water to enter the ditch.

Temporary Work Completed: A temporary ditch block was constructed by using local materials and sandbags at the point where the water was on surface along ditch line (Figure 14). This water was diverted to the west off the ROW. Silt barriers using straw matting were installed

Proposed Long Term Remediation: In March, 2002, a foam ditch block was installed to bring the spring that was noted to surface, but this has failed. The roach will be dug out when conditions allow and another ditch block installed to bring this water to surface. Permanent water diversion berms will be constructed to ensure that the surface water flows are directed off the ROW before entering the drainage (Figure 14). The diversion ditch located near the top of the slope will be repaired to prevent further entry of water into the ditch. The eroded ditch will be backfilled, and disturbed areas will be seeded with the appropriate seed mixture and fertilized.

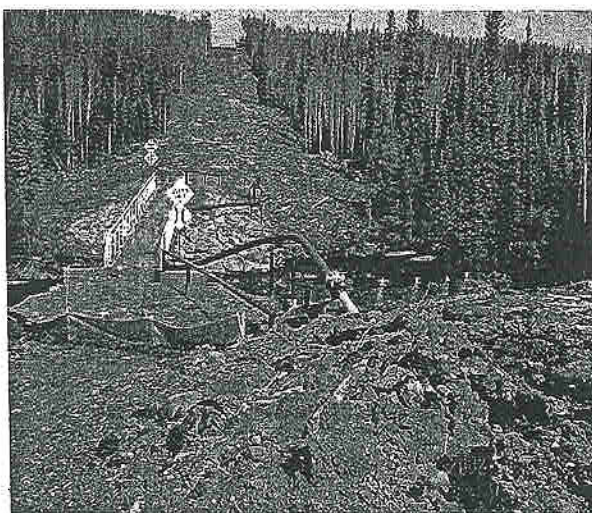
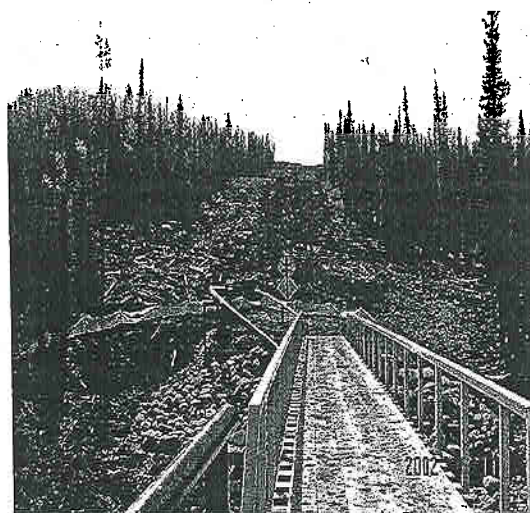
Issue: A small flow of water from a natural drainage was noted to enter the ditch approximately 110 metres up slope from the quad bridge, and then flowed out of the ditch where the pipeline comes to surface before going onto the bridge. Some erosion has occurred, as silt was noted near the bank of the tributary of the Cameron River (INAC identified the tributary as Herbal Creek). One of the diversion berms constructed in March, 2002 was directing water into the ditch.

16). The diversion berm that was directing water into the ditch was repaired.

Long Term Remediation Plans: Paramount will monitor and maintain the temporary measures. The eroded portion of the ditch and ROW will be repaired, as will the approach to the south end of the quad bridge. If required, an additional diversion berm will be installed at the bottom of the slope, below the point where the pipe exits the ground to proceed onto the quad bridge. The slope will be seeded with the approved seed mixture and fertilized to provide additional stability.

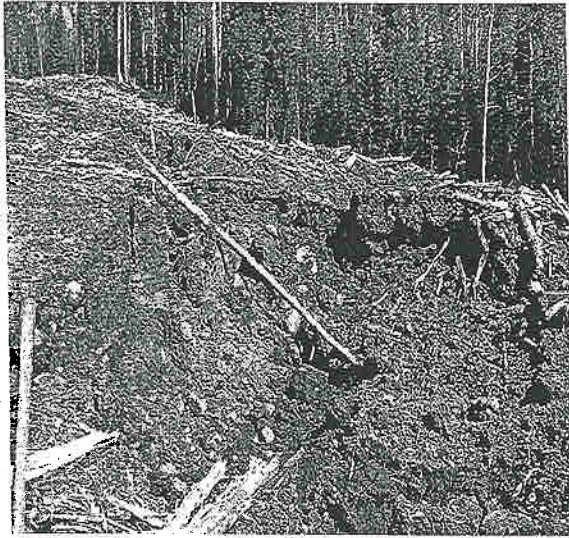
Issue: Water from a muskeg area at the very top of the hill flowed down the ROW to the crest of the hill, and then down the ditch line for approximately 100 metres (Figure 17). This caused erosion on the slope, and particularly on one, ten metre section of the ditch that exhibited exposed pipe and the destruction of a foam ditch plug. The water then exits the trench and follows a natural low lying area to exit the ROW to the east. Deposited soil is located on, and adjacent to, the ROW where the water exited the ROW.

Area J, erosion, facing east

Long Term Remediation Plans: Paramount will monitor and maintain the temporary measures. Permanent water diversion berms will be constructed at the crest of the hill and on the slope as required, with appropriate spacing (Figure 17). The areas that have been eroded will be backfilled and contoured, and damaged ditch plugs repaired. A silt fence will be erected down slope of the point where the pipe comes out of the trench by the bridge to prevent heavy rains from depositing silt into the creek. The ROW leading up the slope and the deposited soils at the base of the hill will be seeded with the approved seed mixture and fertilized.

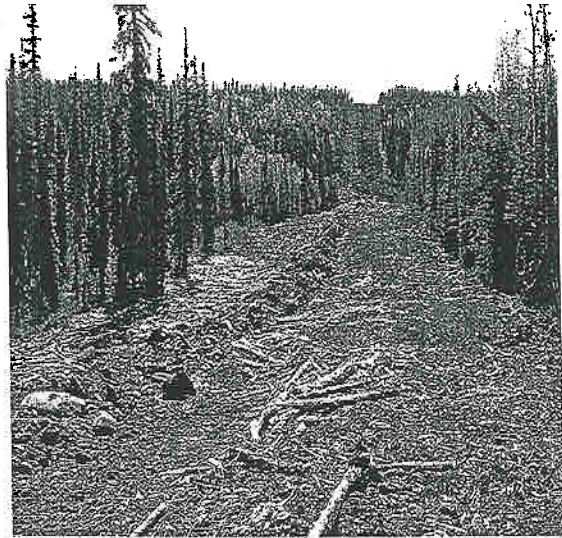
Area J, deposited soils, facing southeast
