DATE February 1, 2012**PROJECT No.** 09-1427-0006/20000/20100**TO** Dave Colbourne
DXB Projects / PWGSC**AECOM DOC. No.** 000-GEN-0-MEM-0006-Rev2_20120201**CC** Rudy Schmidtke, AECOM**GAL DOC. No.** 154**FROM** Darren Kennard**EMAIL** dkennard@golder.com**PUBLIC ACCESS CONTROLS ABOVE ARSENIC STOPE B2-08, GIANT MINE REMEDIATION PROJECT****1.0 B2-08 CROWN PILLAR STABILITY ASSESSMENT**

Project title/Titre du projet
**GIANT MINE
REMEDATION PROJECT
YELLOWKNIFE, N.W.T.**

POTENTIAL SURFACE SUBSIDENCE
ARSENIC STOPE B2-08,
RECOMMENDATION FOR FENCE
TO ADDRESS PUBLIC HAZARD

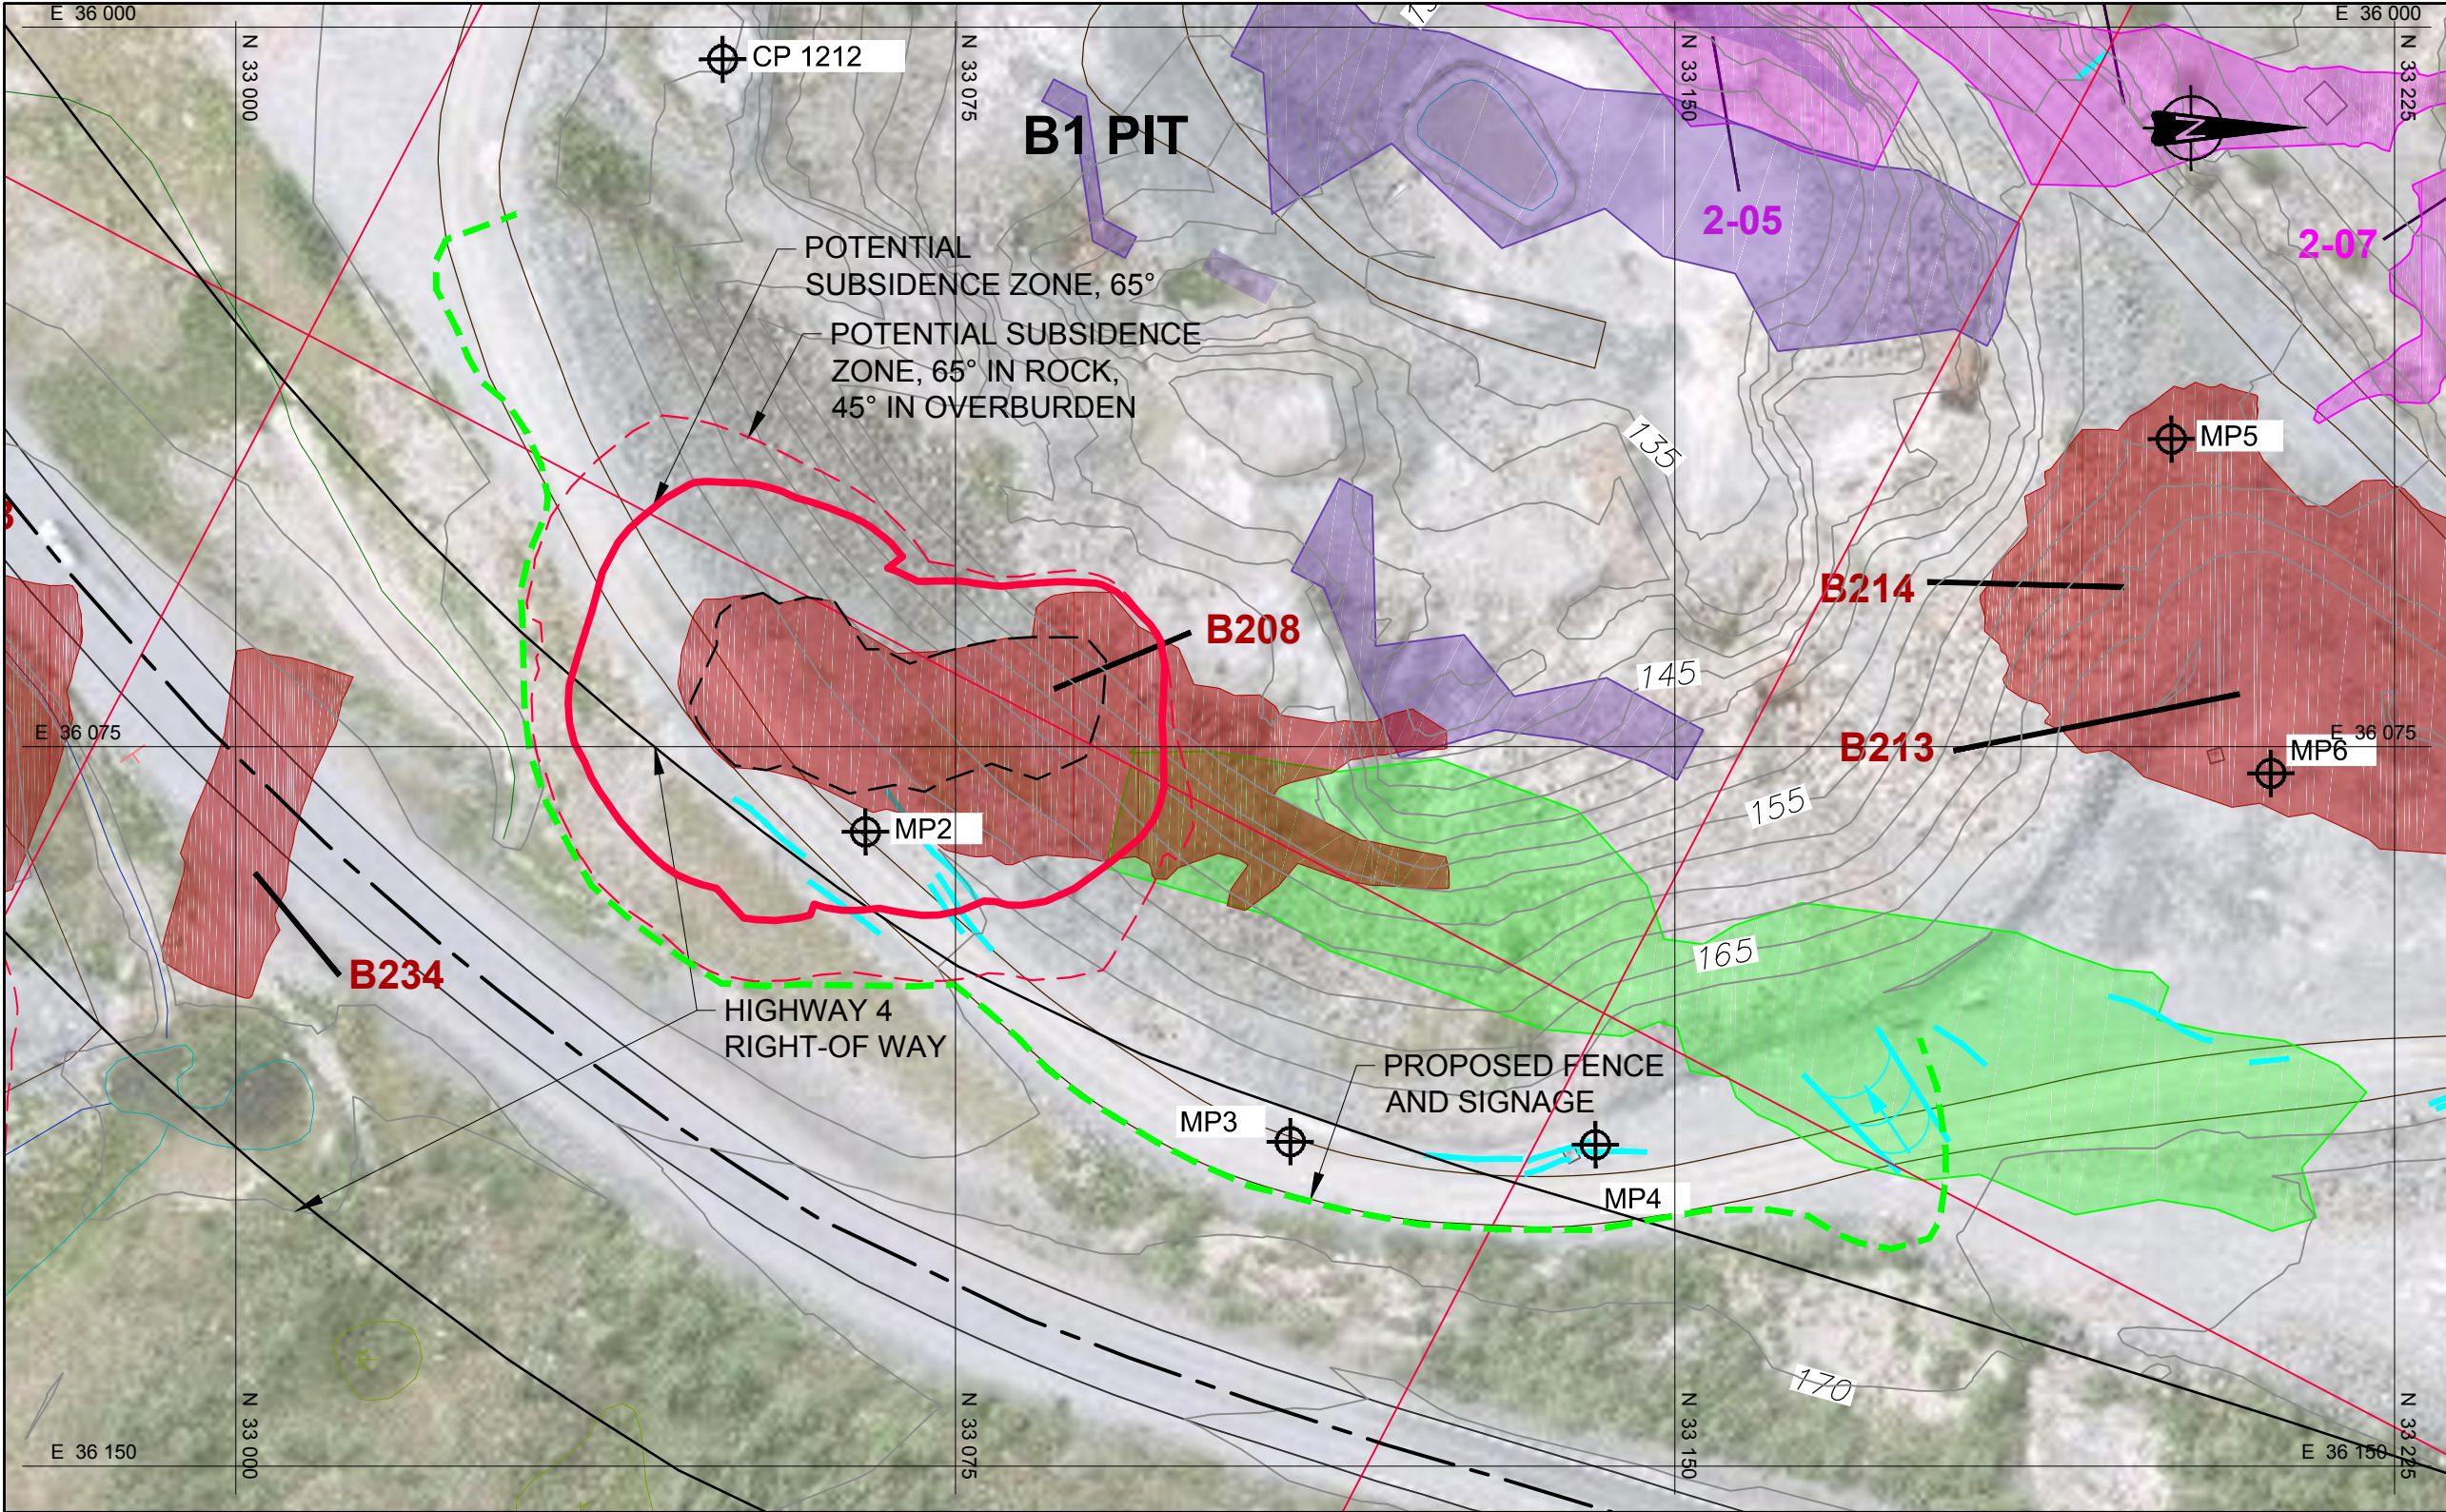
No obvious evidence of crown pillar failure has been observed near arsenic Stope B-208, but surface cracking on the mine access road situated at the crest of B1 open-pit has been observed and movement of existing monitoring points (see Figure 2) in the area has been measured. Although it has been postulated that the movement is associated with overburden soils moving towards B1 open-pit (Golder Document 051 and e-mail communication with PWGSC) the mechanism of this movement has not been fully investigated or confirmed.

A 10% probability of crown pillar failure would be considered relatively low for an active mine site but given that public access in the area of arsenic Stope B2-08 occurs, tension cracks have been observed in the area, and the slope above the stope may be moving, elevated prudence is warranted.

Any large scale crown pillar failure would be expected to manifest itself initially within the 65° perimeter with a gradual progression to the outer perimeter as the failure progressed in the overburden materials. Crown pillar failures can occur quickly and the current monitoring and reporting system is not sufficient to allow routine surface access in the area.

Golder recommends that public access to the area above arsenic Stope B2-08 be restricted as soon as practical. A typical solution could include erection of a fence between the portion of B1 open pit near arsenic Stope B2-08 and Highway 4 as shown in concept on Figure 2 (actual location to be confirmed in the field by AANDC).
