**DATE** May 26, 2011**PROJECT No.** 09-1427-0006/6000/6200**TO** Des O'Connor  
PWGSC**AECOM DOC. No.** 313-UG-13-MEM-0005-Rev1\_20110526**CC** Rudy Schmitke, AECOM**GAL DOC. No.** 060**FROM** Darren Kennard and John Hull**EMAIL** dkennard@golder.com; jhull@golder.com**OPINION ON THE STABILITY OF ARSENIC STOPE B2-12/13/14 AND SURFACE ACCESS CONTROLS**

PROJECT		GIANT MINE REMEDATION PROJECT YELLOWKNIFE, N.W.T.	
TITLE		<b>POTENTIAL SURFACE SUBSIDENCE LIMITS AND PRISM MONITORING POINTS</b>	
PROJECT No. 09-1427-0006	PHASE No. 6000/6200	DESIGN DTK 24-MAY-11	SCALE AS SHOWN REV. 0
CADD MP 24-MAY-11	CHECK DTK 25-MAY-11	<b>FIGURE 1</b>	
REVIEW DTK 25-MAY-11

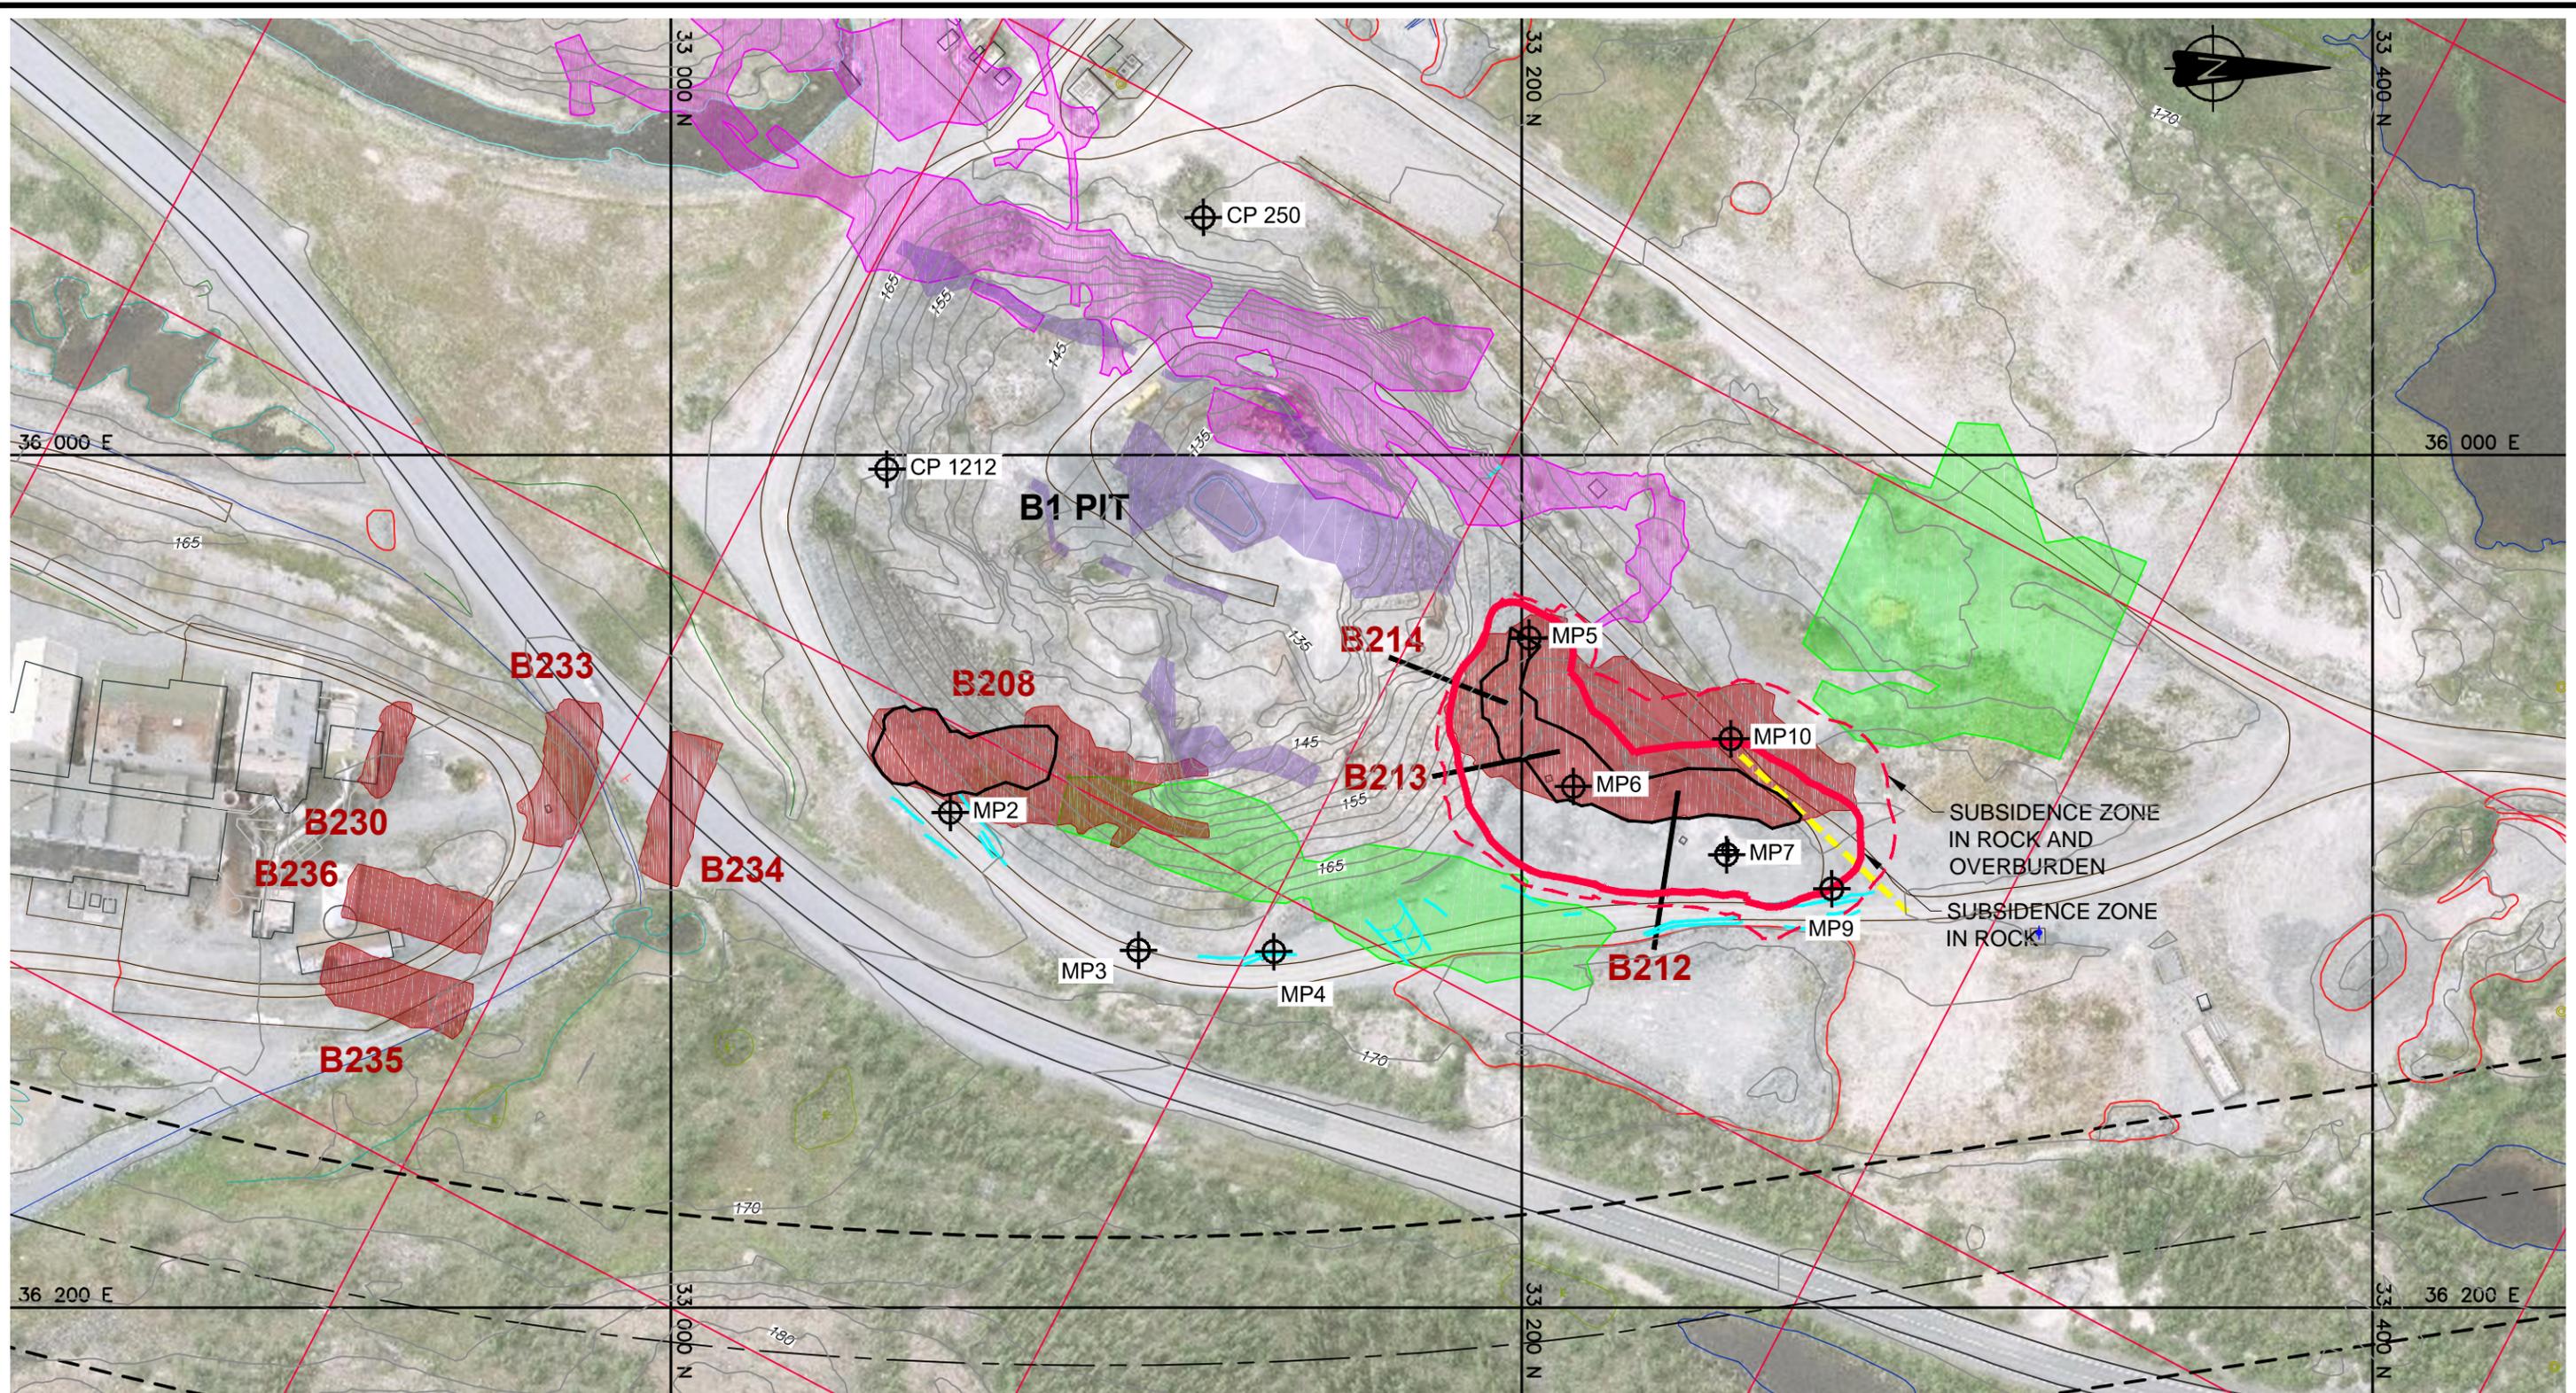
- Comparison of a level survey carried out on the B1 pit access road in 2011 and contours derived from air photos taken in 2003 suggests up to 1.0 m of subsidence within the zone outlined in Figure 1 over the last 8 years. This road is on soil backfill placed in the pit.

- Surface soil cracking has been observed well back from the crest of B1 pit that could be related to subsidence of the crown pillar. The location of the cracks is shown in Figure 1.

In order to understand the zone of impact of a potential crown pillar failure a subsidence zone was drawn from the top of the stope to surface using the following cave angles as shown in Figure 1:

- Dipping portion of the stope (B2-12/13):
  - 55° on the footwall (east) side
  - 75° on the hangingwall (west side)
- Vertical portion of the stope (B2-14):
  - 65° on all sides

Any initial failure of the rock in the crown pillar would likely quickly propagate to surface within this zone but with time the failure zone would expand in the surface overburden to a slope of approximately 45° as shown as a second surface subsidence perimeter in Figure 1.

Because the current monitoring system is subjected to freeze thaw effects and possible ice lens melting during the break-up period (early spring and late fall) the reliability of the system as an indicator of crown pillar stability is currently limited. Thus, Golder recommends that all vehicles stay off the area above B2-12/13/14 within the inner potential subsidence zone shown on Figure 1 until further notice. Foot access can be allowed if a procedure of thorough inspection for fresh and new cracking is carried out prior to access within this zone. Golder will provide further advice on access over the area outside the break-up period at a later date under but agrees with the current advice documented in INAC's Giant Mine Risk Registry item 5.2.2 which states that only light vehicles are allowed in B1 pit at all times so the care and maintenance contractor needs to be reminded of this.

Monitoring in addition to the current system is recommended to determine if the crown pillar is deforming, the extent of the deformation, and the movement mechanisms involved. This monitoring will be used to help plan the mitigation work and for assessment of both worker and public safety but as noted above it will not provide a fail-safe warning of impending failure. Golder can provide advice on additional geotechnical evaluation to help limit uncertainty in the predicted probability of failure of the crown pillar and a more sophisticated monitoring system if requested to do so.
