Conveyor gallery

Roaster Complex - Interior Highly Contaminated with Arsenic, Asbestos and other hazardous materials.

Roaster Complex - Continuously Deteriorating Increasing Risks of Exposure

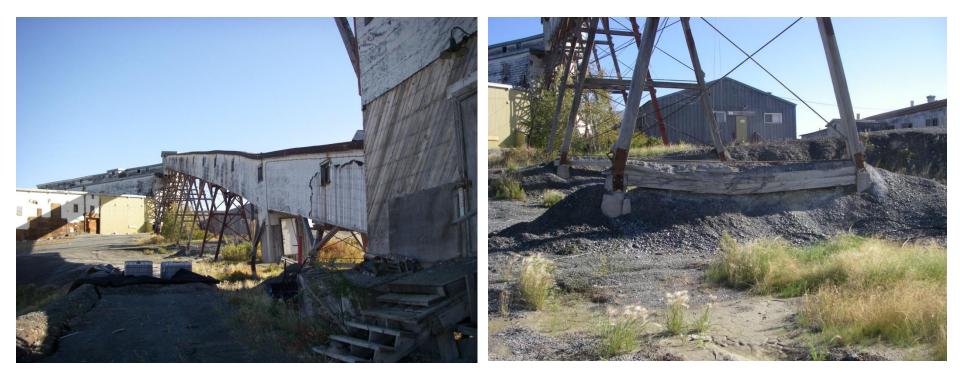
September 2011 – Uneven roof line indicates structure is moving

September 2011 – Damaged support frame and concrete support pier

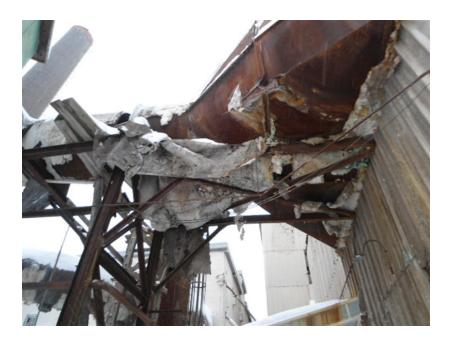
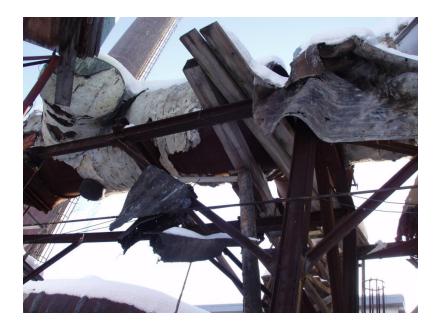
Contain arsenic trioxide and insulated with asbestos
Evidence of corrosion and weather damaged and risk of collapse

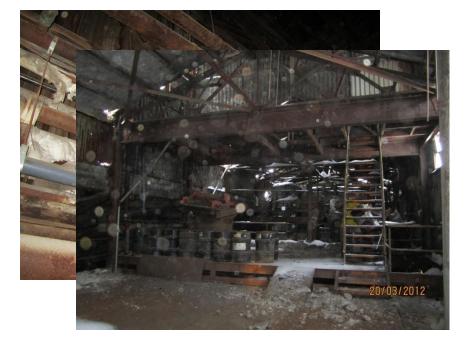
•Asbestos insulation in poor condition, fallen off on pipes, ceilings, etc.

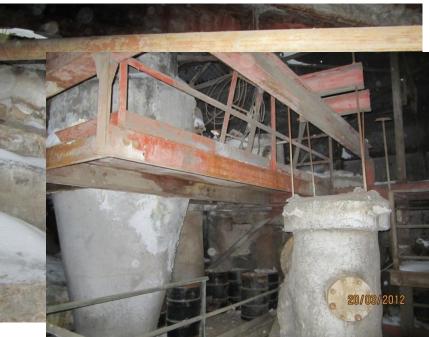
Abandoned duct network containing arsenic trioxide.

•Surfaces Contaminated with arsenic dust

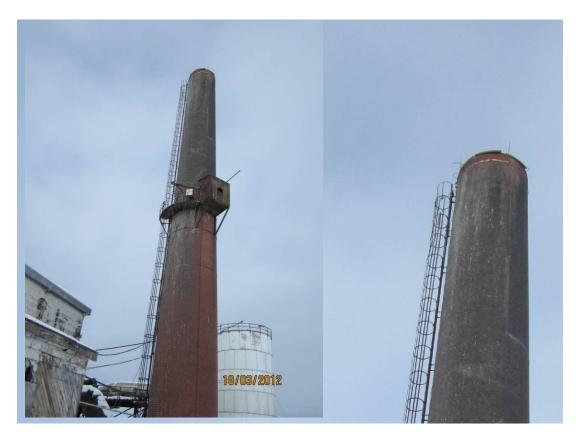
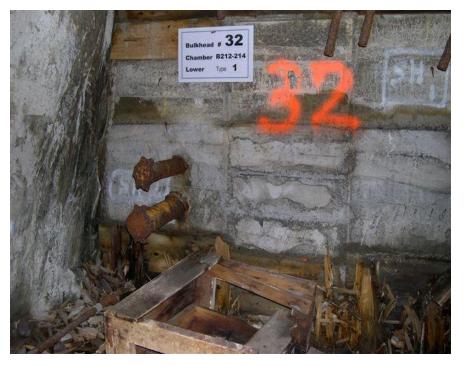
Roaster Stack

• Stack reported to contain ~14 tons of Arsenic Trioxide

• Deterioration and shifted steel plates at top of stack
