Site Visit Report

Mackenzie Valley Environmental Impact Review Board's visit

to the Prairie Creek Minesite

Distributed on July 28, 2009

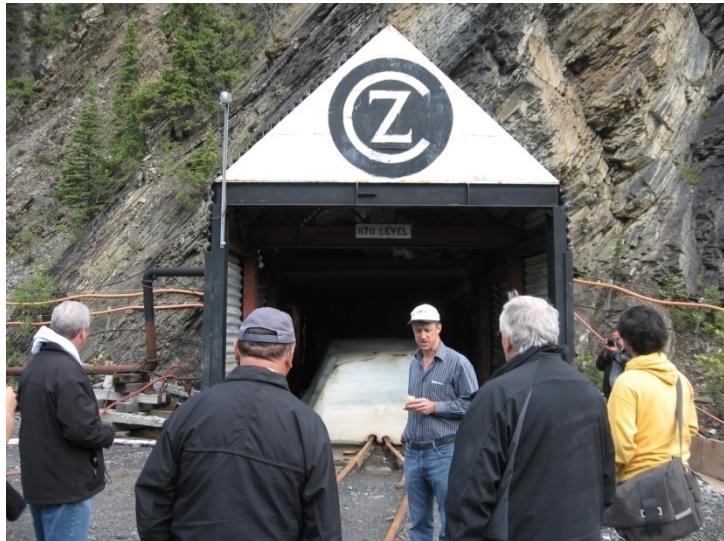
Photo 1: David Harpley describes mine operations at 870 m portal

The group began a walking tour of the minesite at the 870 m portal (Photo 1). A new portal to access underground workings during mine operations is proposed adjacent to this location. The proposed pathway for ore from the portal to the mill was described. David Harpley discussed current seasonal drainage from the portal, the existing water treatment plant and polishing pond for treated mine water. Ditching and seepage issues around the mill site were also described.

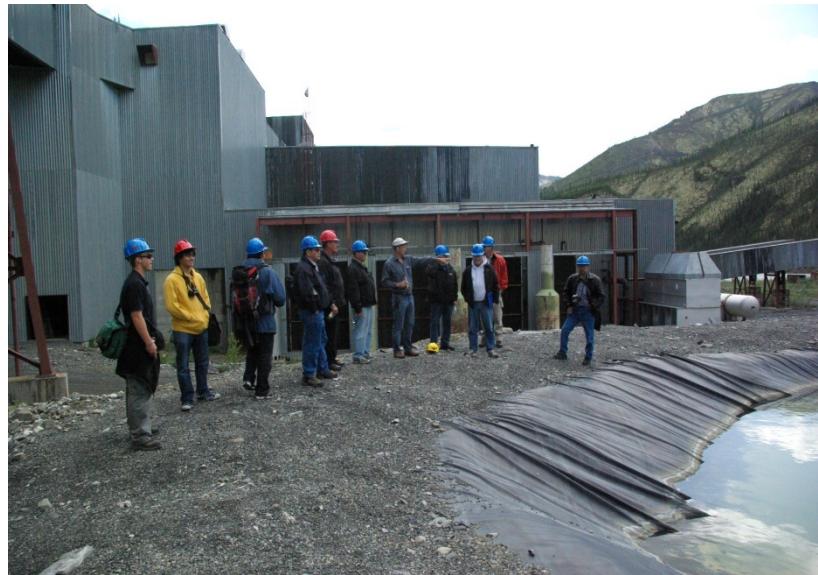
Photo 2: Group at polishing pond with mill in background

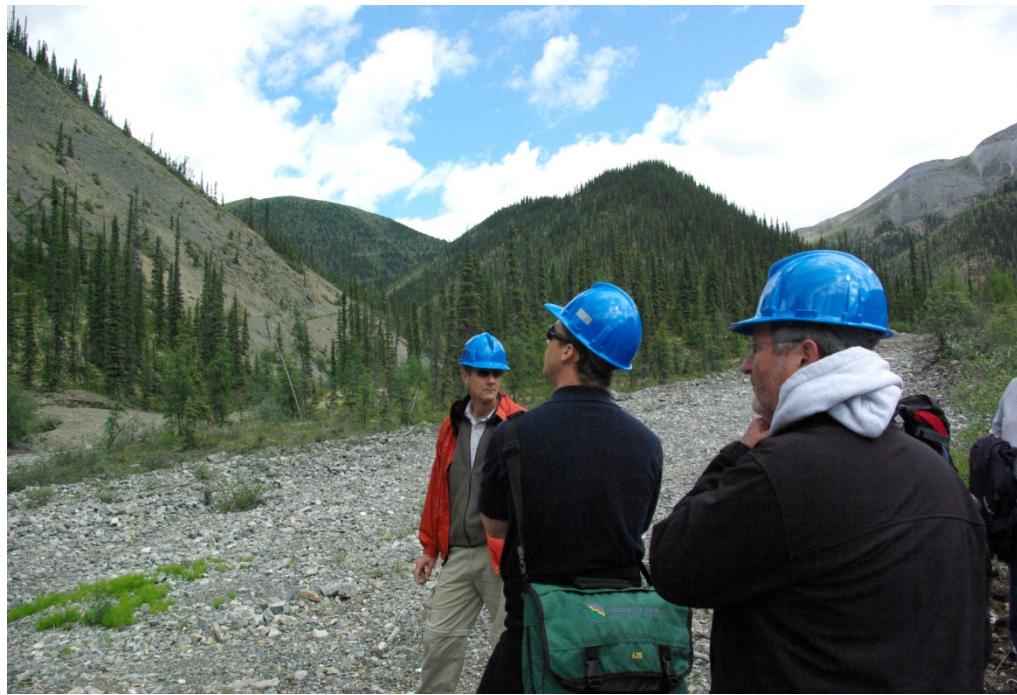
development of the waste rock pile is proposed (Photo 3). The tour continued to the water discharge location at Prairie Creek and along the flood protection dike where the existing sewage treatment plant and other mine facilities were viewed and discussed. Proposed modifications to the water storage pond and the location of the temporary tailings storage pad were also described by David Harpley.

Photo 3: Waste rock pile location in valley to left of photo
