Board Decision – Geotechnical Assessment of the Polishing Pond

TECHNICAL MEMORANDUM

TO: Alan Taylor, P.Geo. **DATE:** May 30, 2006
 Dave Harpley, P.Geo.
FROM: Dave Caughill, John Hull **JOB NO:** 06-1413-024.6000
EMAIL: Dave.caughill@golder.com
RE: **QUALITY CONTROL FOR CONSTRUCTION OF POLISHING
 POND, 2006 CONSTRUCTION SEASON**

Activity Report Relating to the
Construction of a Polishing Pond at the
Prairie Creek Minesite, Northwest Territories

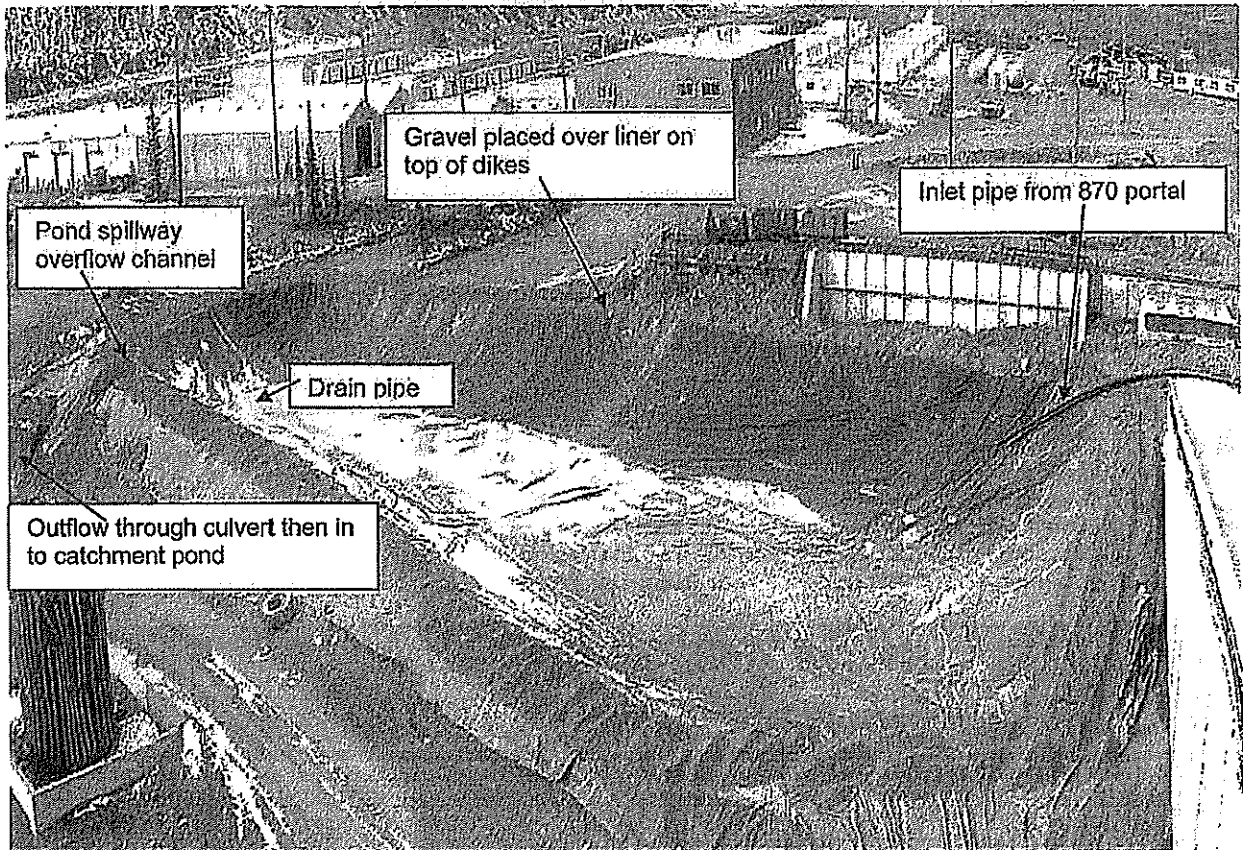
October 21

Photograph taken from the roof of the mill, conveyor into the mill is on the right side of picture. Tarp had partially been blown off by strong winds, temporarily held down by large tires. Remove tires and dig with back hoe 1 meter channel below top of dike in southwest corner of south wall for pond spillway drainage which reports to same culvert as the pipe draining the bottom of the pond. Place extra liner in channel and replace main tarp over area. Load, haul and dump 6 truck loads of gravel onto roads outside pond. Use CAT loader with bucket to carry gravel up and place on the crest of the dikes over top of liner to hold tarp down. Inlet pipes placed on the conveyor. Cold temperatures precludes any further work on the pond until Spring 2006.
