GAHCHO KUÉ PROJECT

2011 Shoreline and Channel Erosion Assessment

Submitted to:
De Beers Canada Inc.

Report Number: 11-1365-0001/DCN-048

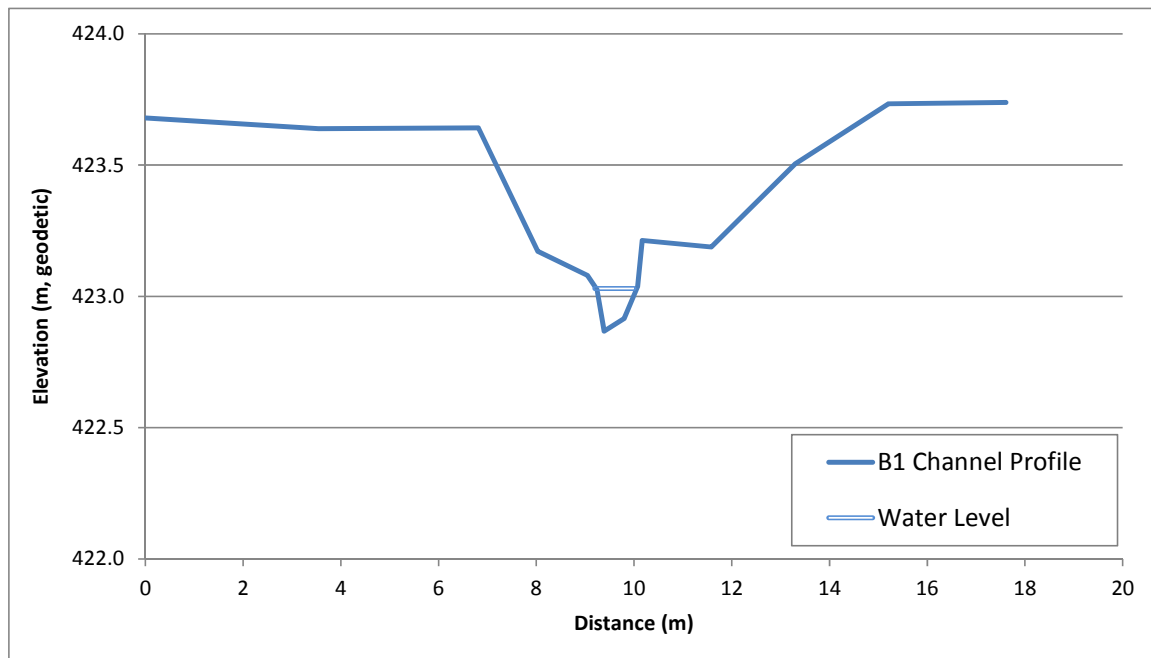
Figure 10: Lake B1 Outlet Channel Cross-Section

The outlet channel flows into Kennady Lake through relatively flat terrain, with surficial material of mixed bog and fen peat. Both banks of the channel have soils consisting of primarily organic materials with some cobbles and trace boulders that armour each bank. The channel is typically less than 1 m deep relative the surrounding terrain and varies in width between 1 and 2.5 m. The channel banks were observed to be a mixture of cobbles with boulders. Small nickpoints were observed where cobbles predominate within the channel along the longitudinal profile.

This channel is proposed to be diverted north-east to Lake N8 during mine operations phase. The newly created channel will be approximately 250 m long with an elevation drop of approximately 1.2 m and therefore a slope gradient of approximately 0.5%. The value is lower than the baseline slope gradient condition of 0.9% and is not expected to produce significant erosional effects along the proposed channel.

The new channel will flow across the same terrain type as the existing channel. It is recommended to recreate the same cobble armoured channel banks and bed channel, with small nickpoints.

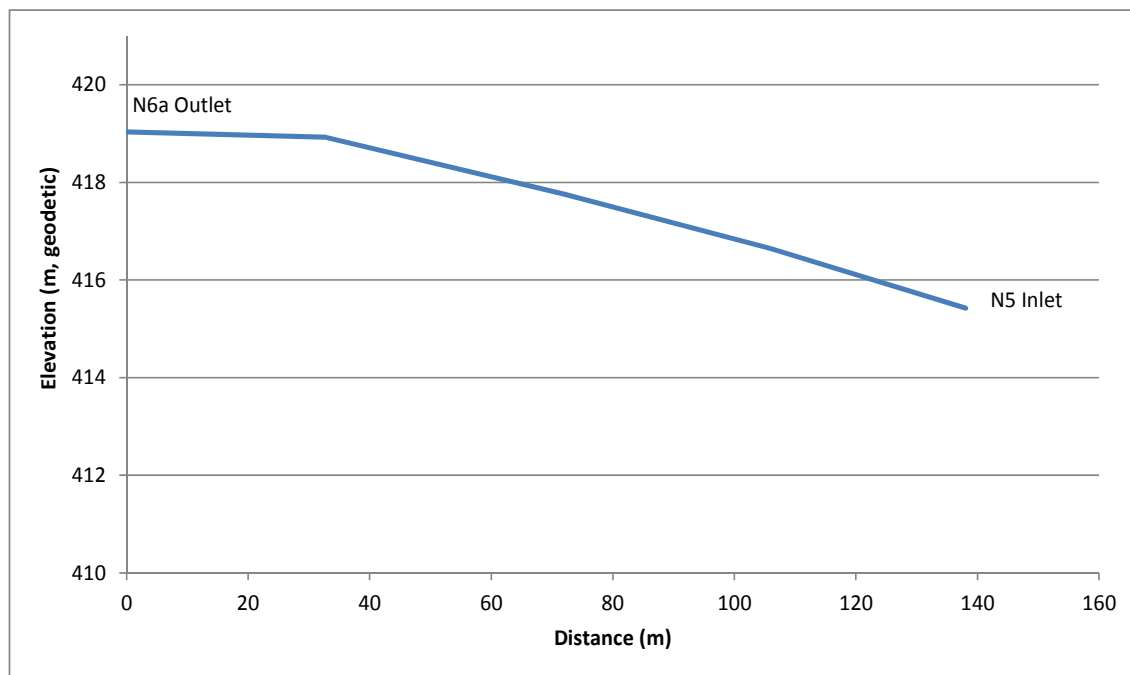
Figure 15: Longitudinal Profile along the Outlet Channel of Lake N6a

Because of its configuration and surficial materials, the N6a outlet channel is capable of conveying the slightly higher flows associated with the Lake B1 outlet diversion, with no additional mitigation necessary during the period with increased flows.

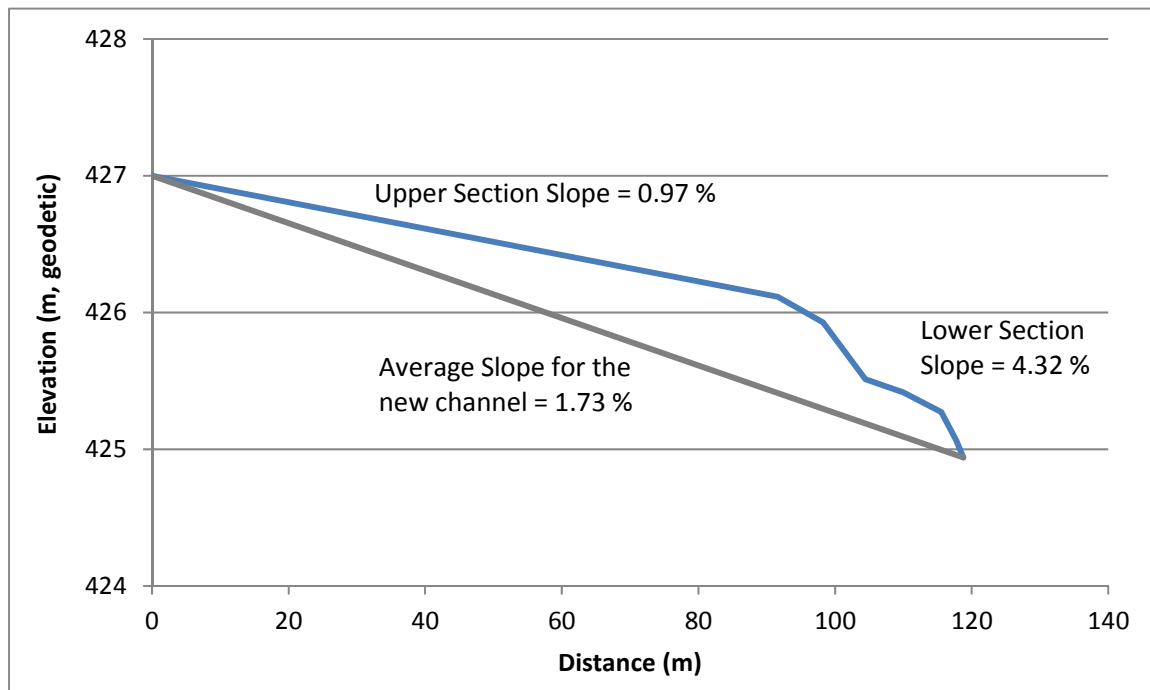
Figure 33: Shoreline Transect at Lake N14 for the new outlet channel from D2-D3 lake.

The figure shows a low slope gradient of approximately 1.0% on the upper part of the transect, and more steep terrain at the existing shoreline with a slope gradient of 4.3%. However, the general slope from the outlet of the new D2-D3 lake to Lake N14 is estimated at 1.7% and this should characterize the slope gradient of the proposed outlet channel. At the same time, the 1.7% slope gradient is close to the measured slope gradient of 1.35% at the outlet of Lake D2 during pre-mining conditions.

The new channel will be located in the same terrain type conditions as the existing D2 outlet channel, therefore delineating and constructing the new channel will require minimum works. It is recommended that mitigation include recreating the same cobble armoured channel banks and bed channel, with small nickpoints as the D2 and D3 outlet channels.

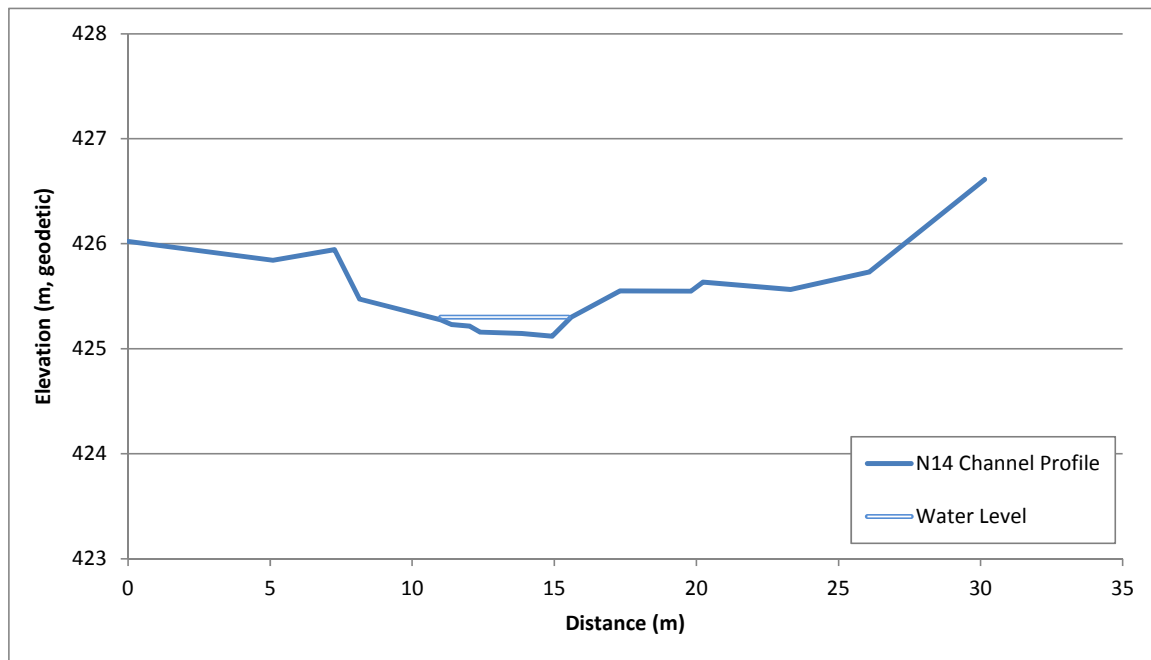
Figure 40: Lake N14 Outlet Channel Cross-Section

The outlet channel flows through a flat terrain consisting mostly of bog and fen peat on top of moraine material. The channel banks on the upstream half of the channel with low slope gradient are armoured with cobbles and boulders. The same material is found on the channel bed with small pockets of gravel and some fine particulate material deposited as a fine layer. On the downstream half of the channel with higher slope gradient, the cobbles and boulders have low density and most of the bed material consists of sand and soils with small nickpoints.

Because of its configuration and surficial materials, and the small change in water level variations during the mine operations period with increased flow, the N14 outlet channel is expected to be within the natural multiannual variation limits (De Beers 2010, Section 9). However, for the downstream half of the channel with mostly sand and soil materials it is recommended as a mitigation measure, to recreate the same cobble armoured channel banks and bed channel as the upstream half of the channel.

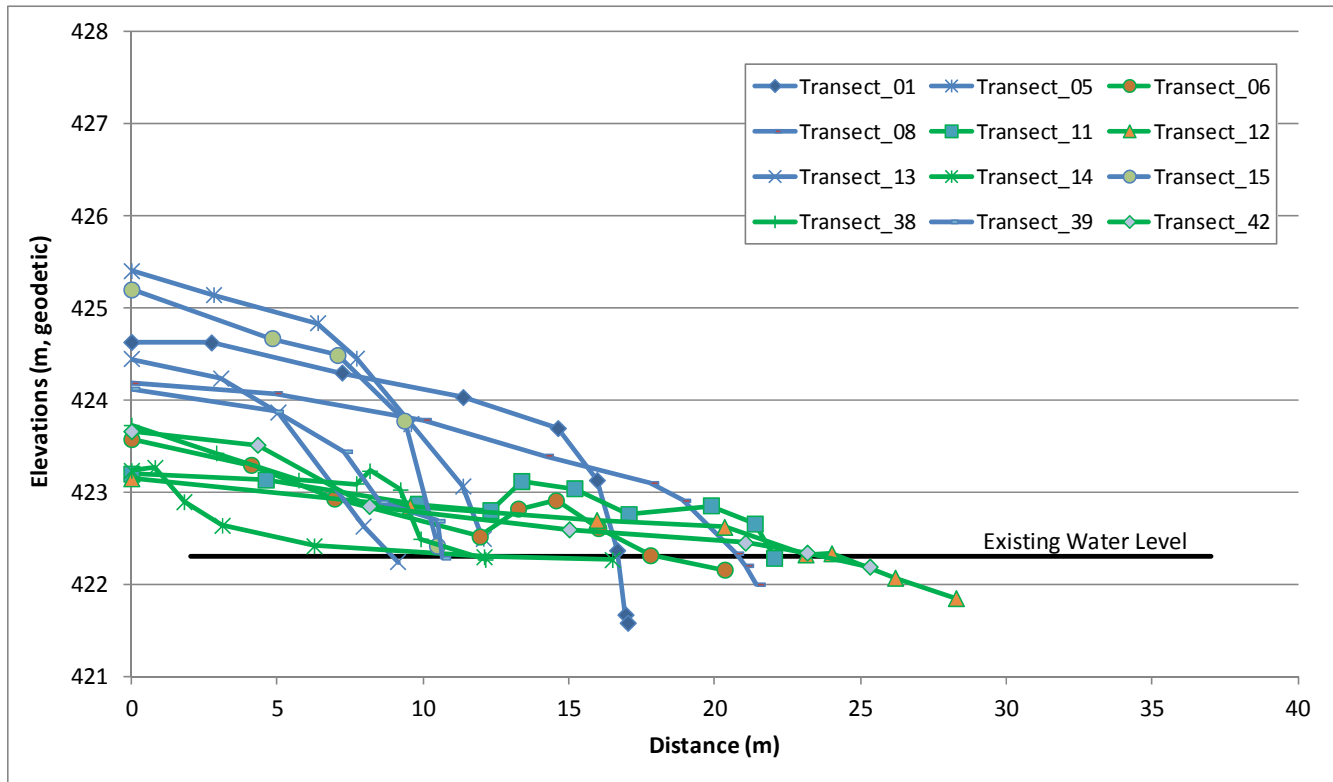
Figure 44: Lake N9 Shoreline Transect Profiles for the west embayment

For the west embayment, two main types of shoreline can be distinguished:

- Low slope gradient morainal terrain type, with boulders and cobbles that form a continuous and uniform water edge. These sections occupy the largest extent of the embayment shoreline and are located on the north and south shores.
- Very inclined shores with bedrock outcrops that form a steep shoreline on the west shore of the embayment. However, smaller areas can be found on the north and south shores but with limited extension.

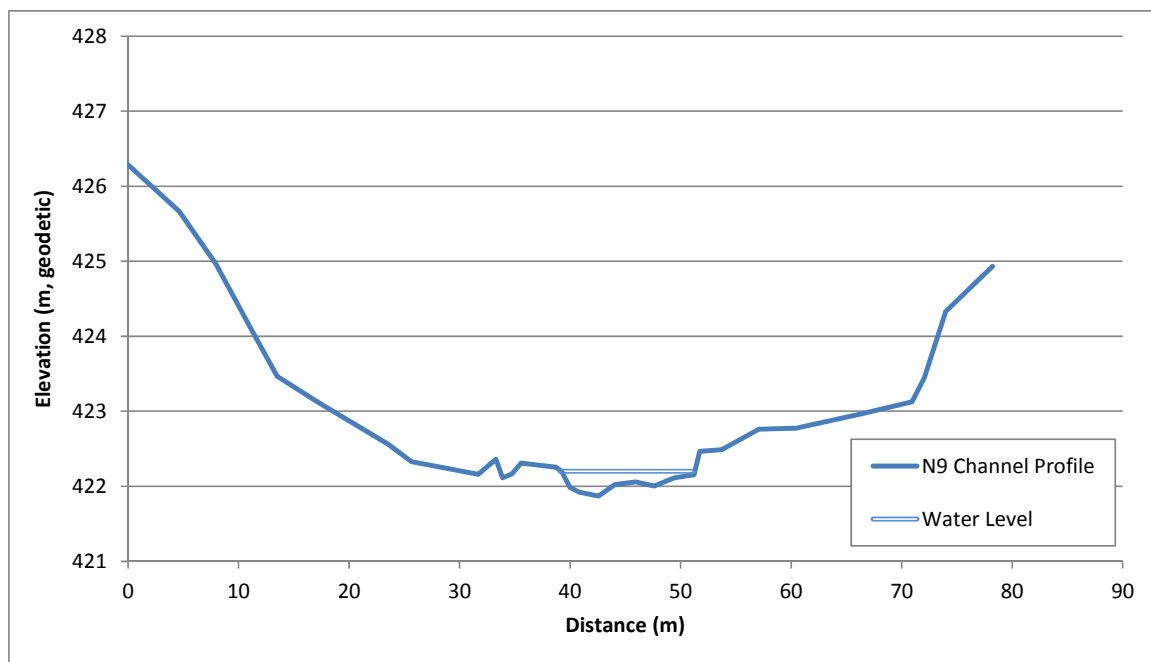
Figure 45: Lake N9 Outlet Channel Cross-Section

The outlet channel flows through a flat terrain consisting mostly of fen on top of moraine material with a boulder substrate. The outlet channel has more than one main channel and flows during high waters occur through multiple smaller channels. Channel banks are armoured with boulders and the same material is found on the channel bed with small pockets of cobbles and some fine particulate material deposited as a fine surface layer.
