**Re: Paramount Resources Ltd.'s ("Paramount") Cameron Hills Oil and Gas Development Project Approved under National Energy Board ("NEB") Order EPO-01-2002 - C-50 Grid 60<sup>0</sup> 10' N, 117<sup>0</sup> 30' W ("C-50") Pipeline Failure**

**CAMERON HILLS GAS GATHERING**

**REPAIR DETAIL**

DRAWING NUMBER: D-CH-G-50-P-02.03

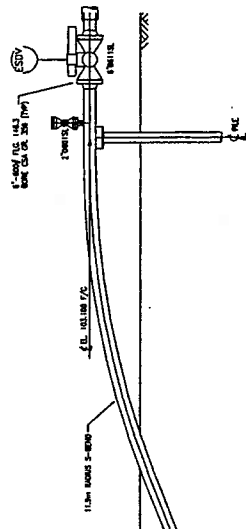
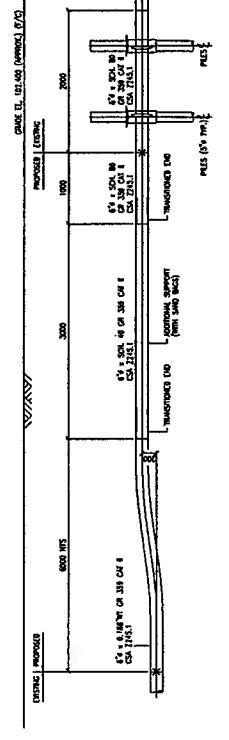
Paramount currently believes that the primary cause of failure was by the settling of the ground near the pipeline anchor location. The stresses caused by the weight of the overburden would be further aggravated by the transition from the heavy wall (11 mm) anchor pipe to the linepipe wall thickness (4.8 mm) and the rigidity of the anchor, which resulted in a lack of flexibility. Therefore the highest point of stresses would be at the weld where the failure occurred.

- The failure occurred with a crack on the top third of the pipe indicating tensile stress in the top of the pipe and a downward force on the linepipe.
- The surface of the trench line had visible indications of settlement near the base of the hill near the failure point.
- When the failed pipe section was removed, the non-anchored side of the failure came to rest approximately 8 inches below the anchored side.

1. The transition from 11 mm to 4.8 mm wall pipe will be done in two steps with 7.2 mm wall pipe as an intermediate step. The purpose of this is to increase the flexibility and reduce the stress concentration of the pipe joining onto the anchor. A drawing is attached for reference.

2. Approximately eighteen feet of line pipe will be pre-bent to accommodate the 8" offset that has occurred due to settling. This will reduce the stresses on the pipe at the anchor.

3. The two transition pieces and pre-bent pipe spool will be welded together using the same welding procedure that was used during the original construction.
