January 7, 2009

File No.: P09363B01

**Taltson Expansion Project**  
**Trudel Creek Erosion Assessment**

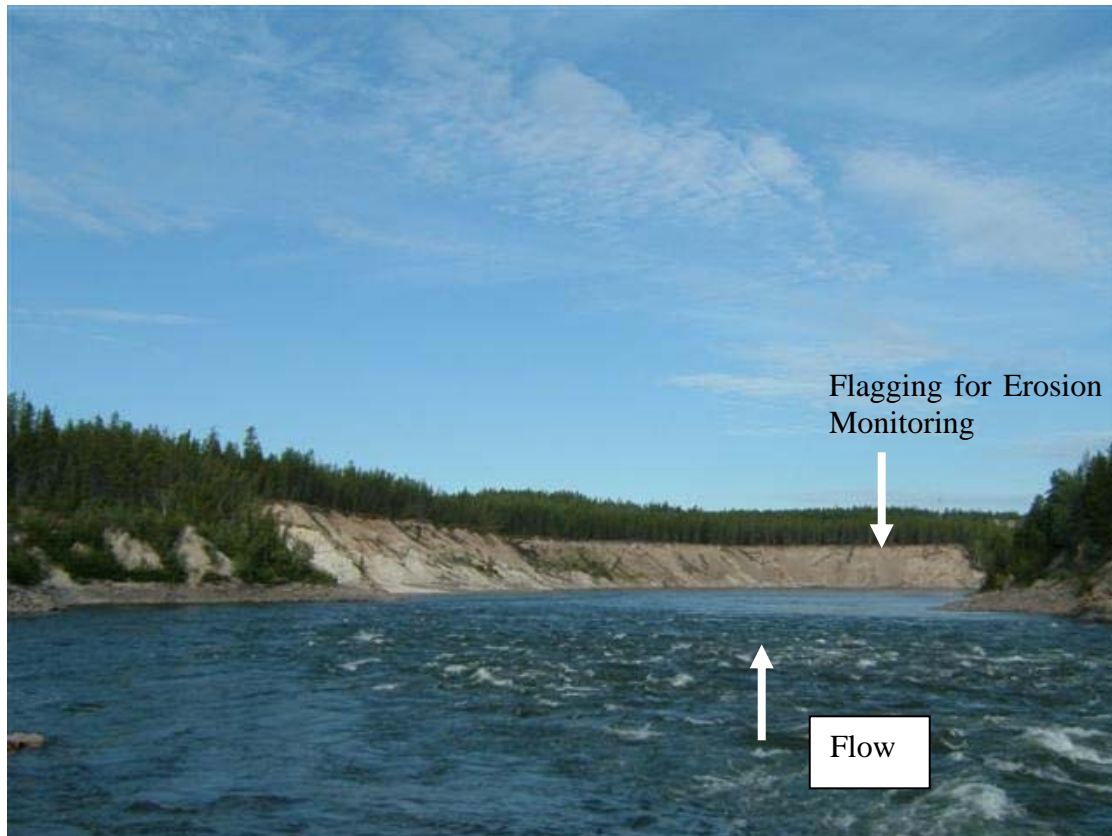
This site is located on a bend on the left bank of Trudel Creek, looking downstream, see Photo 2.1 and Figures I-1 and I-2 in Appendix I. It consists of a high bank composed of sandy, silt and clay. There are fingers of bedrock outcrops at several locations along the toe of Site 1 that reduce erosion, see Photo 2.2. The upstream portion of Site 1 has toe armouring by cobbles and boulders, see Photo 2.3. The downstream end of Site 1 has high steep sand banks with no toe armouring, see Photo 2.4. There are areas of erodible clay that are being undercut and eroded by surface runoff coming down the slope. There are several mud slide areas that are delivering trees and sediment to the river, see Photo 2.5. These mud slides, created by water draining off the upper slopes, tend to destabilize the banks.

**Photo 2.1 Looking downstream at Erosion Site 1 and Erosion Monitoring Site (July 9, 2008).**

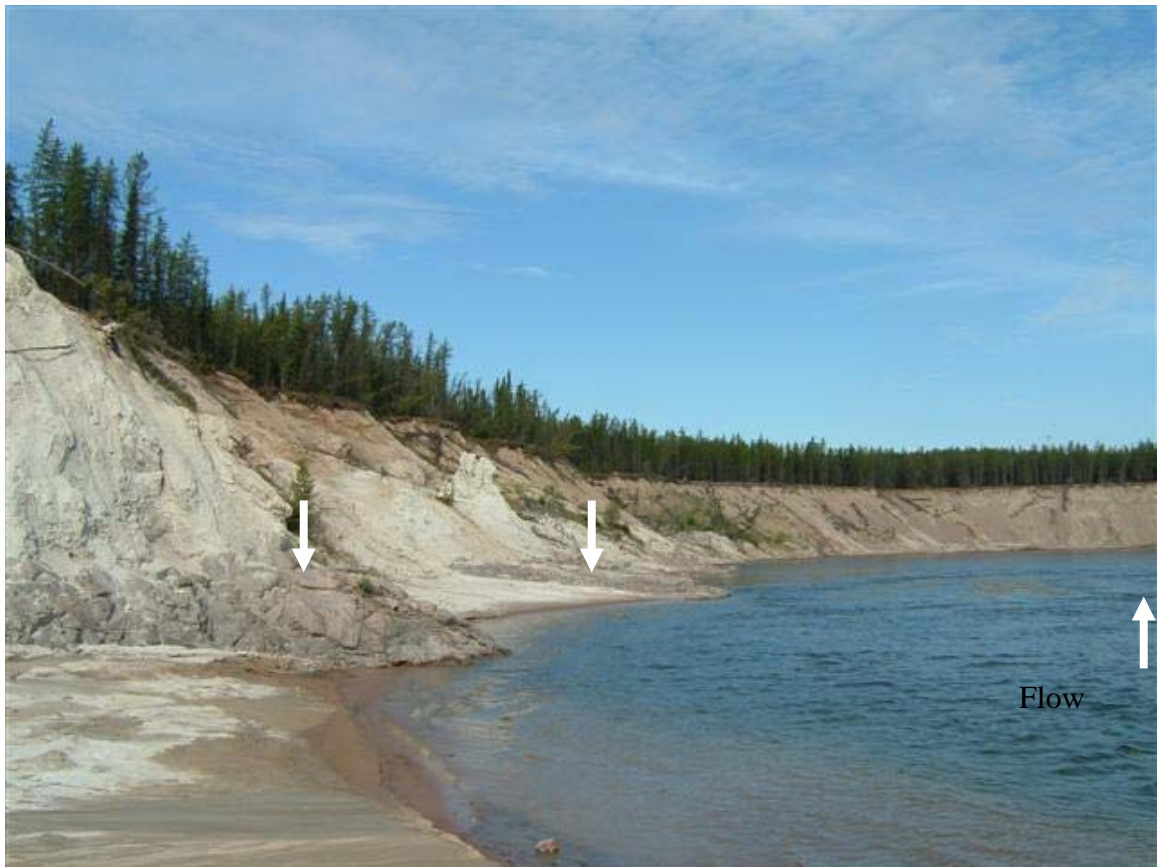
**Photo 2.2 Bedrock outcrops at Site 1 (July 9, 2008).**

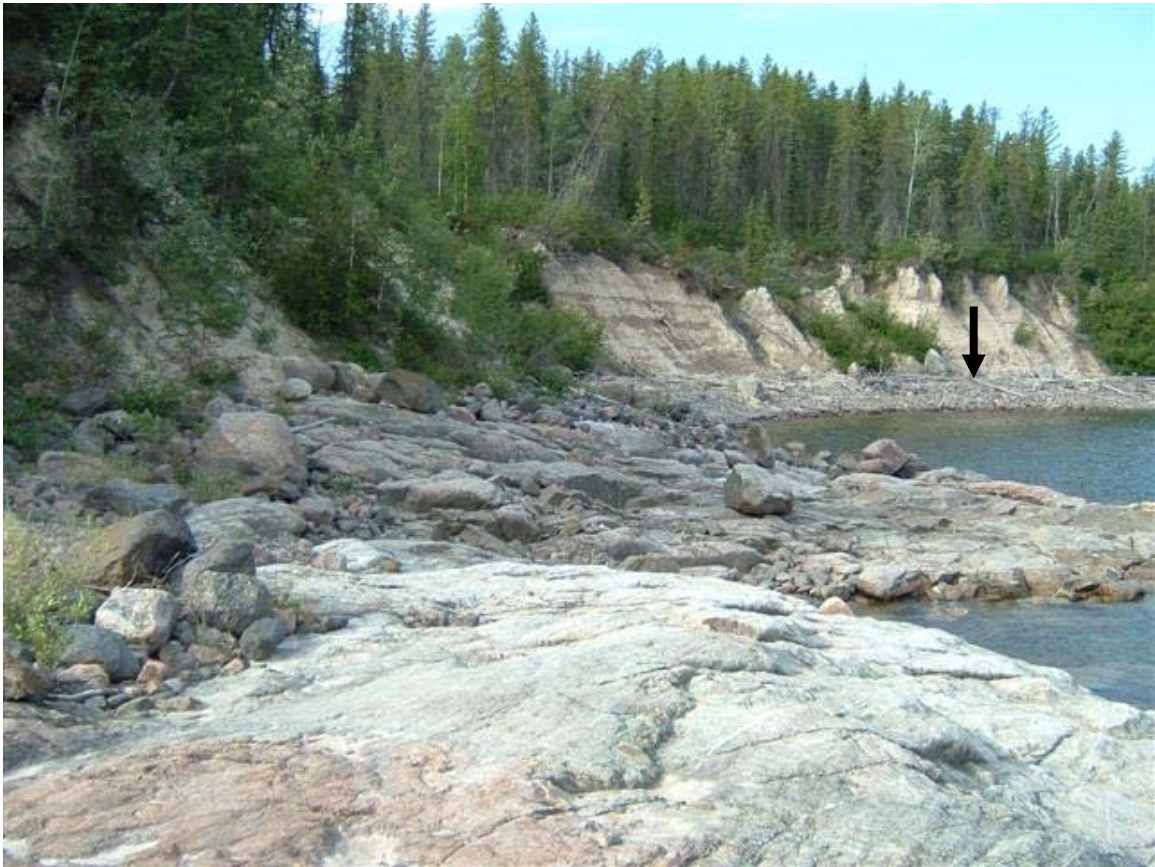
**Photo 2.3 Cobble and boulder toe armouring (July 9, 2008).**

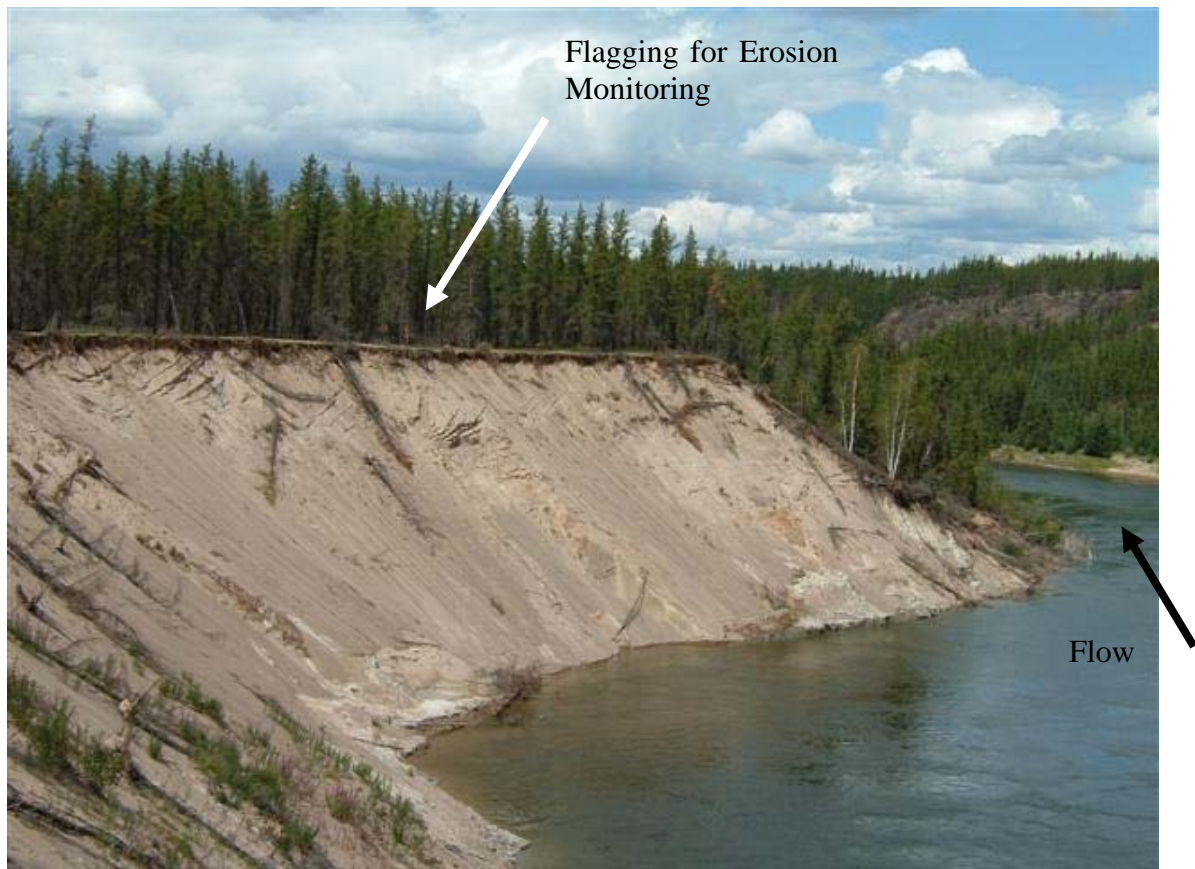
**Photo 2.4 Looking downstream at Site 1 where there is no toe armouring (July 9, 2008).**

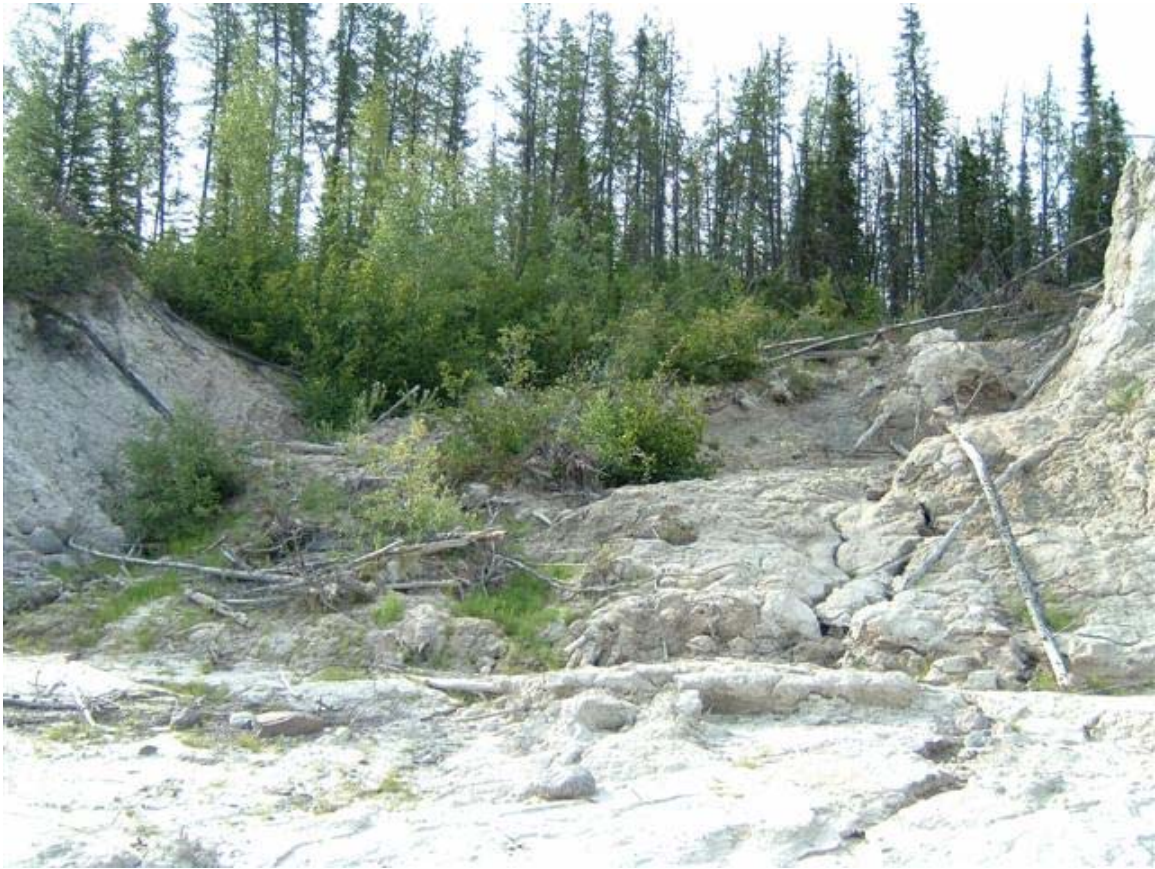
**Photo 2.5 One of several mud slides supplying sediment to Trudel Creek at Site 1 (July 9, 2008).**

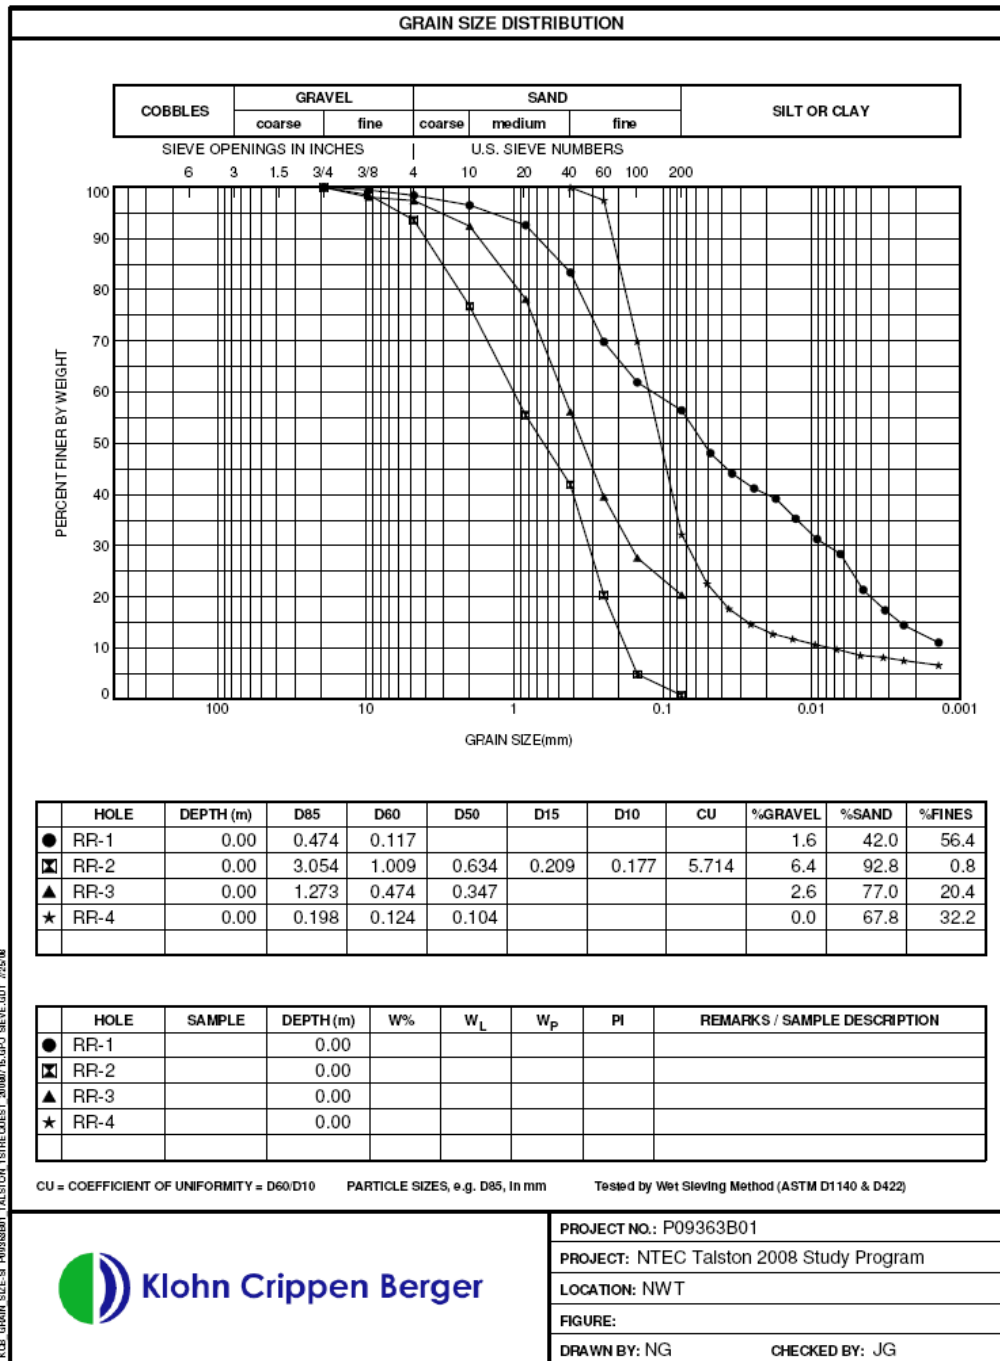
**Figure 2-2 Grain Size Analyses Results.**

A sample of the bank clay material was taken and a sieve analysis was carried out, see Sample RR-1, on Figure 2-2. This material has 56% fines and 42% sand, and is very erodible. Other areas of this eroding site are mostly composed of sands.

Soil Sample RR-2 was taken from sand bank at Site 2. Figure 2-2 shows that this bank is mainly sand, consisting of about 93% sand, 6% gravel and 1% fines. This bank will self armour over a very long period as the sands are washed away. There was evidence of self armouring after significant erosion had occurred. Sample RR-3 was taken at the toe of the bank on the sand bar. This sample has 77% sand and 20% fines, reflective of this lower velocity backwater sediment deposition location.

The grain size analyses, presented in Figure 2-2 , are indicative of the erodible fine grain materials that are present along Trudel Creek. Sites 1 and 2 are similar, with high sloping banks that are being eroded at the toe. The sample taken at Site 1 was specifically in an area of the site that contained erodible clay, and so it has 56% fines and some cohesion.

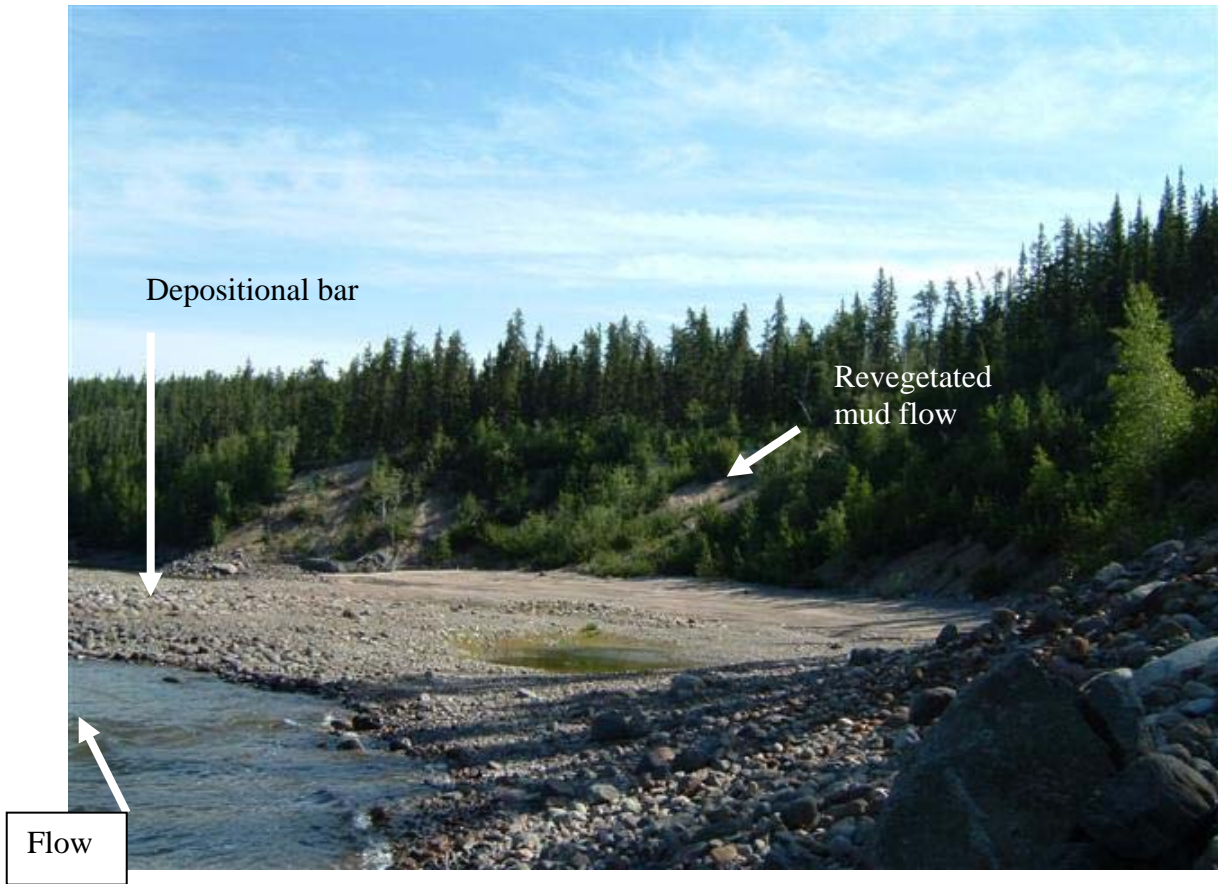
**Photo 2.6 Downstream end of Site 2 with depositional bar and eroding bank (July 9, 2008).**

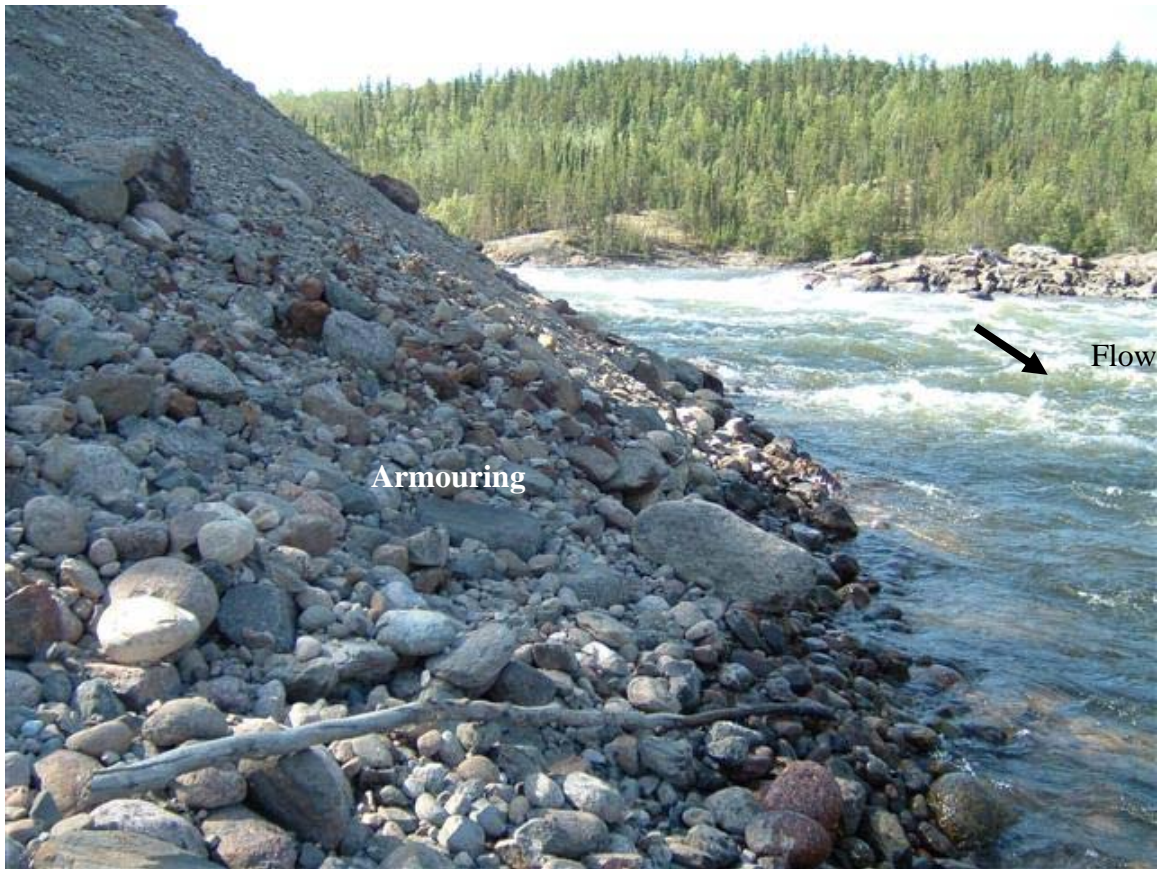
The upstream portion of Site 2 had substantially armoured itself over the last 43 years, since the construction of the hydropower plant in 1965. Fallen trees at the top of the slope indicated that some erosion was still taking place at the toe of this slope.

**Photo 2.7 Upstream end of Site 2 with eroding esker slope (July 9, 2008).**

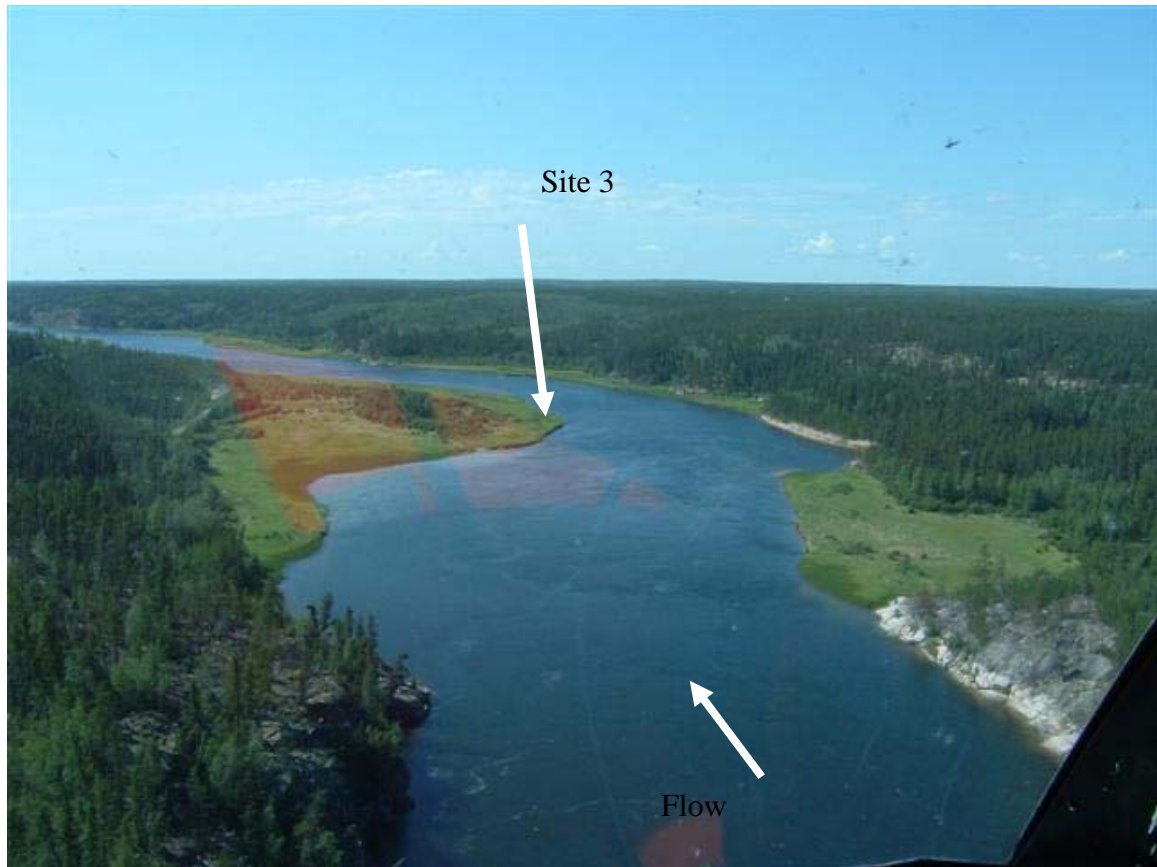
Site 3 is a low bar on the left bank of Trudel Creek, located approximately 4 km downstream from the South Valley Spillway (SVS), see Photo 2.8 and Figures I-5 and I-6. The bar had not yet been flooded this year and had long grass growing on it. Large pieces of the bank had fallen into the creek and large tension cracks were evident, see Photo 2.9 and Photo 2.10. Soil Sample RR-4 was taken from this bank. This sample has 68% sand and 32% fines, providing some cohesion, as can be seen in Photo 2.10.

**Photo 2.8 Looking downstream at Site 3 (July 9, 2008).**

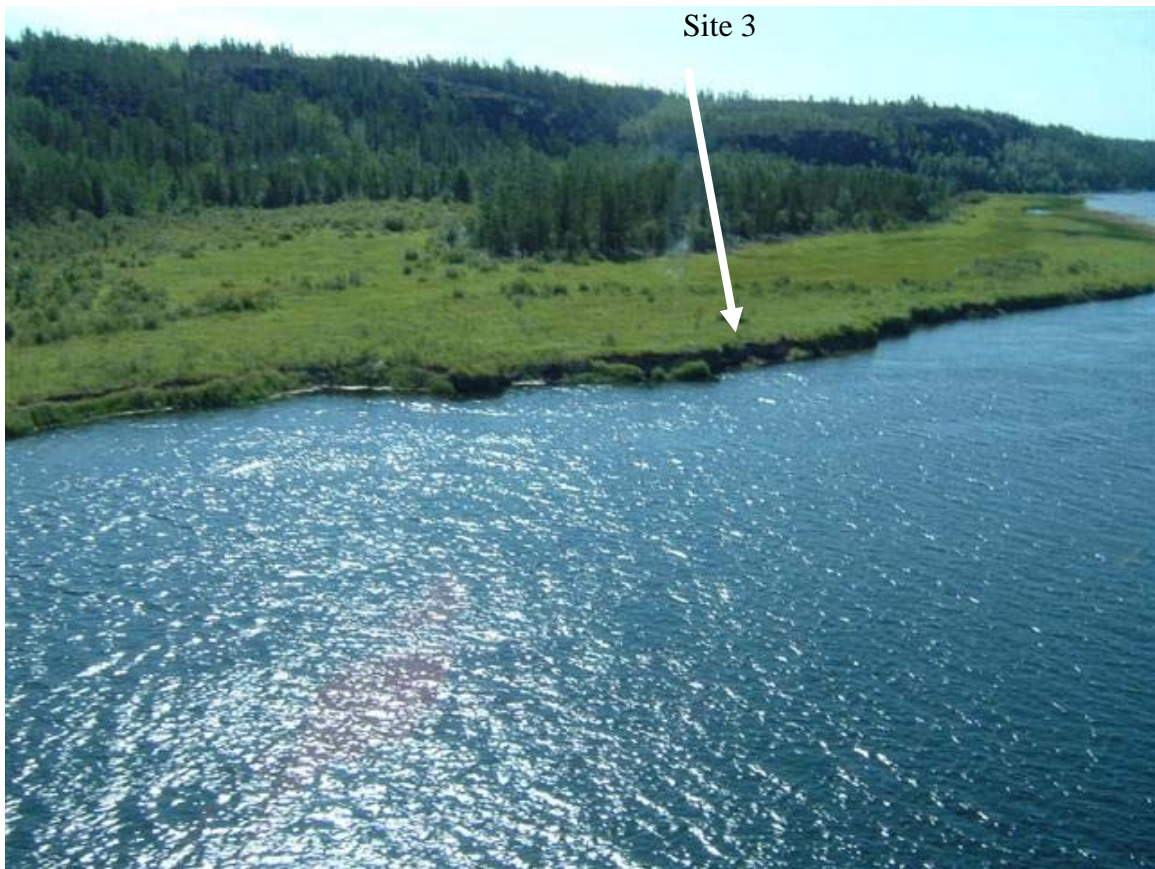
**Photo 2.9 Pieces of the low bank falling into the creek (July 9, 2008).**

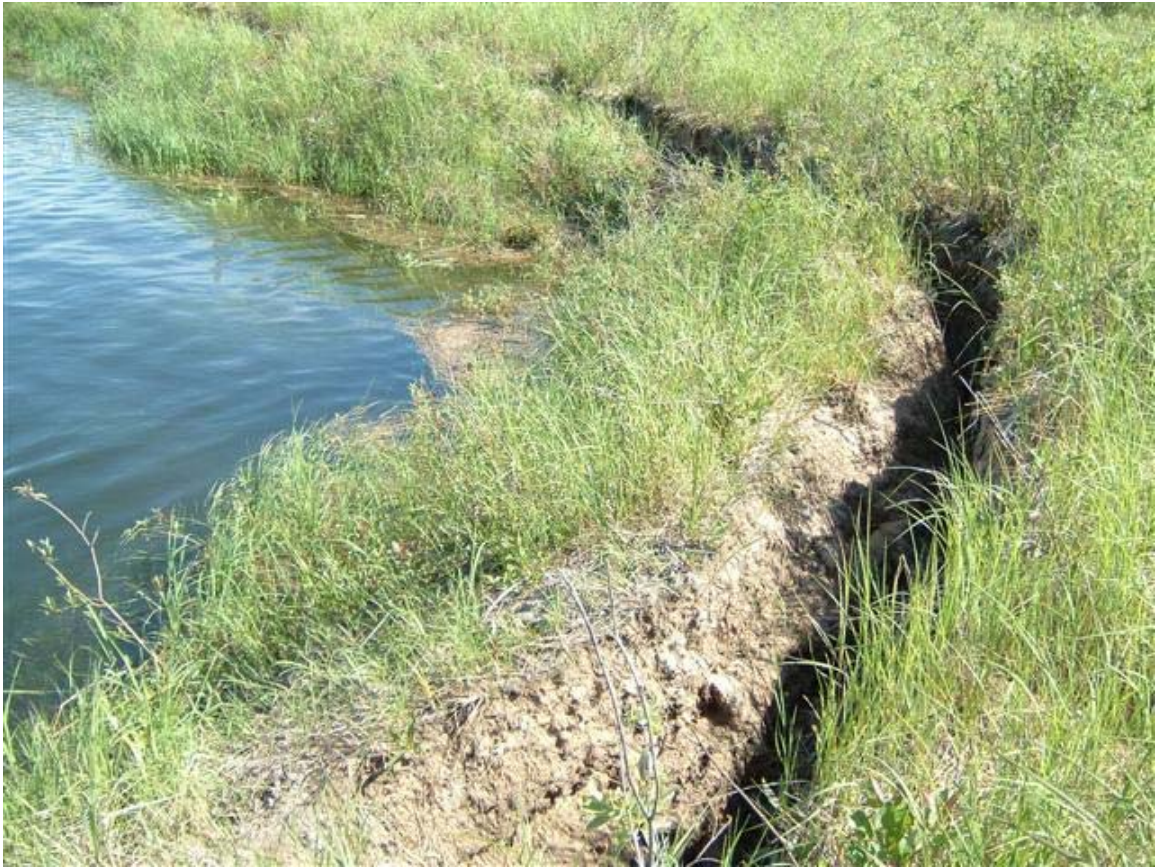
**Photo 2.10 Large tension crack at Site 3 (July 9, 2008).**

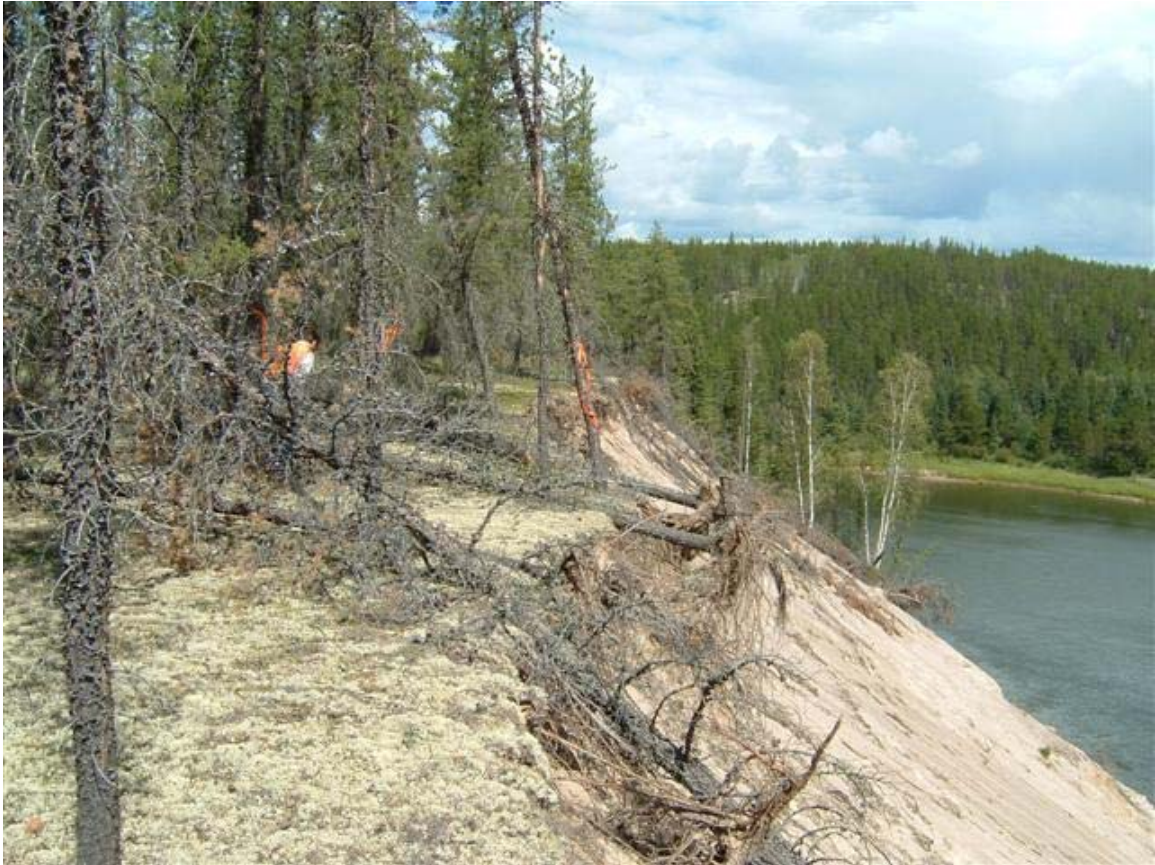
This monitoring site is located at the downstream end of Site 1, see Photo 2.4 and Appendix I, Figures I-1 and I-2. This location was selected as it appeared to be active and there was no armouring of the toe of the slope at the water line. This site is located at the end of a fairly straight reach, with direct impingement of the creek on the toe of the bank. Three trees were flagged so that they could be seen by a hovering helicopter, see Photo 3.1. Orange flagging tape was placed on three trees: one tree on the edge of the top of the slope; one tree 2.6 m from the edge; and one tree 3.6 m from the edge.

**Photo 3.1 Looking downstream at erosion monitoring Site 1 (July 9, 2008).**

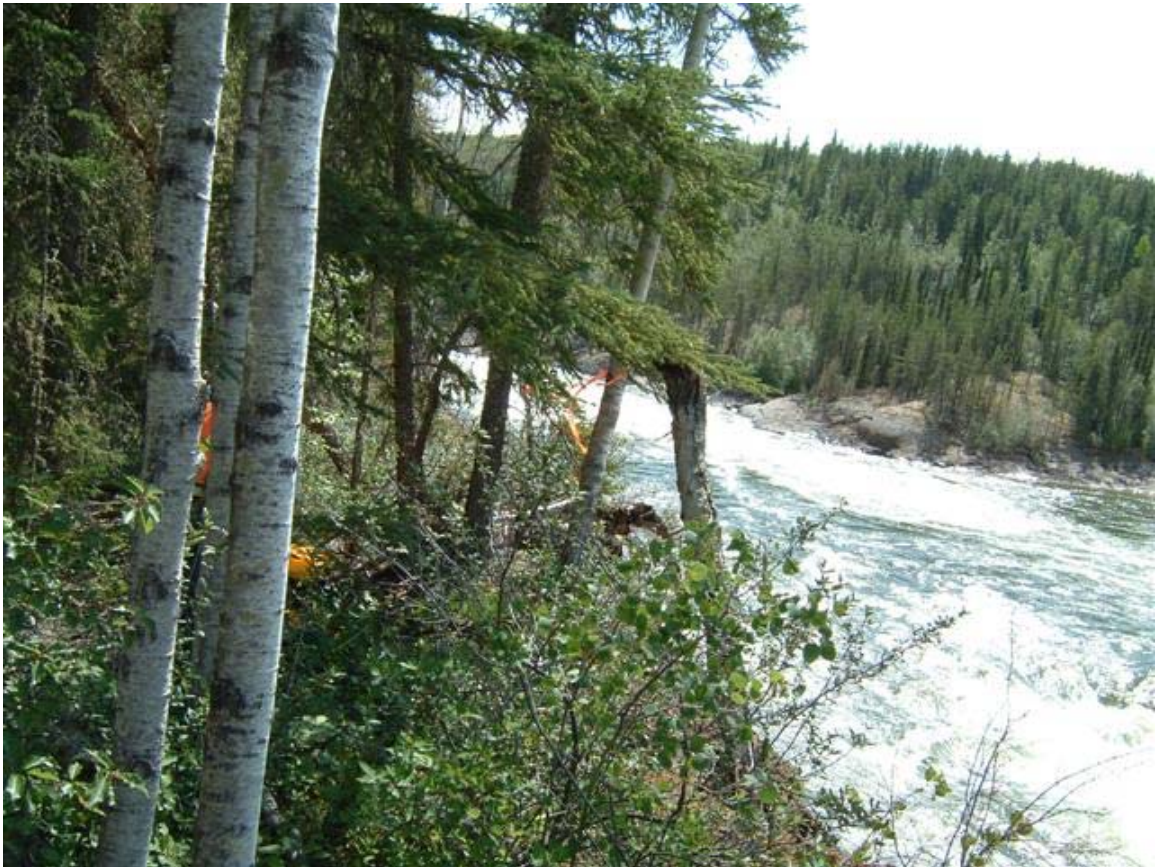
This site is located at the upstream end of Site 2, adjacent to a cascade; and Photo 3.2 and Appendix I, Figures I-3 and I-4. The slope is somewhat armoured along the toe, but is still eroding as demonstrated by the fallen trees. Orange flagging tape was placed on three trees: one tree on the crest of the slope; one tree 1.9 m from the edge; and one tree 4.0 m from the edge. Flagging was also placed on two other trees on the edge of the slope, one upstream and one downstream of the monitoring site.

**Photo 3.2: Looking upstream at erosion monitoring Site 2 (July 9, 2008).**

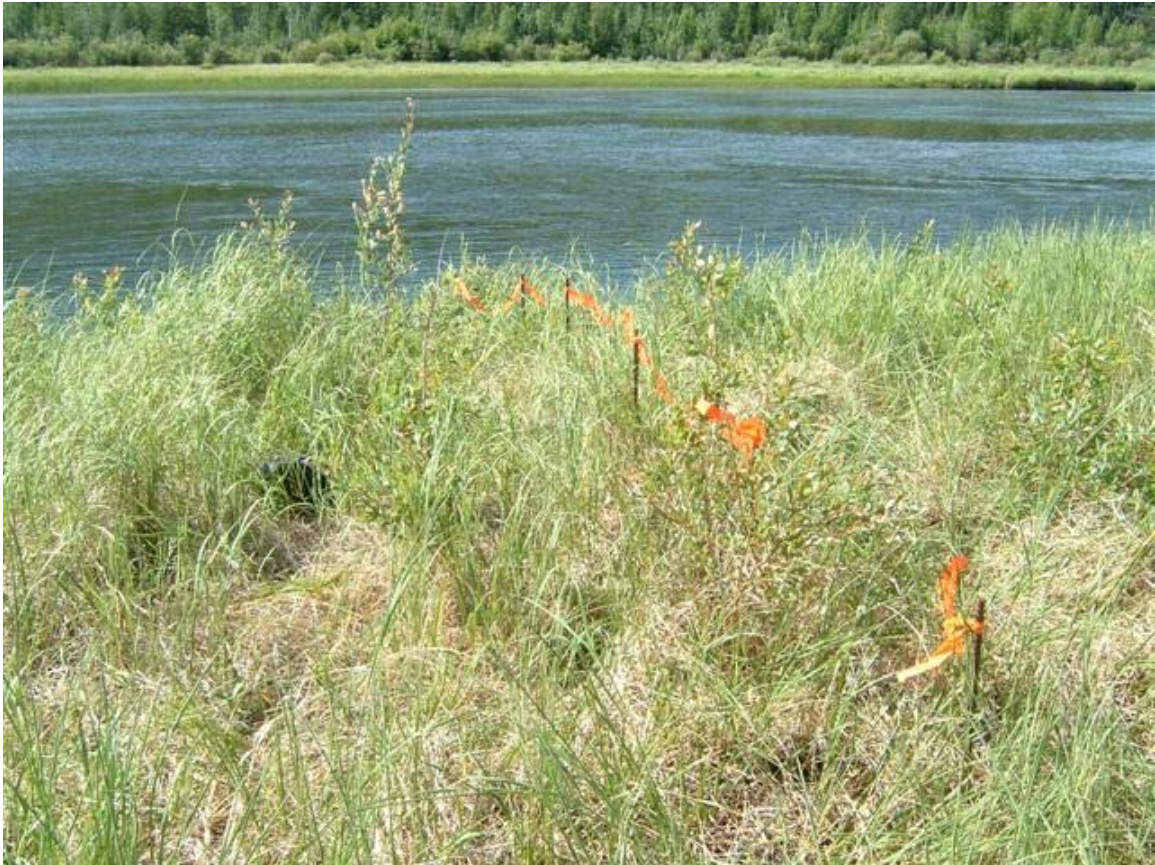
This site is located at the same location as the previously described Site 3, see Figure 2-1 and Appendix I, Figures I-5 and I-6. Five 1.2 m long reinforcing rods were driven into the ground at 1 m spacing, see Photo 3.3. These markers may need to be lengthened so that they can be seen through the tall grass. Also, 2 m to 2.5 m long rods may be necessary should high flows submerge the area and cause the existing rods to vibrate looser be disturbed by floating debris. The ground appears to be soft enough for the longer rods to be installed.

**Photo 3.3 Site 3 with 5 flagged rods at 1.0 m spacing (July 9, 2008).**

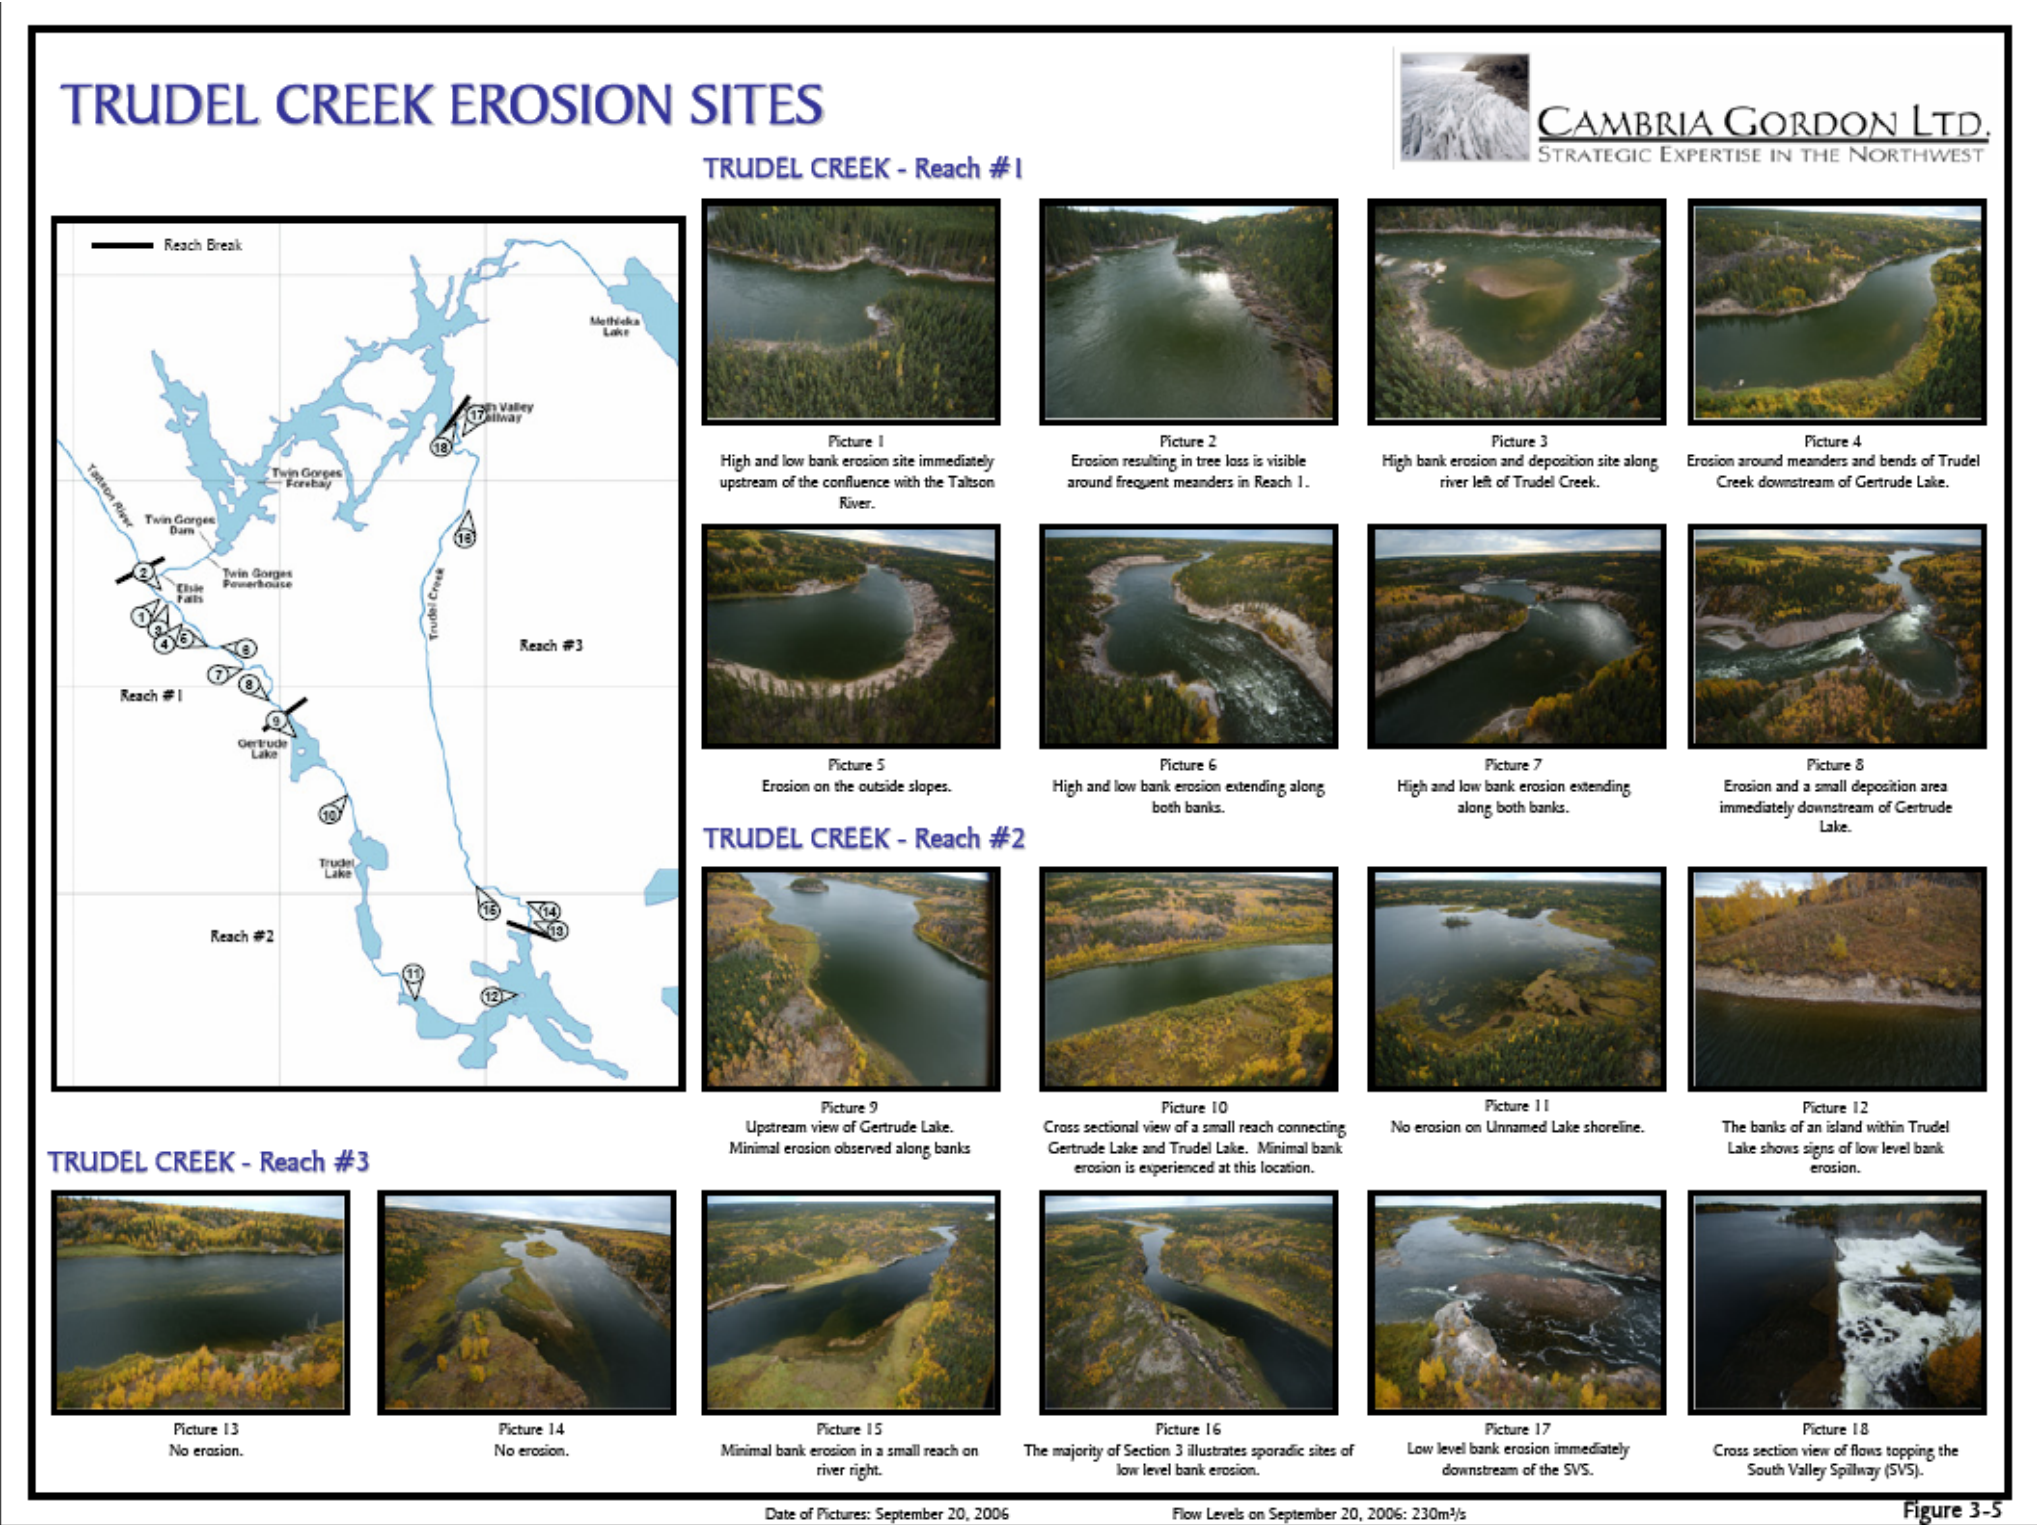
to self armouring and widening of the river in some locations. Figure 5-1 shows existing erosion sites identified by Cambria Gordon during previous studies. Some of these sites area also identified on Figures III-1 and III-2, in Appendix III.

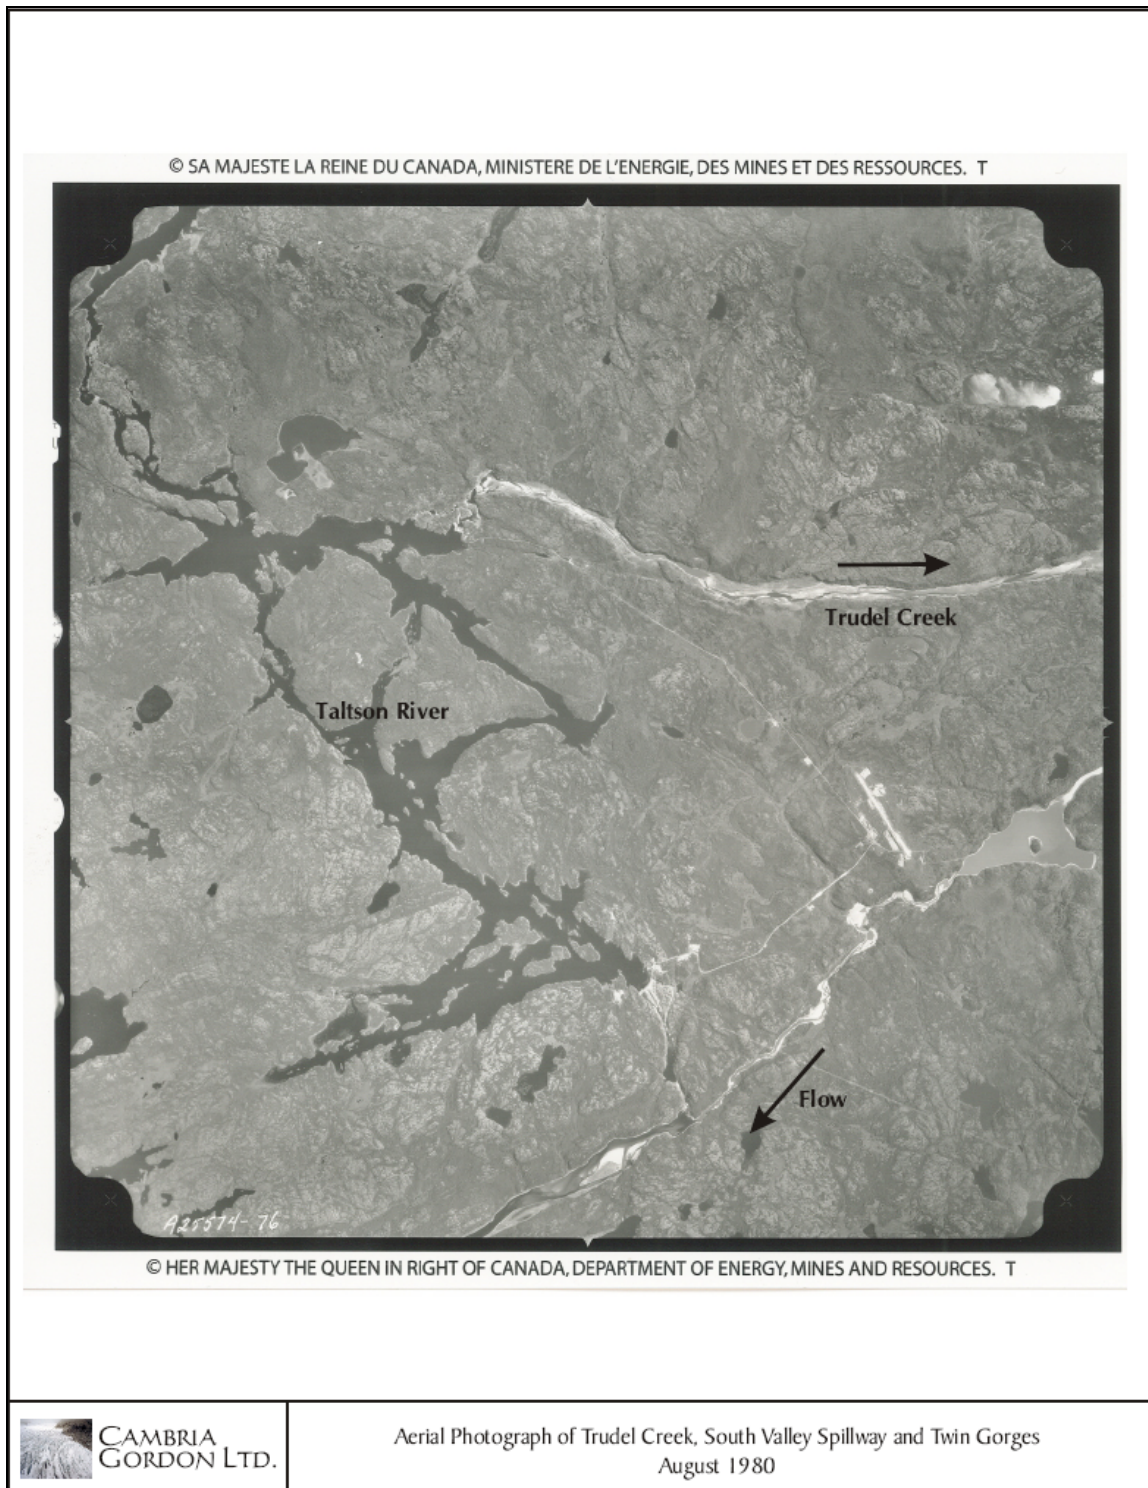
**Figure II-4**

Figure II-4 is a 1980 air photo showing the upstream and downstream portions of the creek. The erosion caused by the high flows is easily seen as the white areas along Trudel Creek. These are the areas that have eroded and are lacking vegetation.
