Hydrotechnical Progress Report

Summary of Fieldwork

Tli Cho Alignment Hydrological
Study

Reference number: S051107

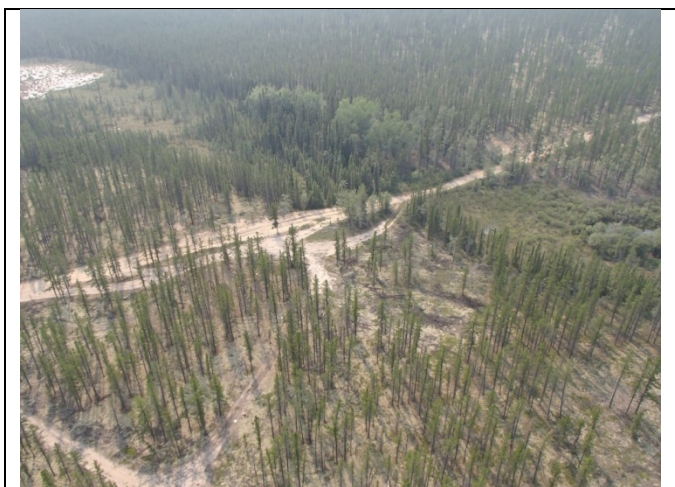
Crossing 1 is a low area with a poorly defined channel and no defined floodplain. Banks are vegetated with low shrubs and some trees. The "channel" was dry but the area of flooding during a rainfall event could be wide due to the flat relief in the area. Stagnant water was observed downstream. Surficial soil appears sandy.

Photo 1: Crossing 1 looking northeast (downstream); note dry conditions and downstream marsh area (July 3, 2014)

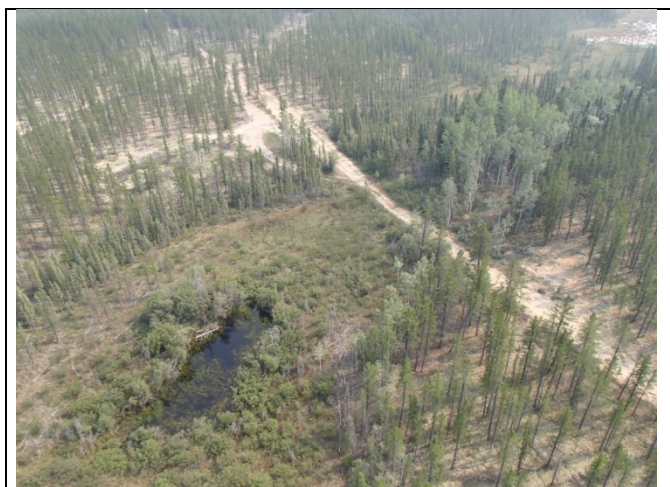
Photo 2: Crossing 1 looking northwest (downstream); stagnant water observed upstream of crossing (July 3, 2014)

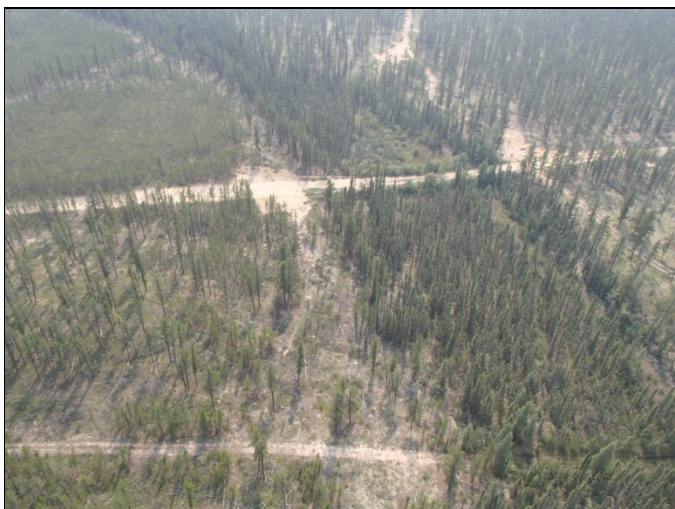
Similar to Crossing 1, Crossing 2 is a low-lying area with a poorly defined channel and floodplain. Banks are vegetated with thick grasses and shrubs as well as a forested area downstream. A small marsh area lies upstream. A significant amount of water must pond prior to spilling at the crossing. The "channel" was dry but the estimated flow width is 3-5 m. Surficial soil is sandy.

Photo 3: Crossing 2 looking northeast (downstream); note sandy surficial soil on roadway and dry conditions (July 3, 2014)

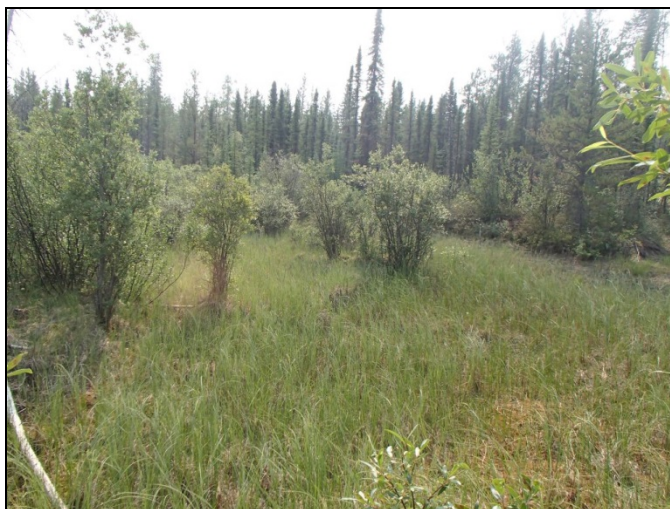
Photo 4: Crossing 2 looking south (upstream); tall grasses and small shrubs in marsh area upstream of crossing

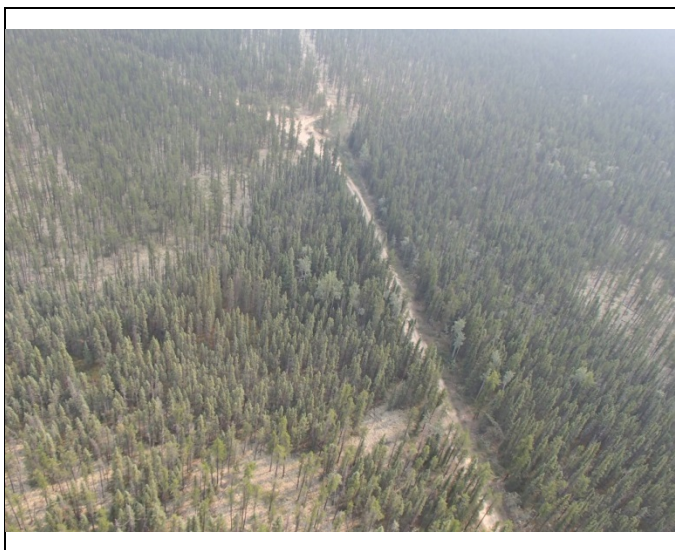
Crossing 3 is similar to both 1 and 2 and has a poorly defined channel with forested banks. Small shrubs and grasses are within the "channel". There is no defined floodplain. Surficial soil appears sandy.

Photo 5: Crossing 3 looking east; note sandy and dry conditions (July 3, 2014)

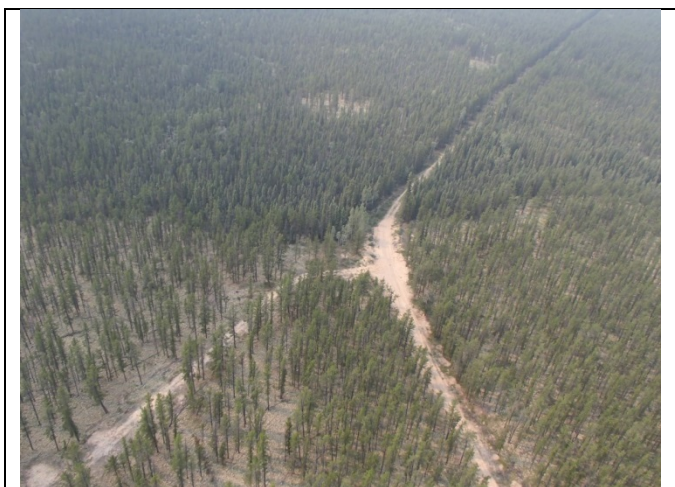
Photo 6: Crossing 3 looking west; vegetation appears to change near crossing (July 3, 2014)

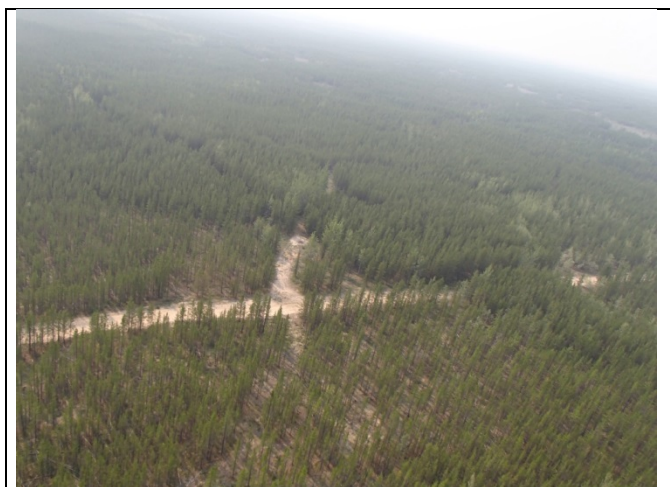
Crossing 4 is a defined, ephemeral channel. Channel bed characteristics are similar to the first three crossings with some shrubs and grasses. The depth of the channel is approximately 0.3 m. An open, marsh area is located upstream of the crossing (see photos). The floodplain is forested with the same grasses and shrubs as the channel. Surficial soil appears sandy.

Photo 7: Crossing 4 looking southwest (upstream); some minor drainage through forest and a defined crossing at road (July 3, 2014)

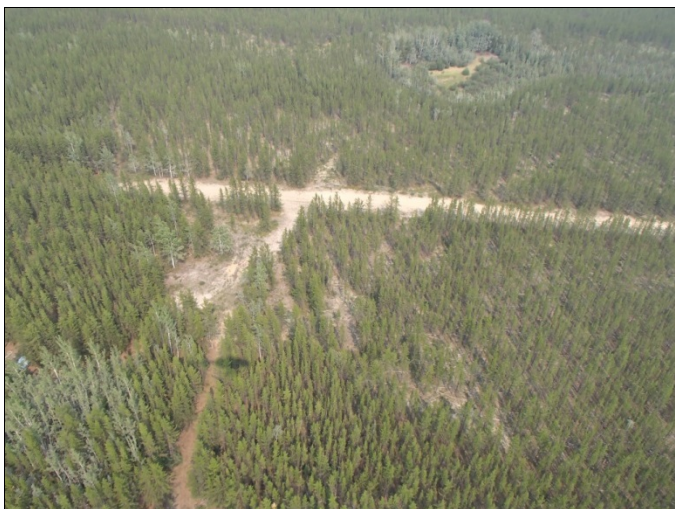
Photo 8: Crossing 4 looking northeast (downstream); clearing/marsh located downstream (north) of crossing (July 3, 2014)

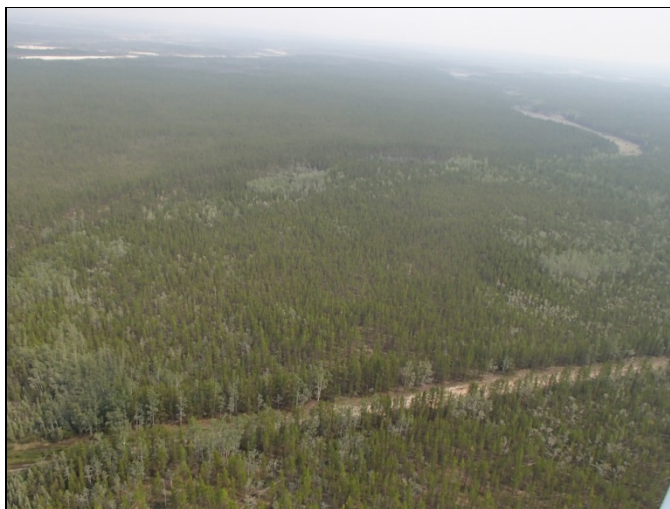
Crossing 5 is poorly defined but a change in vegetation was observed downstream where flooding occurs during rainfall events. The channel has shrubs, trees, and grasses within the channel bed. Further downstream the channel opens up and is not as thickly forested as at the crossing location. Surficial soil appears sandy.

Photo 9: Crossing 5 looking southeast; downstream watercourse in background (July 3, 2014)

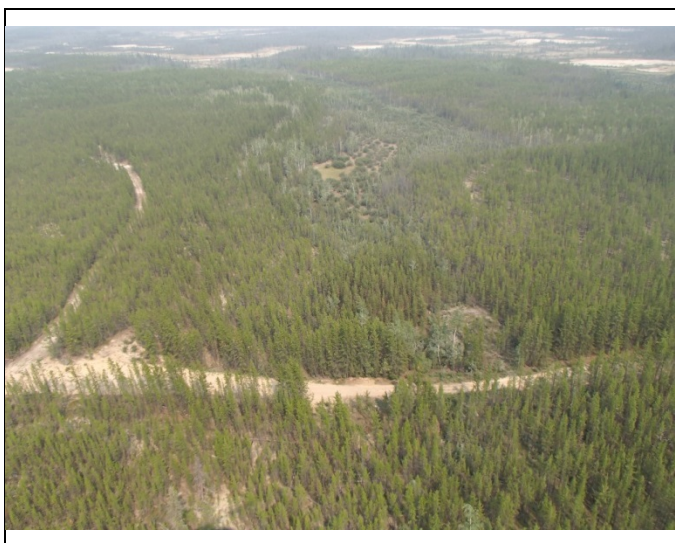
Photo 10: Crossing 5 looking northeast (downstream); note vegetation change showing extents of flooding downstream of crossing and width of flooding at crossing (July 3, 2014)

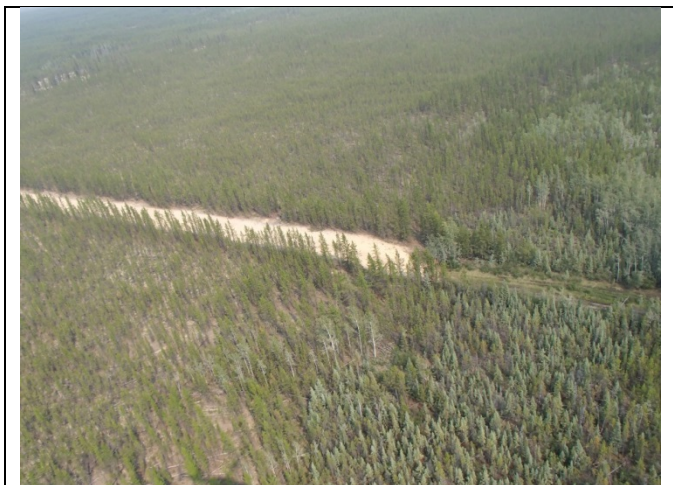
Crossing 6 is poorly defined, however a change in the vegetation and forest type within the crossing location shows the extent of flooding during rainfall events. The crossing is a low area with signs of recent flooding. The channel and floodplain are not defined and the channel bed is full of shrubs and grasses. Surficial soil appears sandy.

Photo 11: Crossing 6 looking northeast (downstream); note low point in road and change of vegetation (July 3, 2014)

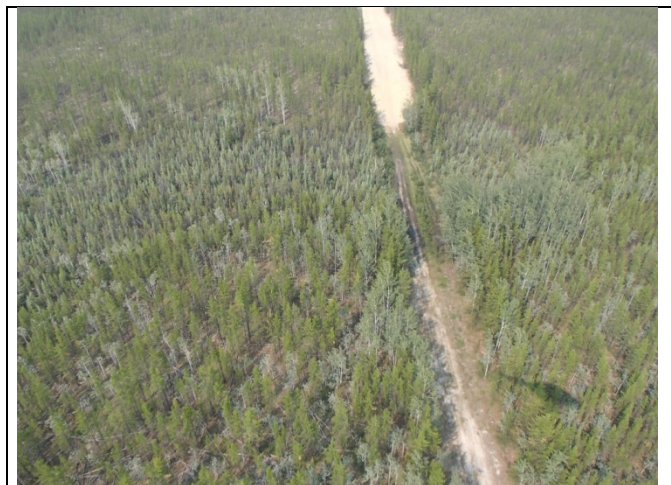
Photo 12: Crossing 6 looking north; extent of previous flooding at crossing approximately 20 m (July 3, 2014)

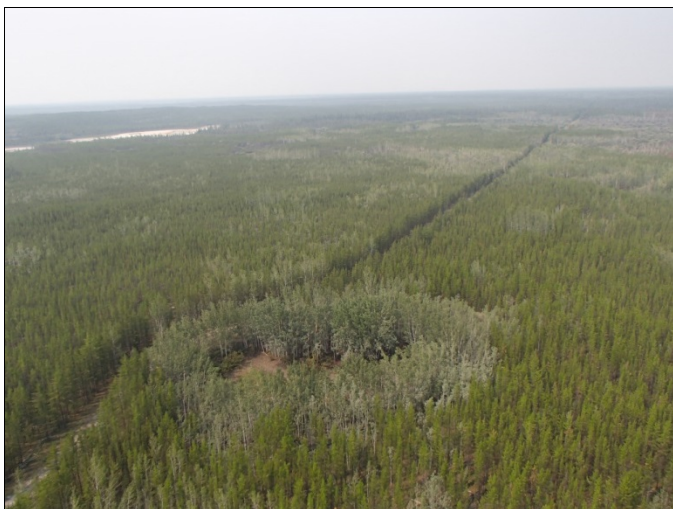
Crossing 7 is a low-lying area where ponding occurs downstream of the road during rainfall events. Soil appears sandy with some organics.

Photo 13: Crossing 7 looking northwest (upstream); low, ponding area on east side of road, no defined channel upstream (July 3, 2014)

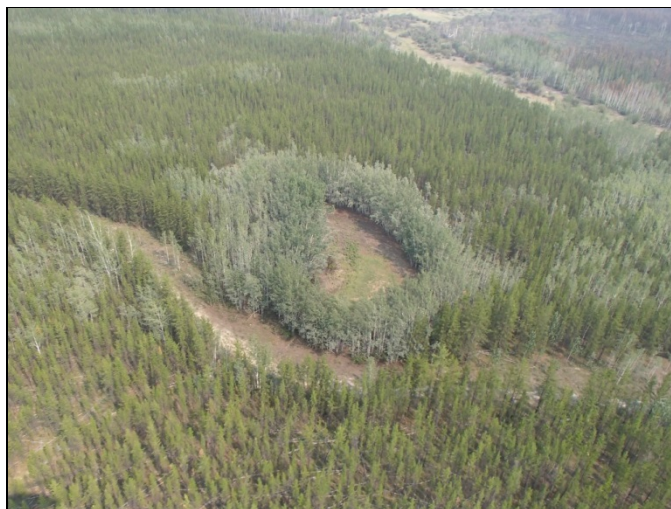
Photo 14: Crossing 7 looking east (downstream); note ponding area and downstream marsh area past forest (July 3, 2014)

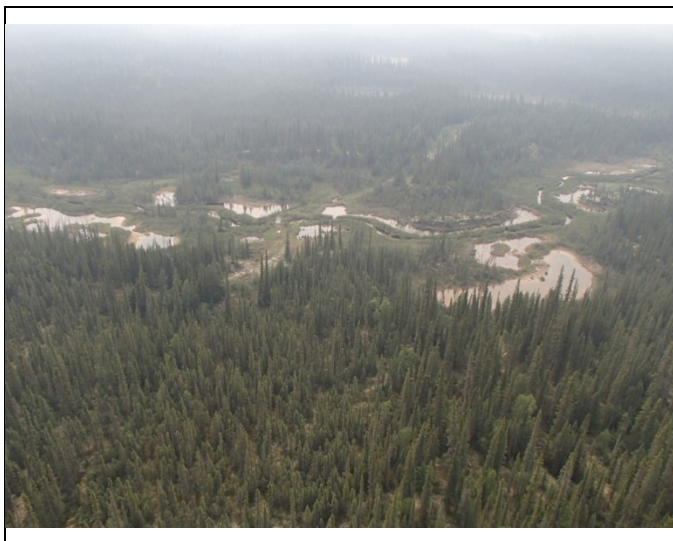
Crossing 8 is a major crossing and is located at a series of well-defined and braided meandering channels within a marsh. The area floods during high water levels following large rainfall events. As water levels recede during dry periods low areas remain wet and small, oxbow ponds are created adjacent to the channel. There is minimal vegetation within the channel while the floodplain is thickly grassed with some trees. The main channel is approximately 3.5 -5 m while the floodplain is between 50-75 m. Bankfull depth within the main channel is 1.5 m. The channel substrate is mainly organic with some fines. The field crew sank 0.5 m into the bed of the channel at the time of the field visit. Erosion of the braided channels is evident.

Photo 15: Crossing 8 looking south; note oxbows and meandering channel. Floodplain approximately 50-75 m wide (July 3, 2014)

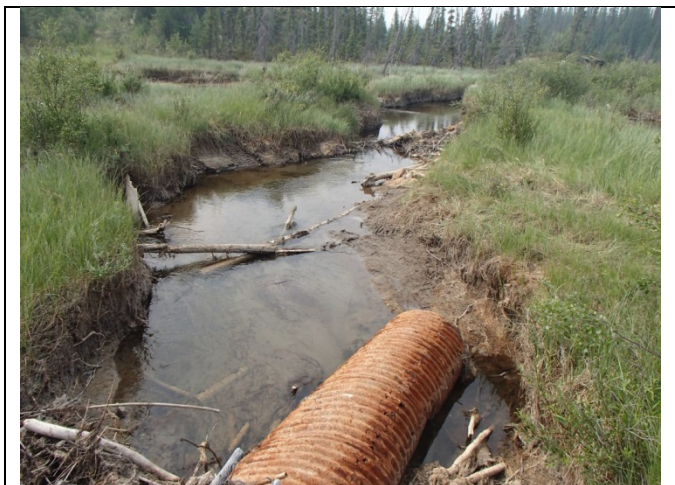
Photo 16: Crossing 8 looking west (upstream); grassed floodplain and organic substrate; note eroded banks with some undercutting (July 3, 2014)

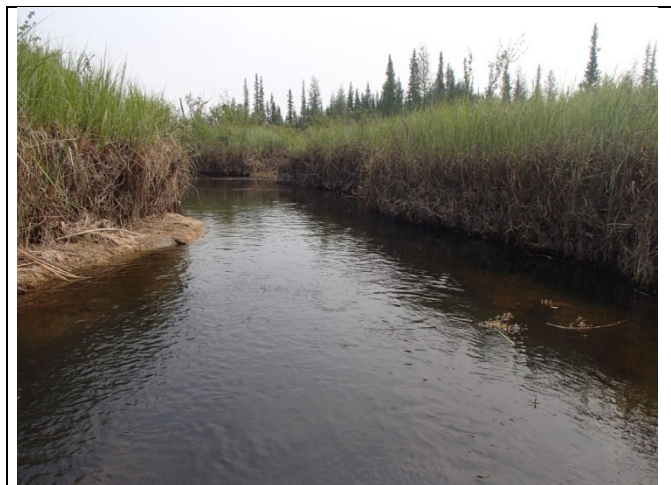
Photo 17: Crossing 8 looking east (downstream) from braided channel; bankfull width = 3.5 m, bankfull depth = 1.5 m (July 3, 2014)

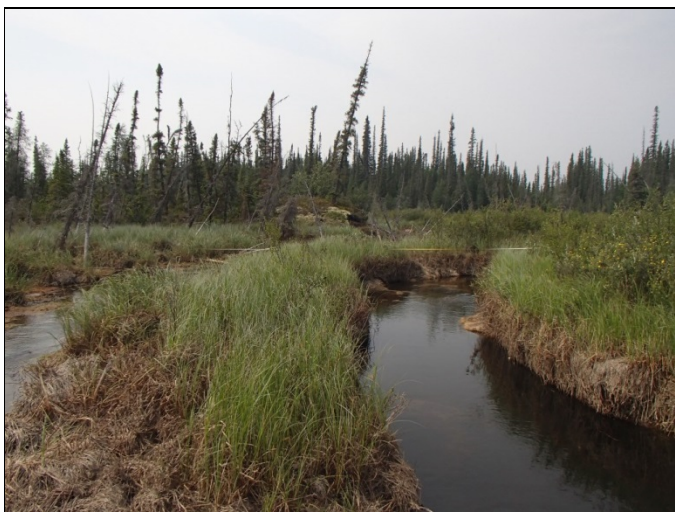
Photo 18: Crossing 8 looking west (upstream) at braided channel; floodplain is grassed with forest at edges, note high water level (July 3, 2014)

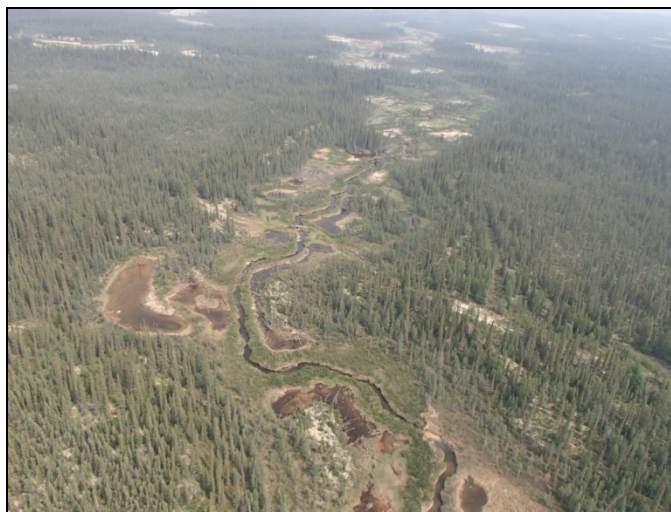
Photo 19: Crossing 8 looking east; meandering channel and oxbows and large floodplain downstream (July 3, 2014)

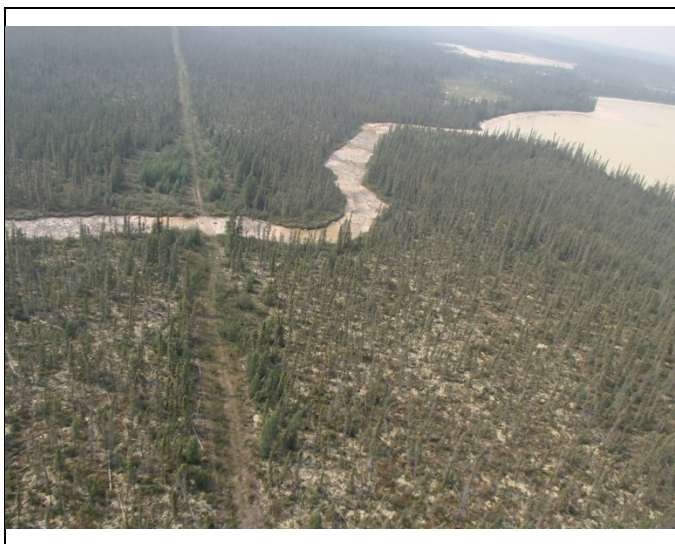
Crossing 9 is a major crossing and is a large, well defined, ephemeral stream. The main channel is an outlet for an upstream lake which flows during large rainfall events when the lake begins to spill. Stagnant water within the channel was observed at the time of the visit. The bankfull width and depth are 11.5 m and 0.80 m, respectively. There is no defined floodplain but the banks are forested. The channel bed consists of cobbles and gravel with some silt and muskeg.

Photo 20: Crossing 9 looking southwest; upstream lake at right edge of photo (July 3, 2014)

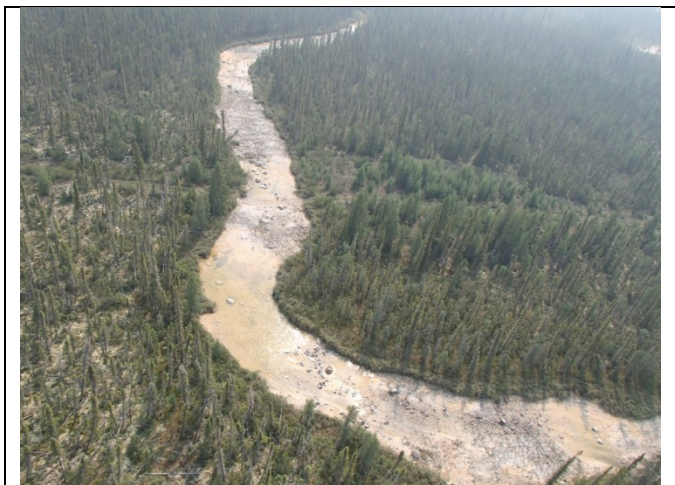
Photo 21: Crossing 9 looking east (downstream); well defined channel with no floodplain (July 3, 2014)

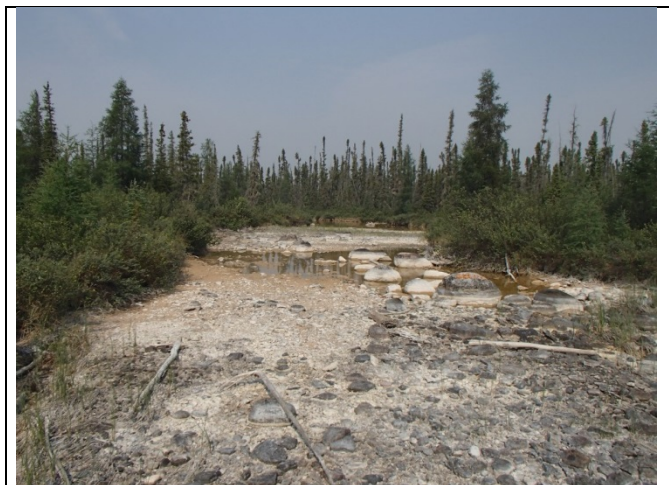
Photo 22: Crossing 9 looking west upstream from bed; note cobbles, gravel and muskeg substrate (July 3, 2014)

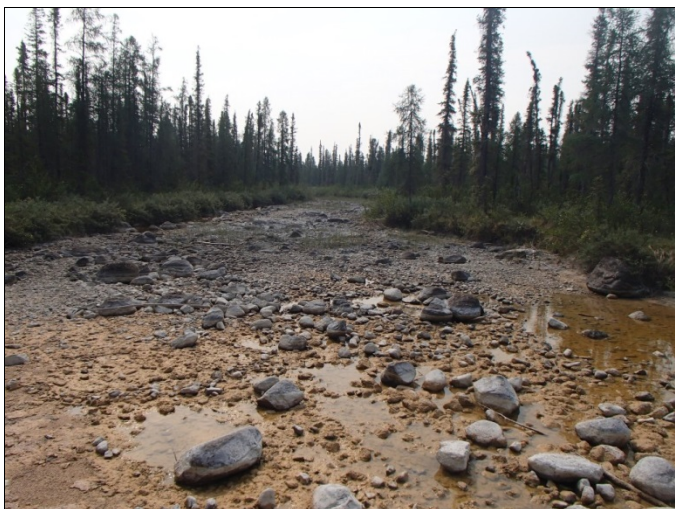
Photo 23: Crossing 9 looking east downstream; bankfull width = 11.5 m, bankfull depth = 0.8 m (July 3, 2014)

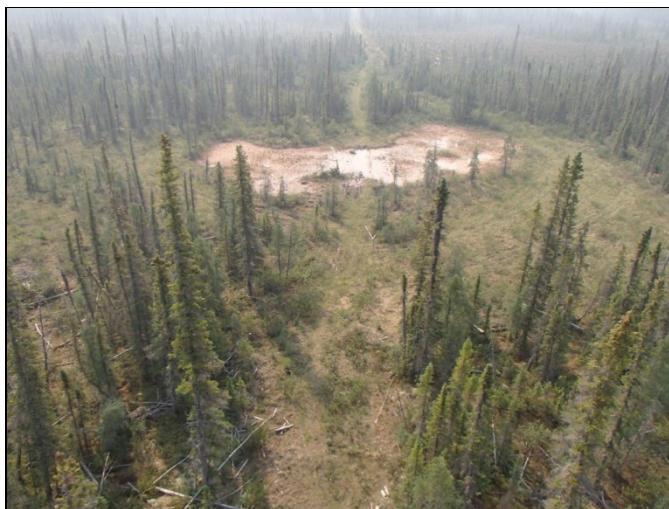
Crossing 10 is a low-lying area where ponding occurs during large rainfall events. There is no defined channel. The area is mainly marsh with muskeg, organics, and grass at the crossing. The surrounding area and floodplain is forested and grassed. The ponding area is approximately 15-20 m wide. A second potential crossing with a small, well-defined, meandering channel was observed just south of the proposed crossing area (see photos).

Photo 24: Crossing 10 looking north; ponding area with standing water (July 3, 2014)

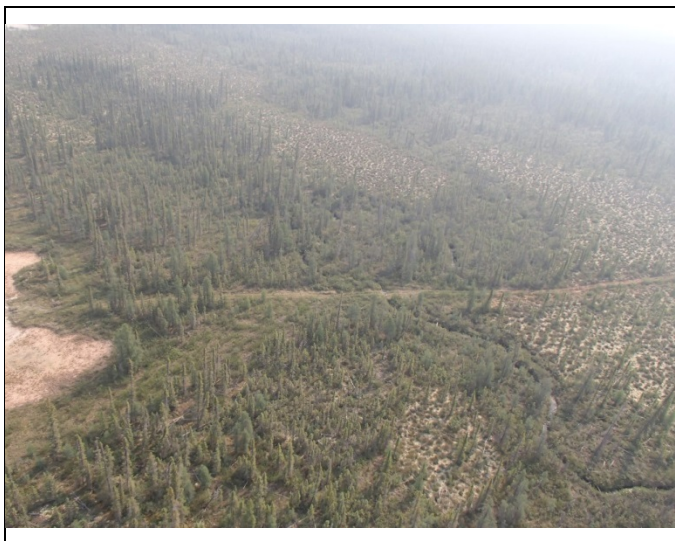
Photo 25: Crossing 10 looking southeast (downstream); crossing at left of photo with small channel crossing at right (July 3, 2014)

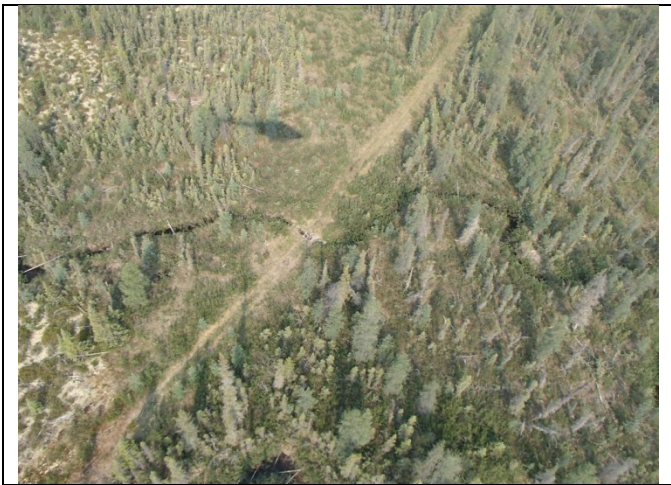
Photo 26: Crossing 10 looking at small channel just south of crossing (July 3, 2014)

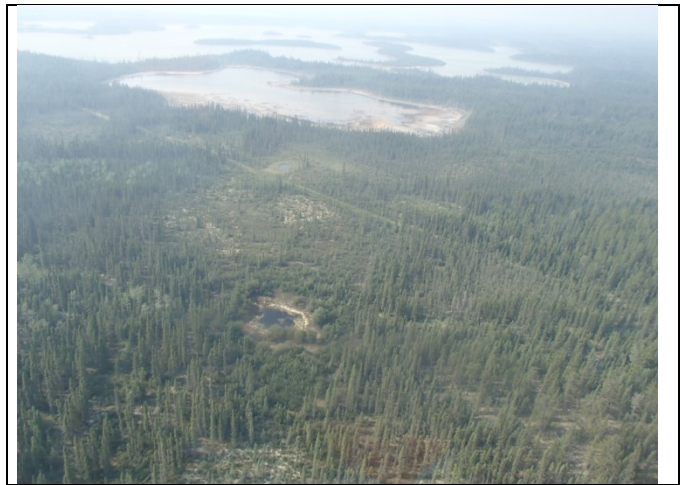
Crossing 11 is similar to 10 with a low-lying, ponding area at the crossing and no defined channel. The area is mainly marsh with muskeg, organics, and grass at the crossing. The area is bounded by two lakes approximately 100-200 m upstream and downstream of the crossing. The areas adjacent to the crossing are forested and grassed. Stagnant water was observed at the time of the field visit.

Photo 27: Crossing 11 looking southwest at upstream lakes; note extent of flooding around crossing with no trees (July 3, 2014)

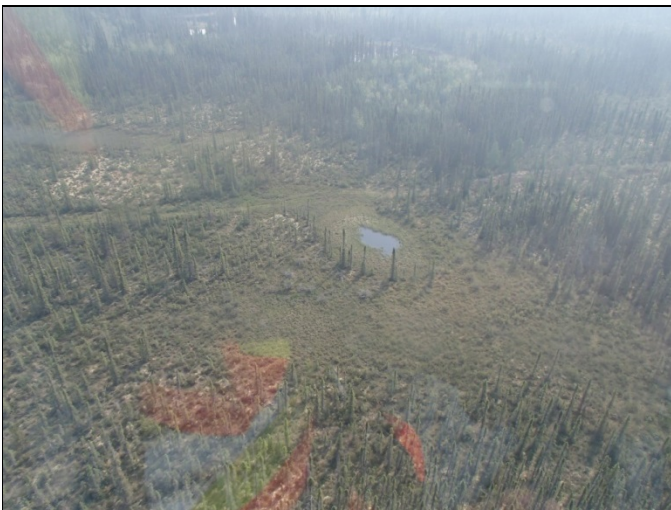
Photo 28: Crossing 11 looking southeast (downstream) (July 3, 2014)

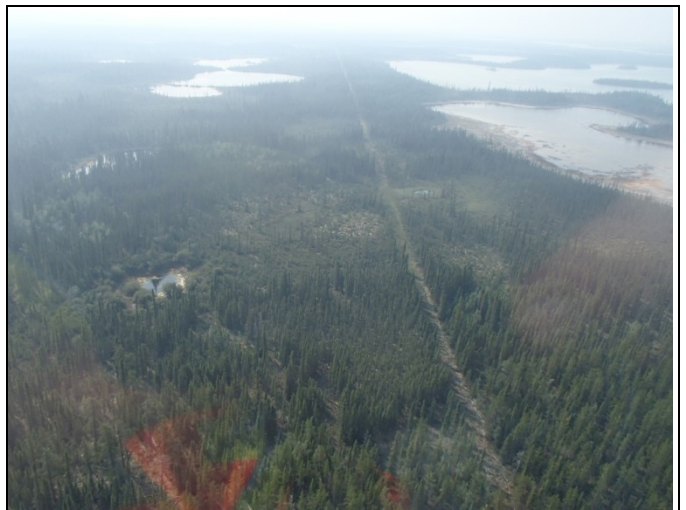
Photo 29: Crossing 11 looking south; upstream lakes and downstream marsh areas (July 3, 2014)

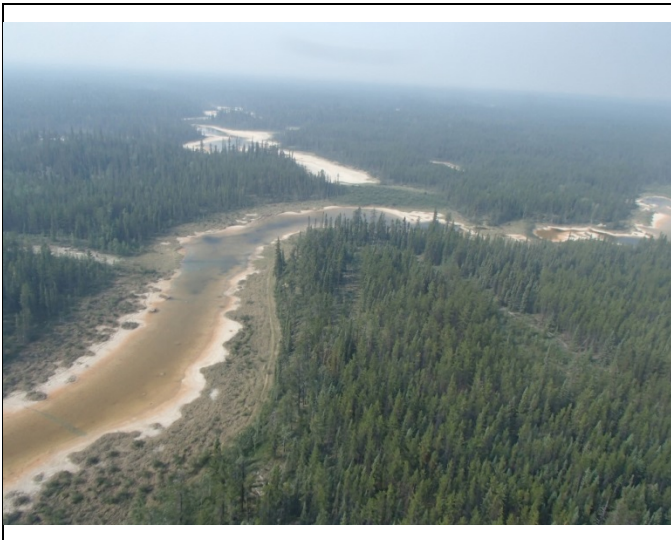
Crossing 12 was a well-defined, wide, meandering channel. No flow was observed but stagnant water was 0.55 m deep. Bankfull depth and width is 1 m and 31 m, respectively. The main channel is un-vegetated while the floodplain is grassed. The substrate within the channel is mainly organic with some fine material. Due to small, natural dams, the depth of water must be approximately 1 m before continuous flow occurs.

Photo 30: Crossing 12 looking northeast (downstream); note wide floodplain (July 3, 2014)

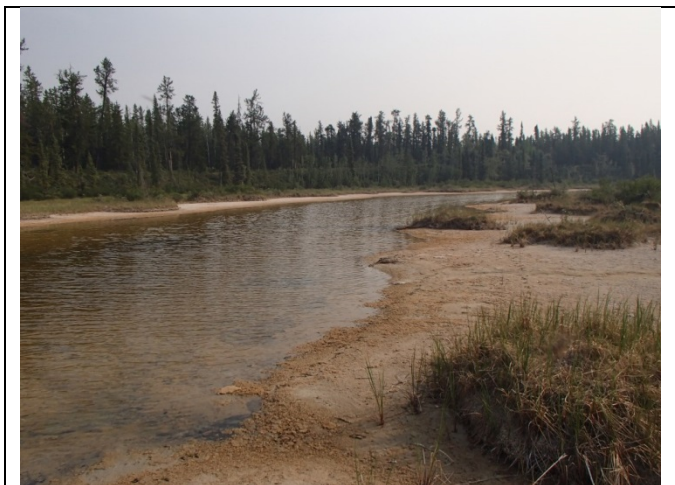
Photo 31: Crossing 12 looking northeast (downstream); bankfull width = 31 m, bankfull depth = 1-1.5 m (July 3, 2014)

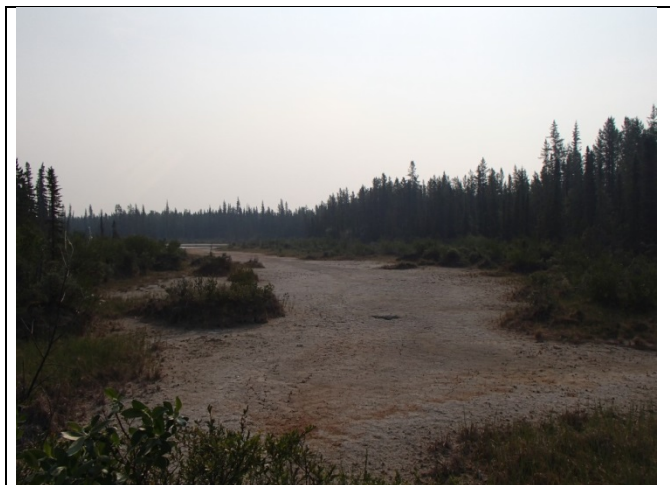
Photo 32: Crossing 12 looking east (downstream); note organic substrate and grassed floodplain (July 3, 2014)

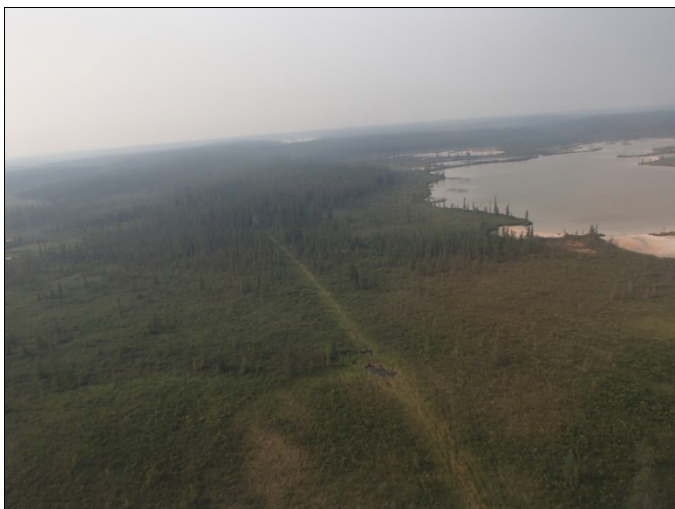
Crossing 13 is a low-lying marsh area bounded by small lakes. Stagnant water was observed at the crossing. Vegetation consists of small shrubs and grasses. Substrate appears organic.

Photo 33: Crossing 13 looking south; upstream lake and stagnant water at crossing (July 3, 2014)

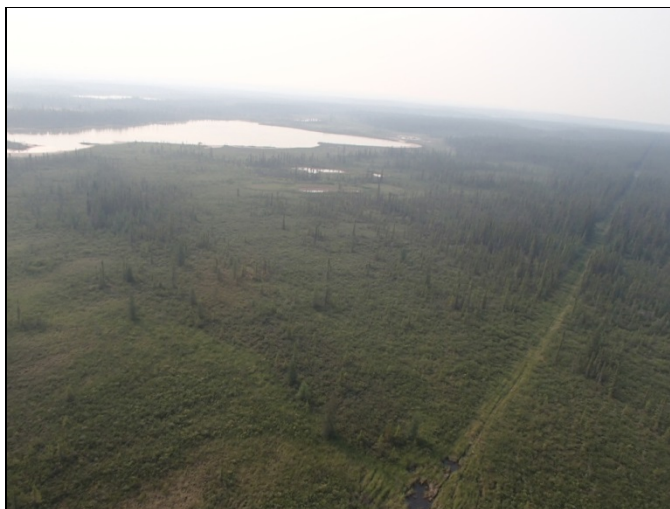
Photo 34: Crossing 13 looking southeast (downstream); no defined channel but wide, grassed area of flooding (July 3, 2014)

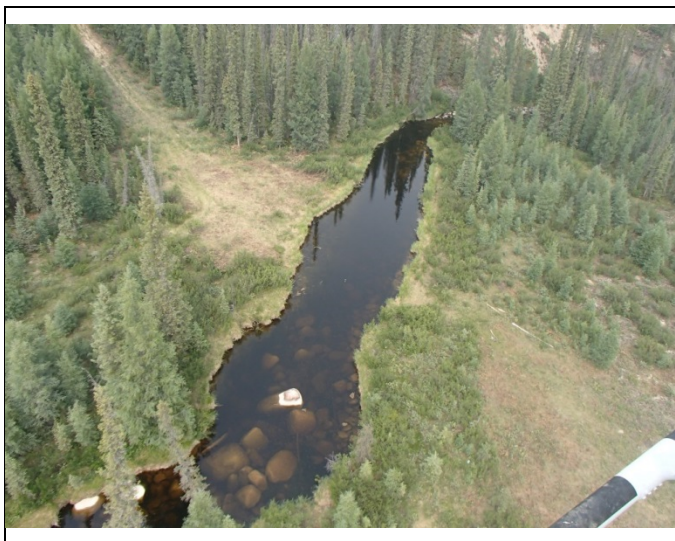
Crossing 14 is a major crossing and is a well-defined meandering channel with riffle-pool sequences. The distance between riffles is approximately 150-200 m. The proposed crossing is located at a pool. The bankfull depth and width at the crossing is estimated at 2.5-3 m and 10 m, respectively. Substrate in the channel is gravel and cobbles with some fine and organic material. The floodplain is grass with forest. The channel banks are undercut and erosion is evident. A higher waterline was observed approximately 0.3 m above the measured depth.

Photo 35: Crossing 14 looking north (downstream); deep pool at crossing with cobbles and gravel substrate, bankfull width = 10 m, bankfull depth = 2.5-3 m (July 2, 2014)

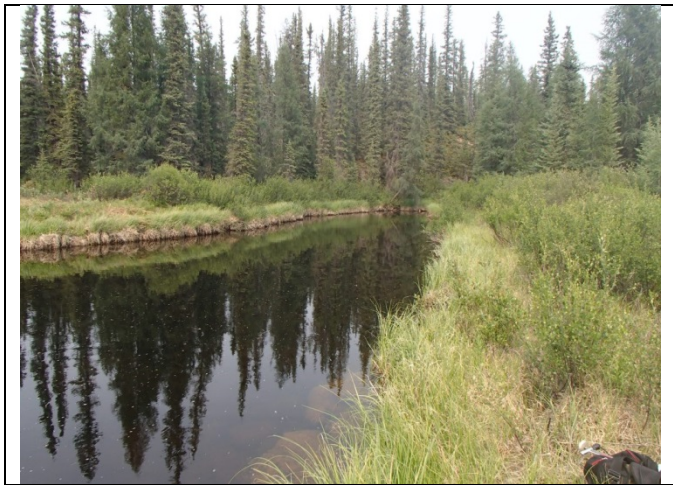
Photo 36: Crossing 14 looking northeast (downstream); wide, meandering channel with grassed floodplain and forest (July 2, 2014)

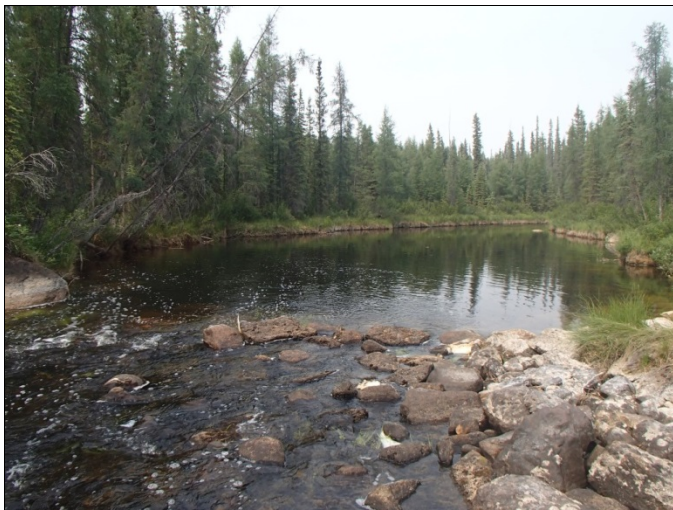
Photo 38: Crossing 14 looking northeast (downstream); upstream riffle looking to pool and crossing downstream (July 2, 2014)

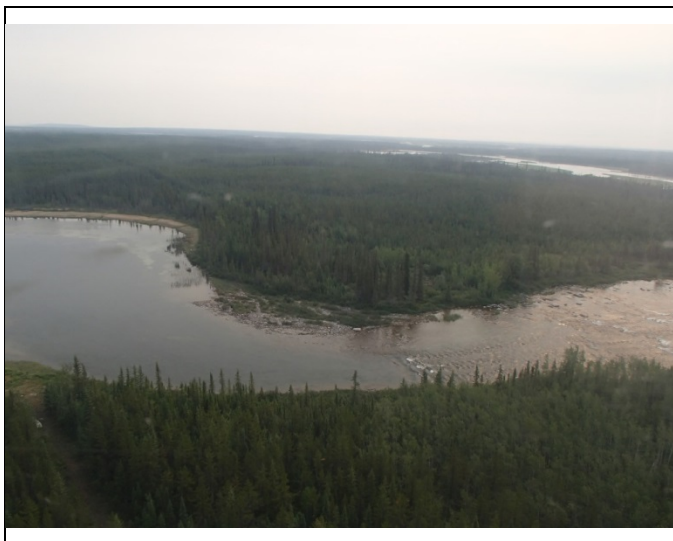
Crossing 15 is a major crossing at a set of rapids on Rivière La Martre and originates from Lac La Martre to the west. The bankfull width is approximately 50-60 m while the bankfull depth is estimated at approximately 3-4 m. The river substrate consists of large boulders and cobbles with gravel. Sediment deposition is evident downstream of the rapids where discharge velocities are much smaller (see photos). A set of falls is located approximately 3-4 km downstream of the rapids. The floodplain consists of marsh areas with tall grasses immediately adjacent to the river which are bounded by thick forest.

Photo 40: Crossing 15 looking north; upstream pool at river bend at left, crossing at rapids (July 2, 2014)

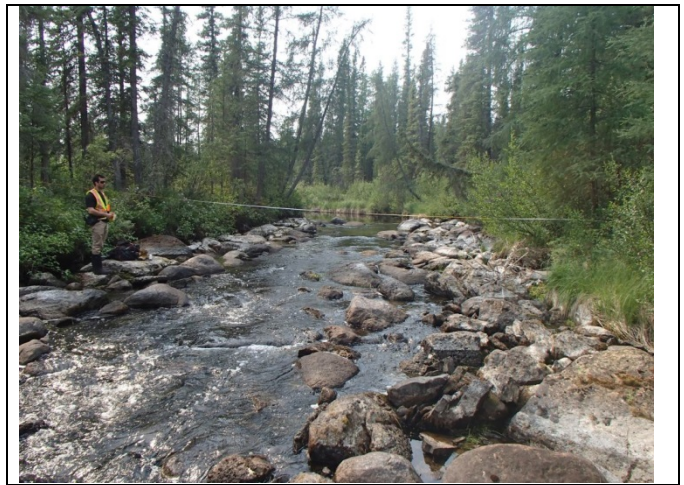
Photo 37: Crossing 14 looking west (upstream); riffle downstream of crossing with large boulders and cobbles (July 2, 2014)

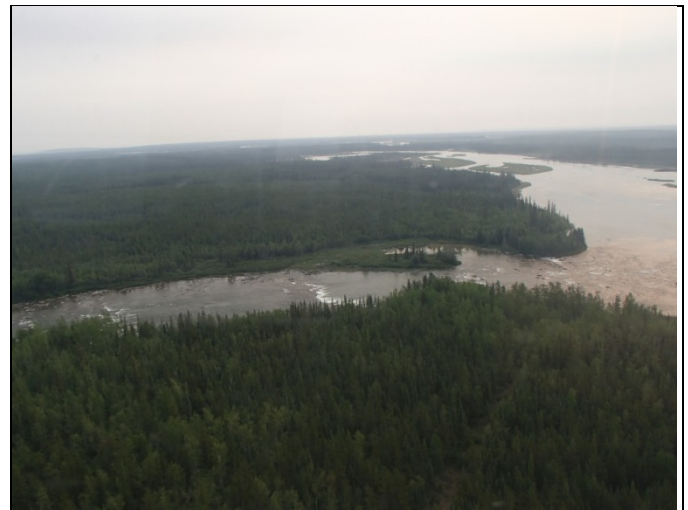
Photo 39: Crossing 15 looking north; note sediment deposition past rapids (July 2, 2014)

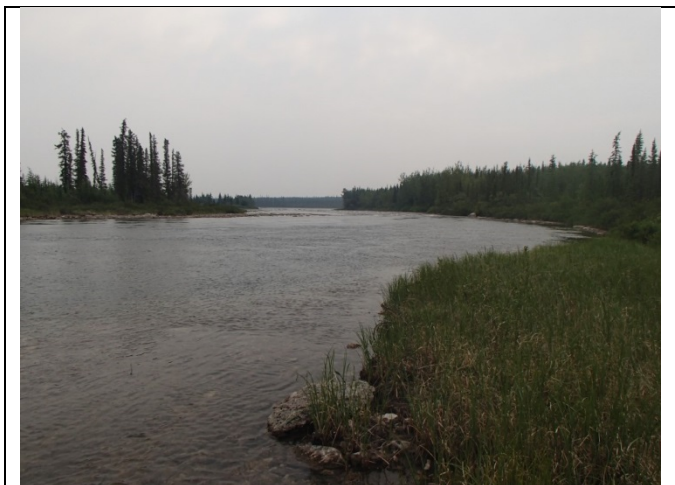
Photo 41: Crossing 15 looking east (downstream); grassed and forested floodplain (July 2, 2014)

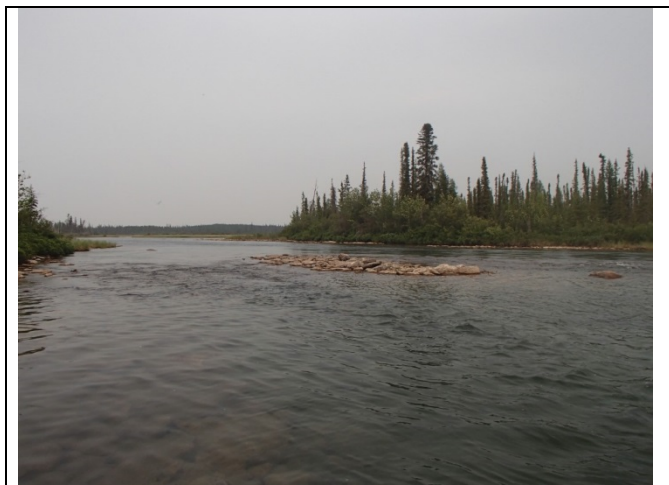
Photo 42: Crossing 15 looking west (upstream); at narrowest point upstream of crossing and river bend (July 2, 2014)

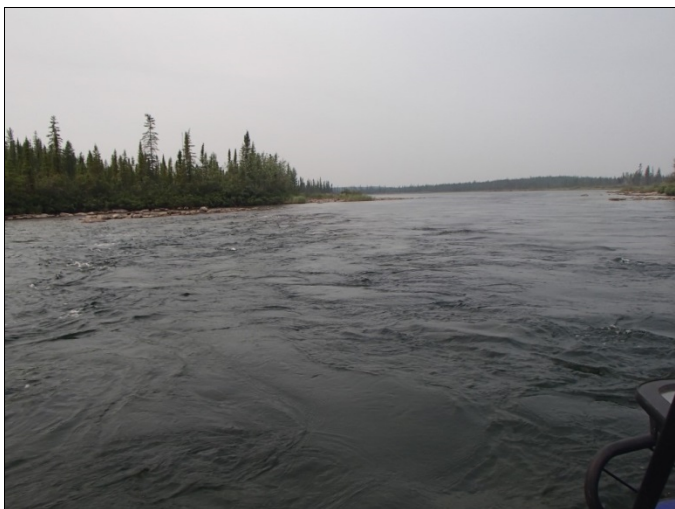
Photo 43: Crossing 15 looking west (downstream); note high velocities and eddies in channel (July 2, 2014)

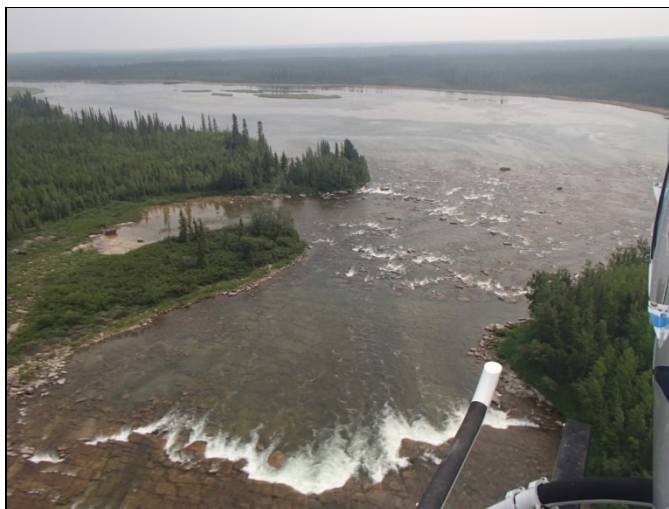
Photo 44: Crossing 15 looking northwest; rapids and downstream pool (July 2, 2014)

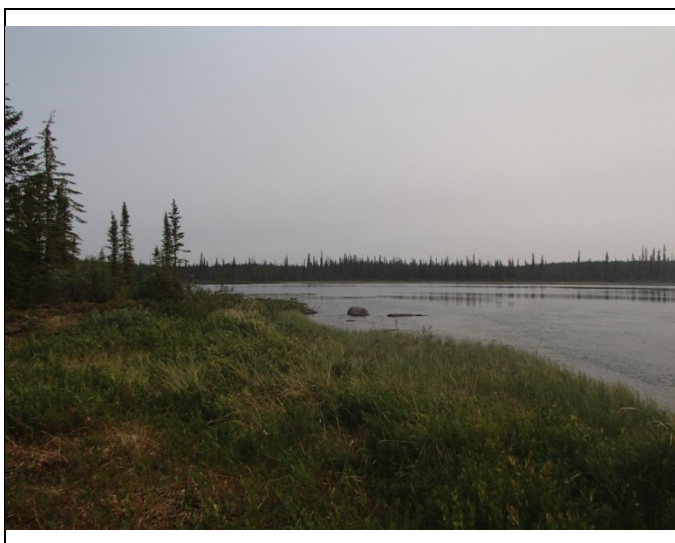
Photo 45: Crossing 15 looking northeast (upstream); grassed floodplain and pool at river bend (July 2, 2014)
