**Thor Lake Project – 2010 Phase I Site Investigation Results and Recommendations.
Report NB10-00556**

To:	David Swisher	Date:	January 25, 2011
Copy To:	Bill Mercer	File No.:	NB101-390/2-A.01
From:	Cara Stapley	Cont. No.:	NB10-00556
Re:	Thor Lake Project - 2010 Phase I Site Investigation Results and Recommendations

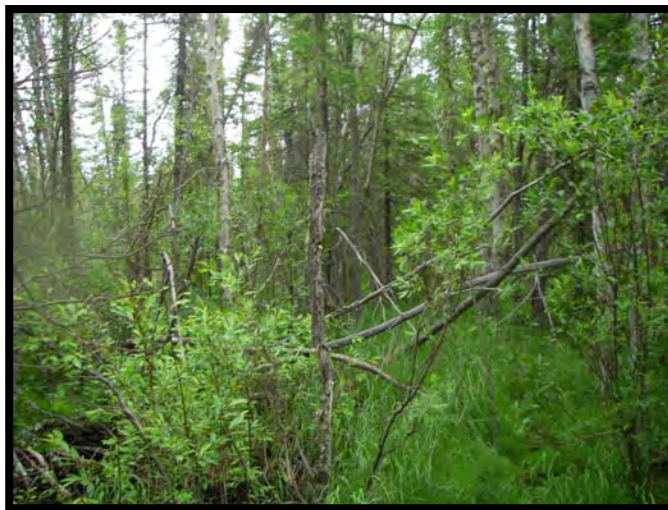
P5 – Buck Lake Outlet Looking SW

- The outlet to the Ring and Buck Lake basin is to the southeast end of Buck Lake as shown on Photos P5, P21, and P22 in Appendix A. There was no distinctive channel found between Buck and Drizzle Lakes. It appears that drainage from Buck to Drizzle Lake occurs as surface flow/seepage through the vegetation.

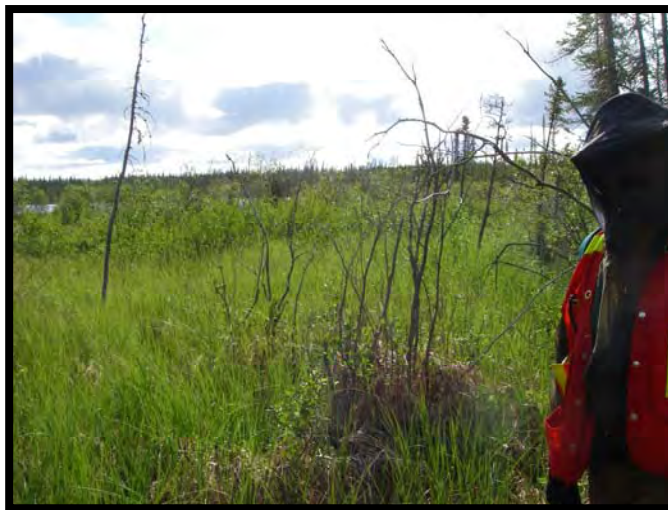
P11 Murky Lake Looking SW

- It is quite Marshy between Drizzle and Murky Lakes as shown in Photos P11 and P12 in Appendix A. A relatively shallow stagnant channel was found that connects the lakes at least during higher runoff periods.

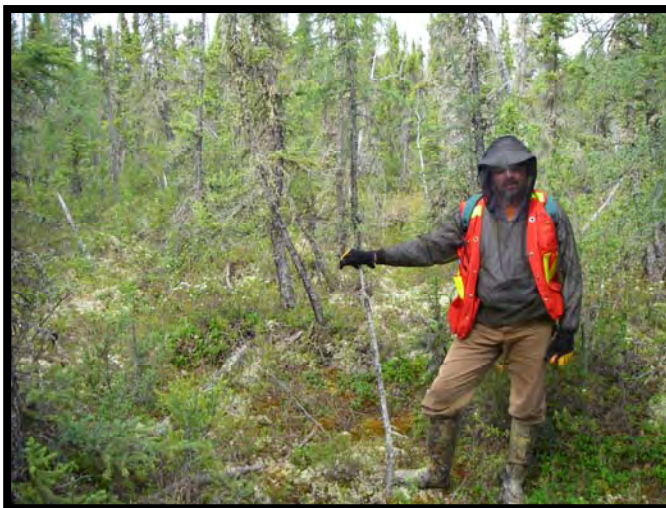
P13 – Excess Water Line Area

- The south side of Murky Lake consists of mostly overburden (Photos P13, P14, P15, and P16) although a bedrock ridge was encountered at P14. In addition, a permafrost feature thought to be a Palsa was encountered as shown on Photo P15. A flowing stream was encountered connecting Murky Lake to Thor Lake.

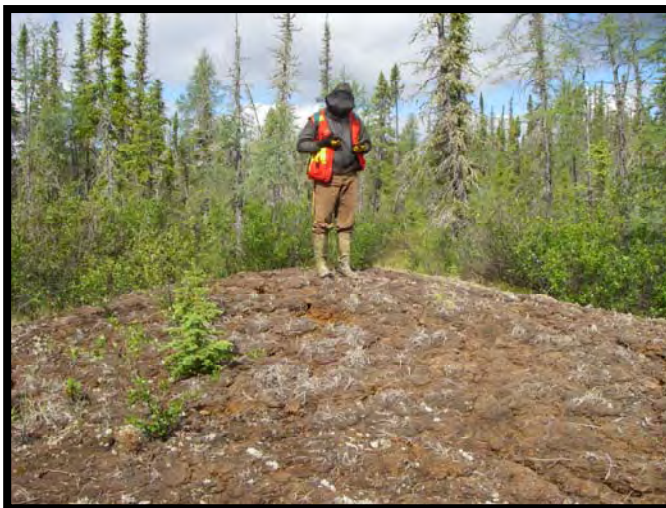
P15 Permafrost Feature

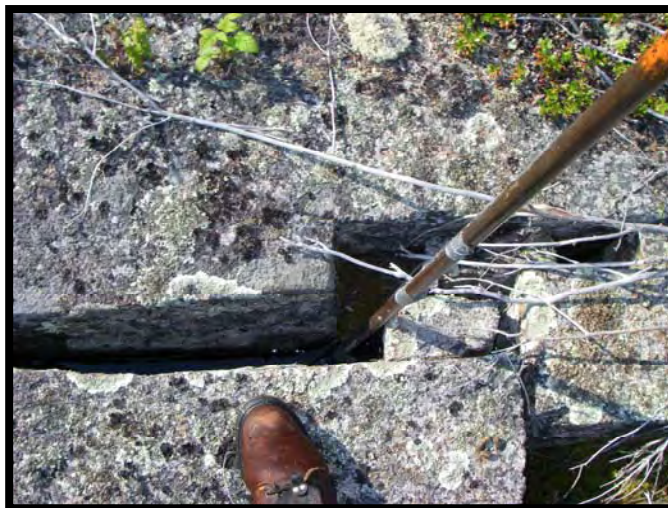
P27 Bedrock Frost Jacking
