Date: September 6, 2016
From: John Wilcockson
To: David Harpley, Canadian Zinc Corp
Subject: **All season road supplementary habitat information**

HCP Ref No.: CZN7932

The purpose of this memo is to provide supplementary habitat information specific to the proposed Prairie Creek all season road.

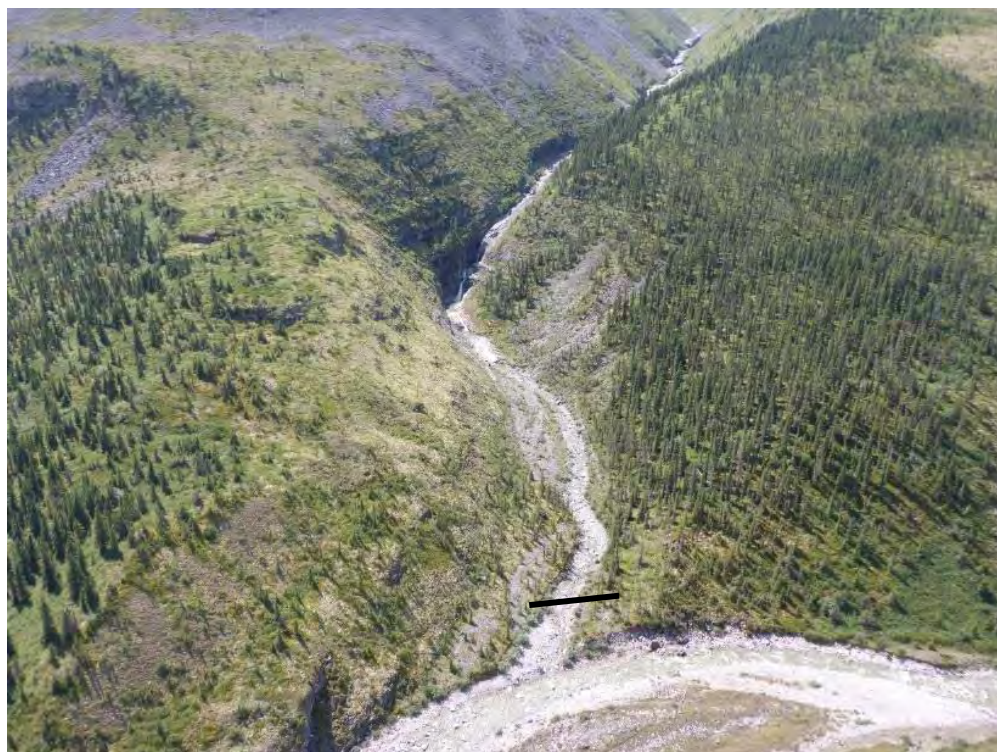
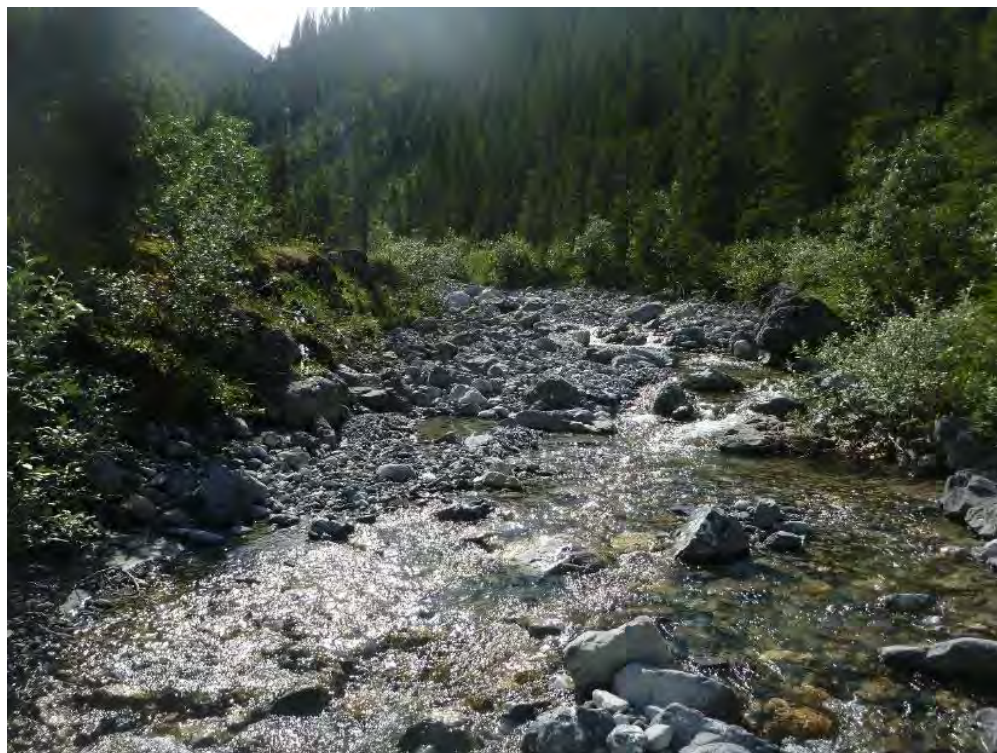
The preferred road alignment between km 28 and 29 was changed after DAR submission. Consequently, two main stem crossings, at km 28.2 to 28.7, were avoided and a single tributary crossing was added at 28.6. The habitat reconnaissance conducted at km 28.6 in July 2016 identified habitat suitable for Arctic grayling for rearing and migration at the site of the crossing. Substrate tended to be coarse and flow was fast. There was negligible cover for fish. Approximately 180 m upstream of the crossing are a series of high gradient shoots and waterfalls preventing upstream fish migration. It is possible that fish spawning habitat exists upstream of the crossing; however, habitat at the crossing location only offers rearing or migration habitat. The intent of the open span bridge planned for the crossing is to avoid encroaching on instream aquatic habitat, thus we do not anticipate any permanent loss of alteration of habitat (Figure 1).

Figure 1 **New crossing at km 28.6 (Tributary of Sundog Creek, looking south, aerial shot).**

Figure 2 **Habitat at new crossing location (km 28.6, tributary of Sundog Creek, looking south).**

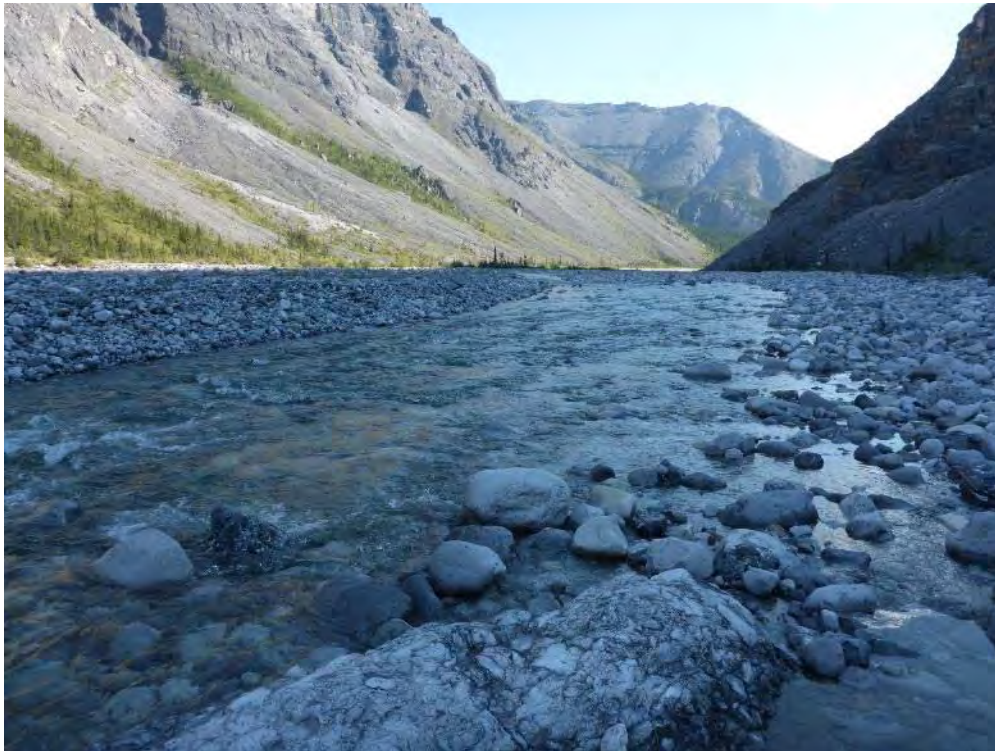
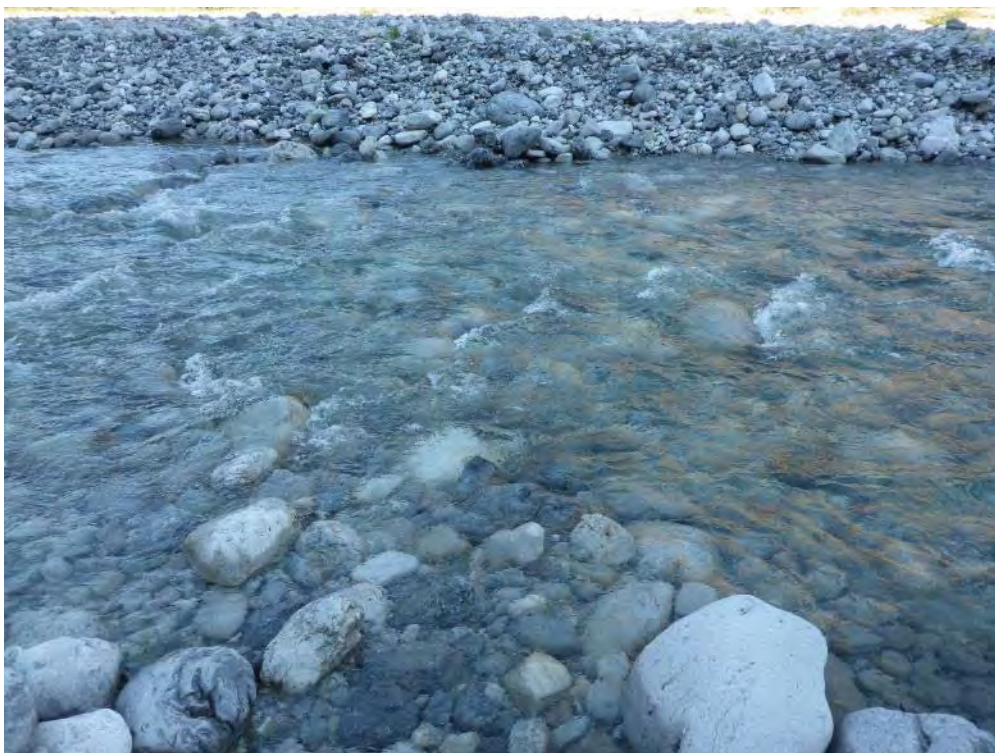
The aquatic habitat in Sundog Creek between km 30 and 40 generally consists of fast riffle habitat (~80%) with associated cobble substrate (Figure 3, Figure 4). This habitat provides potential migratory habitat for Arctic grayling, and potential spawning and rearing habitat for slimy sculpin.

Figure 3 Sundog Creek looking downstream, showing most common morphology (fast riffle).

Figure 4 Sundog showing most common substrates (flow to the right).

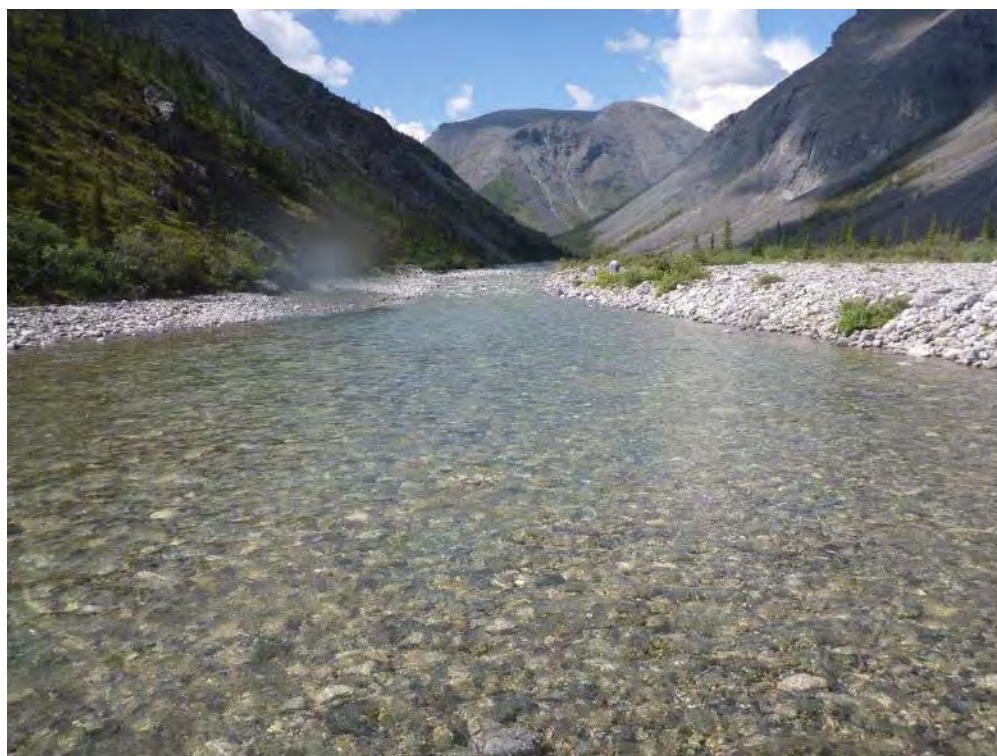
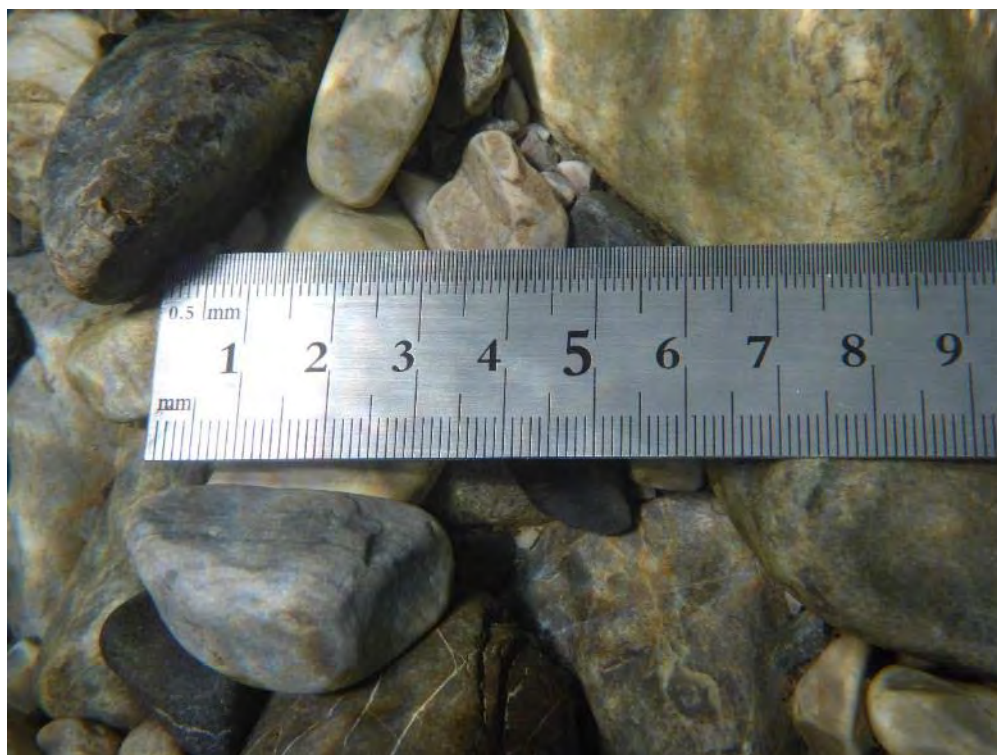
Between 15 and 20% of habitat in this section of Sundog Creek consists of a slower riffle (Figure 5 and Figure 6). The habitat here is characterized by the presence of large gravel. These substrates are within the size range used by Arctic grayling for spawning². However, Arctic grayling generally use tributaries for reproduction and it is uncertain whether they use the large gravels in the slower riffles found in the thalweg and secondary channels of Sundog creek. Slimy sculpin may use this habitat for rearing, but due to the smaller size of substrate, it would provide less cover and refuge from flow².

Figure 5 Sundog Creek, slow-riffle habitat occurring in 15 to 20% of the stream.

Figure 6 Sundog Creek, substrates common to the slow-riffle habitat.

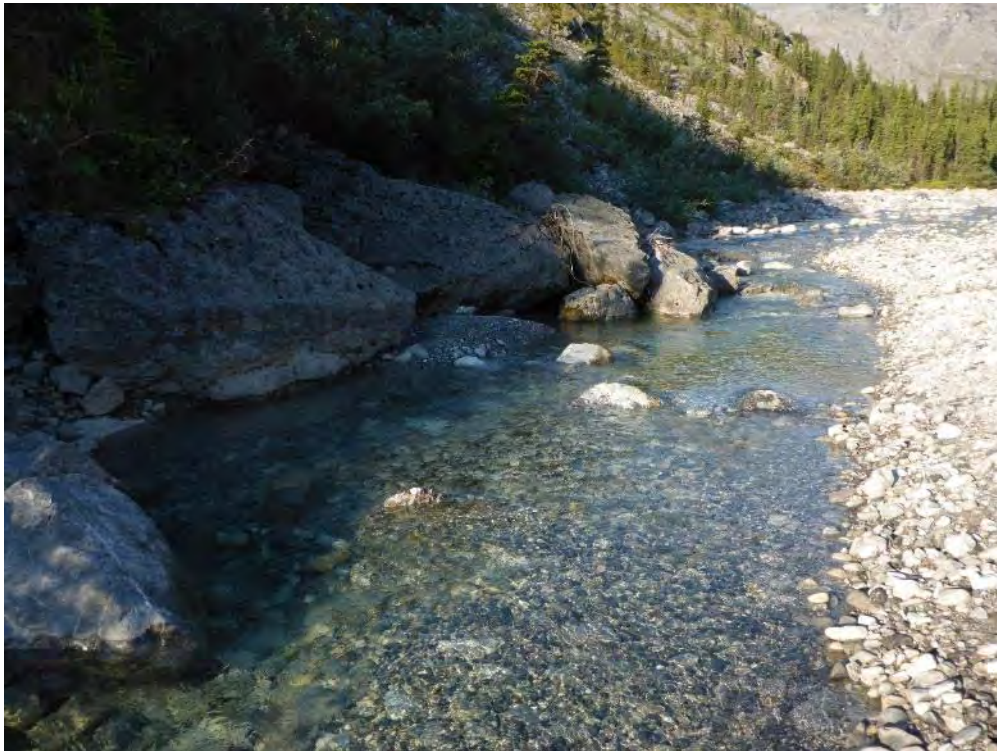
Less than 5% of habitat by area in this section of Sundog Creek consists of pools and back-eddies typically located behind boulders and encroaching bedrock (Figure 7). Substrates vary from sand to small boulders. There are pockets of fine gravels which would appear to be good spawning habitat for Arctic grayling (Figure 8). The boulders also provide refuge to grayling and sculpin during freshet and periods of greater flows after large precipitation events. The diversity of substrate, depths and flows created by the boulders create good rearing habitat for both Arctic grayling and slimy sculpin. The deepest (and largest) of the pools observed was at km 35.3, which was 1.5 m deep and approximately 10 m long at the time of survey (Figure 9 and Figure 10). This pool is immediately upstream of the proposed diversion and outside of the road envelope and therefore would not be affected by the all-season road construction. This pool is not likely to provide overwintering refuge, as it is anticipated that the depth of water would decrease substantially in the fall and winter, and therefore it is likely the residual pool would freeze to bottom. Ice thickness in the Nahanni region is typically 1 m in winter. The remainder of pools observed were smaller and less than 70 cm deep, and would likely freeze to bottom in winter.

Figure 7 Sundog Creek showing side channel with boulders along south margin (looking upstream).

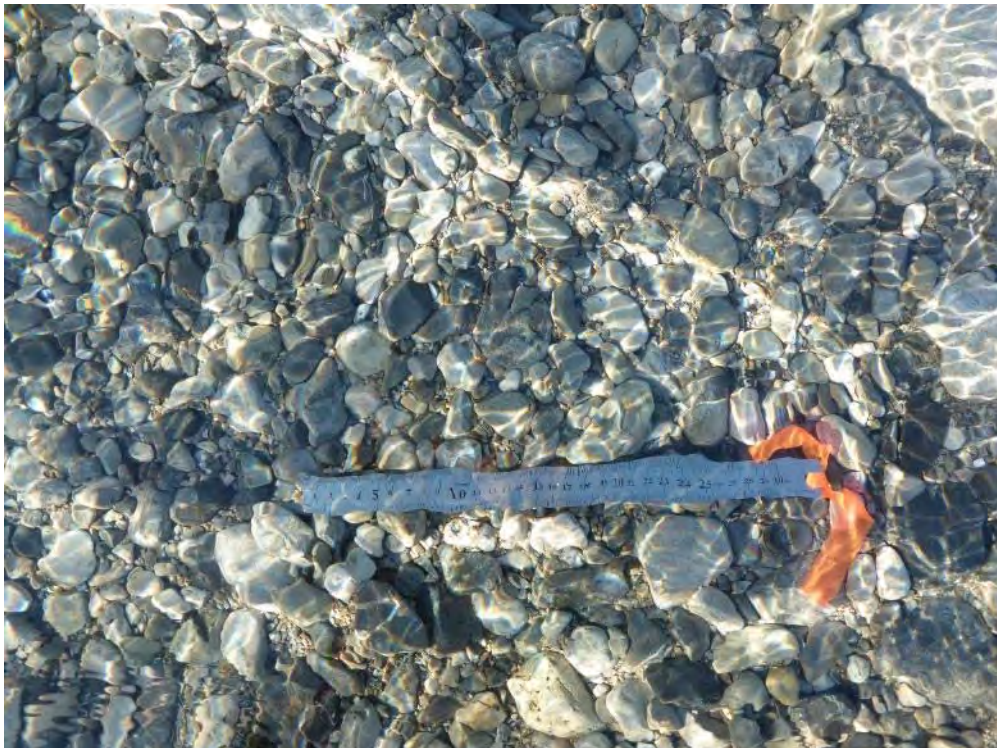
Figure 8 Sundog Creek - Pockets of smaller substrates often found downstream of boulders and pools.

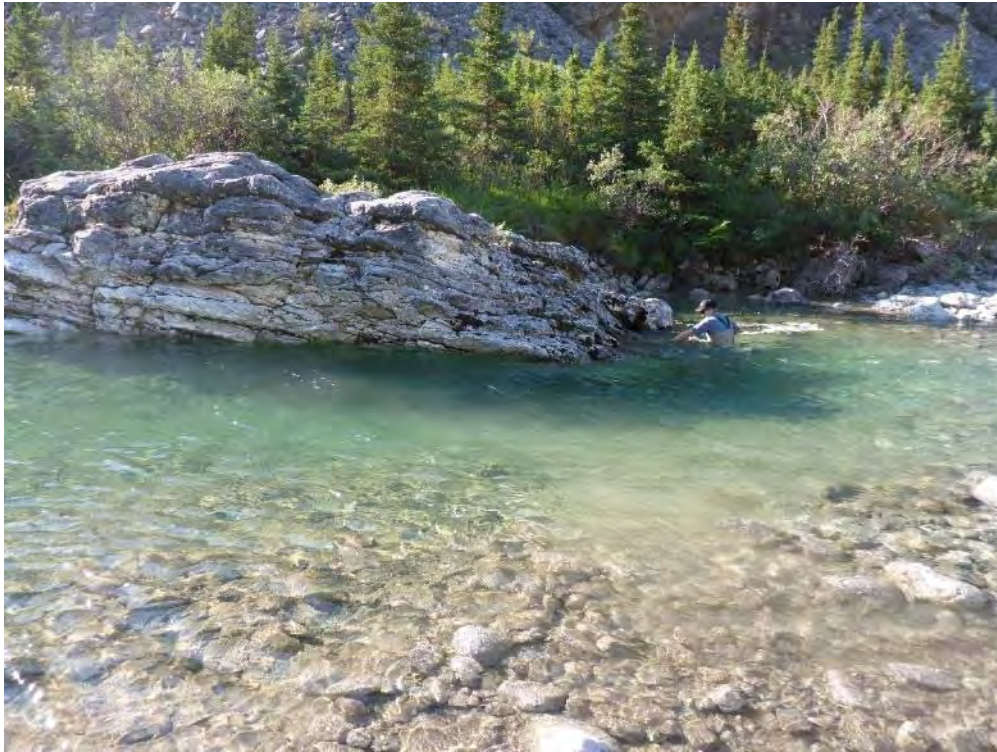
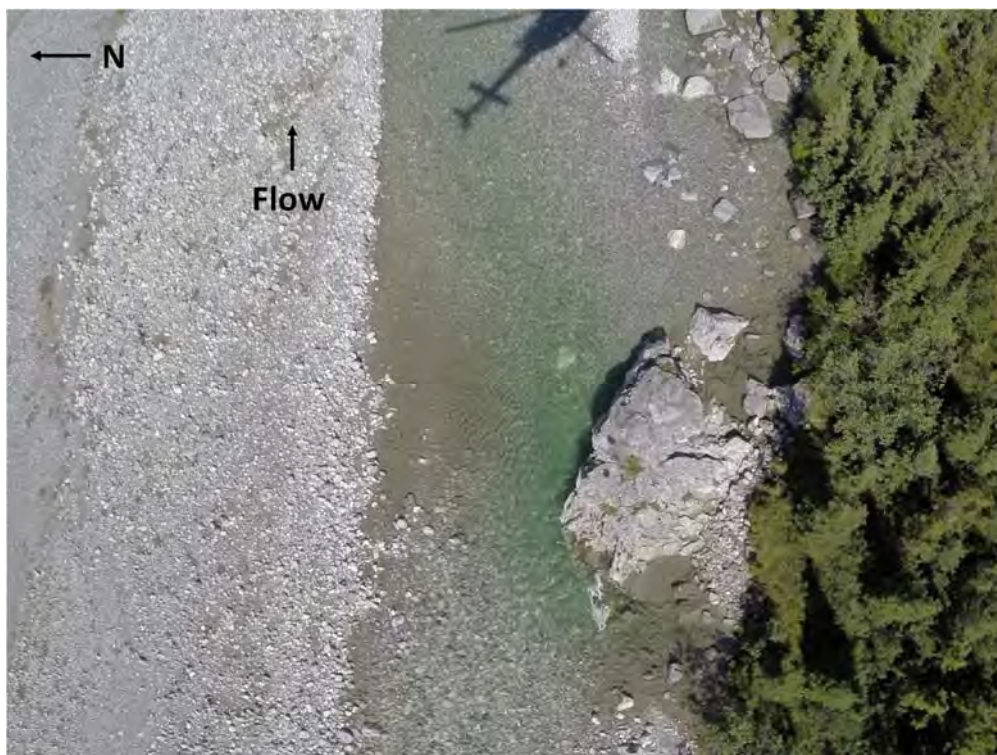
Figure 9 Sundog Creek – largest pool observed adjacent to the all season road.

Figure 10 Sundog Creek – largest pool observed adjacent to the all season road – aerial view.

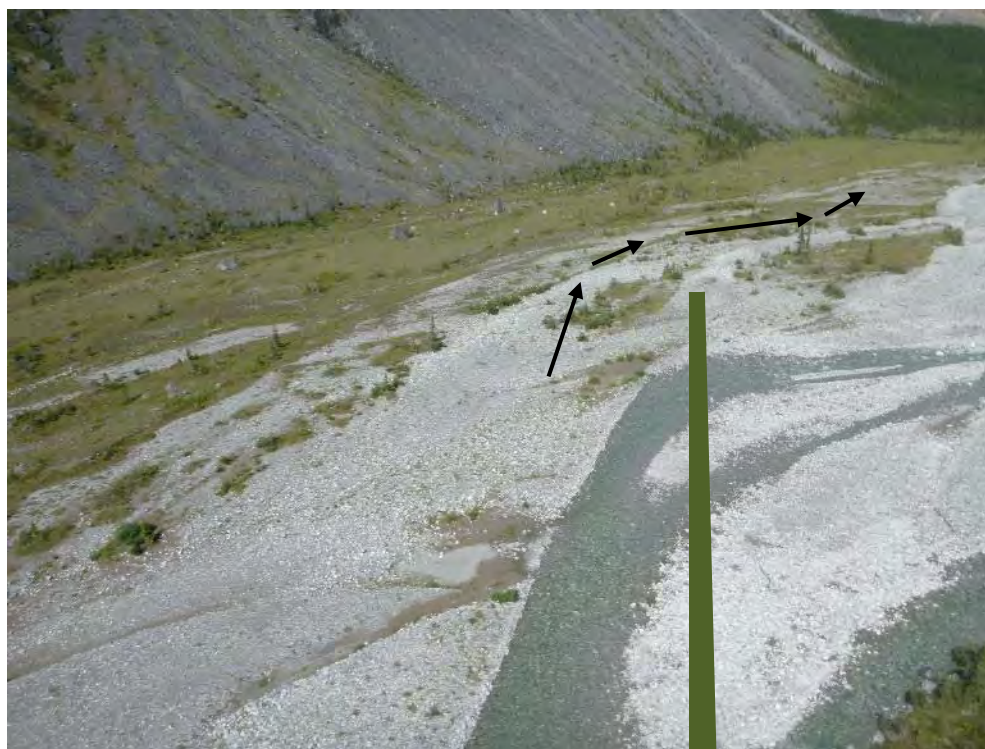
At the upstream extent of the diversion, there are currently two side channels from the existing main channel branching off the thalweg to the south. A diversion berm would be placed parallel to the thalweg upstream of the new channel to cut off the side channels and the thalweg as it takes a right hand turn to head east (Figure 11). A preliminary design of the diversion has been provided by Tetra Tech (2016). At the head of the new channel, substrates consist largely of cobble imbedded in sand (Figure 12). Fine material is generally deposited at the head of old channels as a stream begins to adopt a new channel (Bill Rozeboom, Tetra Tech, pers. comm.). Downstream of the head of the new channel, the morphology appears to be similar to the existing channel, having varying gradients and channel widths. There were several locations having accumulations of sand in the channel, which would have deposited as the thalweg was diverted away.

Figure 11 Location of proposed diversion with estimated location of berm (in green), km 35.4, photo looking north-east.

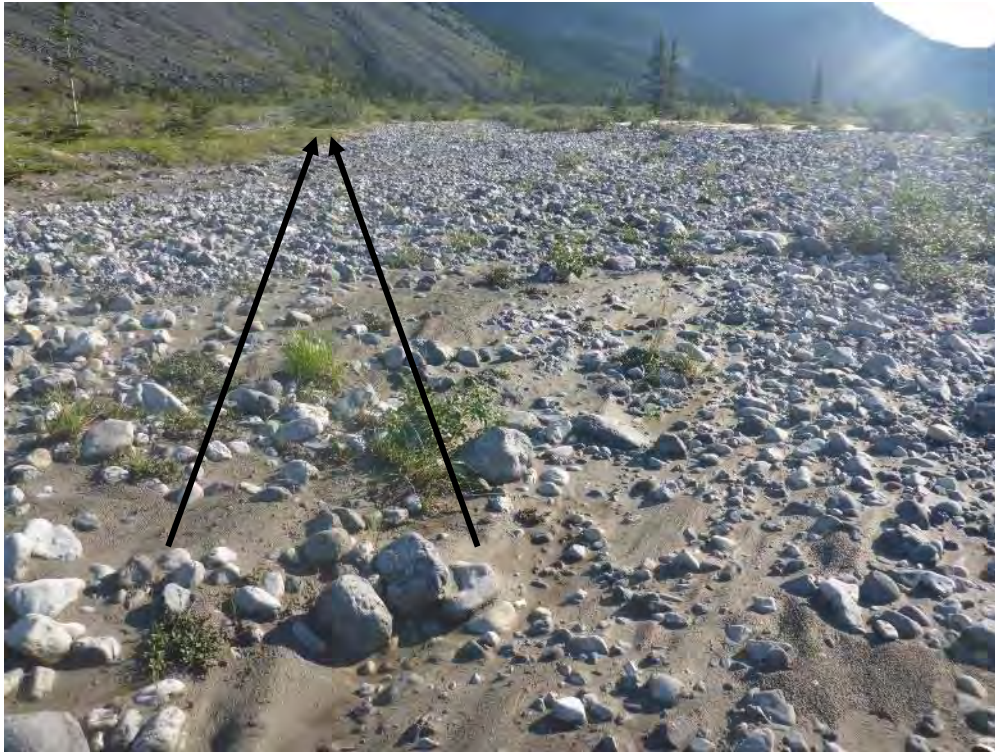
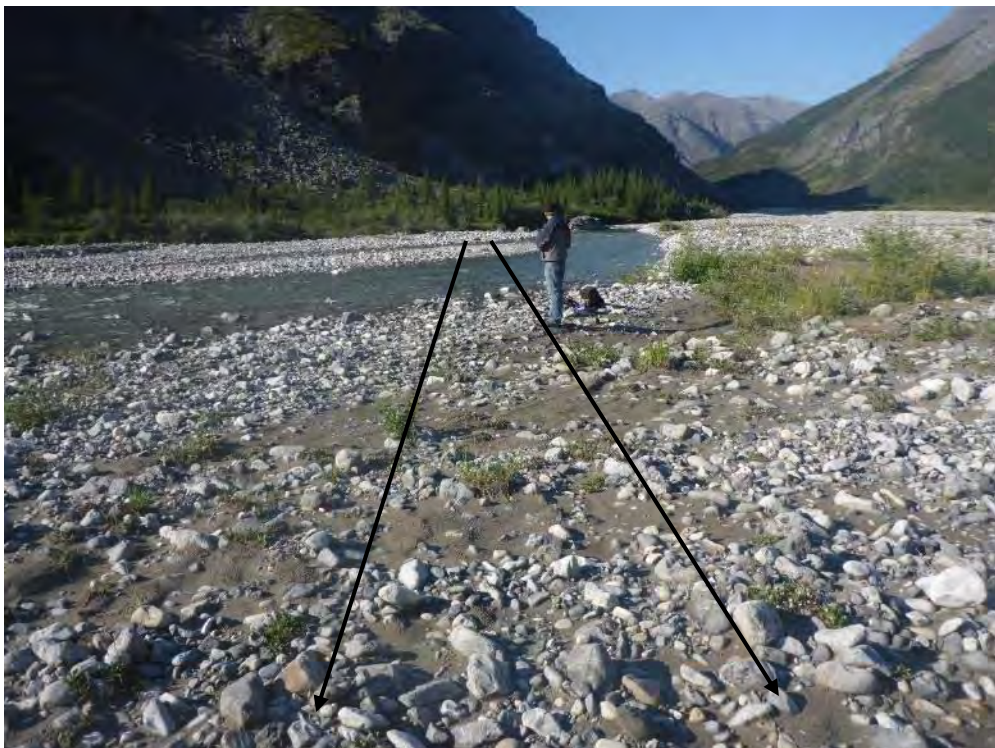
Figure 12 Ground-level shot looking downstream in proposed future wetted channel.

Figure 13 Ground level shot looking upstream showing connection to proposed future wetted channel.

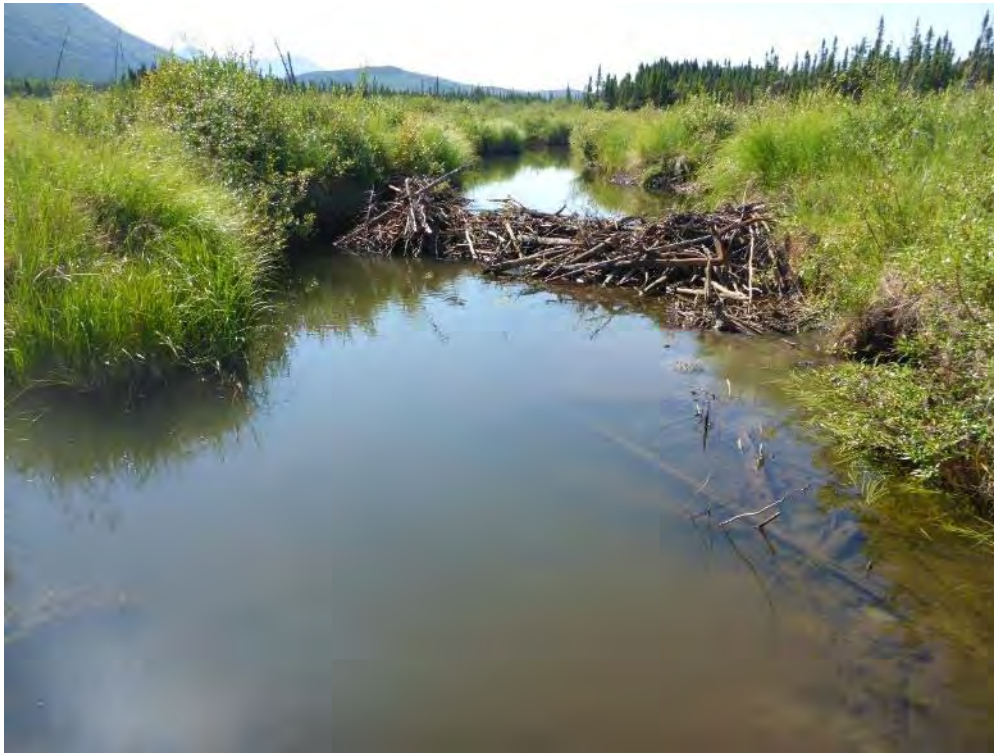
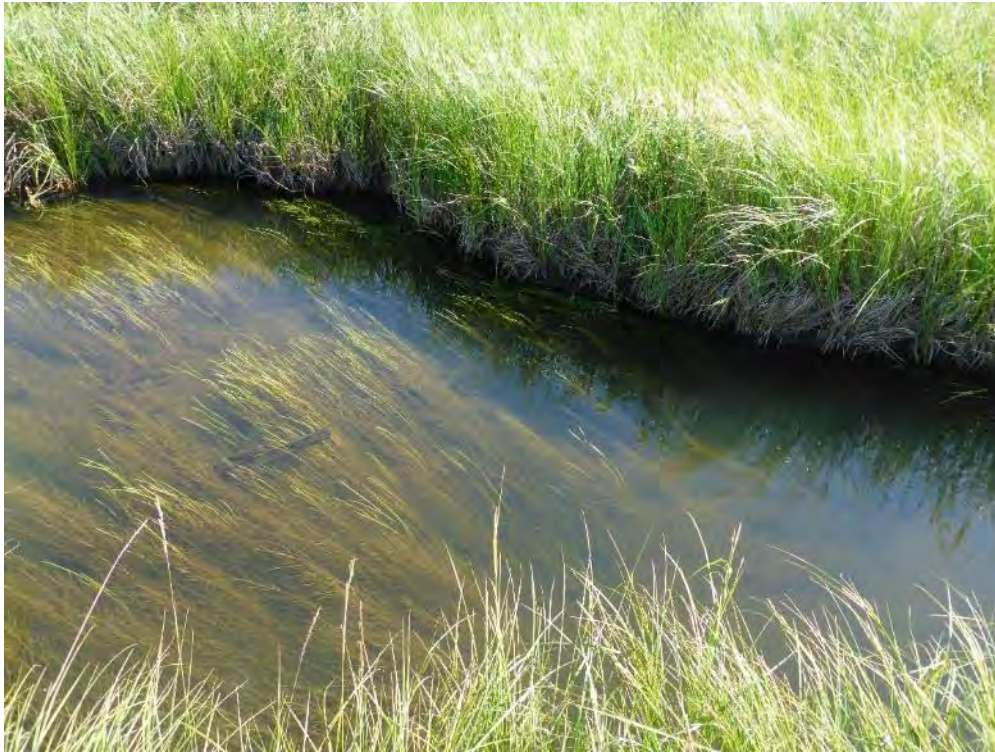
The new alignment crosses a north-flowing un-named creek. This creek consists of low-gradient meandering channels, having a high frequency of beaver dams. Observations suggest that this stream provides poor fish habitat. The site reconnaissance in July 14, 2016, found moderate dissolved oxygen concentrations (7.6mg/L), abundant instream vegetation, and swimming insects suggesting the absence of fish³.

Figure 14 **New crossing near km111.3 Unnamed Creek; photo looking south (upstream).**

Figure 15 **New crossing near km111.3 Unnamed Creek.**

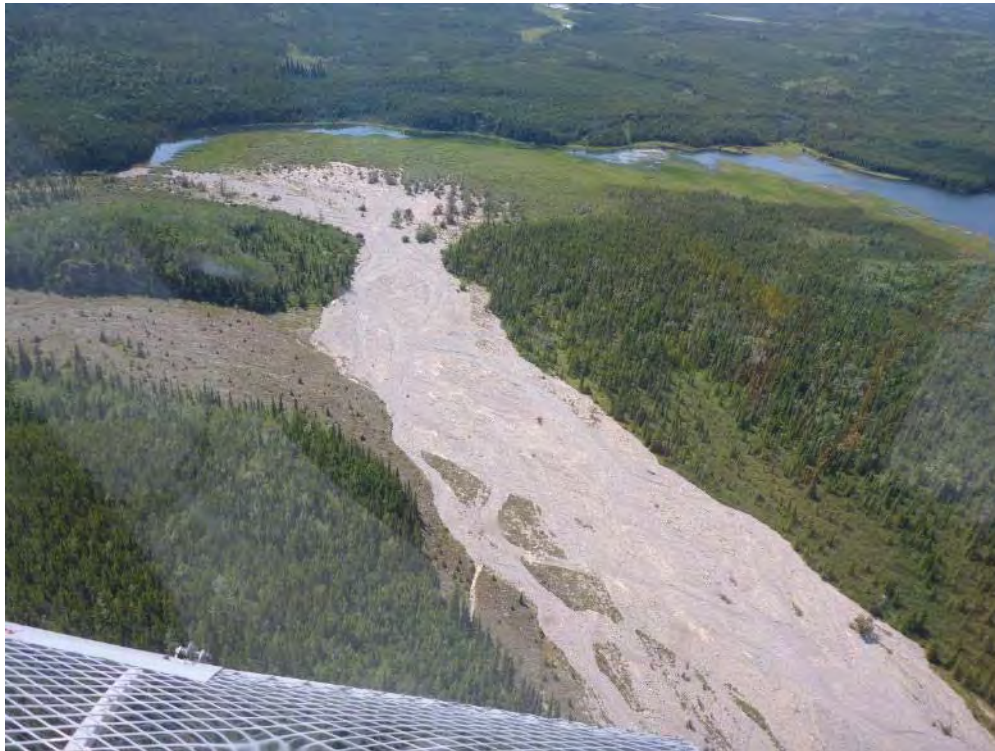
At km 119, the road crosses a large alluvial outwash fan. This outwash fan drains a mountainous watershed approximately 8 km long, and drains into the Grainger River as it exits Gap Lake. It was completely dry during field visits in July and September 2014 and July 2016. It is anticipated that the only time it is wetted is during large rainfall events coinciding with rapid melting of snow on adjacent mountains. Due to the highly ephemeral nature of this water feature, it is unlikely to provide aquatic habitat.

Figure 16 **km 119 – Crossing of alluvial outwash fan (near bottom of photo); photo looking South.**

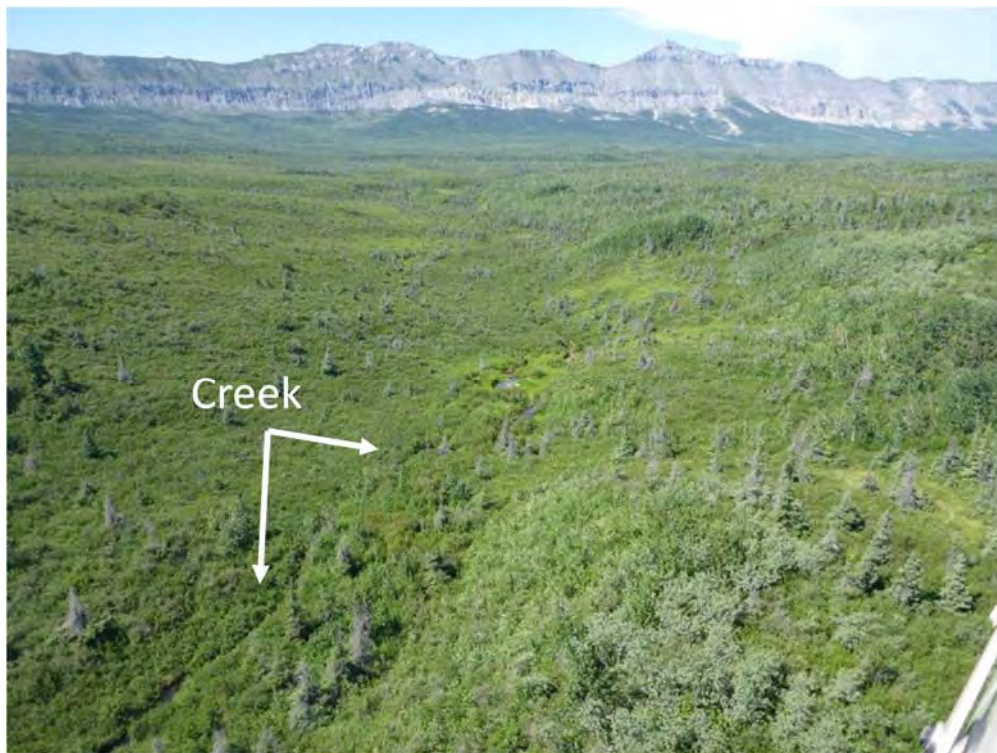
Between km 126 and 143 small tributaries flowing from the east side of the first Nahanni Range flow east towards progressively lower gradient slopes (Figure 17). These streams typically drain to wetlands or are beaver impounded (Figure 18). It is believed that these streams are not accessible to fish at the road crossings.

Figure 17 Tributary to Granger River showing decrease of gradient with distance from Nahanni Range (i.e., downstream of proposed road) ~km 128 – 139; photo looking west.

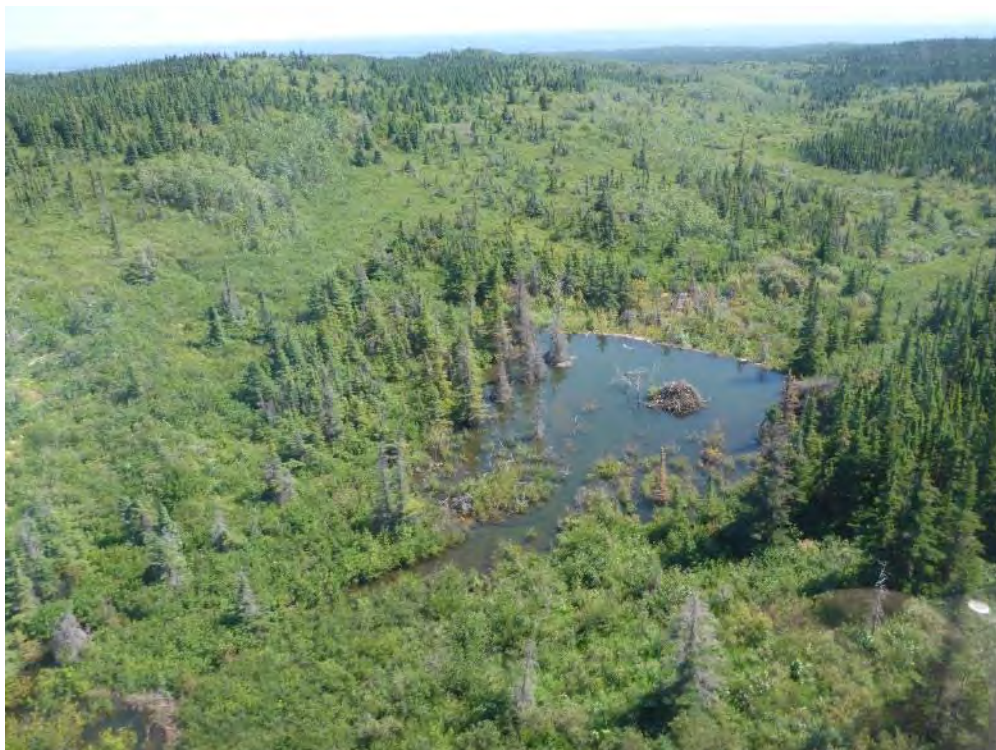
Figure 18 Beaver dam on tributary to Granger River ~km 136.

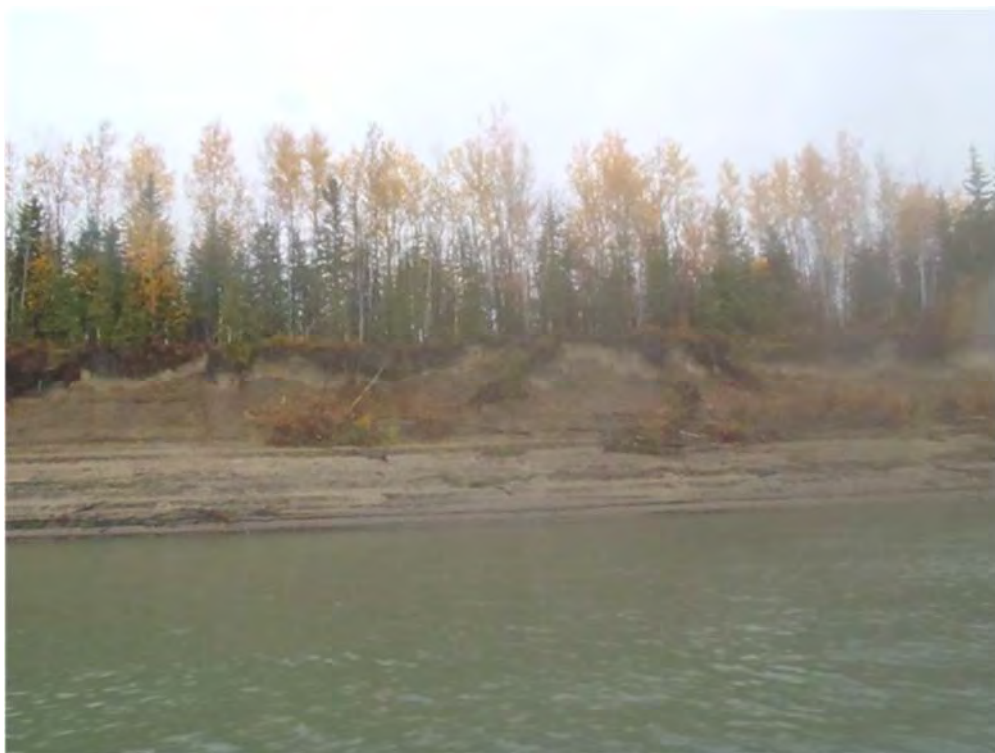
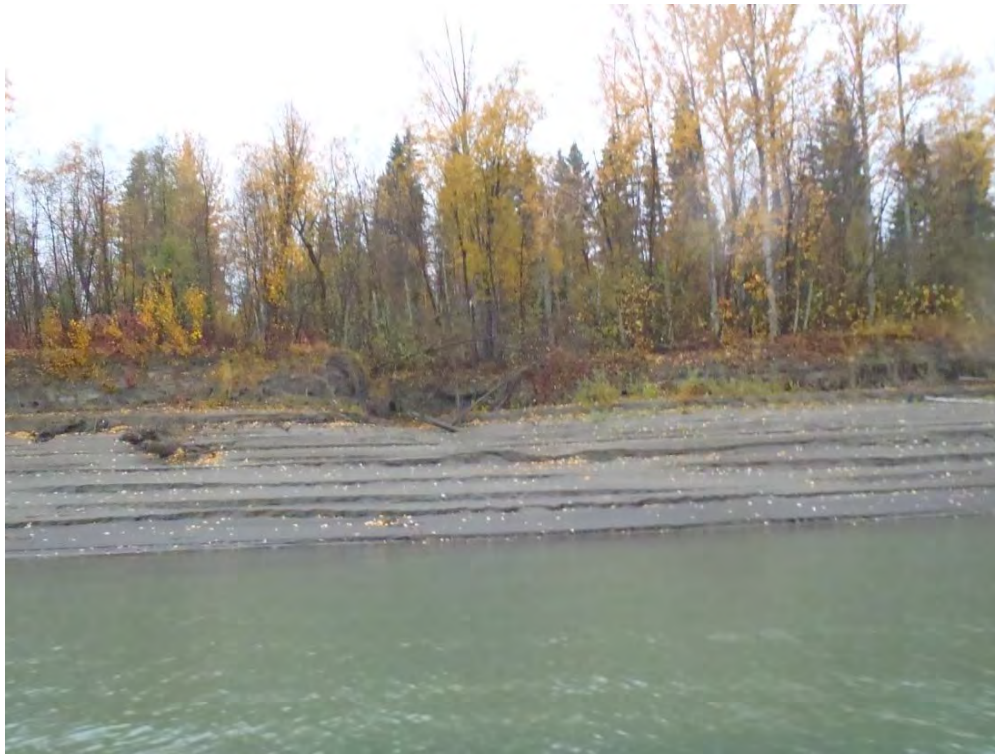
In September 2014, Hatfield and CZN staff visited the proposed Liard Crossing location. The purpose of this visit was to gather site bathymetric and hydrological data as well as some habitat information. The data from 2014 was used to retrospectively create a field habitat sheet for the proposed barge crossing. The bathymetry data was provided in Appendix 11 of the DAR. A field habitat sheet is provided as Attachment 2. Habitat consists of run morphology with predominantly sand/silt substrates. Based on available data, the habitat at the proposed Liard River crossing does not appear to be unique to the area. It is likely that this portion of the Liard River is used for fish migration purposes only.

Figure 19 **Liard River adjacent to crossing location example of bank substrate [photo 1].**

Figure 20 Liard River adjacent to crossing location example of bank substrate [photo 2].
