## **Mapping Summary Report Proposed Prairie Creek Mine All-Season Road Northwest Territories**

PRESENTED TO  
**Canadian Zinc Corporation**

DECEMBER 3, 2015  
ISSUED FOR USE  
FILE: Y14103320-01.003

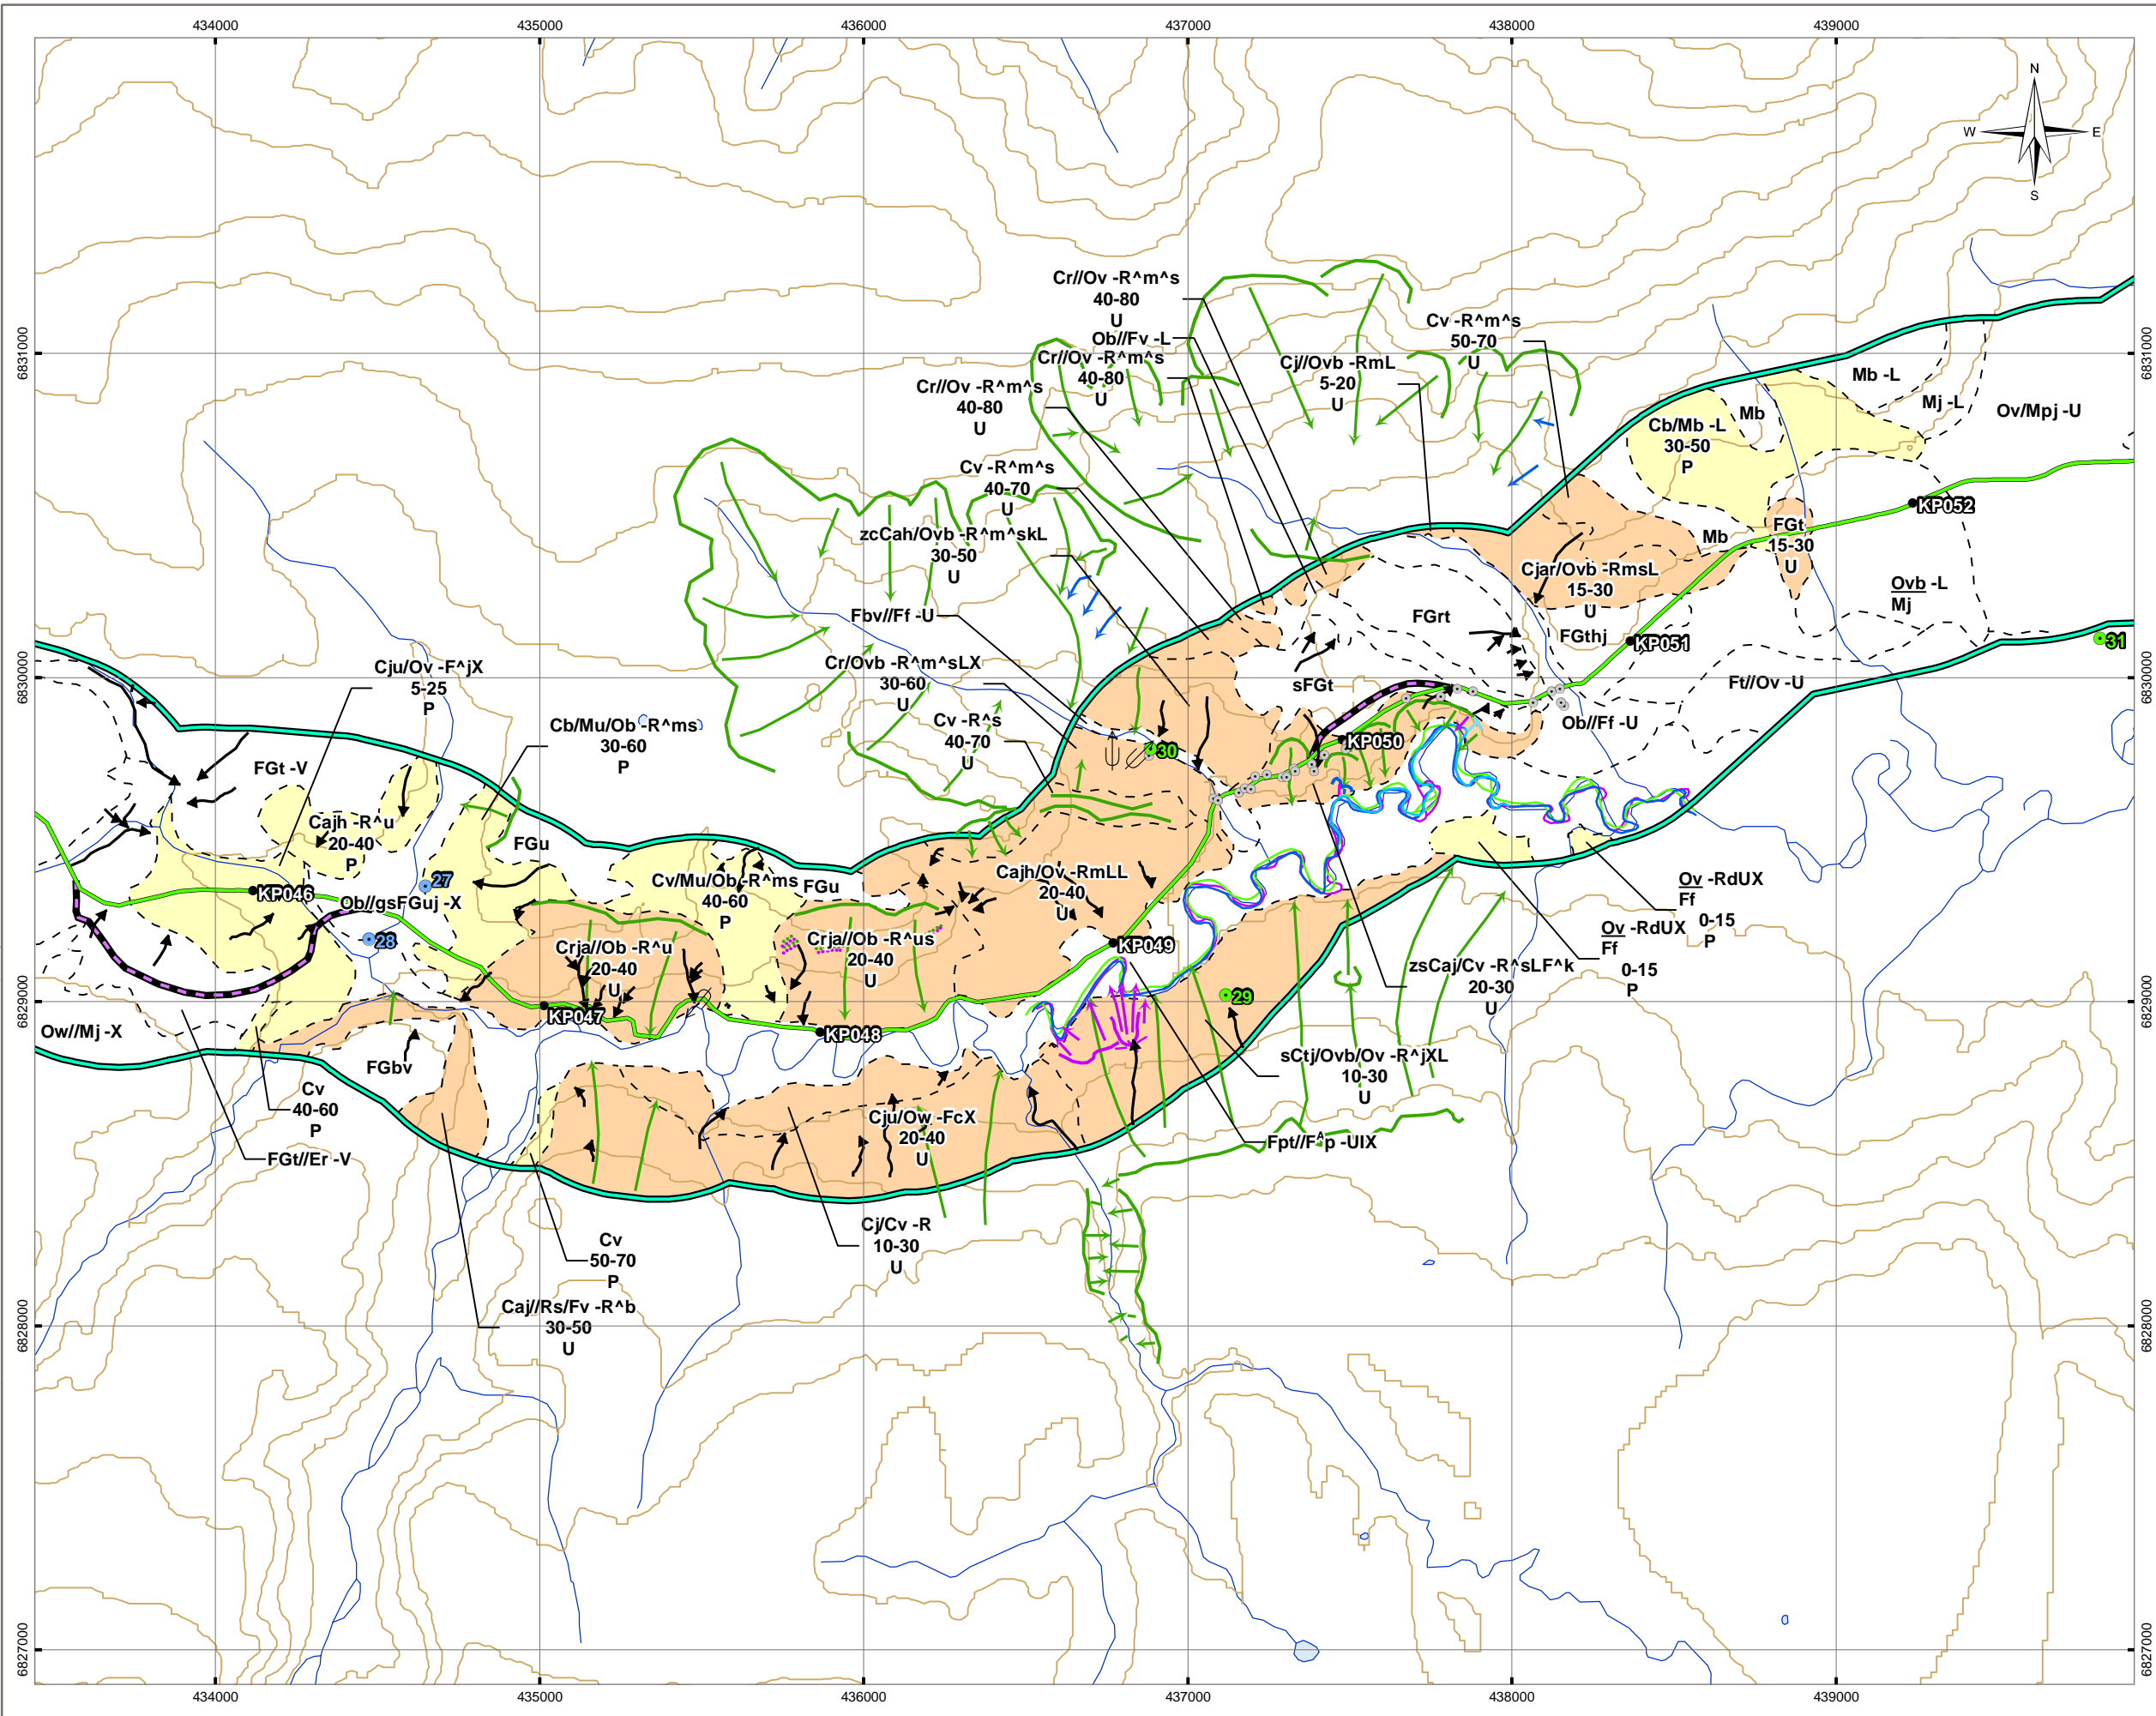
Several small debris slides, including the active one south of TFSA Site 29, have formed by riverbank erosion near KP050. A few small debris slides are new features on the 1994 photos (Figure A08). Two of these are caused by river bank erosion. The slide at KP050.5 is fresh looking in both sets of air photos, but it had widened slightly by 1994. The small slide feature adjacent to the newer head scarp (south of KP050.7) is an old slide that is covered with vegetation in both the 1949 and the 1994 photos. The proposed road's closest points to the debris slide head scarps are 9 m and 17 m from the scarp edges. Moving the proposed alignment further northwest as shown in Figure A08 will allow the road to avoid this area. Grades do not allow the road to avoid an old debris slide at KP049.8, so debris slide mitigation will be required across the slide area. A slope stability evaluation will be needed

A post-1994 slide south of KP49 visible on the 2012 LiDAR image was confirmed by fieldwork in 2014 (Figure A08). This slide was initiated by toe removal in two locations caused by creek flow. It is a translational slide in glaciofluvial sand and its toe extends across the former river location. Tension cracks visible above the slide indicate that it will continue to fail in the future, which is consistent with ongoing removal of the sandy toe deposits by the creek. The proposed road is not affected by this slide.

At the slide locations, the outer bends have eroded 8 to 26 m further into the banks. This has initiated the post-1994 slide south of KP49 and the slide at KP49.9, and has expanded the slide at KP50.5. The 1983 photos show that the expansion of the latter slide occurred sometime before 1983. The position of the creek in 1983 has been added at this location on Figure A08. Outer bank erosion is evidently the cause of the debris slide at this location. If the maximum erosion of 26 m over the time interval of 45 years is selected, then bank erosion is occurring at a rate of approximately 58 cm per year. This rate is not linear, but episodic, with expansion occurring mainly in flood years. This means that the amount of erosion could be much larger than 58 cm in flood years, with little or no erosion occurring in other years.

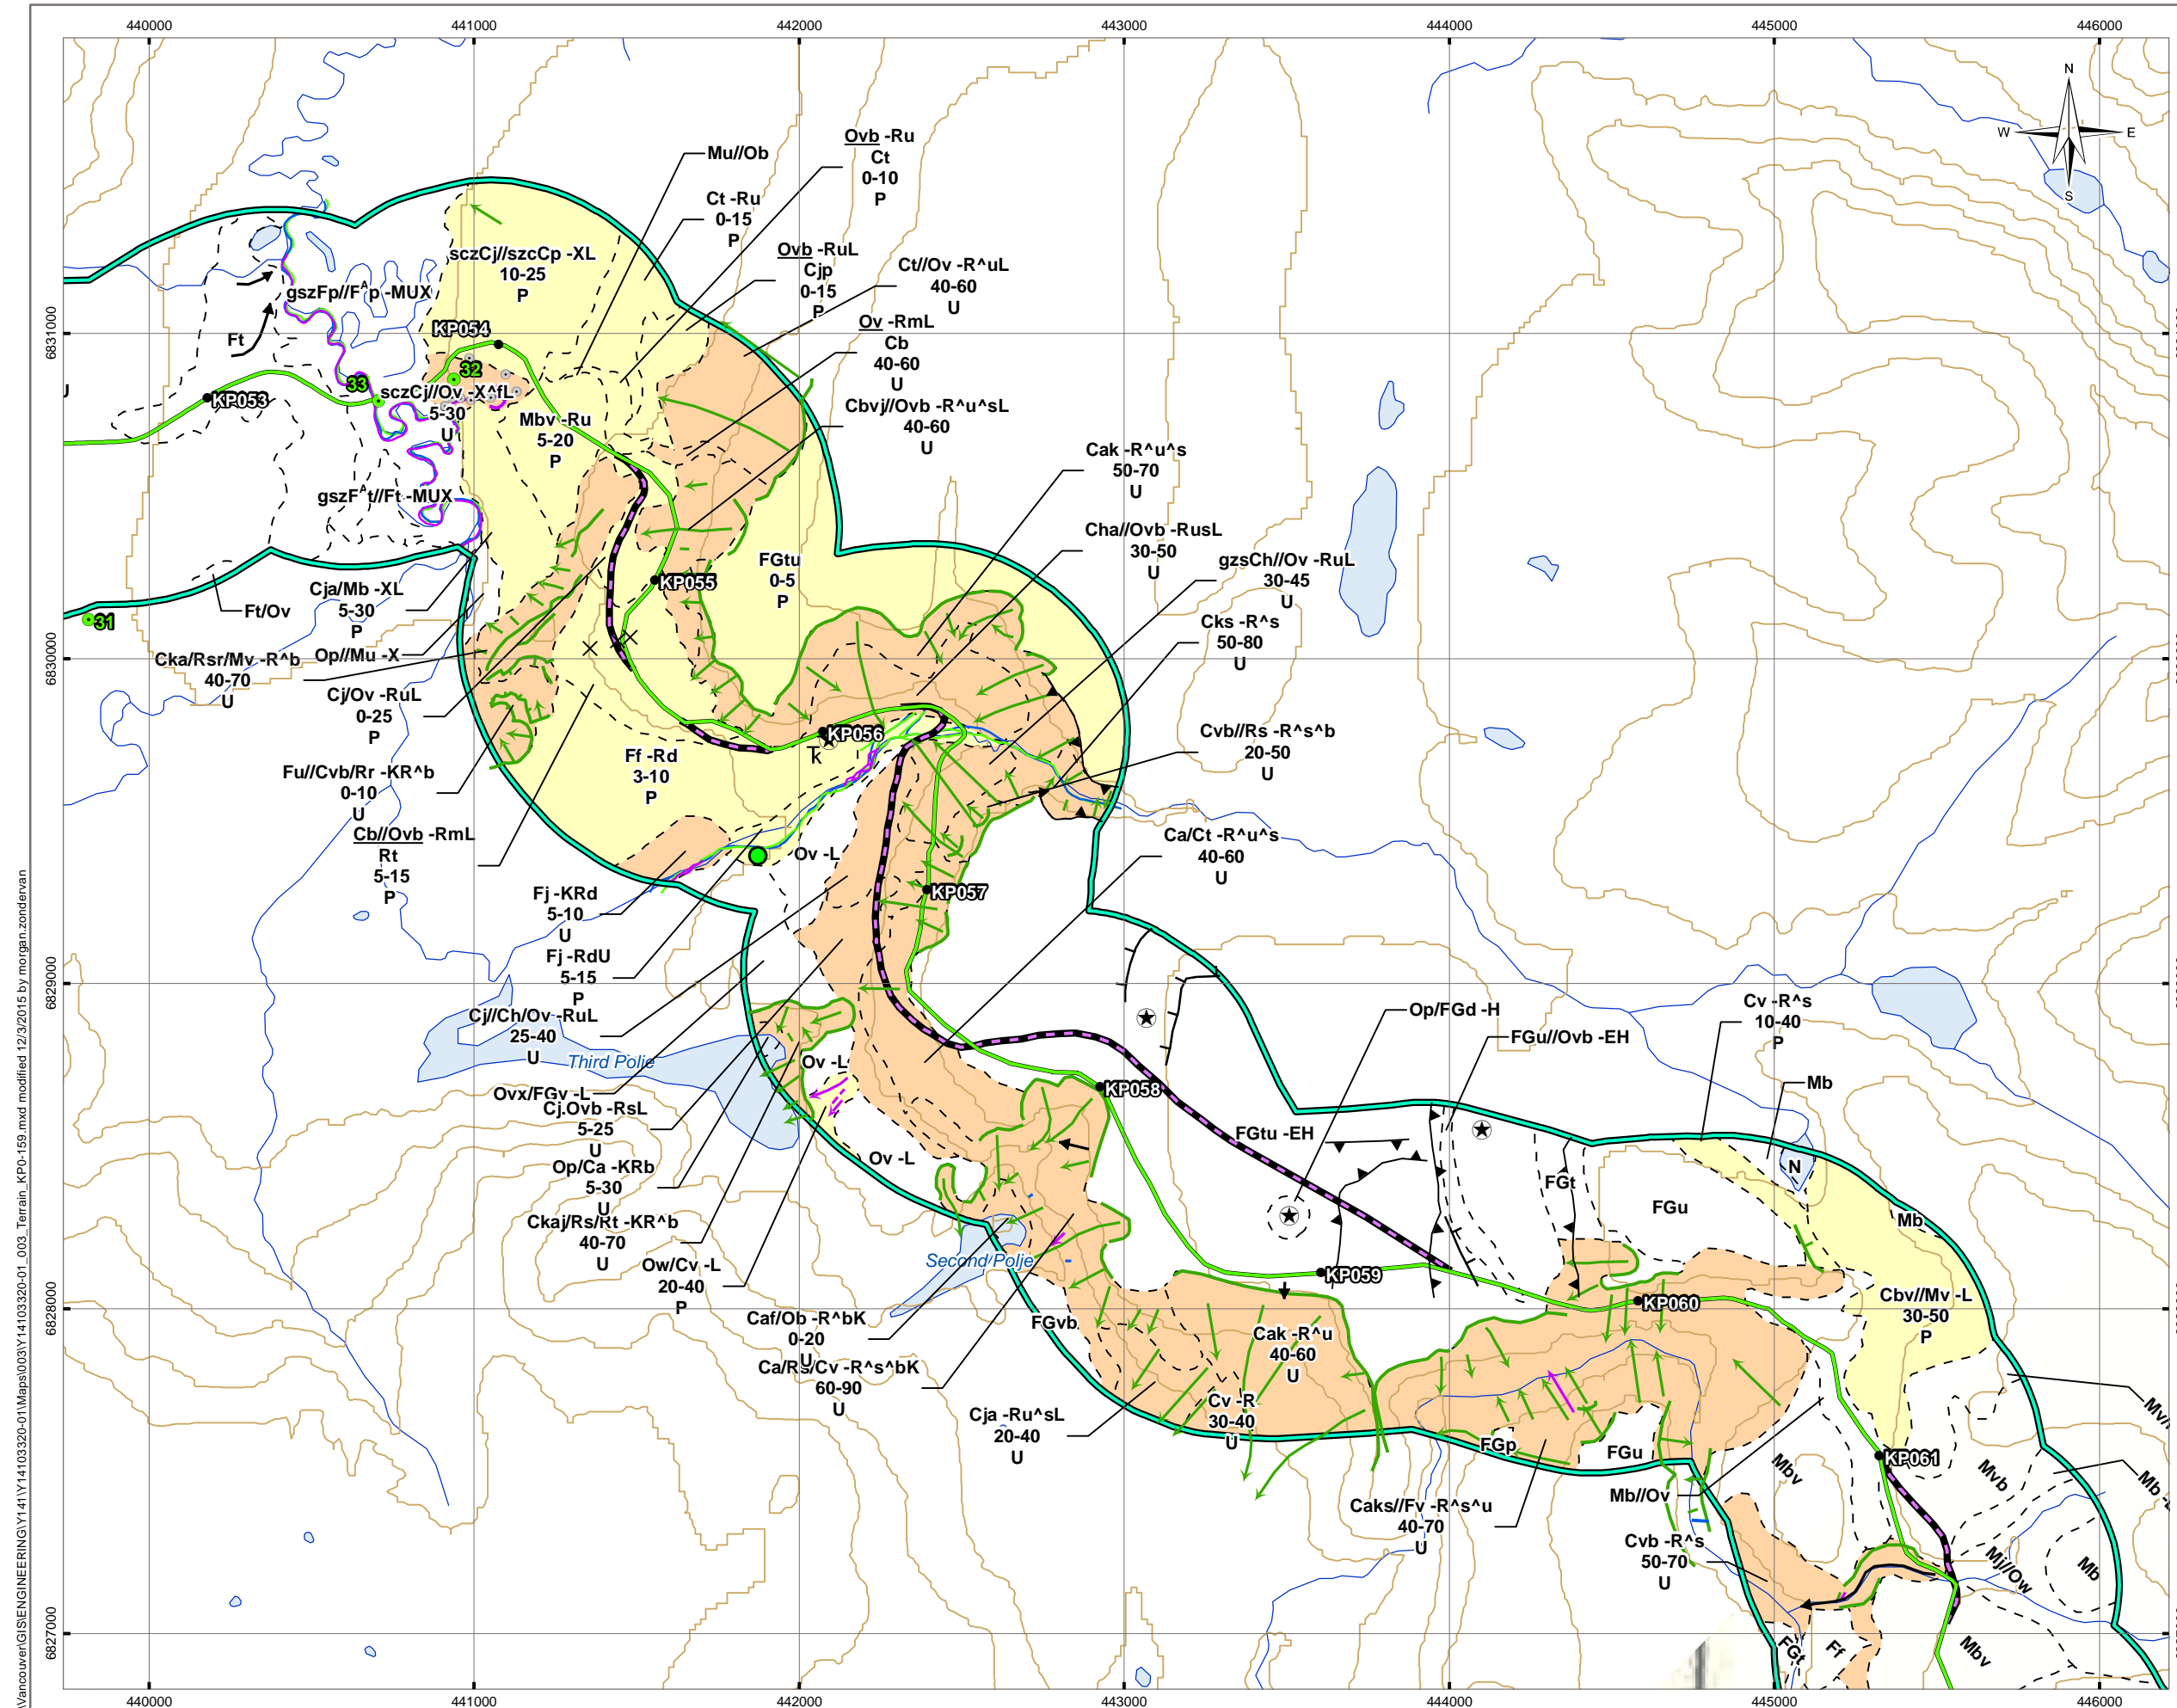
## Figure A09

From KP053.7 to KP054.2, permafrost processes are evident near the road alignment (Figure A09). A thaw slump/flow on a northwest-facing slope that was identified in the field is also evident on the LiDAR bare-earth image, but is not present on the 1994 air photos (Figure A09). Such slides generally retrogress (expand upslope) as freshly-exposed ice-rich permafrost thaws. However, the adjacent mapped polygon does not appear to have permafrost near the surface as tree growth is quite consistent there (and there is no seepage, which may be an indication of permafrost presence). If that is the case, then the slide could grow no more than about 50 m upslope and would not affect the proposed route alignment. However, this area should be probed for permafrost presence/depth to confirm.
