Parks Canada Preliminary Screening under the *Mackenzie Valley Resource Management Act*

Náíłıcho (Virginia Falls) Facilities Rehabilitation
Nahanni National Park Reserve, NT

NAH2017-002

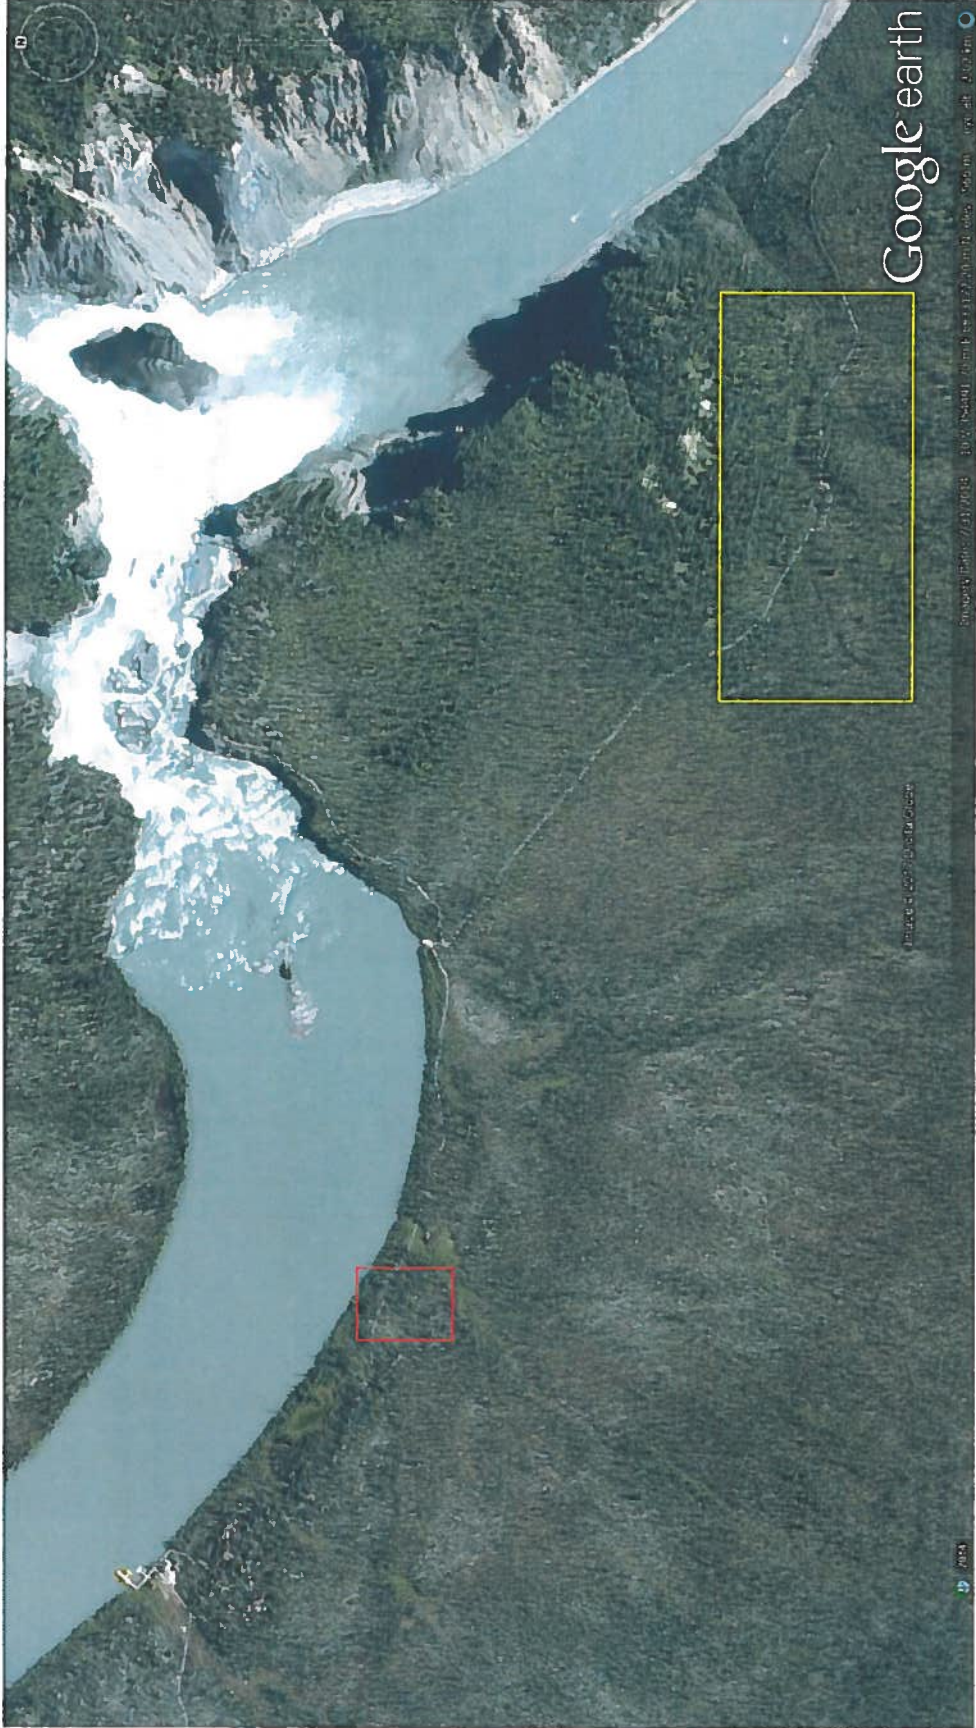
Figure 2: Overview of existing Najijcho campground, docks, and boardwalk system. Red box indicates location of proposed maintenance storage area and yellow box indicates location of the proposed boardwalk reroute.

- Construction of a maintenance storage area (Figure 5) between the campground and portage boardwalk to improve functionality, aesthetics and increase visitor safety by removing construction material/tools from visitor arrival/departure area and providing a suitable location for boat and helicopter slinging access. The proposed tree clearing will encompass approximately 9m x 12m and, if feasible, sections of the old boardwalk removed from the proposed boardwalk reroute will be used to construct the pad (supported by footings) for the storage area.

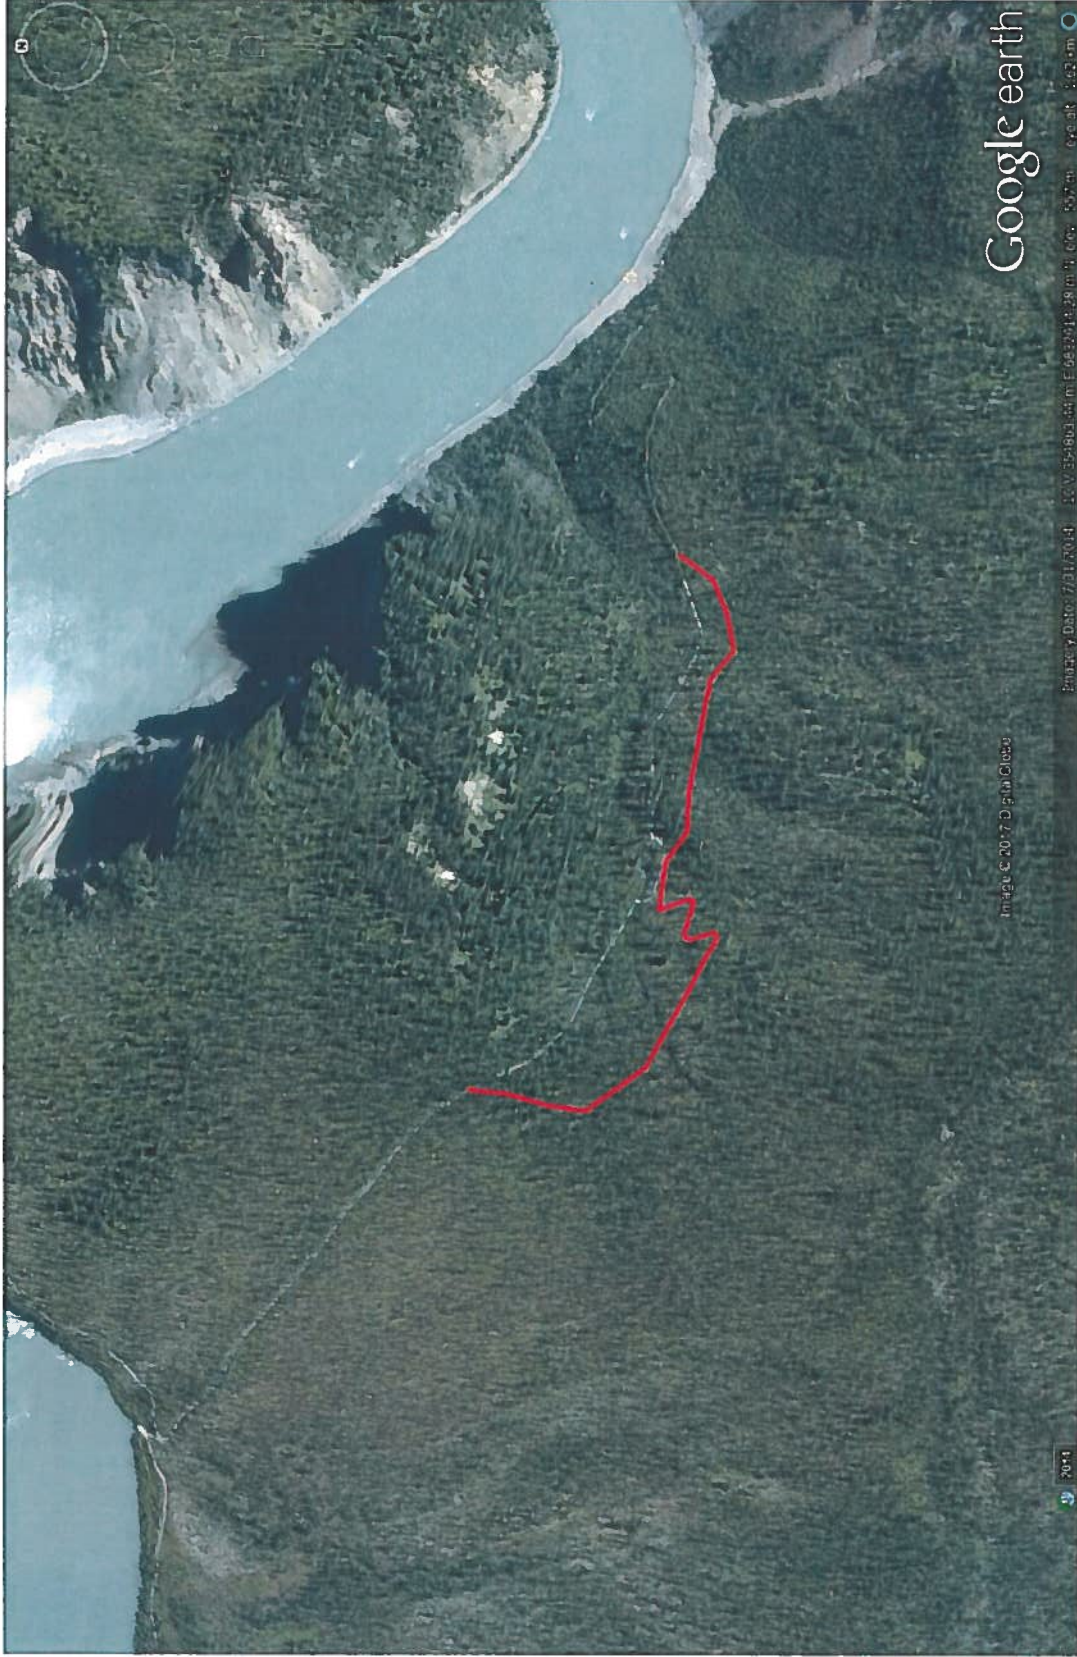
Figure 4: Red line indicates proposed boardwalk reroute to avoid wet/steep areas of the portage where possible. Canoe rests will be provided at S-bends. The existing boardwalk between the reroute start and terminus will be removed and the area restored to its natural habitat.

- Stabilization/rerouting of falls and portage boardwalks (Figure 4) to minimize exposure to wet/sloping areas and ecological restoration of areas where boardwalk has been removed. Tree clearing for the reroute area will occur over an area approximately 2.5 m wide x 623 m long;

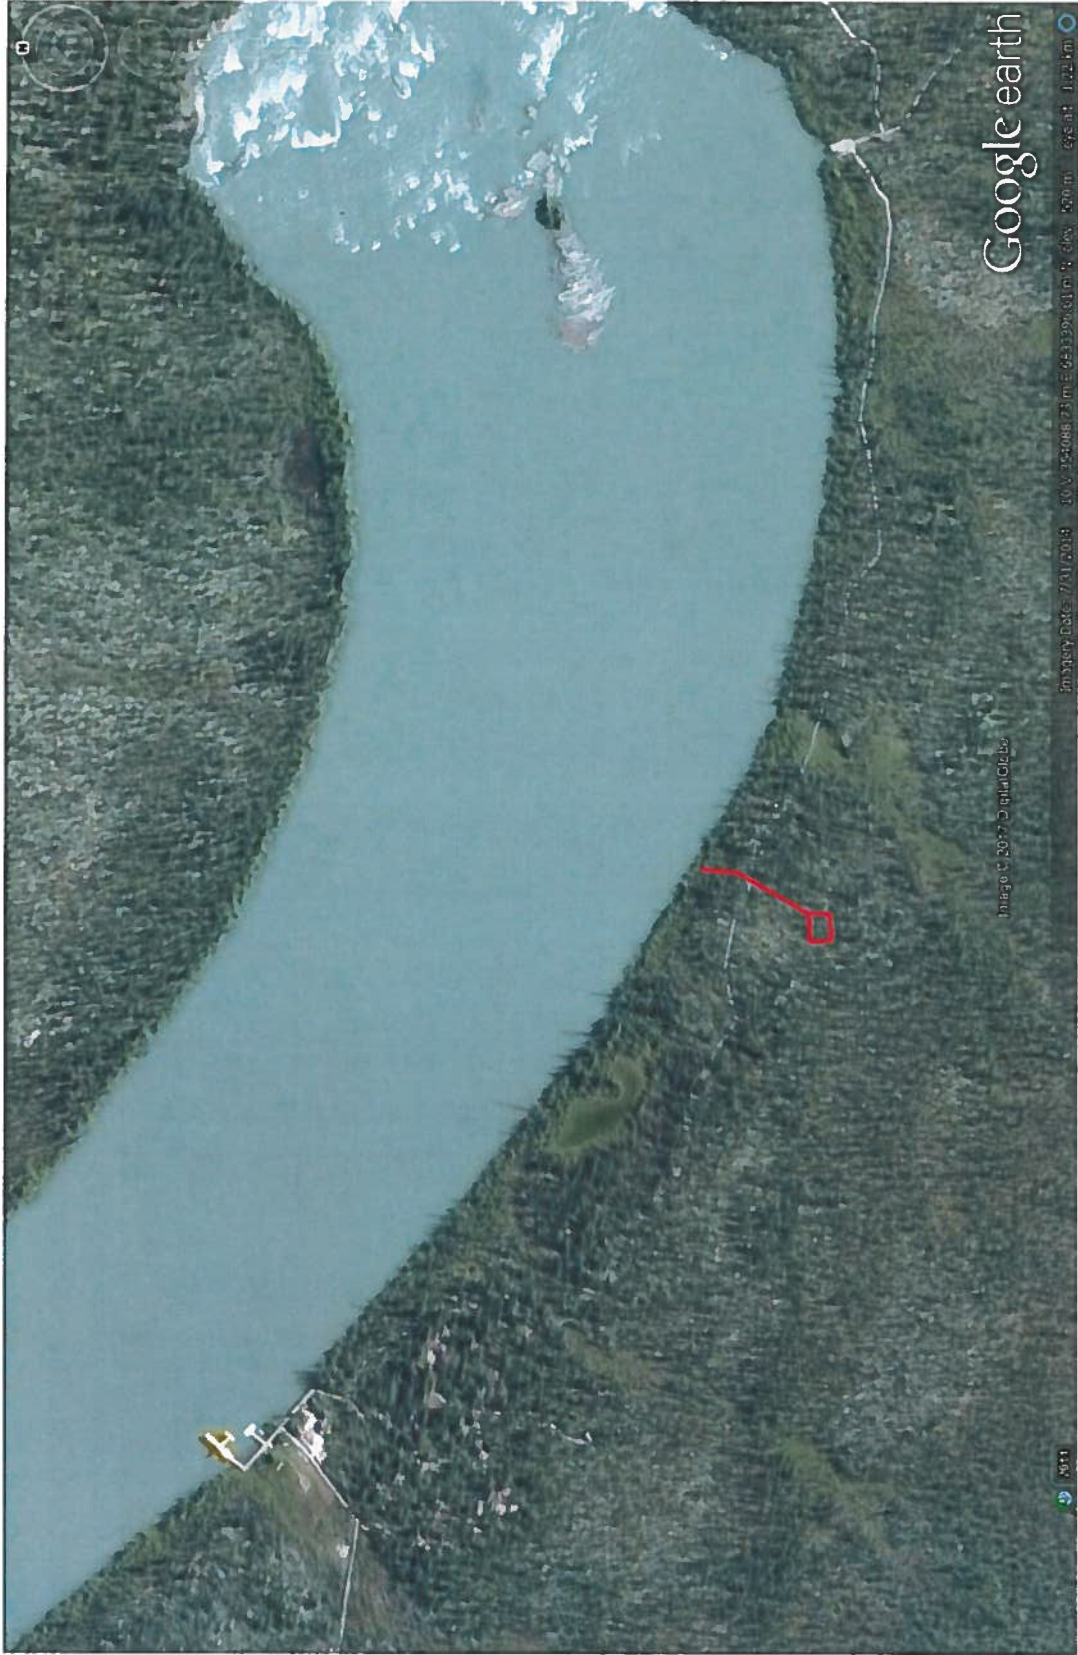
Figure 5: Red lines indicate proposed maintenance storage area. Note location on higher ground/well-drained soils and safely/aesthetically located away from docks, main boardwalk landing area, and campground.

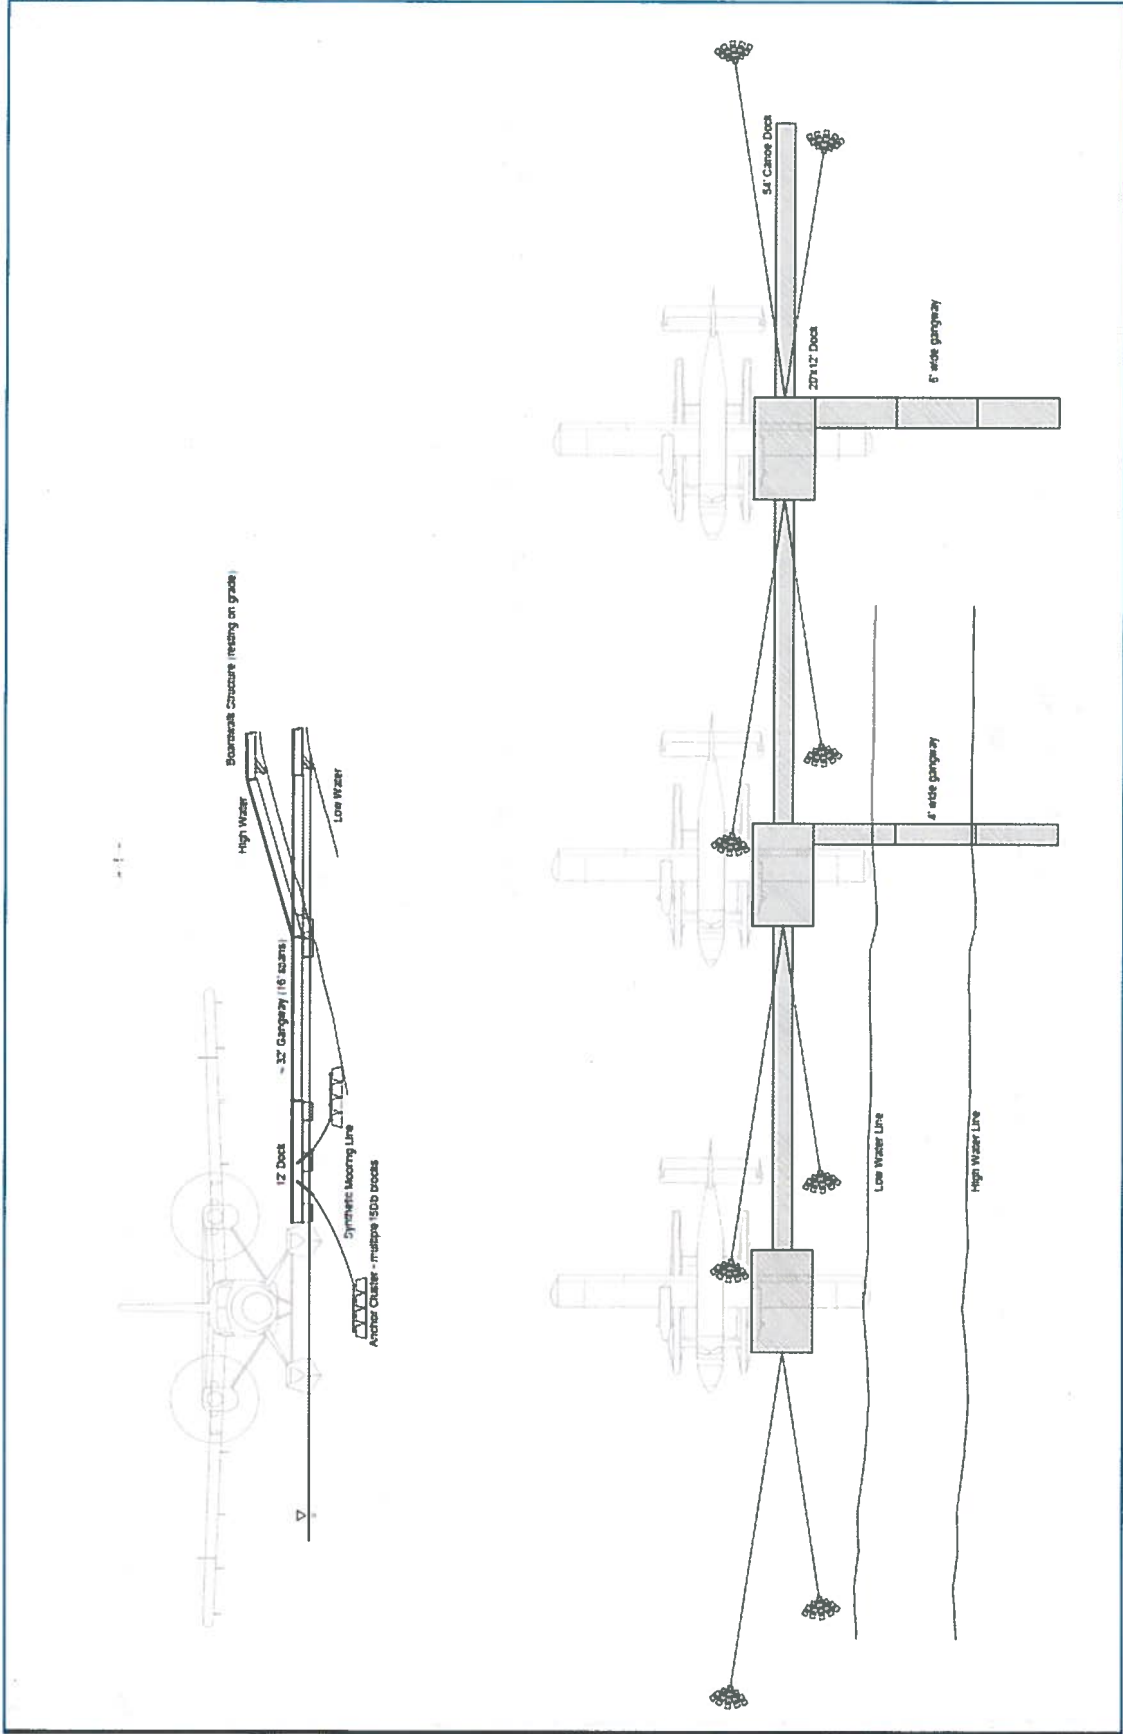
Figure 6. Proposed underwater anchor option for floating docks

- Land-based anchors for the docks, if used, will include up to five excavations approximately 1 m³ each containing a partially buried gabion basket of compacted earth or gravel. Alternatively, in-water anchors may be used; these will consist of multiple 150 pound blocks (metal or other non-leaching materials). Anchors will be connected to the docks using synthetic mooring line and cable (Figures 6 and 7).

See report - Carroll, P. July 7, 2017. <i>Náijlcho/Virginia Falls Soil Sample Monitoring for Potential Impacts on Cultural Resources: Archaeology Permit Final Report</i> . Parks Canada, Nahanni National Park	
Department/Agency/Institution: Tetra Tech Canada Inc	Date of Request: Ongoing: Duration of development planning phase and as subsequently required
Expert's Name & Contact Information: Tim Schaap Albert Leung PO Box 2244, 201, 4916 - 49 Street , Yellowknife, NT X1A 2P7 Direct +1 (867) 766-3728 x224 Mobile +1 (867) 688-1748	Title: Geotechnical Engineer Hydrotechnical Engineer
Expertise Requested: Floating dock and anchor design, including river flow modelling.	
Response: See Figures 6 and 7. Final report will be provided to Parks Canada in September 2017.

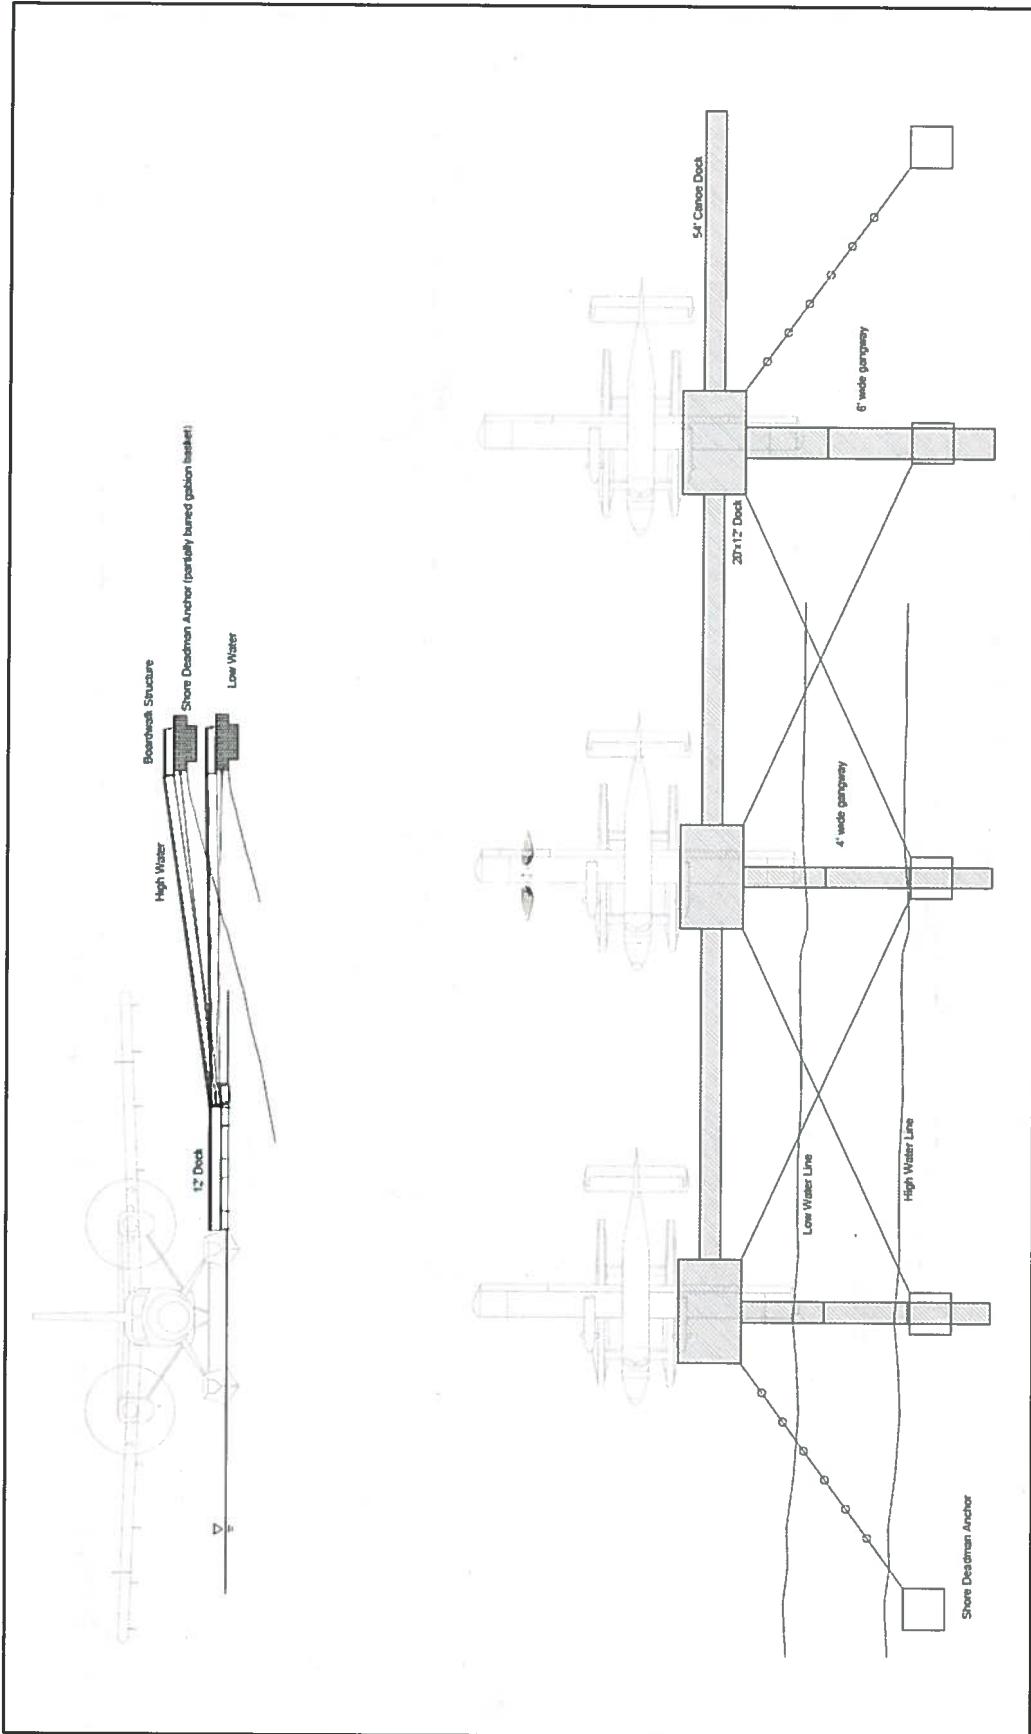
Figure 7. Proposed shore anchor option for floating docks

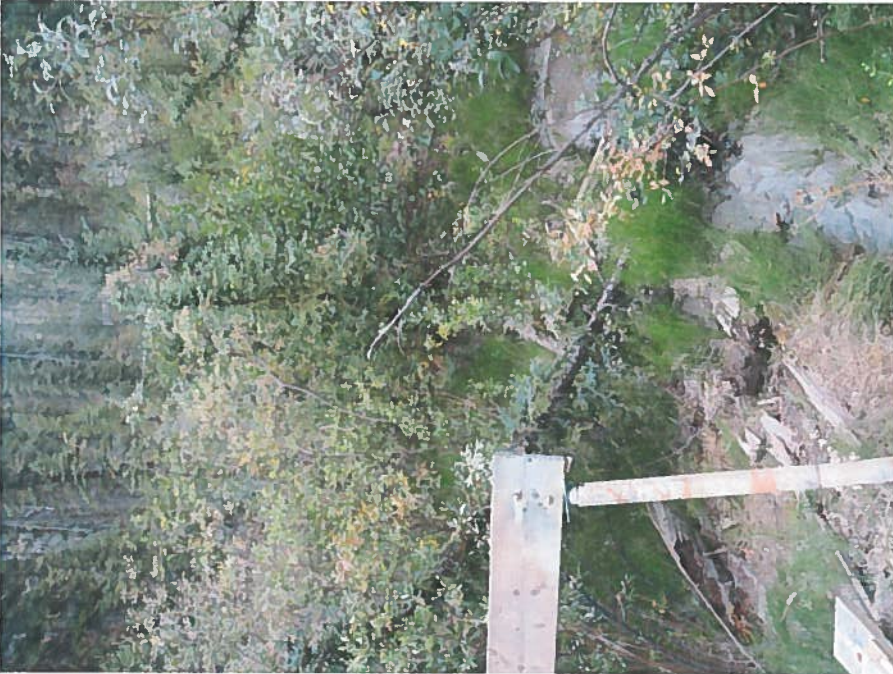
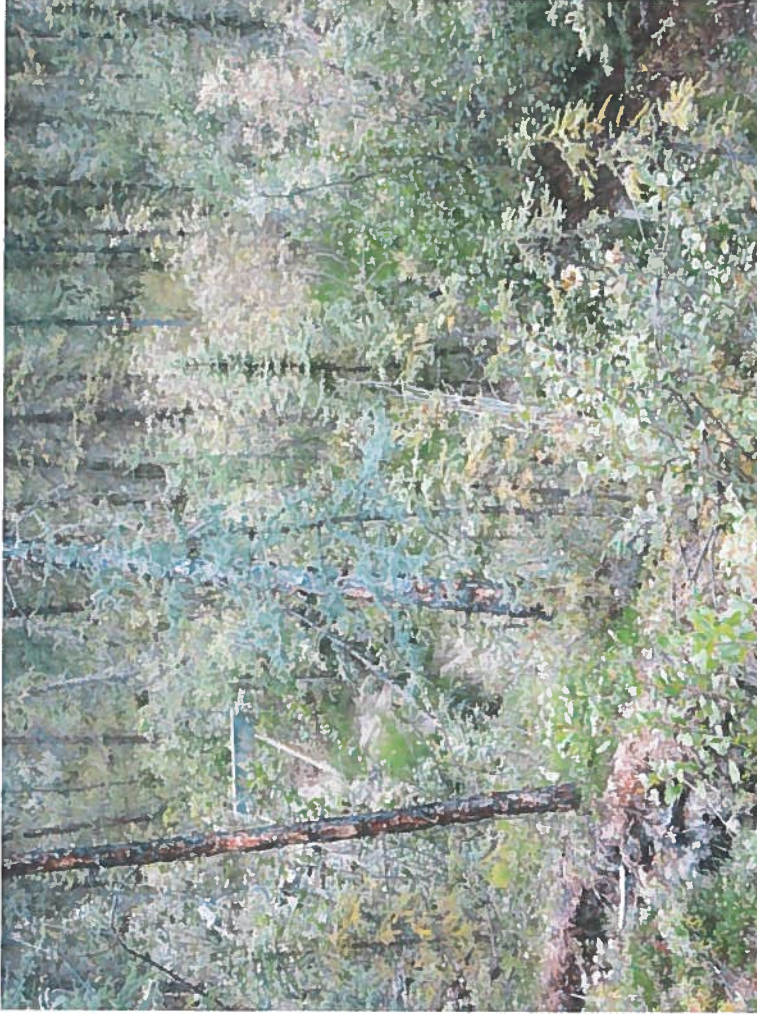
Figures 8 and 9: Section of boardwalk rerouted in 2010, showing naturally occurring restoration occurring along path of old boardwalk location.

12. Felled trees will be provided to visitors for firewood.
13. Ecological restoration of the removed sections of the boardwalk will take place using natural means; all debris (e.g.; metal sections of removed helical piers, lumber) will be removed to enhance the process that is already well underway.
