Giant Mine Environmental Assessment

Technical Session Undertakings

An Examination of Arsenic Contamination in the Roaster and Gas Handling Complex at the Giant Mill, February 2003

**AN EXAMINATION OF ARSENIC
CONTAMINATION IN THE ROASTER
AND GAS HANDLING COMPLEX
AT THE GIANT MILL**

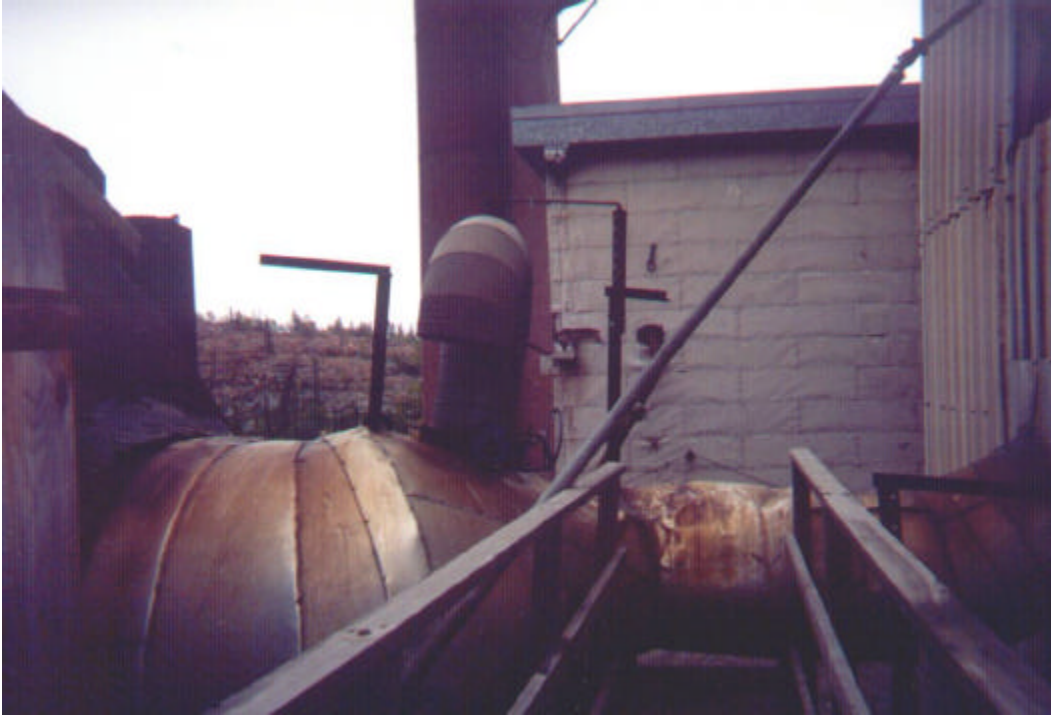
Photo #1: Transition section between roaster and Cottrell. Note change of diameter where the more recent flue replaced a section of much larger diameter old flue.

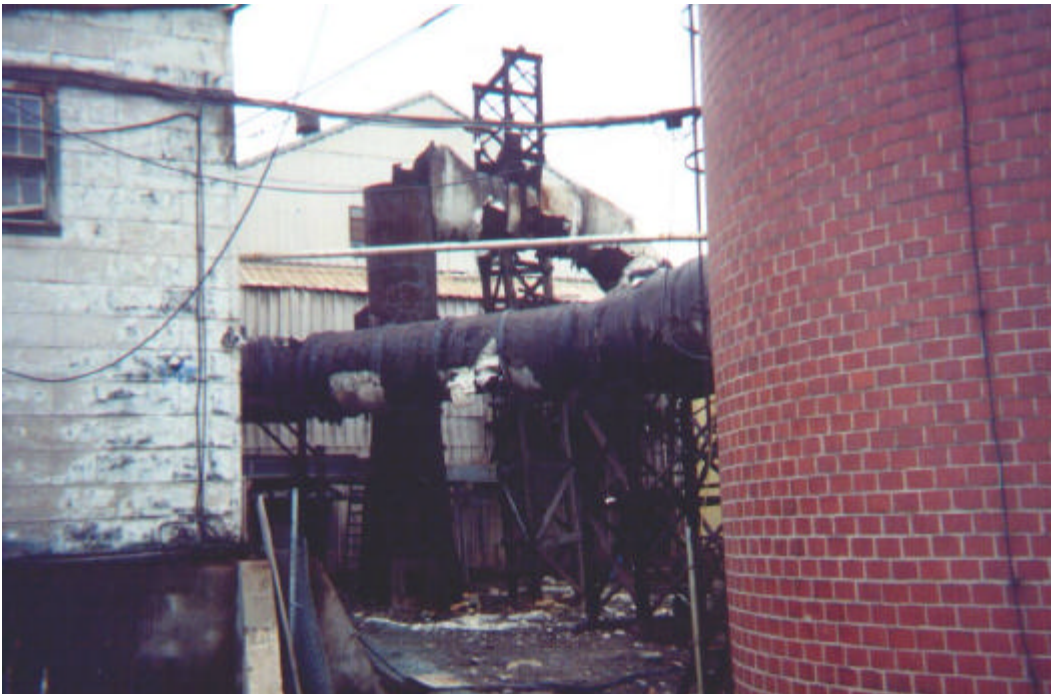
Photo #2: This view shows the base of the brick stack, the 40' high column, and the flue connecting the (no longer existing) AC roaster and the base of the stack.

The stack has an inside diameter of 9 feet and is 150 feet high. There is an accumulation of damp arsenic dust in the base of the stack measuring about 9 feet high. This can be accessed from above by climbing onto the ducting between the stack fan and the stack, and entering through the open arch. The cleanout access is at ground level and is covered with a hinged door. Cleanout of the entire accumulation from the lower hatch would be very slow and difficult and it is recommended that most of the job be accomplished from above. It is possible that a heavy duty industrial vacuum system can recover the dust. Another, less desirable alternative, is to shovel the dust into drums and hoist them out using a mobile crane, electric hoist, etc.

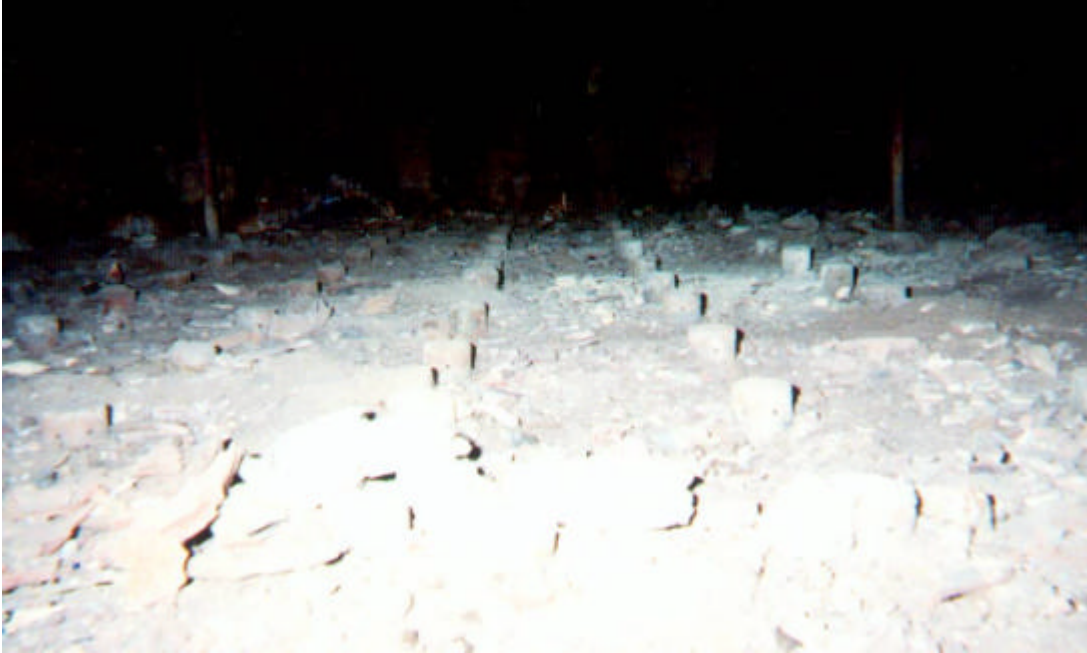
Photo #3: Tuyeres in #2 roaster vessel

The roaster vessels have some buildup on the interior walls that should be removed prior to unbricking. This can be done using scaffolds and scaling hammers. The insulation on the exterior of the roasters likely contains asbestos. The insulation has been encapsulated, but removal may pose some breathing hazards. This is true of the wall insulation in the roaster building as well.

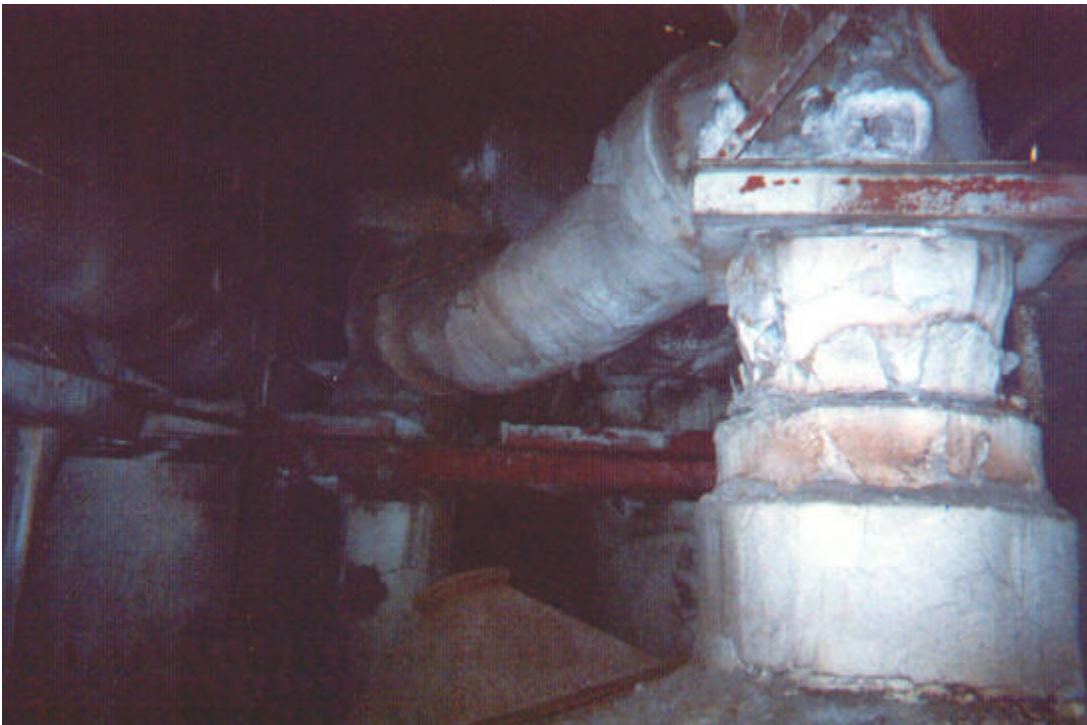
Photo #4: Exhaust flue from #2 roaster vessel to the dust collection cyclones. Note the white crystalline arsenic formation.

The roaster flues are relatively clean on the inside, but high temperature warping has caused the bolted flanges to leak in several places, resulting in heavy encrustations of arsenic crystals on the exterior. The insulation on these flues is in poor condition and is thoroughly contaminated. The insulation should be carefully removed and placed into drums, and, if possible, the flues should be dismantled by removing the bolts in the flanges. However, it is possible that a cutting torch will be required, and appropriate

safety precautions will be necessary. This applies to all flues and cyclones in the area above the roasters.

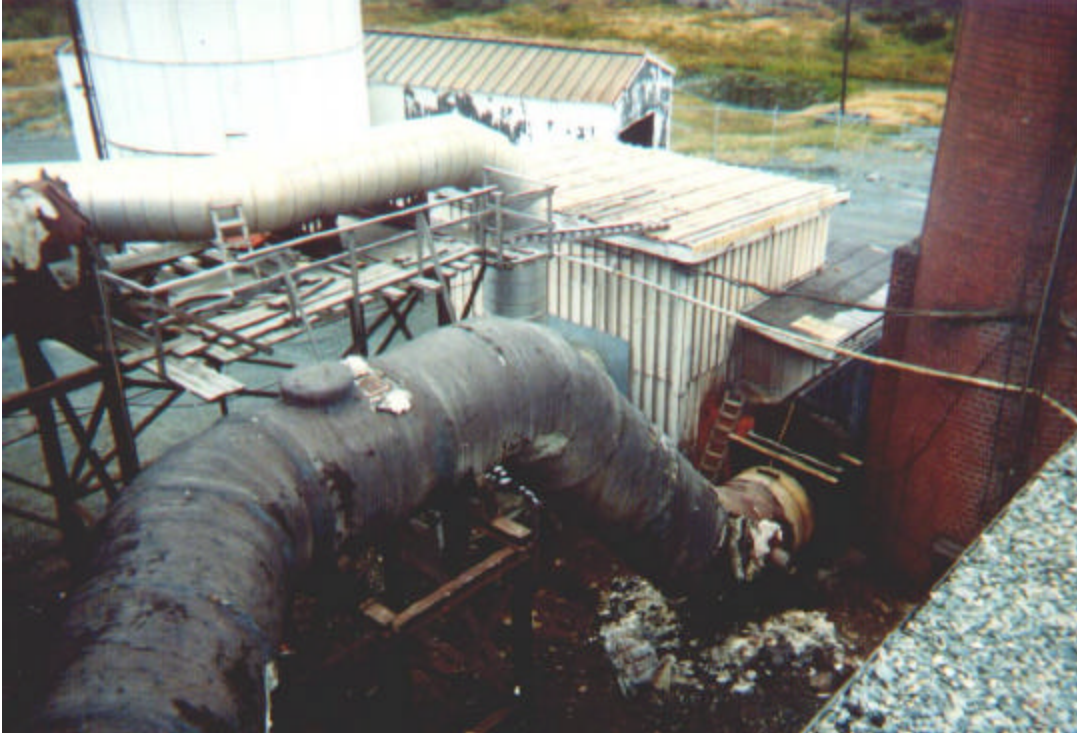
Photo #5: The black flue is direct from the AC roaster building to the base of the stack. The aluminum clad flue is quite recent, from the baghouse to the stack fan inlet.

The flues between the gas cooling fan and the baghouse, as well as the flues from the baghouse to the stack fan, are of recent construction and are in excellent condition. They are 42" diameter, 3/8" fiberglass wall and are insulated with 1" of rockwool, clad in aluminum sheet and strapped with stainless steel bands. They contain very little dust, less than 1/4" in most places. To remove, they should be cut into convenient lengths using a power saw, and lowered to the ground with a crane. The loose dust may be dumped onto a tarp or prepared pad, and collected into drums. The clean flue sections may then be further cleaned with a water spray prior to disposal.

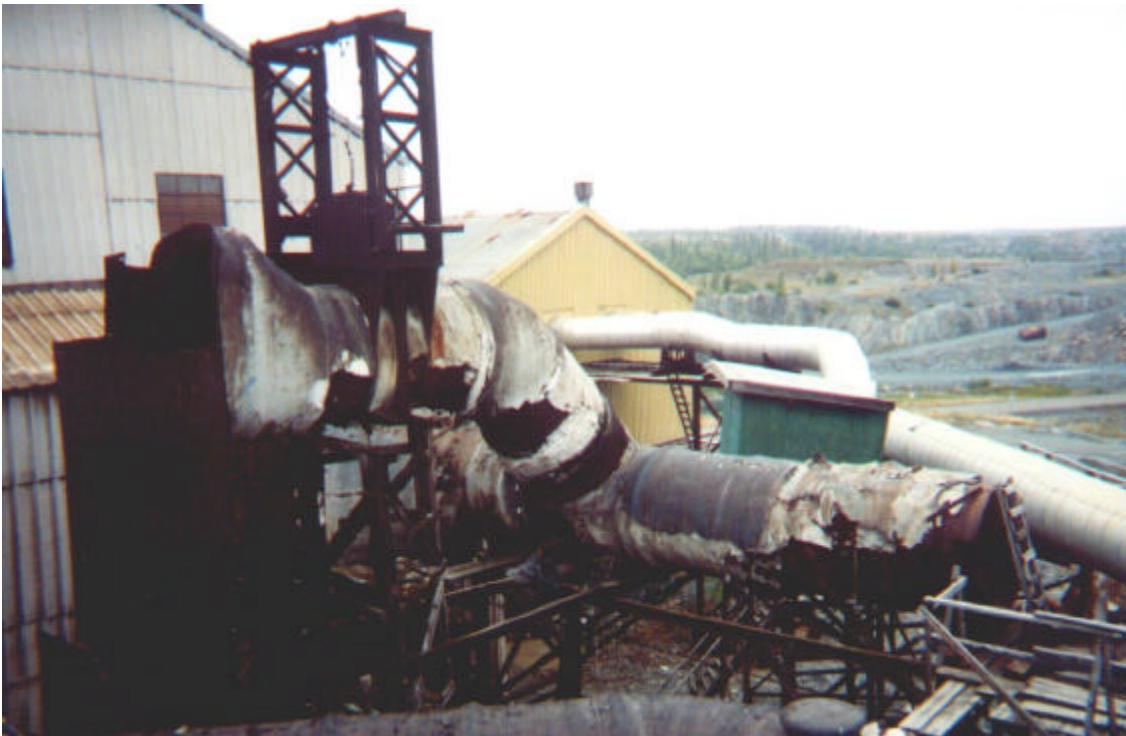
Photo #6: An old flue section that once connected the Cottrells to the stack (pre arsenic baghouse).

It is estimated that 60 tons of dust is contained in the 70" diameter flues. Much of the dust is loose and can be recovered using a heavy duty vacuum system. Some of the material however, is very hard and crusted over, and will have to be broken with hammers and scaling tools. The old flues are covered in insulation, generally in poor condition. There is some contamination associated with parts of the insulation, and care should be taken when removing it. After cleaning, the flues will have to be cut into manageable lengths using a cutting torch. Appropriate breathing apparatus will be required for all of this work.

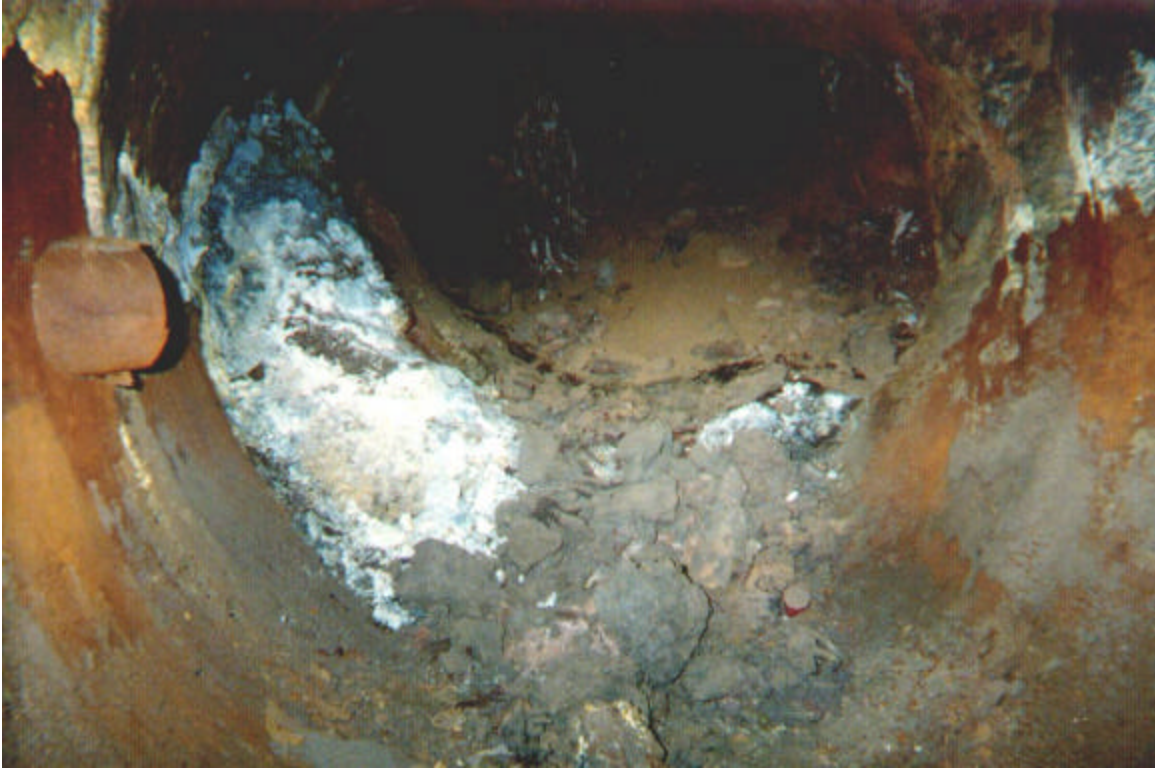
Photo # 7: Flue section in roaster building. Note nipple for air lancing blockages.

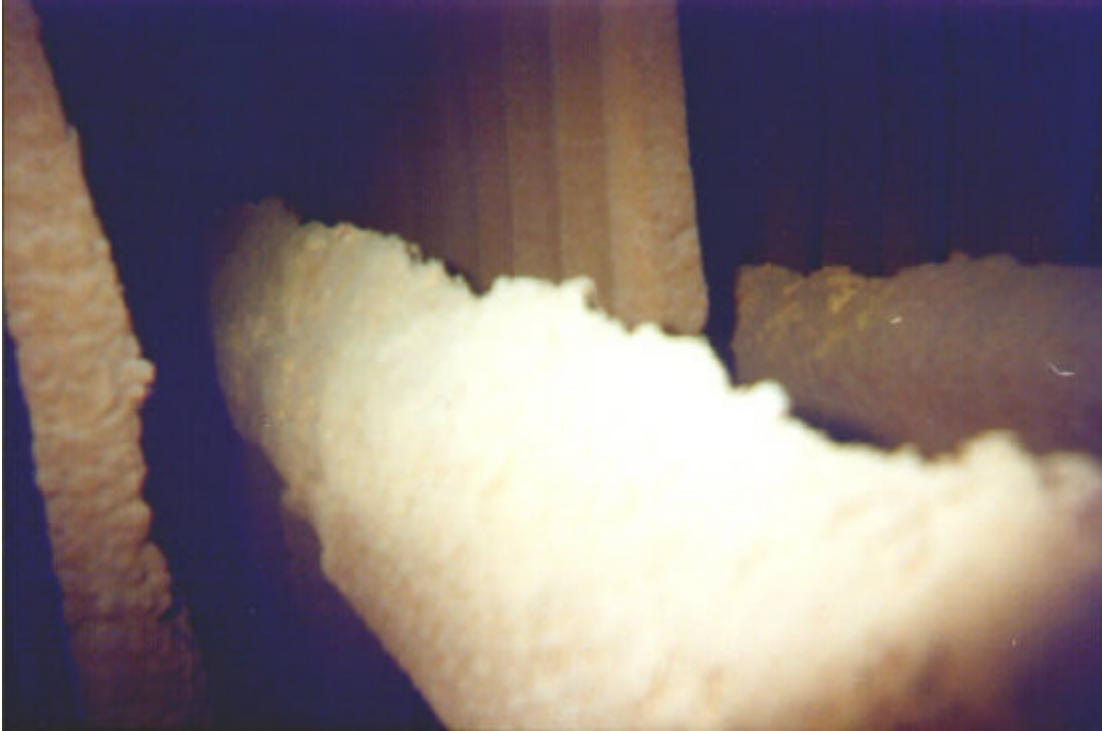
Photo #9: Inside #4 compartment of Cottrell. Note heavy dust buildup on frames between Rod curtains

After the rods and spacer bars have been removed from the Cottrells, there will be sufficient room to erect scaffolding to permit cleaning the walls, partitions, etc. This can be accomplished using scaling bars, scaling hammers, etc. The material that is dropped into the hoppers can be removed via the screw conveyors, and placed into drums.

Following cleanup of the Cottrell internals, the insulation can be stripped and the sheet metal cut in to manageable sections for final cleanup and disposal.

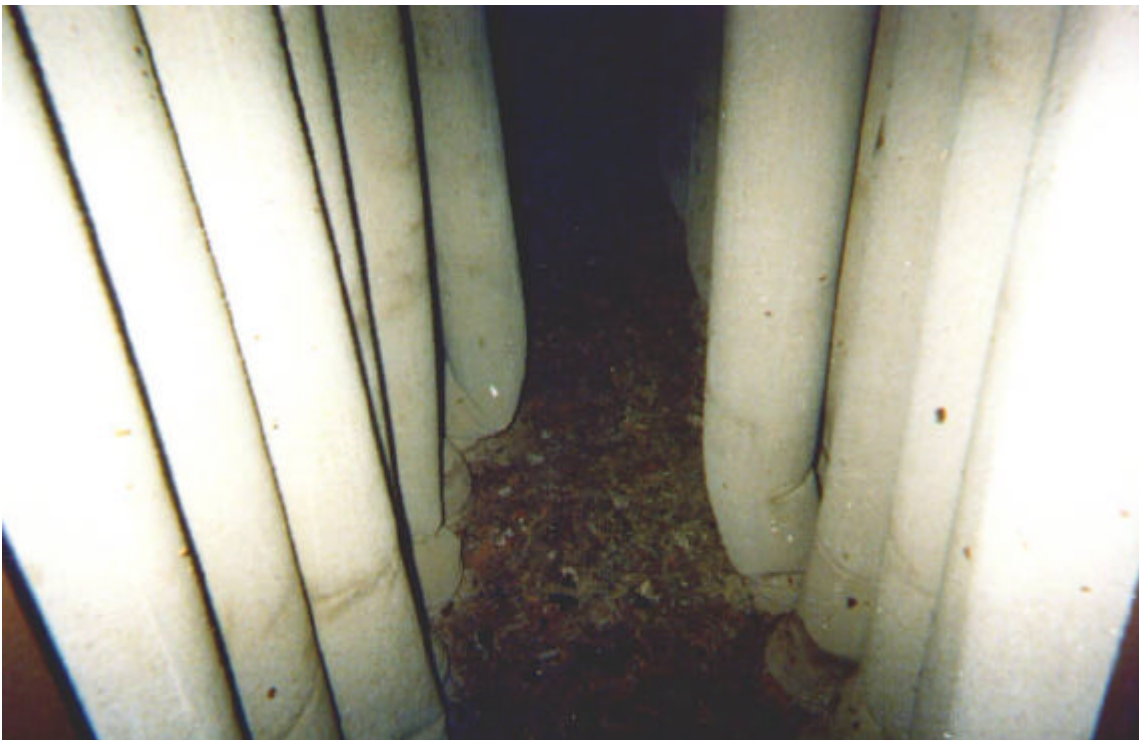
Photo #10: #6 baghouse compartment. Bags are in good condition and the compartment relatively clean. Dust collects on the inside of the bag in this type of collector.

The baghouse contains twenty four hundred 5" x 10' fabric filter bags in eight compartments. The compartments are made of sheet metal panels covered in insulation. Each pair of compartments is equipped with a screw conveyor. Cleanout of the equipment first requires removal of the filter bags. The base of each bag is fastened to the tubesheet with gear clamps and attached to the shaking mechanism at the top with a loop of fabric around the hanger. The bags should be manually shaken before removal to dislodge any arsenic that may be adhering to the inner walls of the bags. The bags can then be packed in open top drums for future disposal.

The baghouse shaking mechanism and discharge plenums should be removed before dismantling the wall and partition panels. Final cleanup of the equipment may be done by high-pressure water spray provided that proper water collection facilities are available.
