To:	Bill Mitchell, DIAND	Date:	January 17, 2006
cc:		From:	Bruce Murphy
Subject:	Site Wide Crown Pillar Stability Investigation	Project #:	1CI001.013.B1.01

This memorandum is a follow up document to the initial review undertaken in August 2005. Since that time the crown pillar areas have been re-examined in further detail in terms of potential consequence of failure and the increased likelihood of failure if the stopes were not filled. Following these evaluations, a recommendation is made as to the specific surface crown pillar areas that need further evaluation and what the requirements of this evaluation should be. As such, this memorandum should be seen to supersede the previous memorandum.

Crown Pillar Stability Assessment
Giant Mine

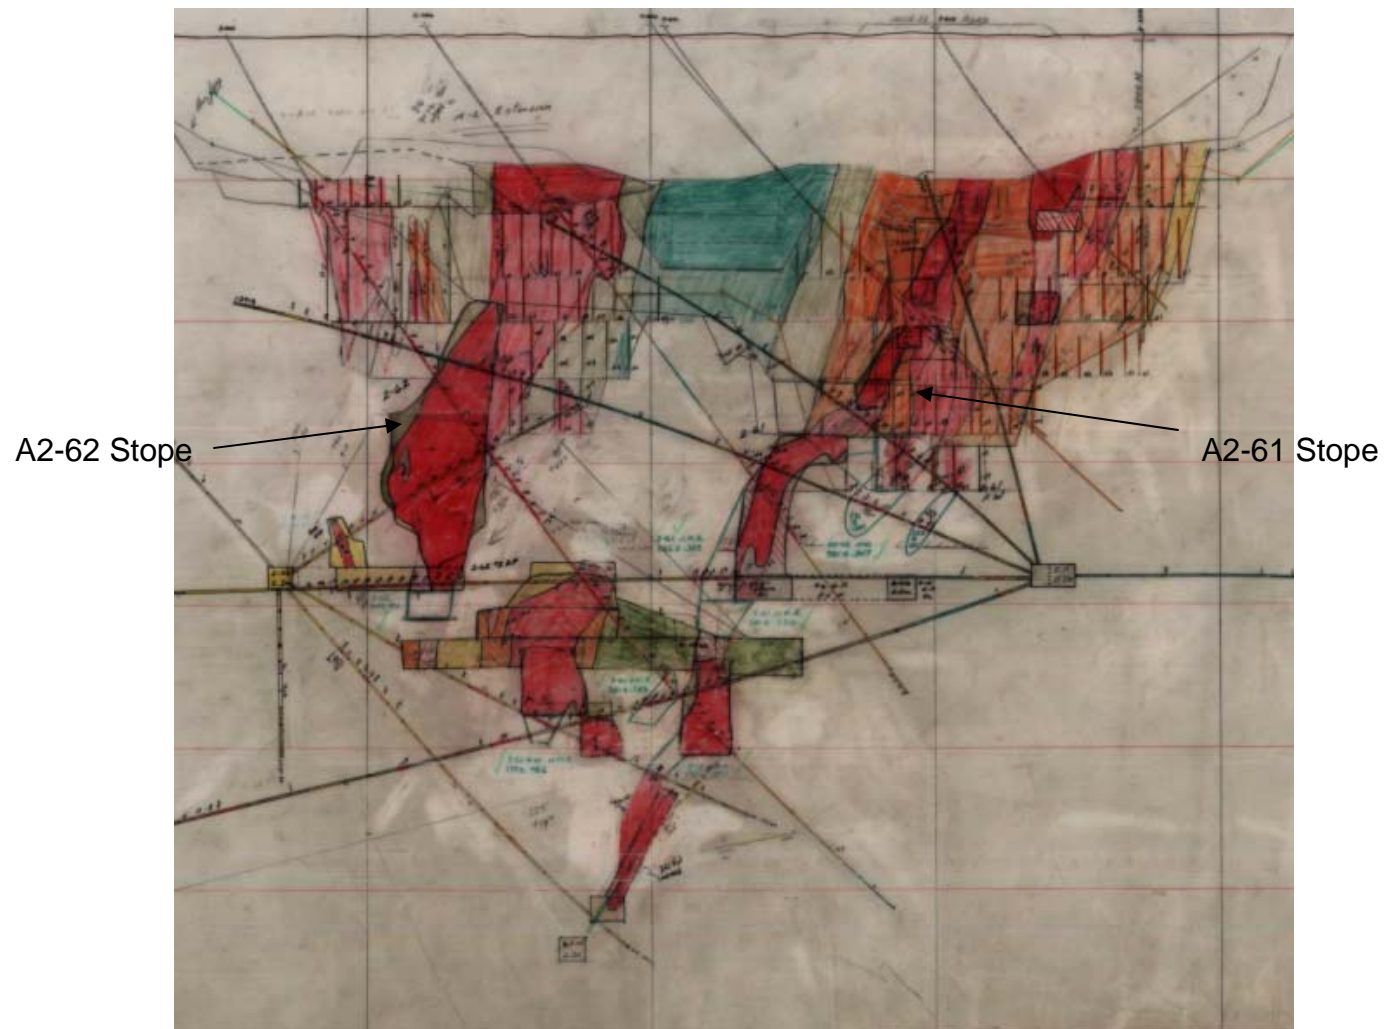
FIGURE:
4

A2-61, A2-62: A-Shaft. 6100S

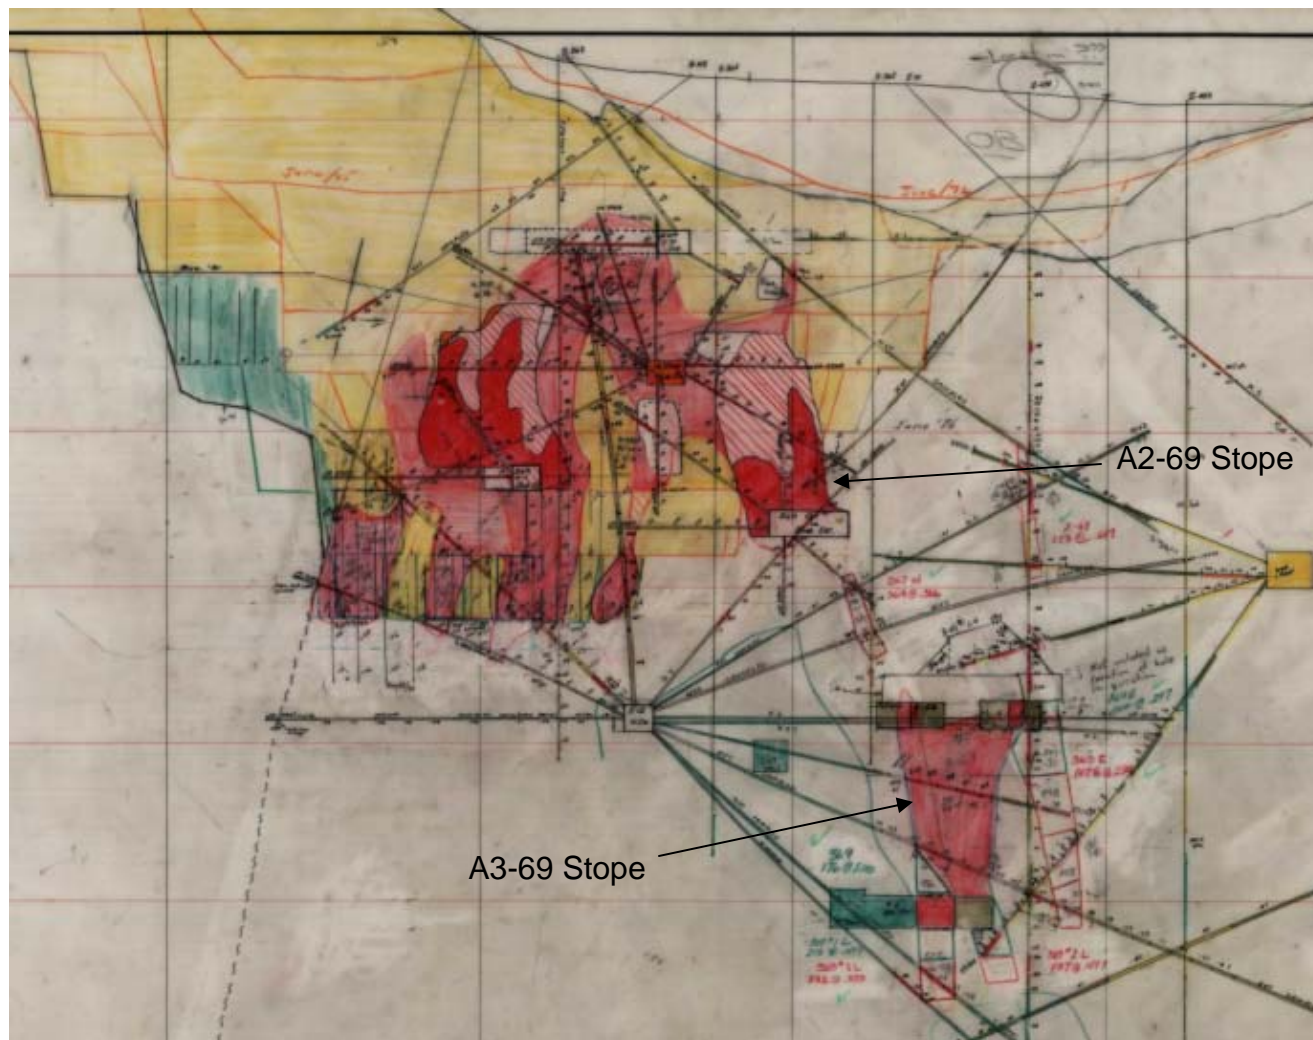
FIGURE::
8

A2-69: A-Shaft, 6800N

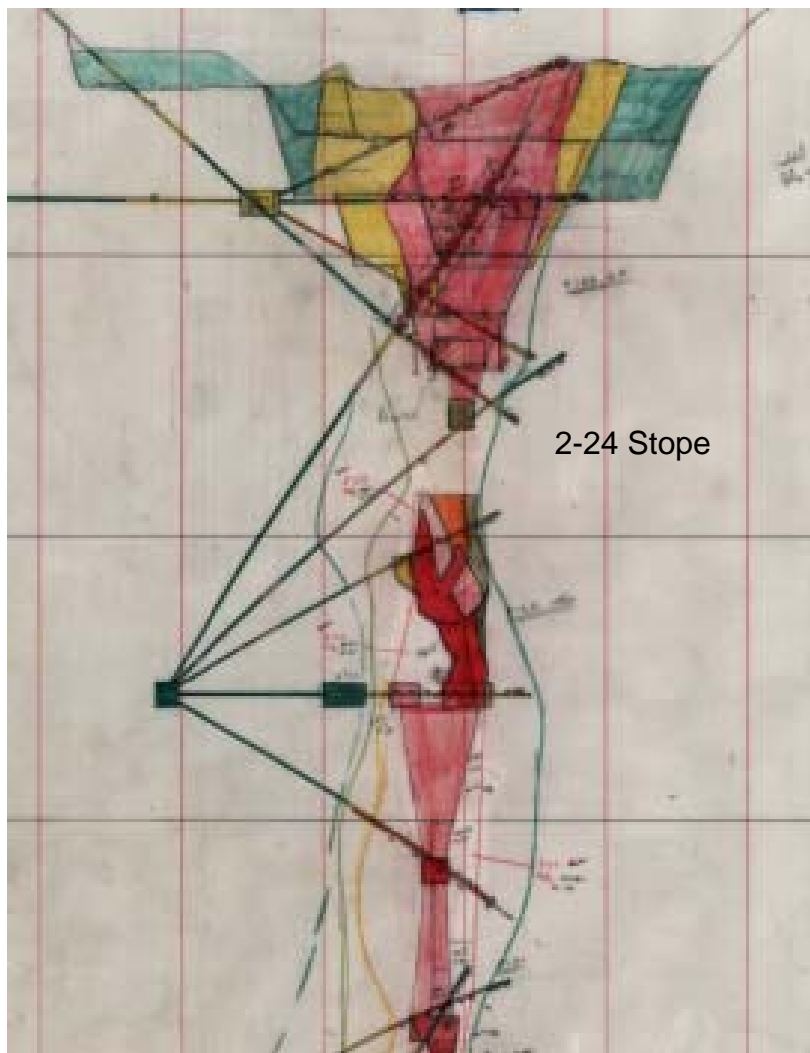
14

2-24 Stope: C-Shaft, 2300S

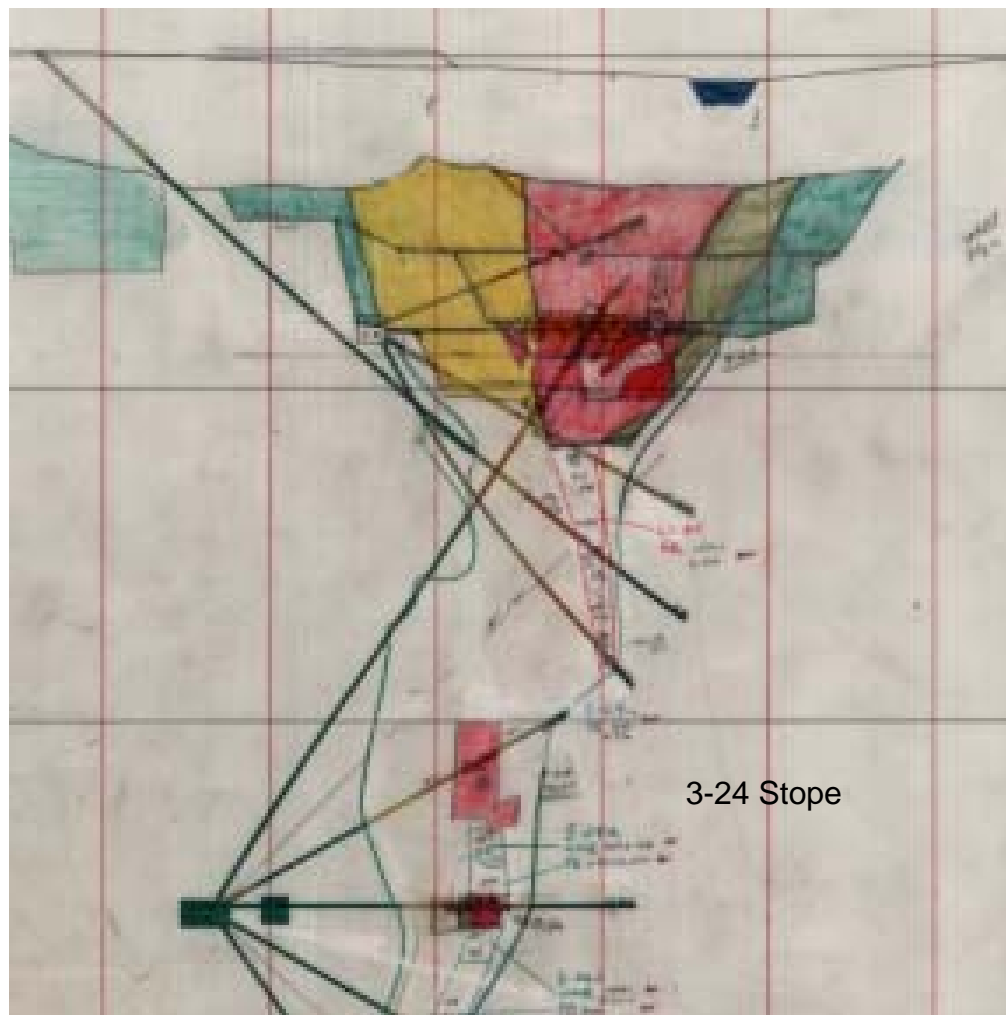
FIGURE::
15

3-24 Stope: C-Shaft, 2400S

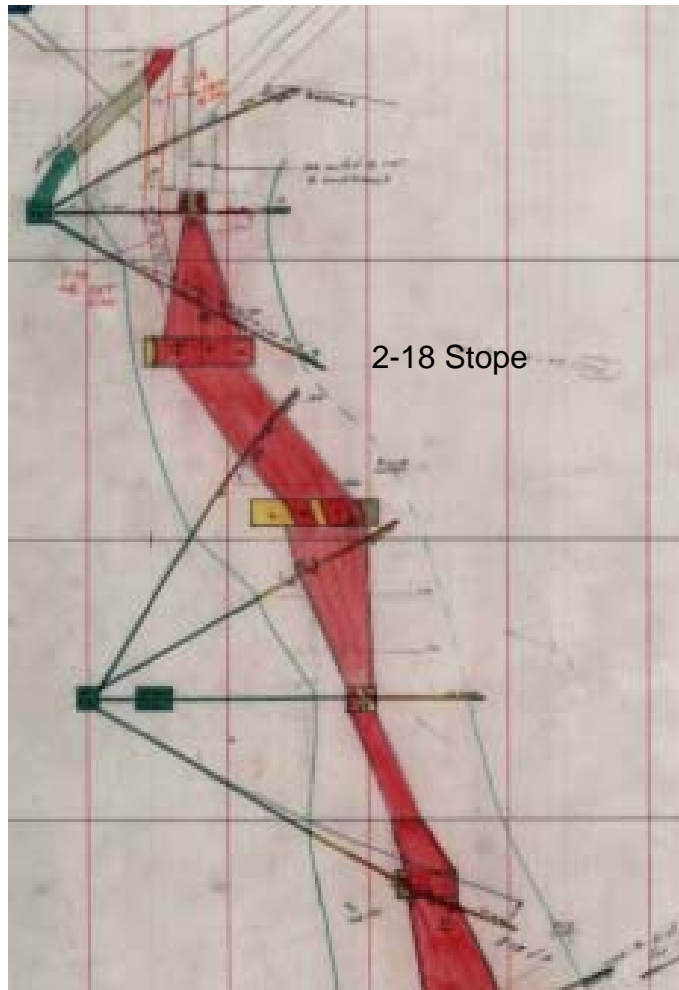
FIGURE::
19

2-18 Stope: C-Shaft, 1850S

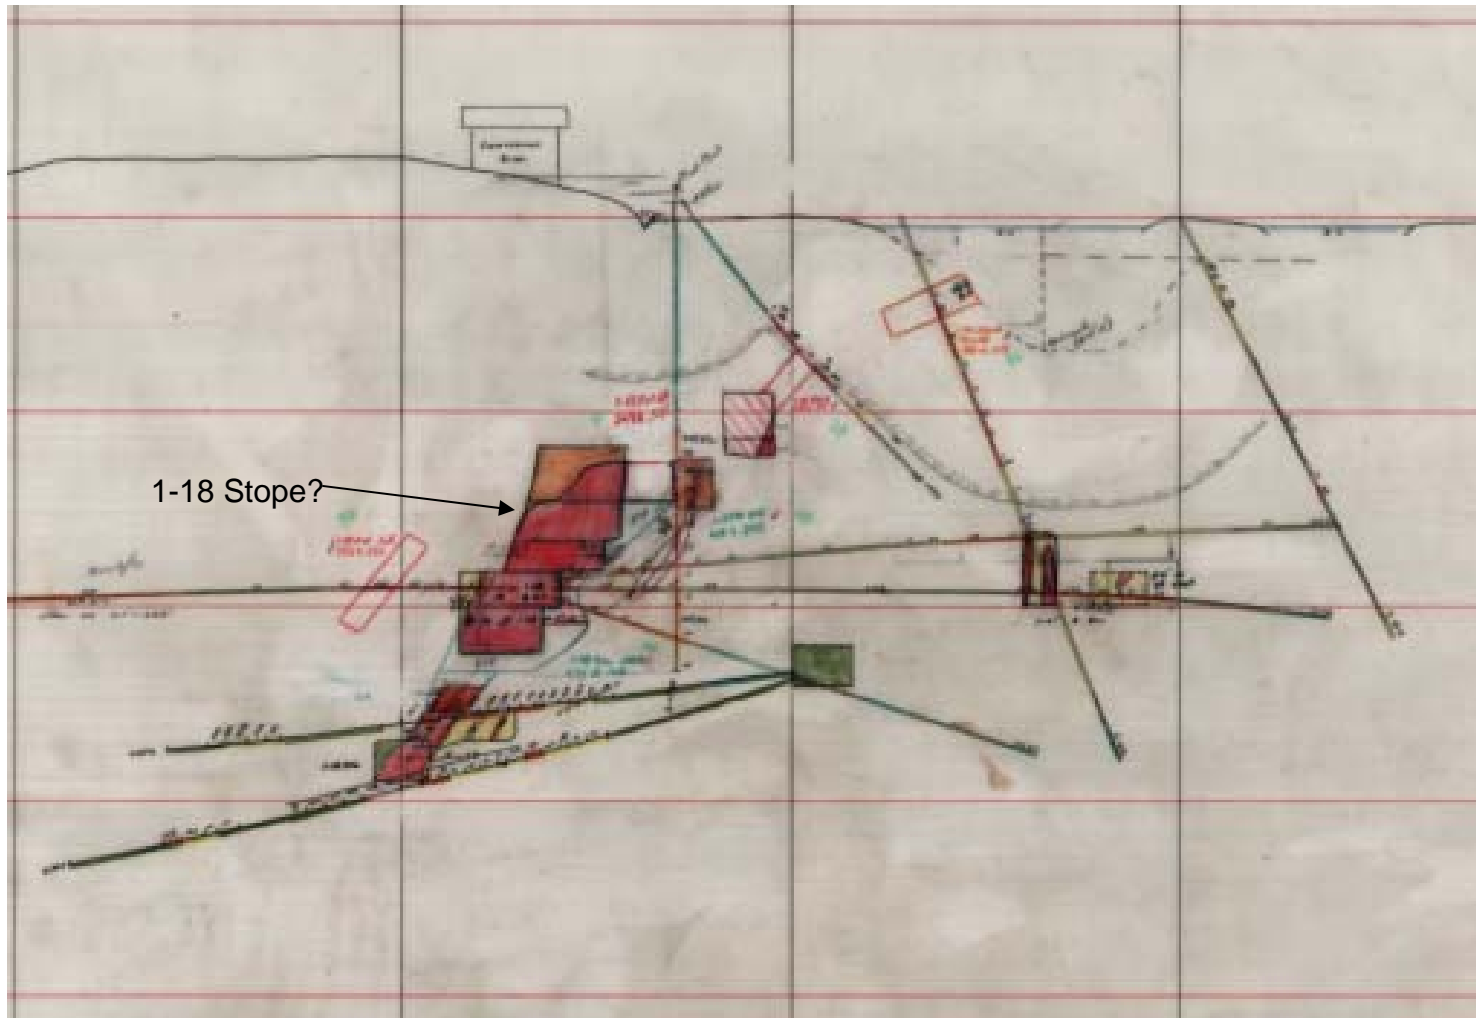
FIGURE::
22

1-18 Stope?: B-Shaft, 100S

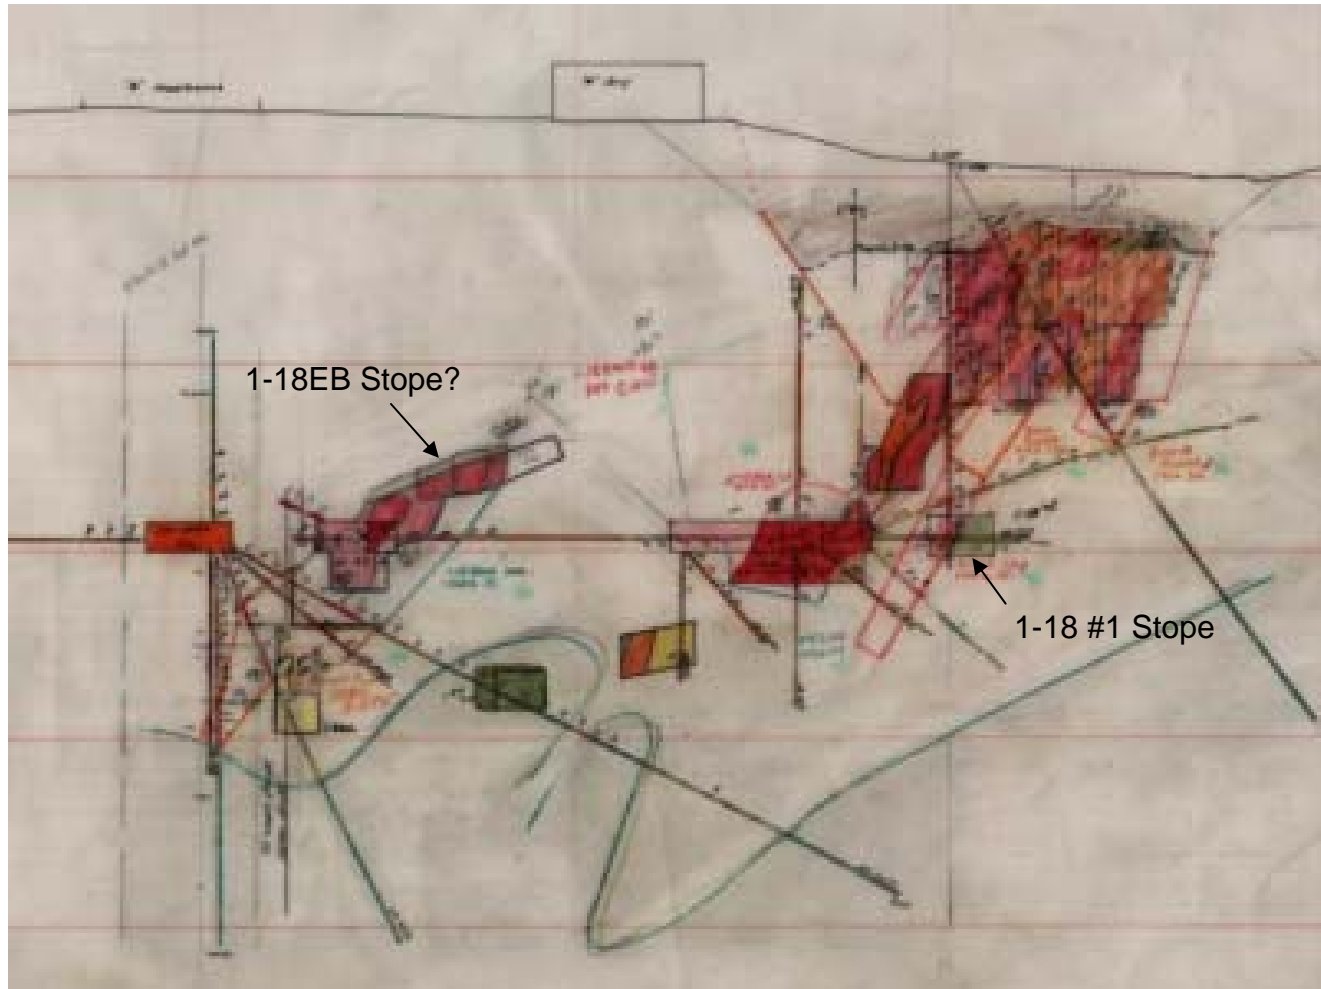
FIGURE::
24

1-18 Stopes: B-Shaft, 25N

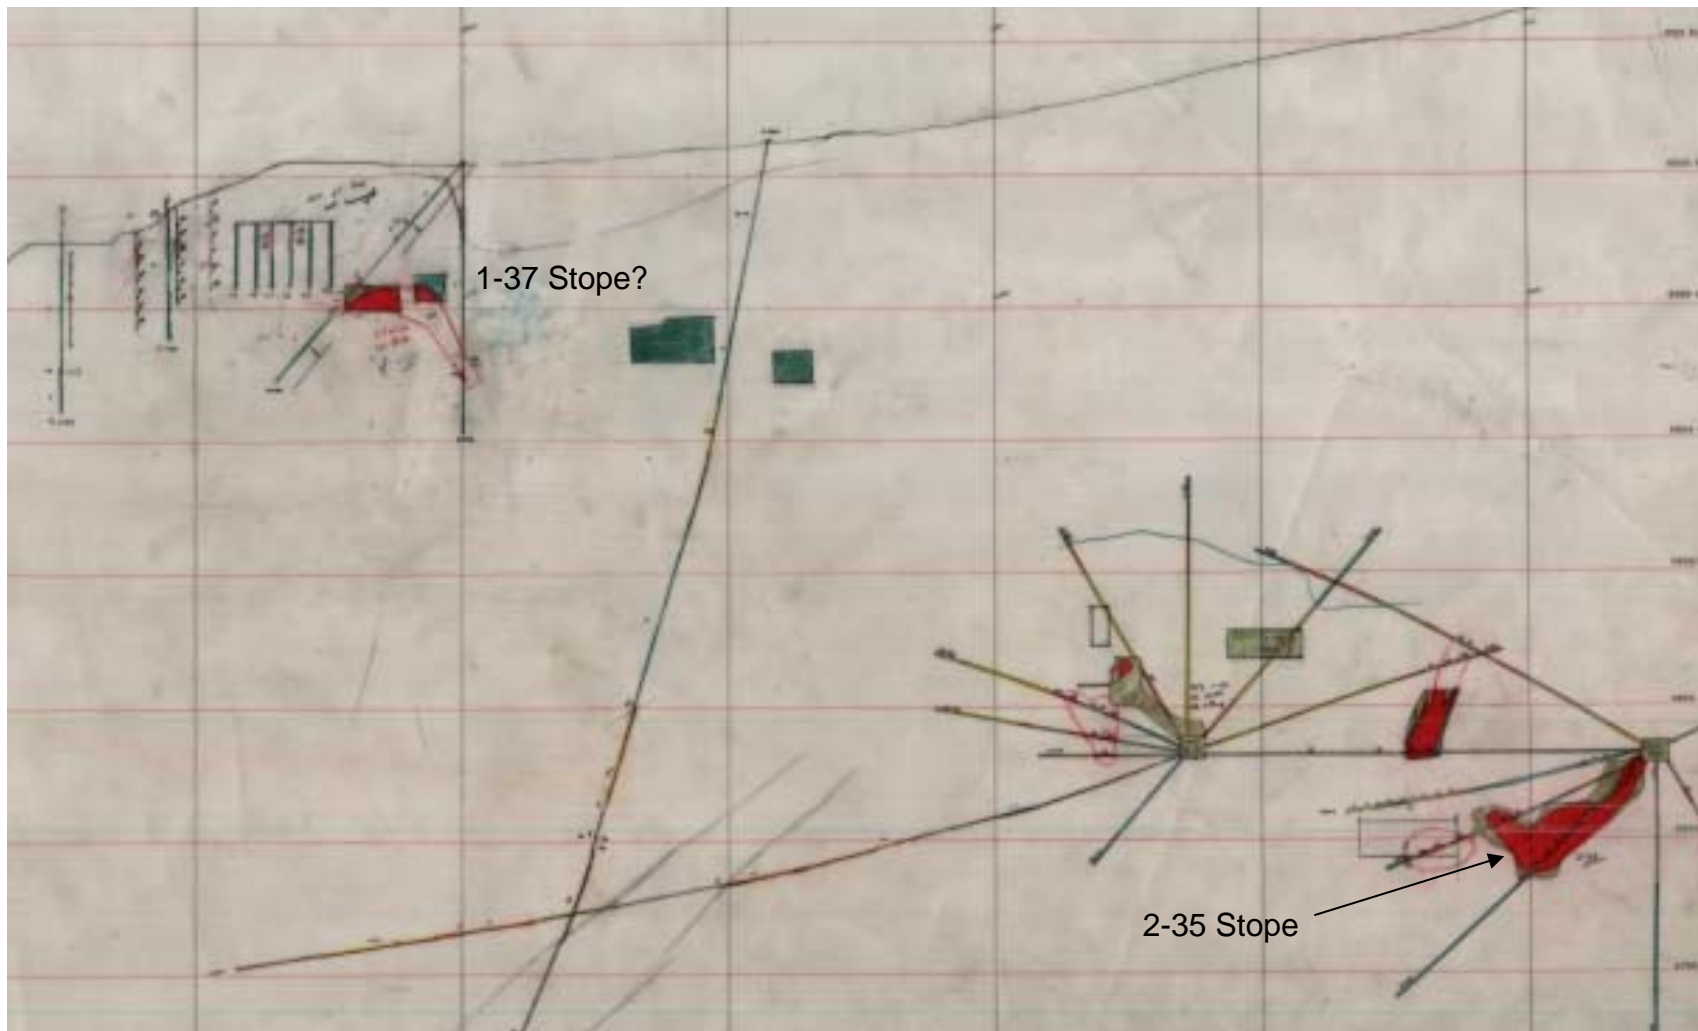
FIGURE::
35

1-37 Stope: B-3, 3650N
