Canadian Zinc Corporation

RECLAMATION ASSESSMENT, INVASIVE AND RARE PLANT SURVEY 2010
PRAIRIE CREEK MINE ACCESS ROAD, NT

April 2011

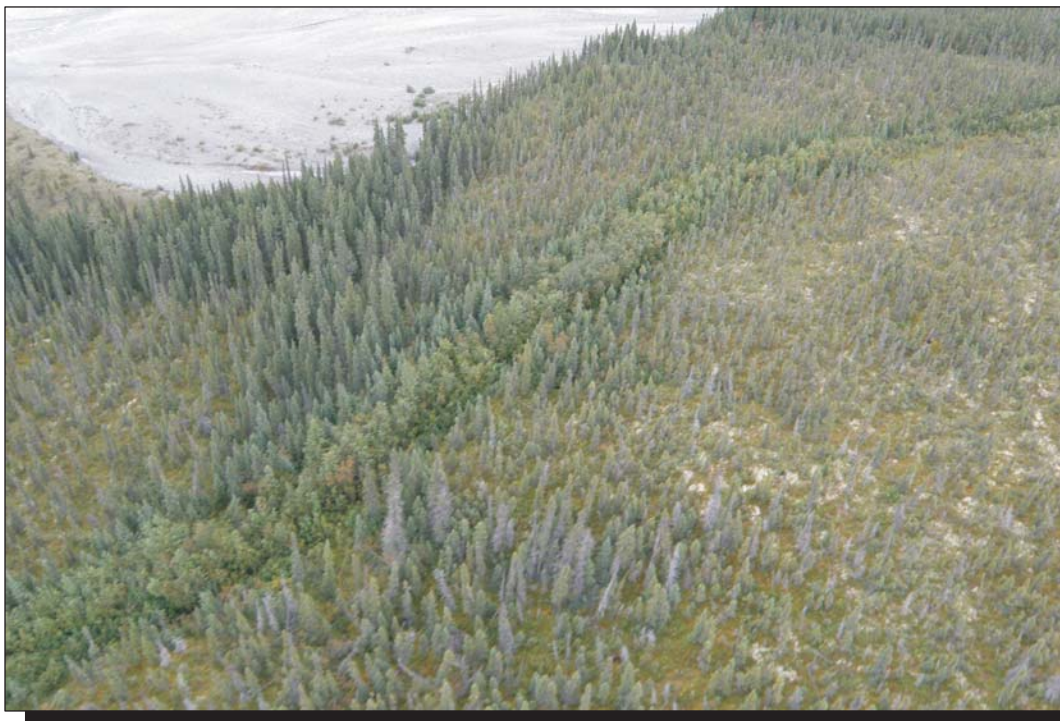
Photograph 1

The light green-coloured strip (appearing near the lower left corner and upwards to the upper right corner of the photo) shows the access road has been re-vegetated by spruce.

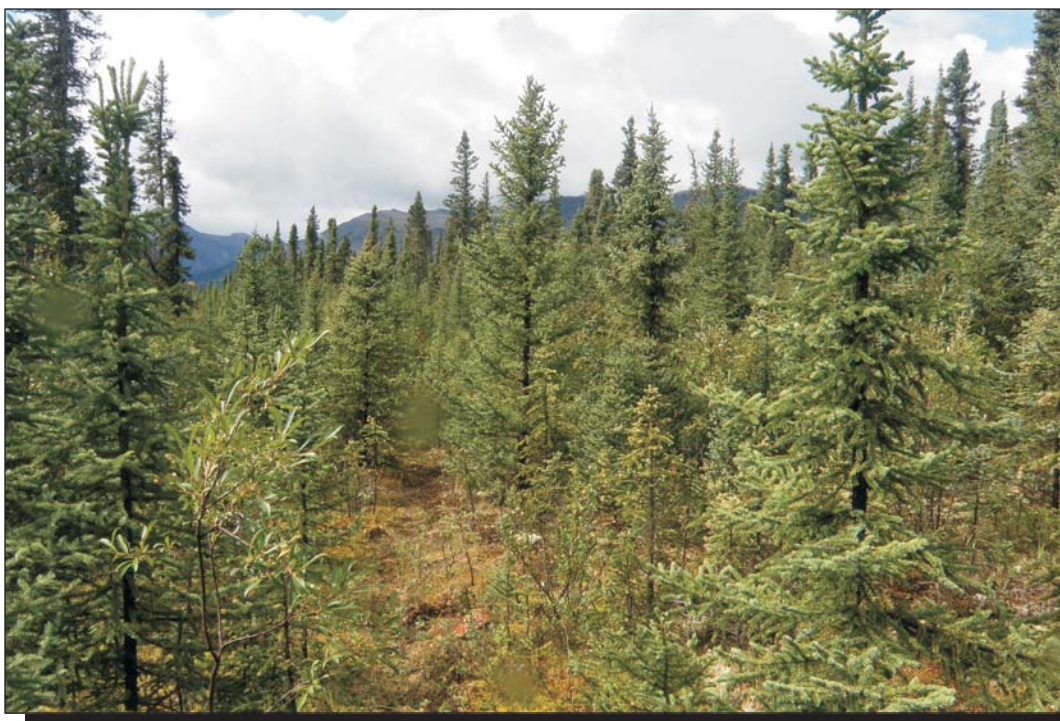
Photograph 2

A ground view of white spruce reclamation along the road with a shrub strata and a thick layer of moss.

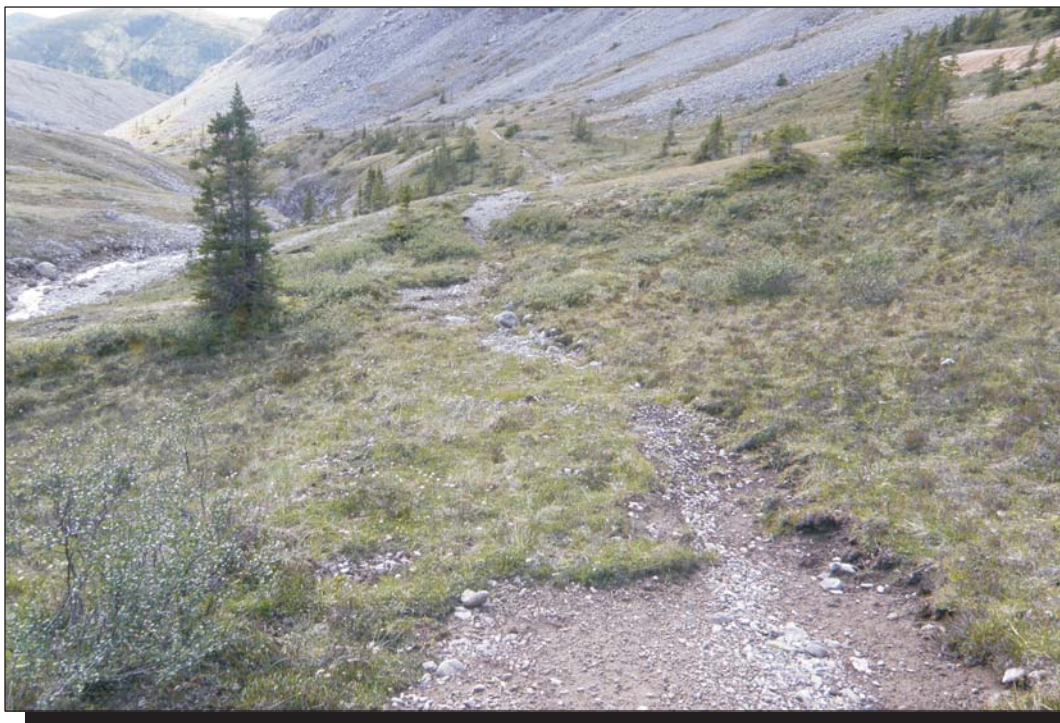
Photograph 4

The best sections of reclamation occur in patches that were likely not scrapped off during the time of road construction.

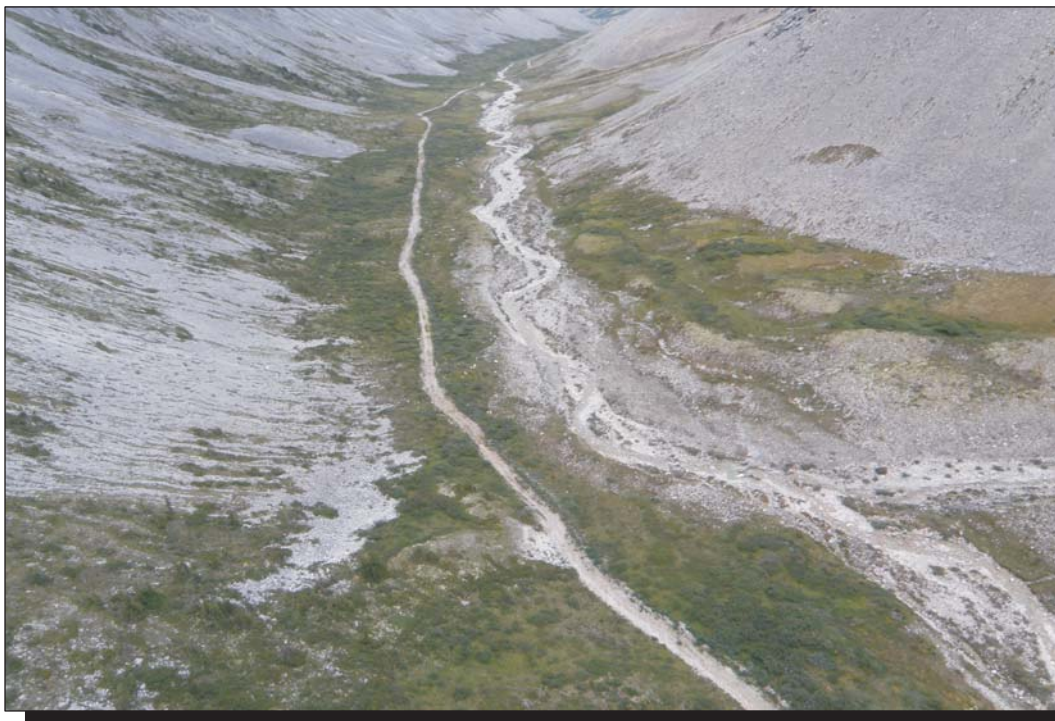
Photograph 5

This section of road has undergone periodic maintenance since 1982 and has not had an opportunity to re-colonize.

The access road passes through a small segment of Subalpine Shrub community type, approximately 5 km in length. This section of road has undergone periodic maintenance since 1982 and has not had an opportunity to re-colonize (Photograph 5). Despite periodic disturbance, willows and horsetails are encroaching across the surface from adjacent habitat (Photograph 6).

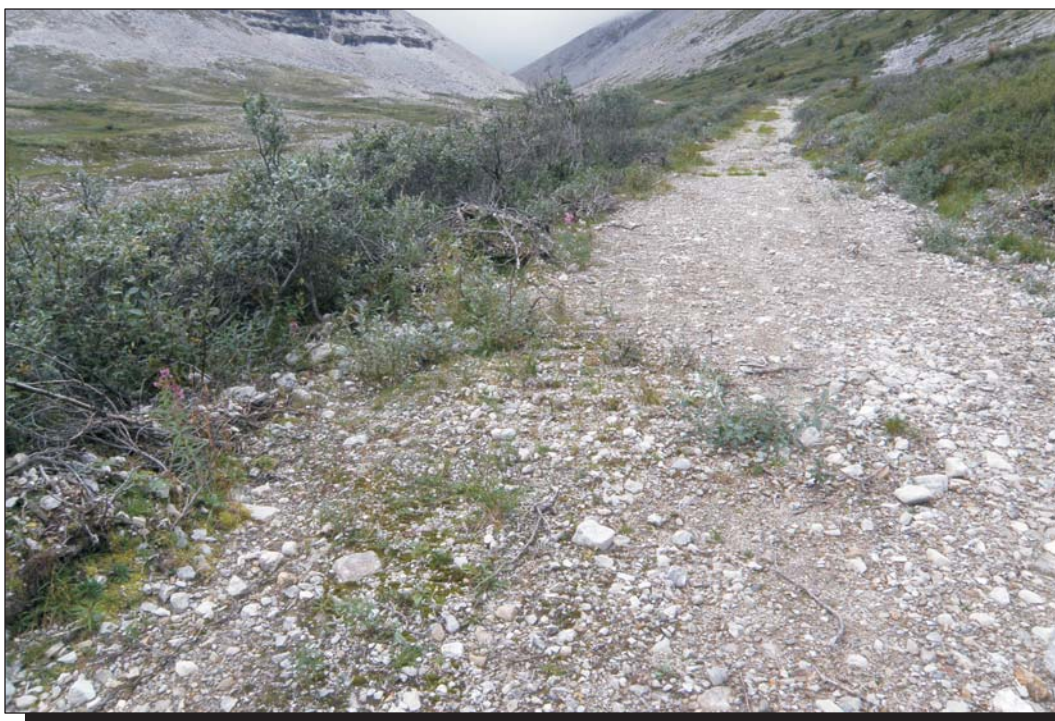
Photograph 6

Despite periodic road maintenance some species such as willows, horsetails, and fireweed are re-establishing themselves along the access road through the Subalpine Shrub community type.

Natural reclamation along this section of road within the Subalpine Shrub community type is at a younger seral stage due to periodic disturbances. Reclamation is slowly occurring by colonizing species such as willow, horsetail, and fireweed (Table 1). Source seed for the reclamation is from adjacent habitat units. Based on field observations, this section of road will re-colonize from adjacent sources once the existing road is left undisturbed.

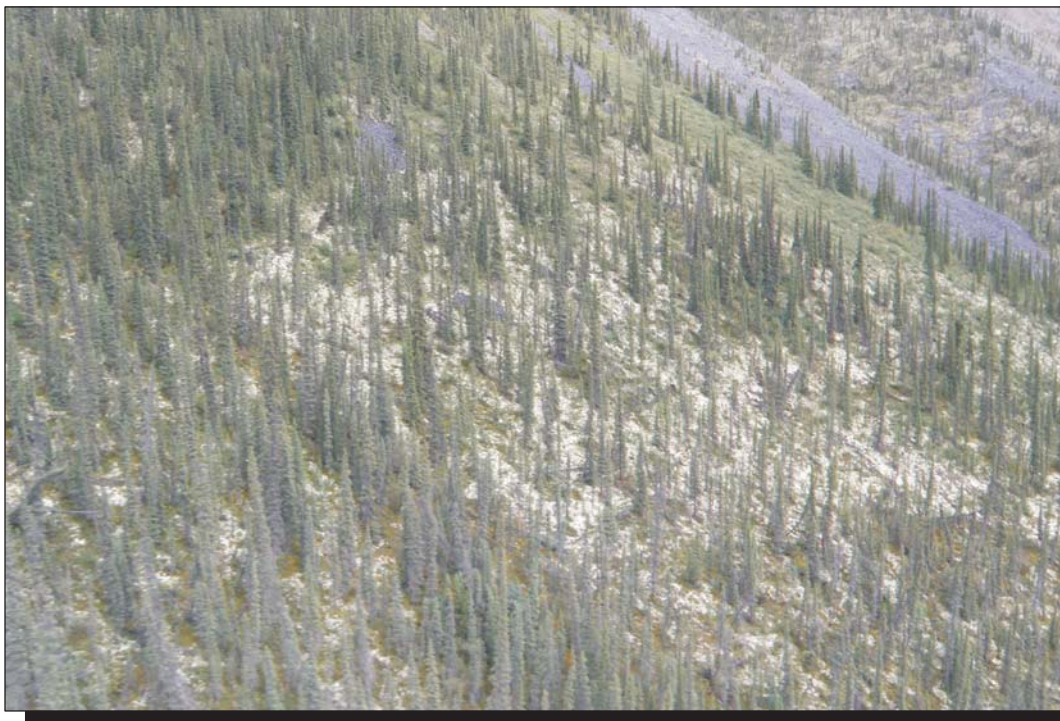
Photograph 7

The Spruce-Lichen community represents a climax community occurring on relatively stable colluvial slopes from the valley bottom to the upper slopes.

The Spruce-Lichen community represents a climax community occurring on relatively stable colluvial slopes from the valley bottom to the upper slopes. This community is susceptible to natural disturbances through snow slides. The climax stage is represented by tall spruce trees and a well developed mat of lichen (*Cladina stellaris*) (Beak 1981).

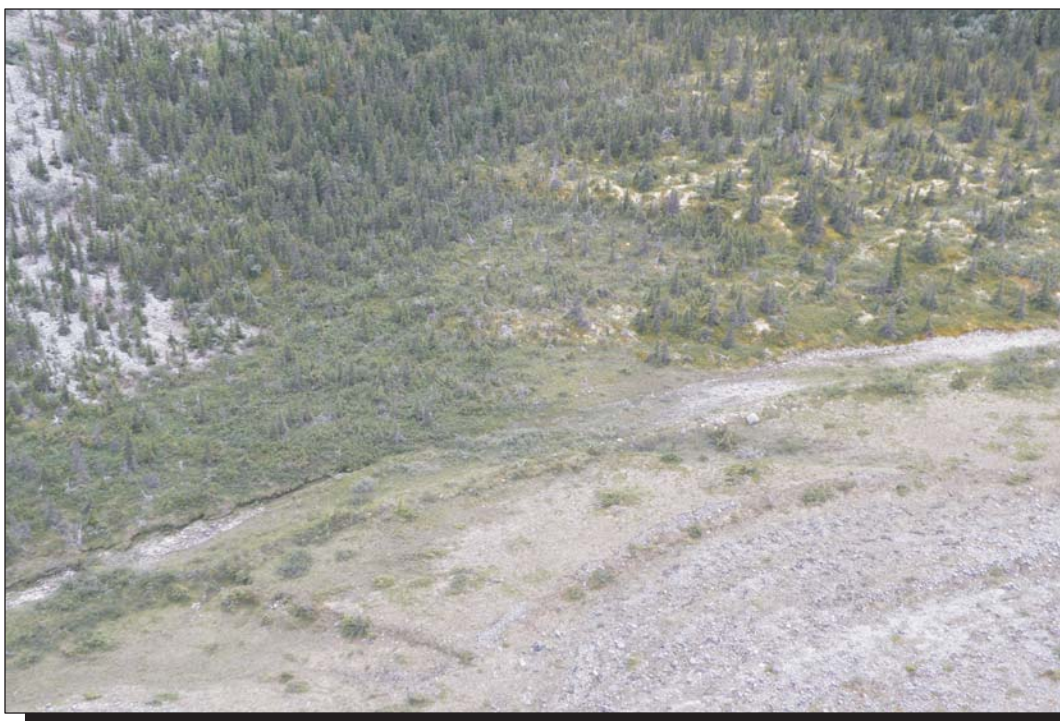
Photograph 8

Only in a few locations does the access road cross over the edge of Spruce-Lichen community types. Despite being exposed to periodic maintenance since 1982 vegetation reclamation is occurring, reverting that section of road back to its original state.

are presently at a young seral stage. This section of road in photograph 8 has been exposed to disturbance through periodic maintenance since 1982, yet reclamation is occurring and species similar to the original community type, such as spruce, are becoming re-establishing on the access road. The herbaceous layer is re-colonizing along with some shrubs (willows – *Salix glauca*). The occasional small spruce is present on the road bed, indicating that spruce regeneration is naturally occurring (Table 1). Source seed for the reclamation is from adjacent habitat. Based on field observations the community will naturally reclaim the access road over time and, if left undisturbed, will develop in to a Spruce-Lichen community.

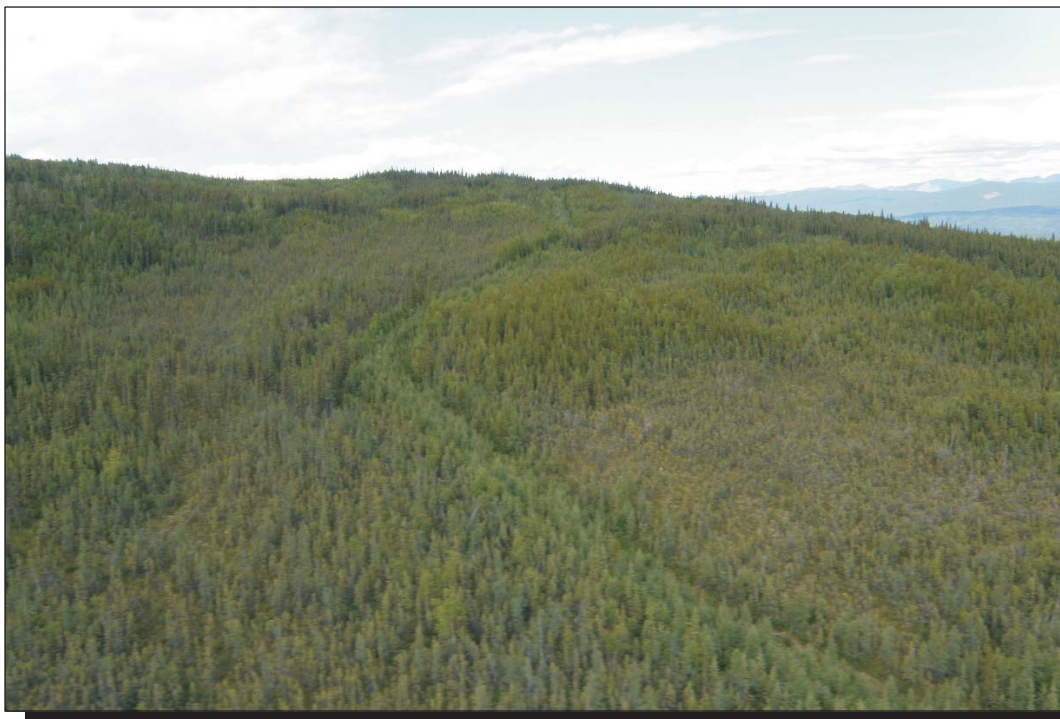
Photograph 10

After 28 years, the habitat along the road bed is developing towards a mature Black Spruce Parkland community.

The section of the access road occurring within the Black Spruce Parkland community type has not been disturbed over the last 28 years and natural reclamation is well established with a dense stand of trees. The advanced state of reclamation along this section of the road is evident in Photographs 9 and 10. After 28 years, the habitat along the access road is developing towards a mature Black Spruce Parkland community. The plant species present on the access road are similar to those in adjacent habitat (Table 1) (Photographs 11 and 12). Based on field observations of the section of road within the Black Spruce Parkland community type, reclamation will occur naturally once the existing road is left undisturbed.

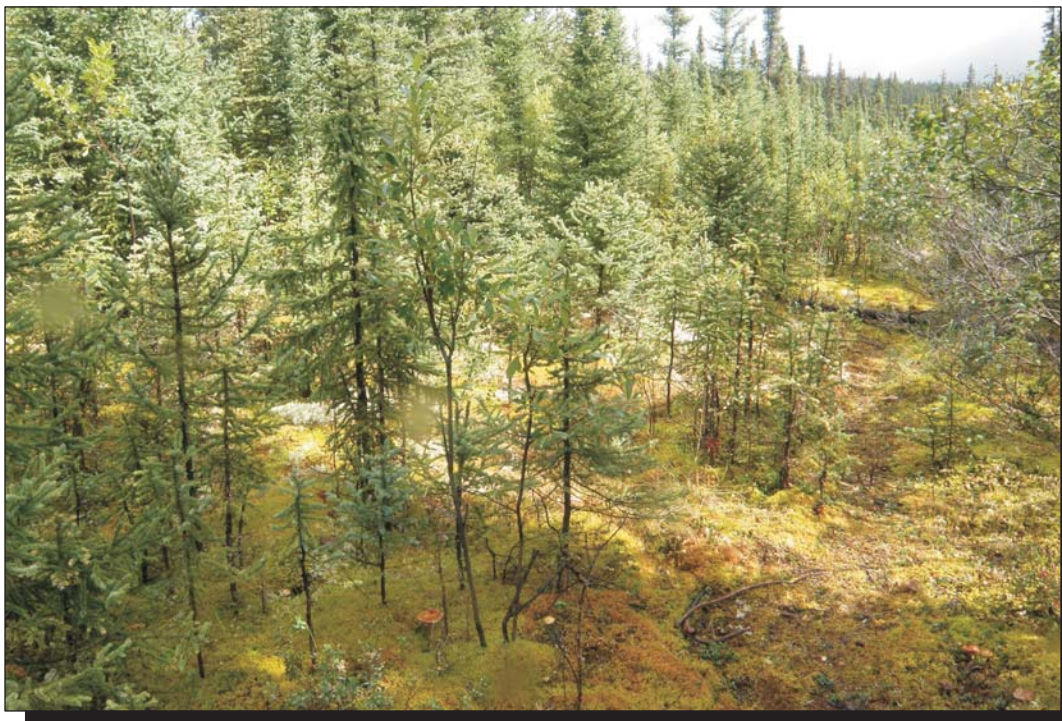
Photograph 11

The Black Spruce community type is developing well with defined stratum layers: small trees, shrubs, herbaceous and ground layers. Along some stretches the moss layer was up to 25 cm thick.

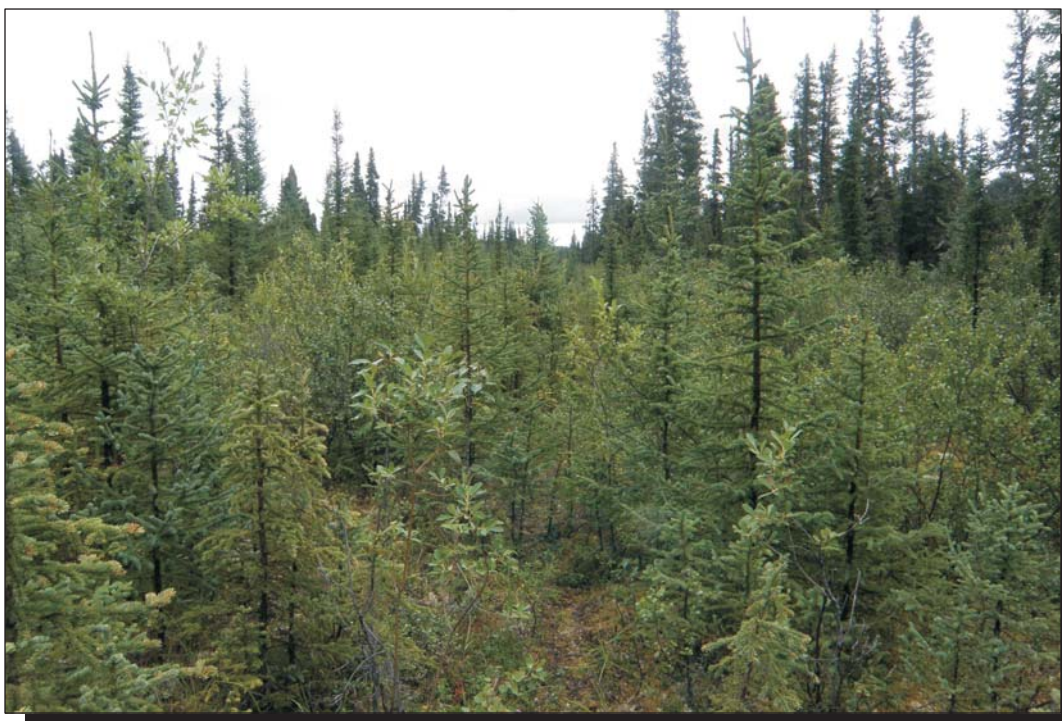
Photograph 12

This photograph shows the dense restocking of spruce trees. Some stretches along the road way were much thicker but could not be effectively photographed for report presentation.

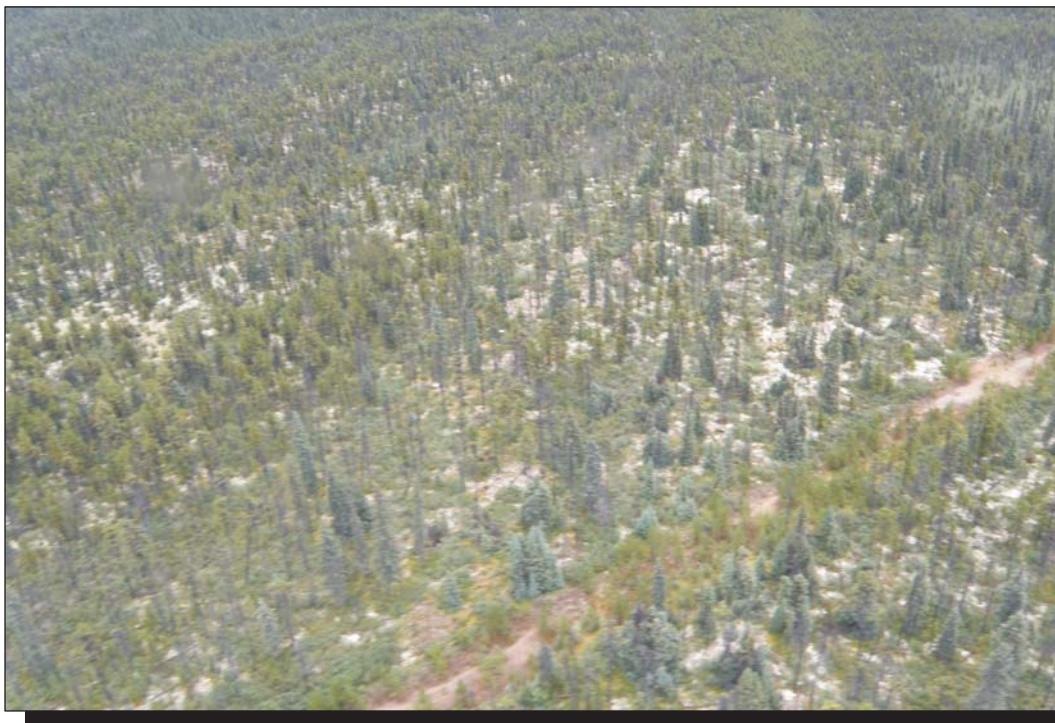
Photograph 13

The Pine Parkland community type occurs on well-drained upland areas. Jack pine is the predominant tree species with smaller amounts of white and black spruce.

The access road traverses approximately 10 km of Pine Parkland community type within the new NNPR boundary. This community type occurs on well-drained upland areas and characteristically has a more open tree canopy with significant coverage of *Cladonia* lichen (Photograph 13). Jack pine is the predominant tree species with smaller amounts of white and black spruce.

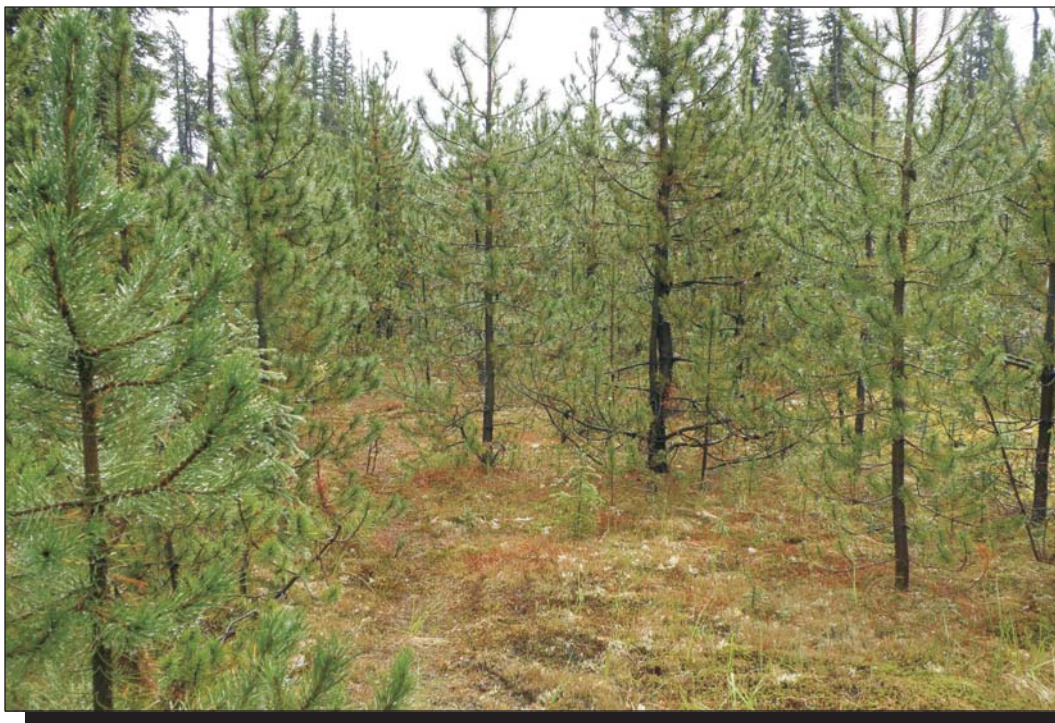
Photograph 14

The plant species present on the access road surface are similar to that in adjacent Pine Parkland community type and include jack pine, white spruce, willow, dwarf birch and cranberry.

This section of the access road has not been disturbed over the last 28 years and reclamation is well underway as can be seen Photograph 14. The plant species present on the access road bed are similar to those in adjacent habitat (Table 1). Based on field observations of the abandoned section of road within the Pine Parkland, reclamation will occur naturally once the existing road is left undisturbed.

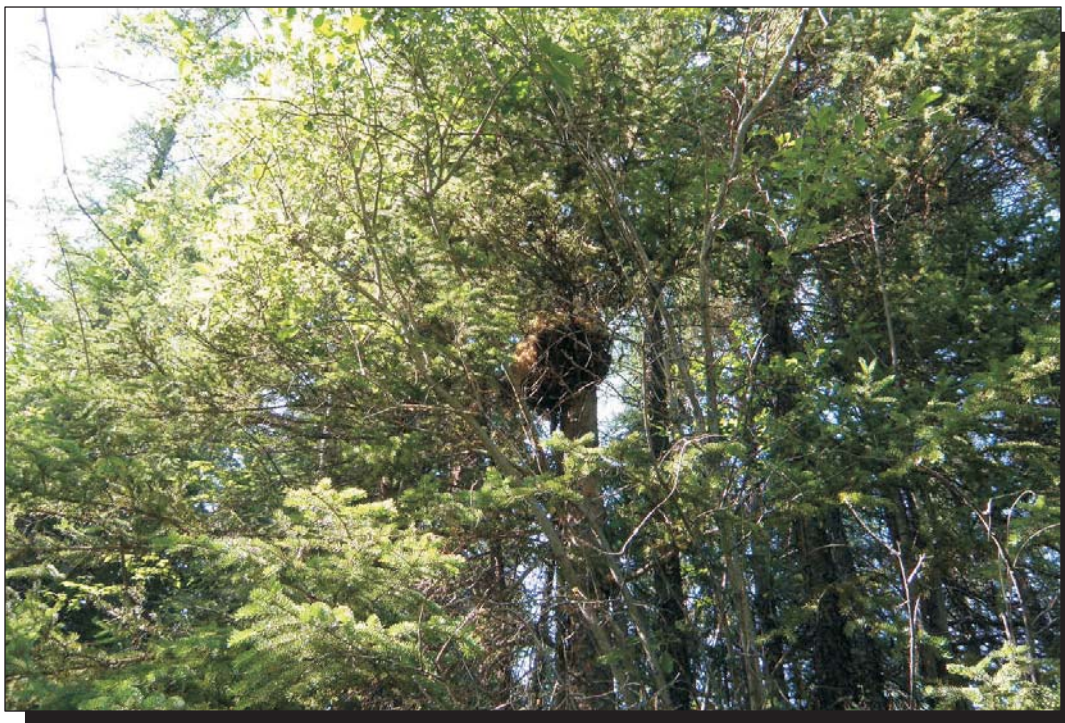
Photograph 16

Natural reclamation along this section of road within the Mixed Conifer–Deciduous community type is well underway, generating a dense stand of mixed trees.

Natural reclamation along this section of road within the Mixed Conifer–Deciduous community type is well underway (Table 1). Source seed for the reclamation is from adjacent habitat units. Based on field observations this section of road is naturally regenerating as a mixed conifer-deciduous community type from adjacent habitats.

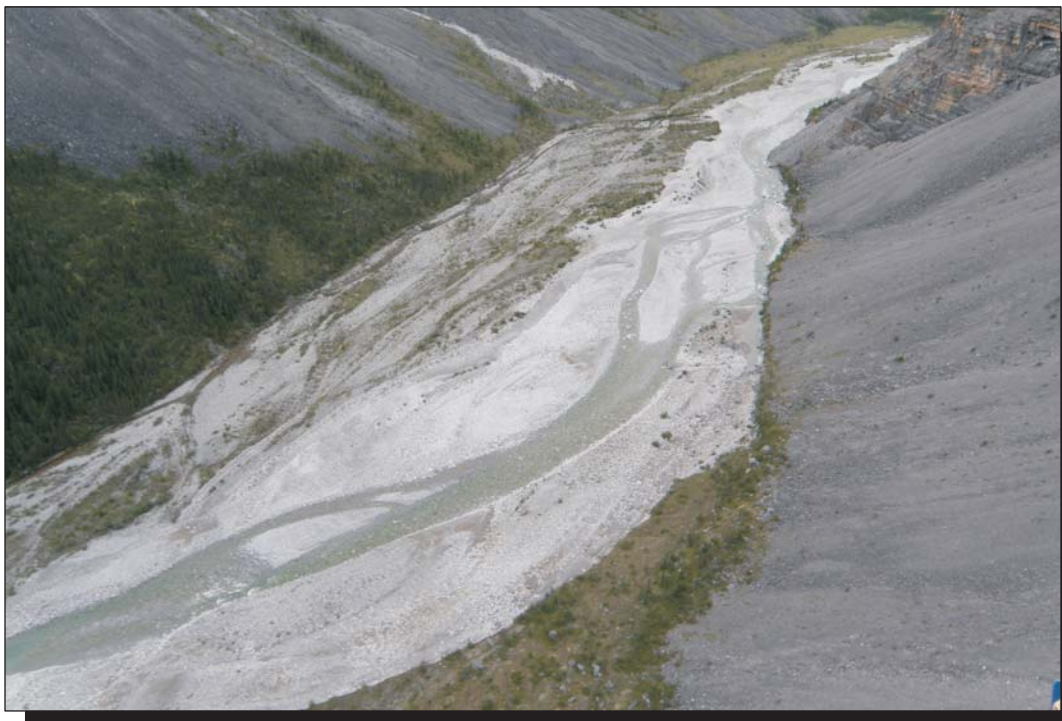
Photograph 17

The Riparian Alluvial community type occurs in the bottom of valleys and consists of vegetated gravel bars within the braided streams.

The Riparian Alluvial community type occurs in the bottom of valleys and consists of vegetated gravel bars within the braided streams. This community type undergoes annual disturbance in the form of erosion and ice-gouging during spring runoff; consequently, it was not assessed in the context of reclamation. Regular disturbance is a natural, recurring event and the species present reflect this situation (Photographs 17 and 18).

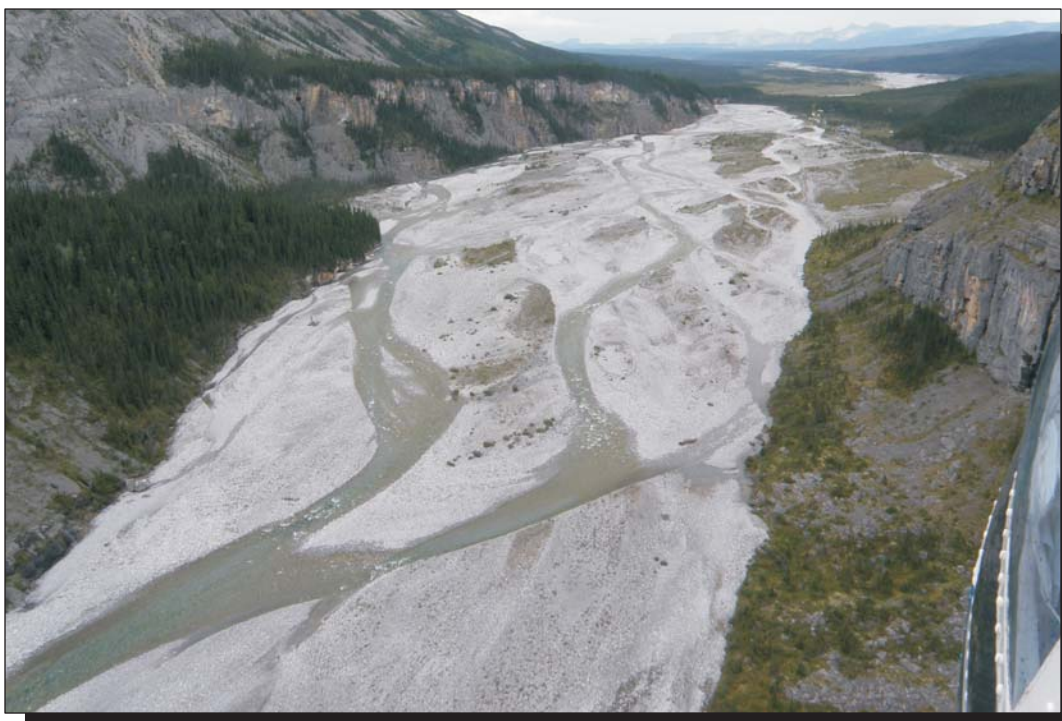
Photograph 18

This community type undergoes annual disturbance in the form of erosion and ice-gouging during spring runoff and was not assessed in context to reclamation.

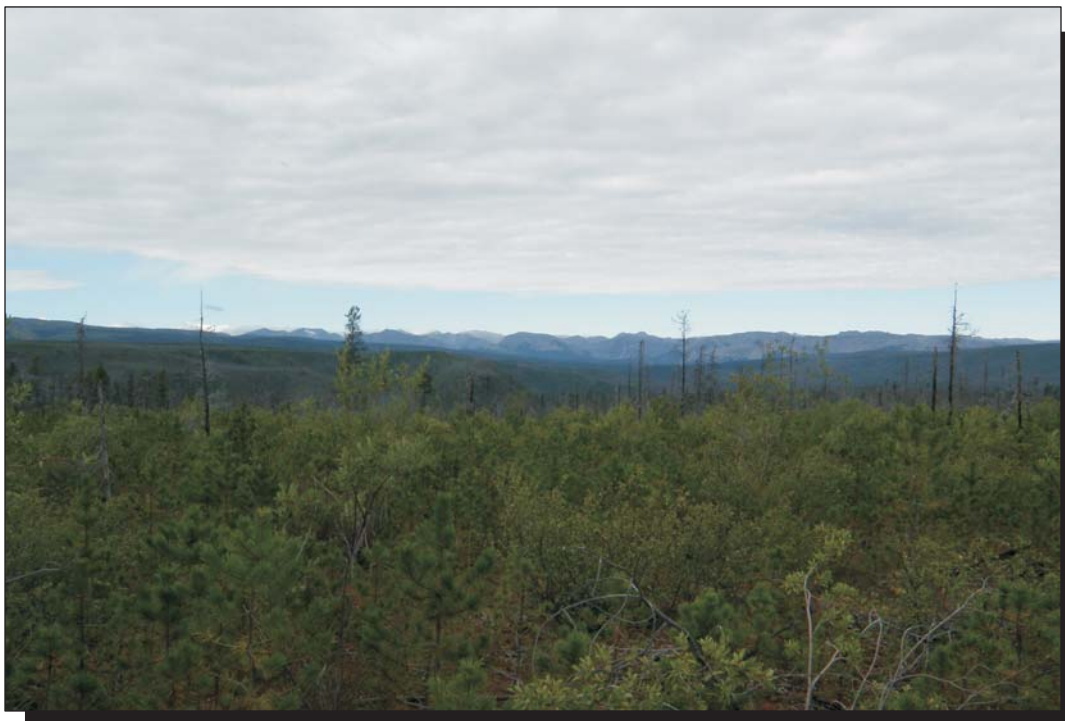
Photograph 19

The habitat for which the proposed Polje By-Pass road alignment traverses was subjected to a forest fire in 1996 that completely burned the majority of standing timber.

The habitat for which the proposed Polje By-Pass road alignment traverses was subjected to a forest fire in 1996 (Kochtubajda *et al.* 2006) that completely burned the majority of standing timber. The only trees to survive the fire were those located adjacent to creeks, in the riparian zones. A jack pine forest has established itself following the fire (Photographs 19 and 20). The entire proposed Polje By-Pass road alignment passes through this community type, with the exception of two creeks where white spruce trees survived the fire. The width of these sites is highly variable, with one swath being only a few metres wide and the second one less than 10 m wide.

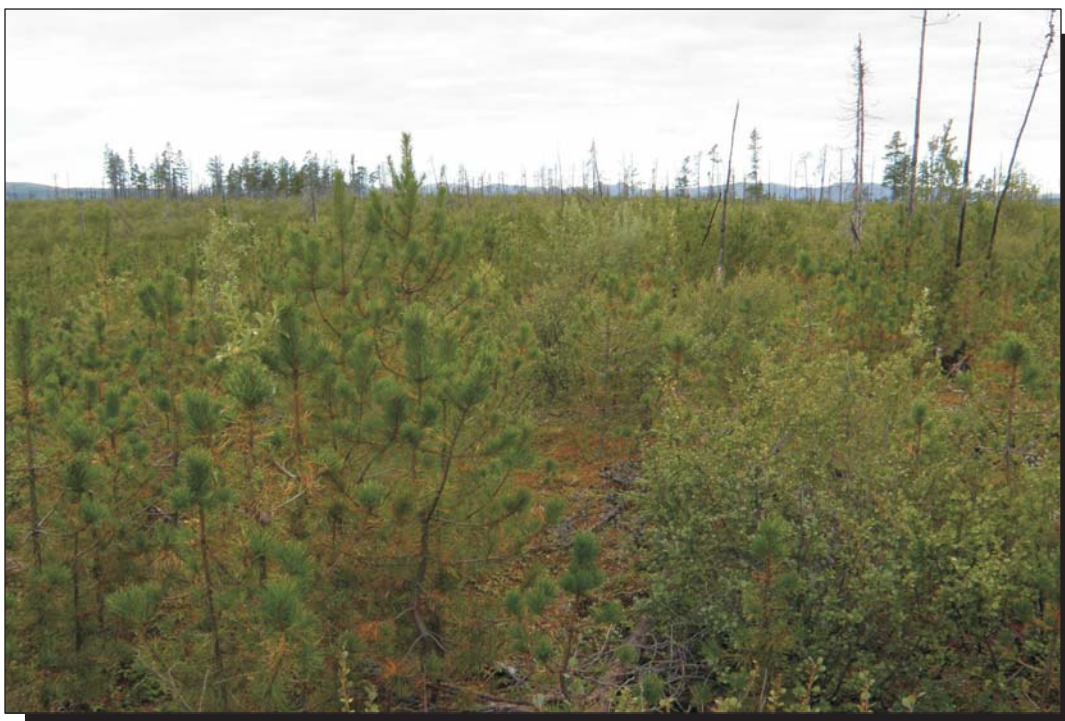
Photograph 20

A jack pine stand has become established along the entire proposed Polje By-Pass road alignment and represents an early seral stage.

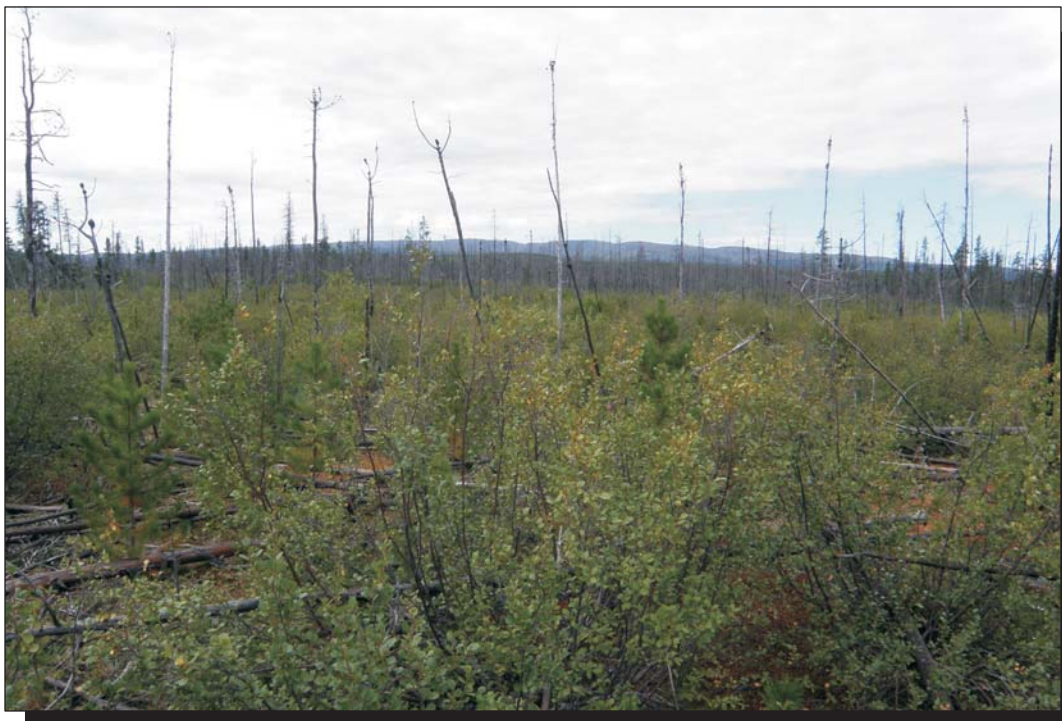
Photograph 21

The shrub stratum canopy closure varied between 10 and 25 % and consisted of two layers, medium and low shrubs, consisting of dwarf birch/ willow and cranberry, respectively.

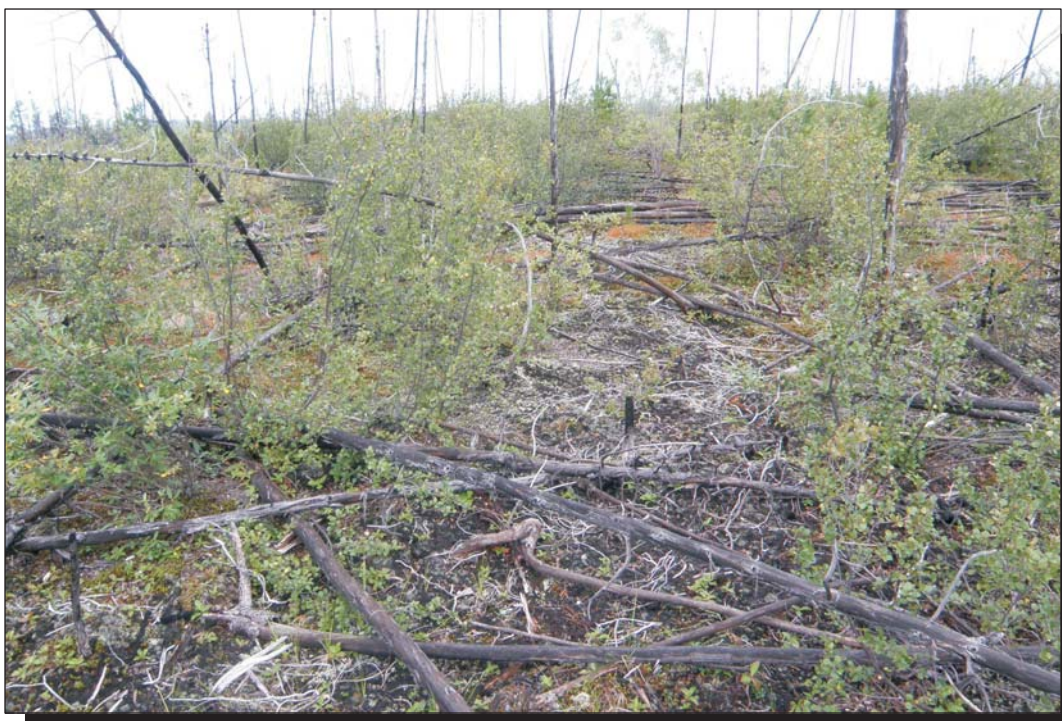
Photograph 22

Many dead trees (snags) were left standing, and considerable debris, in the form of tree trunks and branches, remain on the ground, with patches of exposed mineral soil throughout.
