APPENDIX Q GRANULAR MATERIAL ASSESSMENT, YELLOWKNIFE GOLD PROJECT, NT
REPORT PREPARED BY EBA ENGINEERING CONSULTANTS LTD.
FOR TYHEE NWT CORP, NOVEMBER 2008

**GRANULAR MATERIAL ASSESSMENT
YELLOWKNIFE GOLD PROJECT, NT**

Y14101117

November 2008

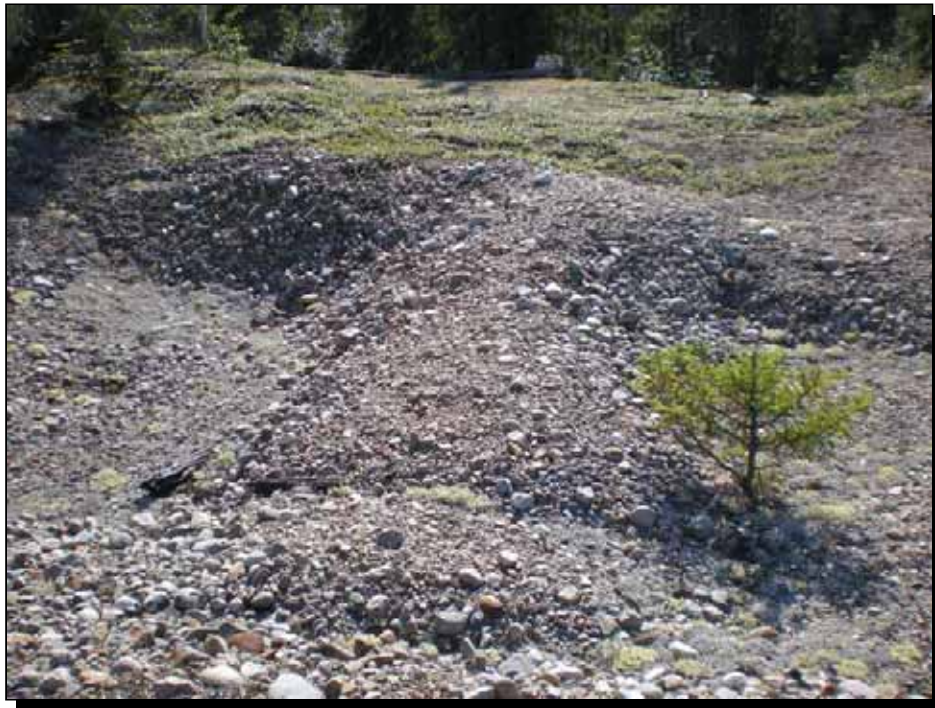
Photo 1
Existing borrow source at S-10

- Construct a winter road to the northern area of interest in proximity to sample S-10 and S-11 to conduct a detailed site investigation. This will serve to accurately determine the quality and quantity of the available material. The investigation would involve mobilizing an excavator to the area in order to advance test pits and take samples at varying depths. A test pit program could also be extended to the area in proximity to S-12 to determine the quality and quantity of available cohesive material. Though due to the high natural moisture content of sample S-12, the area may not be penetrable until the ground thaws in late spring.

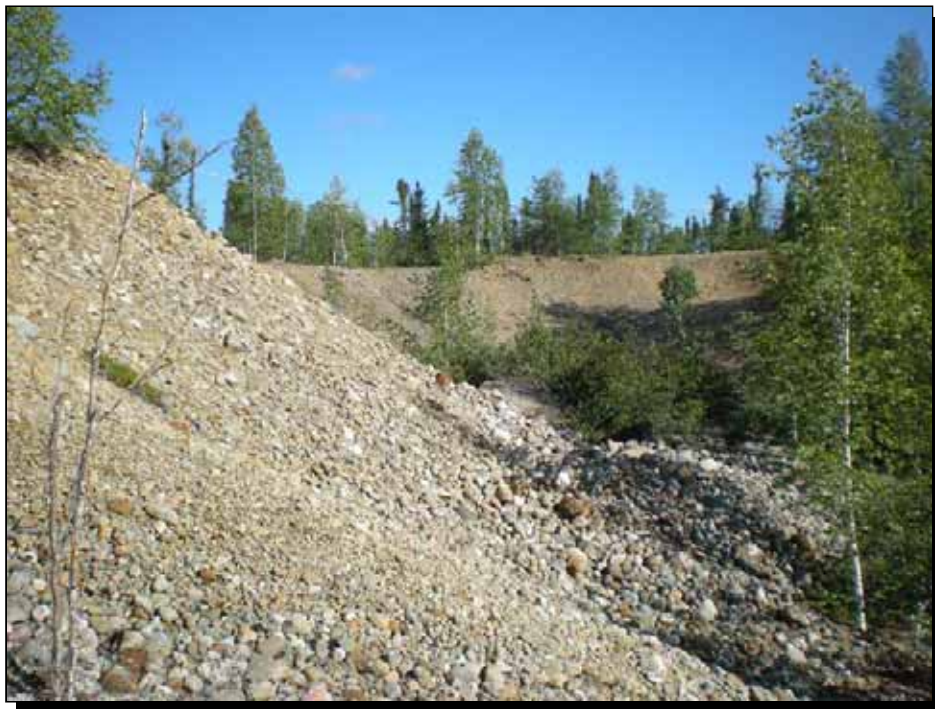
Photo 2
Existing borrow source at S-10

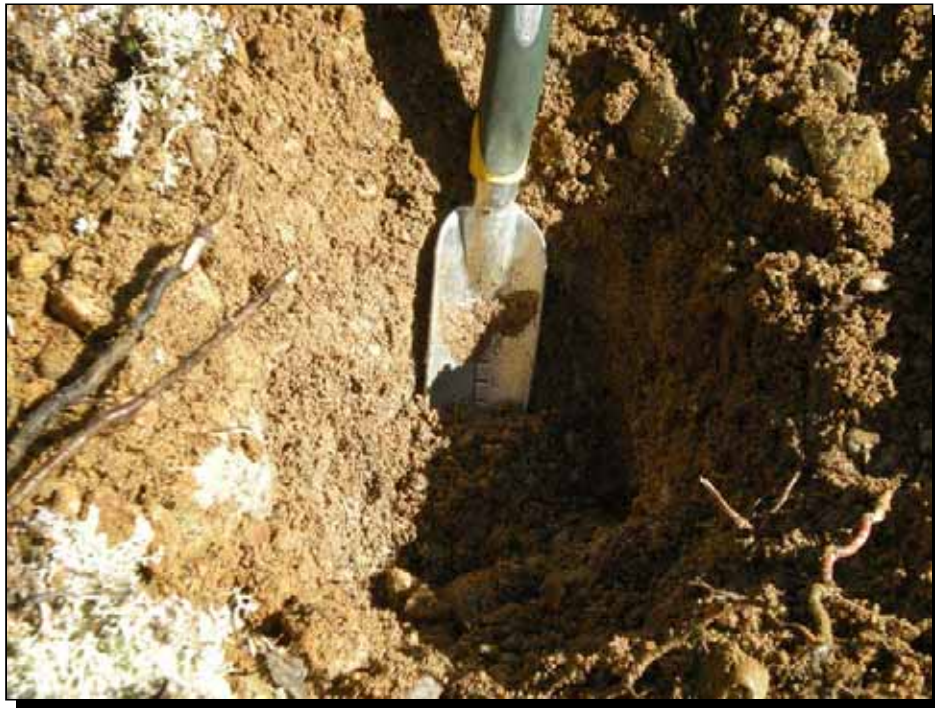
Photo 3
Sand and gravel at S-04

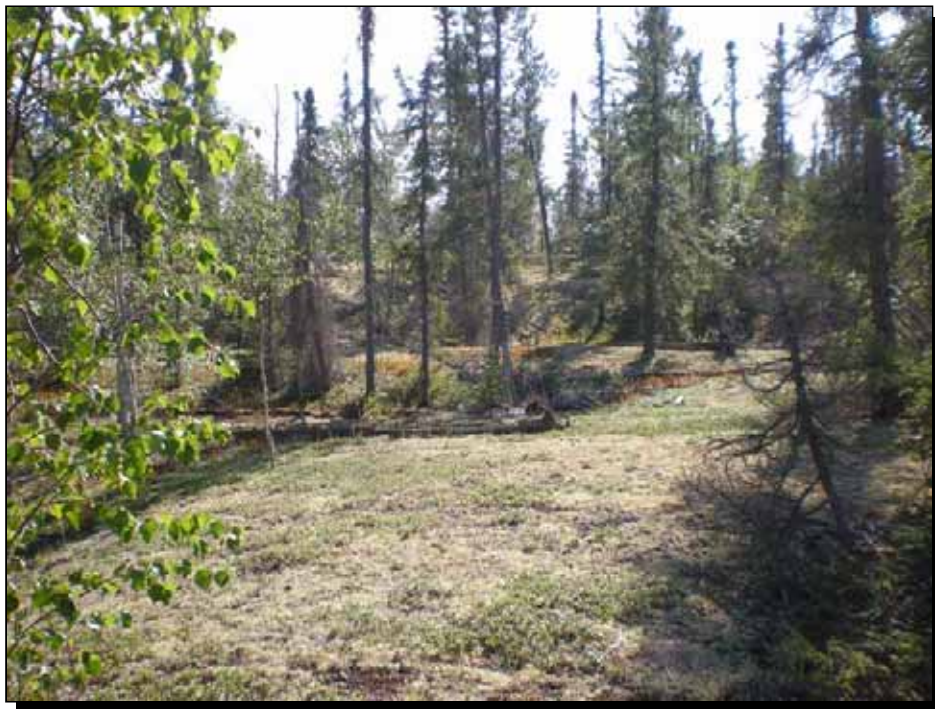
Photo 4
Typical terrain around S-04

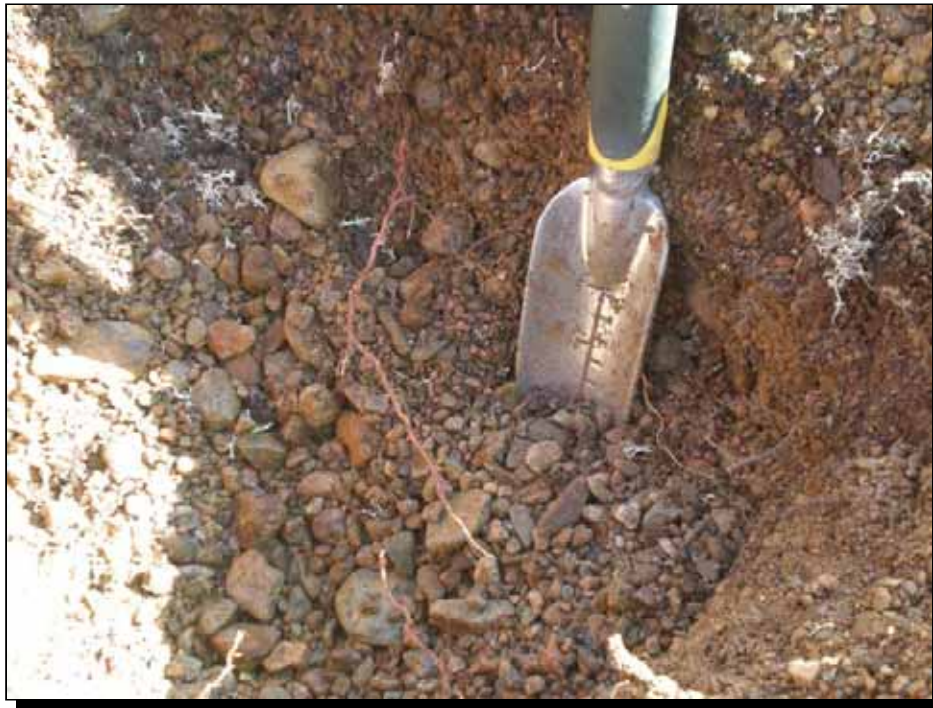
Photo 5
Gravel at S-02

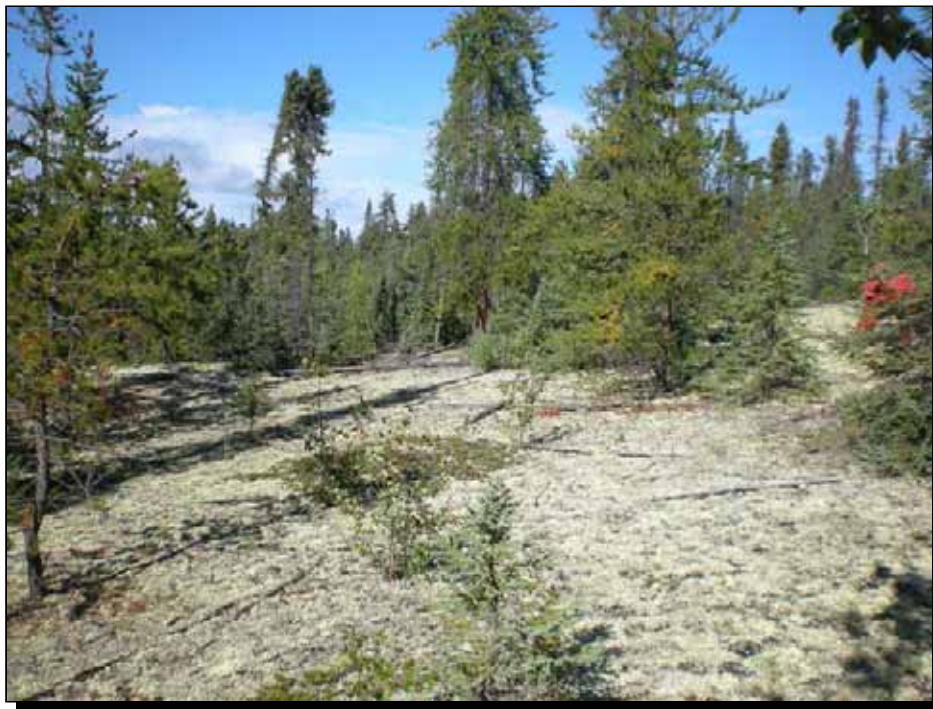
Photo 6
Typical terrain at S-02

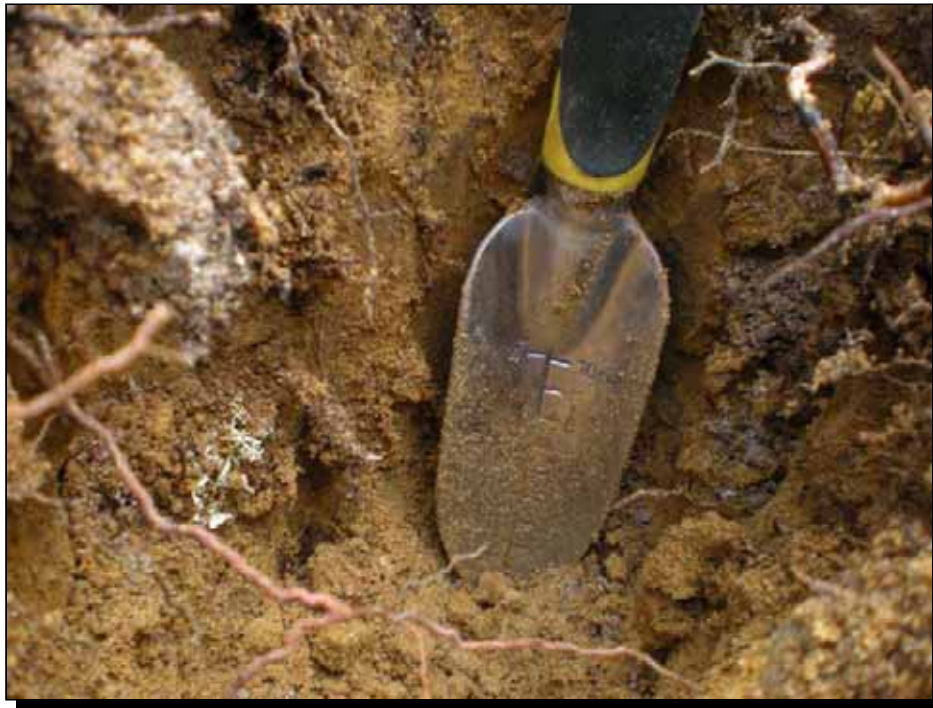
Photo 7
Sand at S-03

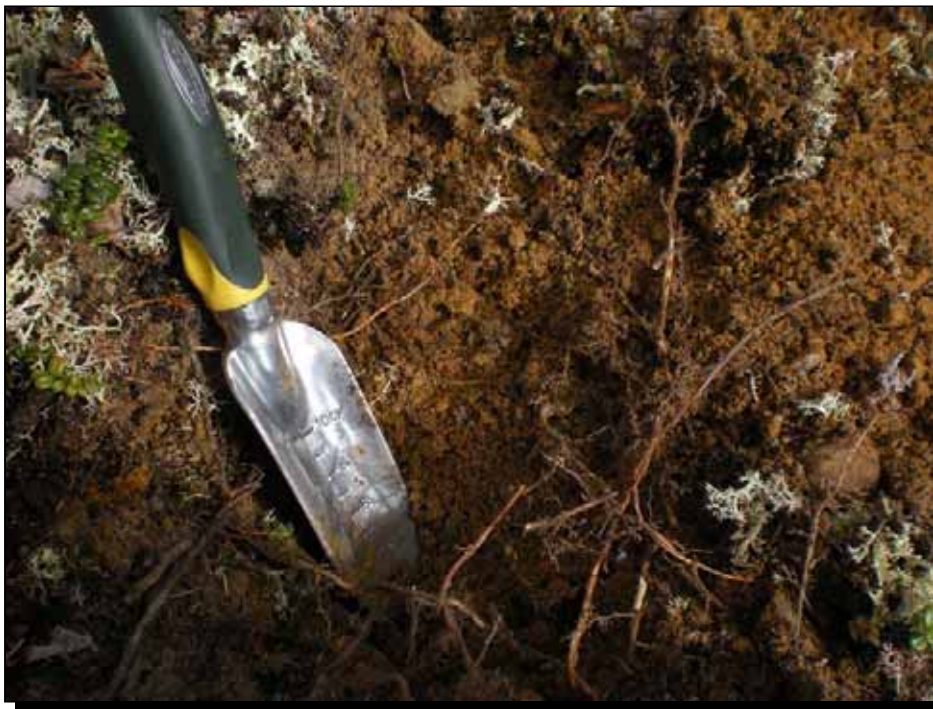
Photo 8
Sand at S-07

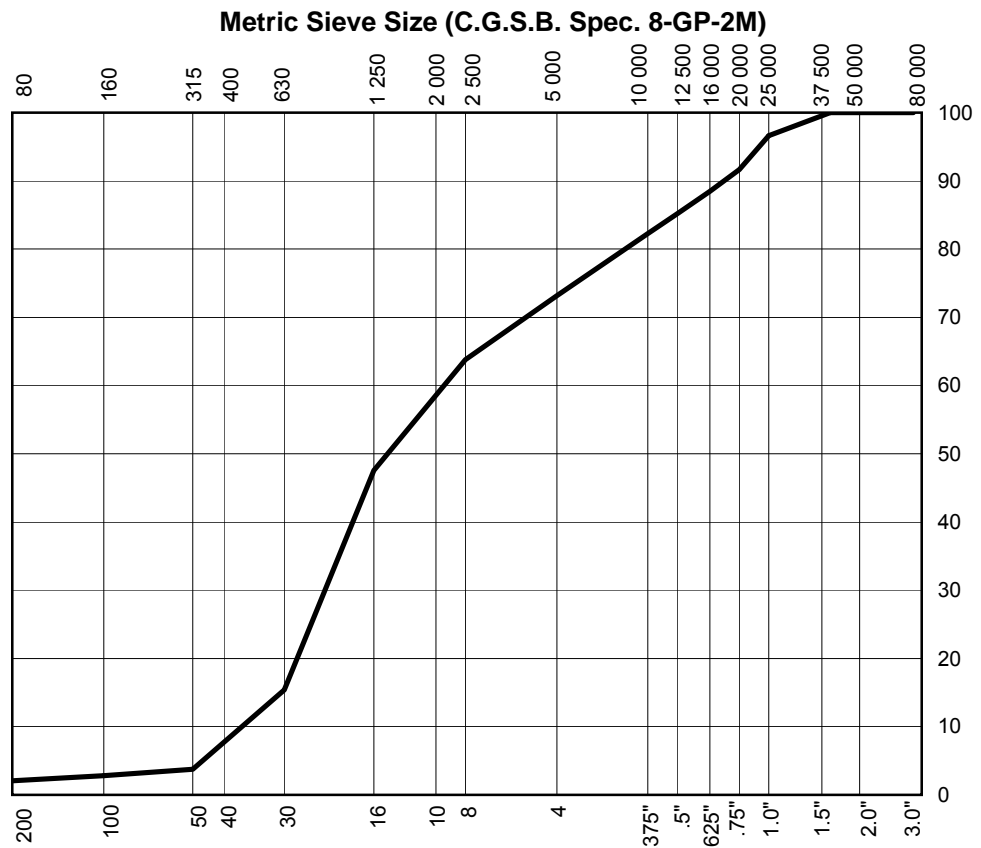
Sample # S-07
Natural Moisture Content: 3.2%
Colour Plate No.: n/d
Bulk Relative Density: n/d
Apparent Relative Density (SSD): n/d
Apparent Relative Density: n/d
Absorption: n/d

Sieve Sizes		% Passing
U.S.	Metric	
3"	80 000	
2"	50 000	
1.5"	37 500	100
1"	25 000	97
.75"	20 000	92
.625"	16 000	88
.5"	12 500	85
.375"	10 000	82
No. 4	5 000	73
No. 8	2 500	64
16	1250	48
30	630	15
50	315	4
100	160	3
200	80	2.1
