# NICO MINE ACCESS ROUTE EVALUATION

**NICO MINE ACCESS  
ROUTE EVALUATION  
(Revision 1)**

EBA ENGINEERING CONSULTANTS LTD.  
YELLOWKNIFE, NORTHWEST TERRITORIES

Project No. 1700127.001

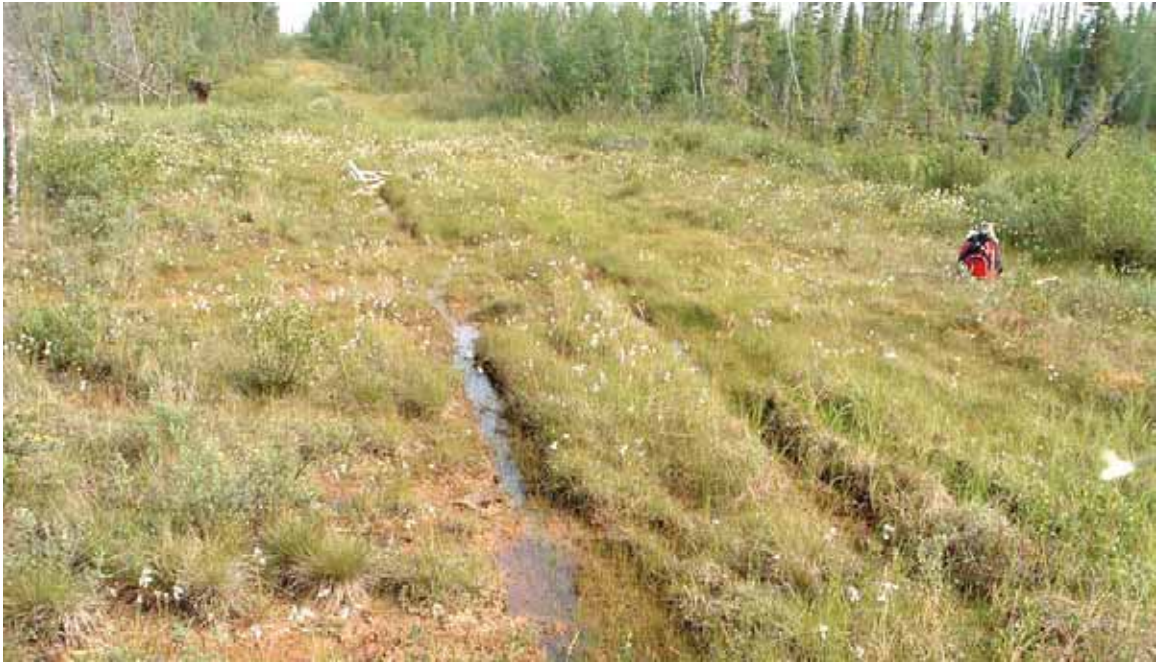
Poorly drained area – Looking towards north, existing trail  
Distance = 1.06 km.

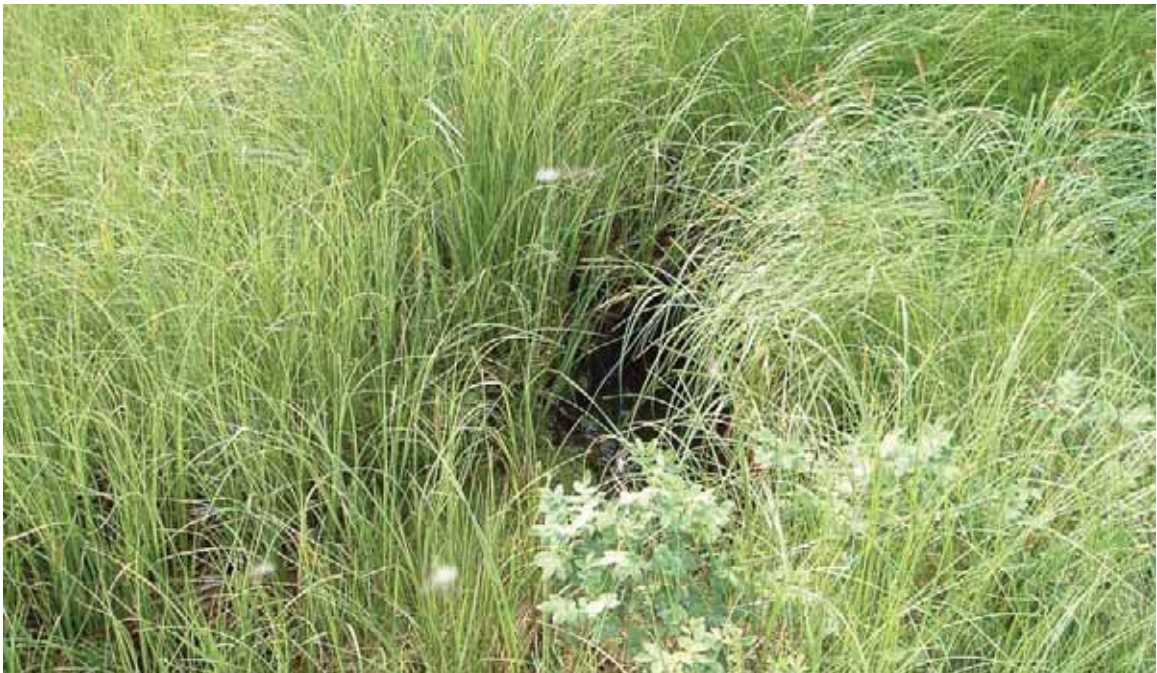
Stream of water – Existing trail, north-south section. Water flowing from west to east. Distance 1.63 km

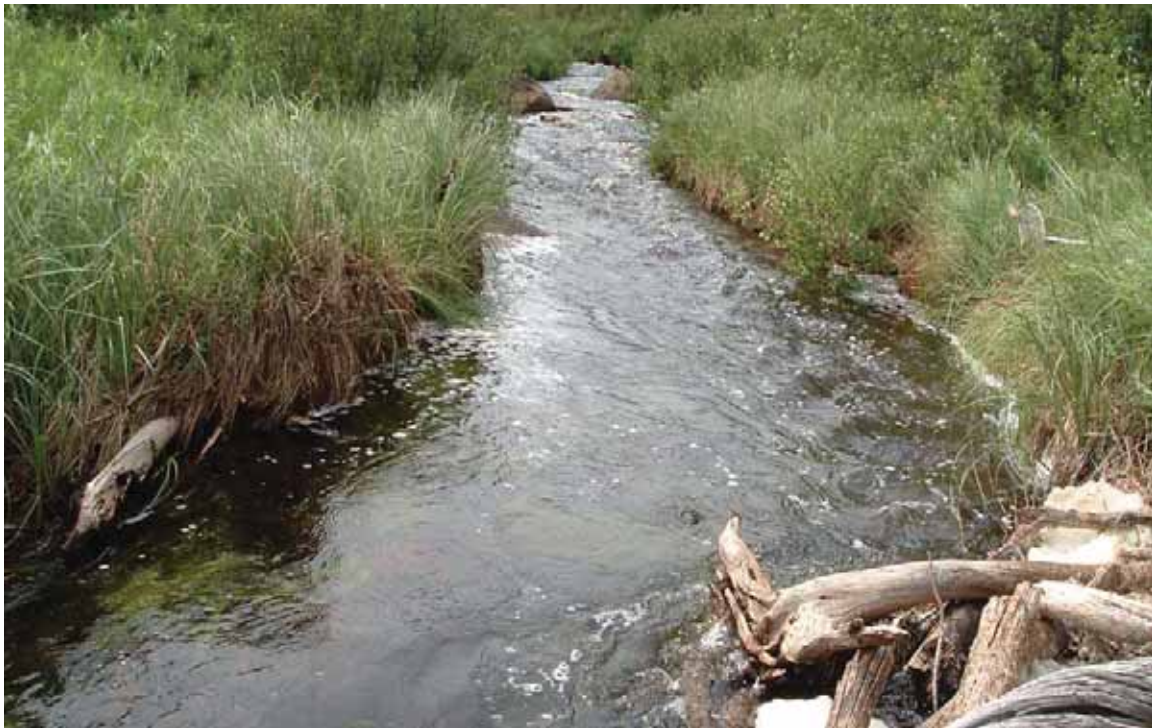
3 m Stream – Existing trail, north-south section. Distance 4.60 km

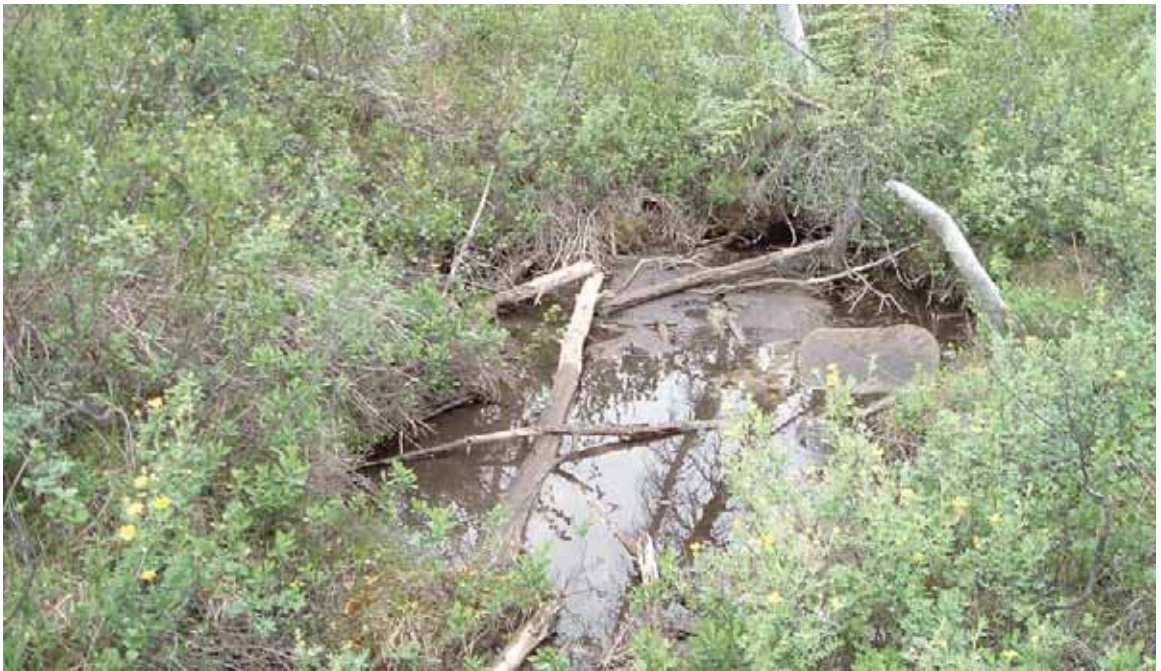
Poorly drained area – Looking towards west, existing trail; Seepage from west to east; culvert may be required; Distance = 6.94 km.

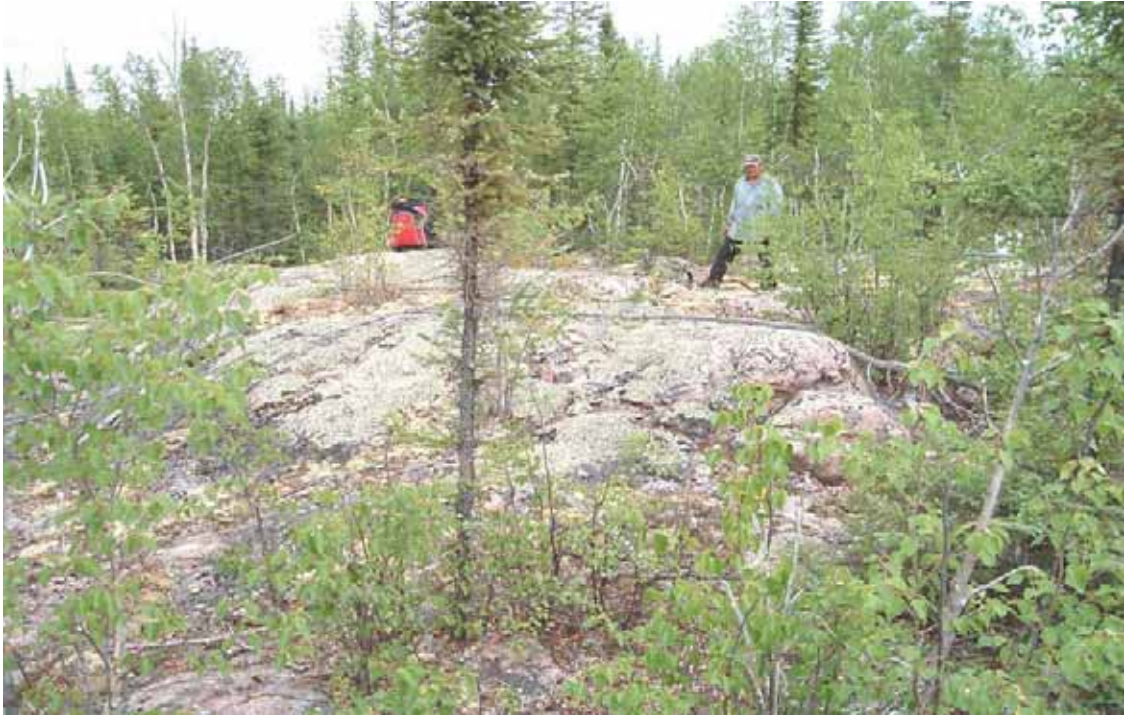
Exposed bedrock along proposed new route – Distance = 22.13 km

Bedrock outcrops were observed along the alignment within Borrow Area 3. Mixtures of boulders, cobbles, and frost-shattered rock were noted within Borrow Area 7. The rock from these borrow areas could be quarried and processed to produce good quality construction materials, if required.

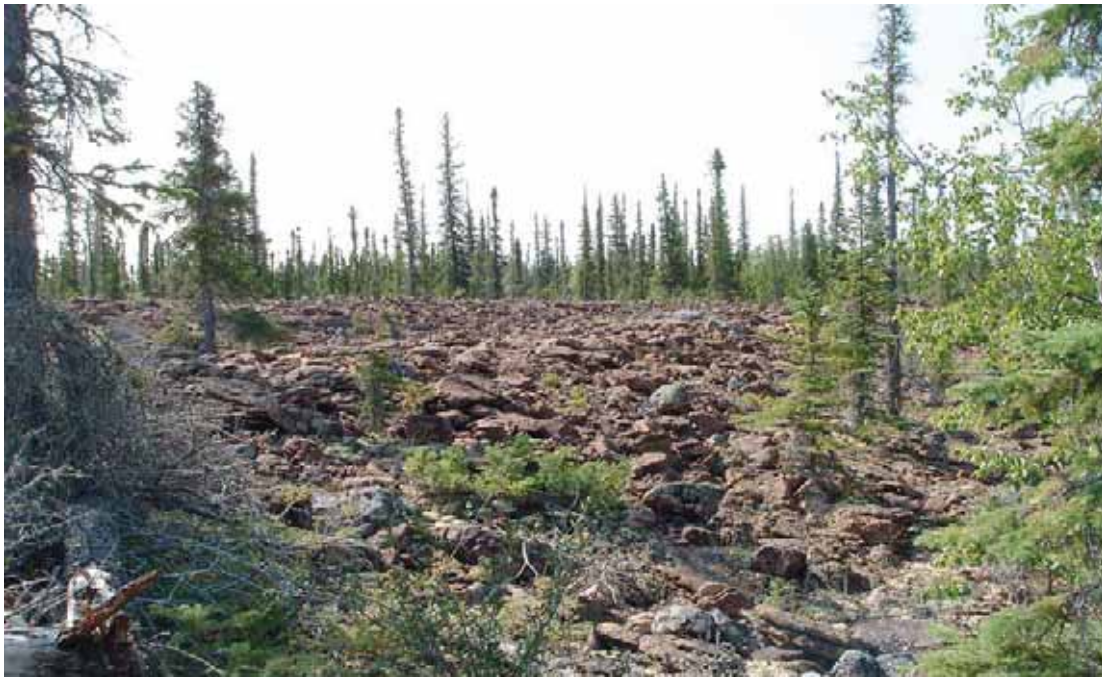
Exposed frost shattered rock – Proposed new route, looking south  
Distance = 41.72 km

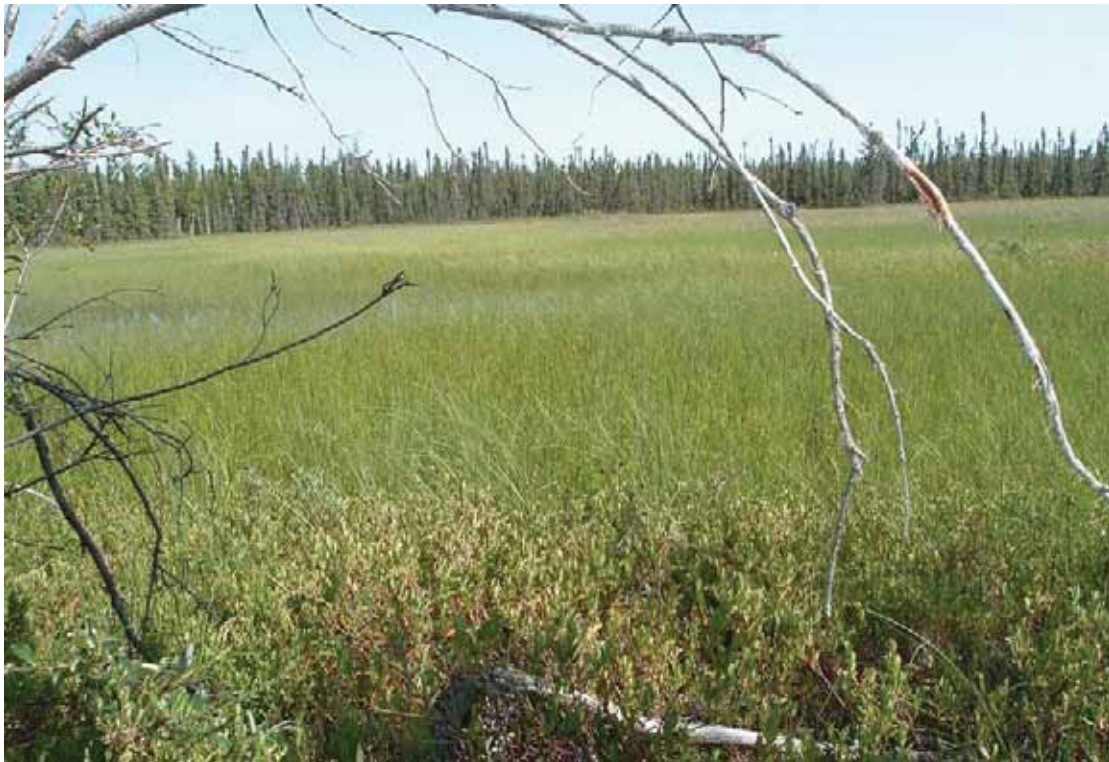
Poor Drainage, Standing Water – Proposed new route, looking northeast  
Distance = 42.61 km

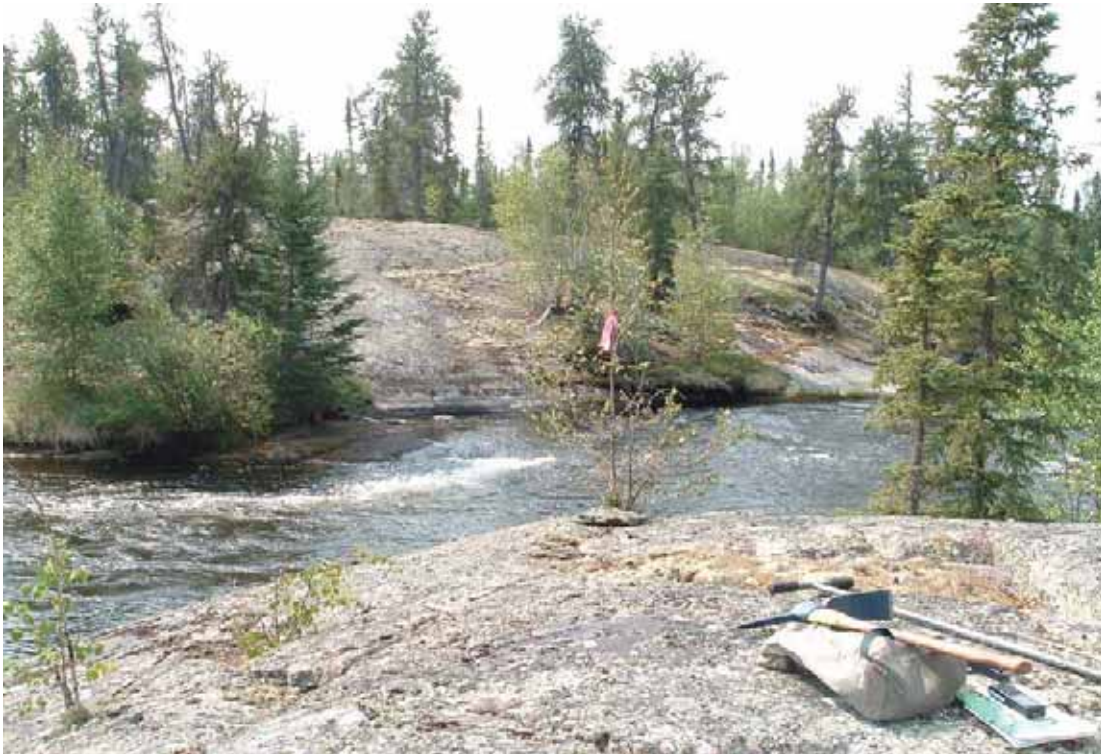
Marian River Crossing – Looking south from north Side of river  
Distance = 47.38 km

**Marian River Crossing (km 47.4):** The Marian River is the major water crossing along the route, where a bridge will be required. The river valley at the proposed location is narrow and is approximately 15 m wide. Competent bedrock is exposed on both sides of the proposed river crossing, which will provide solid foundation for bridge abutments/piers. A single span steel girder bridge with concrete abutments is envisioned at this location. Alternatively low profile arch with headwalls could also be considered.

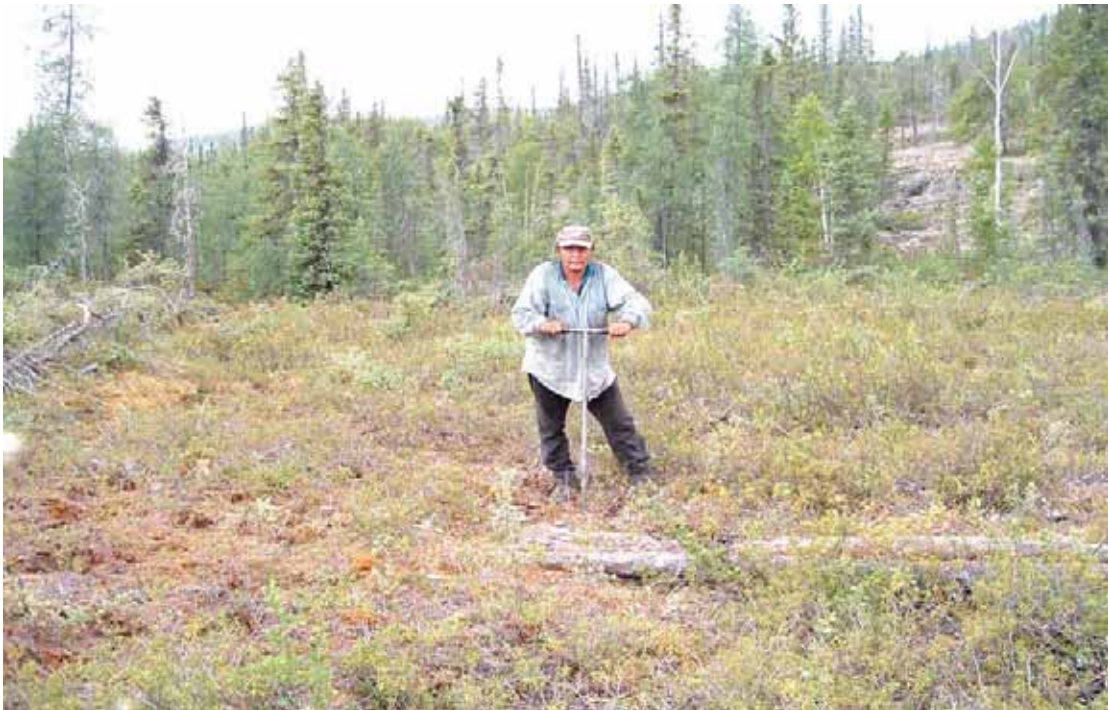
NICO mine site – Checking subsurface soils and permafrost

The subject area is in the zone of widespread discontinuous permafrost. Permafrost was identified at many places along the last six kilometres south of the NICO mine site, i.e. from the end of Borrow Area 7 to the plant site. The presence of permafrost could not be confirmed at other locations along the route, either because permafrost was not present or it was depressed and could not be confirmed with the shallow hand probe holes.

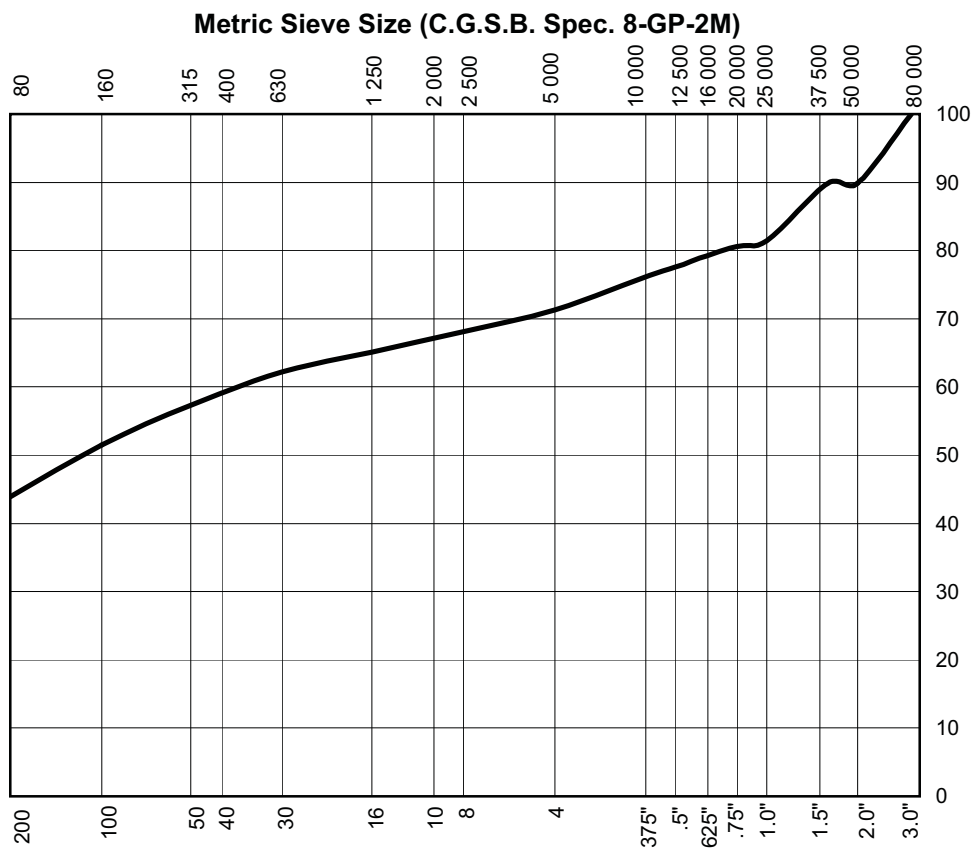
Sieve Sizes		% Passing
U.S.	Metric	
3"	80 000	100
2"	50 000	90
1.5"	37 500	90
1"	25 000	81
.75"	20 000	81
.625"	16 000	79
.5"	12 500	78
.375"	10 000	76
No. 4	5 000	71
No. 8	2 500	68
16	1250	65
30	630	62
50	315	57
100	160	52
200	80	43.9

Remarks: High content of the organic material.
