Fish and Fish Habitat Assessment of Watercourses Along the Proposed Nico All-Weather Road

December 2007
07-1373-0068

**FORTUNE MINERALS LTD.
NICO PROJECT**

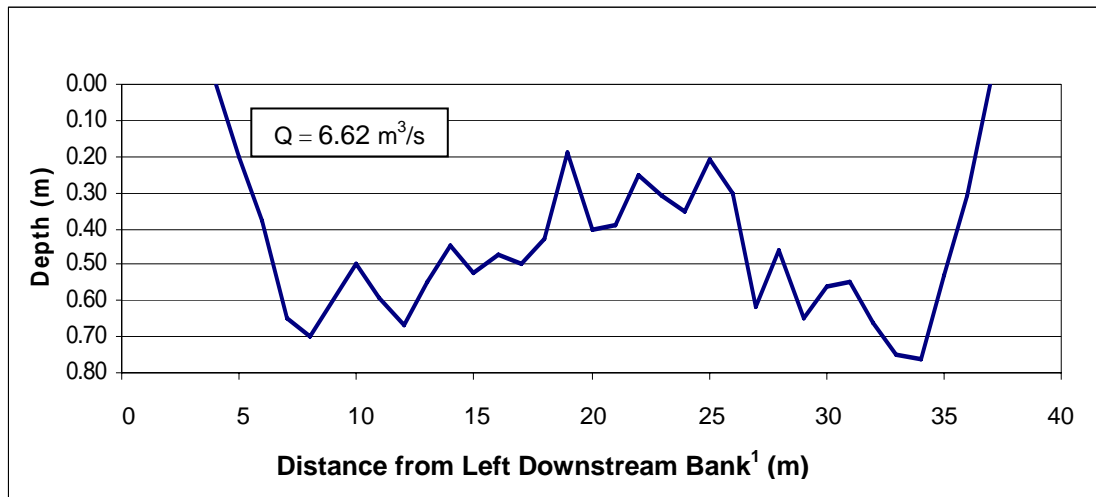
¹LDB = Left bank looking downstream

Figure 4 Flow Cross Section for Watercourse C8 – Marian River, July 25, 2005.

A detailed fish habitat assessment in the vicinity of the road crossing was completed on July 18, 2004. At the time of the survey, the wetted width of the river varied between 16 and 40 m (average wetted width of 25.6 m). The bankfull width at the proposed crossing was 33.1 m. The maximum recorded water depth within the surveyed section was 2.6 m. Stream discharge was not recorded in 2004; however, seasonal data are available from 2005 to 2007 and are summarized in Table 3.4.

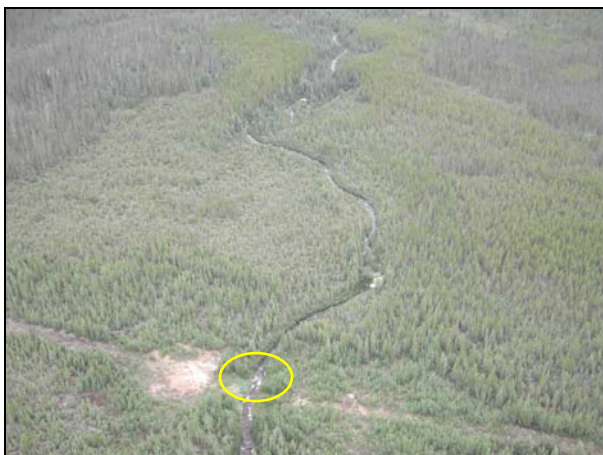
August 16th, 2005. Downstream aerial view of the proposed crossing location.

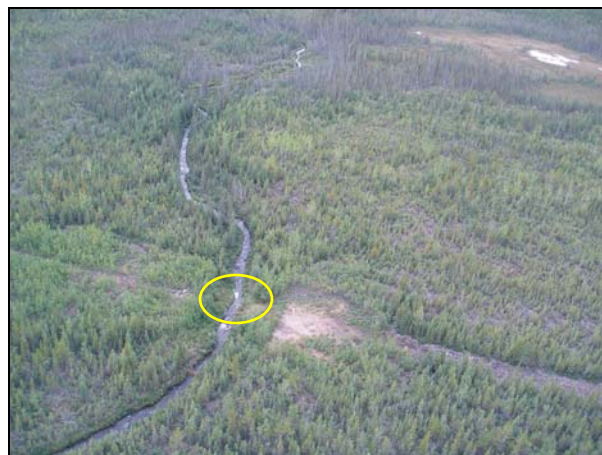
August 16th, 2005. Upstream aerial view of the proposed crossing location.

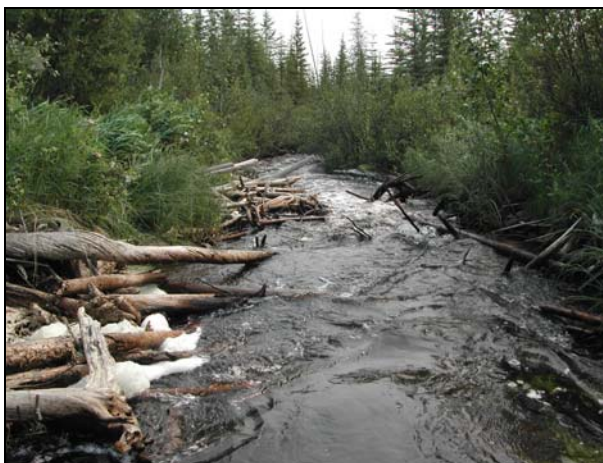
August 16th, 2005. Downstream view of the Riffle and Run habitat at the proposed crossing.

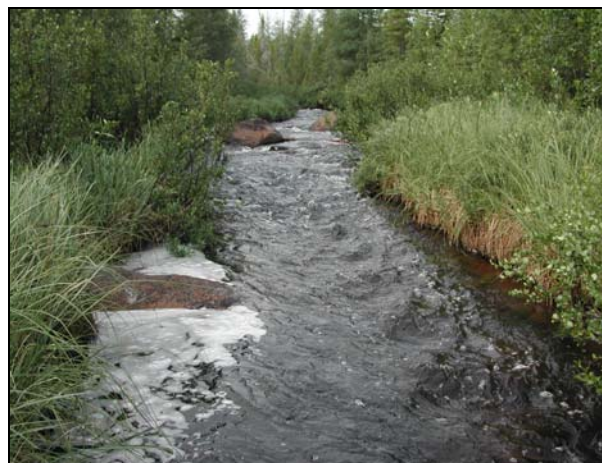
August 16th, 2005. Upstream view of the Run habitat at the proposed crossing.

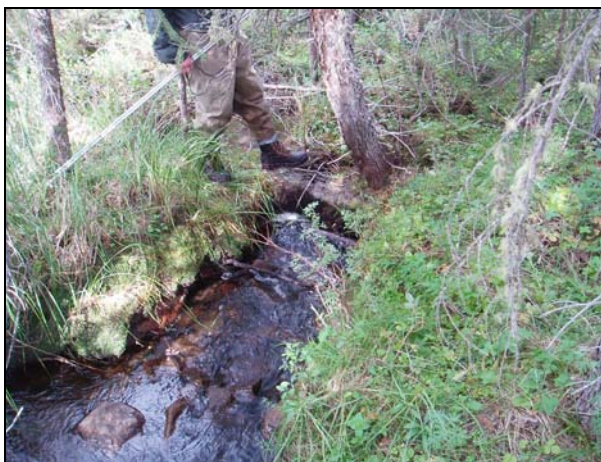
August 16, 2005. Downstream of proposed crossing where the stream flow goes underground.

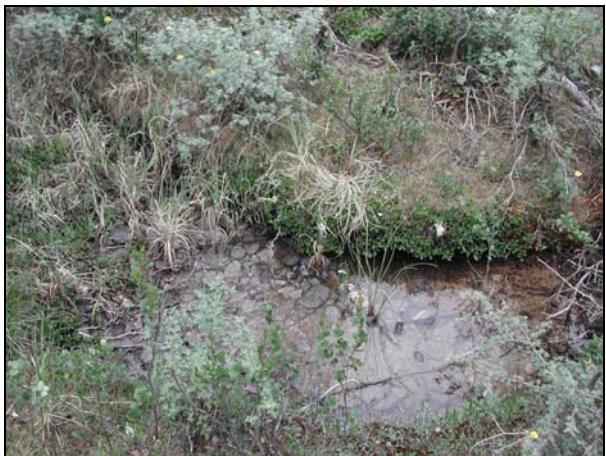
June 20, 2004. Upstream habitat at the proposed crossing.

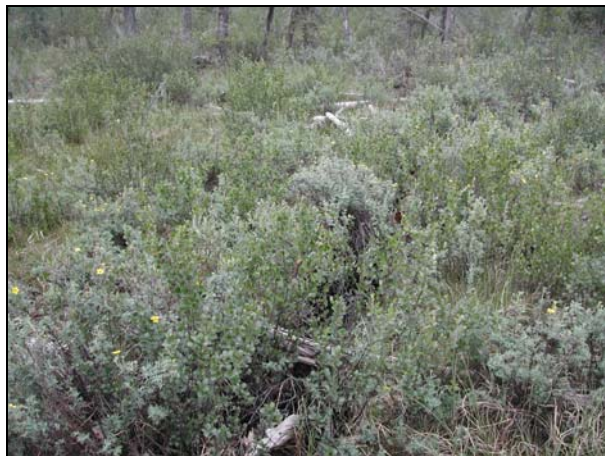
June 20, 2004. Downstream view of the habitat at the proposed crossing.

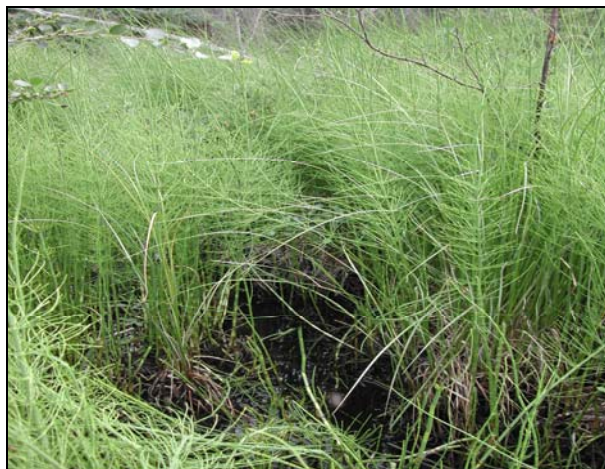
June 20, 2004. Watercourse condition at the proposed crossing.

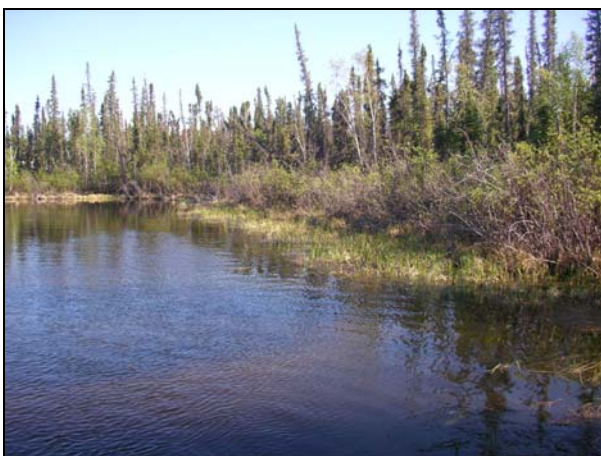
June 11th, 2005. Looking immediately downstream of the proposed crossing where juvenile lake whitefish were captured.
