Dust Suppression Pilot Study Report 2018/2019

February 2020

RE: Submission of Ekati Diamond Mine Dust Suppression Pilot Study Report, 2018/2019

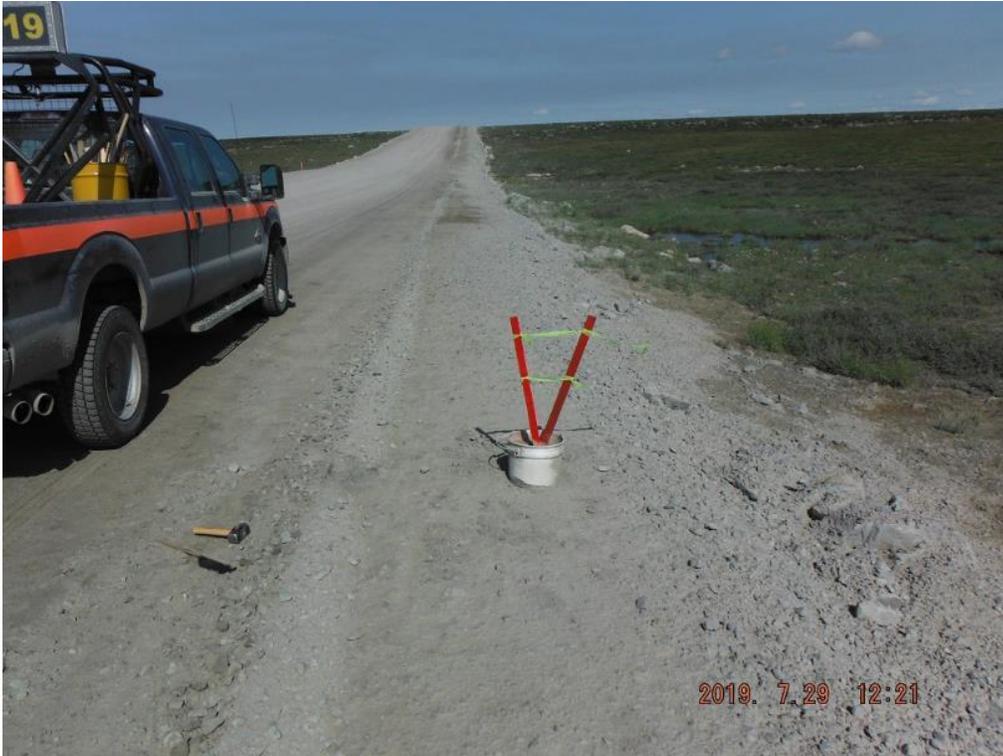
FIGURE 4. THE STAKED BUFFER AREA LOCATIONS FOR THE ENVIROKLEEN APPLICATION ON SABLE ROAD, 2019

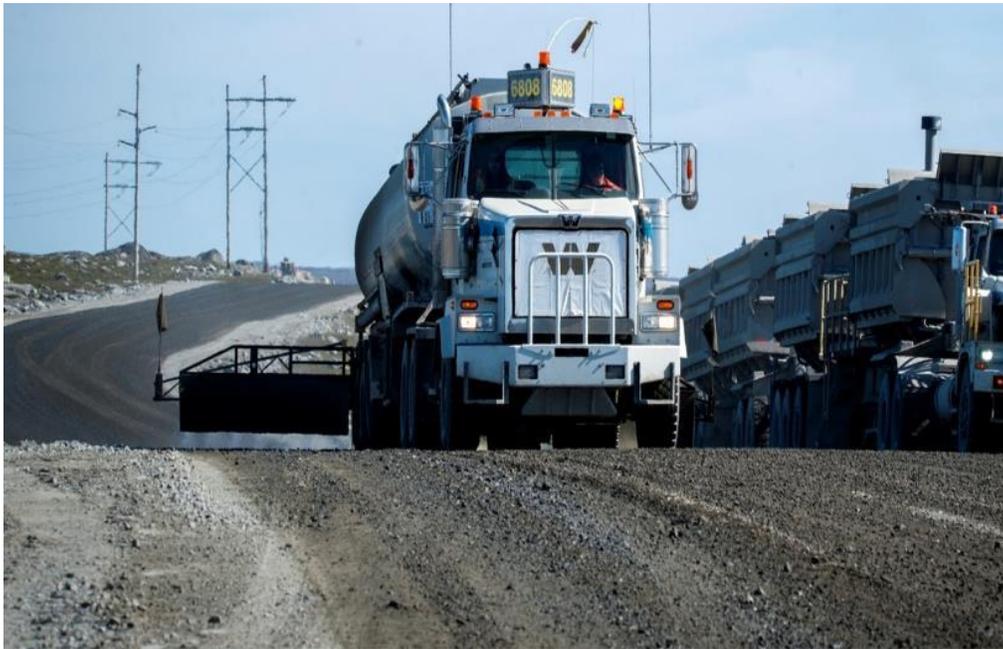
FIGURE 5. ENVIROKLEEN BULK FLUID TRUCK WITH 25 FT SPRAYER USED FOR APPLICATIONS, 2017 TO 2019

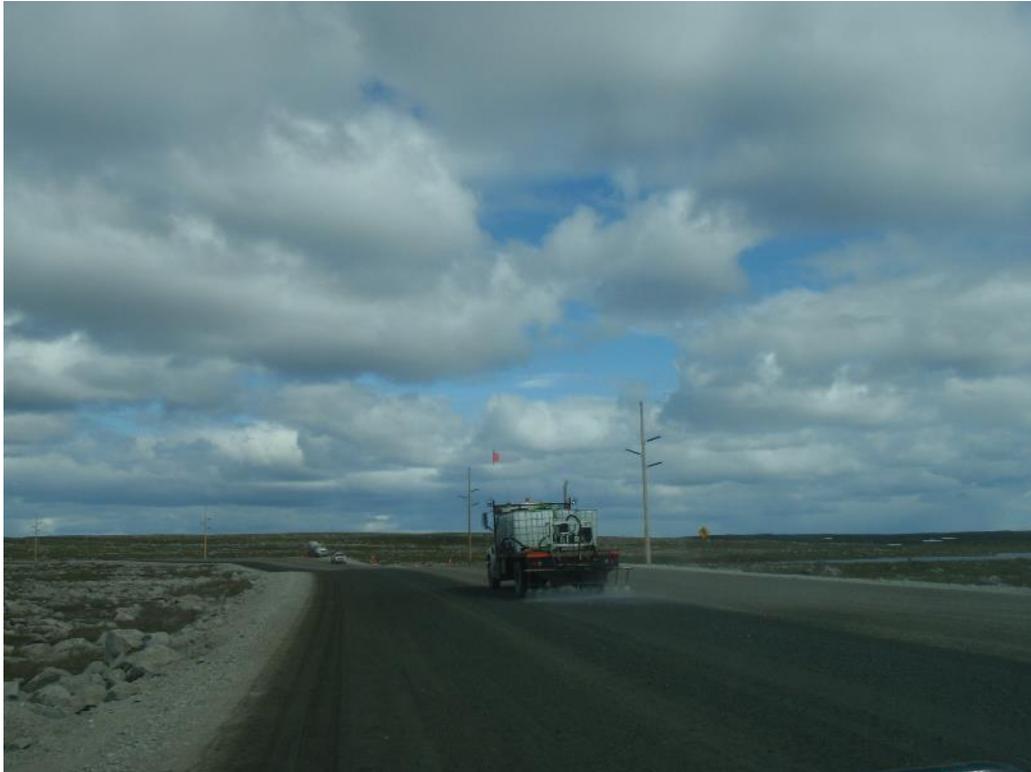
FIGURE 6. ENVIROKLEEN SPRAYER AND TOTES USED FOR APPLICATIONS, 2015 TO 2016

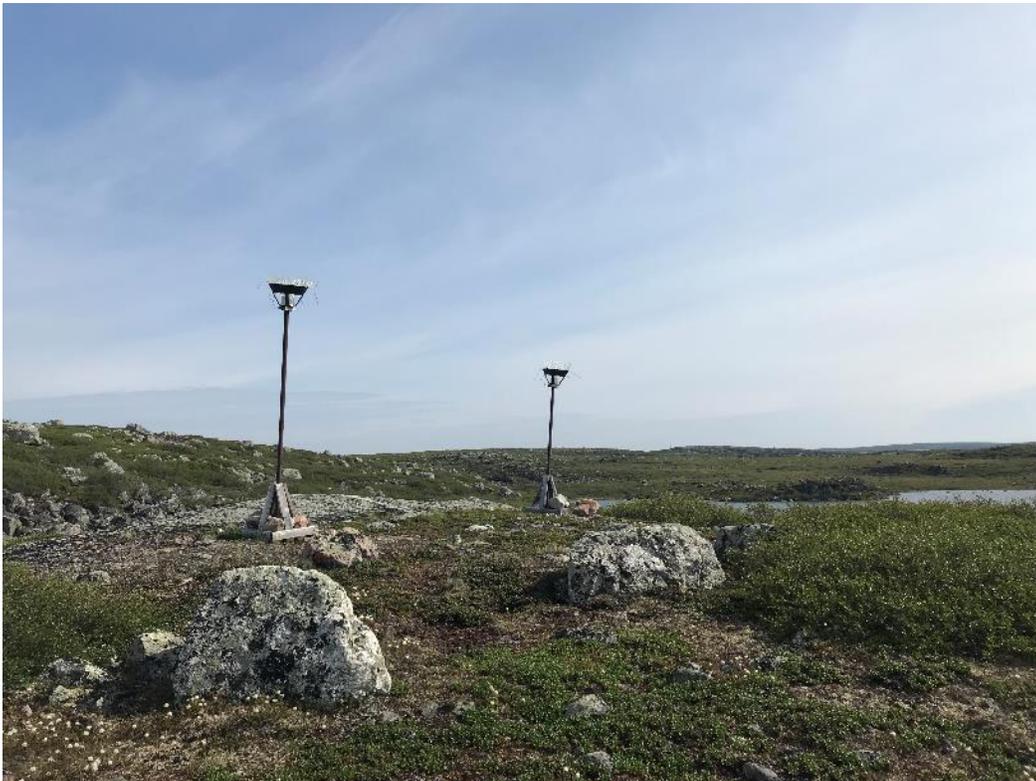
FIGURE 7. DUSTFALL STATION WITH TWO PARALLEL COLLECTORS, JULY 2019

Each dustfall station consisted of paired dustfall collection containers (Figure 7 **Error! Reference source not found.**), one of which collects for analysis of particulate, sulphate and nitrate and the other for total metals. The dustfall monitoring stations were constructed and positioned in accordance with the methods outlined in ASTM D1739-98 (2010). The stations consisted of a canister containing a collection medium (deionized water with algaecide) that was exposed to the ambient air for a period of approximately 30 days between June and September. The collectors were outfitted with bird-spikes to minimize sample contamination by bird fecal matter. Each dustfall transect is oriented perpendicular to the road and includes dustfall collectors at 30 m from the road centerline on the predominant upwind side of the road, as well as at 30 m, 90 m, and 300 m (and in most cases 1000 m from the road) on the predominant downwind side of the road.

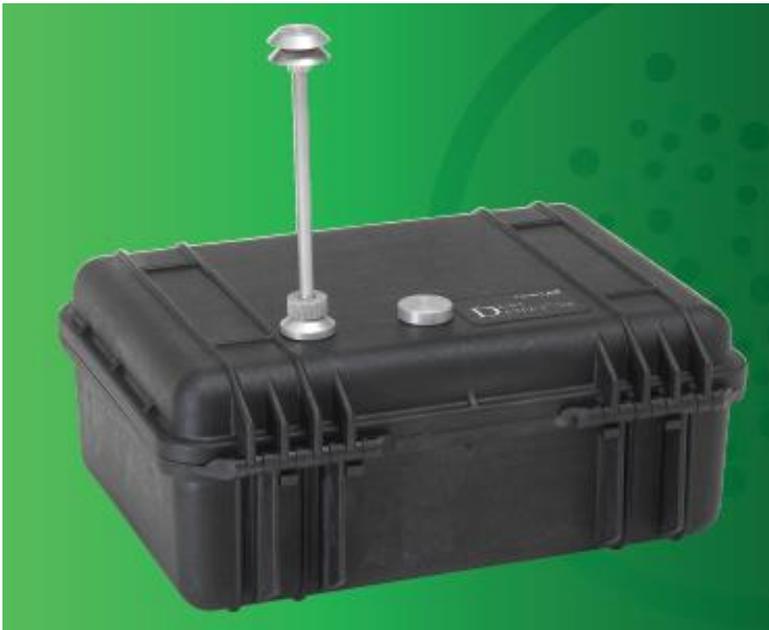
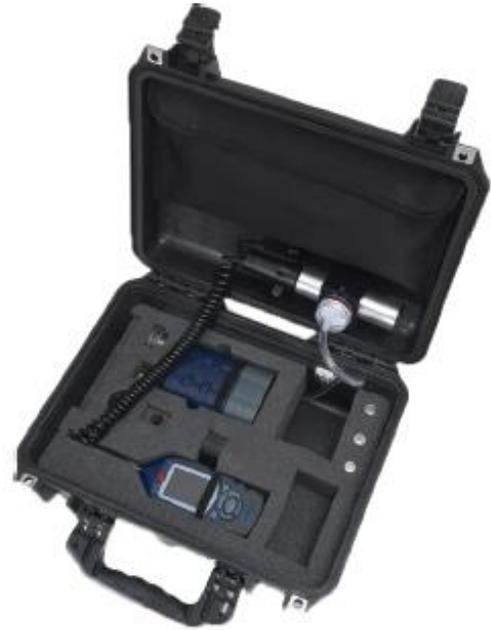
FIGURE 8. CASELLA DUST DETECTIVE UNITS

In 2018 and 2019, Dominion used Casella Microdust Dust Detectives (Figure 8) to measure real-time dust migration to both the downwind and upwind sides of the EnviroKleen treated road (Figure 9). The data provided by castella monitors is intended to provide real time information on the performance of EnviroKleen, which in turn can be used to trigger proactive reapplication of dust suppressant as performance reduces and dust levels begin to rise. The Casella Microdust Dust Detective uses an advanced forward light scattering principle to make accurate and repeatable measurements of suspended particulate concentrations. The units are capable of detecting concentrations of total suspended particulate (TSP) between 0.001 mg/m³ and 2,500 mg/m³. Units were programmed a record a flow reading of 2.00L/m, at 10 second or 60 second intervals.

For each monitoring event, the units were deployed in the morning and retrieved at the end of the day. The units were programmed to record particulate concentrations every 10 seconds while deployed at the MisNew and Sable monitoring sites and every 60 seconds at the Mis monitoring site. Dominion deployed the dust detectives during the open water period, both before and after the initial application of EnviroKleen. The deployment frequency was once per week in 2018 and every five days in 2019, however, the units cannot be deployed during wet or rainy conditions, which limited their use. The units were calibrated and cleaned once a week at minimum, and more often as needed.

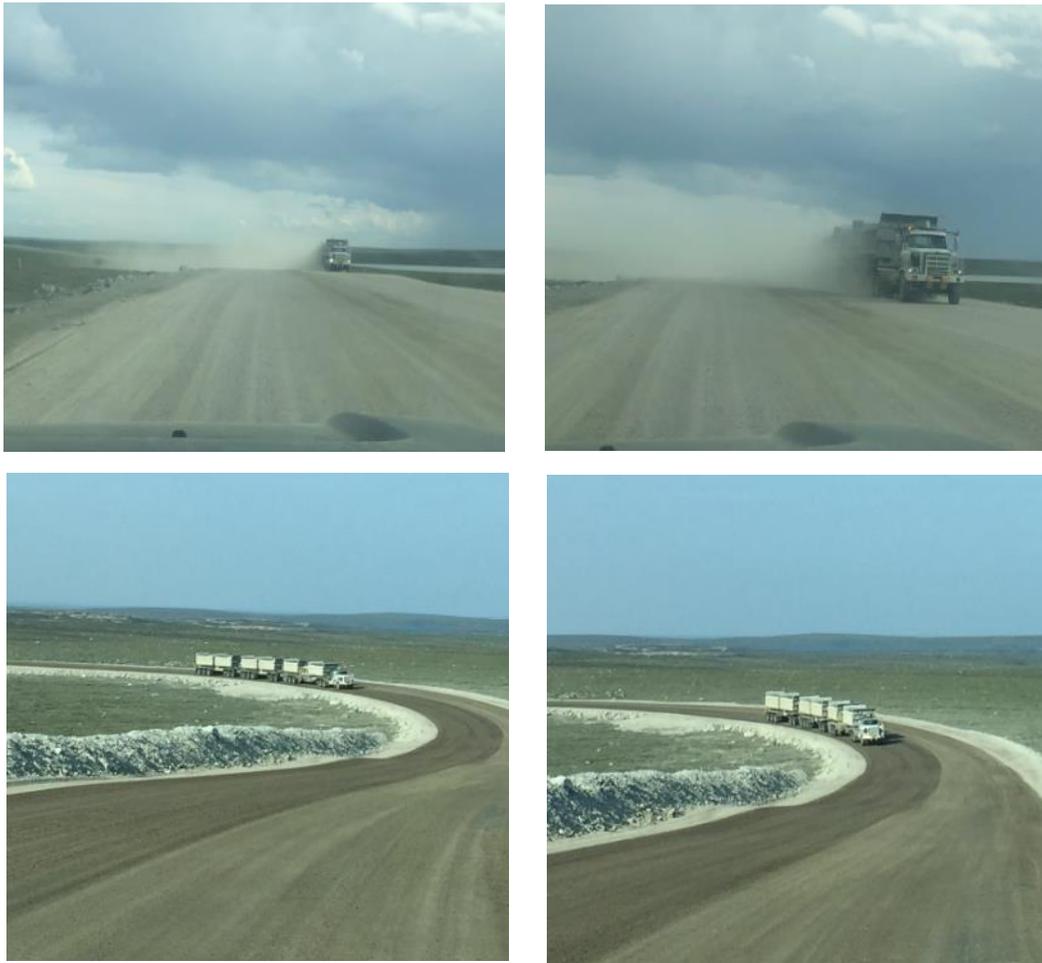
FIGURE 19. VIDEO OBSERVATIONS OF DUAL POWERED ROAD TRAIN VEHICLE BEFORE (TOP PANEL) AND AFTER (BOTTOM PANEL) ENVIROKLEEN MAINTENANCE APPLICATION ON SABLE ROAD, 2019

Results from video footage recorded prior to and subsequent to the first maintenance application on Sable Road in 2019 (July 29 to August 1, 2019) visually illustrated the reduced dust levels dispersed from the DRPT vehicle following an EnviroKleen maintenance application (Figure 19).
