**GNWT Response to:  
GoC NRCan IR#1 (ID15)**

Acting at the authorization of Tlicho Engineering and Environmental Services Ltd. (Tlicho), Stantec Consulting Ltd. (Stantec) carried out a geotechnical investigation in support of the culvert planned at 'Crossing #5' along the proposed Tlicho All Season Access Road (TASR). The purpose of the investigation was to characterize subsurface conditions and provide geotechnical comments and recommendations to assist with culvert design and site development.

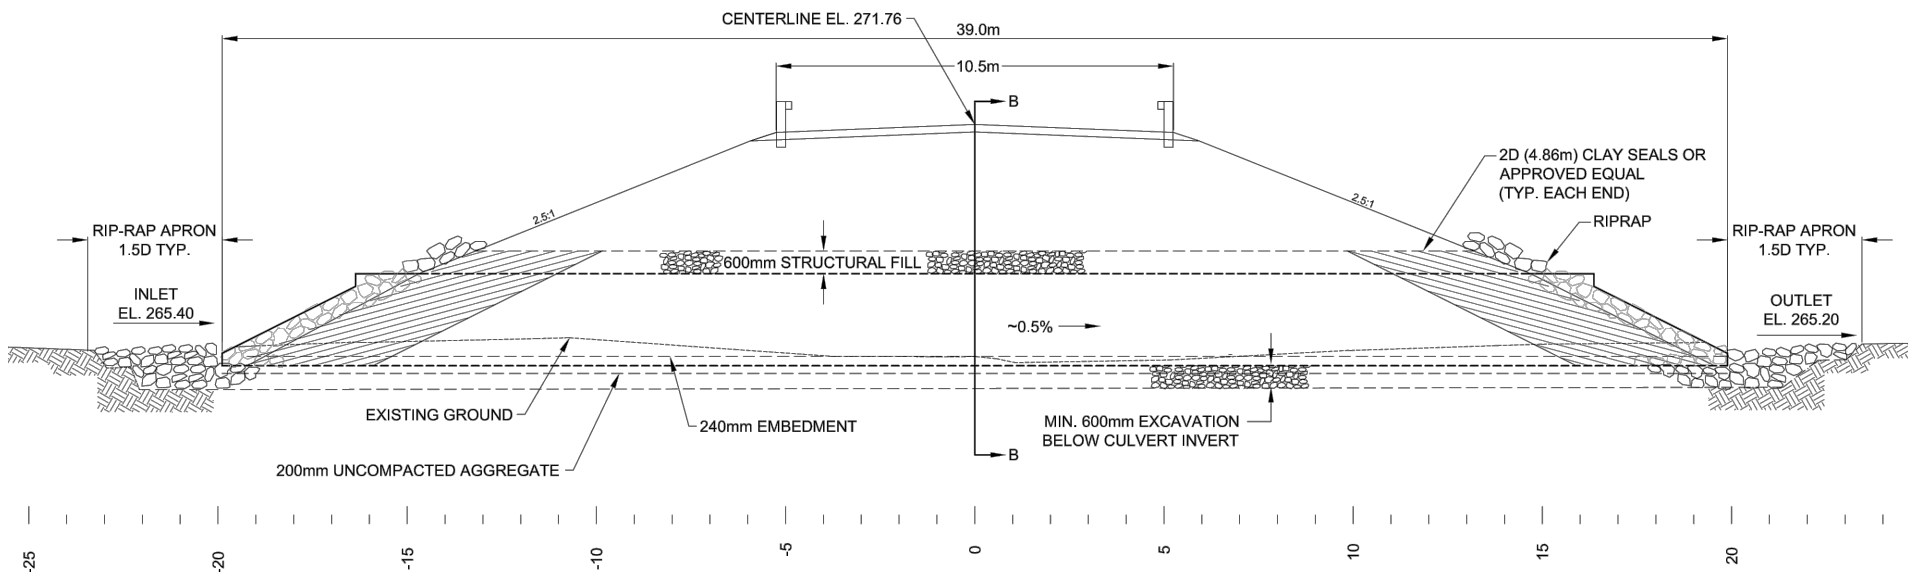
CULVERT PROFILE A-A @ 16+532  
1:200

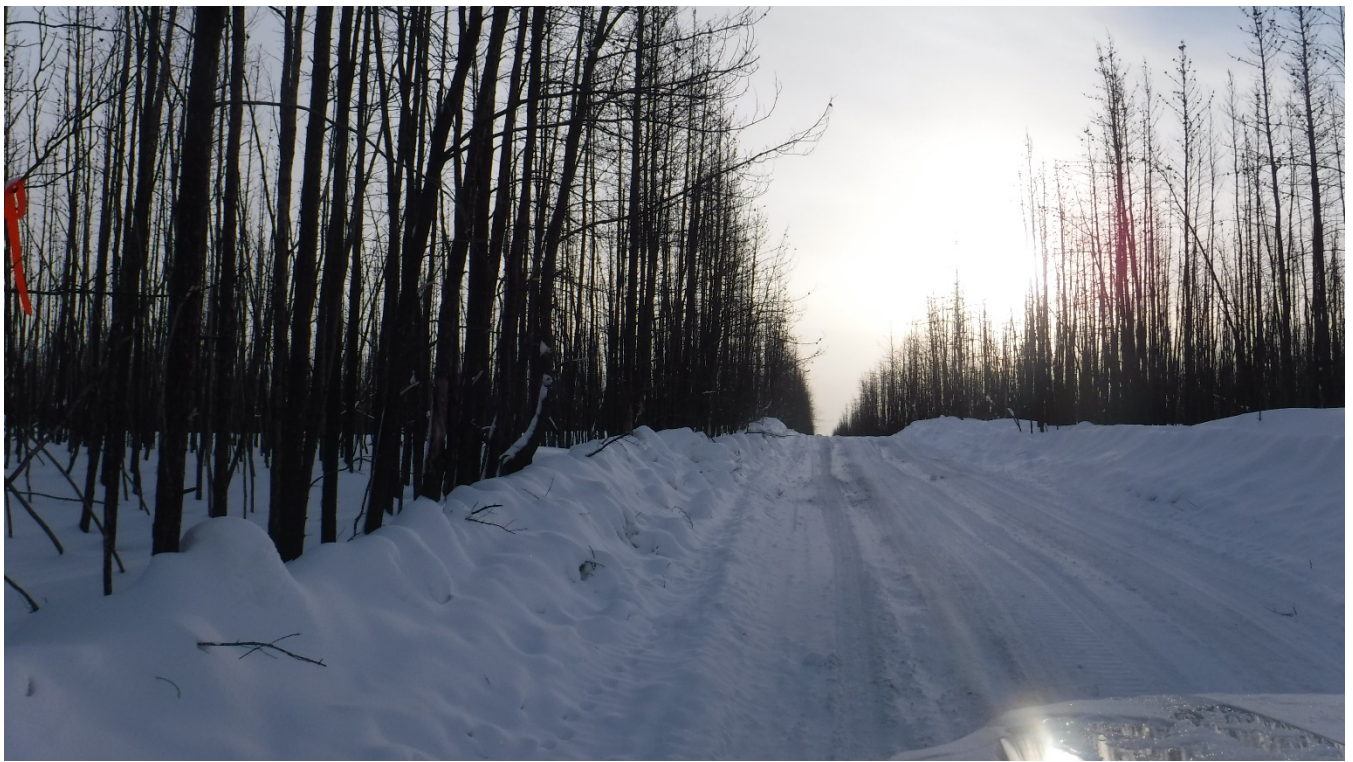
**Photo No. 1: Borehole BH17-13 location (looking southeast).**

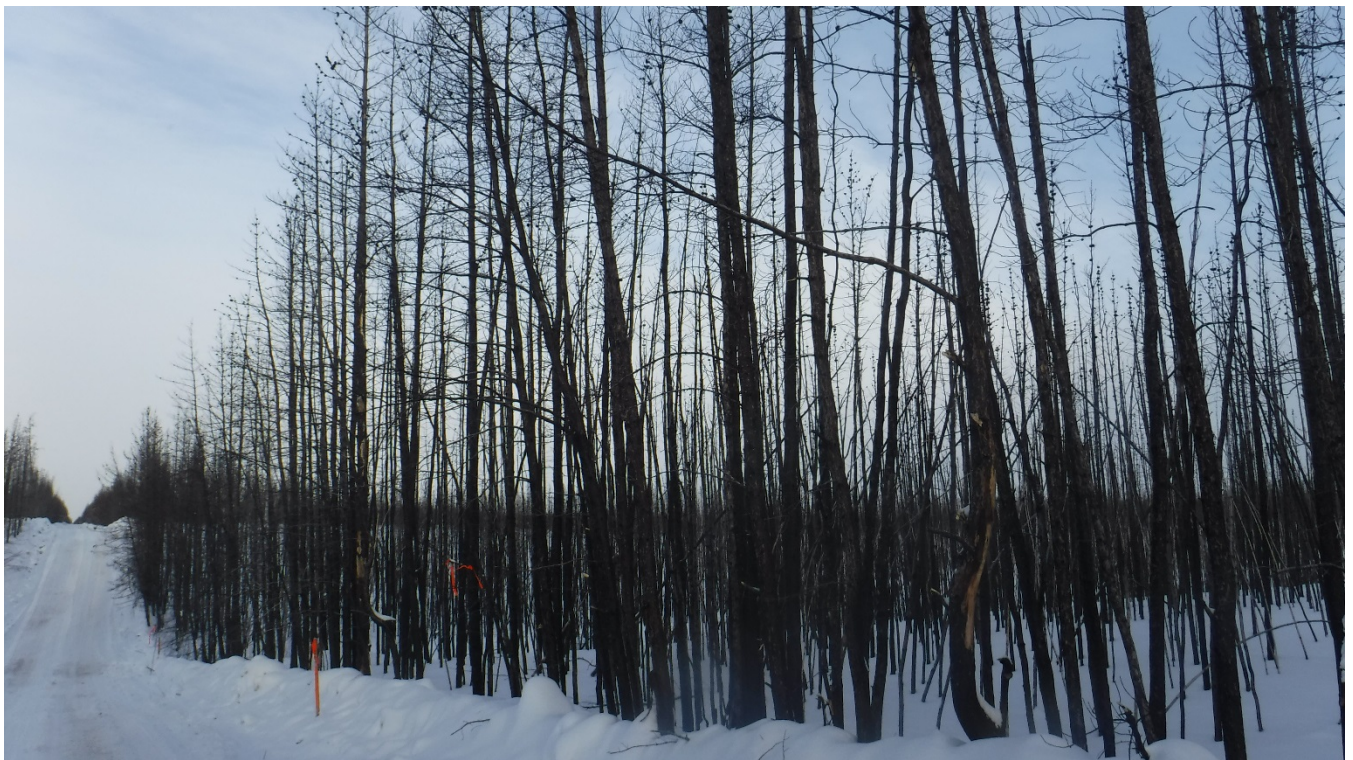
**Photo No. 2: Borehole BH17-13 location (looking northwest to BH17-14C)**

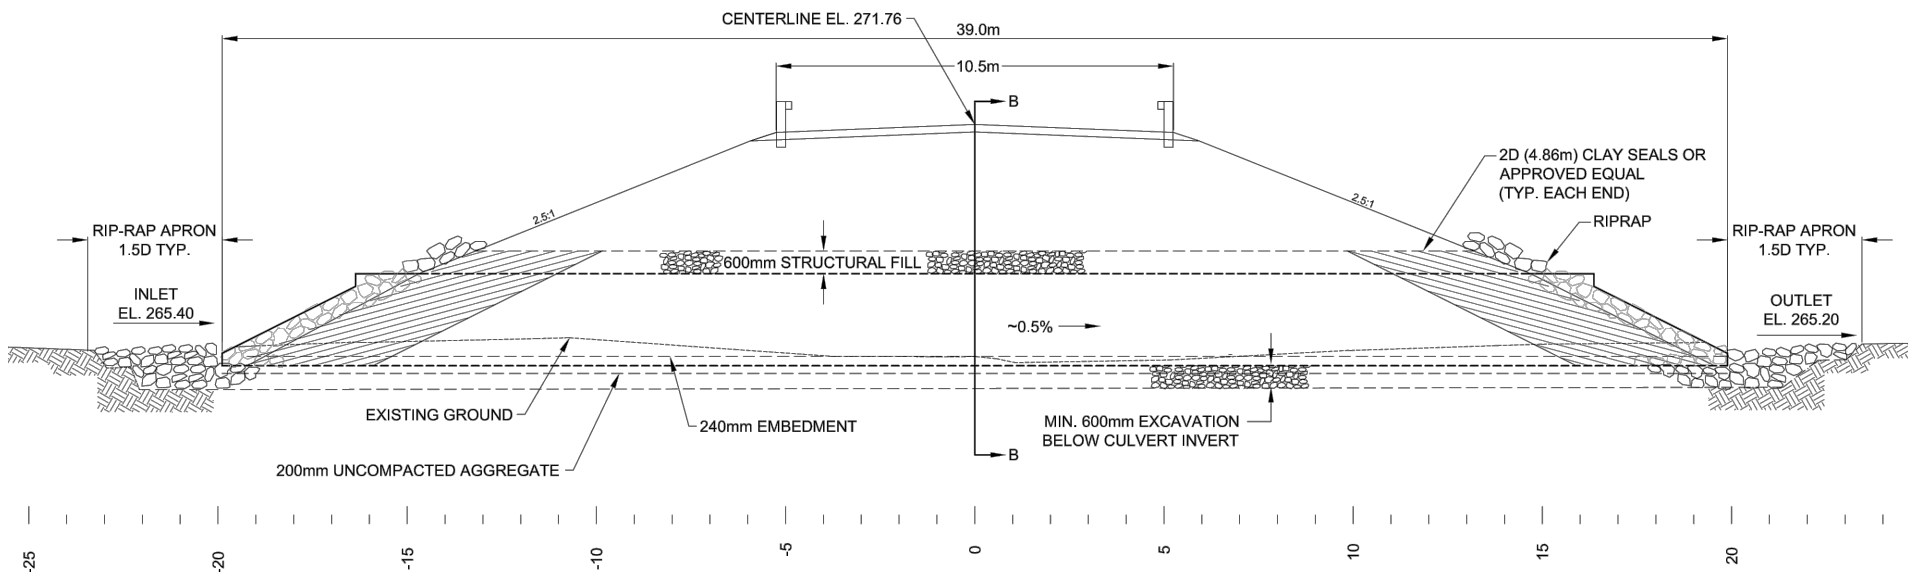
CULVERT PROFILE A-A @ 16+532  
1:200

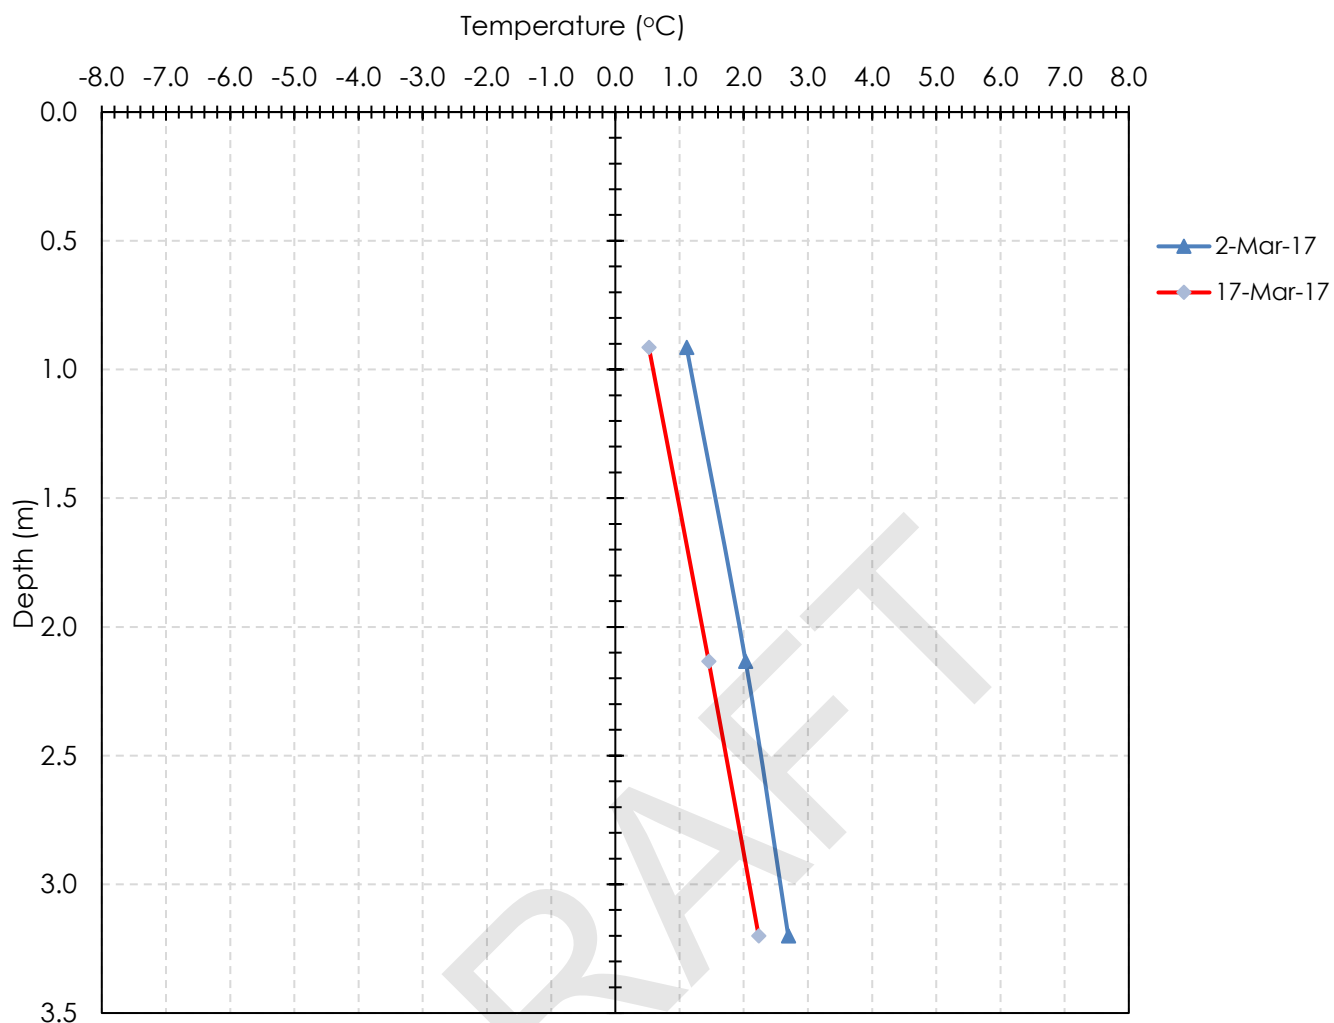
Borehole	BH-16C					
Drilled:	24-Feb-17		Drilled Depth:		3.4	m
Installed:	24-Feb-17					
Reading			Bead	TS4339	TS4334	TS4337
Date		Days	Depth (m)	0.91	2.13	3.20
Post-Install	24-Feb-17	0	R (ohms)	9.78	8.36	5.74
			T (°C)	0.0	3.1	10.8
2	2-Mar-17	6	R (ohms)	9.25	8.83	8.54
			T (°C)	1.1	2.0	2.7
3	17-Mar-17	21	R (ohms)	9.53	9.09	8.74
			T (°C)	0.5	1.5	2.2

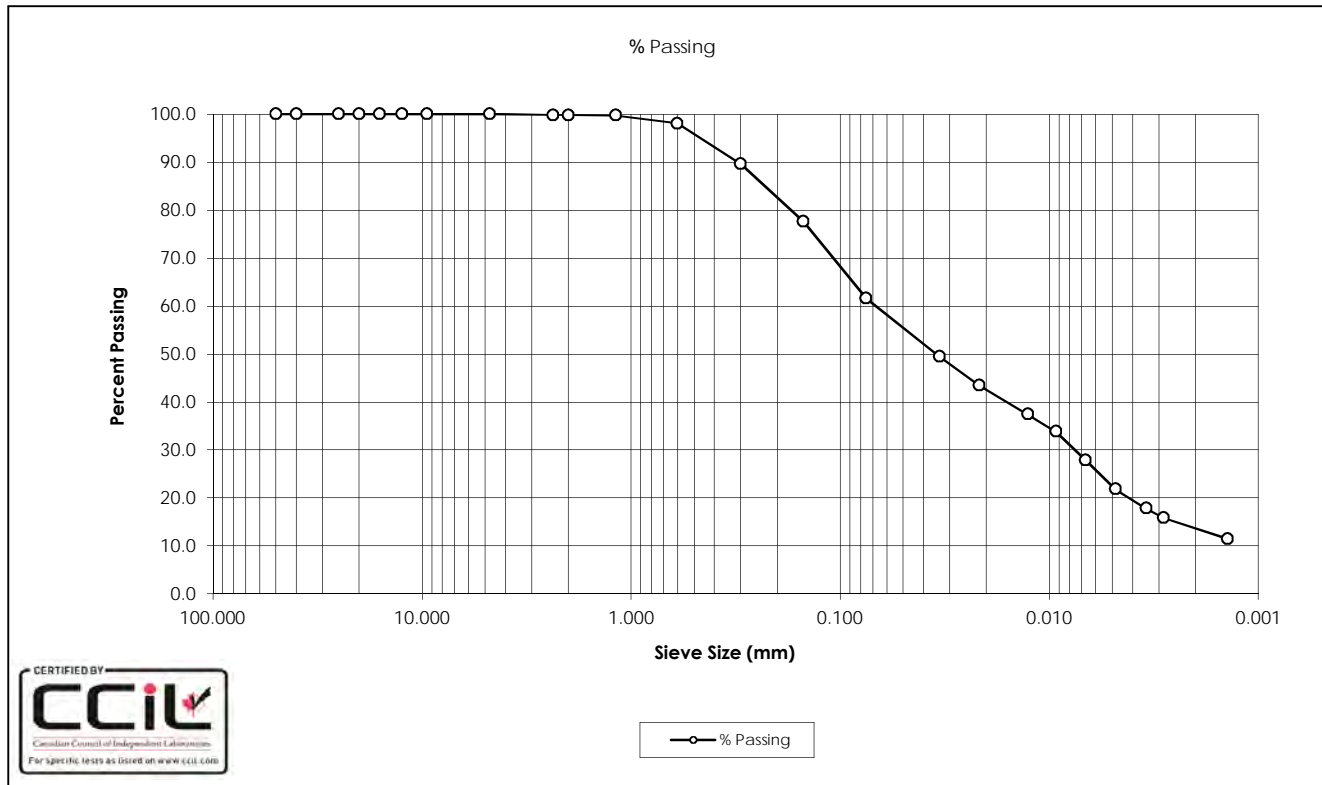
DATE TESTED: April 16, 2017  
DATE RECEIVED: February 27, 2017  
SAMPLE DESCRIPTION: Sandy silt

Sieve (mm)	Sample % Passing	Sieve (mm)	Sample % Passing
50.0	100.0	0.0067	27.8
40.0	100.0	0.0048	21.8
25.0	100.0	0.0034	17.8
20.0	100.0	0.0028	15.8
16.0	100.0	0.0014	11.4
12.5	100.0		
9.5	100.0		
4.75	100.0		
2.36	99.8		
2.00	99.8		
1.18	99.8		
0.600	98.1		
0.300	89.6		
0.150	77.6		
0.075	61.6		
0.0333	49.5		
0.0215	43.4		
0.0127	37.4		
0.0093	33.8		
Gravel:	0.0%	D <sub>10</sub> :	-
Sand:	38.4%	D <sub>30</sub> :	0.0077
Silt:	47.9%	D <sub>60</sub> :	0.0701
Clay:	13.7%	C <sub>u</sub> :	-
		C <sub>c</sub> :	-

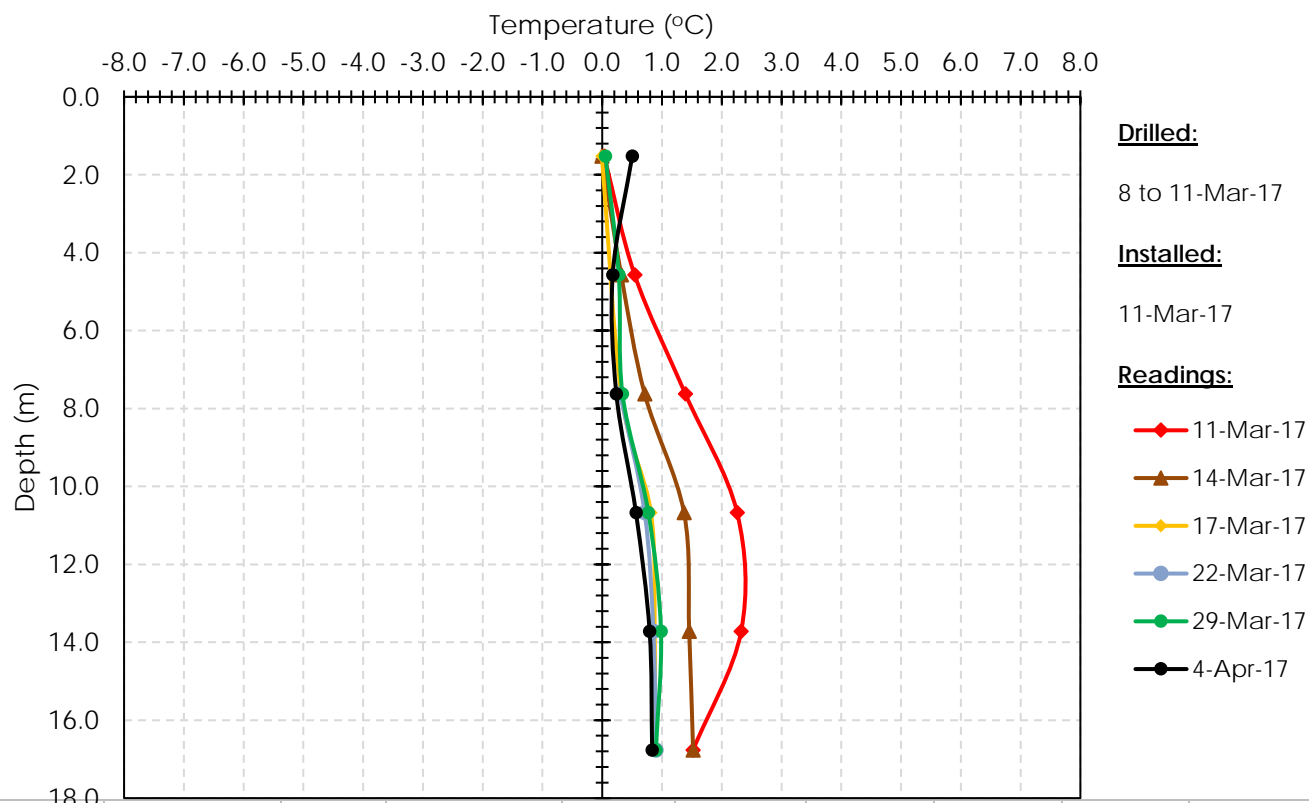
Borehole		BH17-31B							
Drilled:		8 to 11-Mar-17		Drilled Depth:		18.90		m	
Installed:		11-Mar-17							
Reading			Bead	TS4363	TS4368	TS4393	TS4392	TS4427	TS4425
Date		Days	Depth (m)	1.52	4.57	7.62	10.67	13.72	16.76
Post-Install	11-Mar-17	0	R (Kilo $\Omega$ )	9.77	9.52	9.12	8.73	8.70	9.06
			T (°C)	0.0	0.5	1.4	2.3	2.3	1.5
2	14-Mar-17	3	R (Kilo $\Omega$ )	9.79	9.63	9.44	9.13	9.09	9.06
			T (°C)	0.0	0.3	0.7	1.4	1.5	1.5
3	17-Mar-17	6	R (Kilo $\Omega$ )	9.79	-	9.63	9.39	9.36	9.36
			T (°C)	0.0	-	0.3	0.8	0.9	0.9
4	22-Mar-17	11	R (Kilo $\Omega$ )	-	-	9.64	9.44	9.37	9.35
			T (°C)	-	-	0.3	0.7	0.9	0.9
5	29-Mar-17	18	R (Kilo $\Omega$ )	9.76	9.65	9.62	9.41	9.31	9.35
			T (°C)	0.1	0.3	0.3	0.8	1.0	0.9
6	4-Apr-17	24	R (Kilo $\Omega$ )	9.54	9.7	9.67	9.51	9.4	9.38
			T (°C)	0.5	0.2	0.2	0.6	0.8	0.8

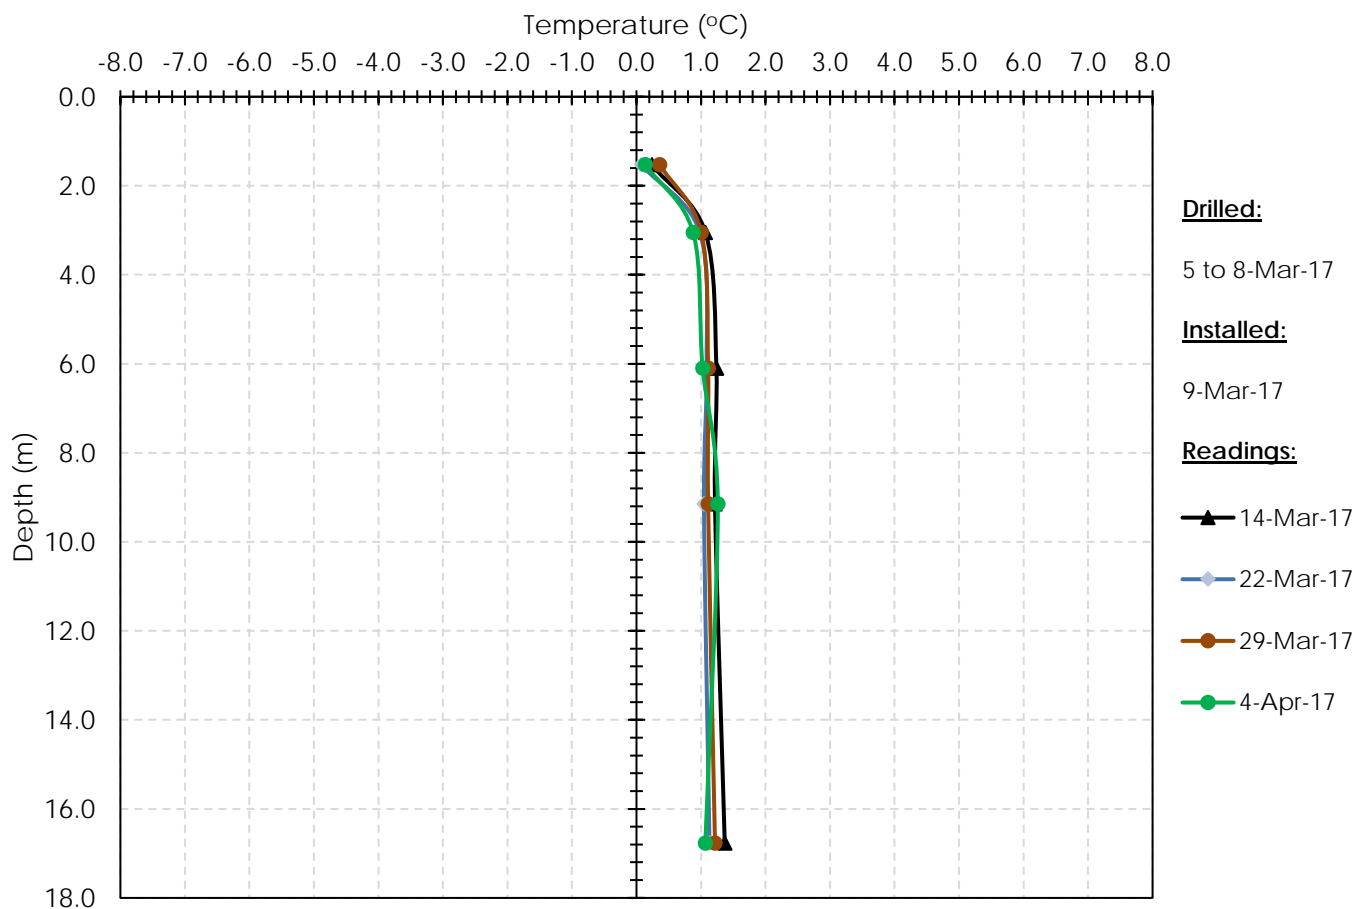
Borehole	BH17-32B							
Drilled:	5 to 8-Mar-17		Drilled Depth:				19.00	m
Installed:	9-Mar-17							
Reading			Bead	TS4424	TS4441	TS4444	TS4435	TS4440
Date		Days	Depth (m)	1.52	3.05	6.10	9.14	16.76
Post-Install	14-Mar-17	5	R (Kilo $\Omega$ )	9.67	9.27	9.19	9.2	9.13
			T ( $^{\circ}\text{C}$ )	0.2	1.1	1.2	1.2	1.4
2	22-Mar-17	13	R (Kilo $\Omega$ )	9.75	9.31	9.26	9.28	9.24
			T ( $^{\circ}\text{C}$ )	0.1	1.0	1.1	1.0	1.1
3	29-Mar-17	20	R (Kilo $\Omega$ )	9.61	9.3	9.25	9.25	9.2
			T ( $^{\circ}\text{C}$ )	0.4	1.0	1.1	1.1	1.2
4	4-Apr-17	26	R (Kilo $\Omega$ )	9.72	9.36	9.29	9.18	9.27
			T ( $^{\circ}\text{C}$ )	0.1	0.9	1.0	1.3	1.1

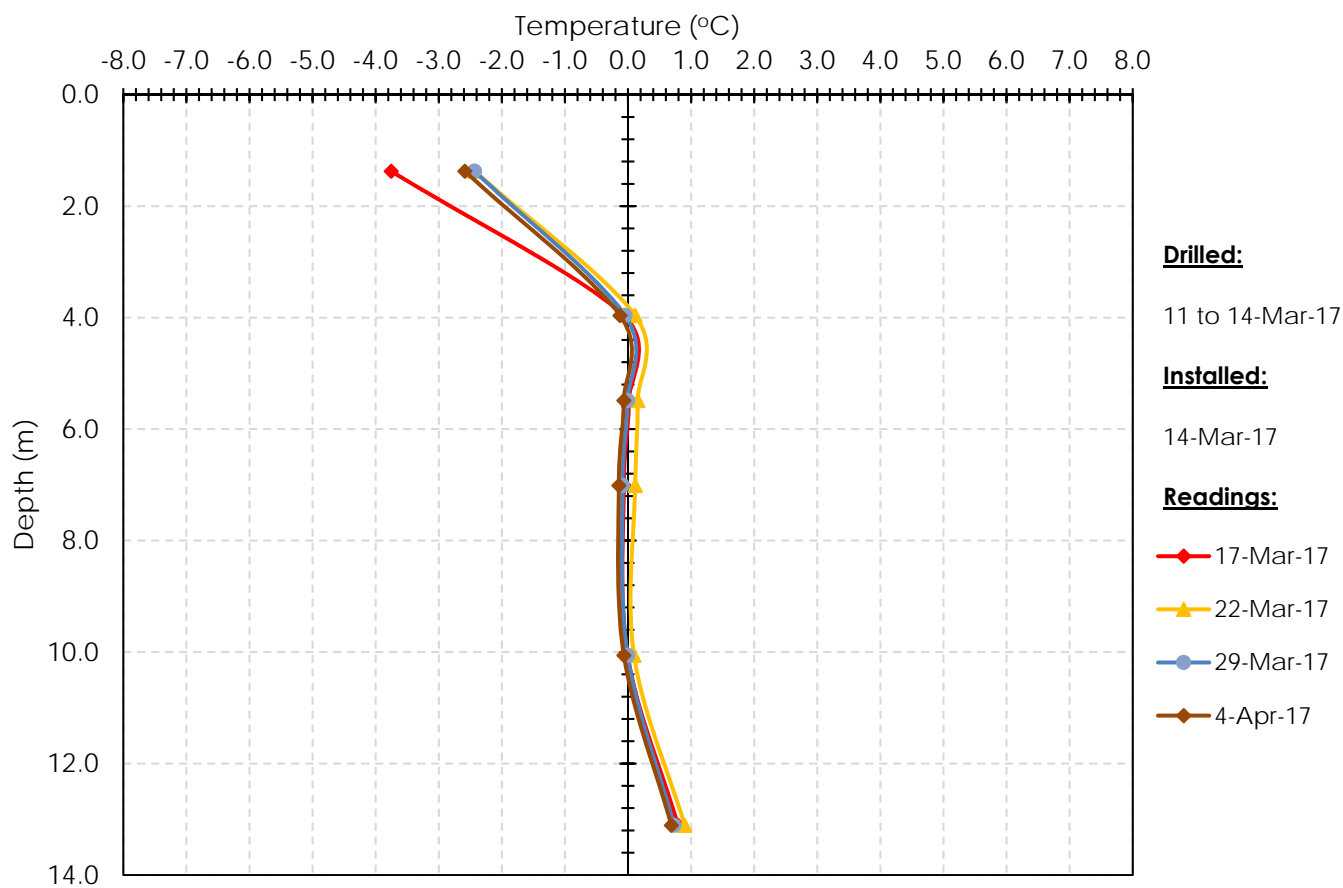
<b>Borehole</b>		<b>BH17-33B</b>							
Drilled:		11 to 14-Mar-17		Drilled Depth:			24.61	m	
Installed:		14-Mar-17							
<b>Reading</b>			<b>Bead</b>	TS4329	TS4328	TS4394	TS4395	TS4407	TS4413
<b>Date</b>		<b>Days</b>	<b>Depth (m)</b>	1.37	3.96	5.49	7.01	10.06	13.11
Post-Install	17-Mar-17	3	<b>R (Kilo Ω)</b>	11.88	9.82	9.78	9.82	9.79	9.40
			<b>T (°C)</b>	-3.8	-0.1	0.0	-0.1	0.0	0.8
2	22-Mar-17	8	<b>R (Kilo Ω)</b>	11.09	9.73	9.71	9.73	9.74	9.35
			<b>T (°C)</b>	-2.4	0.1	0.2	0.1	0.1	0.9
3	29-Mar-17	15	<b>R (Kilo Ω)</b>	11.09	9.81	9.79	9.83	9.79	9.43
			<b>T (°C)</b>	-2.4	0.0	0.0	-0.1	0.0	0.7
4	4-Apr-17	21	<b>R (Kilo Ω)</b>	11.18	9.85	9.82	9.86	9.82	9.45
			<b>T (°C)</b>	-2.6	-0.1	-0.1	-0.1	-0.1	0.7

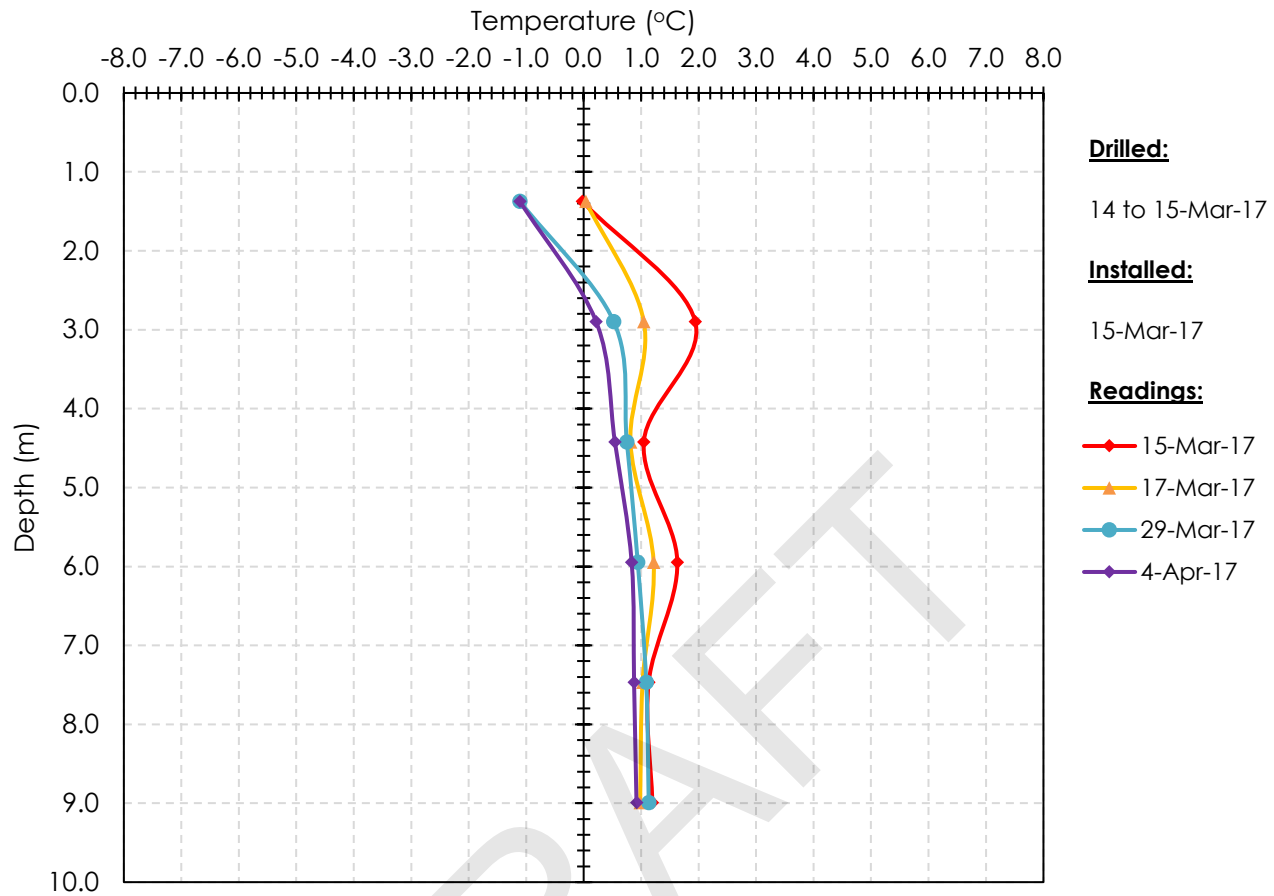
Borehole	BH17-38B								
Drilled:	14 to 15-Mar-17	Drilled Depth:		9.83	m				
Installed:	15-Mar-17								
Reading		Bead	TS4333	TS4332	TS4400	TS4398	TS4396	TS4397	
Date		Days	Depth (m)	1.37	2.90	4.42	5.94	7.47	8.99
Post-Install	15-Mar-17	0	R (Kilo Ω)	9.80	8.87	9.28	9.01	9.24	9.21
			T (°C)	0.0	1.9	1.0	1.6	1.1	1.2
2	17-Mar-17	2	R (Kilo Ω)	9.77	9.28	9.39	9.2	9.29	9.31
			T (°C)	0.0	1.0	0.8	1.2	1.0	1.0
4	29-Mar-17	14	R (Kilo Ω)	10.36	9.53	9.42	9.33	9.26	9.24
			T (°C)	-1.1	0.5	0.8	0.9	1.1	1.1
5	4-Apr-17	20	R (Kilo Ω)	10.36	9.68	9.52	9.38	9.36	9.34
			T (°C)	-1.1	0.2	0.5	0.8	0.9	0.9

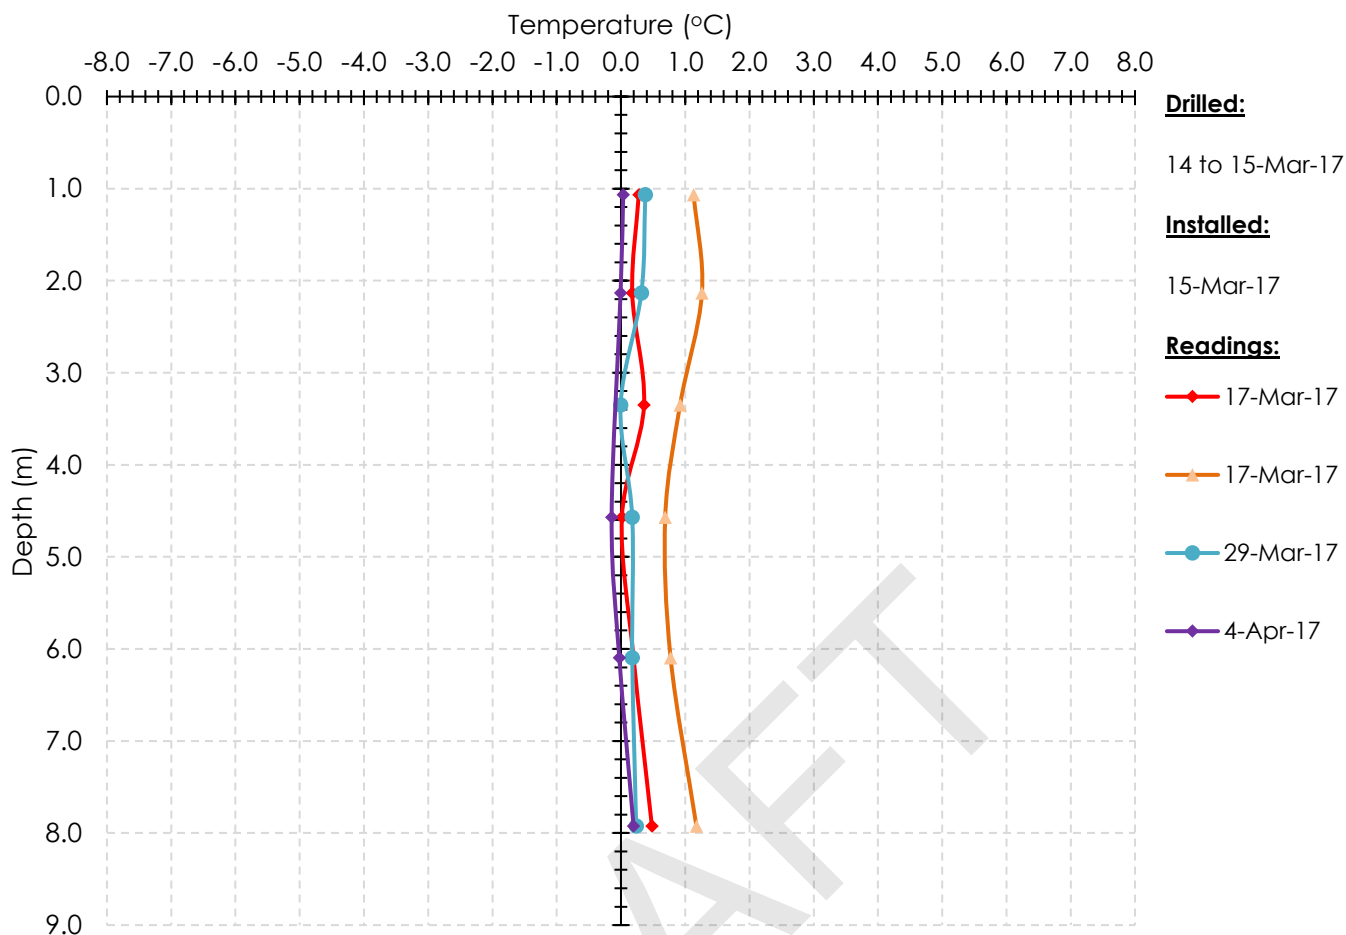
Borehole		BH17-39B							
Drilled:		15 to 16-Mar-17		Drilled Depth:		9.75		m	
Installed:		16-Mar-17							
Reading			Bead	TS4326	TS4324	TS4403	TS4402	TS4399	TS4401
Date		Days	Depth (m)	1.07	2.13	3.35	4.57	6.10	7.92
1	17-Mar-17	1	R (Kilo $\Omega$ )	9.65	9.70	9.61	9.78	9.69	9.55
			T (°C)	0.3	0.2	0.4	0.0	0.2	0.5
2	17-Mar-17	1	R (Kilo $\Omega$ )	9.24	9.18	9.34	9.45	9.41	9.22
			T (°C)	1.1	1.3	0.9	0.7	0.8	1.2
3	29-Mar-17	13	R (Kilo $\Omega$ )	9.60	9.63	9.79	9.7	9.7	9.67
			T (°C)	0.4	0.3	0.0	0.2	0.2	0.2
4	4-Apr-17	19	R (Kilo $\Omega$ )	9.77	9.79	-	9.86	9.8	9.69
			T (°C)	0.0	0.0	-	-0.1	0.0	0.2

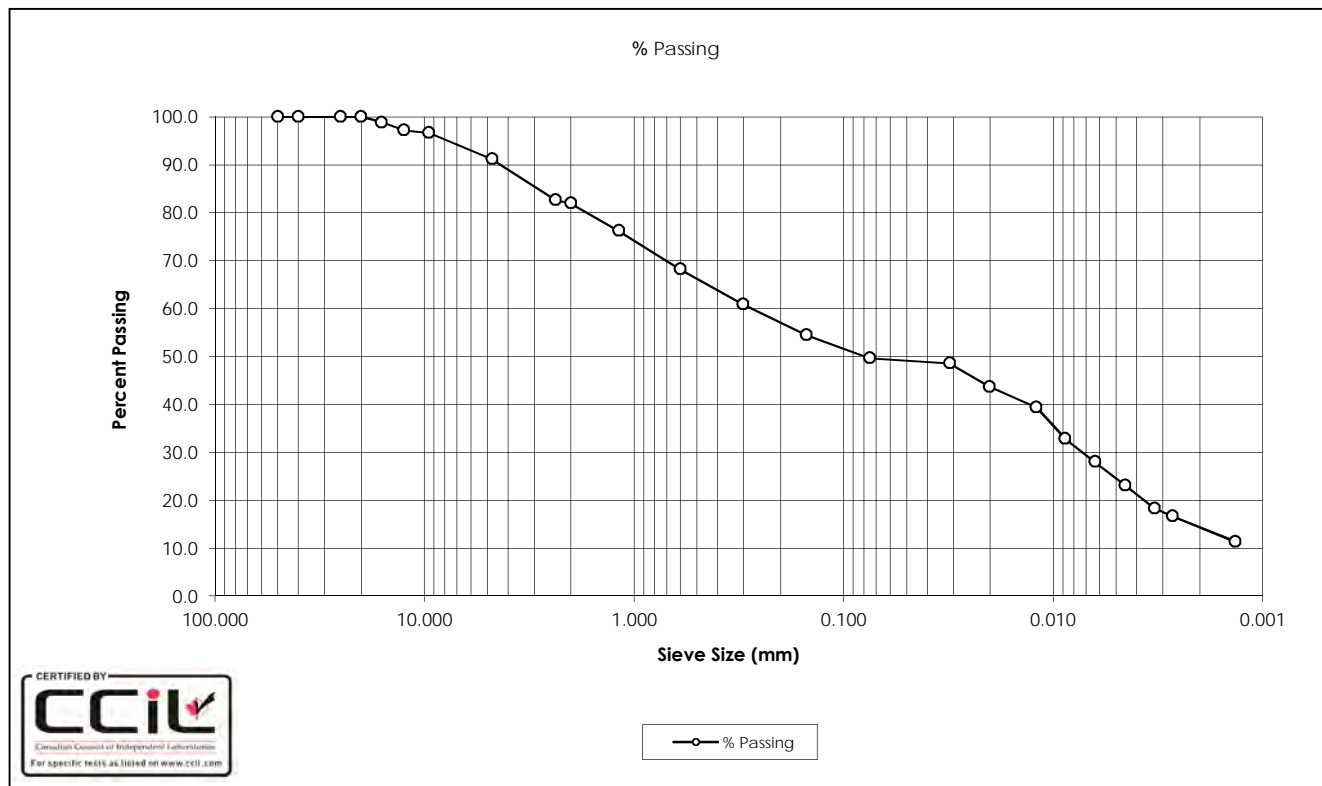
SAMPLE DESCRIPTION: Silty Sand (SM)

Sieve (mm)	Sample % Passing	Sieve (mm)	Sample % Passing
50.0	100.0	0.0063	28.0
40.0	100.0	0.0045	23.1
25.0	100.0	0.0033	18.3
20.0	100.0	0.0027	16.7
16.0	98.9	0.0013	11.3
12.5	97.2		
9.5	96.7		
4.75	91.1		
2.36	82.7		
2.00	82.0		
1.18	76.2		
0.600	68.2		
0.300	60.8		
0.150	54.4		
0.075	49.6		
0.0311	48.6		
0.0201	43.7		
0.0120	39.3		
0.0088	32.9		
Gravel:	8.9%	D <sub>10</sub> :	-
Sand:	41.5%	D <sub>30</sub> :	0.0074
Silt:	35.2%	D <sub>60</sub> :	0.2814
Clay:	14.4%	C <sub>u</sub> :	-
		C <sub>c</sub> :	-

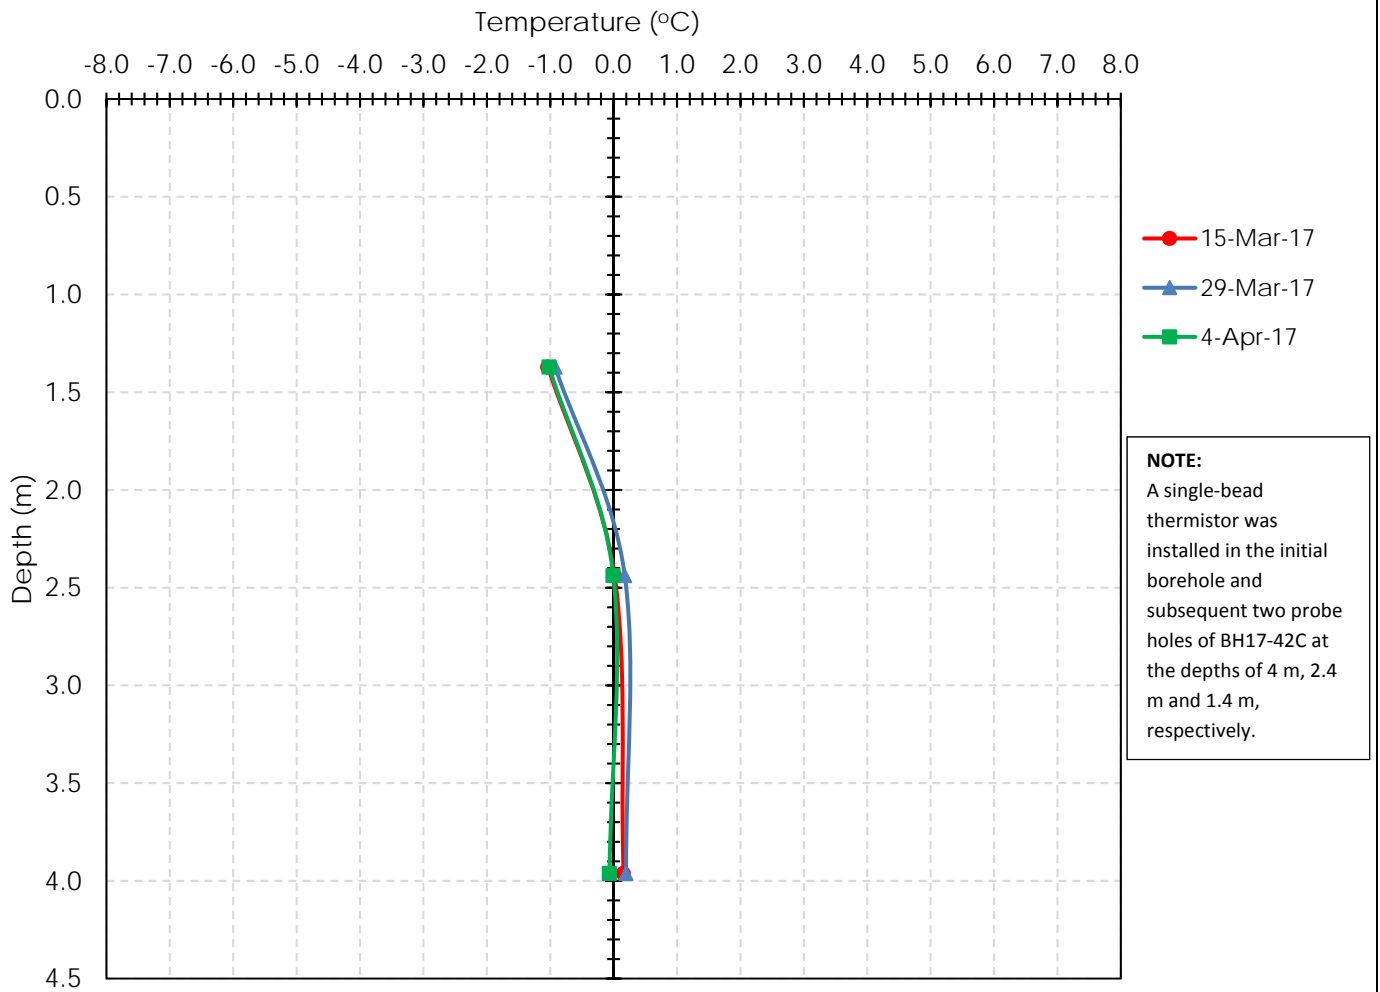
Borehole	BH17-42C					
Drilled:	13-Mar-17		Drilled Depth:		3.96	m
Installed:	13-Mar-17					
Reading			Bead	TS4350	TS4369	TS4352
Date		Days	Depth (m)	1.37	2.44	3.96
Post-Install	13-Mar-17	0	R (ohms)	16.40	18.40	14.00
			T (°C)	-9.8	-11.9	-6.9
2	15-Mar-17	2	R (ohms)	10.32	9.78	9.71
			T (°C)	-1.0	0.0	0.2
3	29-Mar-17	16	R (ohms)	10.26	9.7	9.69
			T (°C)	-0.9	0.2	0.2
4	4-Apr-17	22	R (ohms)	10.31	9.79	9.82
			T (°C)	-1.0	0.0	-0.1

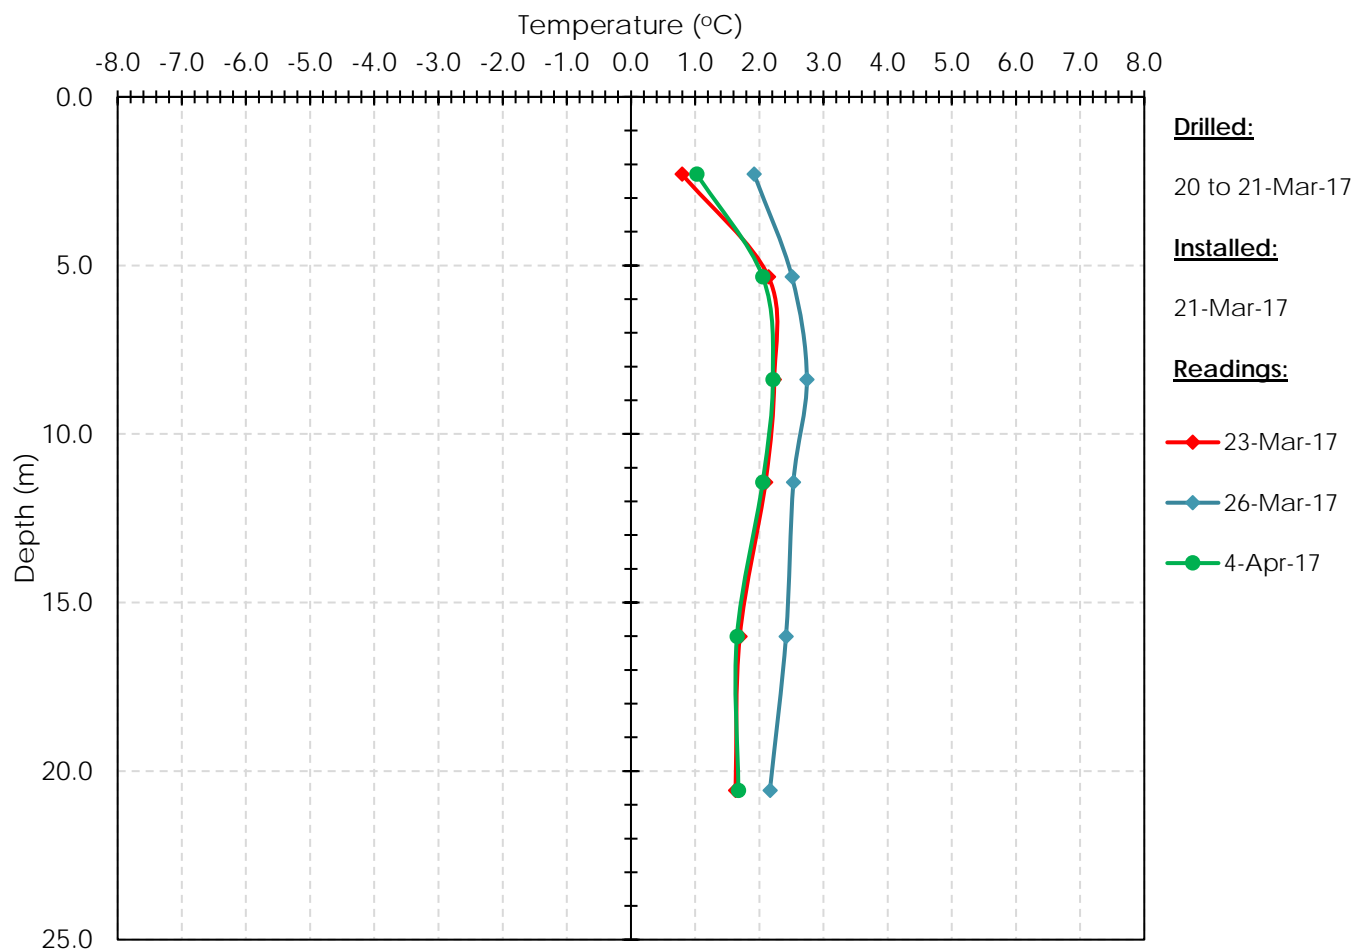
<b>Borehole</b>	<b>BH-57B</b>								
Drilled:	20 to 21-Mar-17				Drilled Depth:			21.95	m
Installed:	21-Mar-17								
<b>Reading</b>		<b>Bead</b>	TS4325	TS4327	TS4389	TS4420	TS4418	TS4436	
<b>Date</b>	<b>Days</b>	<b>Depth (m)</b>	2.29	5.33	8.38	11.43	16.00	20.57	
Post-Install	23-Mar-17	2	<b>R (Kilo Ω)</b>	9.40	8.78	8.74	8.80	8.98	9.01
			<b>T (°C)</b>	0.8	2.1	2.2	2.1	1.7	1.6
2	24-Mar-17	3	<b>R (Kilo Ω)</b>	8.75	8.76	8.28	8.08	8.40	8.39
			<b>T (°C)</b>	2.2	2.2	3.3	3.8	3.0	3.0
3	4-Apr-17	14	<b>R (Kilo Ω)</b>	9.29	8.82	8.75	8.82	9	8.99
			<b>T (°C)</b>	1.0	2.1	2.2	2.1	1.7	1.7

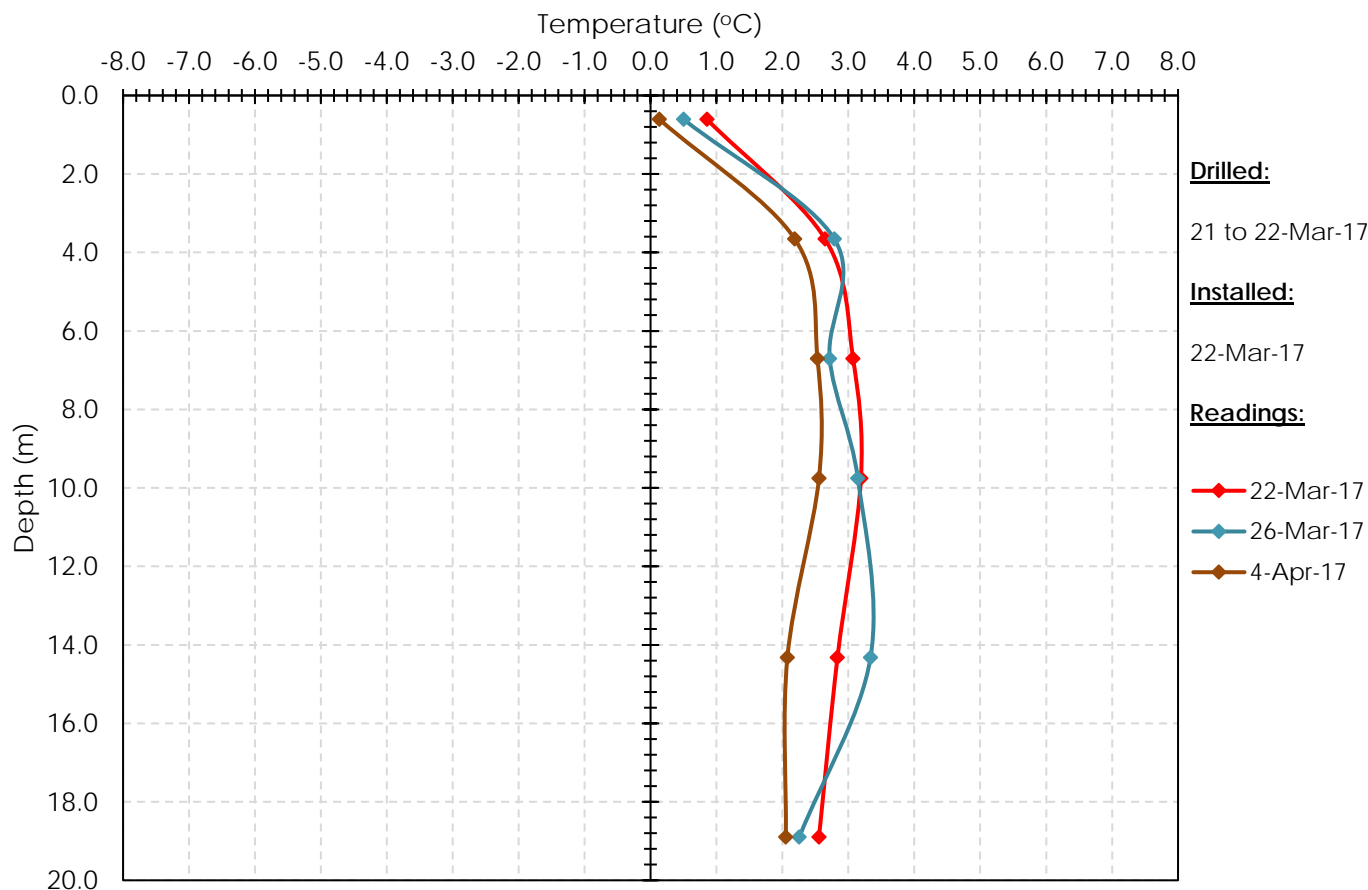
<b>Borehole</b>	<b>BH-59B</b>								
Drilled:	21 to 22-Mar-17			Drilled Depth:			20.88	m	
Installed:	22-Mar-17								
<b>Reading</b>		<b>Bead</b>	TS4390	TS4391	TS4404	TS4408	TS4442	TS4443	
<b>Date</b>	<b>Days</b>	<b>Depth (m)</b>	0.61	3.66	6.71	9.75	14.33	18.90	
Post-Install	22-Mar-17	0	<b>R (Kilo Ω)</b>	9.37	8.56	8.38	8.33	8.48	8.60
			<b>T (°C)</b>	0.9	2.6	3.1	3.2	2.8	2.6
2	26-Mar-17	4	<b>R (Kilo Ω)</b>	9.54	8.5	8.53	8.35	8.27	8.73
			<b>T (°C)</b>	0.5	2.8	2.7	3.1	3.3	2.3
3	4-Apr-17	13	<b>R (Kilo Ω)</b>	9.72	8.76	8.61	8.6	8.81	8.82
			<b>T (°C)</b>	0.1	2.2	2.5	2.6	2.1	2.1

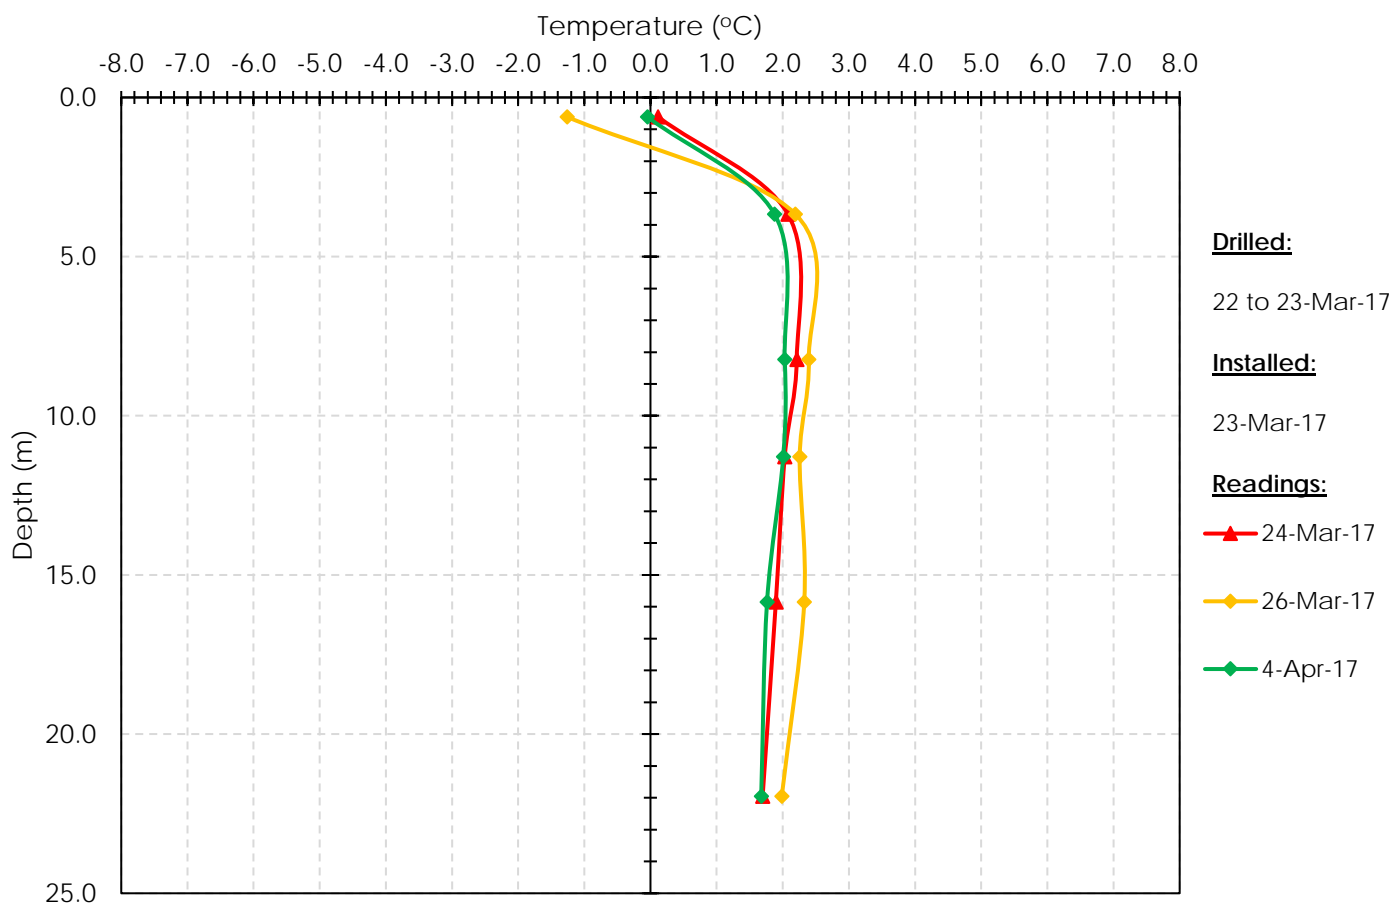
Borehole	BH-60B									
Drilled:	22 to 23-Mar-17					Drilled Depth:			23.47	m
Installed:	23-Mar-17									
Reading			Bead	TS4384	TS4388	TS4419	TS4422	TS4426	TS4431	
Date		Days	Depth (m)	0.61	3.66	8.23	11.28	15.85	21.95	
Post-Install	23-Mar-17	0	R (Kilo Ω)	7.15	6.63	8.14	6.68	8.08	7.55	
			T (°C)	6.3	7.8	3.7	7.7	3.8	5.2	
2	24-Mar-17	1	R (Kilo Ω)	9.73	8.81	8.75	8.83	8.89	8.98	
			T (°C)	0.1	2.1	2.2	2.0	1.9	1.7	
3	26-Mar-17	3	R (Kilo Ω)	10.44	8.76	8.67	8.73	8.7	8.85	
			T (°C)	-1.3	2.2	2.4	2.3	2.3	2.0	
4	4-Apr-17	12	R (Kilo Ω)	9.81	8.9	8.83	8.84	8.95	8.99	
			T (°C)	0.0	1.9	2.0	2.0	1.8	1.7

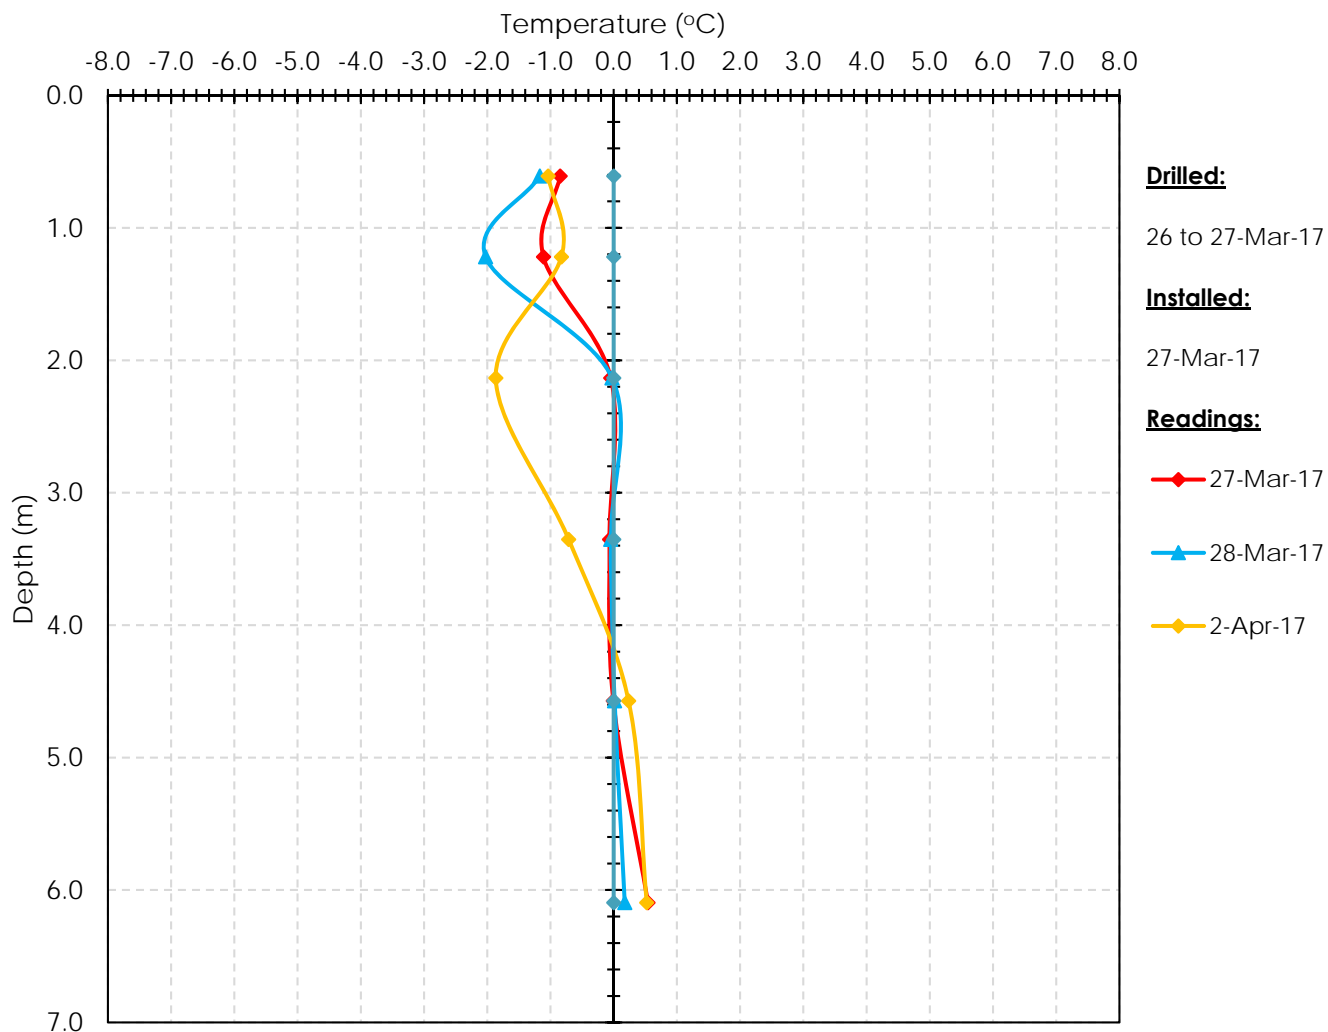
<b>Borehole</b>		<b>BH17-71B</b>							
Drilled:		26 to 27-Mar-17			Drilled Depth:			9.75	m
Installed:		27-Mar-17							
<b>Reading</b>			<b>Bead</b>	#6	#5	#4	#3	#2	#1
				TS4412	TS4405	TS4406	TS4416	TS4410	TS4434
<b>Date</b>		<b>Days</b>	<b>Depth (m)</b>	0.61	1.22	2.13	3.35	4.57	6.10
Post-Install	27-Mar-17	0	<b>R (Kilo Ω)</b>	10.22	10.36	9.81	9.82	9.79	9.52
			<b>T (°C)</b>	-0.8	-1.1	0.0	-0.1	0.0	0.5
2	28-Mar-17	1	<b>R (Kilo Ω)</b>	10.39	10.86	9.8	9.81	9.78	9.7
			<b>T (°C)</b>	-1.2	-2.0	0.0	0.0	0.0	0.2
3	2-Apr-17	6	<b>R (Kilo Ω)</b>	10.32	10.21	10.77	10.15	9.67	9.53
			<b>T (°C)</b>	-1.0	-0.8	-1.9	-0.7	0.2	0.5
