**GNWT Response to:  
GoC NRCan IR#1 (ID15)**

Acting at the authorization of Tlicho Engineering and Environmental Services Ltd. (Tlicho), Stantec Consulting Ltd. (Stantec) carried out a geotechnical investigation in support of the culvert planned at 'Crossing #5' along the proposed Tlicho All Season Access Road (TASR). The purpose of the investigation was to characterize subsurface conditions and provide geotechnical comments and recommendations to assist with culvert design and site development.

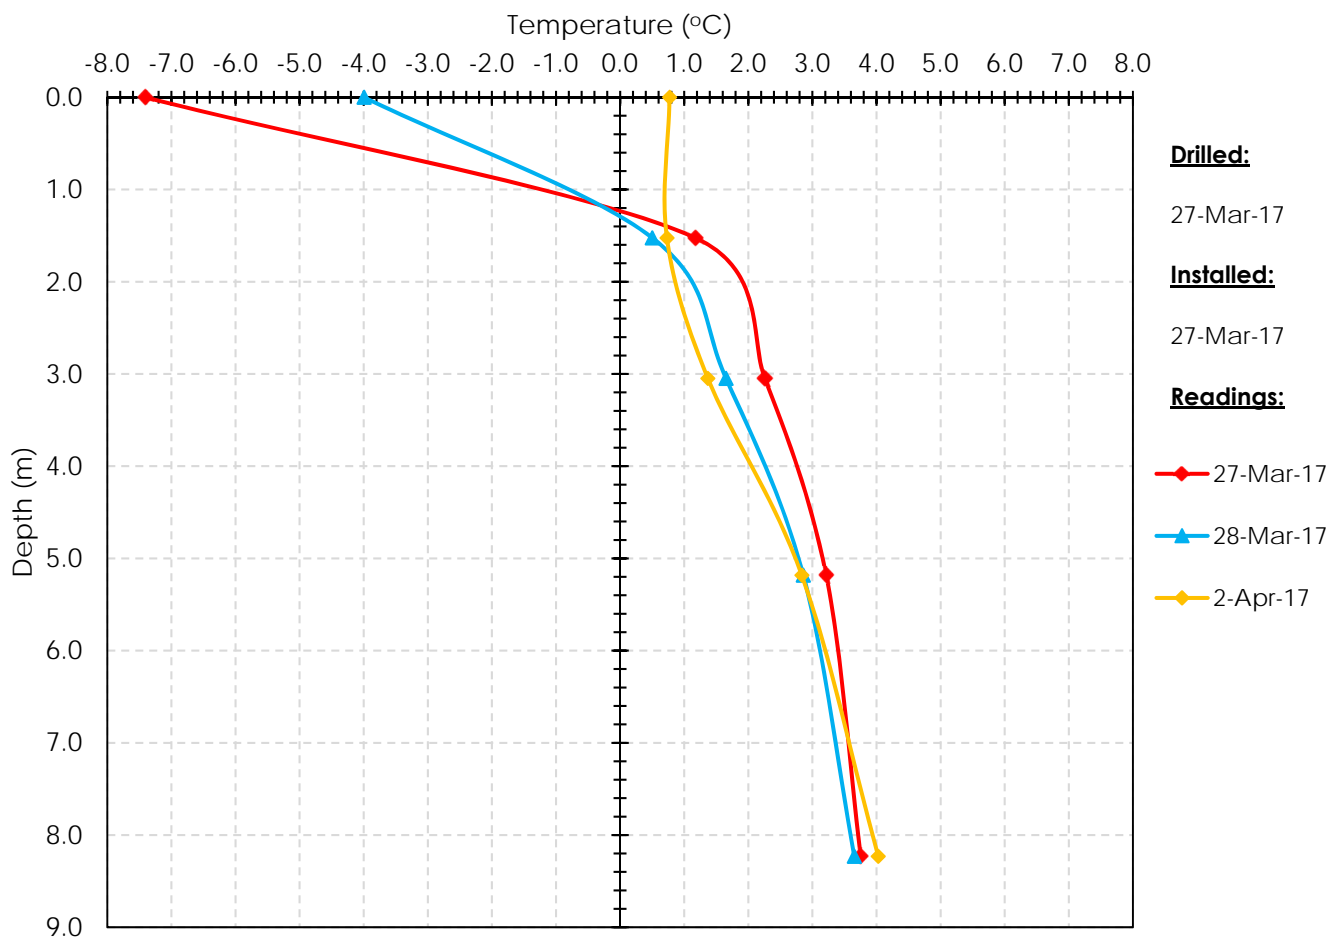
Borehole	BH17-72B							
Drilled:	27-Mar-17		Drilled Depth:			11.28	m	
Installed:	27-Mar-17							
Reading			Bead	TS4376	TS4374	TS4415	TS4428	TS4429
Date		Days	Depth (m)	0.00	1.52	3.05	5.18	8.23
Post-Install	27-Mar-17	0	R (Kilo Ω)	14.41	9.22	8.73	8.32	8.10
			T (°C)	-7.4	1.2	2.3	3.2	3.8
2	28-Mar-17	1	R (Kilo Ω)	12.03	9.54	9.00	8.47	8.14
			T (°C)	-4.0	0.5	1.7	2.9	3.7
3	2-Apr-17	6	R (Kilo Ω)	9.41	9.43	9.13	8.48	7.99
			T (°C)	0.8	0.7	1.4	2.8	4.0

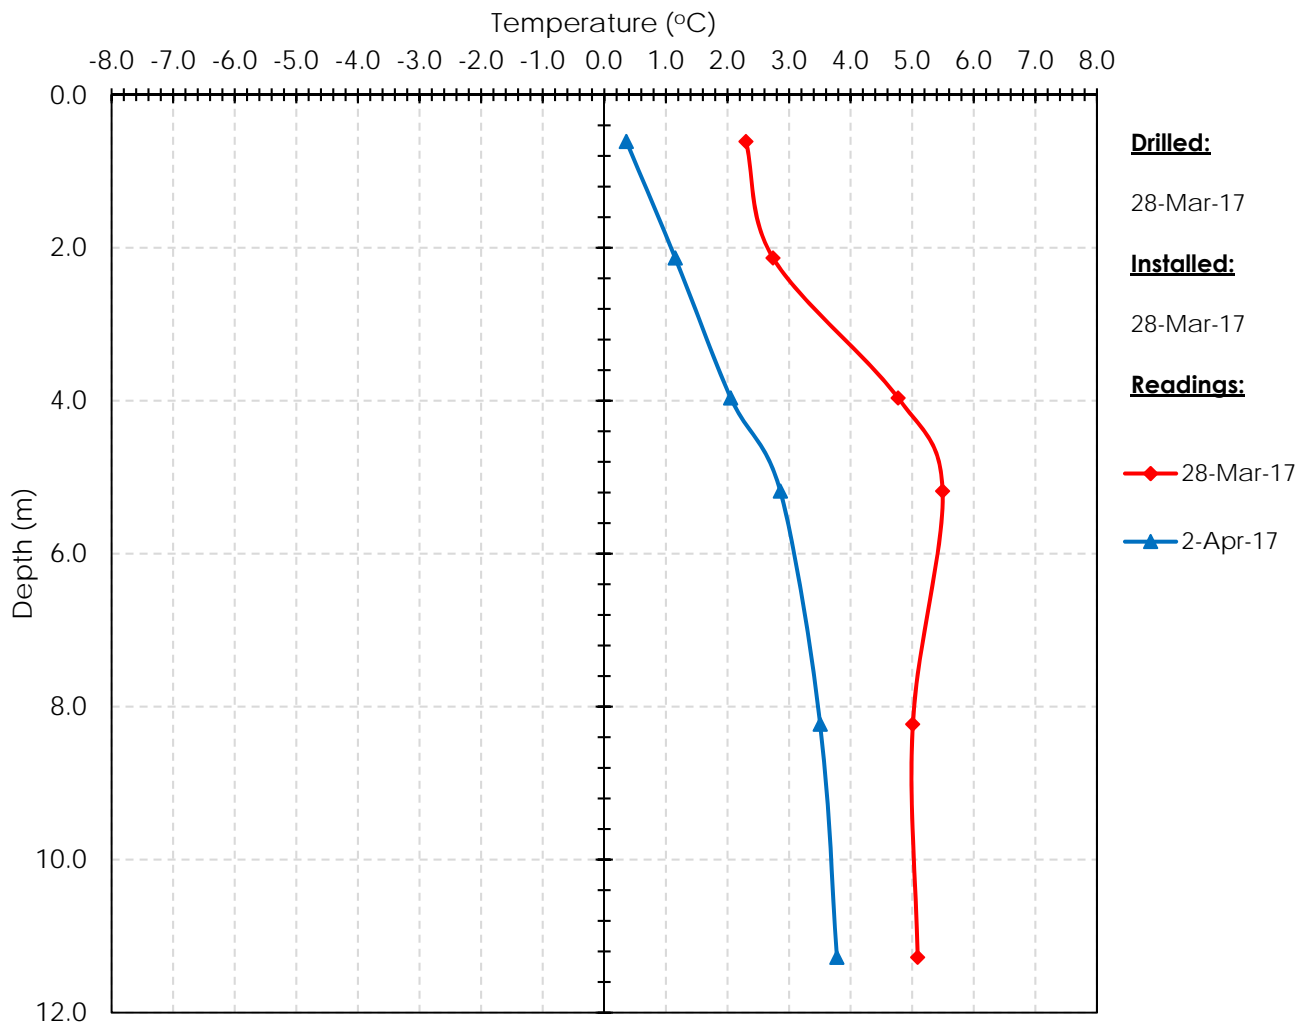
<b>Borehole</b>	<b>BH-73B</b>								
Drilled:	28-Mar-17			Drilled Depth:		12.80	m		
Installed:	28-Mar-17								
Reading		Bead	#6	#5	#4	#3	#2	#1	
			TS4445	TS4430	TS4447	TS4446	TS4432	TS4433	
Date	Days	Depth (m)	0.61	2.13	3.96	5.18	8.23	11.28	
Post-Install	28-Mar-17	0	R (Kilo $\Omega$ )	8.71	8.52	7.70	7.43	7.61	7.58
			T (°C)	2.3	2.7	4.8	5.5	5.0	5.1
2	2-Apr-17	5	R (Kilo $\Omega$ )	9.61	9.23	8.82	8.47	8.2	8.09
			T (°C)	0.4	1.2	2.1	2.9	3.5	3.8

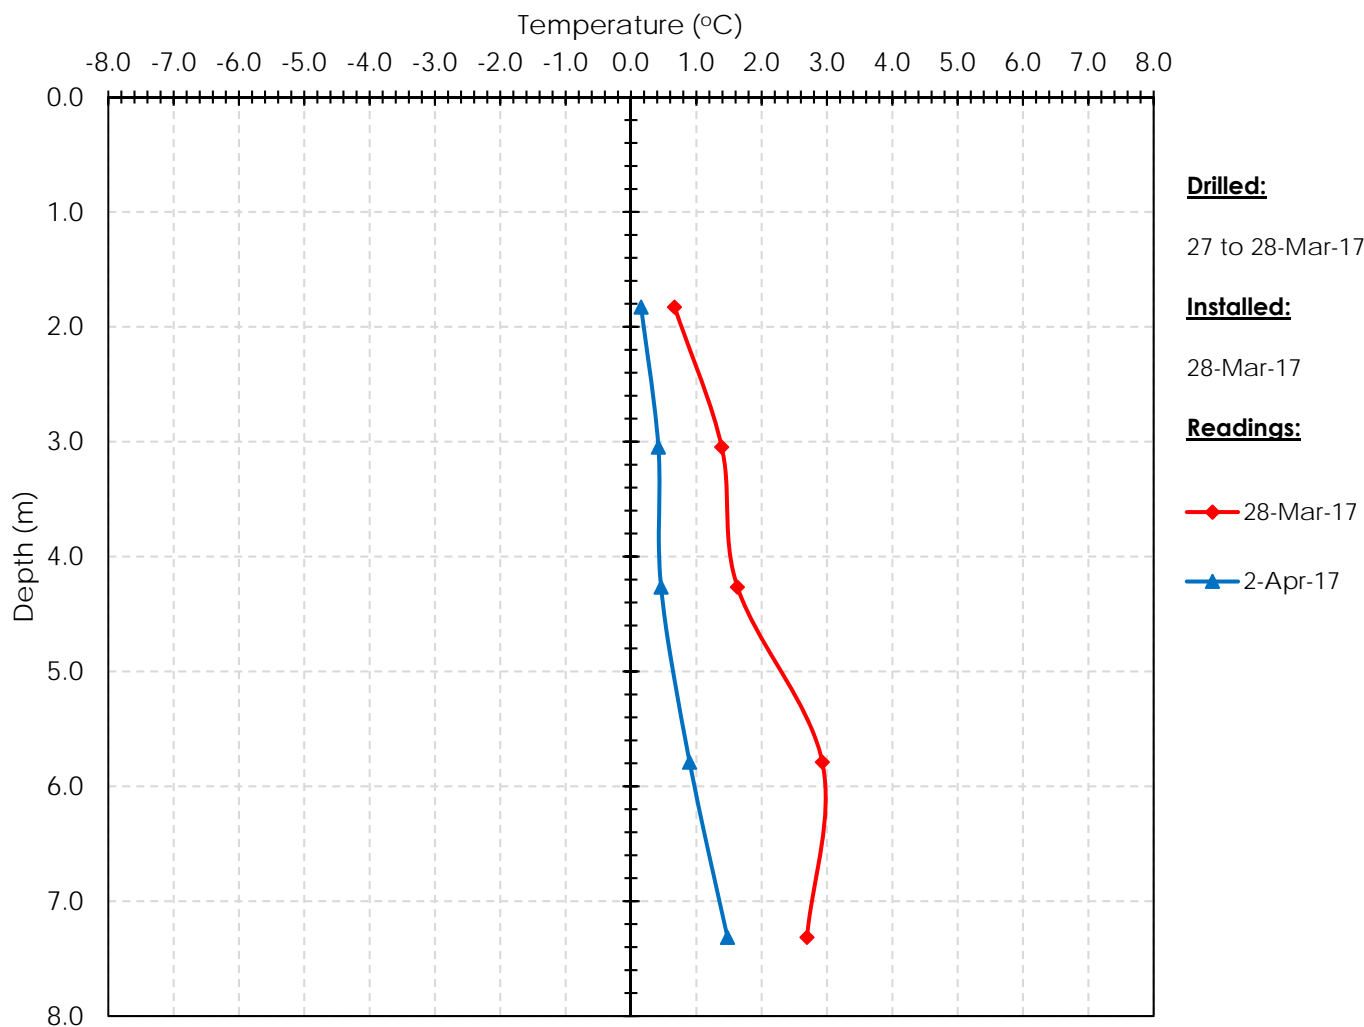
<b>Borehole</b>		<b>BH17-74B</b>							
Drilled:		27 to 28-Mar-17		Drilled Depth:			11.28	m	
Installed:		28-Mar-17							
<b>Reading</b>			<b>Bead</b>	#6	#5	#4	#3	#2	#1
				TS4342	TS4356	TS4343	TS4423	TS4411	TS4409
<b>Date</b>		<b>Days</b>	<b>Depth (m)</b>	0.61	1.83	3.05	4.27	5.79	7.32
Post-Install	28-Mar-17	0	R (Kilo $\Omega$ )	-	9.46	9.12	9.01	8.44	8.54
			T (°C)	-	0.7	1.4	1.6	2.9	2.7
2	2-Apr-17	5	R (Kilo $\Omega$ )	-	9.71	9.58	9.56	9.35	9.08
			T (°C)	-	0.2	0.4	0.5	0.9	1.5
