**Dezé Energy Corporation
Taltson River Hydroelectric Expansion Project**

**July-August 2008 Littoral Habitat Assessment of
Lady Gray Lake, Nonacho Lake and Trudel Creek**

February 2009

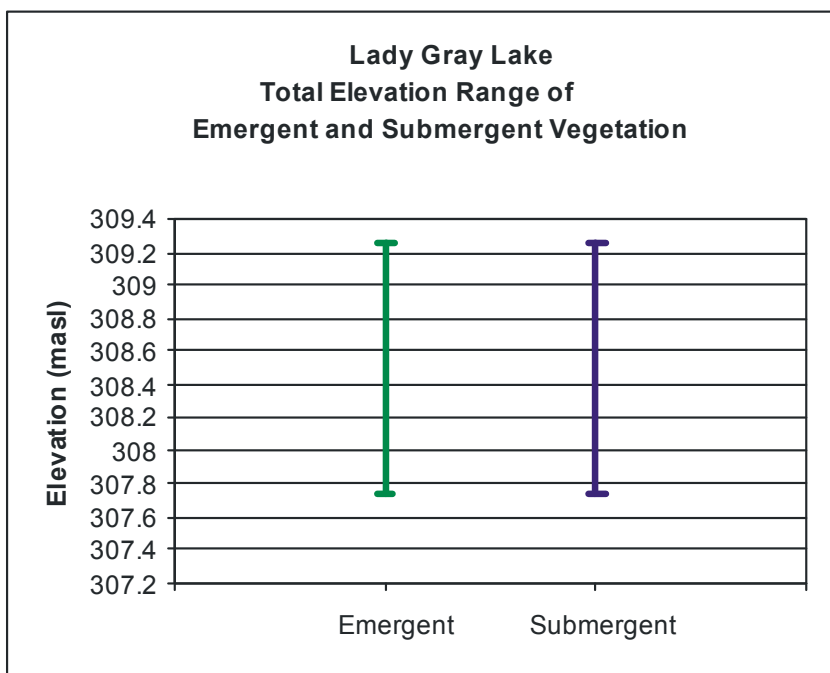
Figure 5. Total elevation range of emergent and submergent vegetation in Lady Gray Lake.

The total elevation range of emergent and submergent vegetation is illustrated in Figure 5. Refer to Appendix A for site specific data on Lady Gray Lake.

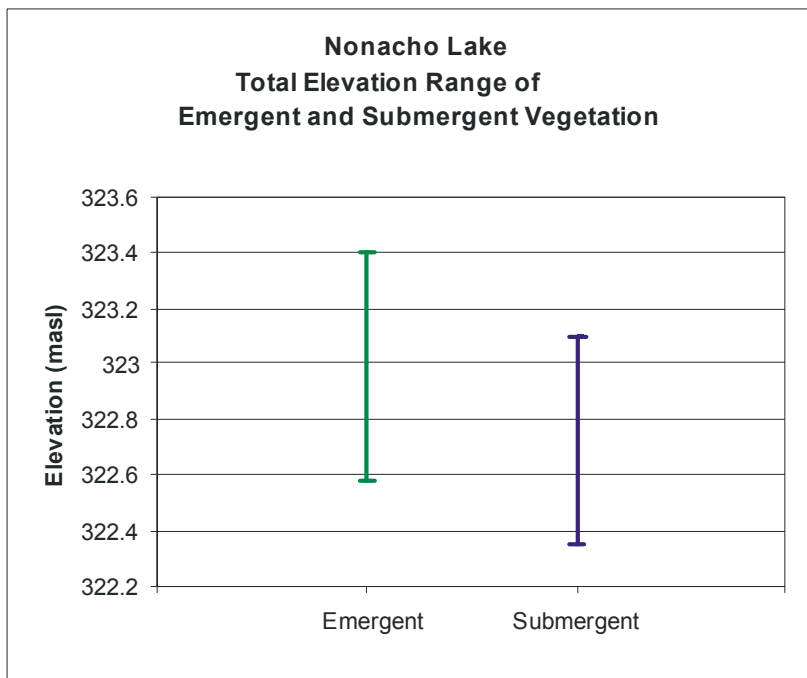
Figure 6. Total elevation range of emergent and submergent vegetation in Nonacho Lake.

The total elevation range of emergent and submergent vegetation in Nonacho Lake is illustrated in Figure 6. Refer to Appendix B for site specific information on Nonacho Lake.

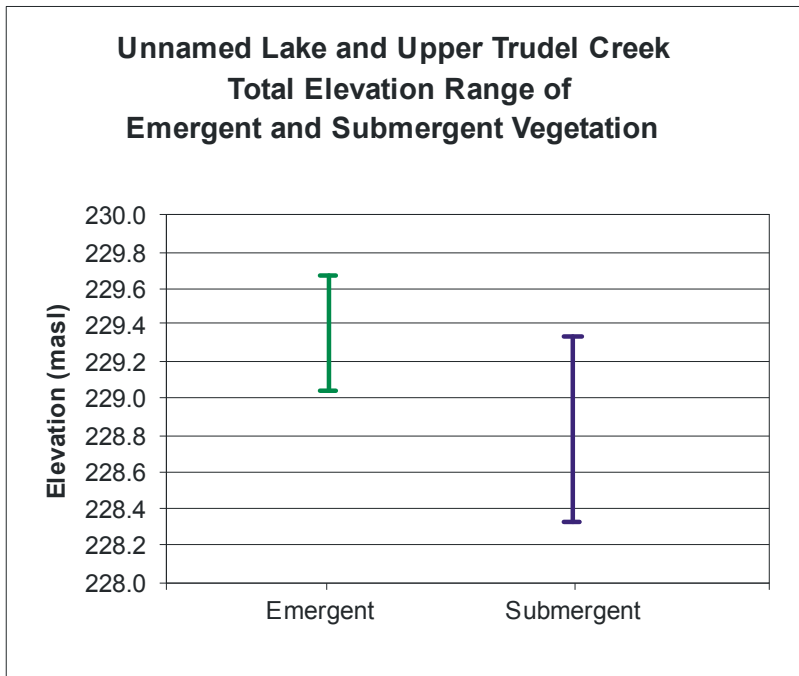
Figure 7. Total elevation range of emergent and submergent vegetation in Unnamed Lake and Upper Trudel Creek (Site 3-5).

Transect measurements indicate that the submergent plant community in the upper reach of Trudel Creek and Unnamed Lake was present within a total elevation range of 229.34 masl to 228.33 masl. These elevation ranges are based only on the transect measurements taken.

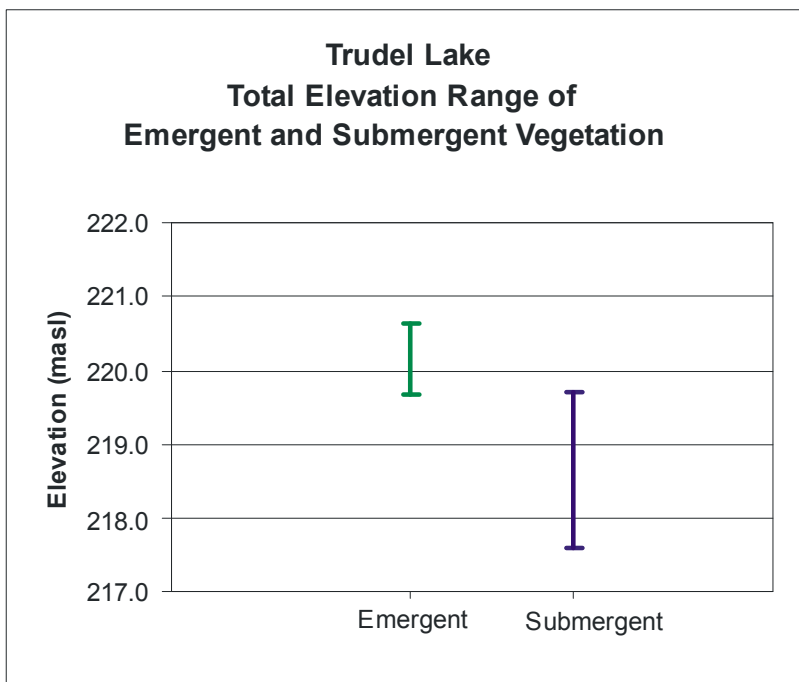
Figure 8. Total elevation range of emergent and submergent vegetation in Trudel Lake (Site 1-2).

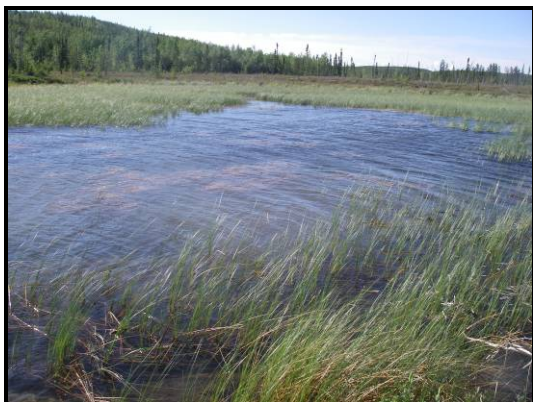
Figure 9. Site 1 sheltered bay area.

Site 1 was located towards the downstream end of Lady Gray Lake. This site was a relatively small and sheltered bay with a deep organic substrate and dense emergent vegetation (Figure 9). This site, along with Site 2, represent relatively isolated shallow habitat compared to the surrounding area of the lake, which is characterized by steeper bedrock banks and little to no submergent vegetation.

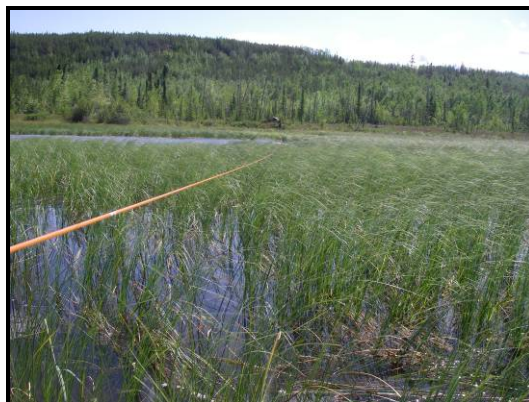
Figure 10. Transect at Site 1.

Depth transects and fish sampling was completed at Site 1 (Figure 10). Site 1 transects and beach seine sampling locations are illustrated in Figure 11.

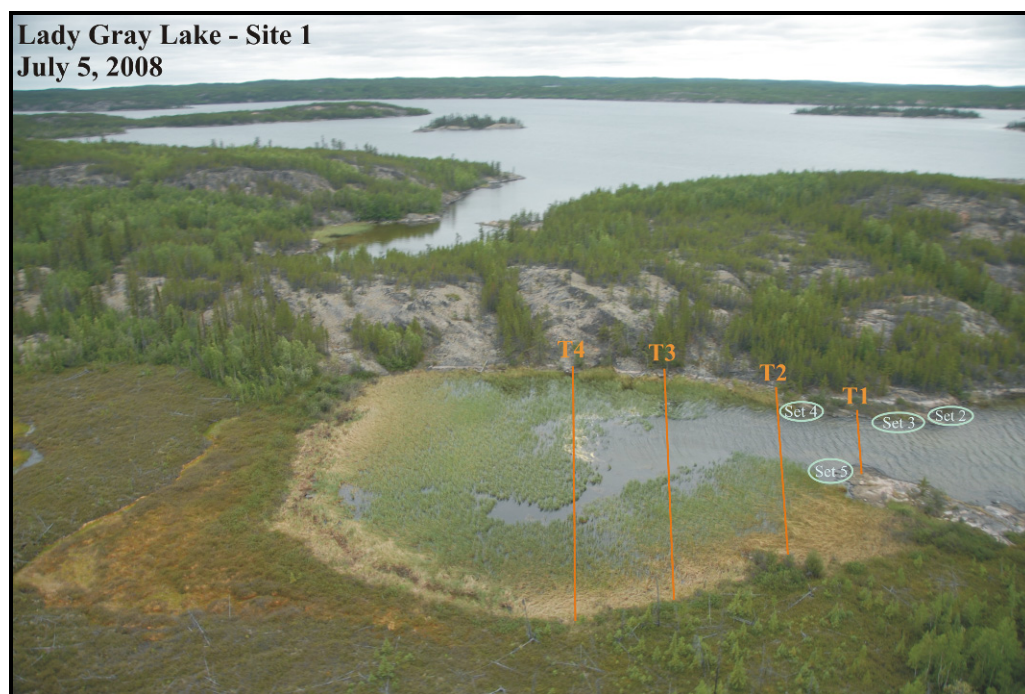
Figure 11. Sample Site 1 on Lady Gray Lake.

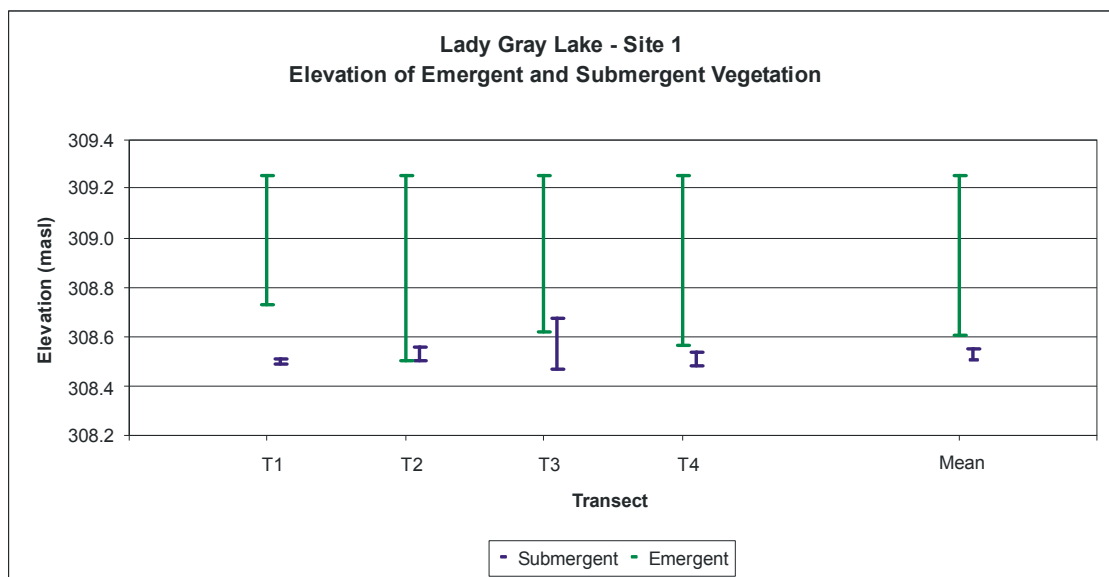
Figure 12. Emergent and submergent elevation range for transects at Site 1.

The elevation range of emergent and submergent vegetation for each transect was determined, along with the mean elevation range for Site 1 which is illustrated in Figure 12.

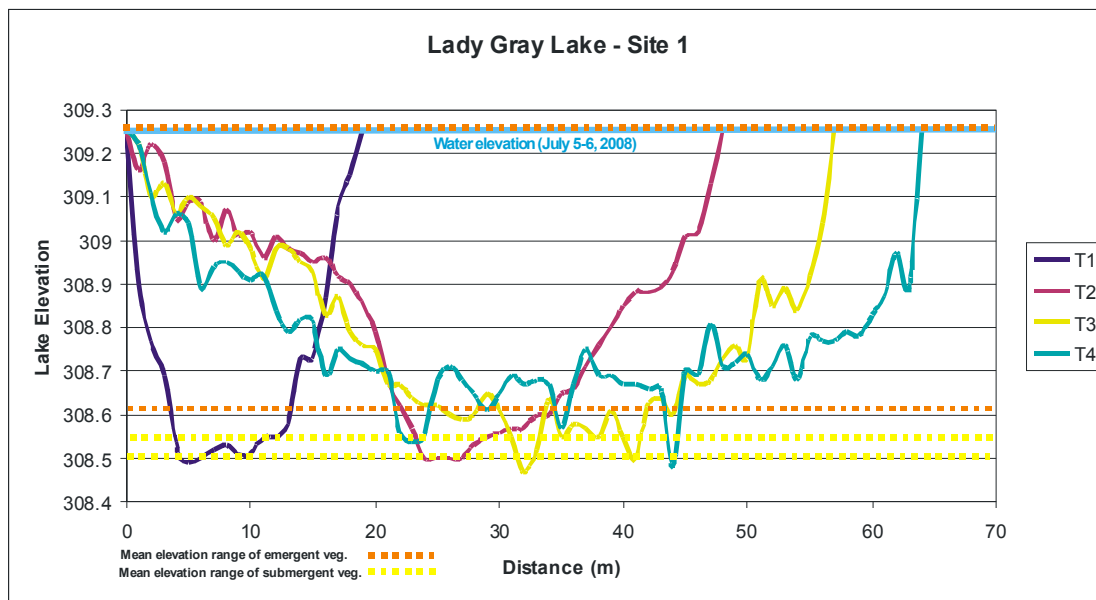
Figure 13. Transect profiles and the mean elevation range of emergent and submergent vegetation at Site 1.

Figure 13 illustrates the bathymetric profile of each transect along with the mean elevation range of emergent and submergent vegetation at the site.

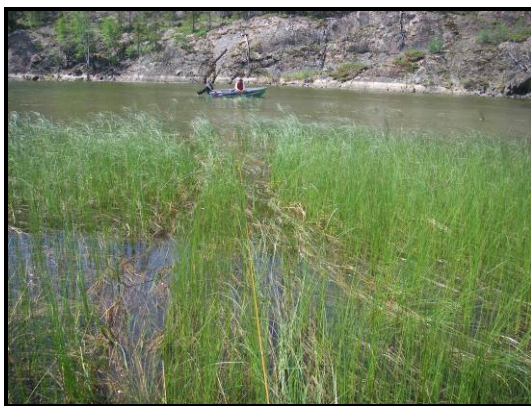
Figure 14. Emergent sedge at Site 2.

Sample Site 2 was located near the downstream end of Lady Gray Lake. The site was a large and sheltered bay area located on an inlet off the main lake. This was a complex site supporting a large sedge platform, emergent sedge, bull rush and pond lily, as well as various submergent species such as pondweed (Figure 14 and Figure 15). The entire bay area was less than 2 m deep. This was a large site so transects were only completed in one area.

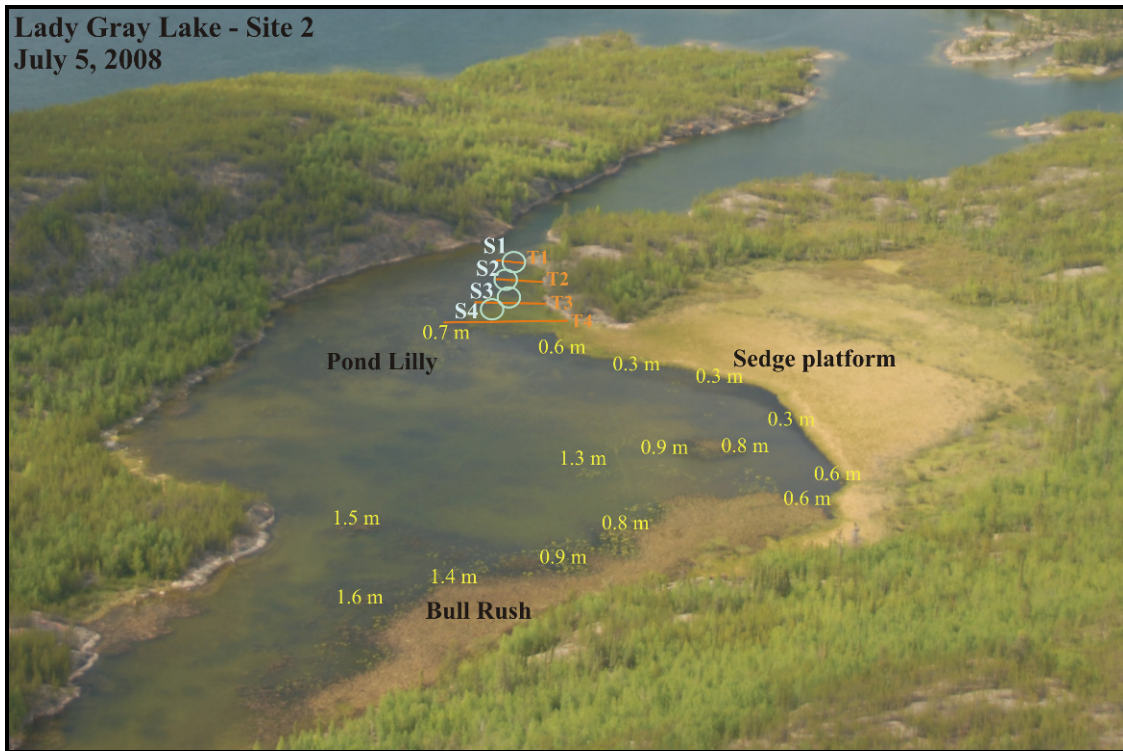
Figure 16. Sample Site 2 on Lady Gray Lake. (S1-S4: seine sample sites, T1-T4: transects)

A total of 4 transects were completed at Site 2. Transect locations are noted in Figure 16 along with notes on depth measurements and beach seine sample sites.

In the shallow area where transects were not completed, depth measurements were taken at transition zones between vegetation types and at the locations where a species ended (Figure 16). The mean depths and corresponding elevation ranges at which each species was present are noted below:

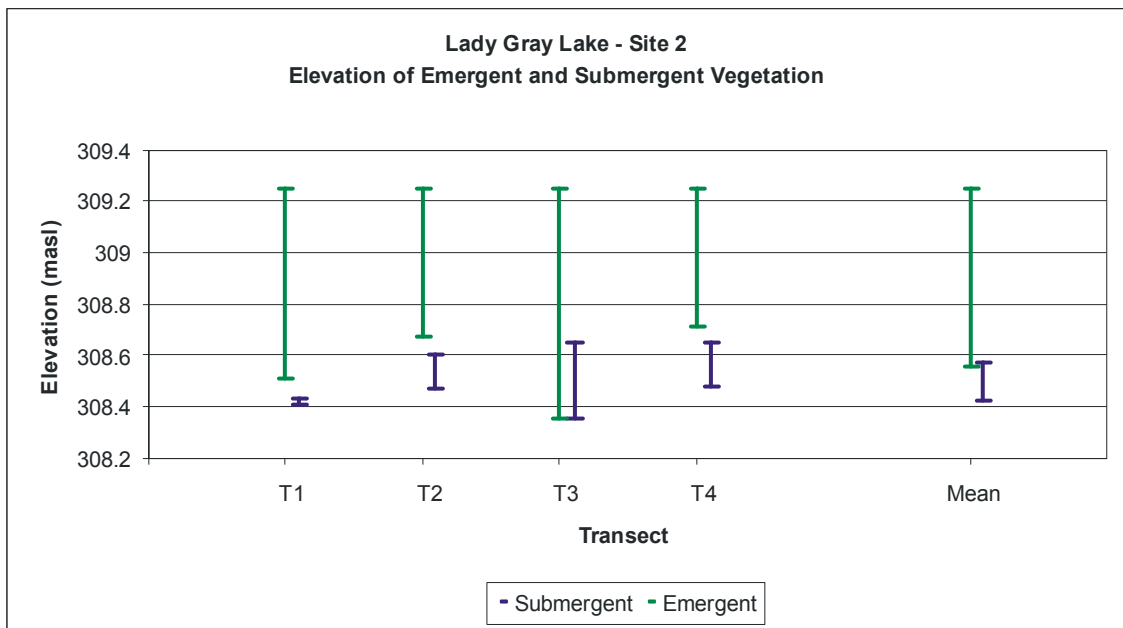
Figure 17. Emergent and submergent elevation range for transects at Site 2.

The elevation range of emergent and submergent vegetation for each transect was determined, along with the mean elevation range for Site 2 which is illustrated in Figure 17.

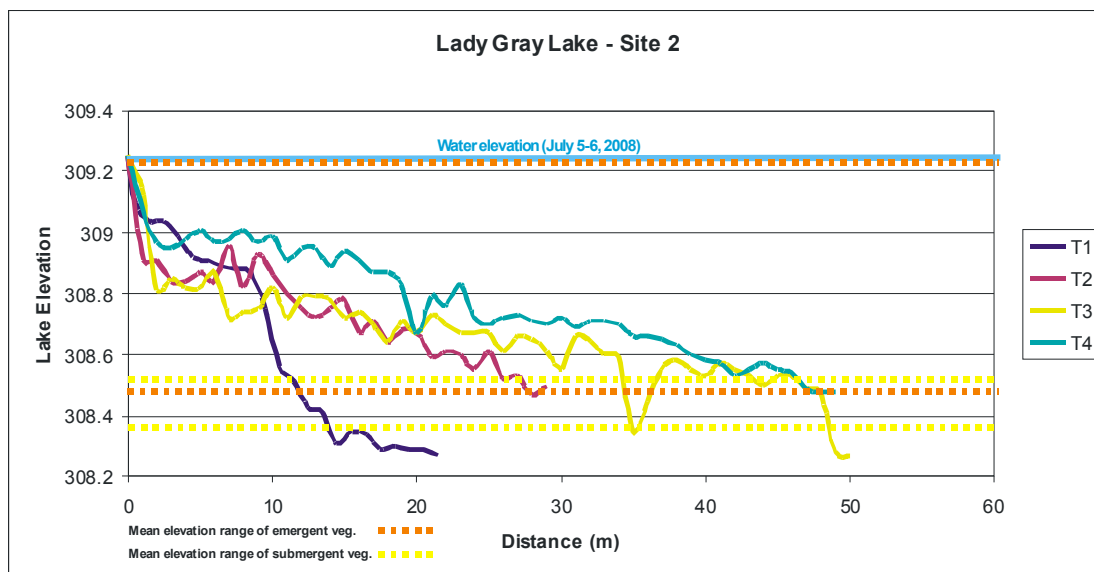
Figure 18. Site 2 transect profiles and mean elevation ranges for emergent and submergent vegetation.

The bathymetric profile of each transect was also graphed in Figure 18 and the mean elevation range for both emergent and submergent vegetation at Site 2 was noted on the graph.

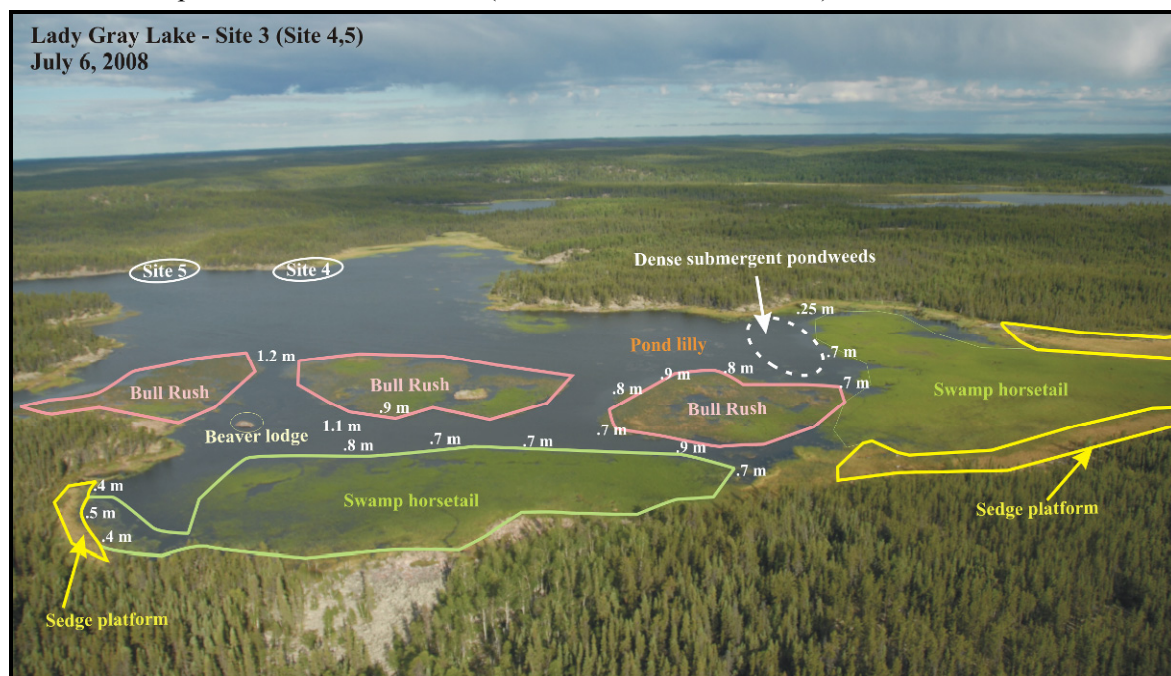
Figure 19 – Site 3 Lady Gray Lake.

of Lady Gray Lake, most likely due to increased exposure and a lack of vegetation and cover. The locations of Sites 4 and 5 are noted in Figure 19 above.

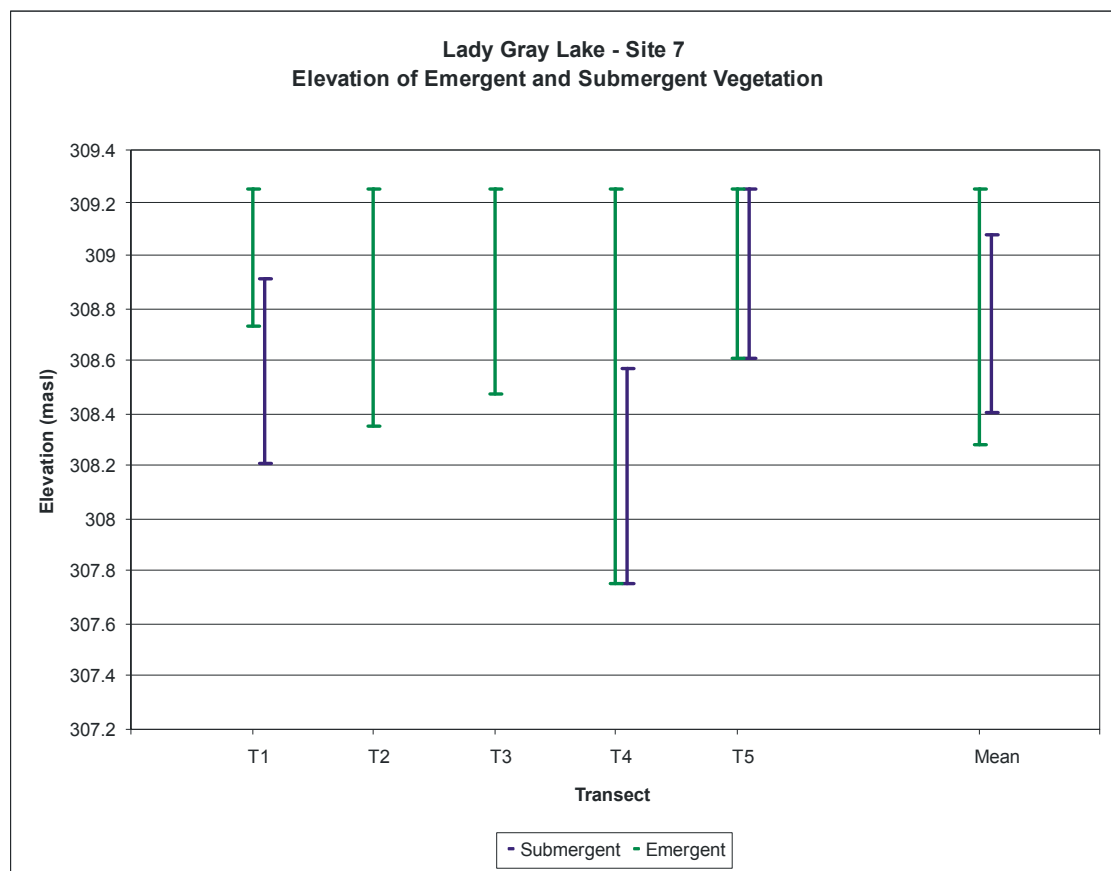
Figure 20. Emergent and submergent elevation ranges for transects at Site 7.

The elevation range of emergent and submergent vegetation for each transect was determined, along with the mean elevation range for Site 7 which is illustrated in Figure 20.

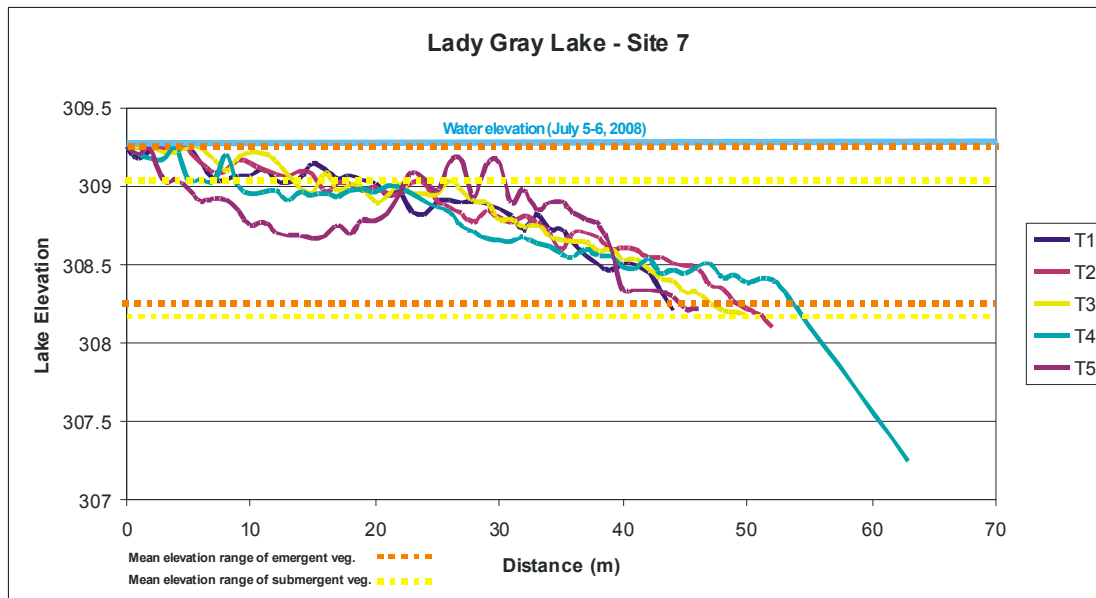
Figure 21. Site 7 transect profiles and mean elevation ranges for emergent and submergent vegetation.

The bathymetric profile of each transect was also graphed (Figure 21) and the mean elevation range for both emergent and submergent vegetation at Site 7 was noted on the graph.

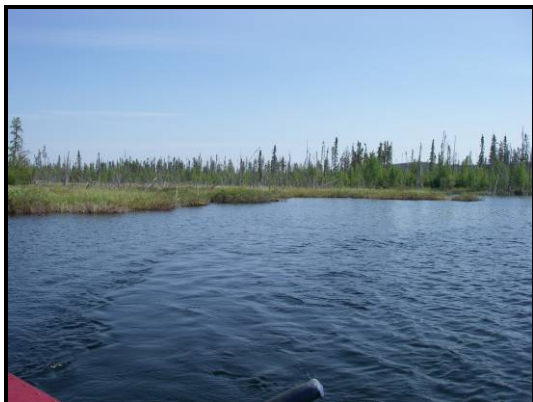
Figure 22. Open water in front of wetland where northern pike were captured.

Site 1 on Nonacho Lake was located a short distance upstream from the Nonacho Control structure. This was a wetland site composed of a floating mat of woody vegetation; therefore, there was no opportunity to conduct transects at this site. Figure 22 and Figure 23 illustrate Site 1 on Nonacho Lake.

Fish sampling was completed at this site using angling. Three large pike were captured just off the edge of the floating mat of vegetation. The area under the vegetation provides excellent cover for pike.

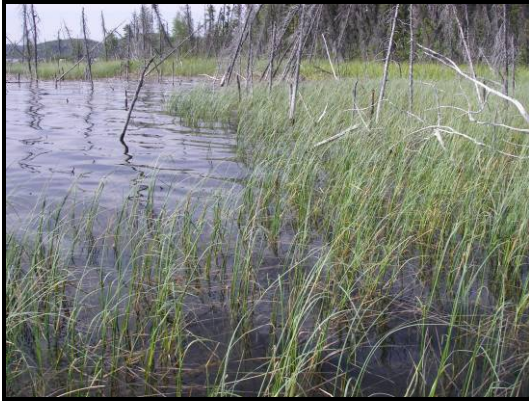
Figure 24. Emergent sedge at Site 2

Site 2 on Nonacho Lake was located in the southwest arm of the lake towards the Nonacho Control structure. This shallow habitat was created with the flooding of Nonacho Lake and contains a large amount of woody debris and dead trees. A deep organic substrate is present in the vegetated area.

Vegetation at this site was composed mainly of emergent water sedge (*Carex aquatilis*) and beaked sedge (*Carex Utriculata*). Sparse submergent vegetation was present; however, it is anticipated that more submergent vegetation would be present in this area later in the growing season. Figure 24 and Figure 25 illustrate the type of habitat present at Site 2 on Nonacho Lake.

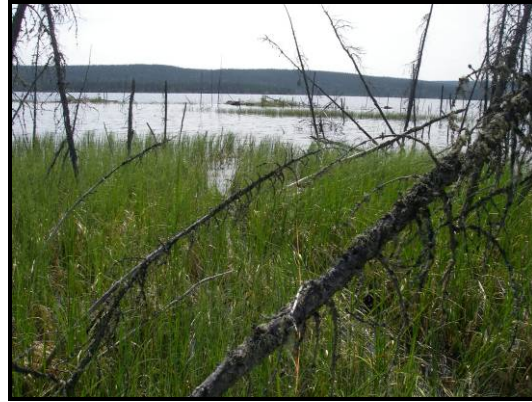
Figure 25. Transect 1 at Site 2.

A total of three transects were completed at this site to determine the elevation range at which the emergent sedge and submergent vegetation communities were growing.

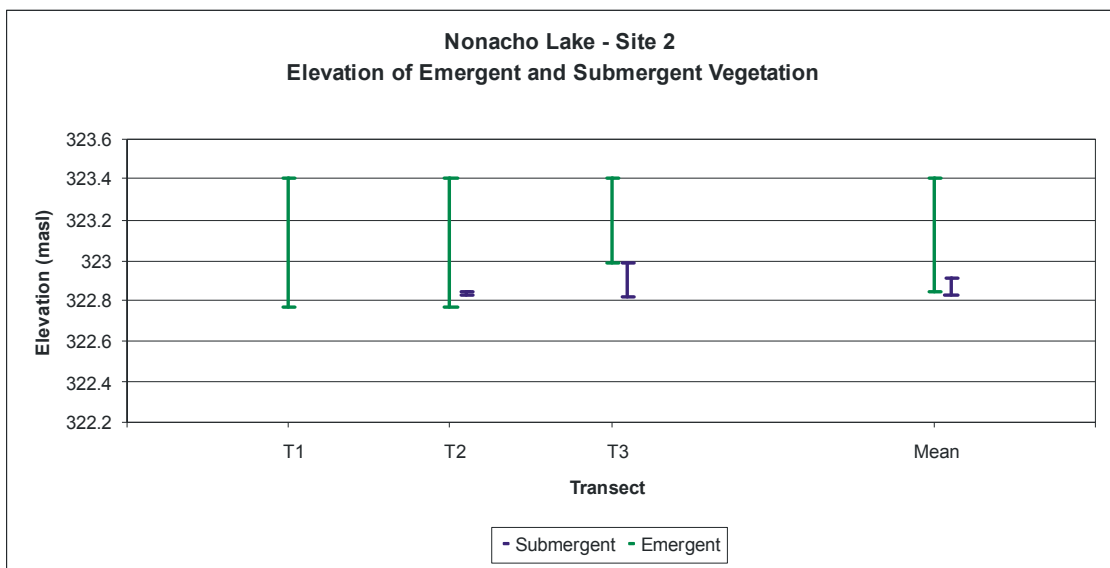
Figure 26. Emergent and submergent elevation ranges for transects at Site 2.

The elevation range of emergent and submergent vegetation for each transect was determined along with the mean elevation range for Site 2, which is illustrated in Figure 26.

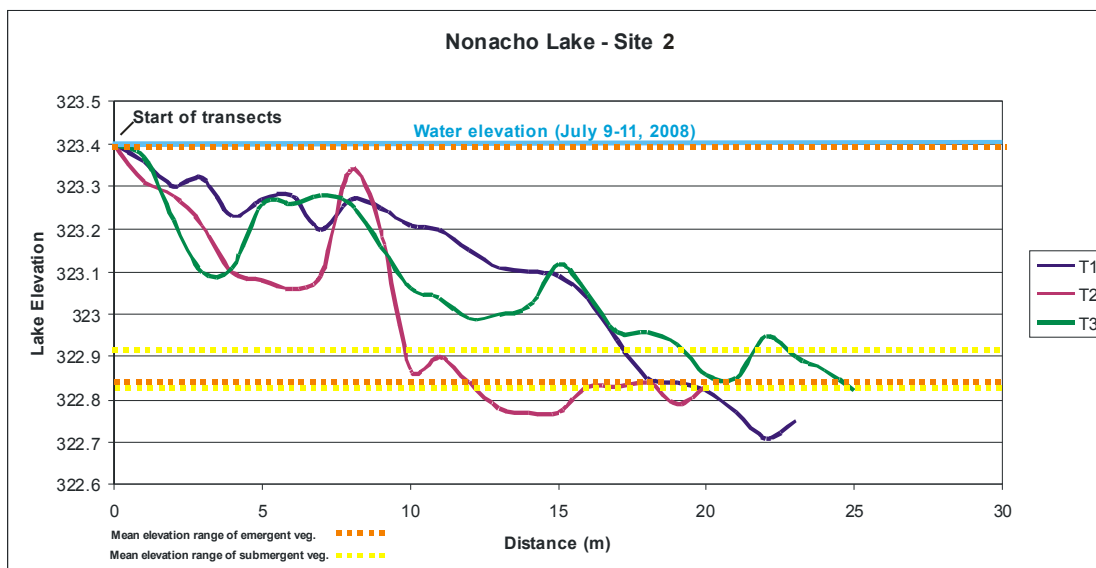
Figure 27. Site 2 transect profiles and mean elevations of emergent and submergent vegetation.

The bathymetric profile of each transect was also graphed (Figure 27) and the mean elevation range for both emergent and submergent vegetation at Site 2 was noted on the graph.

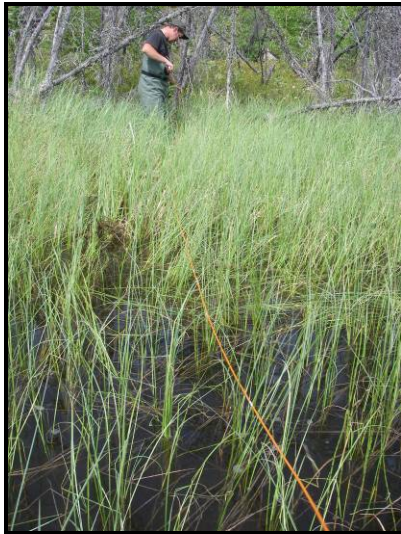
Figure 28. Transect 1 at Site 3.

Site 3 on Nonacho Lake is located in the southwest arm of the lake in a large bay area which is separated from the main lake by a narrow inlet. It is likely that this area was not connected to the main lake before the Nonacho Dam was in place. Water depths in this area did not exceed approximately 2.5 m. Figure 28 illustrates transect 1 and the emergent vegetation present at Site 3 on Nonacho Lake.

Emergent vegetation was present around the entire bay, extending out from small sedge platforms in most areas.

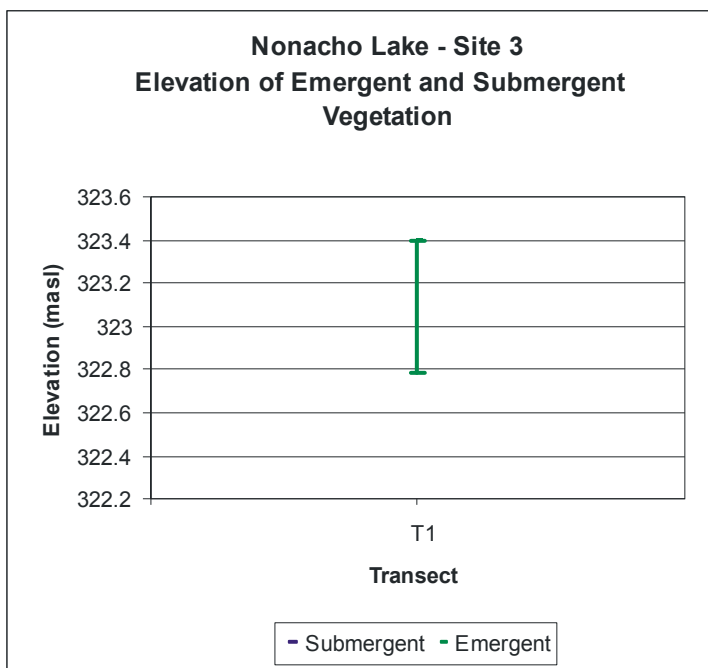
Figure 29. Emergent vegetation elevation range for the transect at Site 3.

The elevation range of the emergent vegetation for the transect, is illustrated in Figure 29.

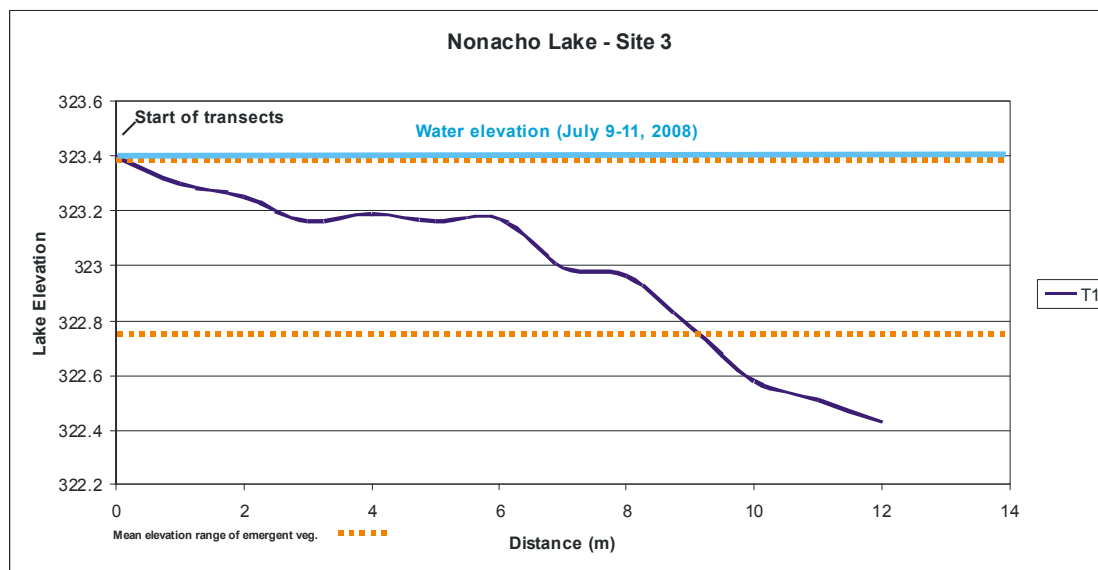
Figure 30. Site 3 transect profile and elevation range of emergent vegetation.

The bathymetric profile of the transect and elevation range of the emergent vegetation is illustrated in Figure 30.

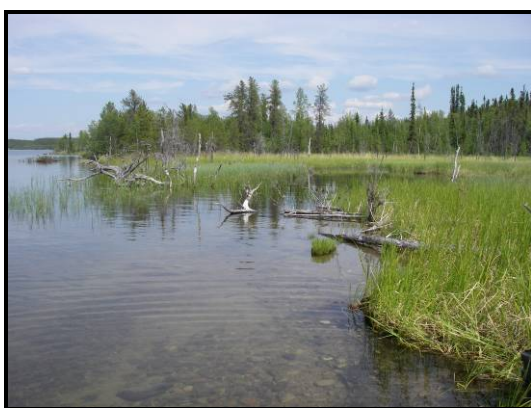
Figure 31. The shoreline of Site 4.

No transects were completed at this site as little emergent vegetation extended out past the sedge platforms and the submergent vegetation was only in the seedling stage. The gravel substrate leading out from the shoreline was covered in dense submergent vegetation seedlings which could be seen out into the water to elevations of 321.4 masl. Figure 31 illustrates the gravel shoreline found at Site 4, while Figure 32 illustrates a juvenile pike captured in the 9 m beach seine along the shoreline.

Site 4 was located near the south end of the northwest arm of the lake. This site was characterized by sand and gravel shoreline and a backwatered bay area containing sedge platforms and a deeper pool area with dense submergent vegetation.

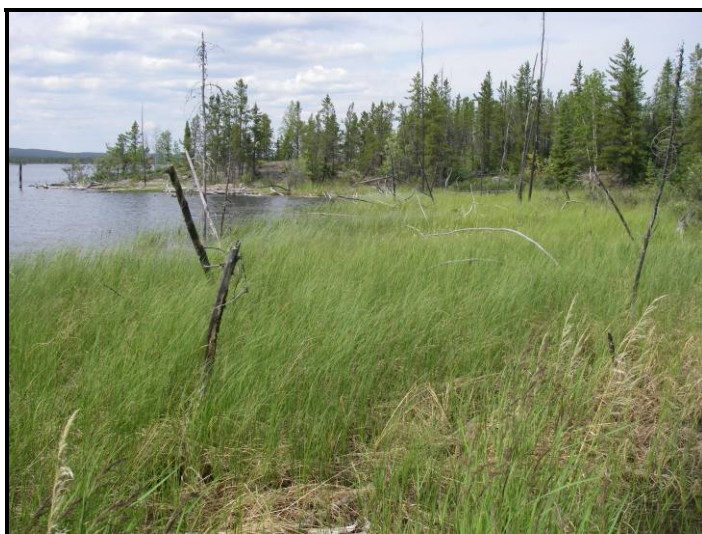
Figure 33. Dense emergent vegetation at Site 5.

Site 5 on Nonacho Lake was located further up the northwest arm of the lake. This site is composed mainly of emergent water sedge and woody debris, on a deep organic substrate. Figure 33 and Figure 34 illustrate the characteristics of Site 5.

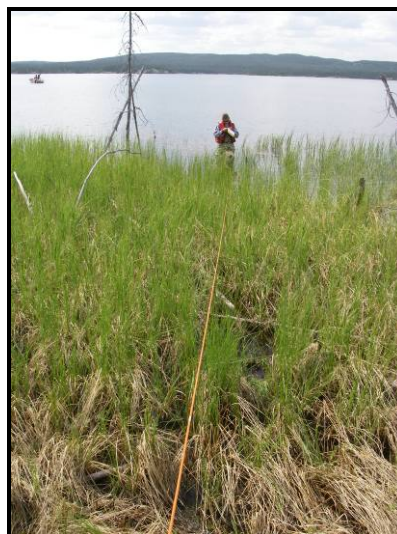
Figure 34. Transect at Site 5.

Three transects were completed at this site, in the emergent and submergent shoreline vegetation. The elevation range of emergent and submergent vegetation for each transect was determined, along with the mean elevation range for Site 5 which is illustrated in Figure 35.

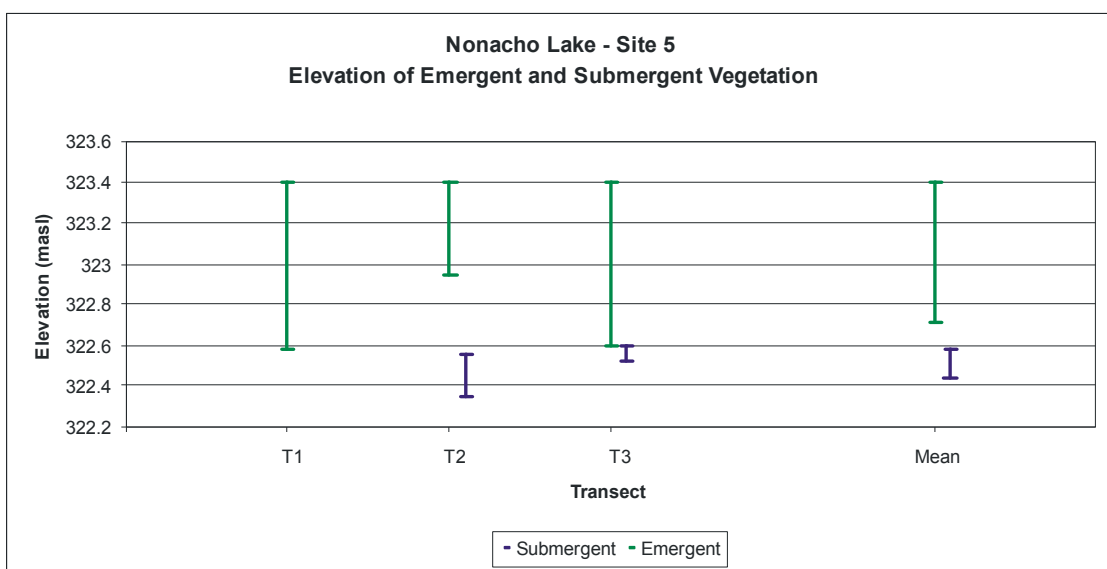
Figure 35. Emergent and submergent elevation ranges for transects at Site 5.

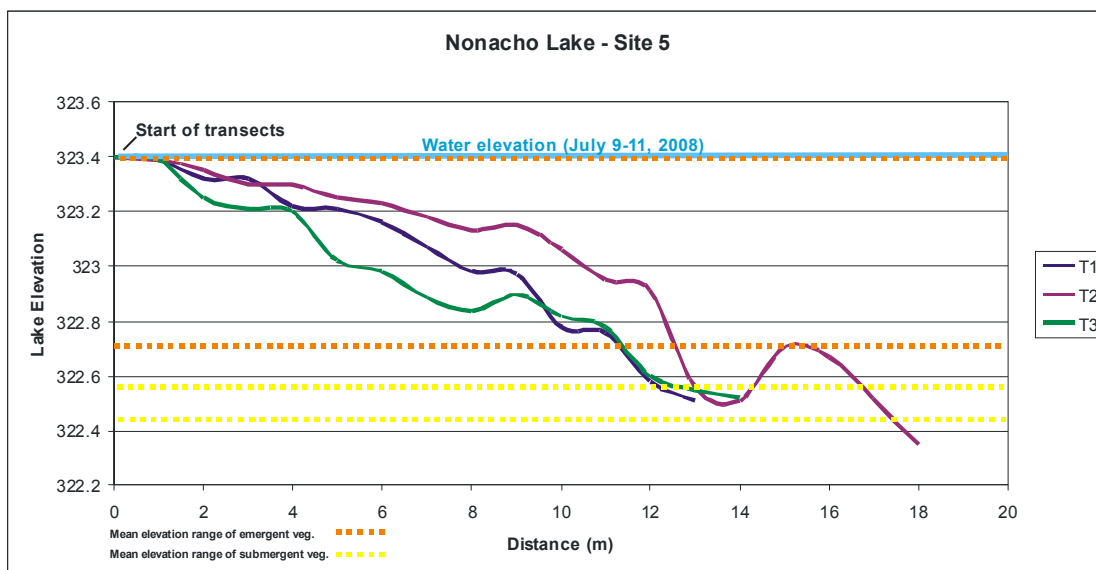
Figure 36. Site 5 transect profiles and mean elevation range for emergent and submergent vegetation.

The bathymetric profile of each transect was also graphed (Figure 36) and the mean elevation range for both emergent and submergent vegetation at Site 5 was noted on the graph.

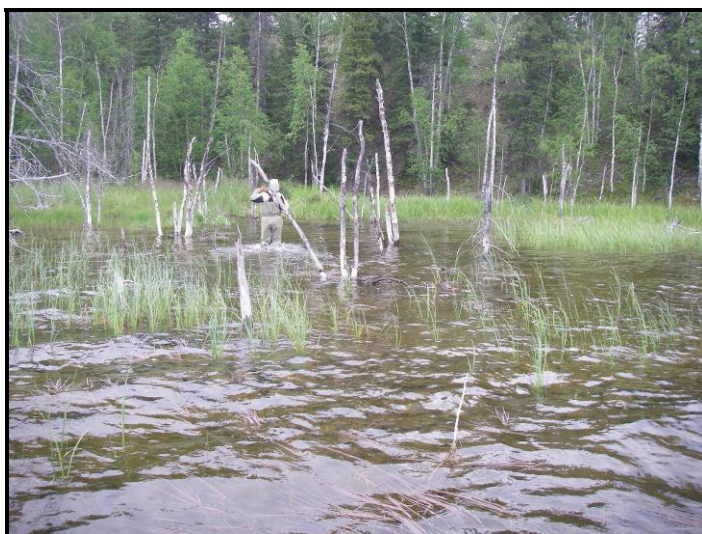
Figure 37. Completing transect at Site 6.

A more variable vegetation community at this site was mainly composed water sedge, marsh cinquefoil, pondweed species and mares tail (Figure 37 and Figure 38).

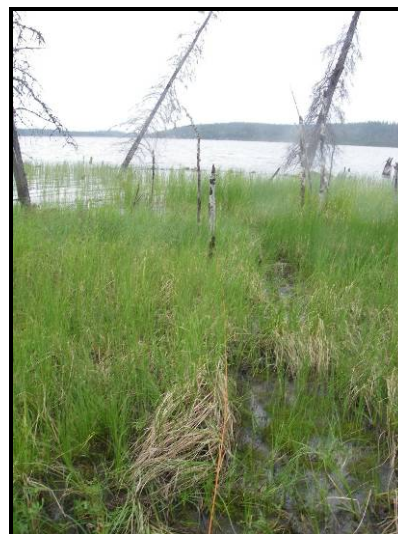
Figure 38. Transect at Site 6.

Three transects were completed at this site to determine the elevation range of the emergent and submergent species.

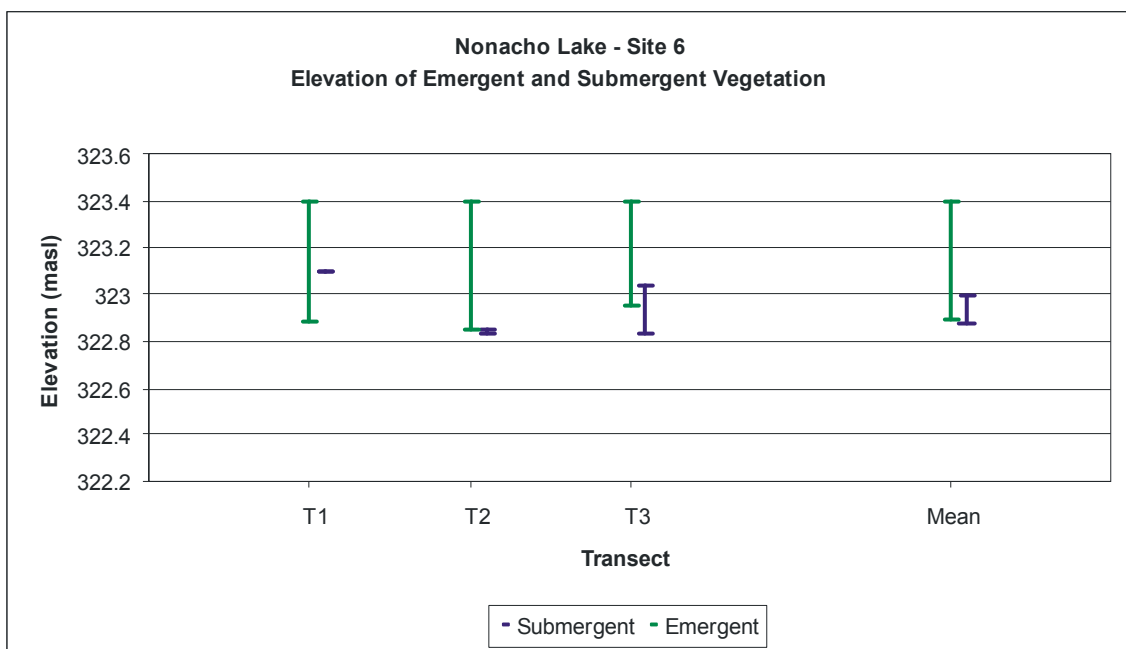
Figure 39. Emergent and submergent elevation ranges for transects at Site 6.

The elevation range of emergent and submergent vegetation for each transect was determined, along with the mean elevation range for Site 6 which is illustrated in Figure 39.

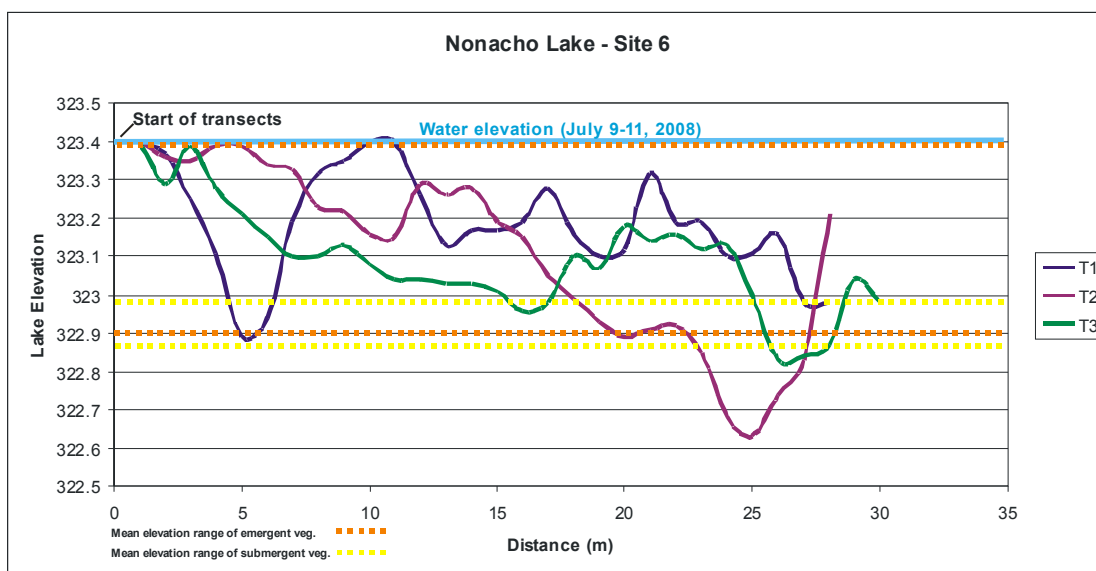
Figure 40. Site 6 transect profiles and elevation ranges of emergent and submergent vegetation.

The bathymetric profile of each transect was also graphed (Figure 40) and the mean elevation range for both emergent and submergent vegetation at Site 6 was noted on the graph.

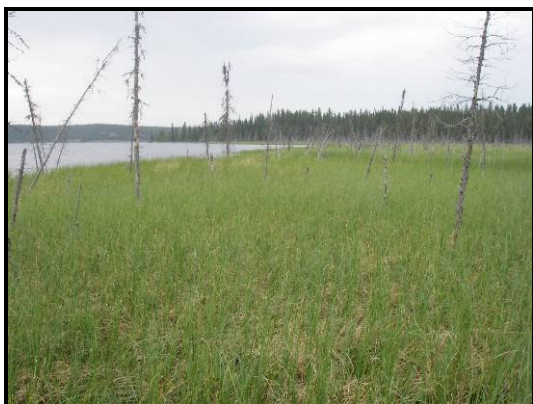
Figure 41. Large sedge platform at Site 7.

Site 7 was located in the north central area of the lake. The area is a large sedge platform which stretches along a shallow shoreline for approximately 300 m (Figure 41).

Fish sampling was completed in the open water adjacent to the sedge platform using angling. One 30 cm pike was captured and is pictured above in Figure 42. The majority of this vegetated area was a sedge platform where only the rooted area was wet. Not enough water was present to allow pike to utilize the majority of this vegetated area.

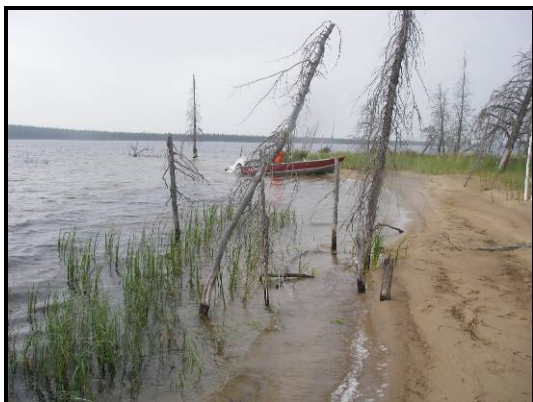
Figure 43. Exposed sandy shoreline.

Site 8 on Nonacho Lake was located in the north central area of the lake on an exposed shoreline (Figure 43). Shallow sand bars extended several hundred metres into the open water adjacent to the emergent sedge along the shore (Figure 44).

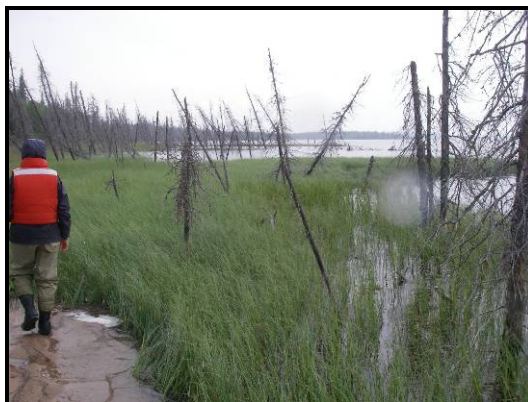
Figure 44. Emergent sedge extends out into the lake on a shallow bench.

Vegetation at this site was mainly composed of water sedge on a fine sandy substrate. No transects were completed at this site, however, depth measurements were taken and the emergent sedge community extended from the water's edge (323.4 masl) out into the lake to an elevation of 322.67 masl.

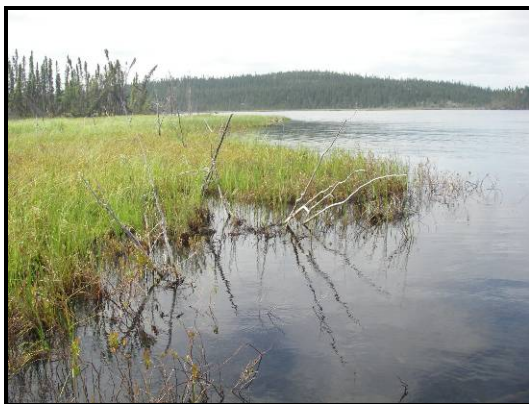
Figure 45. Sedge platform at Site 9.

Site 9 on Nonacho Lake was a very large site encompassing a bay area separated from the main lake by a narrow inlet. This bay area was most likely an independent water body prior to the installation of the Nonacho Dam. The shoreline of this shallow bay was characterized by large flat sedge platforms and floating mats of vegetation and woody plants (Figure 45). Emergent sedge was also found in several areas along the shoreline extending out from the shore at the edge of the sedge platform (Figure 46). The main emergent species found in this area included water sedge, beaked sedge and cattails (*Typha*).

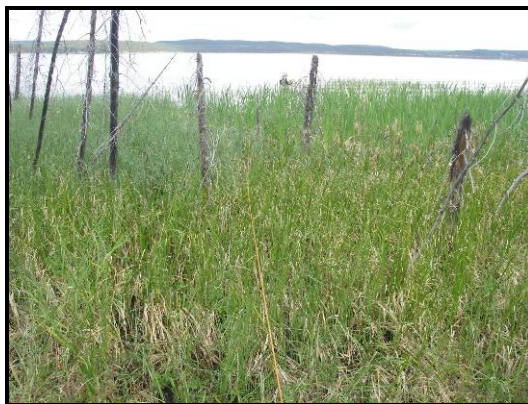
Figure 46. Transect through the emergent vegetation at Site 9.

Two transects were completed in an area where emergent vegetation extended out from the shoreline. The elevation range of emergent and submergent vegetation for each transect was determined, along with the mean elevation range for Site 3 which is illustrated in Figure 47.

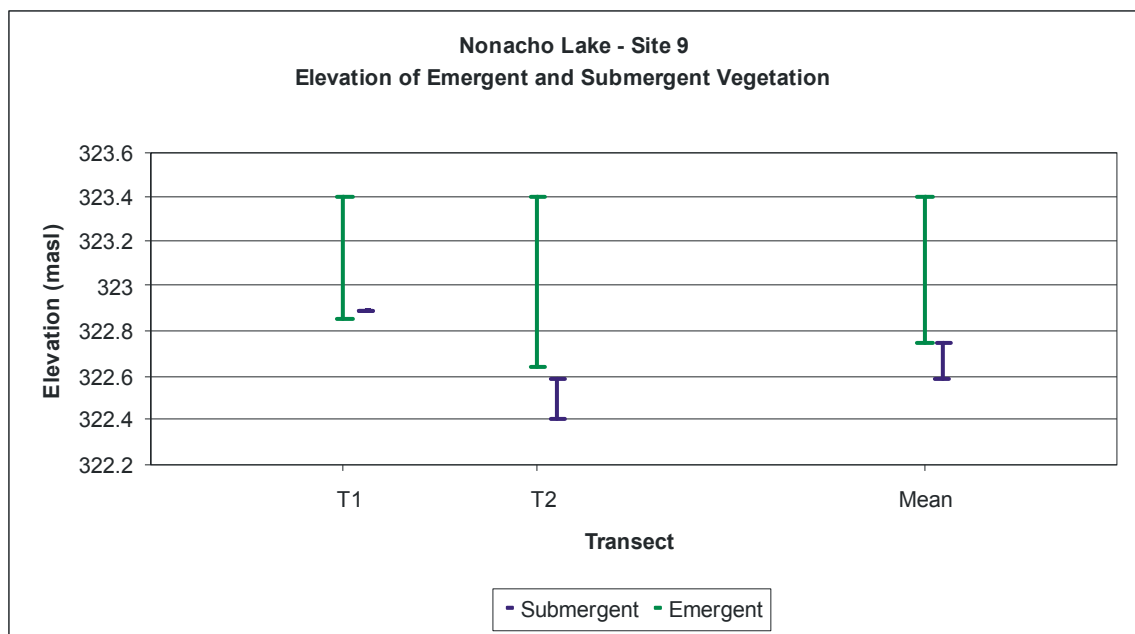
Figure 47. Emergent and submergent elevation ranges for transects at Site 9.

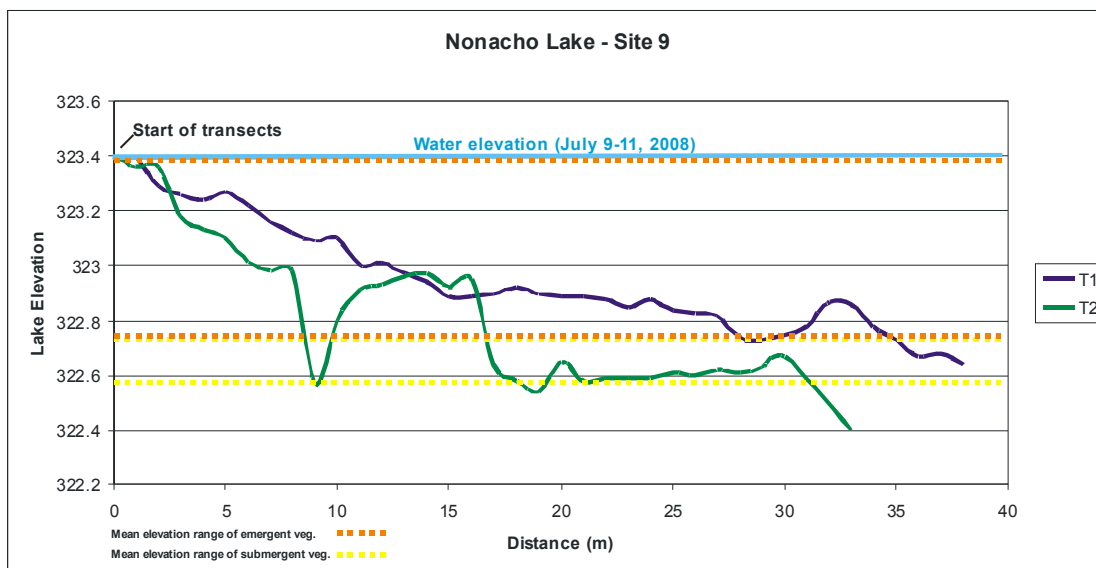
Figure 48. Site 9 transect profiles and elevation range of emergent and submergent vegetation.

The bathymetric profile of each transect was also graphed (Figure 48) and the mean elevation range for both emergent and submergent vegetation at Site 3 was noted on the graph.

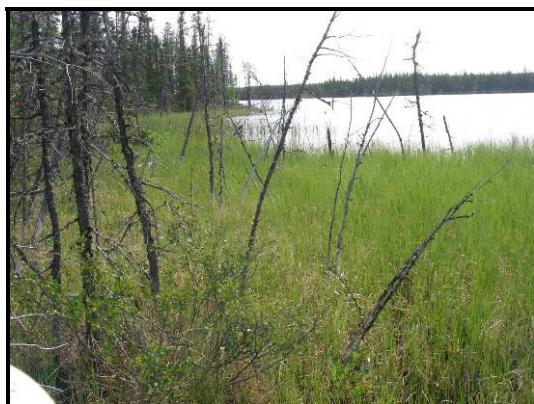
Figure 49. Dead trees and debris extend out into the wetland area.

Site 12 on Nonacho Lake was located in the south west arm of the lake upstream from Tronka Chua Gap. A deep organic substrate and large amounts of woody debris and dead trees were present in this area (Figure 49). Emergent vegetation extended out from the shallow shoreline around a small bay area (Figure 50).
