**Dezé Energy Corporation
Taltson River Hydroelectric Expansion Project**

**July-August 2008 Littoral Habitat Assessment of
Lady Gray Lake, Nonacho Lake and Trudel Creek**

February 2009

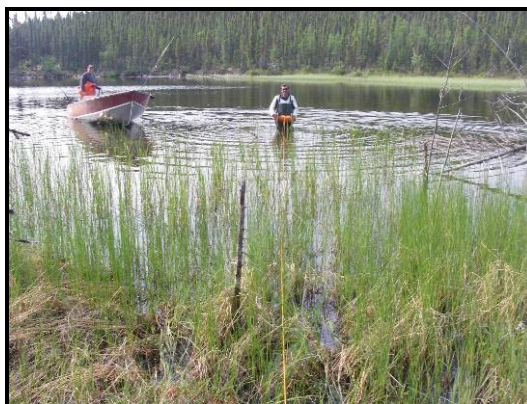
Figure 50. Transect through emergent vegetation.

Site 12 on Nonacho Lake was located in the south west arm of the lake upstream from Tronka Chua Gap. A deep organic substrate and large amounts of woody debris and dead trees were present in this area (Figure 49). Emergent vegetation extended out from the shallow shoreline around a small bay area (Figure 50).

Vegetation at this site was mainly composed of water sedge and marsh cinquefoil. Some submergent pond weed extended out past the extent of the sedge. A total of three transects were completed at this site.

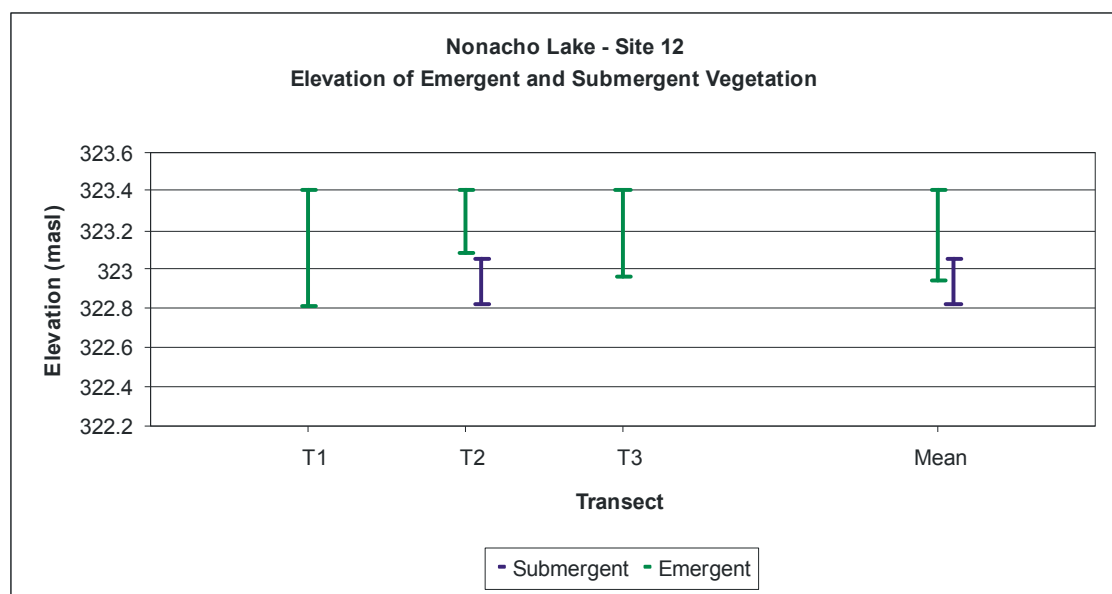
Figure 51. Emergent and submergent elevation ranges for transects at Site 12.

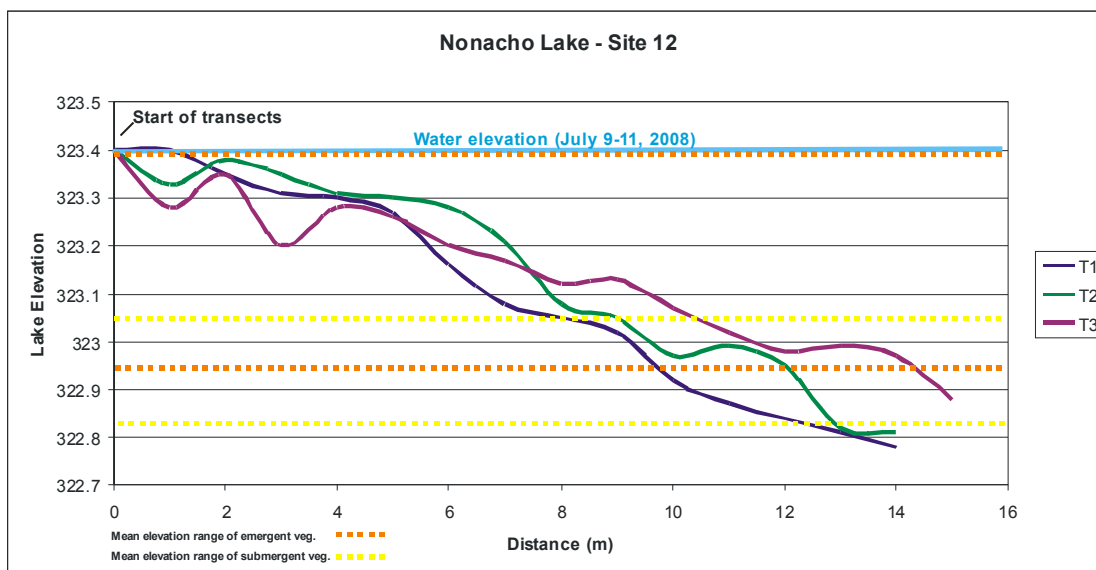
Figure 52. Site 12 transect profiles and mean elevation range of emergent and submergent vegetation.

The bathymetric profile of each transect was also graphed in Figure 52, and the mean elevation range for both emergent and submergent vegetation at Site 3 was noted on the graph.

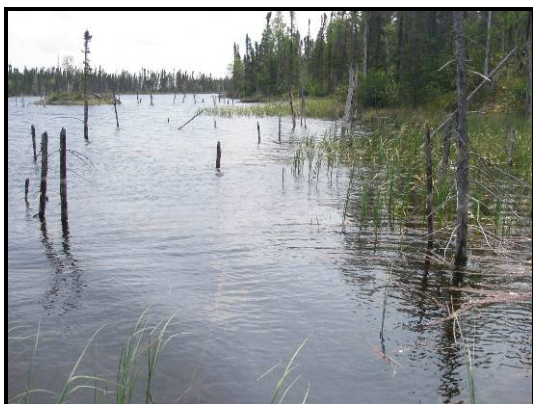
Figure 53. Sheltered bench habitat with submergent vegetation.

A small band of emergent sedge extended out from the shoreline around this bay area. The main species at this site was water sedge. A minimal amount of submergent pondweed was also present, but was not noted on the transect profiles (Figure 53 and Figure 54).

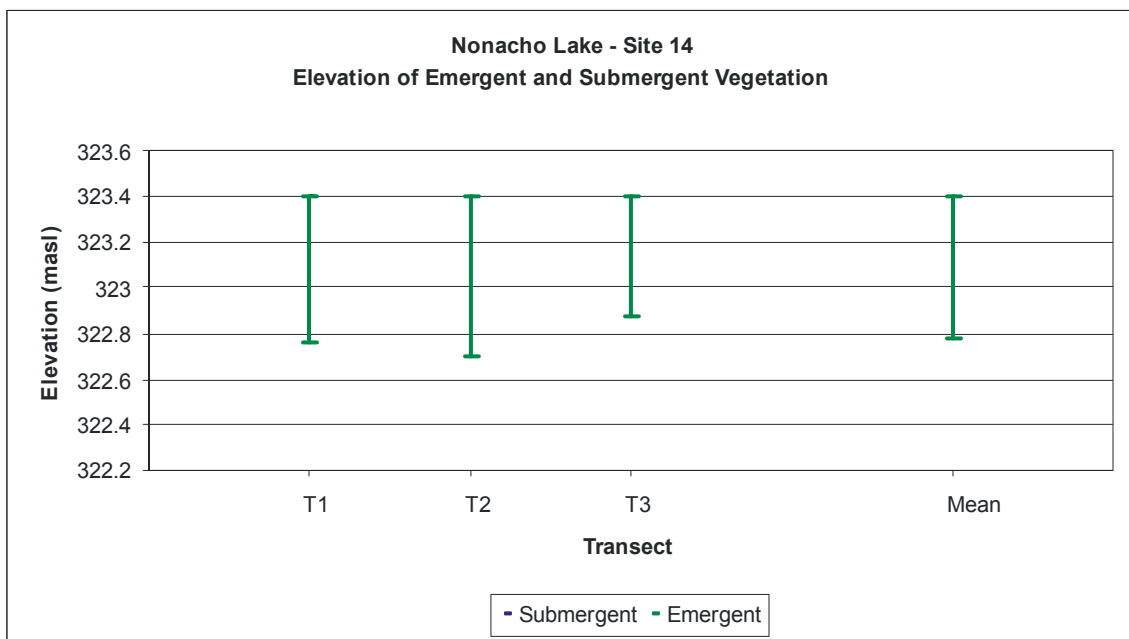
Figure 55. Emergent and submergent elevation ranges for transects at Site 14.

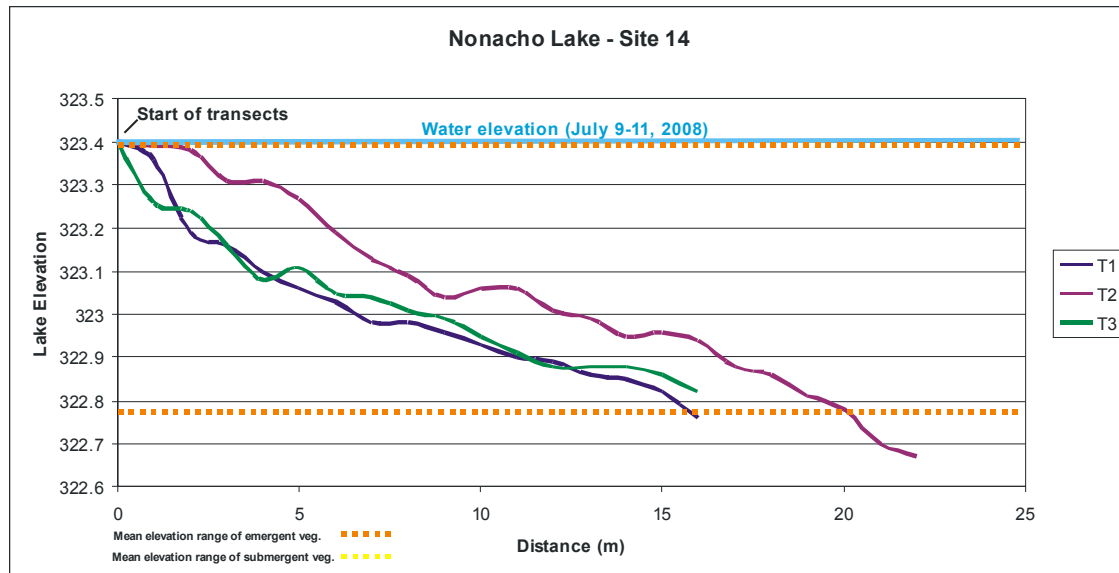
Figure 56. Site 14 transect profiles and mean elevation ranges of emergent and submergent vegetation.

The bathymetric profile of each transect was also graphed and the mean elevation range for both emergent and submergent vegetation at Site 14 was noted in Figure 56.

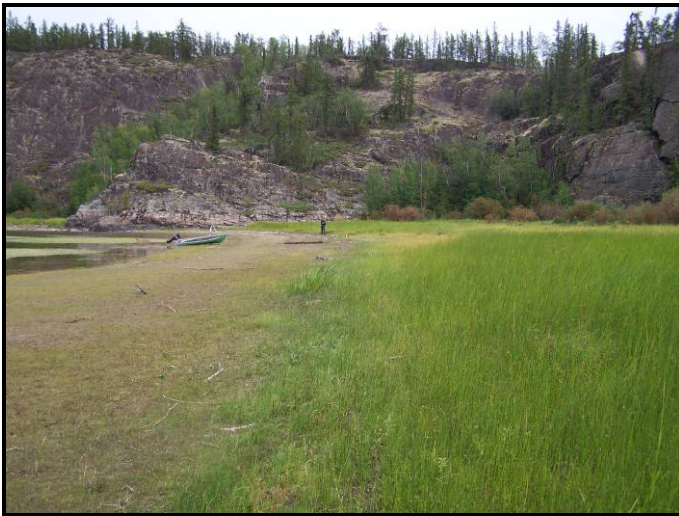
Figure 57. Site 1, at the upstream end of Trudel Lake.

Sites 1 and 2 were both located in Trudel Lake which is in the mid-reach of Trudel Creek. Site 1 is at the upper end of the lake and Site 2 at the lower end of the lake. These sites are both characterized by low gradient shorelines and fine substrates. Site 1 is illustrated in Figure 57 and Figure 58. Site 2 is illustrated in Figure 59 and Figure 60.

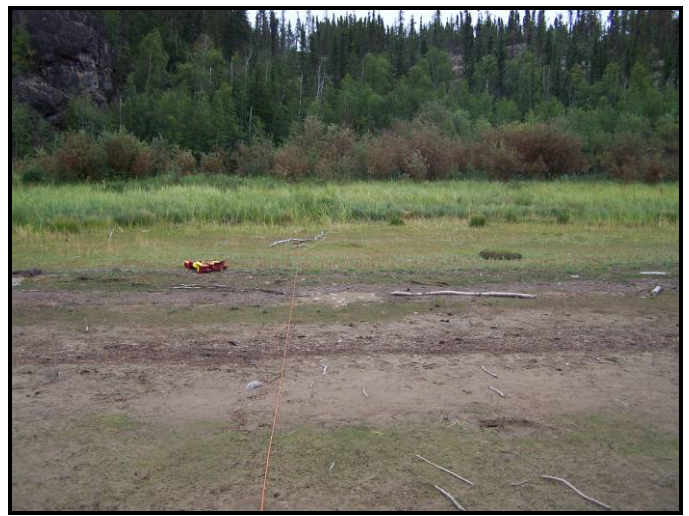
Figure 58. Site 1, transect 2.

At Site 1, a total of 3 transects were completed. One transect was completed at Site 2. The elevation range of emergent and submergent vegetation for each transect was determined,

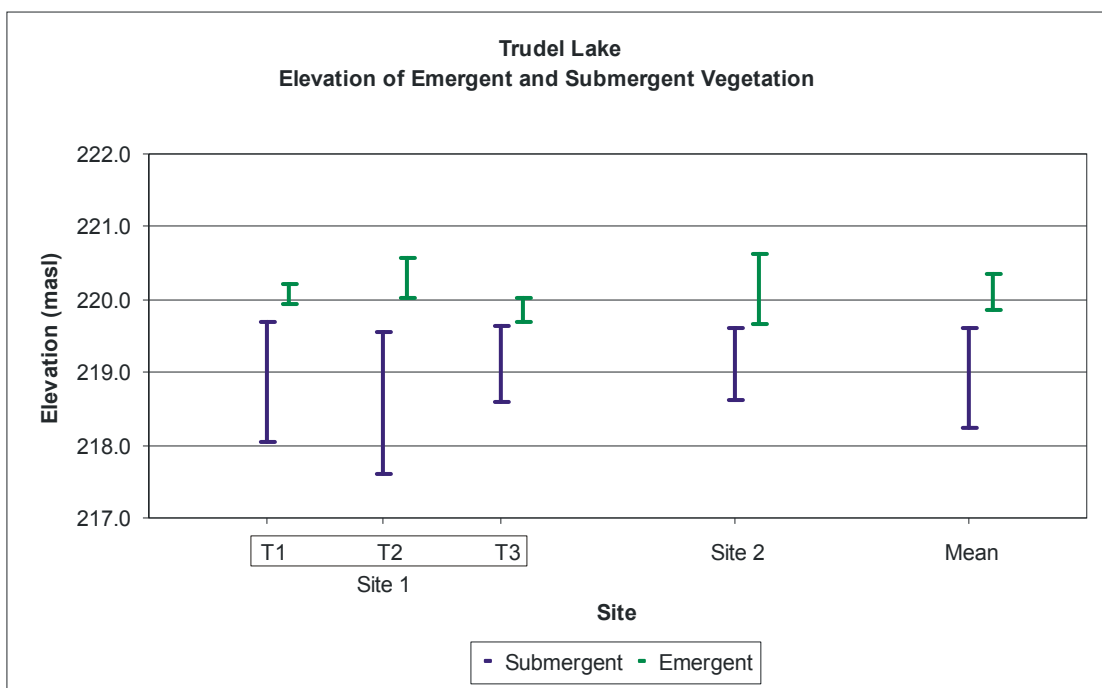
Figure 61. Elevation Ranges of Emergent and Submergent Vegetation at Sites 1 and 2 in Trudel Lake.

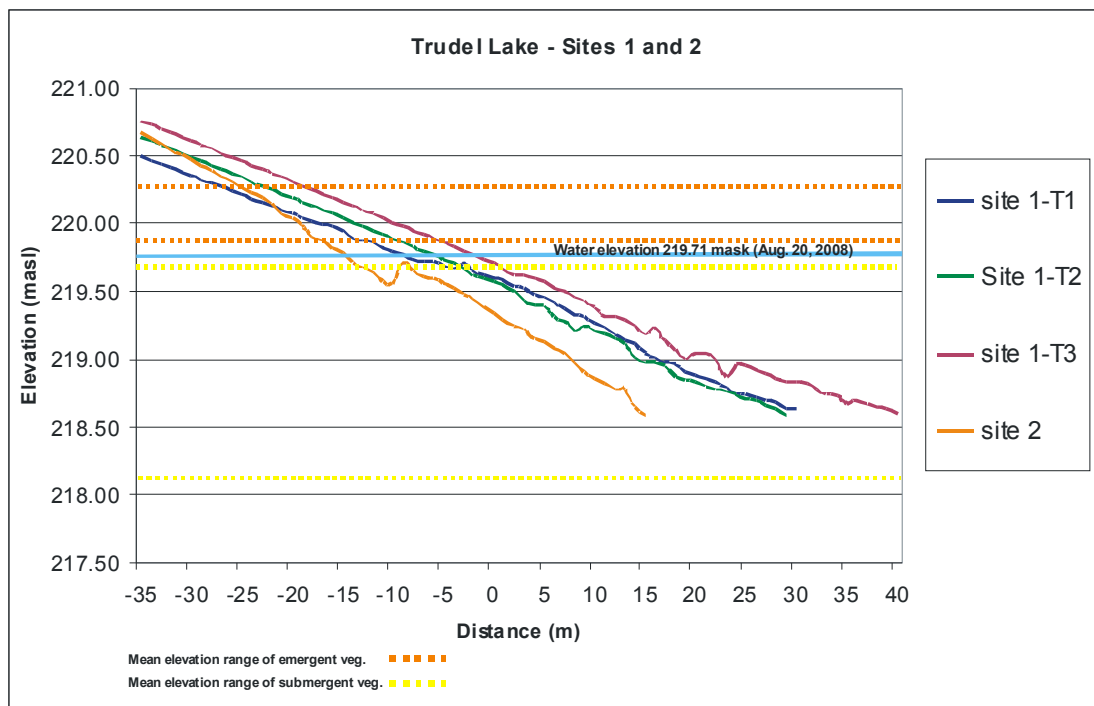
Figure 62. Site 1 and 2 transect profiles and mean elevation ranges of emergent and submergent vegetation.

The bathymetric profiles of each transect at Sites 1 and 2 were also graphed and the mean elevation range for both emergent and submergent vegetation was noted in Figure 62.

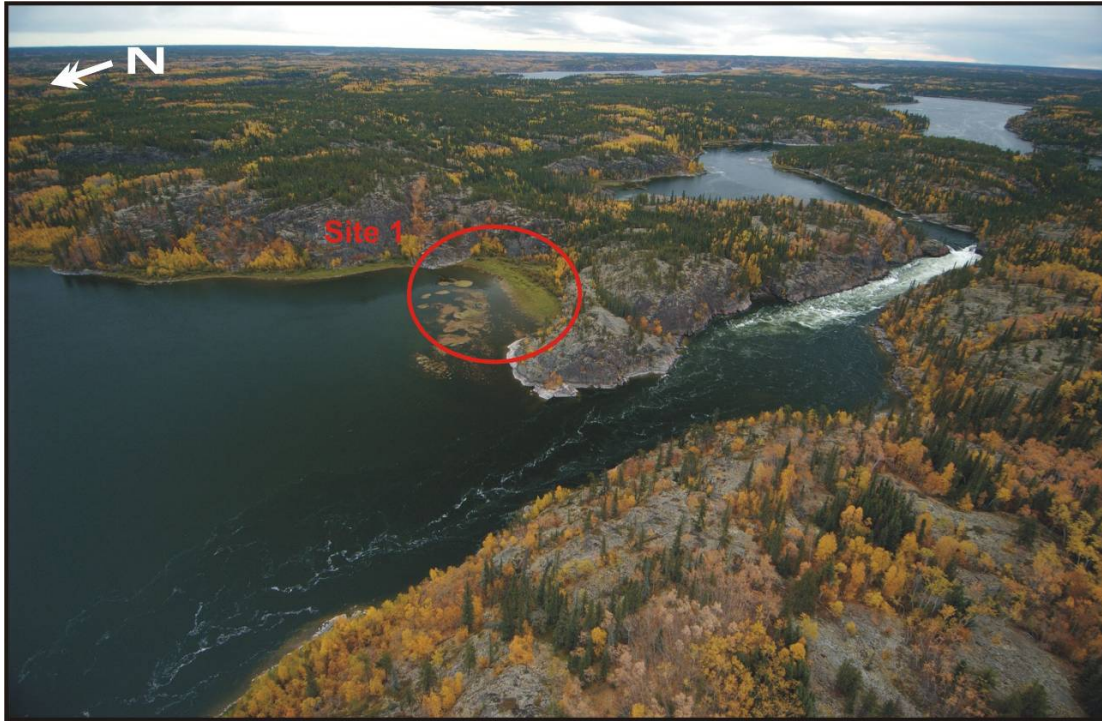
Figure 63. Site 1 – Sheltered bay on south end of Trudel Lake.

Site 1 was located in a shallow bay at the south end of Trudel Lake (Figure 63). Vegetation cover along shore and in shallow water areas extended less than 1.0 m in depth below the waterline elevation at the time of assessment. Vegetation was patchy and consisted primarily of submergent species such as awlwort (*Subularia aquatica*) and narrow-leaved bur-reed (*Sparganium angustifolium*) with trace occurrences of clasping-leaf pondweed (*Potamogeton perfoliatus*).

Clasping- leaf pondweed as well as various-leaved pondweed (*Potamogeton perfoliatus*) were the primary species present at between 1.0 and 3.0 m below the waterline elevation and occurred in relatively dense patches approximately 15 – 30 m from the waters edge. Substrates in this area were dominated by fines with small cobbles scattered throughout.

Emergent species including beaked sedge (*Carex utriculata*), Pacific water parsley (*Oenanthe sarmentosa*), horsetails (*Equisetum* spp.), and various grass species dominated the herbaceous vegetation community in areas that were less frequently inundated.

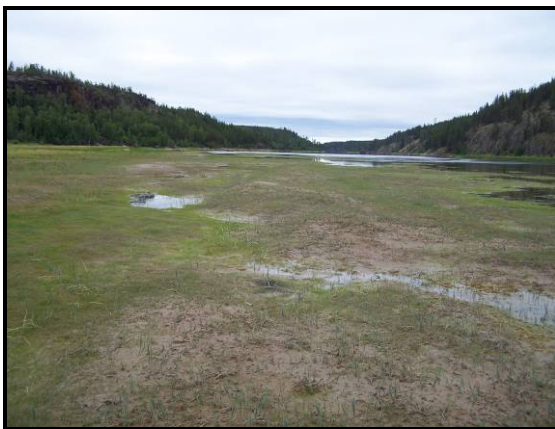
Figure 65. Bench type shoreline at Site 3 on upper Trudel Creek.

Site 3 was located in the upper reach of Trudel Creek, and Sites 4 and 5 were located in Unnamed Lake. Site 3 was located on a bar characterized by a low gradient shoreline and fine substrates. Sites 4 and 5 also had low gradient shorelines leading into the shallow waters of Unnamed Lake. Site 3 is illustrated in Figure 65 and Site 4 in Figure 66.

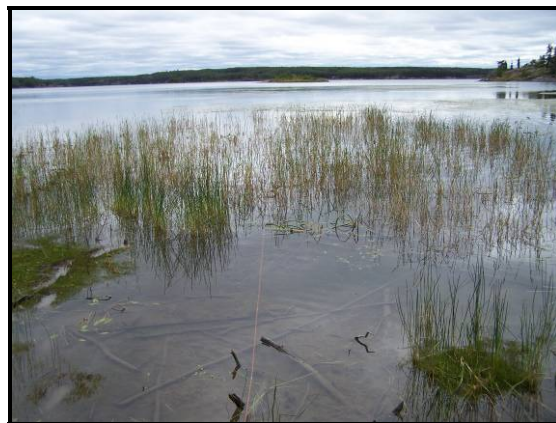
Figure 66. Transect at site 4 on Unnamed Lake.

One transect was completed at each of Sites 3, 4 and 5. The elevation range of emergent and submergent vegetation for each transect was determined, along with the mean elevation range for these three sites. This data is illustrated in Figure 67.

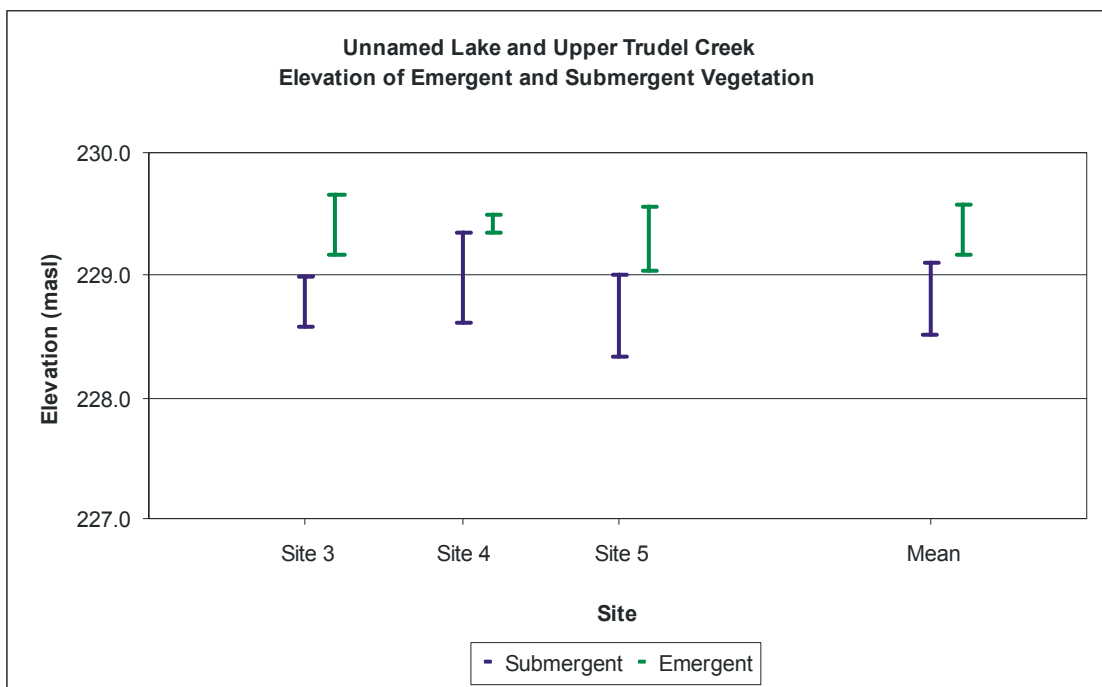
Figure 67. Elevation Ranges of Emergent and Submergent Vegetation at Sites 3, 4 and 5 in Unnamed Lake and Upper Trudel Creek.

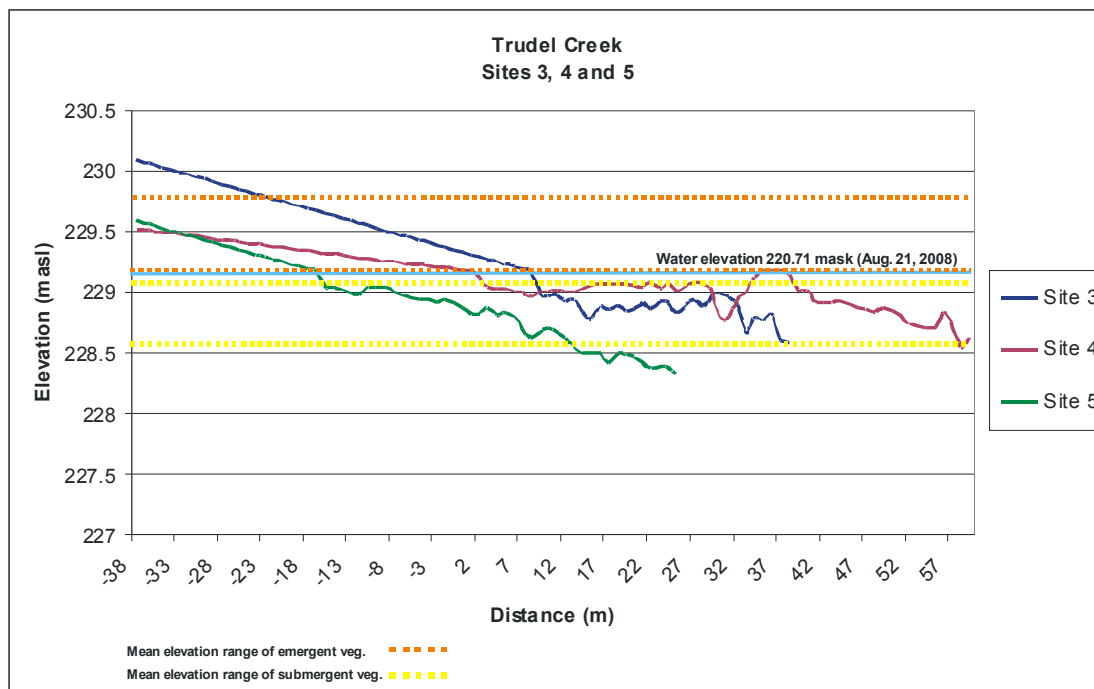
Figure 68. Site 3, 4 and 5 transect profiles and mean elevation ranges of emergent and submergent vegetation.

The bathymetric profile of each transect at Site 3, 4 and 5 were also graphed and the mean elevation range for both emergent and submergent vegetation was noted in Figure 68.

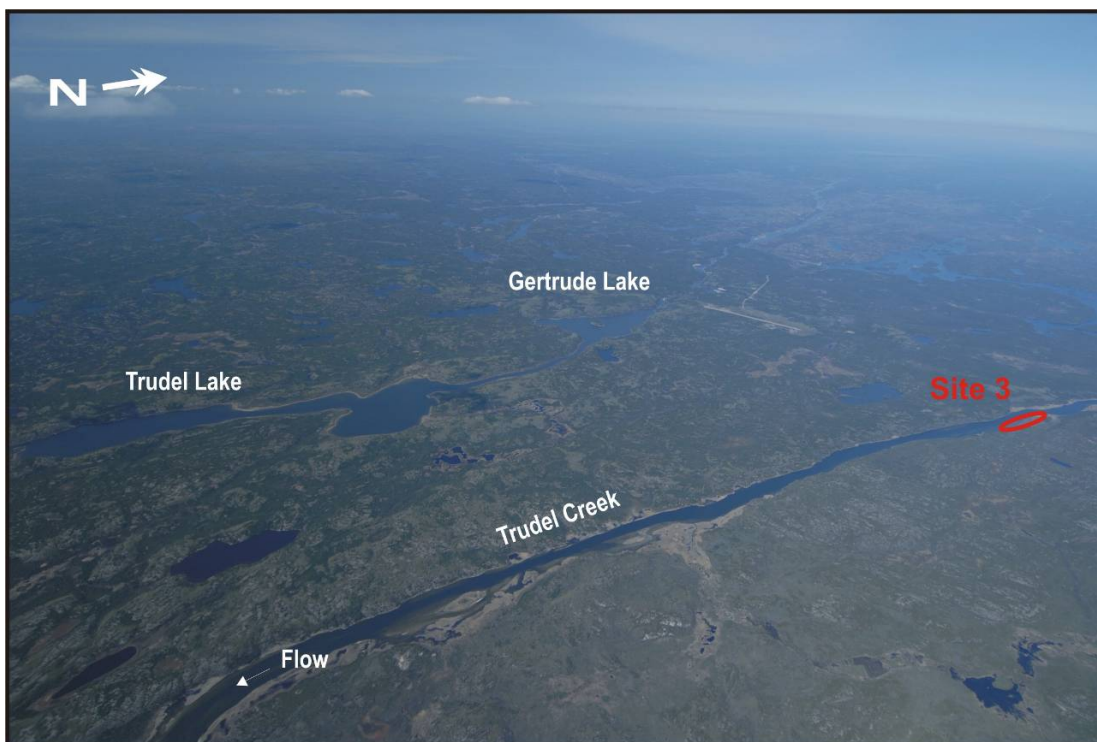
Figure 69. Site 3 – Sediment bench downstream of South Valley Spillway.

Site 3 was located on a relatively shallow sediment bench in upper Trudel Creek (Figure 69), just downstream the South Valley Spillway. Vegetation growth ended abruptly at the end of the sediment bar. Vegetation cover in shallow water areas was fairly uniform. Dominant species included awlwort (*Subularia aquatica*), large leaved white water-crowfoot (*Ranunculus aquatilis*), common Mare's tail (*Hippuris vulgaris*), narrow-leaved bur-reed (*Sparganium angustifolium*), milfoil species (*Myriophyllum* spp.), rushes (*Juncus* spp.), horsetails (*Equisetum* spp.), arum-leaved arrowhead (*Sagittaria cuneata*), water-starwort sp. (*Callitriche* sp.) and pondweeds (*Potamogeton* spp.). Substrates in this area were dominated by fines with small cobbles scattered throughout.

Inland areas that appeared to be less frequently inundated supported the typical sedge/grass community observed at Sites 1 and 2. Primary species included beaked sedge (*Carex utriculata*), grasses and horsetails (*Equisetum* spp.). Pacific water parsley (*Oenanthe sarmentosa*) was present as a minor component.
