INAC BAKER CREEK REMEDIATION PROJECT

INDEX MAP OF REACHES 1 - 6

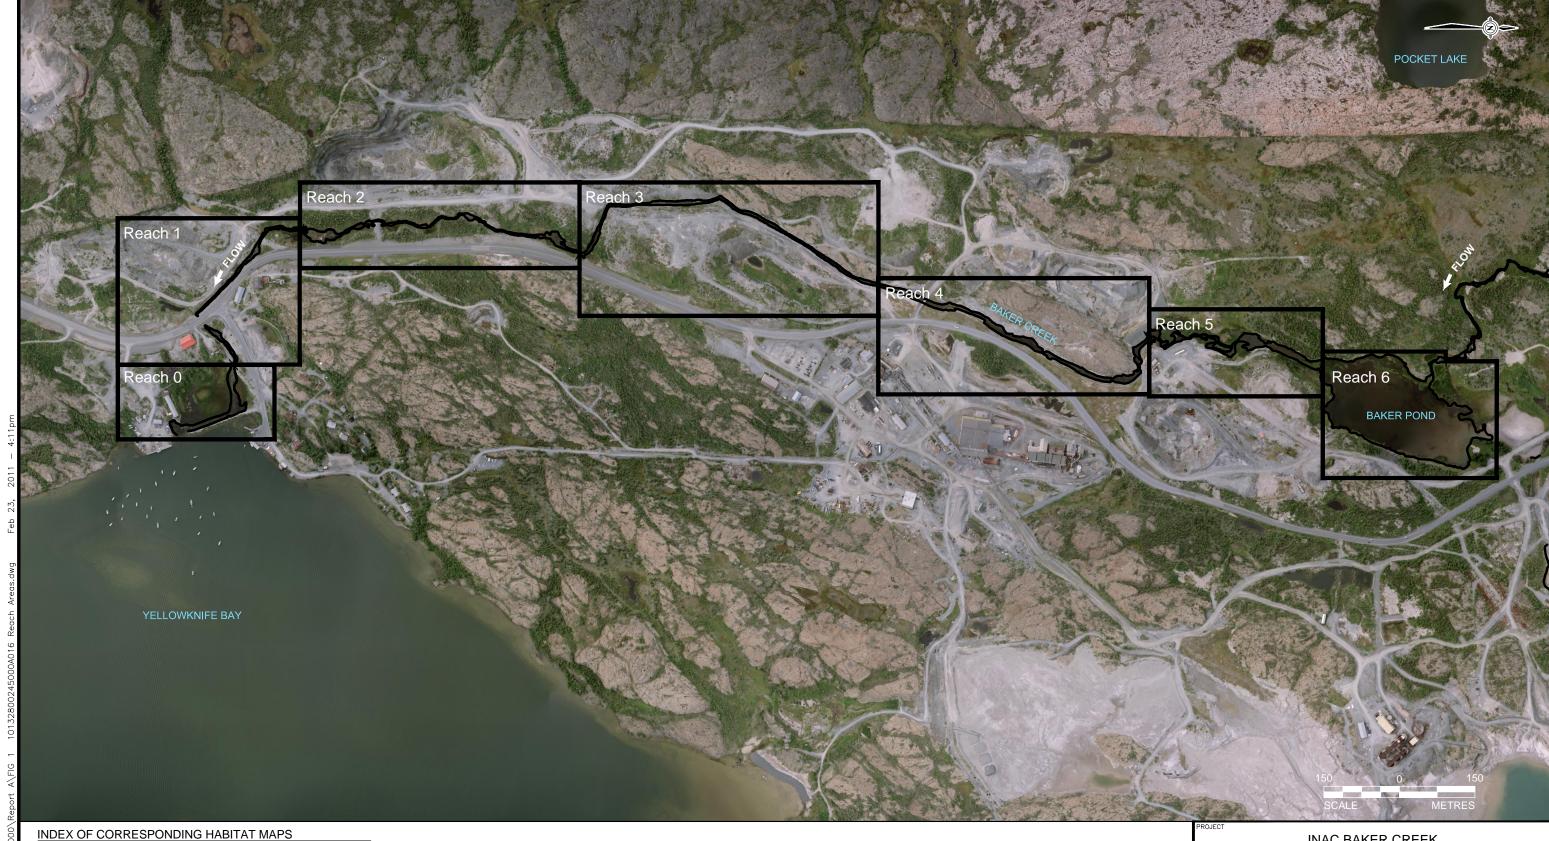
lo.10132800245000A016	FILE	3.0024.5000	Г 10.1328	ROJECT
AS SHOWN REV. 0	SCA	29/10/10	НМ	ESIGN
		23/02/11	DLM	CADD
IGURE: 1		23/02/11	PV	HECK
	1	07/00/44	11114	7.0EW

REACH 0 - FIGURE 2

REACH 1 - FIGURE 3 AND FIGURE 4 REACH 2 - FIGURE 5 AND FIGURE 6

REACH 3 - FIGURE 7, FIGURE 8 AND FIGURE 9

REACH 4 - FIGURE 10 AND FIGURE 11

REACH 5 - FIGURE 12 AND FIGURE 13 REACH 6 - FIGURE 14, FIGURE 15 AND FIGURE 16

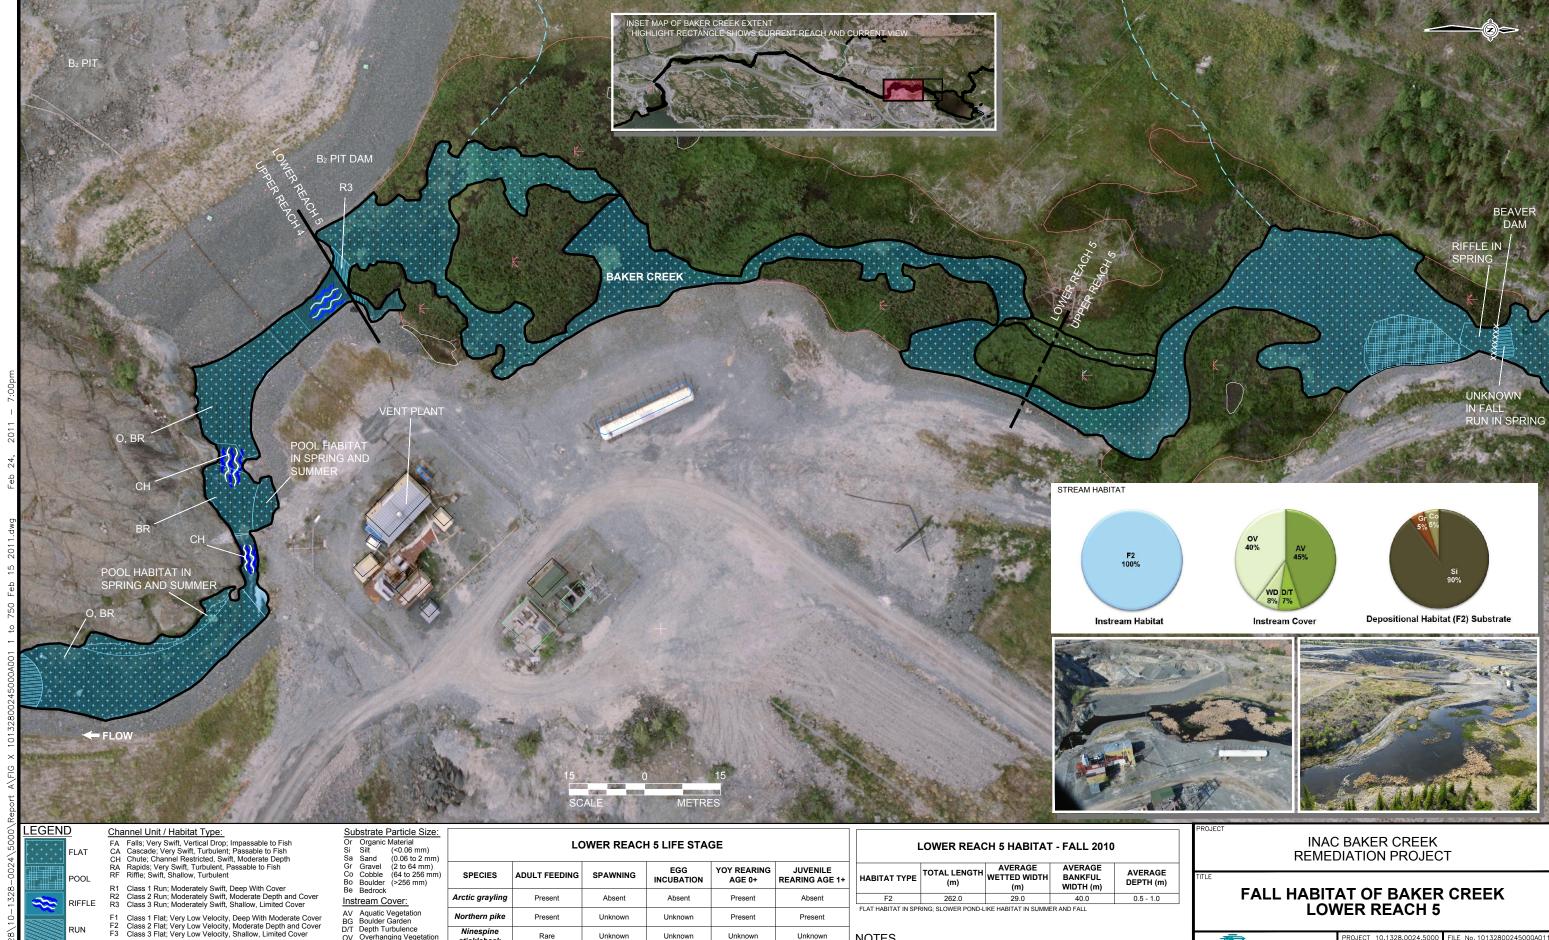
PROJECT 10.1328.0024.5000 FILE No. 10132800245000A0 HM 28/10/1 SCALE AS SHOWN REV. DLM 23/02/ FIGURE: 12

P1 Class 1 Scour Pool; Slow, Deep

Channel Form:

AV Aquatic Vegetation
BG Boulder Garden
D/T Depth Turbulence
OV Overhanging Vegetation
UC Undercut Bank

stickleback FISH INFORMATION BASED ON HISTORICAL DATA AND REVIEW OF 2010 FIELD SURVEYS

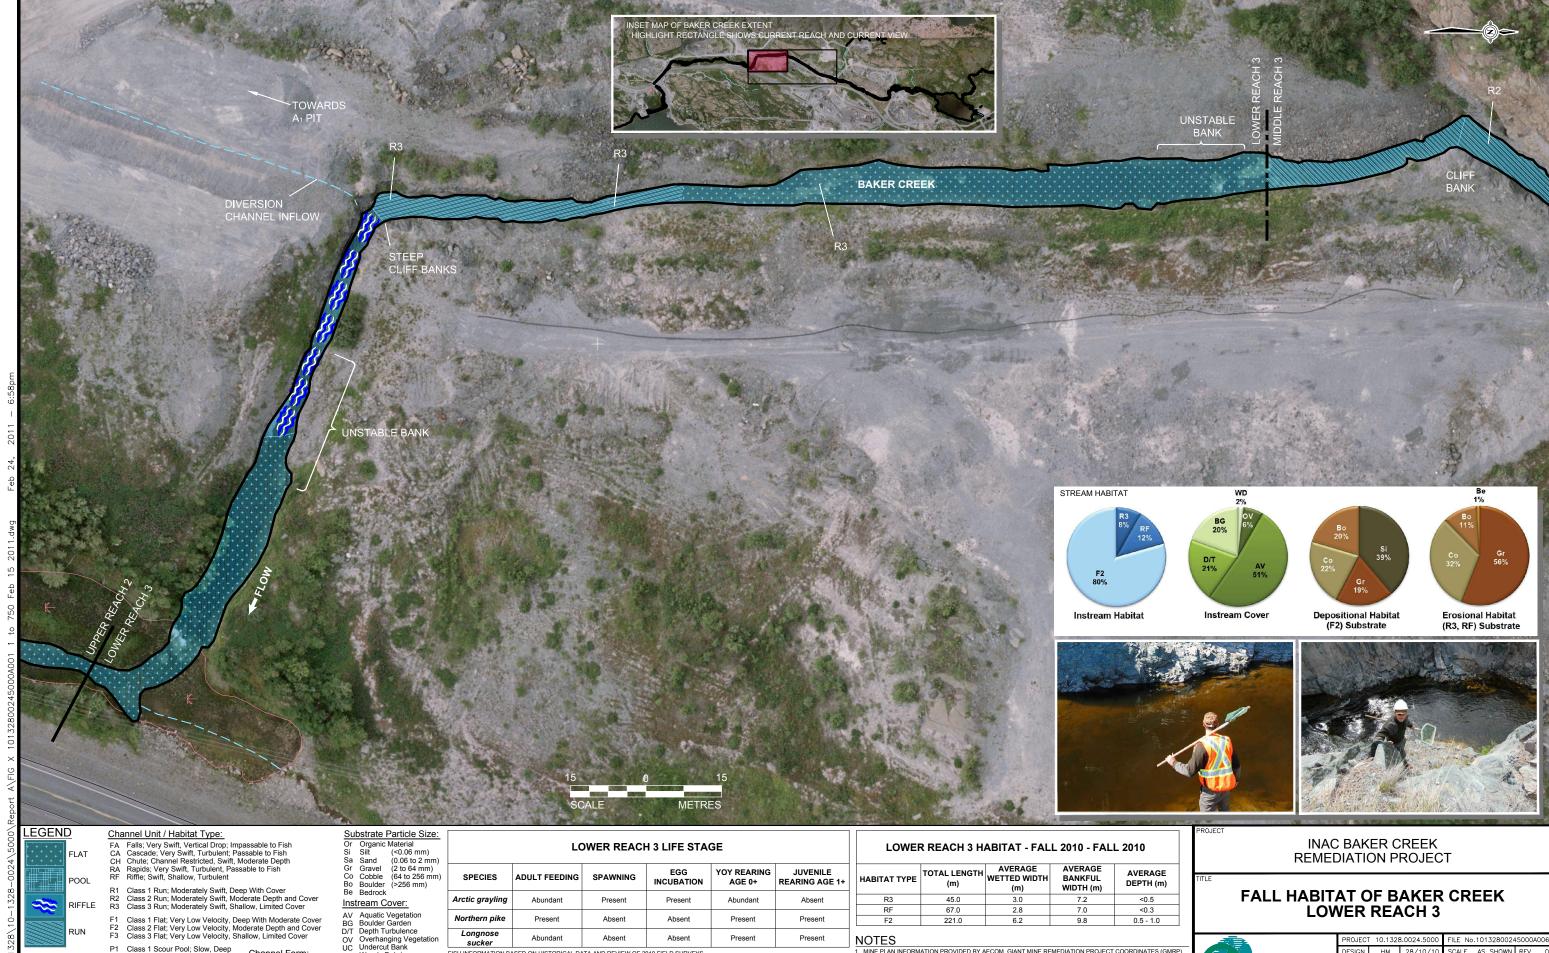
ROJEC	JECT 10.1328.0024.5000		FILE No	.101	3280024	15000/
ESIGN	НМ	28/10/10	SCALE	AS	SHOWN	REV.
CADD	DLM	23/02/11				
HECK			l FI	G١	URE	: 7
				_

P1 Class 1 Scour Pool; Slow, Deep

Channel Form:

BR Broad Channel Form IN Incised Channel Form O Open Channel Form

FISH INFORMATION BASED ON HISTORICAL DATA AND REVIEW OF 2010 FIELD SURVEYS

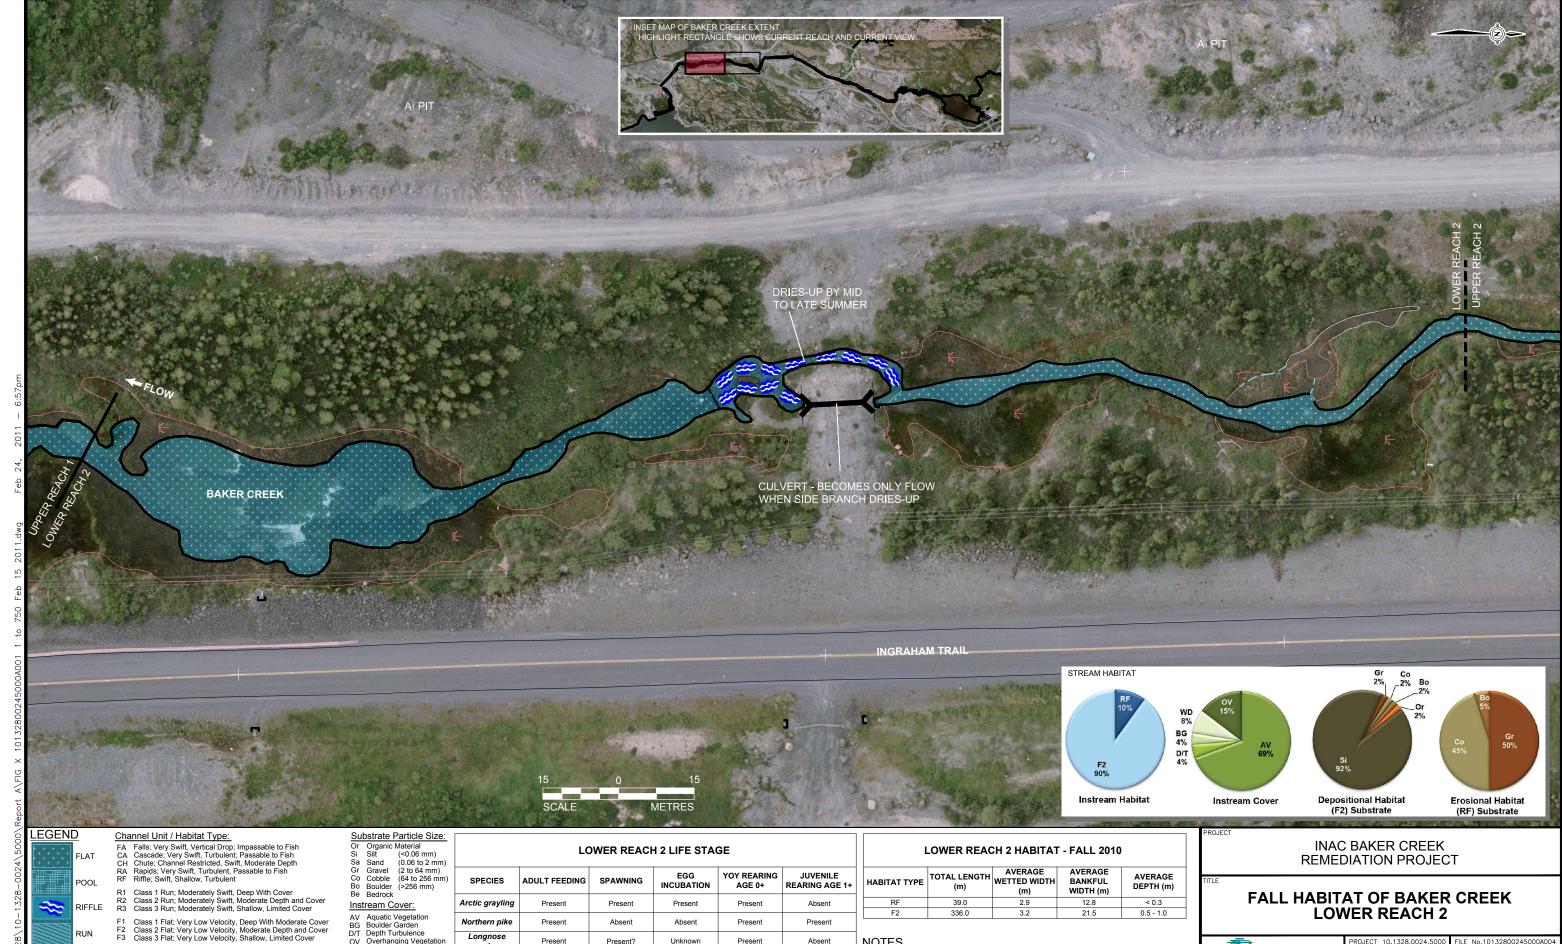
CHECK	FIGURE: 5
CADD DLM 23/02/11	
DESIGN HM 28/10/10 SC	CALE AS SHOWN REV. (
PROJECT 10.1328.0024.5000 FIL	E No.10132800245000A00

P1 Class 1 Scour Pool; Slow, Deep

Channel Form: BR Broad Channel Form
IN Incised Channel Form
O Open Channel Form

AV Aquatic Vegetation
BG Boulder Garden
D/T Depth Turbulence
OV Overhanging Vegetation
UC Undercut Bank

SPECIES	ADULT FEEDING	SPAWNING	EGG INCUBATION	YOY REARING AGE 0+	JUVENILE REARING AGE 1+
Arctic grayling	Present	Present	Present	Present	Absent
Northern pike	Present	Absent	Absent	Present	Present
Longnose sucker	Present	Present?	Unknown	Present	Absent

FISH INFORMATION BASED ON HISTORICAL DATA AND REVIEW OF 2010 FIELD SURVEYS

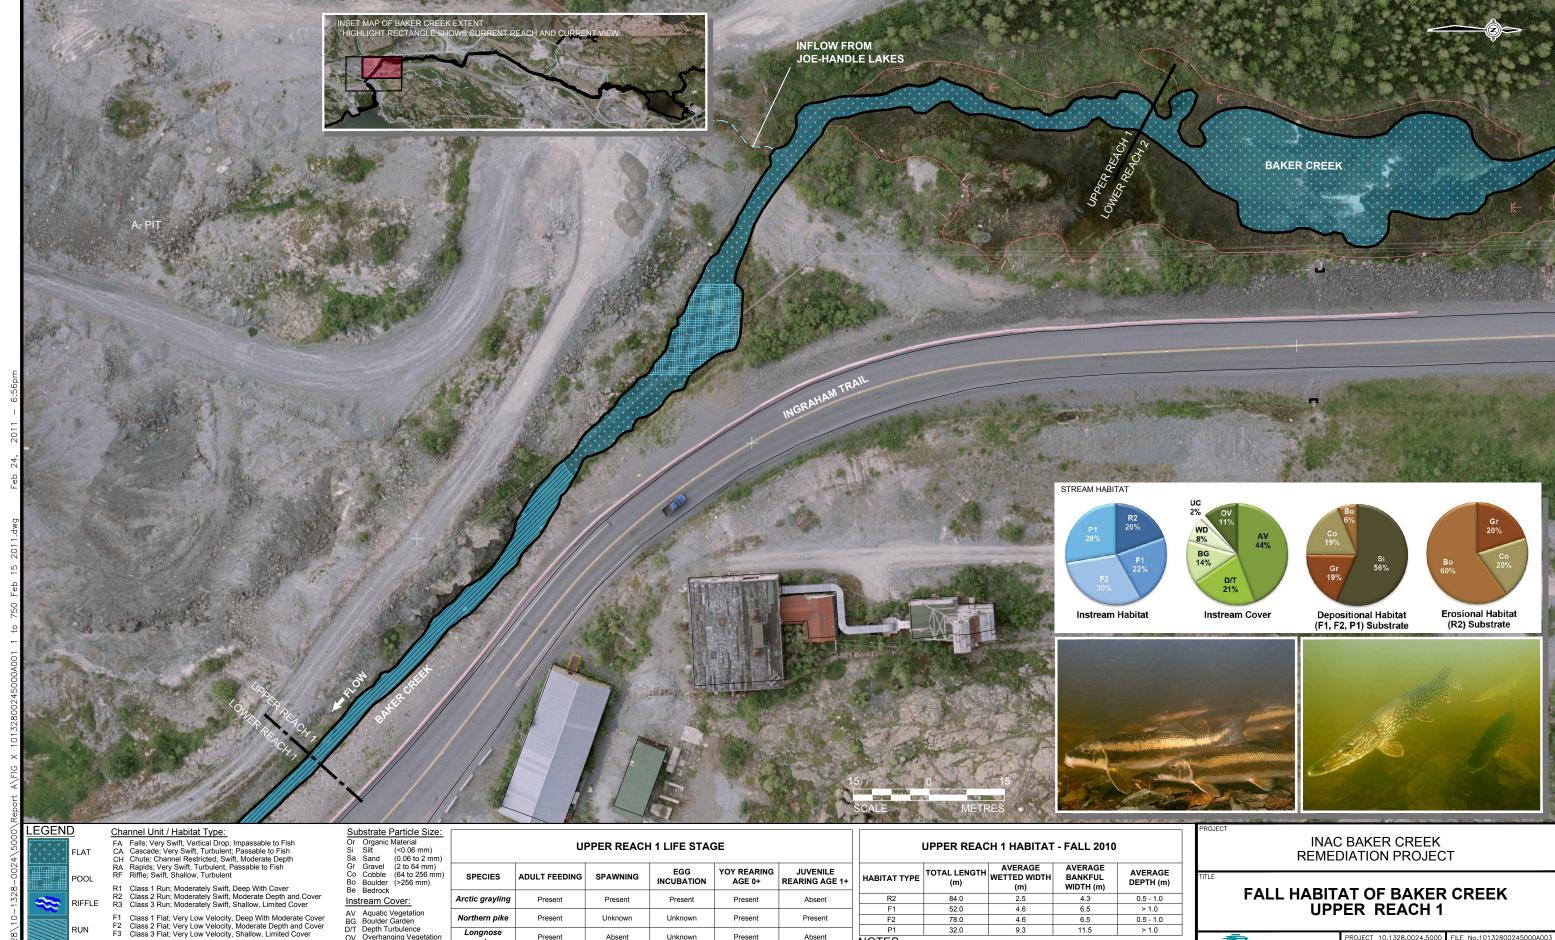
PROJECT 10.1328.0024.5000			FILE No.10132800245000A003
DESIGN	НМ	28/10/10	SCALE AS SHOWN REV. C
CADD	DLM	23/02/11	
CHECK			FIGURE: 4

P1 Class 1 Scour Pool; Slow, Deep

Channel Form: BR Broad Channel Form IN Incised Channel Form O Open Channel Form

AV Aquatic Vegetation
BG Boulder Garden
D/T Depth Turbulence
OV Overhanging Vegetation
UC Undercut Bank

Present Absent Unknown Absent sucker Slimy sculpin Present? Unknown Unknown

FISH INFORMATION BASED ON HISTORICAL DATA AND REVIEW OF 2010 FIELD SURVEYS
