**AN EXAMINATION OF ARSENIC
CONTAMINATION IN THE ROASTER
AND GAS HANDLING COMPLEX
AT THE GIANT MILL**

February, 2003

Northwest Consulting Limited conducted a study of arsenic contamination in the roaster and gas-handling complex of the Giant mill during the third quarter of 2002. The study is intended to provide information necessary for the evaluation of cleanup requirements prior to demolition of the plant.

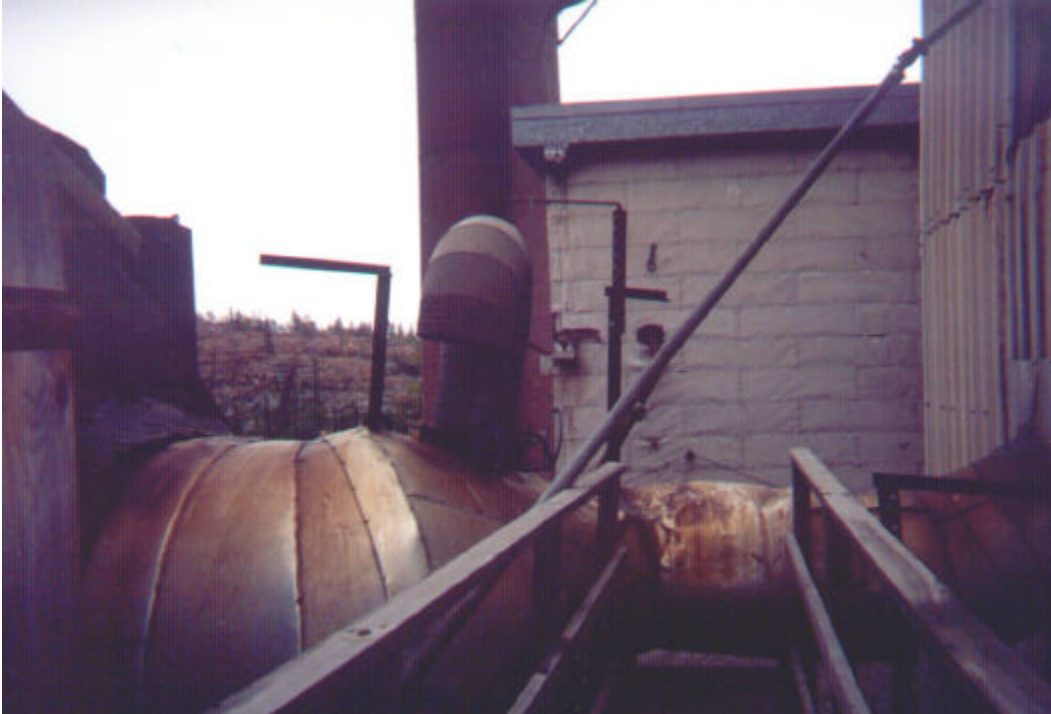
Photo #1: Transition section between roaster and Cottrell. Note change of diameter where the more recent flue replaced a section of much larger diameter old flue.

The roaster flues are relatively clean on the inside, but high temperature warping has caused the bolted flanges to leak in several places, resulting in heavy encrustations of arsenic crystals on the exterior. The insulation on these flues is in poor condition and is thoroughly contaminated. The insulation should be carefully removed and placed into drums, and, if possible, the flues should be dismantled by removing the bolts in the flanges. However, it is possible that a cutting torch will be required, and appropriate

safety precautions will be necessary. This applies to all flues and cyclones in the area above the roasters.

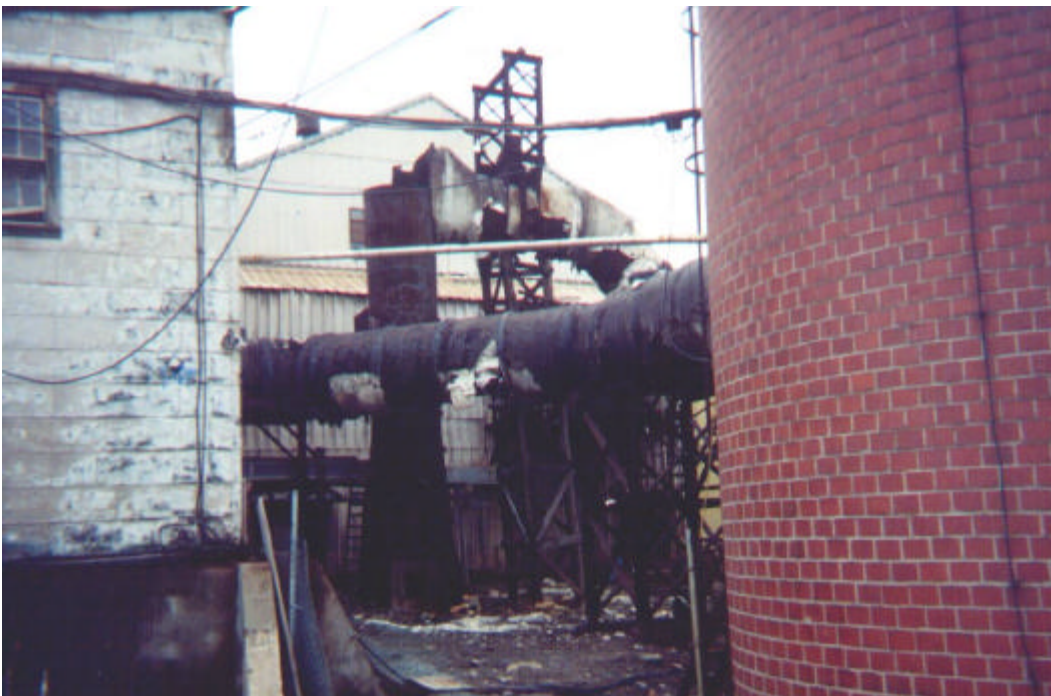
Photo #2: This view shows the base of the brick stack, the 40' high column, and the flue connecting the (no longer existing) AC roaster and the base of the stack.

The stack has an inside diameter of 9 feet and is 150 feet high. There is an accumulation of damp arsenic dust in the base of the stack measuring about 9 feet high. This can be accessed from above by climbing onto the ducting between the stack fan and the stack, and entering through the open arch. The cleanout access is at ground level and is covered with a hinged door. Cleanout of the entire accumulation from the lower hatch would be very slow and difficult and it is recommended that most of the job be accomplished from above. It is possible that a heavy duty industrial vacuum system can recover the dust. Another, less desirable alternative, is to shovel the dust into drums and hoist them out using a mobile crane, electric hoist, etc.

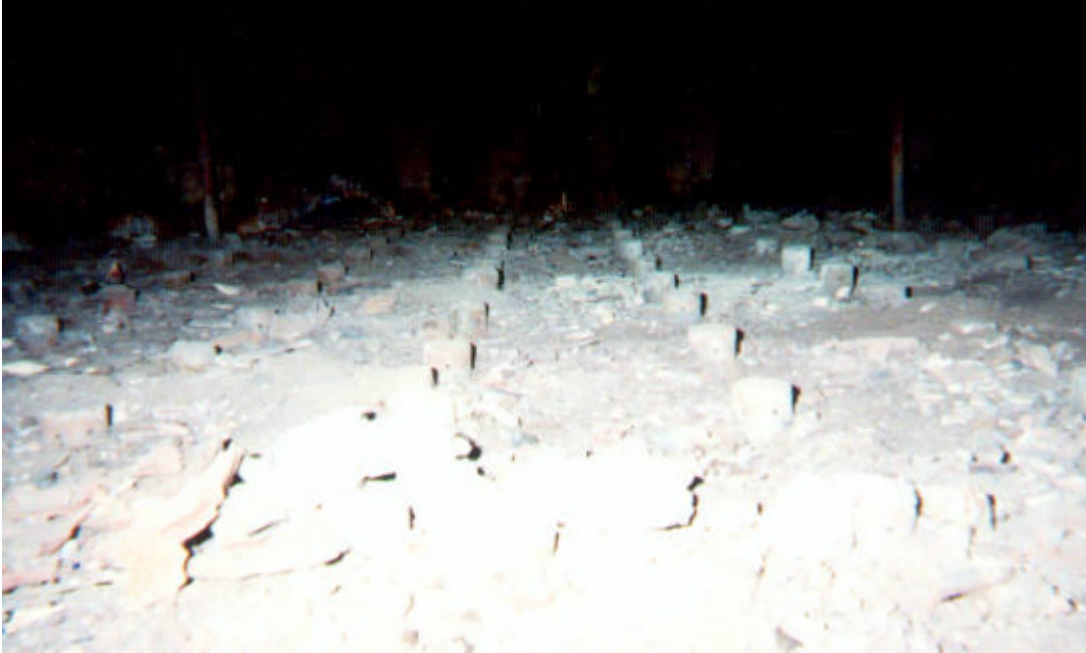
Photo #3: Tuyeres in #2 roaster vessel

The roaster vessels have some buildup on the interior walls that should be removed prior to unbricking. This can be done using scaffolds and scaling hammers. The insulation on the exterior of the roasters likely contains asbestos. The insulation has been encapsulated, but removal may pose some breathing hazards. This is true of the wall insulation in the roaster building as well.

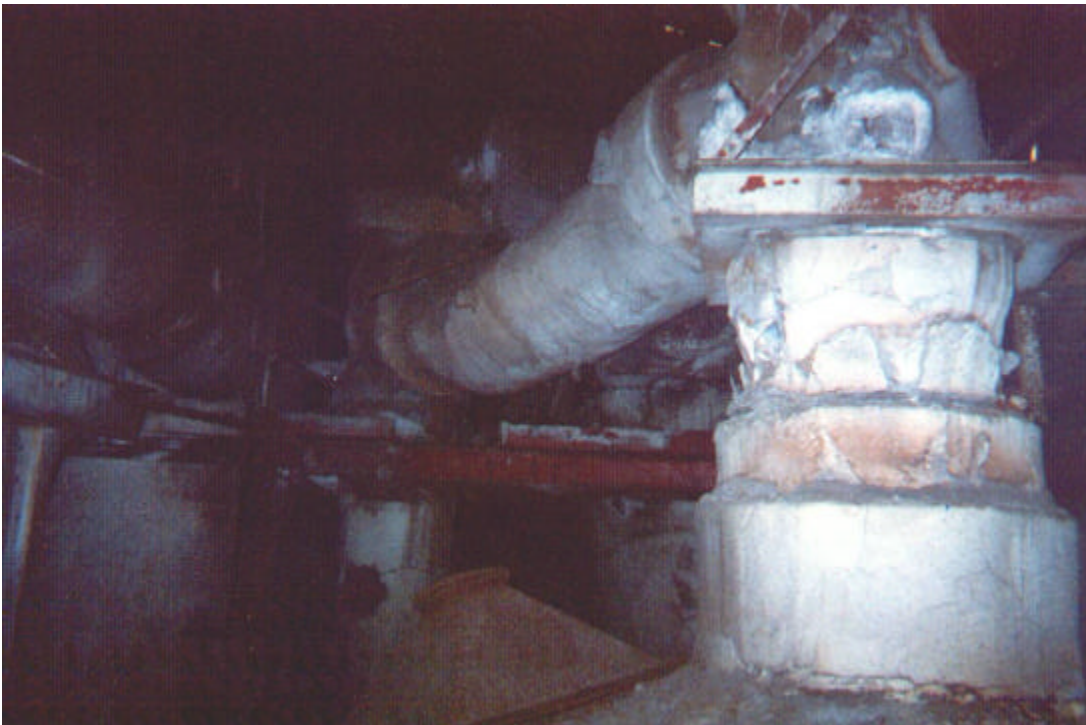
Photo #4: Exhaust flue from #2 roaster vessel to the dust collection cyclones. Note the white crystalline arsenic formation.

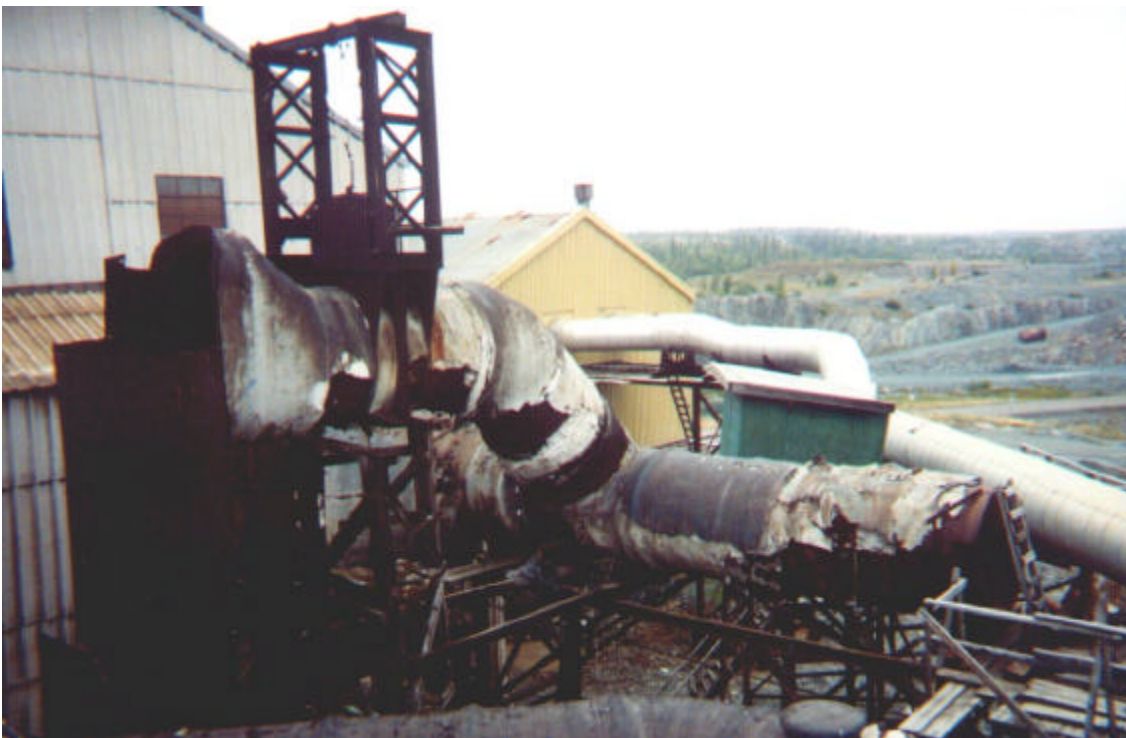
Photo #6: An old flue section that once connected the Cottrells to the stack (pre arsenic baghouse).

It is estimated that 60 tons of dust is contained in the 70" diameter flues. Much of the dust is loose and can be recovered using a heavy duty vacuum system. Some of the material however, is very hard and crusted over, and will have to be broken with hammers and scaling tools. The old flues are covered in insulation, generally in poor condition. There is some contamination associated with parts of the insulation, and care should be taken when removing it. After cleaning, the flues will have to be cut into manageable lengths using a cutting torch. Appropriate breathing apparatus will be required for all of this work.

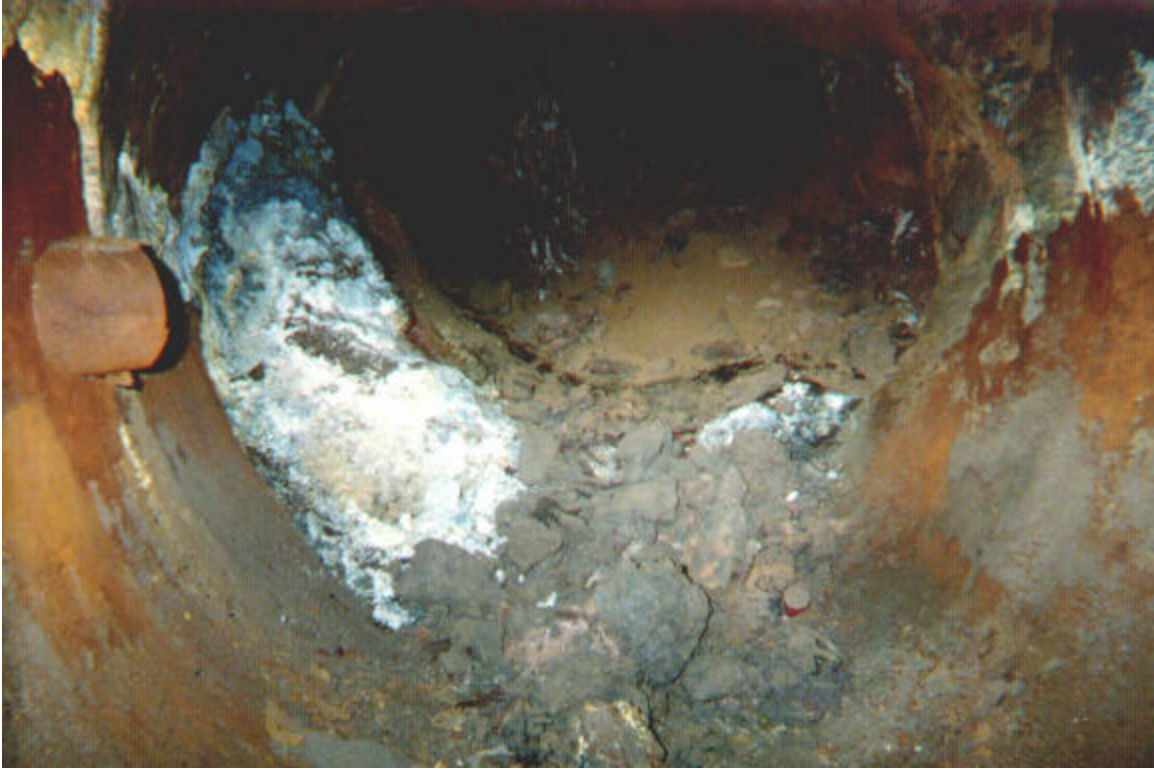
Photo # 7: Flue section in roaster building. Note nipple for air lancing blockages.

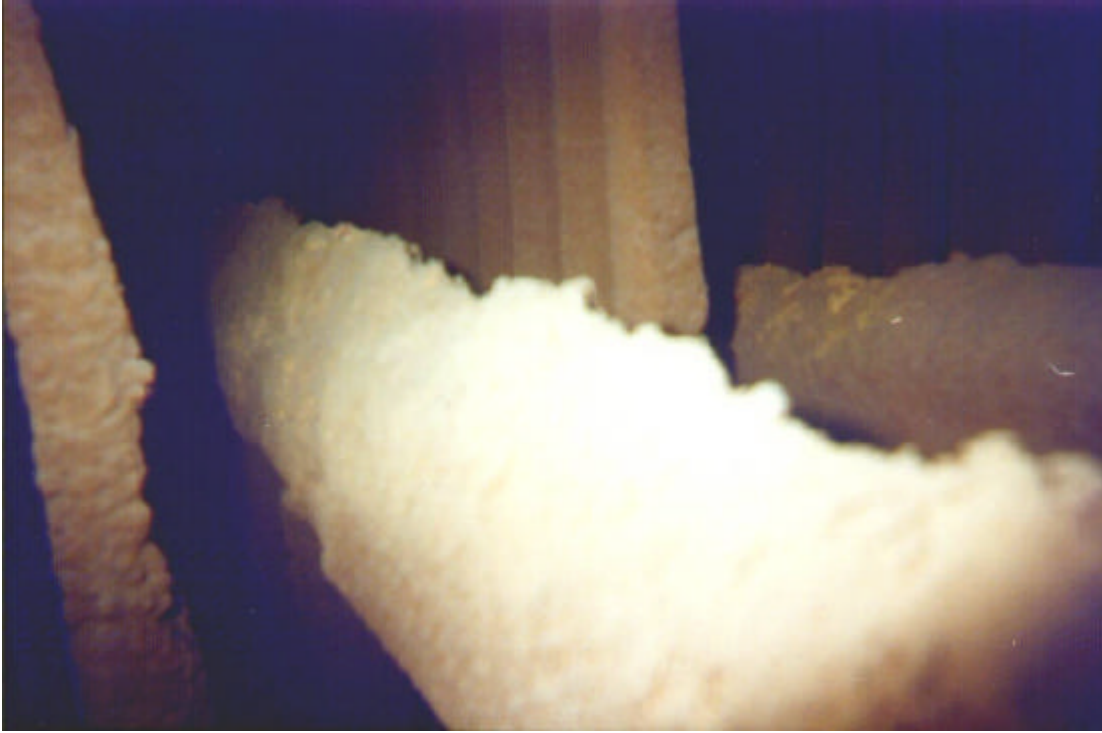
Photo #9: Inside #4 compartment of Cottrell. Note heavy dust buildup on frames between Rod curtains

All of the internal framework and sheet metal, including ladders, dampers, partitions, etc. is heavily built up with dust or scale, which will be knocked down into the collecting hoppers as the rods are being removed.

After the rods and spacer bars have been removed from the Cottrells, there will be sufficient room to erect scaffolding to permit cleaning the walls, partitions, etc. This can be accomplished using scaling bars, scaling hammers, etc. The material that is dropped into the hoppers can be removed via the screw conveyors, and placed into drums.

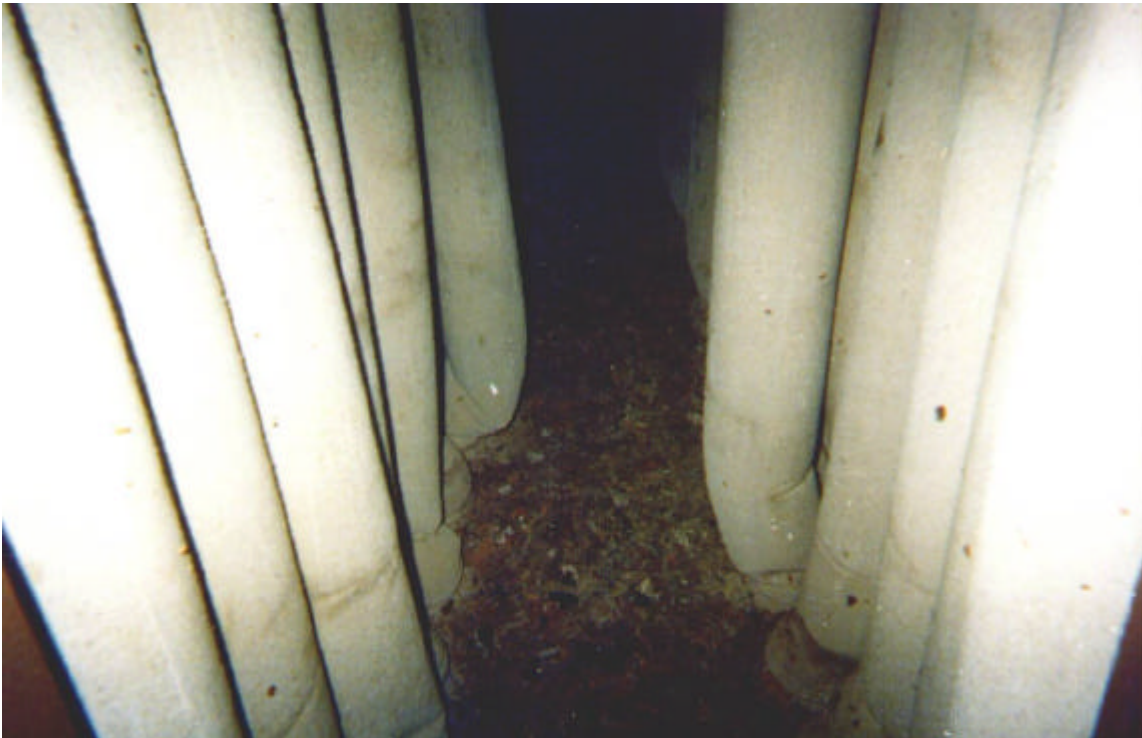
Photo #10: #6 baghouse compartment. Bags are in good condition and the compartment relatively clean. Dust collects on the inside of the bag in this type of collector.

The baghouse contains twenty four hundred 5" x 10' fabric filter bags in eight compartments. The compartments are made of sheet metal panels covered in insulation. Each pair of compartments is equipped with a screw conveyor. Cleanout of the equipment first requires removal of the filter bags. The base of each bag is fastened to the tubesheet with gear clamps and attached to the shaking mechanism at the top with a loop of fabric around the hanger. The bags should be manually shaken before removal to dislodge any arsenic that may be adhering to the inner walls of the bags. The bags can then be packed in open top drums for future disposal.

The baghouse shaking mechanism and discharge plenums should be removed before dismantling the wall and partition panels. Final cleanup of the equipment may be done by high-pressure water spray provided that proper water collection facilities are available.
