APPENDIX 4

Subject: Stream Crossing Design Water Levels for Prairie Creek Mine Access Road
Northwest Territories

Table 1 - Summary of Design Flows and Water Levels

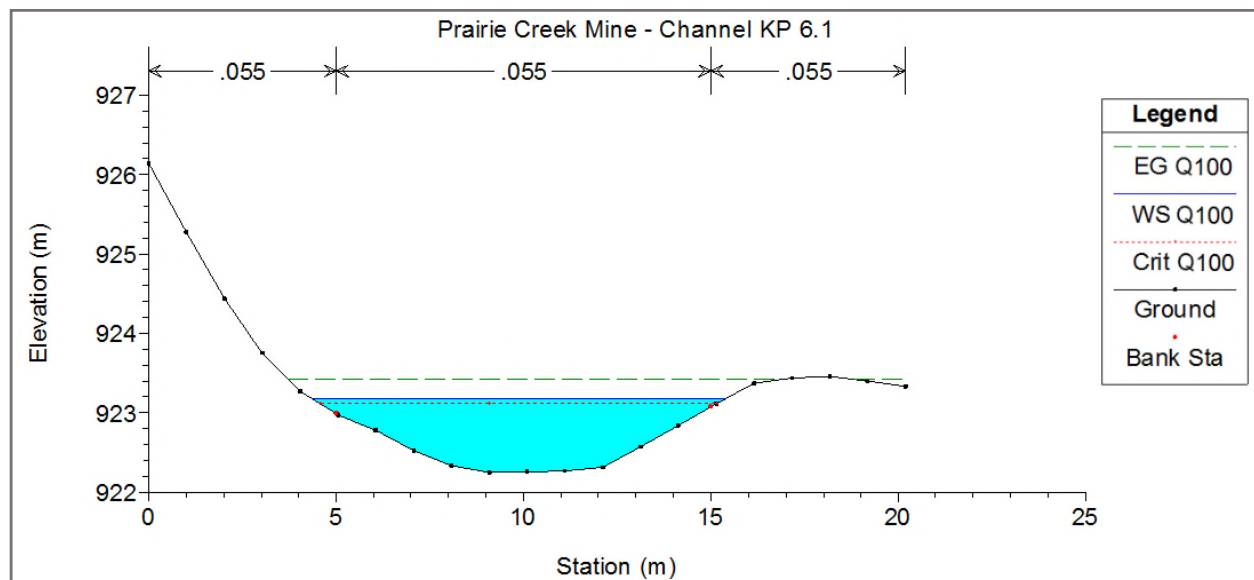
Figure 3: KP 6.1, Casket Creek, HEC-RAS model result for 100-year flood. Results shown are for scenario in which flow is confined to the presently active main channel on the left side of the alluvial fan where a bridge presently exists.

6.1	Casket Creek	alluvial fan	15.2	14.6	0.027	0.055	0.055	922.24	11	923.17	0.93	923.42	1.18	2.2	Analysis assumes water confined to left flowpath at existing bridge

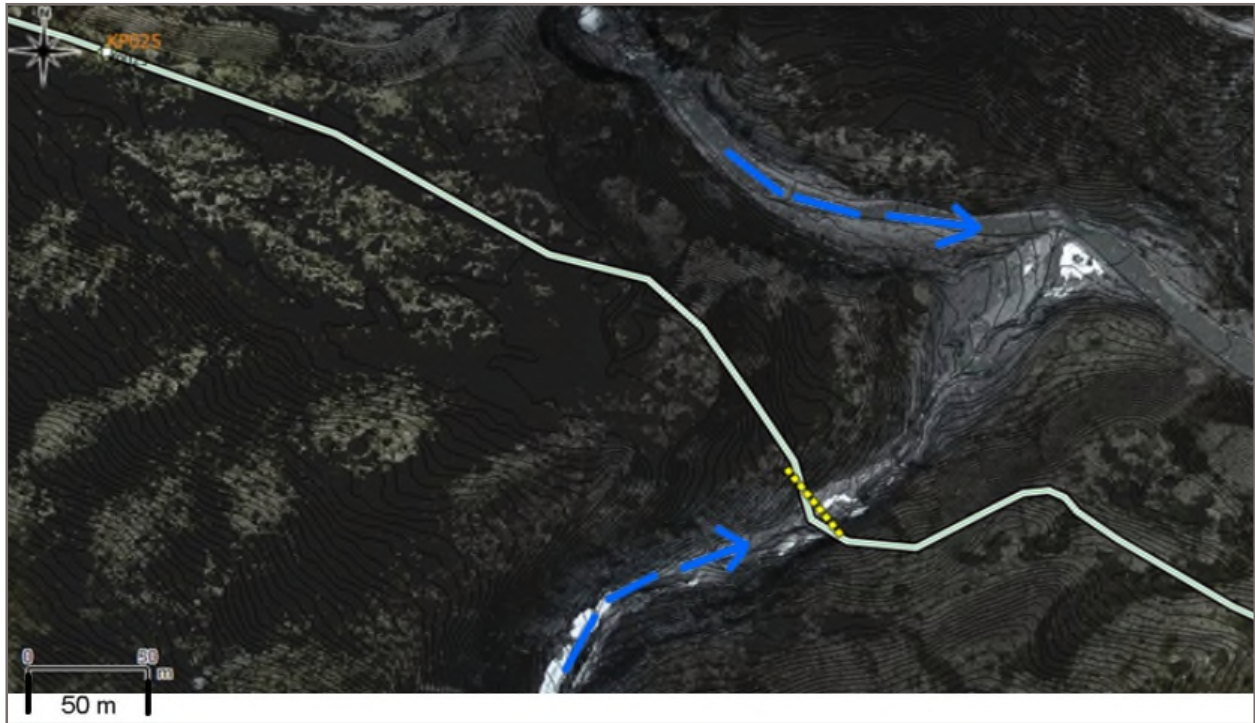
Figure 6: KP 25.3, Sundog Tributary. 2014 road alignment shown on 2012 orthophoto image. Flow is left to right. Channel cross section view taken at yellow dashed line viewing downstream.

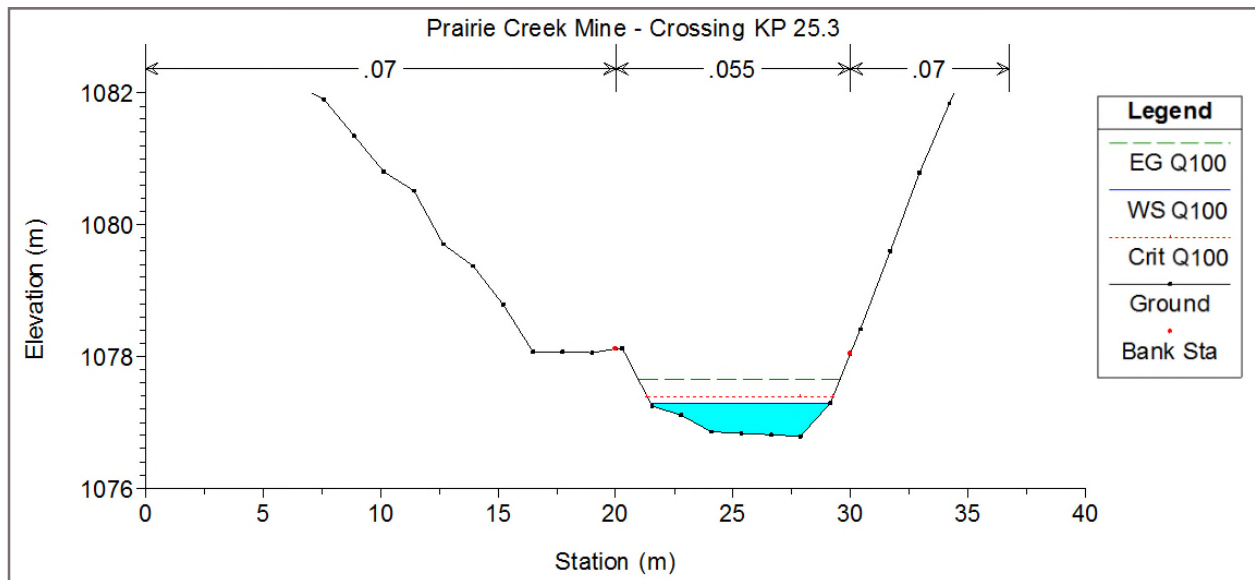
Figure 7: KP 25.3, Sundog Tributary, HEC-RAS model result for 100-year flood.

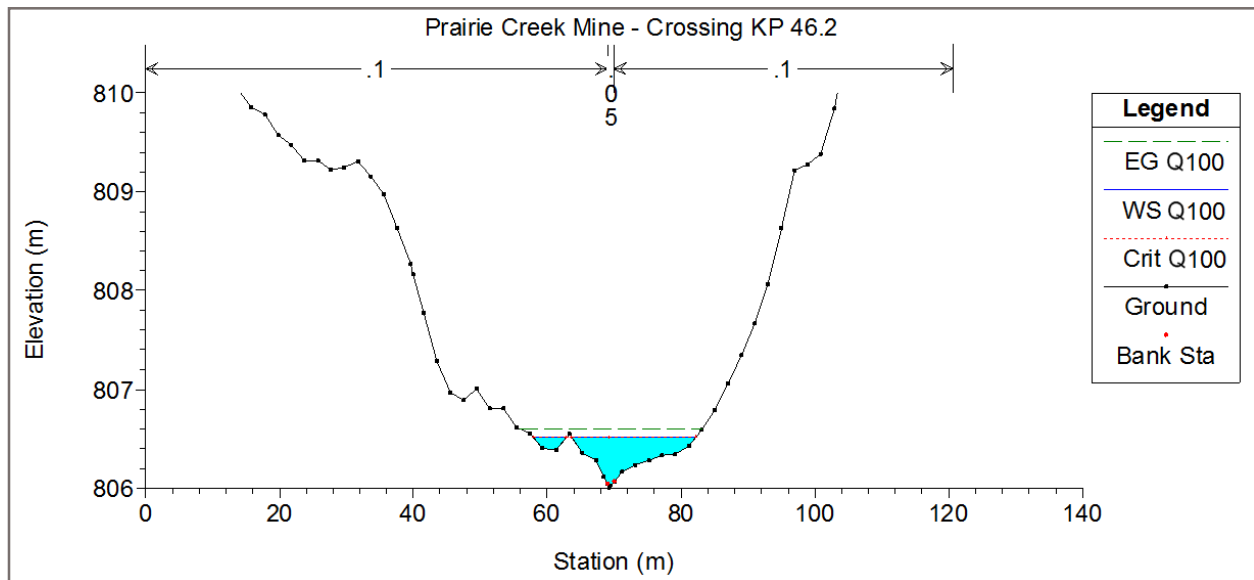
Figure 15: KP 46.2 Polje Trib. (Hatfield KP 47.0). HEC-RAS model result for 100-year flood.

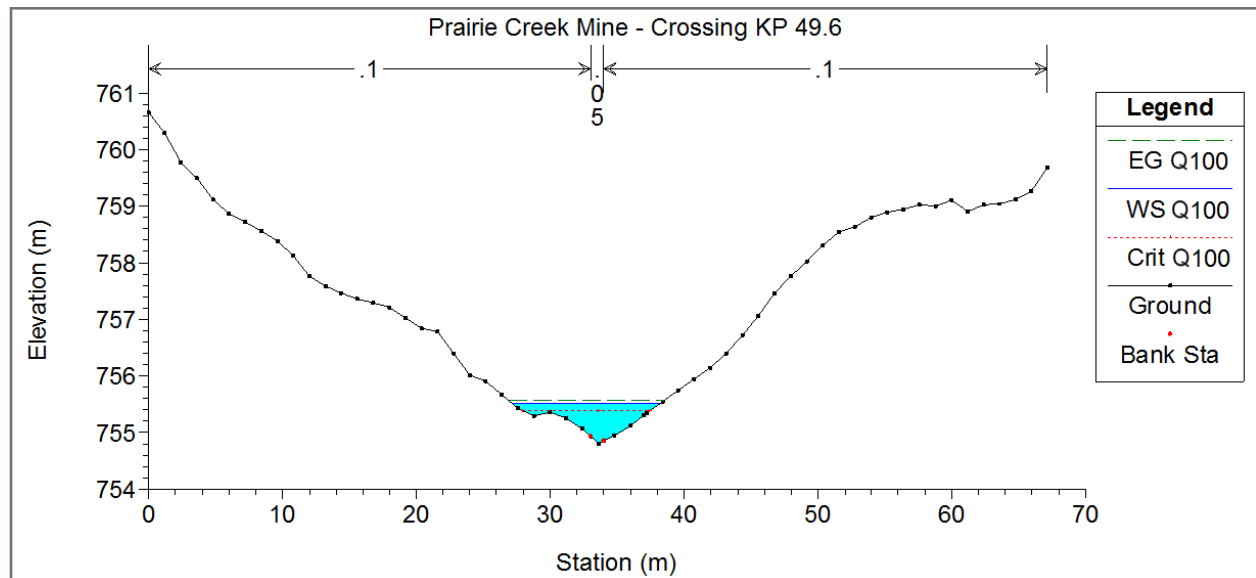
Figure 17: KP 49.6 Polje Trib. (Hatfield KP 50.2). HEC-RAS model result for 100-year flood.

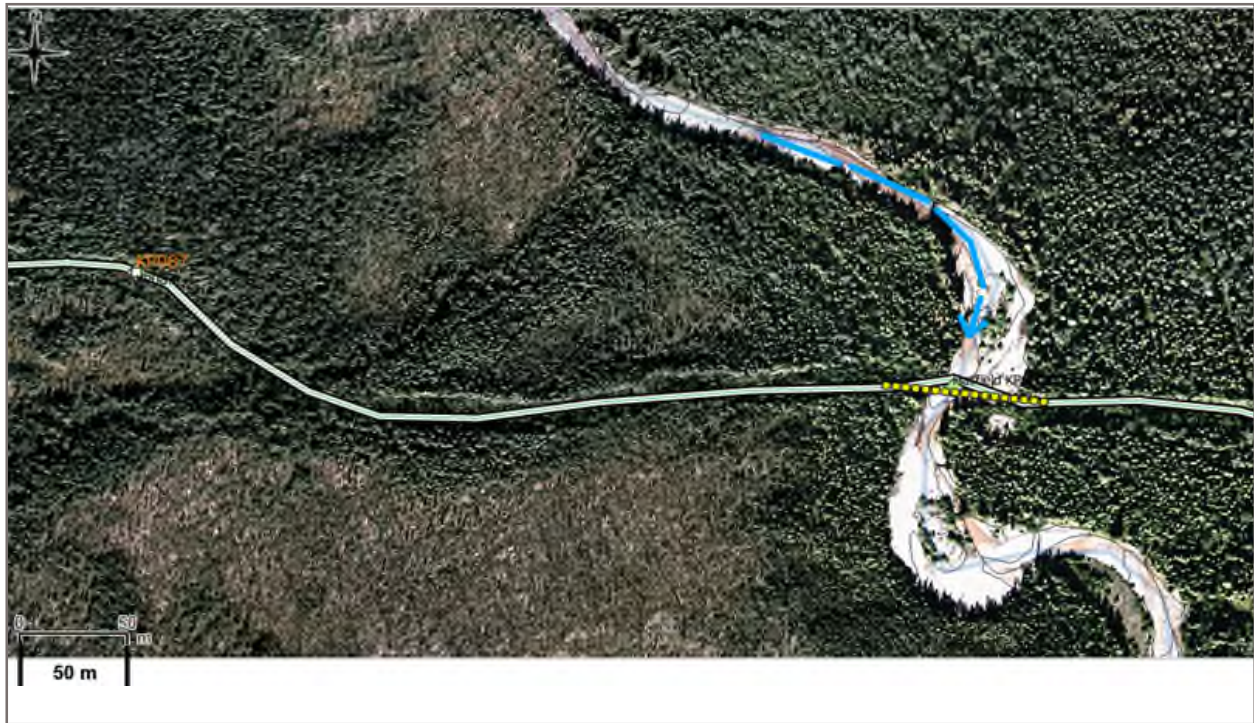
Figure 20: KP 87.4 Tetcela Trib at Old Road. 2014 road alignment shown on 2012 orthophoto image. Flow is top to bottom. Channel cross section view taken at yellow dashed line viewing downstream.

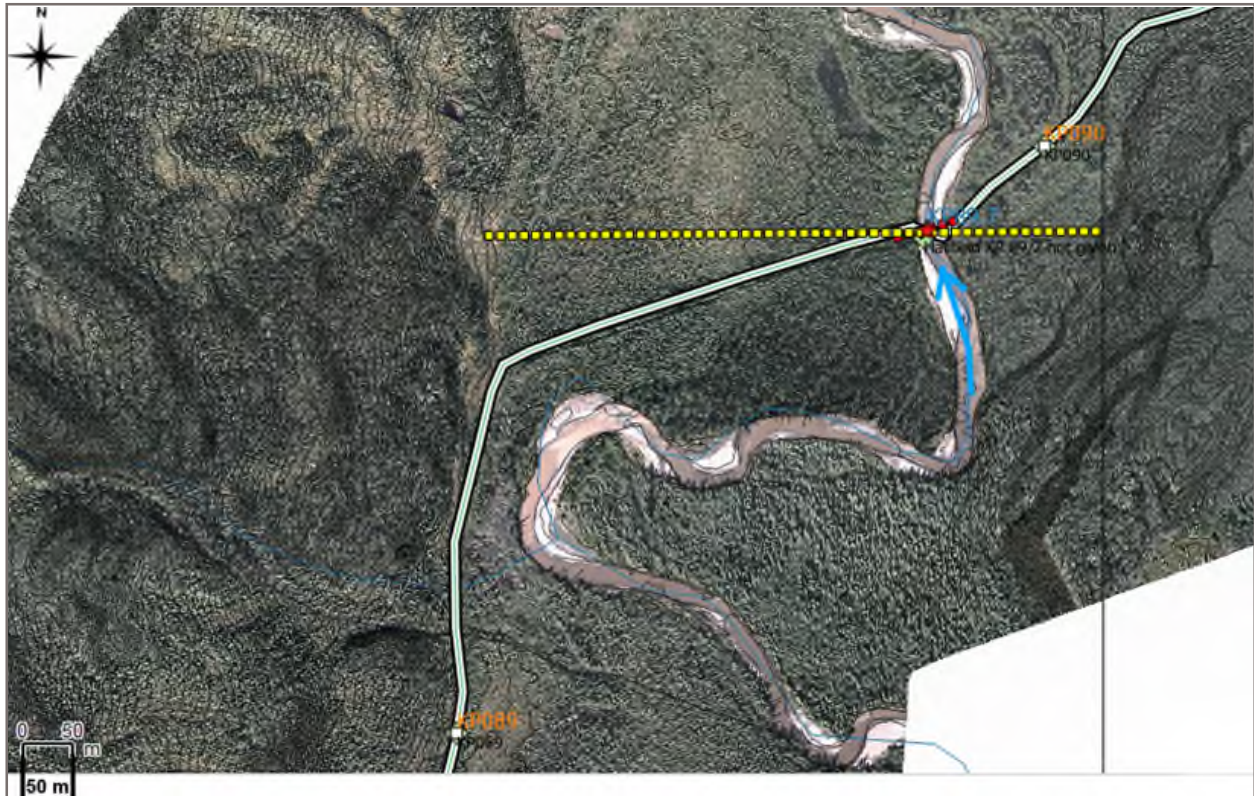
Figure 22: KP 89.7 Tetcela Mainstem at Old Road. 2014 road alignment shown on 2012 orthophoto image. Flow is bottom to top. Channel cross section view taken at yellow dashed line viewing downstream.

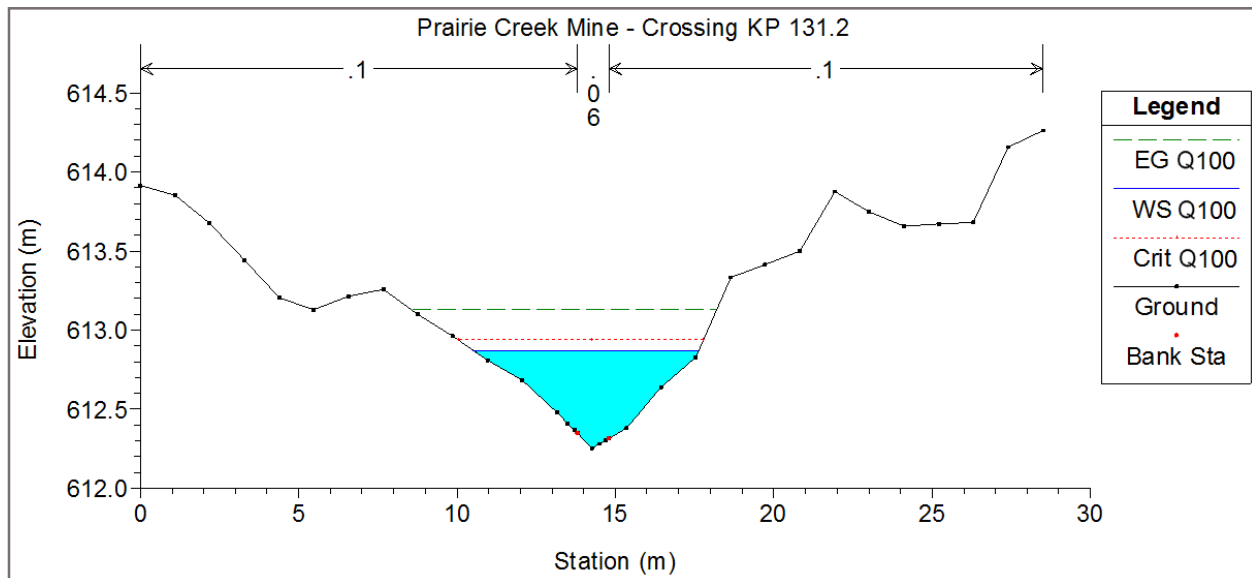
Figure 31: KP 131.2 Grainger Trib. (Hatfield KP 131.3). HEC-RAS model result for 100-year flood.

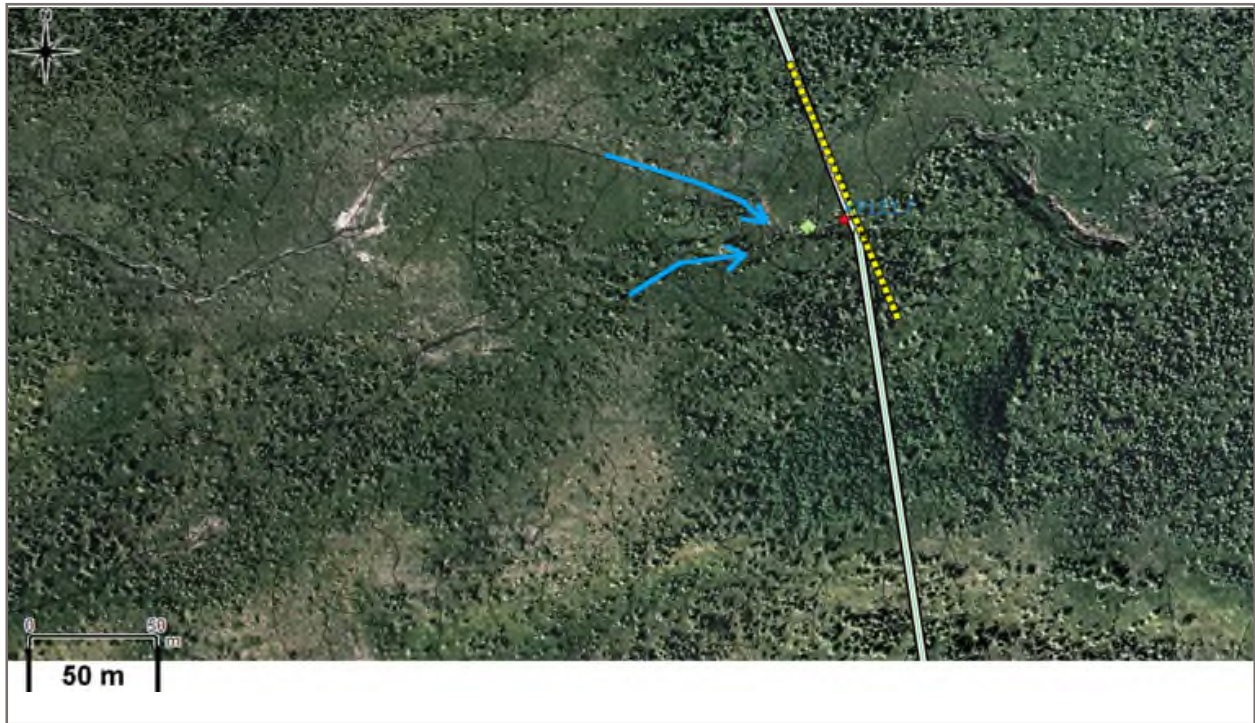
Figure 32: KP 133.2 Grainger Trib. (Hatfield KP 133.7). 2014 road alignment shown on 2012 orthophoto image. Flow is left to right. Channel cross section view taken at yellow dashed line viewing downstream.

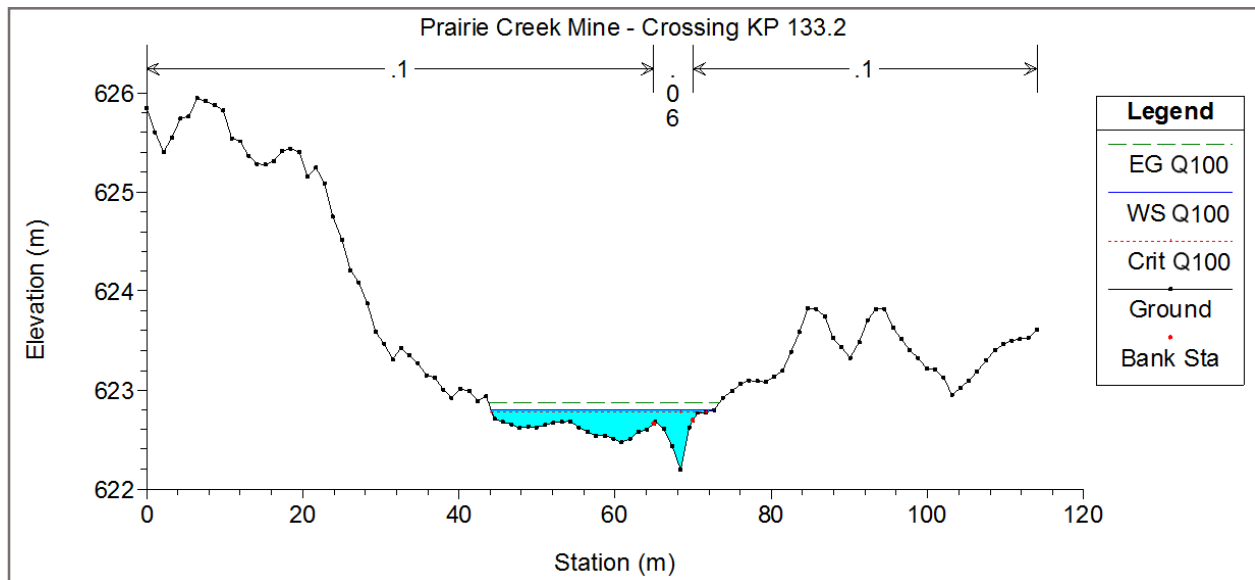
Figure 33: KP 133.2 Grainger Trib. (Hatfield KP 133.7). HEC-RAS model result for 100-year flood.

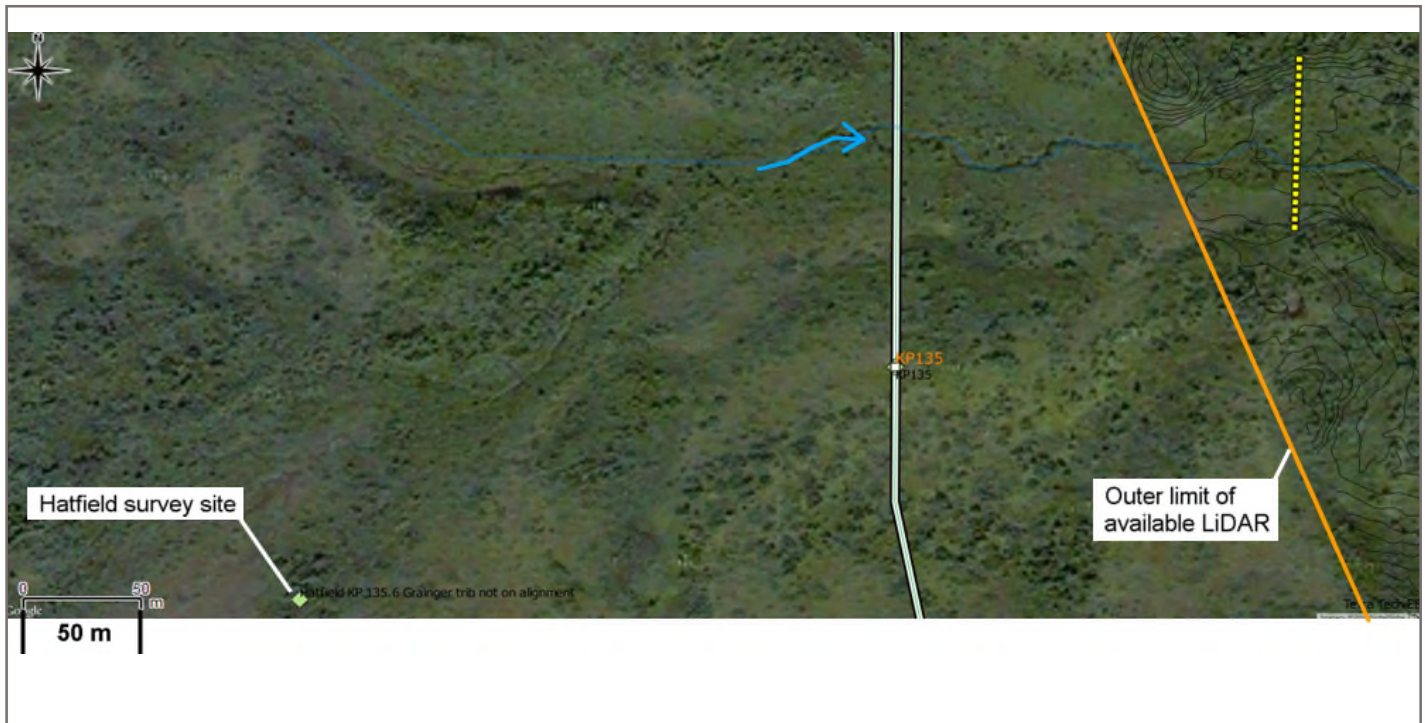
Figure 34: KP 134.9 Grainger Trib. (Hatfield KP 135.6). 2014 road alignment shown on Google Earth image. Flow is left to right. 2012 LiDAR data and orthophoto imagery not available for the 2014 crossing location due to alignment change. Channel cross section view taken at yellow dashed line viewing downstream, and located downstream from road crossing in reach with available LiDAR data.

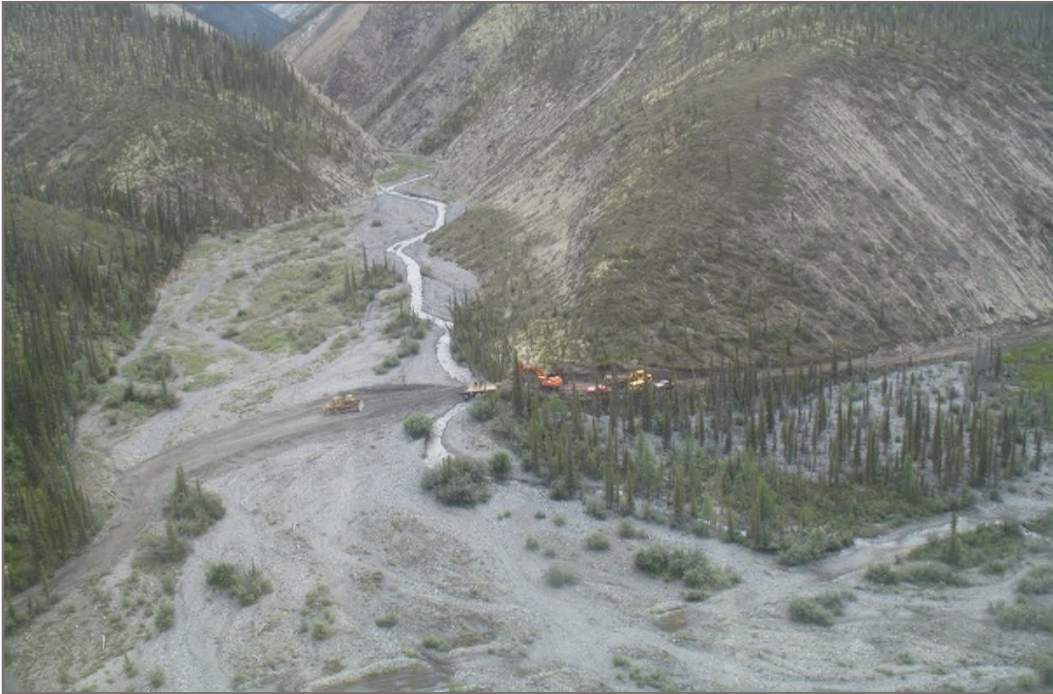
Photo 1: KP 6.1, Casket Creek. Aerial image viewing upstream, 2008. Active alluvial fan area with split flows and shifting of the main channel being likely during major flood events.

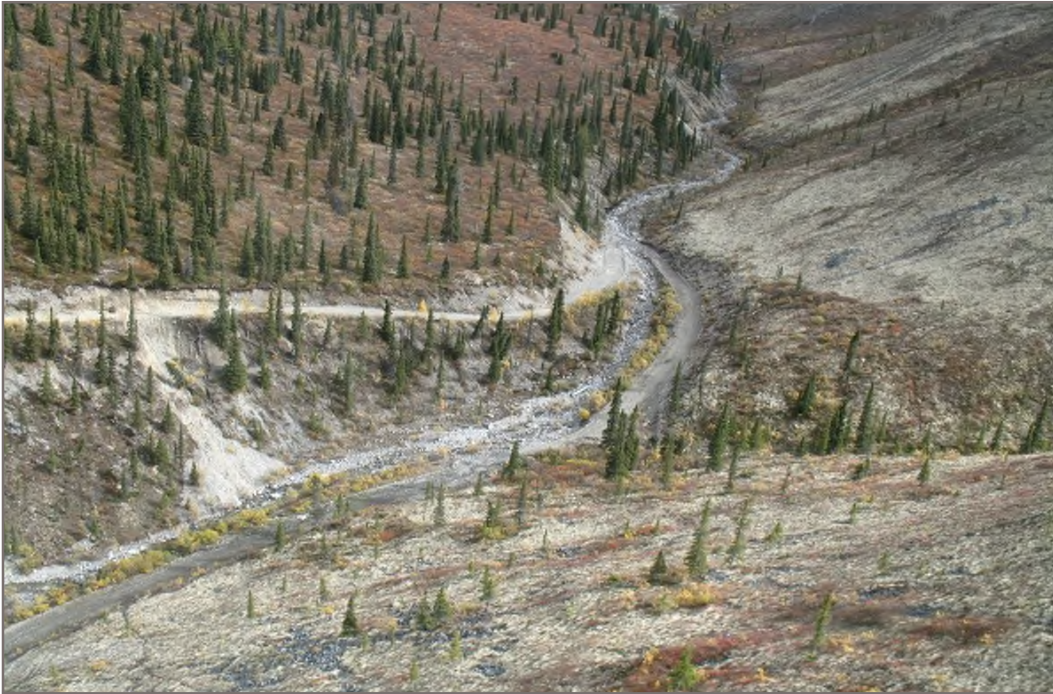
Photo 3: KP 6.1, Funeral Creek. View upstream to incised channel at original hairpin crossing. New crossing will be about 50 m upstream from original crossing.

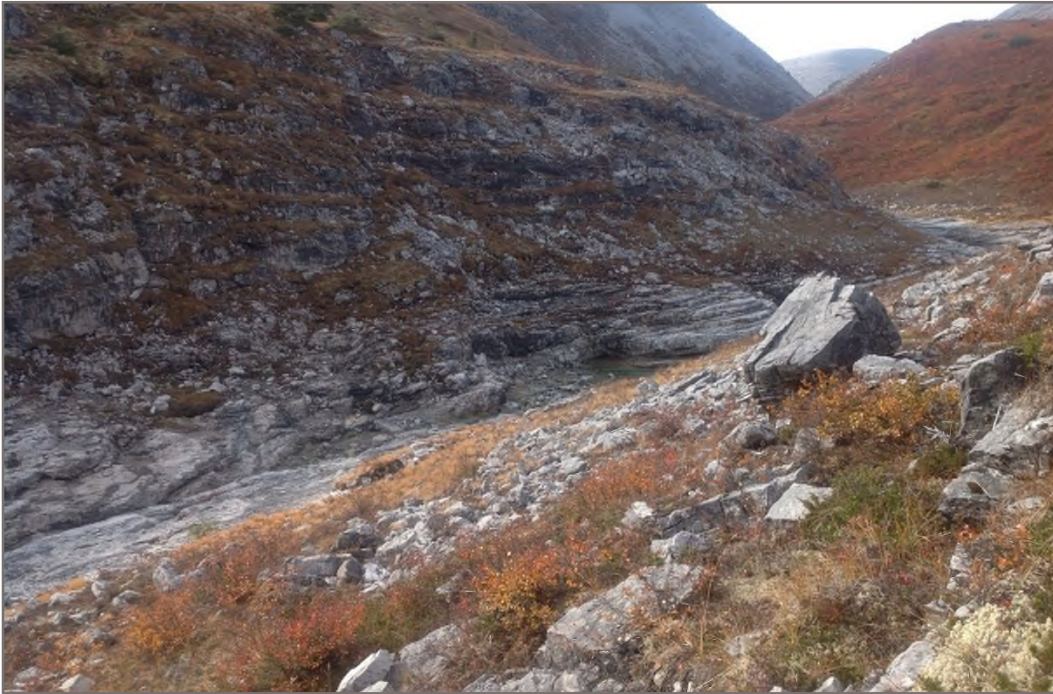
Photo 5: KP 25.3 Sundog Tributary. Incised channel with bedrock control.

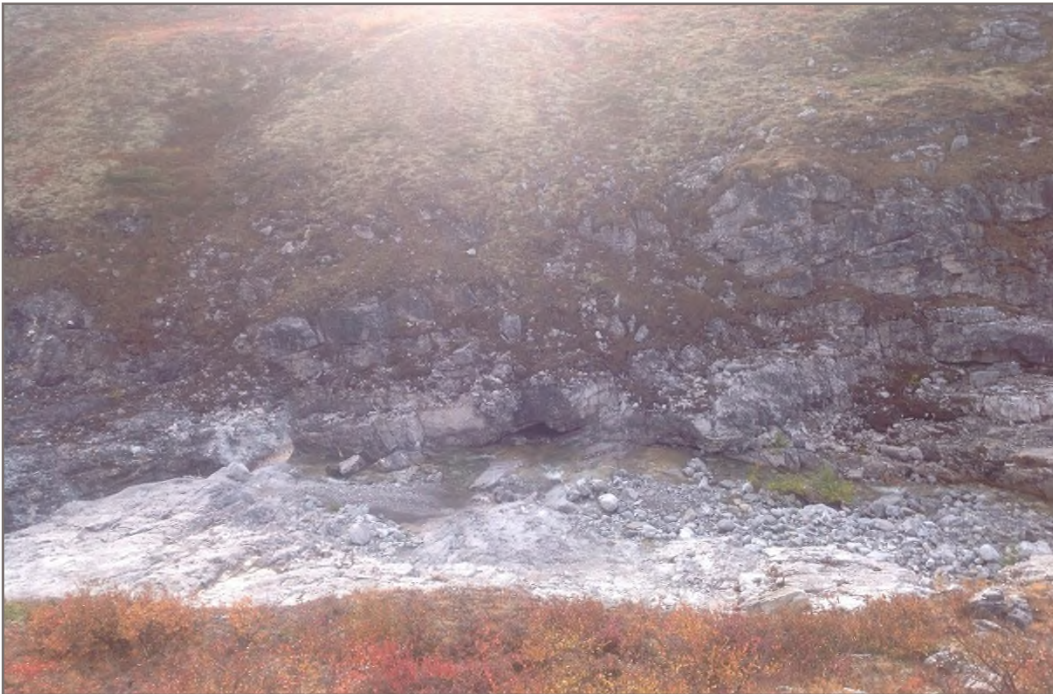
Photo 6: KP 25.3 Sundog Tributary. Incised channel with bedrock control.

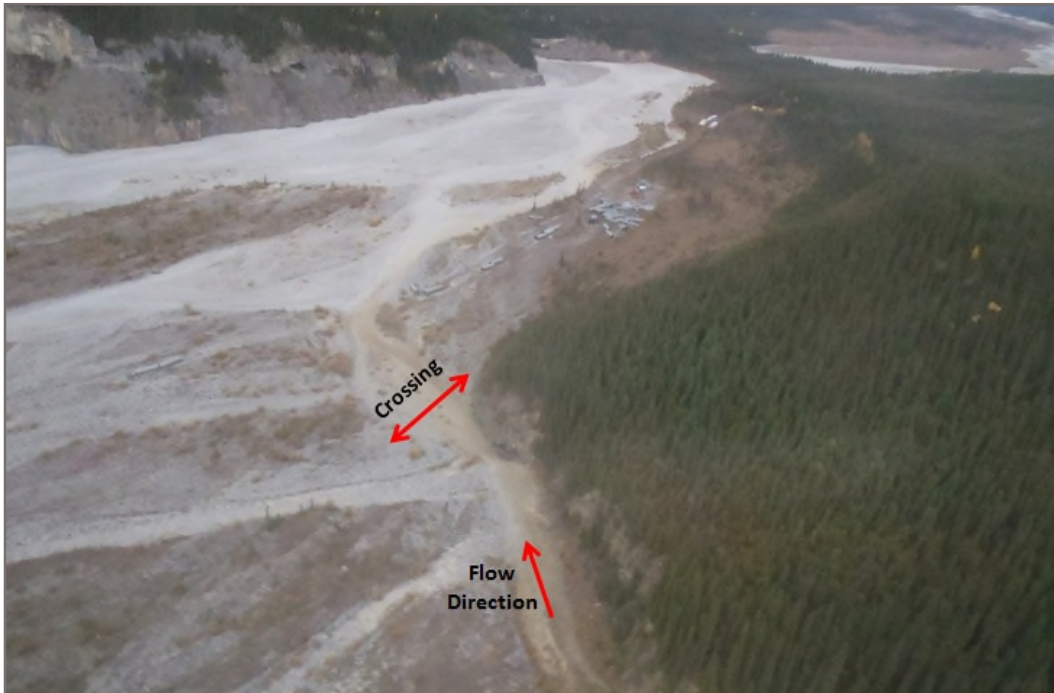
Photo 9: KP 39.4 Sundog Trib. (Hatfield KP 39.8), viewing downstream. Crossing is at confluence with main channel Sundog Creek at top of image.

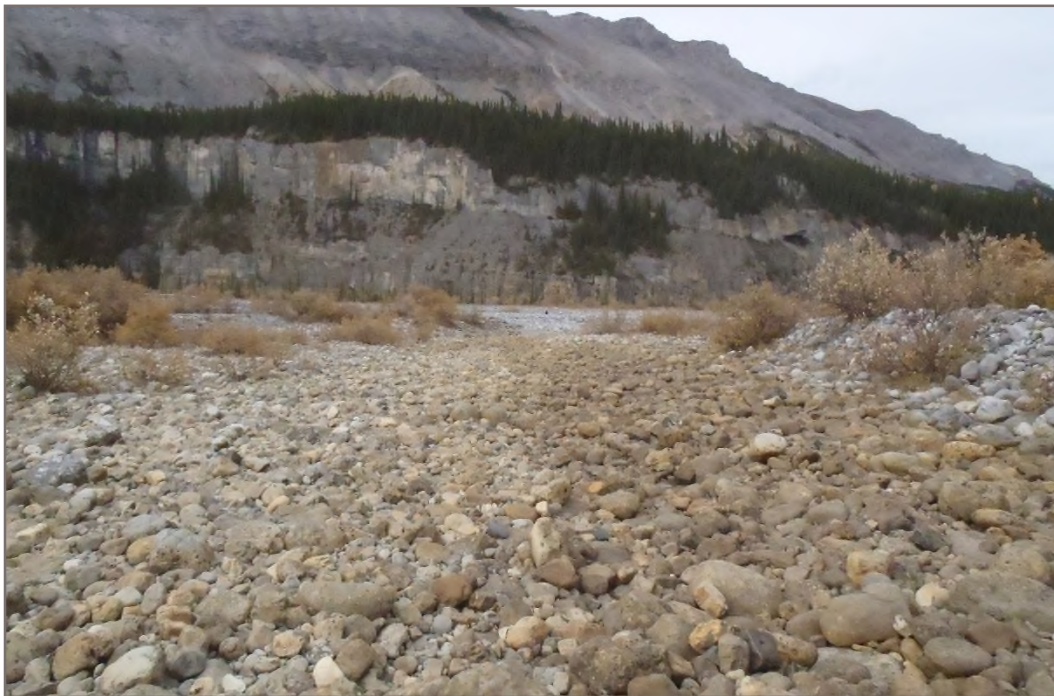
Photo 10: KP 39.4 Sundog Trib. (Hatfield KP 39.8), viewing downstream along dry tributary channel. Crossing is at confluence with main channel Sundog Creek at top of image. Photo taken September 2014.

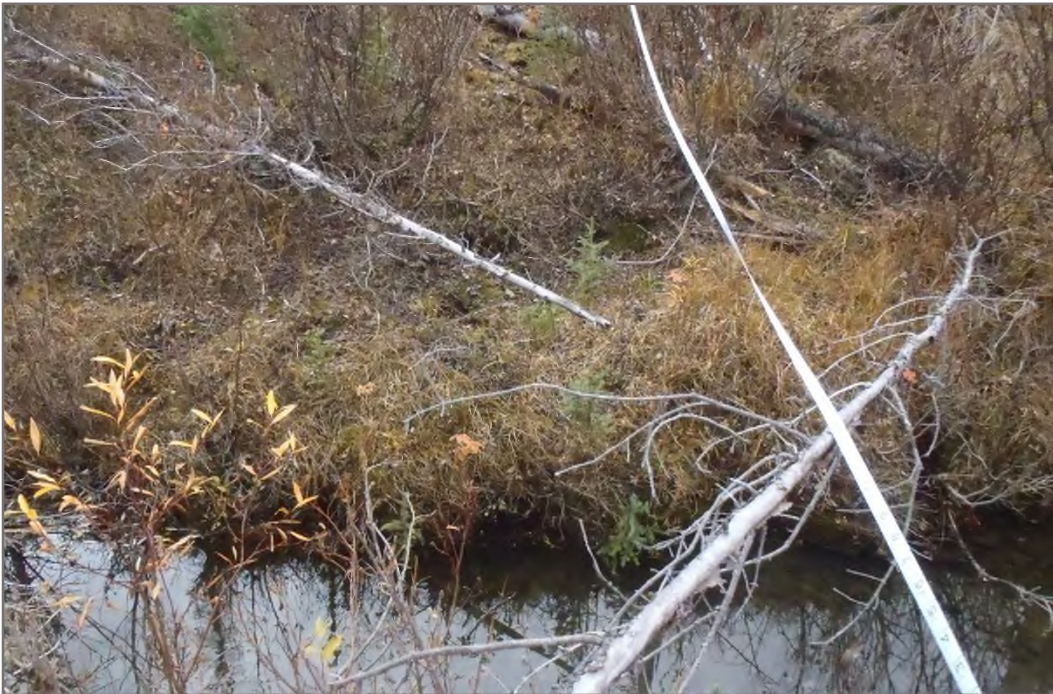
Photo 15: KP 53.6 Polje Trib. (Hatfield KP 54.3). Survey tape is visible, stretched across channel.
