Our File: EA1415-01

CanZinc responded to the first round of information request (IR) on May 9th, 2016. Some of the responses were not input into the online review system table but rather input as an attachment. The IR responses that were attachments to individual IRs have been compiled here into one pdf document to assist parties. The individual IR responses included are:

REPLY TO DFN IR15

PRAIRIE CREEK ALL-SEASON ROAD

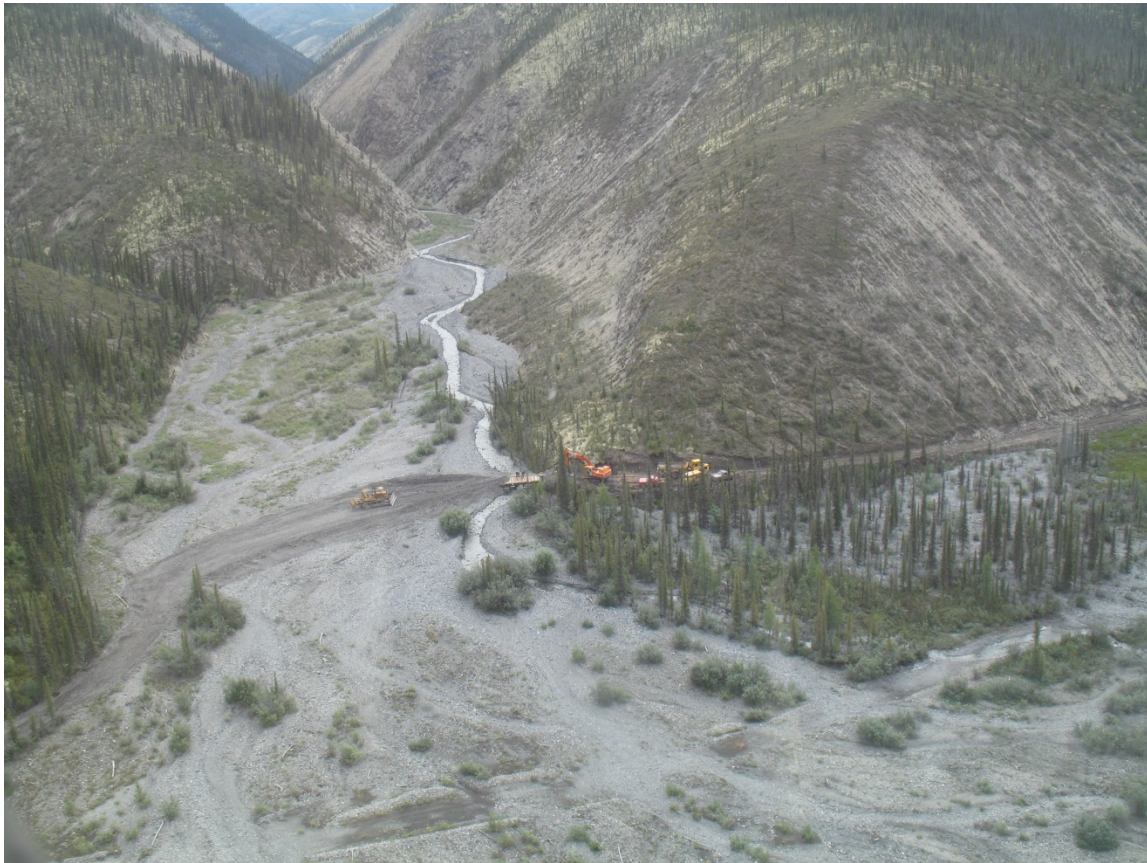
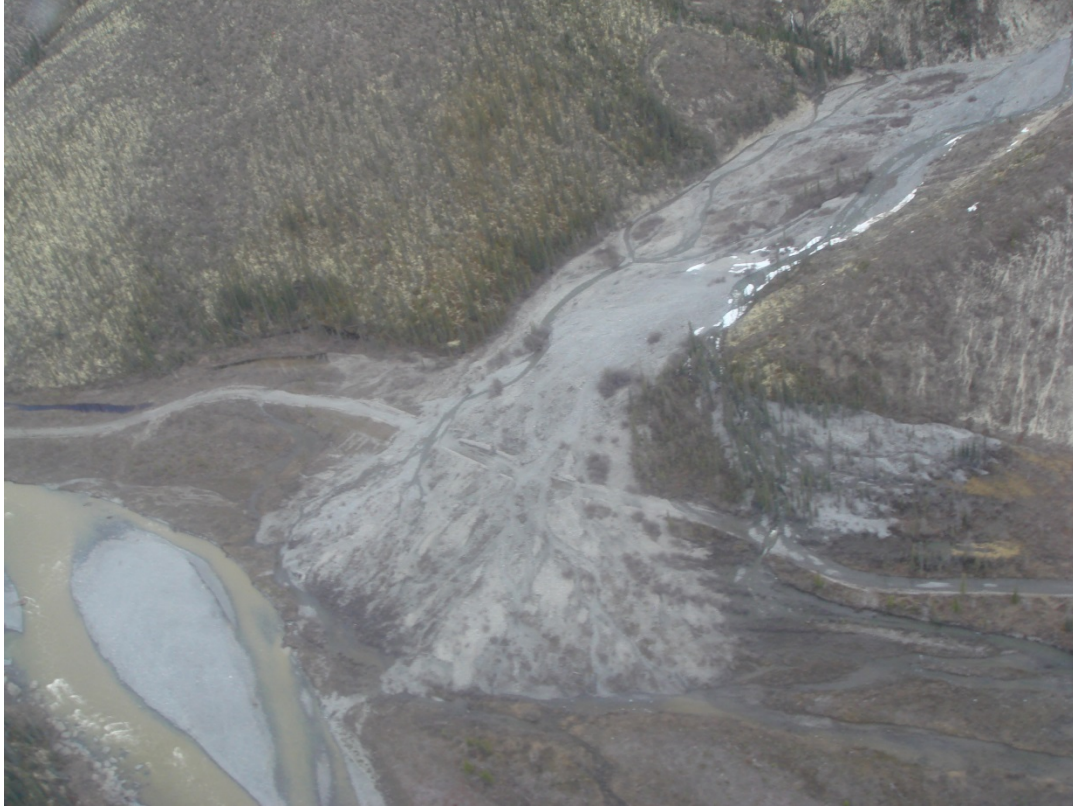
Casket Creek is about 5 m wide, within a floodplain about 80 m wide. See photo below showing existing bridge crossing under construction. The channel is stable during low to medium flows, but secondary channels to the north carry water during high flows. There is a smaller tributary creek that enters the floodplain on the north side, but is dry except during high flows. The main channel can carry a significant bedload during high flows, as evidenced by the alluvial fan material in the floodplain and upon entering the Prairie Creek valley. During high flows, there are multiple braided channels downstream of the crossing location. See 2nd photo below.

The proposed crossing design consists of a larger span to replace the existing span. The southern abutment is rock. The crossing location is at the point where the floodplain enters the Prairie Creek valley. Crossing the floodplain is not ideal, but is the best location considering the less suitable terrain upstream and downstream. The crossing design includes armour elements to train the main channel under the bridge, and prevent a back eddy. Culverts will be placed in the northern approach to carry water during high flows that departs from the main channel upstream. A culvert is also provided for the northern tributary channel. The road bed on the alluvial fan will be at a lower elevation than the bridge and armoured against erosion from high flows. In the event of very high flows, water will be able to flow over the road bed in addition to under the bridge and through the culverts carrying bedload. This design minimizes the risk of damage to road structures. The design also provides flow paths for water during all flows, and outlets for bedload movement beyond the road alignment without upstream accumulation. Avulsion of the main channel is unlikely given that the channel enters the floodplain on the south side upstream. An air photo image from 1949 is attached (Km 6), with a comparable one from 2012 for comparison. These show that the main channel has remained relatively stable along the south side of the floodplain. However, monitoring during high flows will occur, and additional channel training implemented if necessary to avoid an avulsion to the north.

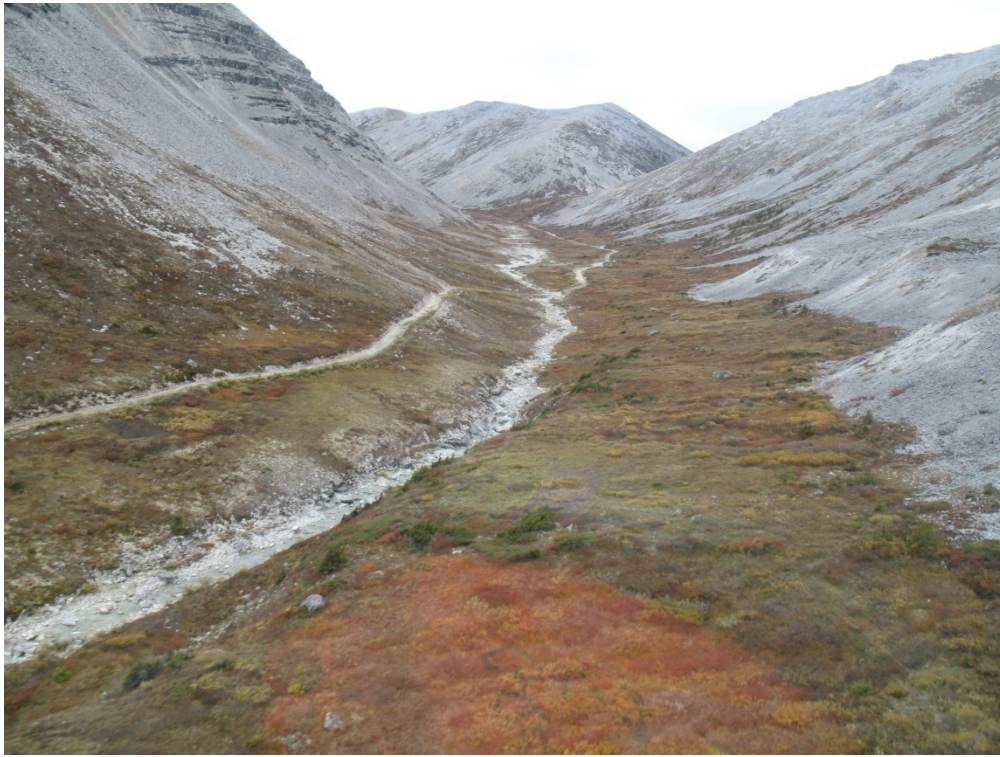
Km 23.4, upper Sundog Creek

The stream at this non-fish bearing crossing is about 5 m wide, and the width at the high water mark (HWM) about 10 m. The photo below shows that the channel is confined by slopes on both sides, with little risk of overbank flooding or avulsion. The crossing location was moved just upstream from the winter road location to allow a more perpendicular crossing alignment. Large

culverts with armour will allow passage of high flows and moderate bedload without erosion or channel constriction.

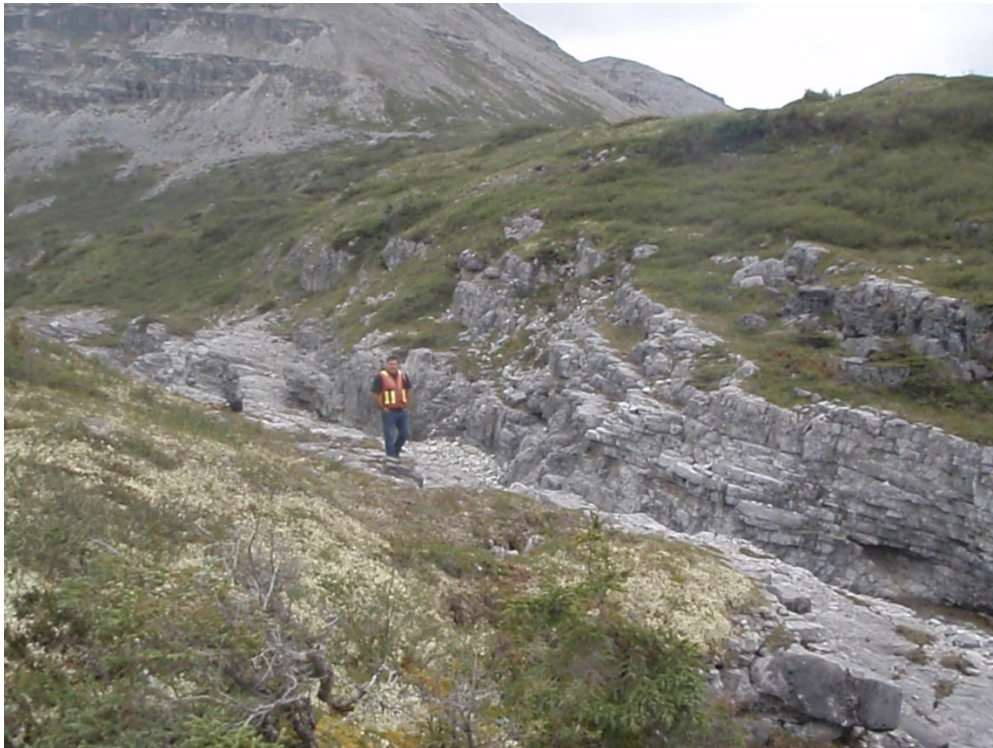
The photo above shows the rock abutments of the proposed span structure where the creek about 7 m wide flows through a deep canyon at its narrowest point (13 m). All structures will be >5 m above the HWM avoiding any interaction with, and effects on, the stream.

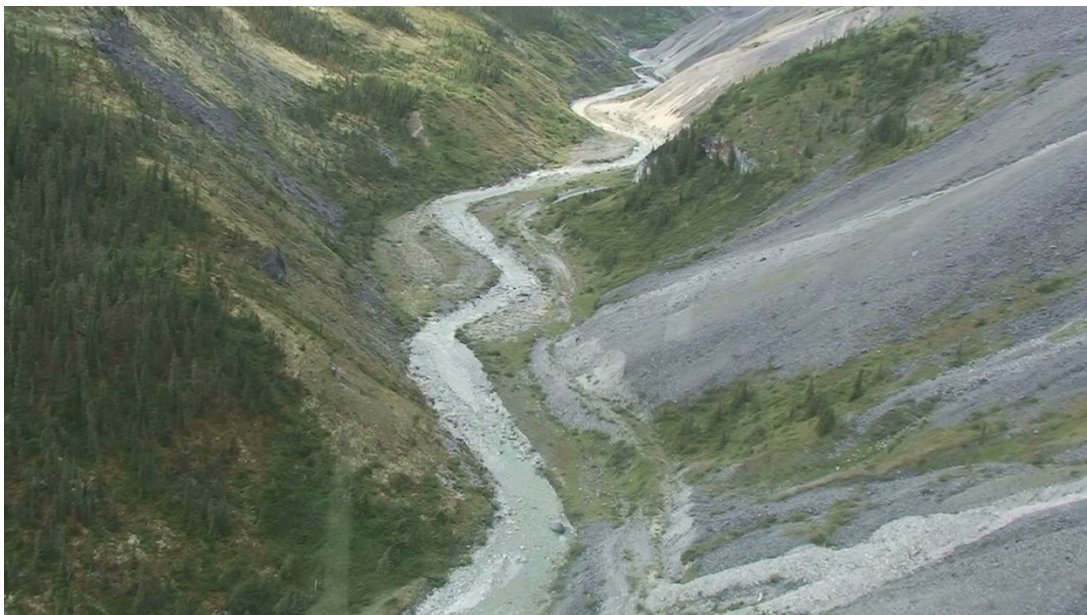
This crossing location is dictated by the previously proposed eastern end of the road re-alignment where the road crosses to the north bank to re-join the old winter alignment. The channel width here is 7 m, and width at the normal HMW 12 m. However, there is a valley bottom width of 45-50 m, and evidence of past high flows that occupied another channel on the south side, and formed a wider channel on the north side. See photo below looking upstream. The crossing design accounts for these issues (see photo in Allnorth report). The upstream inlet to the old southern channel will be blocked by an armoured berm. Overbank flooding on the north side will be prevented by extending the northern bridge abutment west with armour, training all flow under the bridge, which will be of sufficient height to allow the constricted water to pass with a higher water level. These elements, together with armoured abutments, will prevent channel avulsion, flooding and damage to the crossing structure, and will allow passage of high flows and moderate bedload. The crossing structures will not alter the shape and hydraulics of the channel, and so bed material accumulation will not occur, as is the case at present.

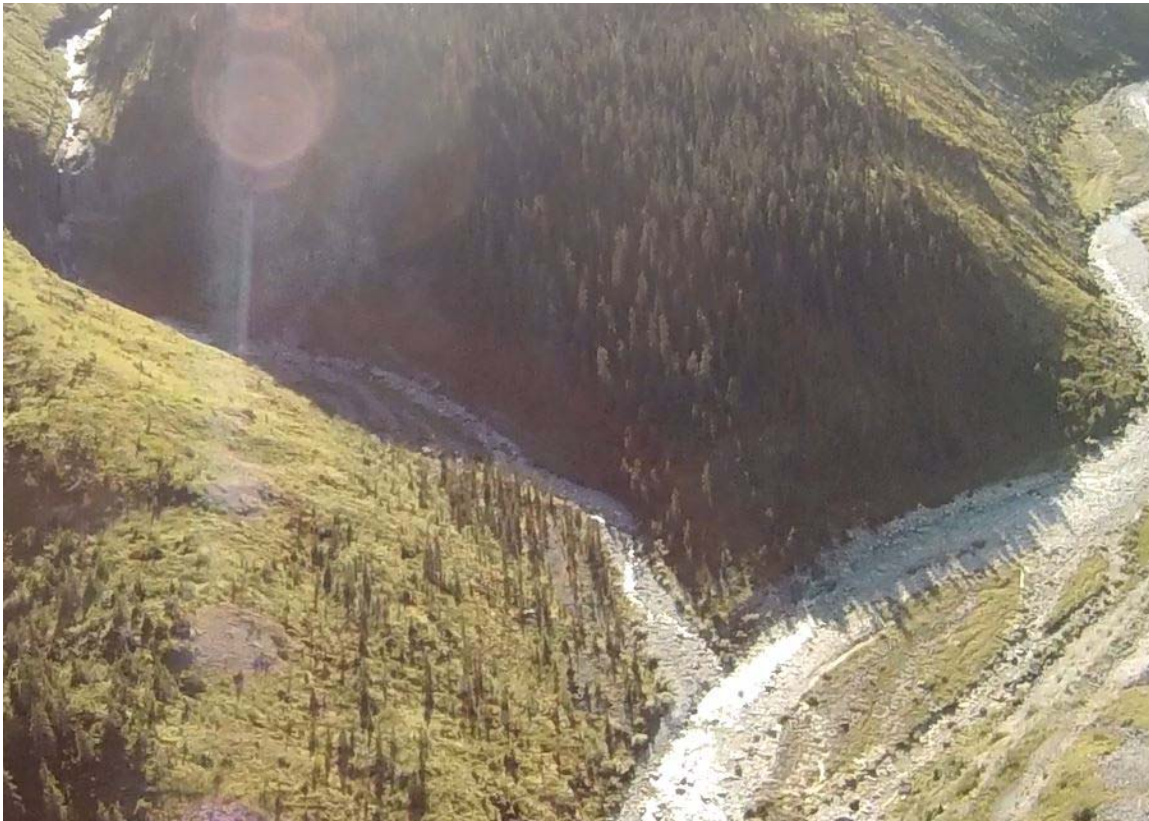
As explained above, this tributary crossing is necessitated by extending the road re-alignment on the south side of Sundog Creek. The creek valley is incised, but as shown in the photo below, the valley bottom is quite broad near the mouth, and the banks of the creek are quite shallow. At the crossing location, the creek is about 3.5 m wide, and width at the HWM is 8 m. The west side of the crossing has a rock slope, and just upstream there is rock in the east bank. The crossing will consist of a span with abutments on stable rocky banks above the HWM. There is no avulsion risk, and no restriction on bedload movement.

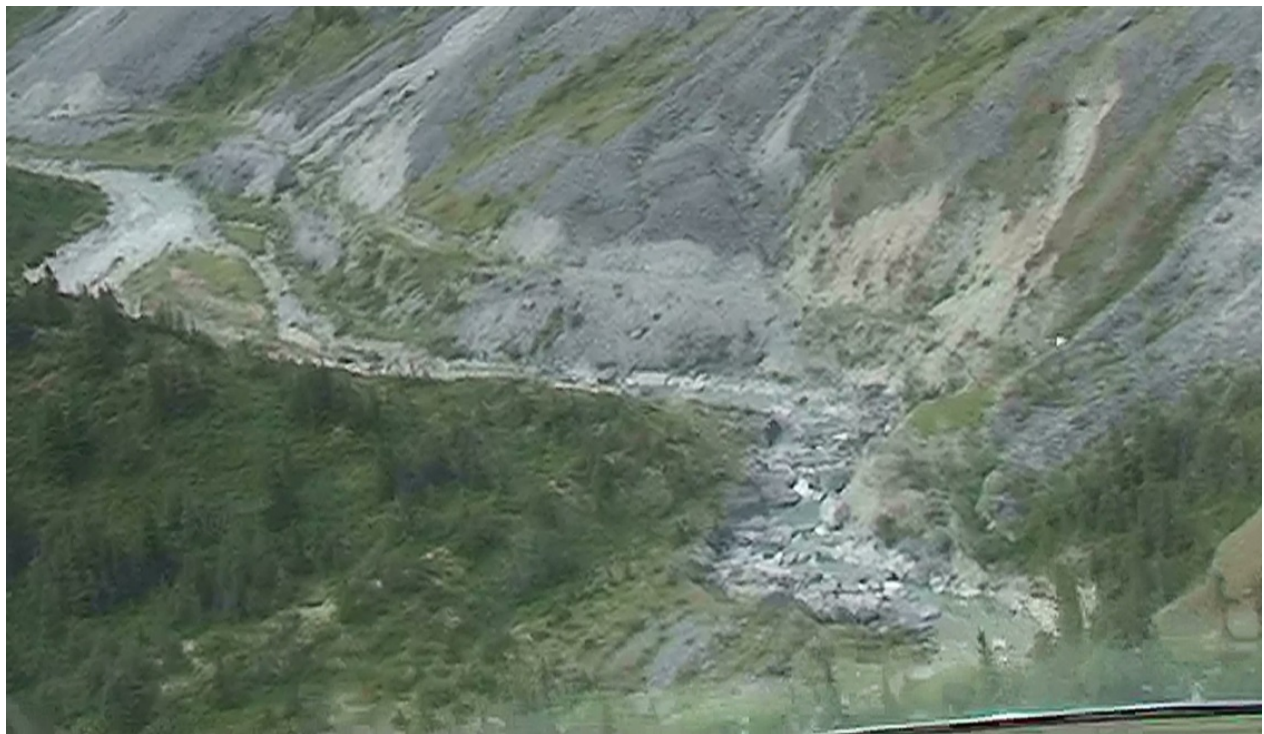
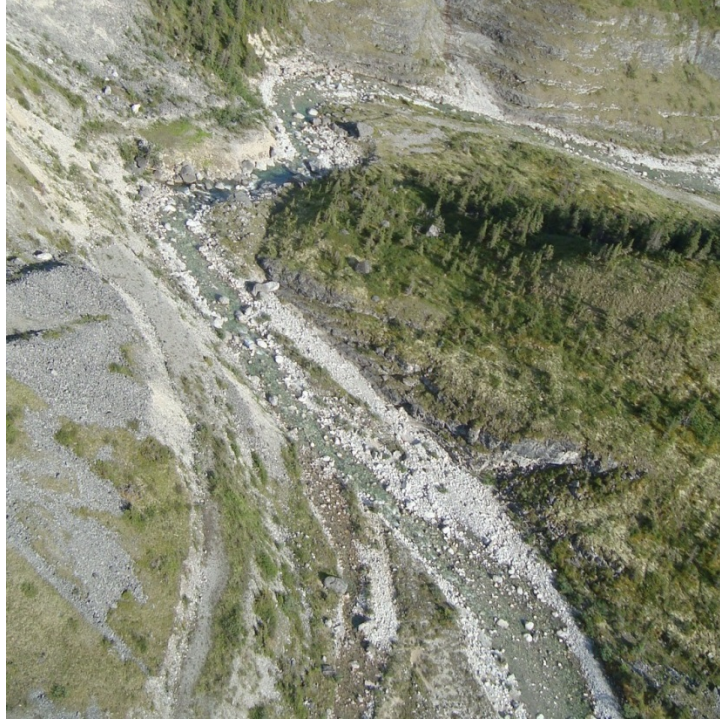
The crossing location was to be moved upstream by about 100 m in response to a terrain hazard identified on the east side of the northern approach at the previous location. However, this crossing will no longer be needed. At the revised crossing location, the stream is about 9 m wide, and width at the HWM 17 m. The floodplain is only slightly greater than the HWM width here due to a narrowing of the valley as a result of a rock spur on the south side. The revised crossing design would consist of a relatively straight-forward, but long, span with no overbank flooding or channel avulsion issues. The design would also not interfere with natural bedload movement. The first photo below shows the old winter crossing location on the right, and the proposed revised location in the centre. The second photo is a closer shot of the revised crossing.

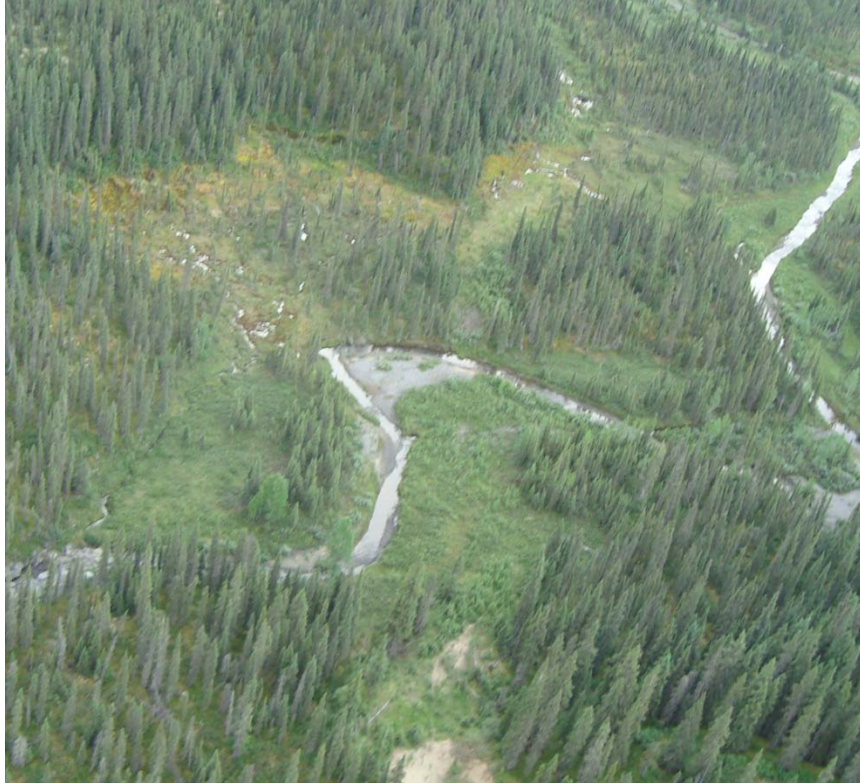
Km 43.15, lower Sundog tributary

This non-fish bearing crossing is in vegetated, open terrain. See photo below. The winter crossing crosses a broader part of the floodplain where overbank high flow has occurred in the past. The proposed all season crossing is about 15 m to the west (right) where the channel is more confined between stands of trees. At this location, the channel is about 5 m wide, and width at the HMW about 7 m. The approaches are also considerably drier. There is little risk of channel avulsion or overbank flooding at the proposed crossing location, as indicated by the lack of evidence of this. The crossing design includes large culverts, but flows and the limited bedload would easily pass through the reach with no constriction or accumulation, respectively.

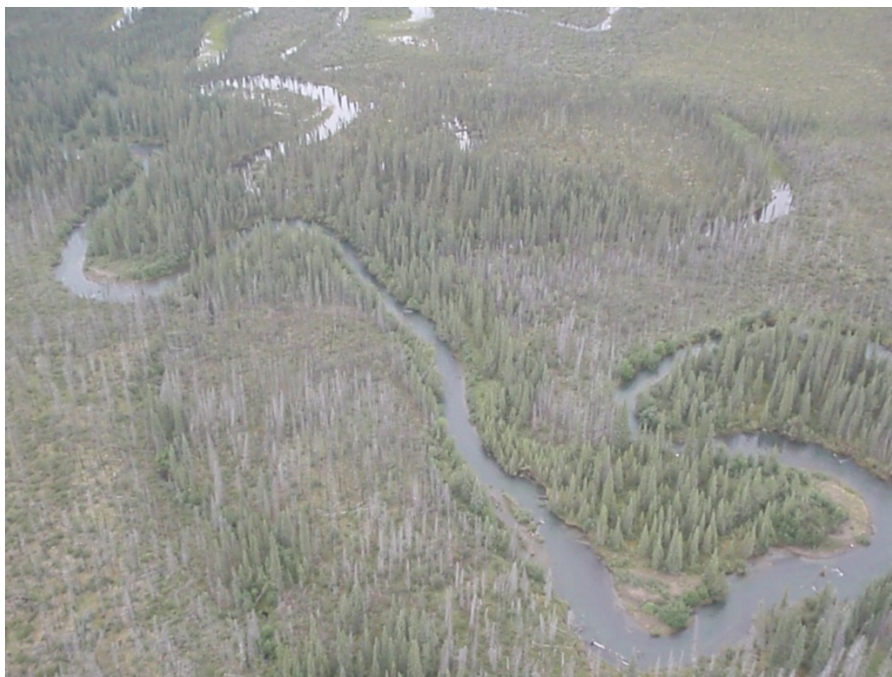
Km 53.55, Polje Creek

Polje Creek is a tributary of Sundog, and drains the Poljes. The channel is incised with banks 1-1.5 m high. Channel width is 6-7 m. The crossing location was chosen because of the straight and narrow channel, and absence of interfering meander bends and ox-bows on the approaches. The proposed span and abutments will be well above the stream due to the incised channel. Bedload is gravel and some cobble, and will pass easily.

The air photos of this crossing location attached show that, while there has been some change in the shape of the channel bends upstream and downstream since 1949, the channel at the crossing location has remained stable.

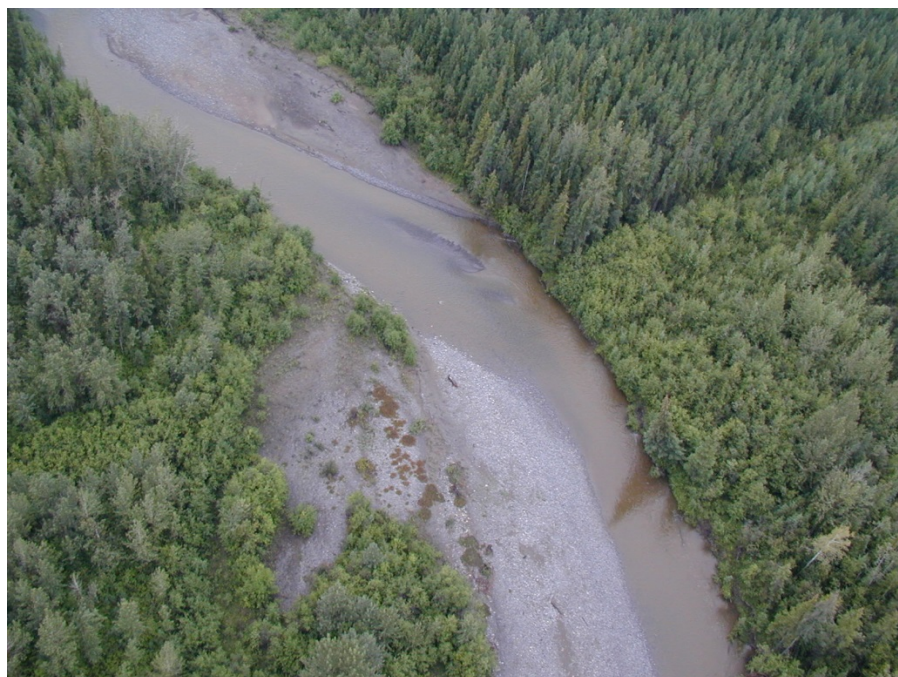
The proposed crossing location is also the old winter crossing location, but a few metres upstream. The channel and floodplain is about 25 m wide. See photo below looking south. Just downstream of the eastern abutment is an area where flooding occurred relatively recently judging from the river bank and absence of vegetation. The bridge approach will be armoured in this area against back-eddy erosion. Bedload is silt and sand and will pass easily. As noted by Allnorth, there are vegetated old meander channels in the area, downstream on the east side for example. There have been no significant changes to the current channel since the 1981 winter road. However, the 1949 air photo (Km 90) shows that changes have occurred since that time. The channel had a downstream flow direction just east of north in 1949, now it is just west of north. This process took approximately 30 years. Erosion of the eastern bank upstream is possible, but this is at about 75 m from the crossing. Erosion of the western bank downstream is also possible, started just beyond the crossing. These longer term processes could eventually affect the crossing, and should be monitored. Bank armouring may be required in future to protect the crossing abutments.

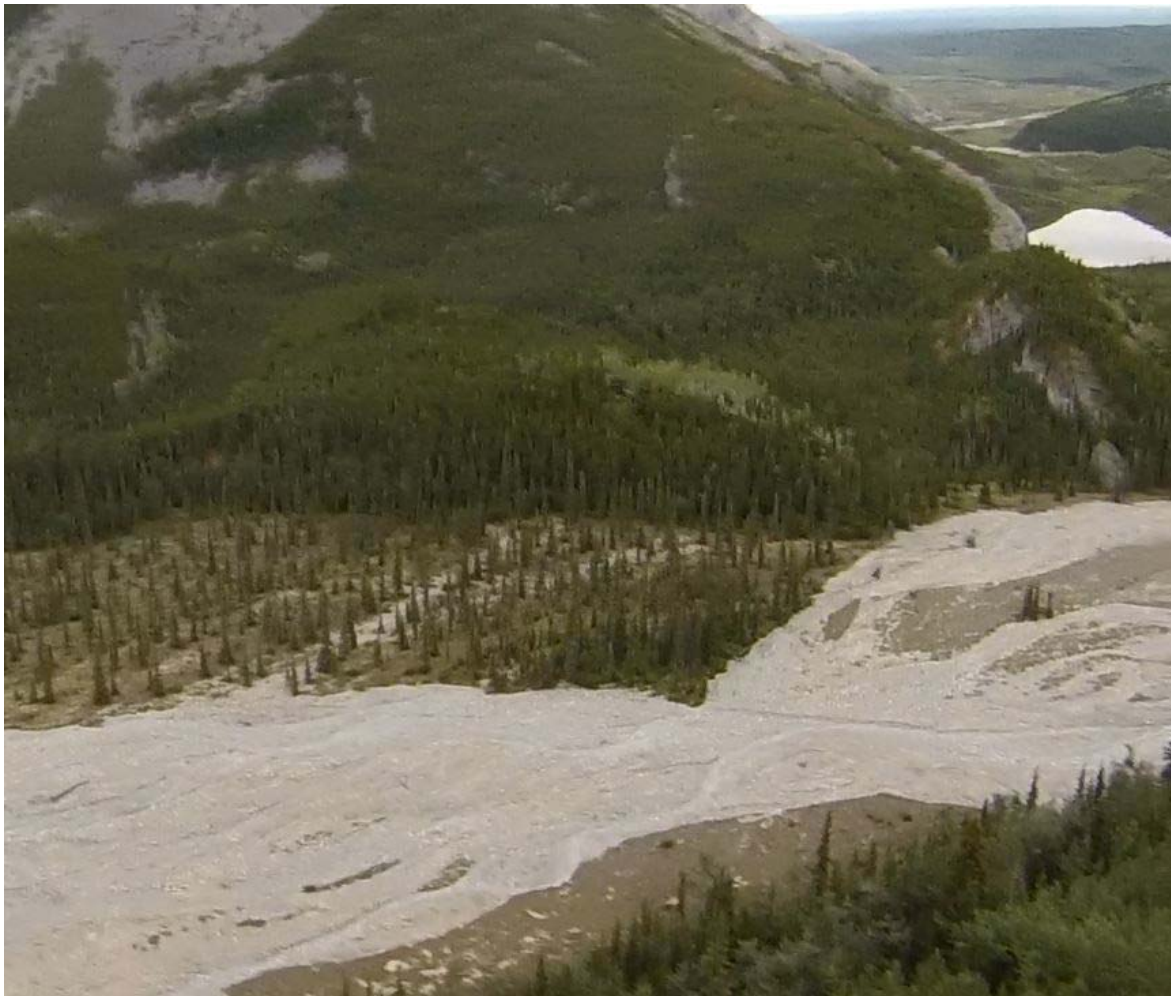
Km 118.1 originally, now Km 119, Grainger tributary

This crossing is on the preferred alternate road alignment, and is of a debris flow channel that only appears to flow during prolonged rainfall. The bedload is coarse cobble, so it is possible that lower flows move within the cobble and are not visible. Regardless, during high water, it is a high energy system. The proposed crossing location has been moved 1.2 km downstream to accommodate an alignment change. This was in response to terrain mapping which identified an unstable area on the eastern bank. A detour around this area is impractical because of grades. The new crossing location avoids the unstable area. The 2012 LiDar shows the crossing to be dry at the time of air photo capture. At least two channels about 3 m wide are visible on the east side of the crossing, within a floodplain area about 37 m wide. The photo below shows that there is old floodplain on the western approach about 30 m wide. There is even older floodplain on the eastern approach, as indicated by mature tree cover, however there are channels in this floodplain which periodically have carried water. Multiple large culverts are proposed across the active floodplain, large enough to pass high water flows and bedload. In addition, the western approach will be armoured against high water flows departing from the floodplain, and the eastern approach will need to address the channels in the old floodplain. The 1949 air photo shows the eastern floodplain area as inactive at the time, but with less vegetation than at present. The eastern abutment of the crossing location is visible as a stable 'island'. Hence, the active channels at the crossing location seem to be stable in terms of alignment.

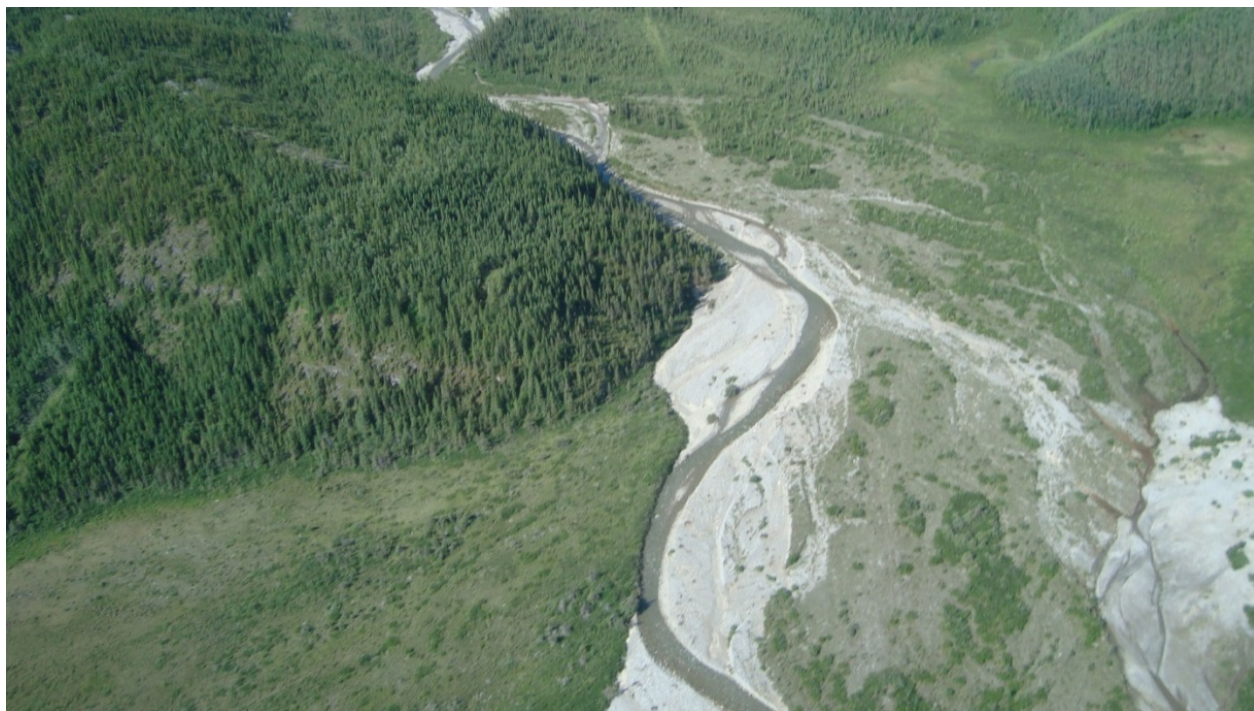
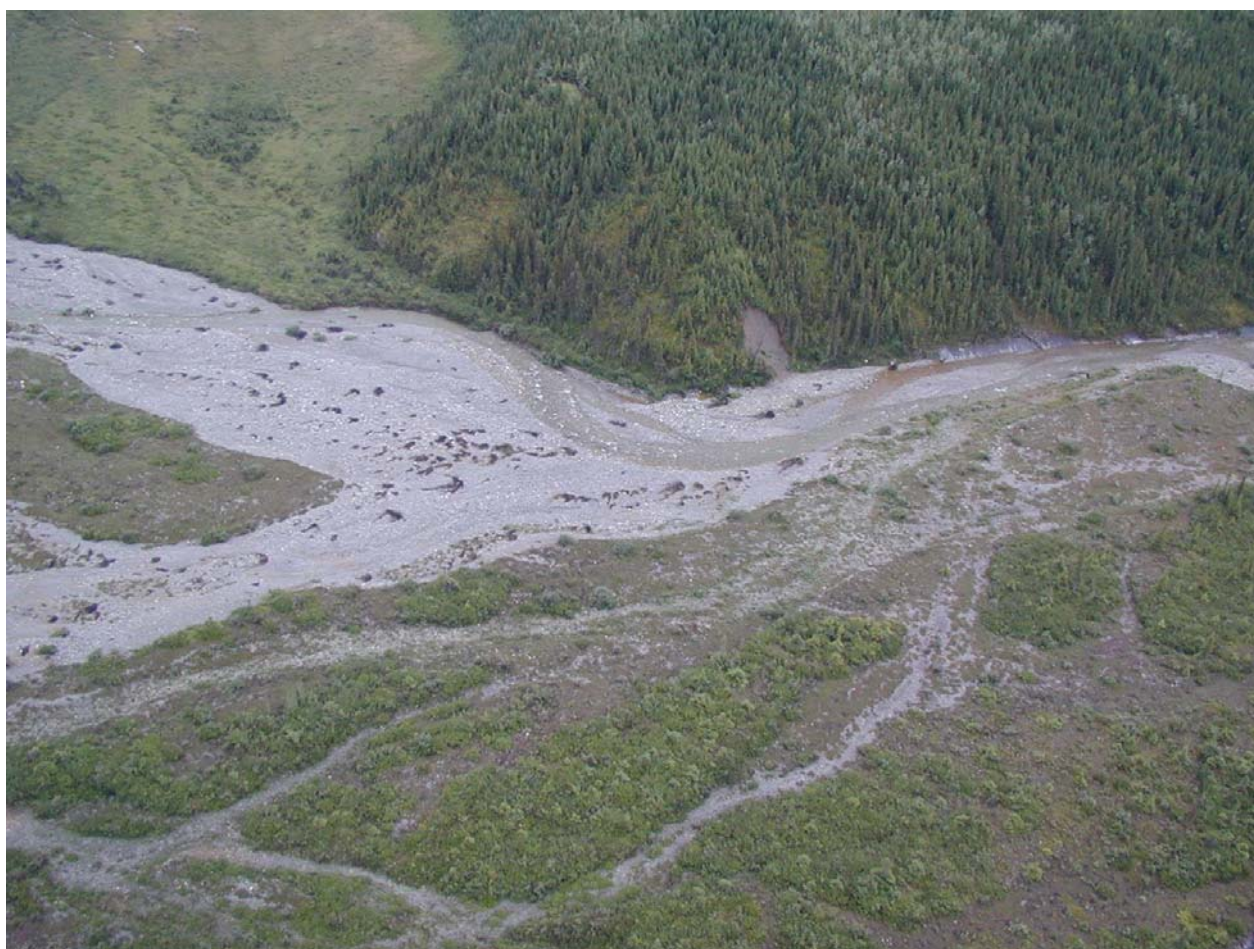
The air photos (Km 125) show that the hydrology in the area of the crossing location has changed since 1949. In 1949, the floodplain area and channels south-west of the crossing were active and un-vegetated. This area is now vegetated. Despite these differences, the channel at the crossing location does not appear to have changed significantly. The engineering works described above should ensure that this remains the case.

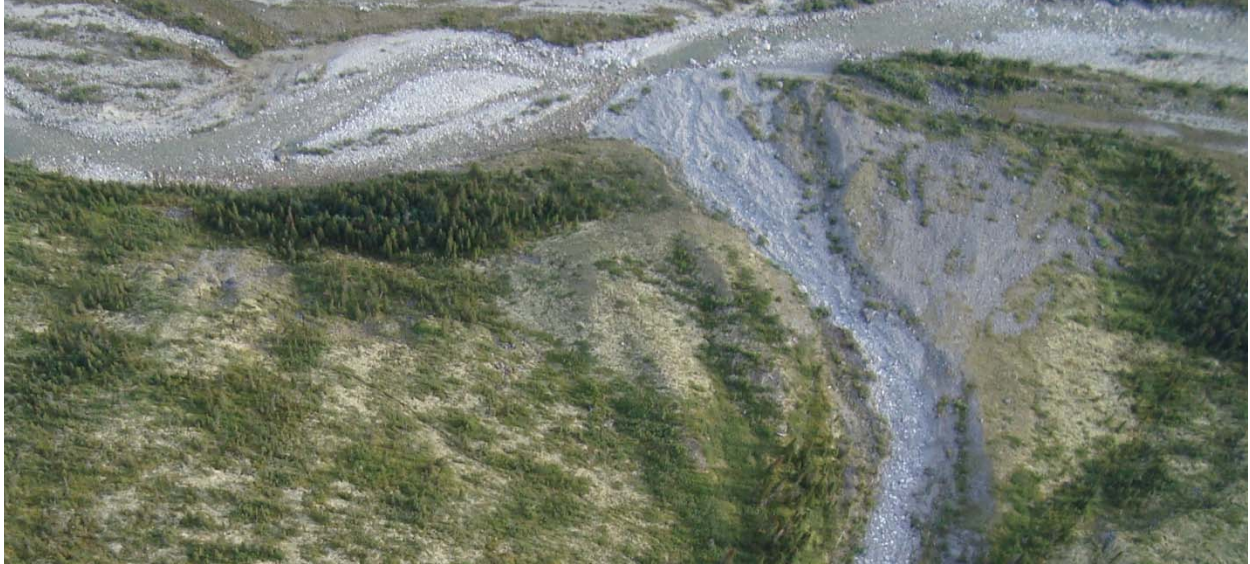
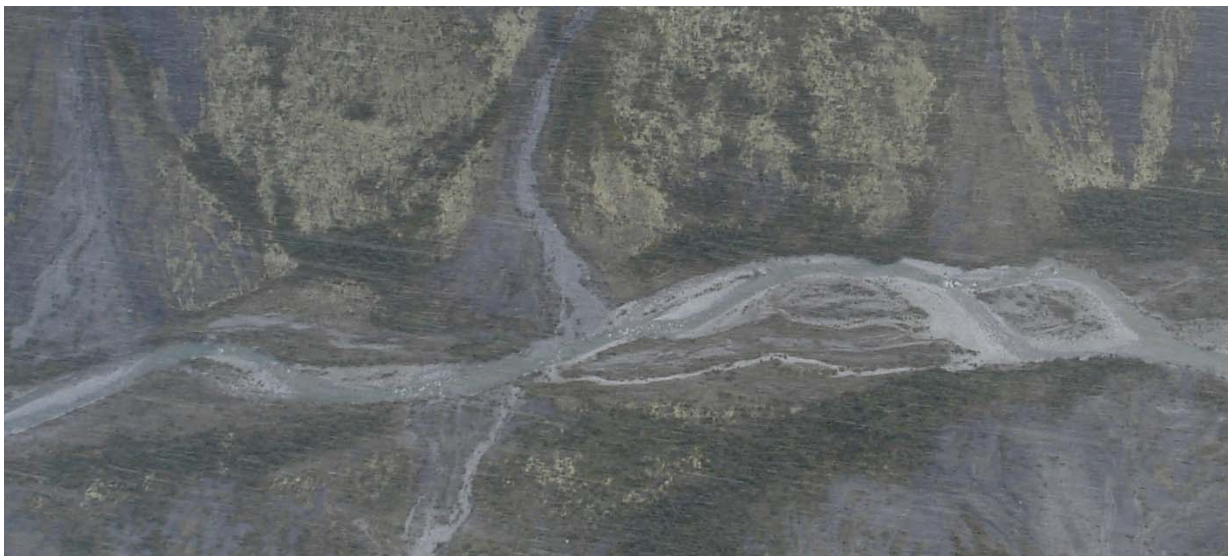
The Km 29-33 road section is discussed with reference to the maps contained in the DAR, Appendix 1, Appendix I. The map on page 9 shows the section. Along this section, the road can be set well back from the creek by using stabilized and vegetated old floodplain, as the winter road alignment did previously for the most part. The winter road alignment is visible in many places, and has not been affected by the creek since construction. There are a few places where the proposed all season road alignment is proximal to the creek. The IR refers to Km 30.6, however the locations where the road is in closest proximity to the creek are Km's 29.8, 31.2 and 31.6. The photo below shows the Km 29.8 location. Note that the winter road is visible on the vegetated bank, but the alignment has been buried under a debris fan. The all season road will cut through the debris fan and maintain the alignment on the bank well away from the creek. The debris fan crossing will include large culverts to pass the material. The 2nd photo below, looking south, shows the Km 31.2 and 31.6 locations. The Km 31.2 location on the right appears to be the closest to the creek. However, vegetated bank is visible, and the all season road will be about 8 m from the creek. For the Km 31.6 location, the old winter road is visible st back from the creek. Therefore, these photos show that the risk of channel avulsion affecting the road over this section is low, and that the better resolution than the maps in the appendix provides a clearer impression of this.

3. Avulsion hazards are discussed below with reference to the Km 29-33 road section adjacent to lower Sundog Creek. The section from Km 33-38 was addressed by Allnorth in their March 18, 2016 report, submitted with our response to the Reasons for Decision (RfD) on Adequacy of the DAR. The lack of avulsion hazard along Prairie and Funeral Creeks is explained in our reply to Board IR7 below. For other road sections parallel to watercourses, such as Tetcela and Grainger Rivers, the road is set well back from the river bank and not at risk.

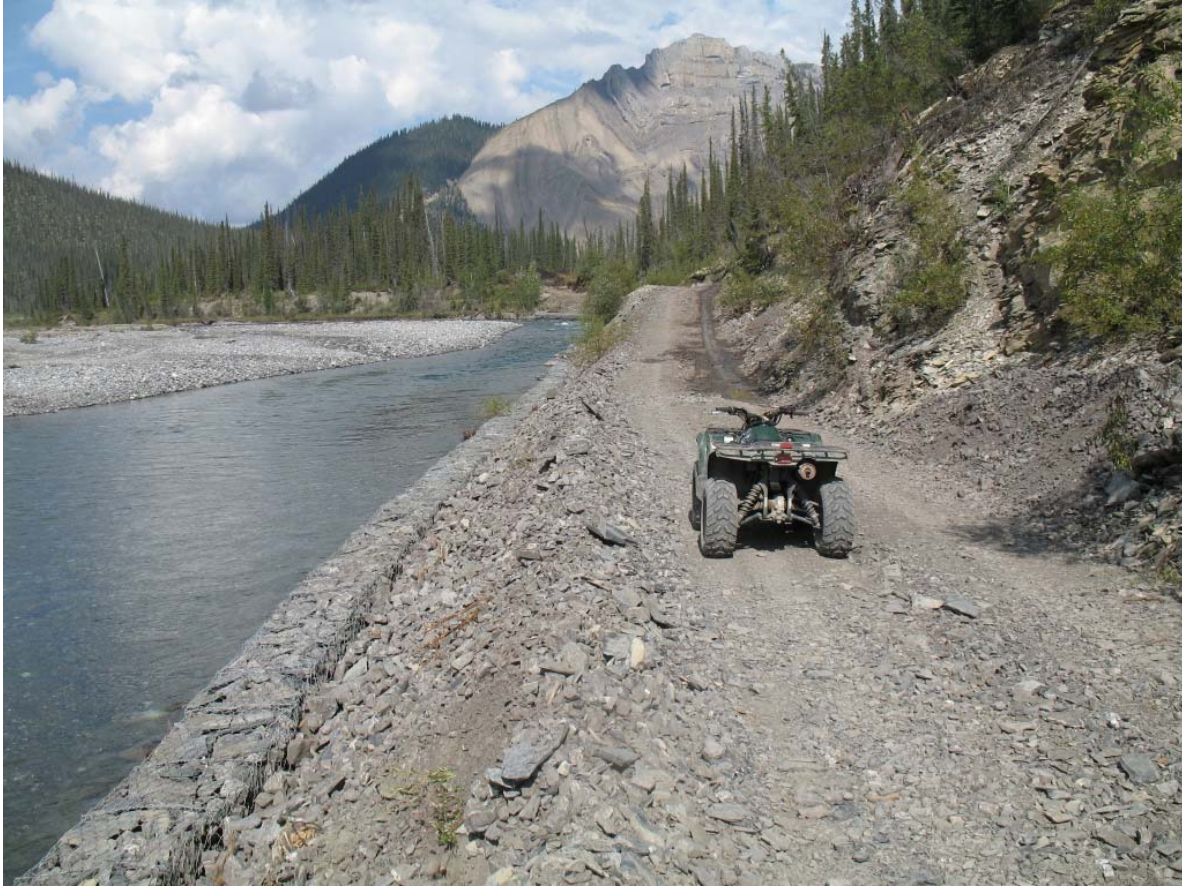
The photo below is at Km 3.6. Sections of the road along Prairie and Funeral Creeks were subject to erosion during the flood events in 2006 and 2007. Note, Cadillac did not armour the road, and erosion prior to these dates had not occurred. CZN re-established the road after the events by installing anchored gabion baskets to rock ledges, and re-building the road bed behind.

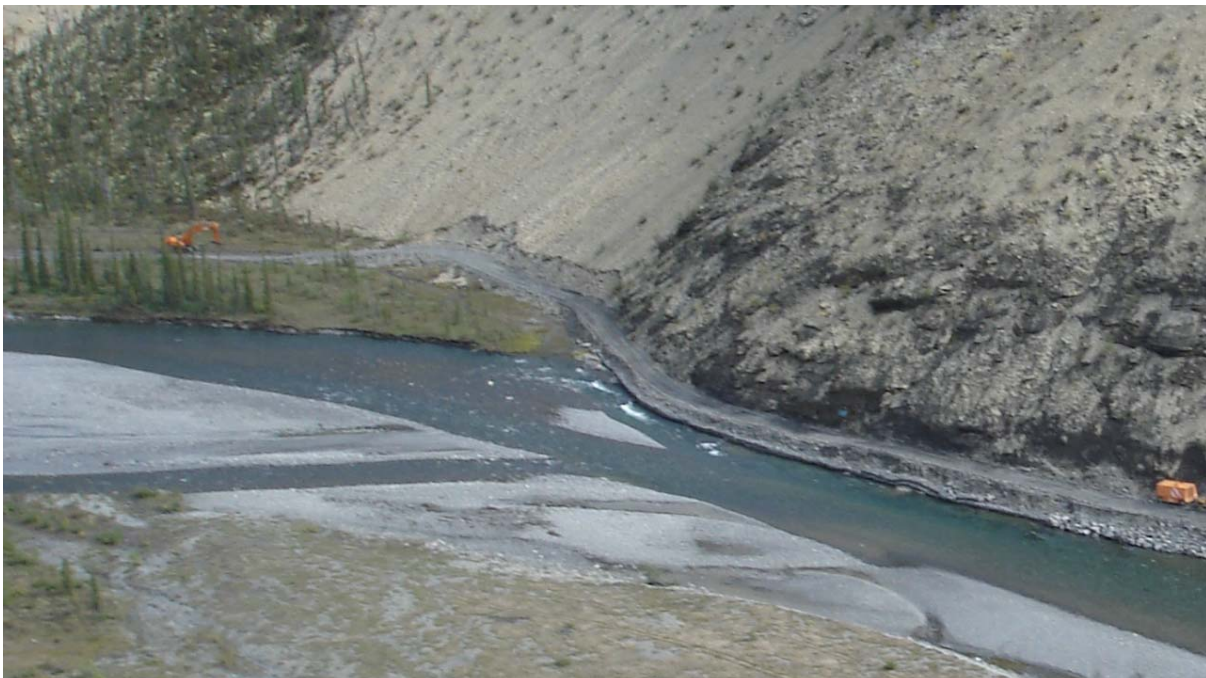
The photo below shows Km 4.2. A meander of Prairie Creek eroded the winter road away at this location. CZN re-built the road by re-aligning it back from the creek. The main channel has since moved to the west side of the floodplain.

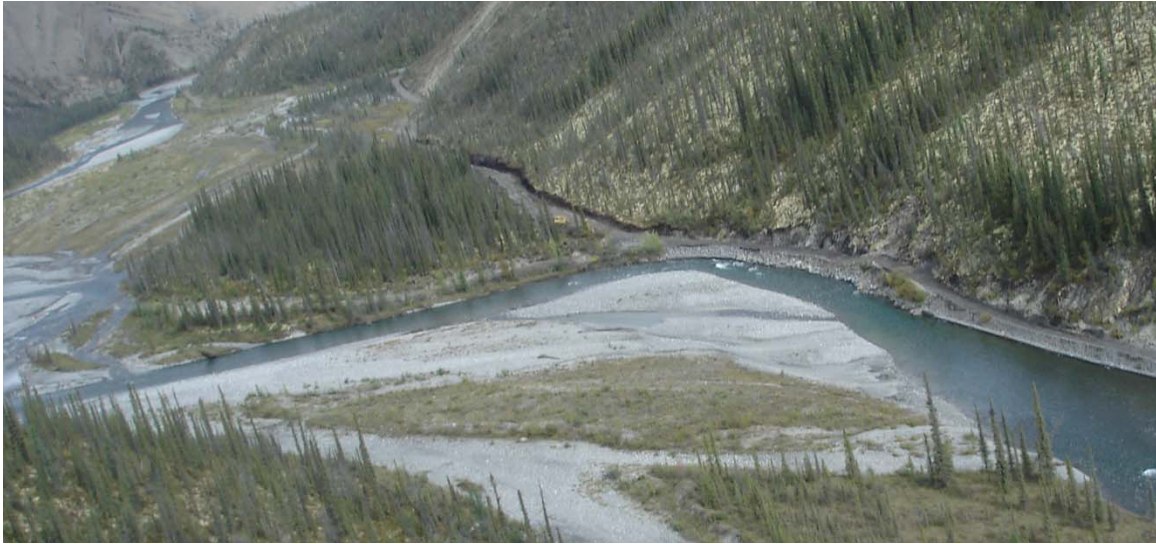
The photo below shows the road section Km 5.3-5.7. The first part is another portion of the road that was eroded and re-built with gabions and armour. The 2nd part is a road re-alignment built because the creek completely removed the old winter alignment at Km 5.7 where a spur projects west into the valley.

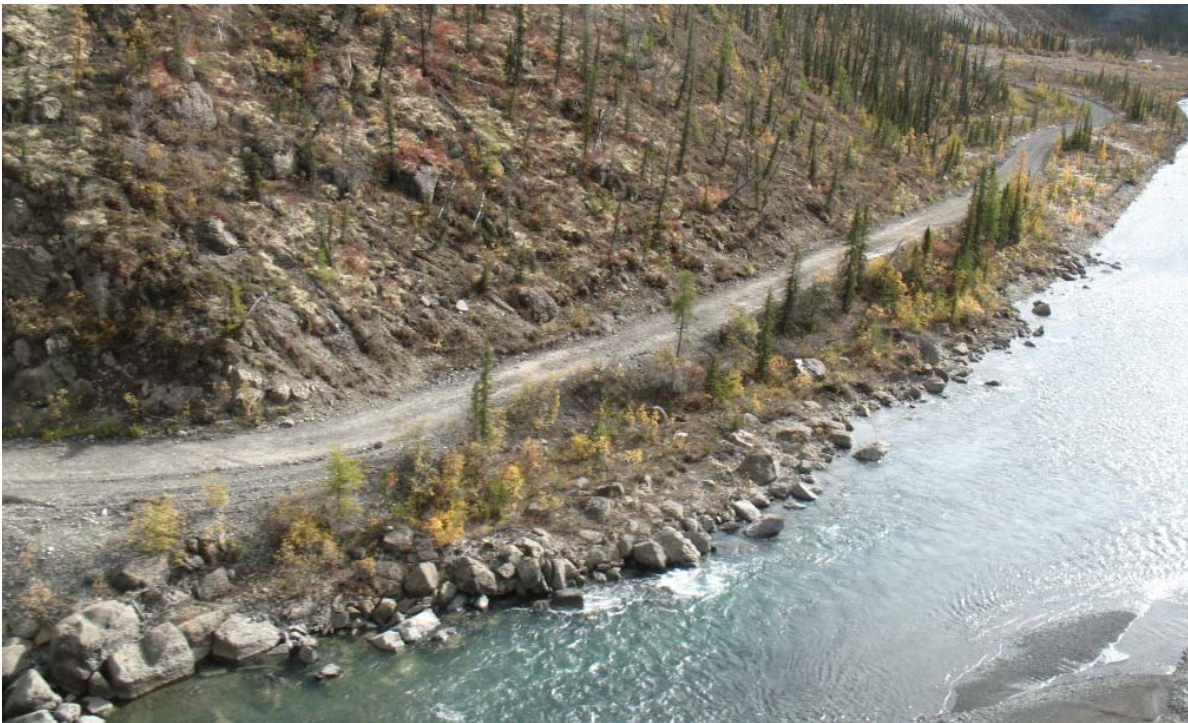
The photo below shows the road section Km 6.4-6.7, where the road is set back from Prairie Creek.

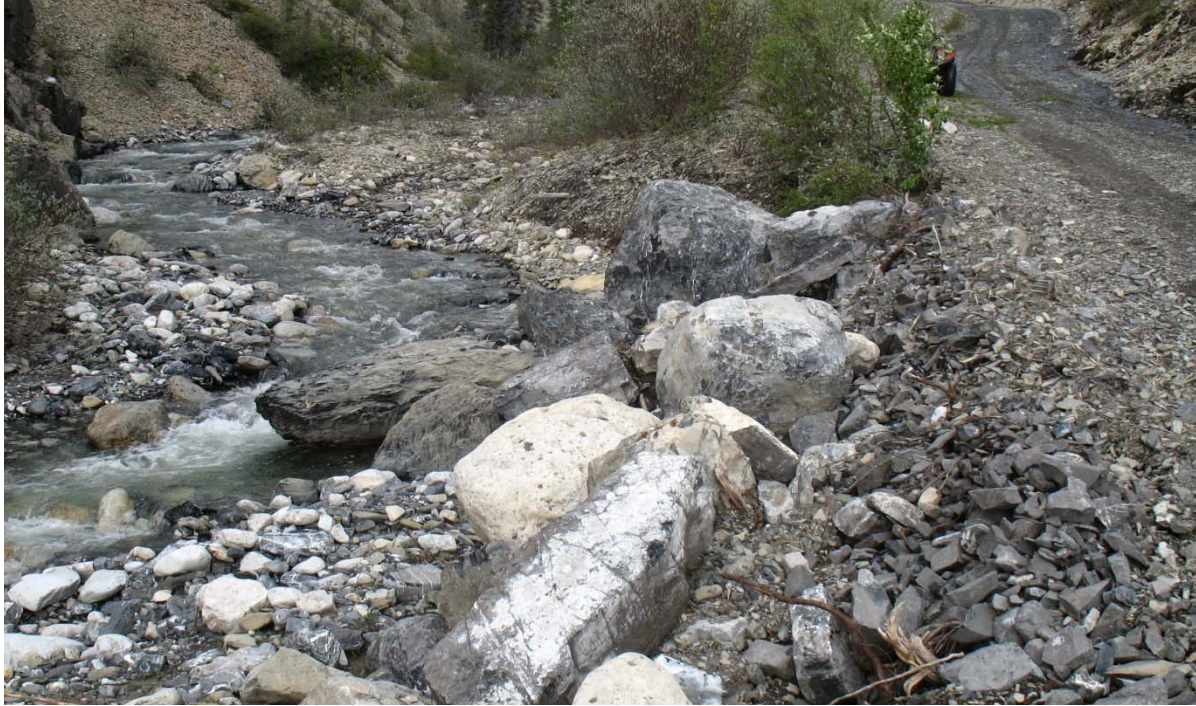
The photo below is at about Km 8.4. This is one of several locations along Funeral Creek where the road was eroded at meander bends during the 2006-2007 flood events, and where armour was subsequently placed.

The purpose of the discussion above is to demonstrate that erosion risks at meanders bends adjacent to Prairie and Funeral Creeks manifested themselves previously and have been addressed. Regarding the Polje Creek crossing location, historical air photos show that the present channel has been stable for some time, and this is not likely to change during the life of the project. The same is true for the Tetcela crossings, even at Km 89.8 where some changes in the channel have occurred since 1949.
