Our File: EA1415-01

CanZinc responded to the first round of information request (IR) on May 9th, 2016. Some of the responses were not input into the online review system table but rather input as an attachment. The IR responses that were attachments to individual IRs have been compiled here into one pdf document to assist parties. The individual IR responses included are:

REPLY TO DFN IR15

PRAIRIE CREEK ALL-SEASON ROAD

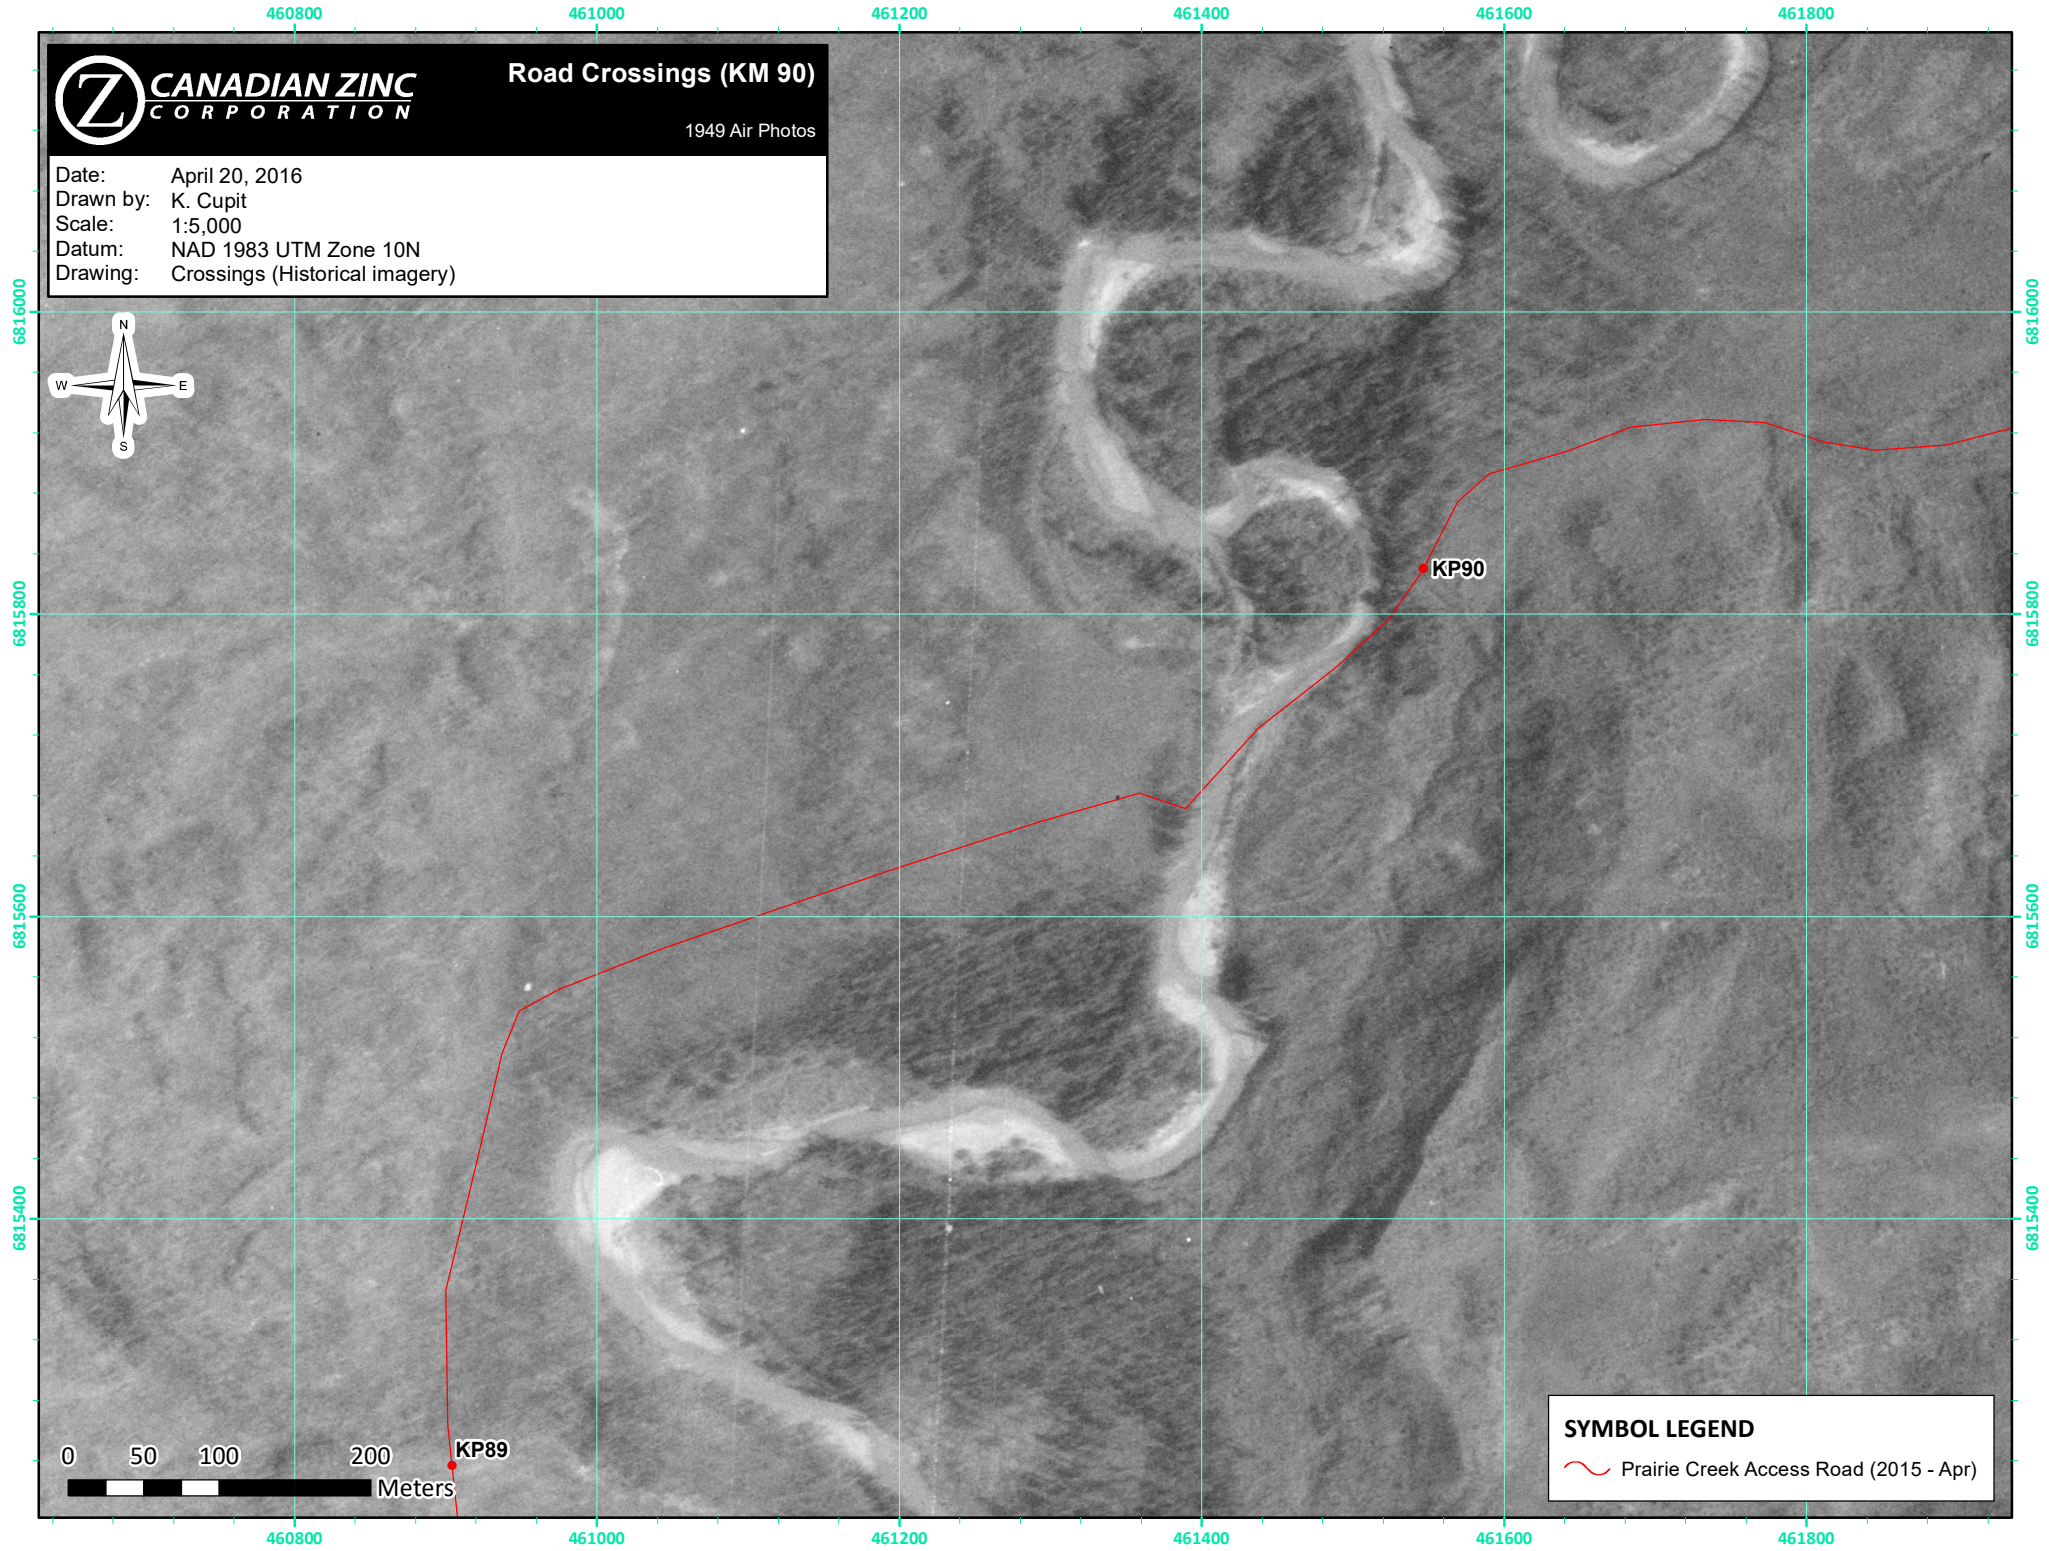
1949 Air Photos

Date: April 20, 2016
Drawn by: K. Cupit
Scale: 1:5,000
Datum: NAD 1983 UTM Zone 10N
Drawing: Crossings (Historical imagery)

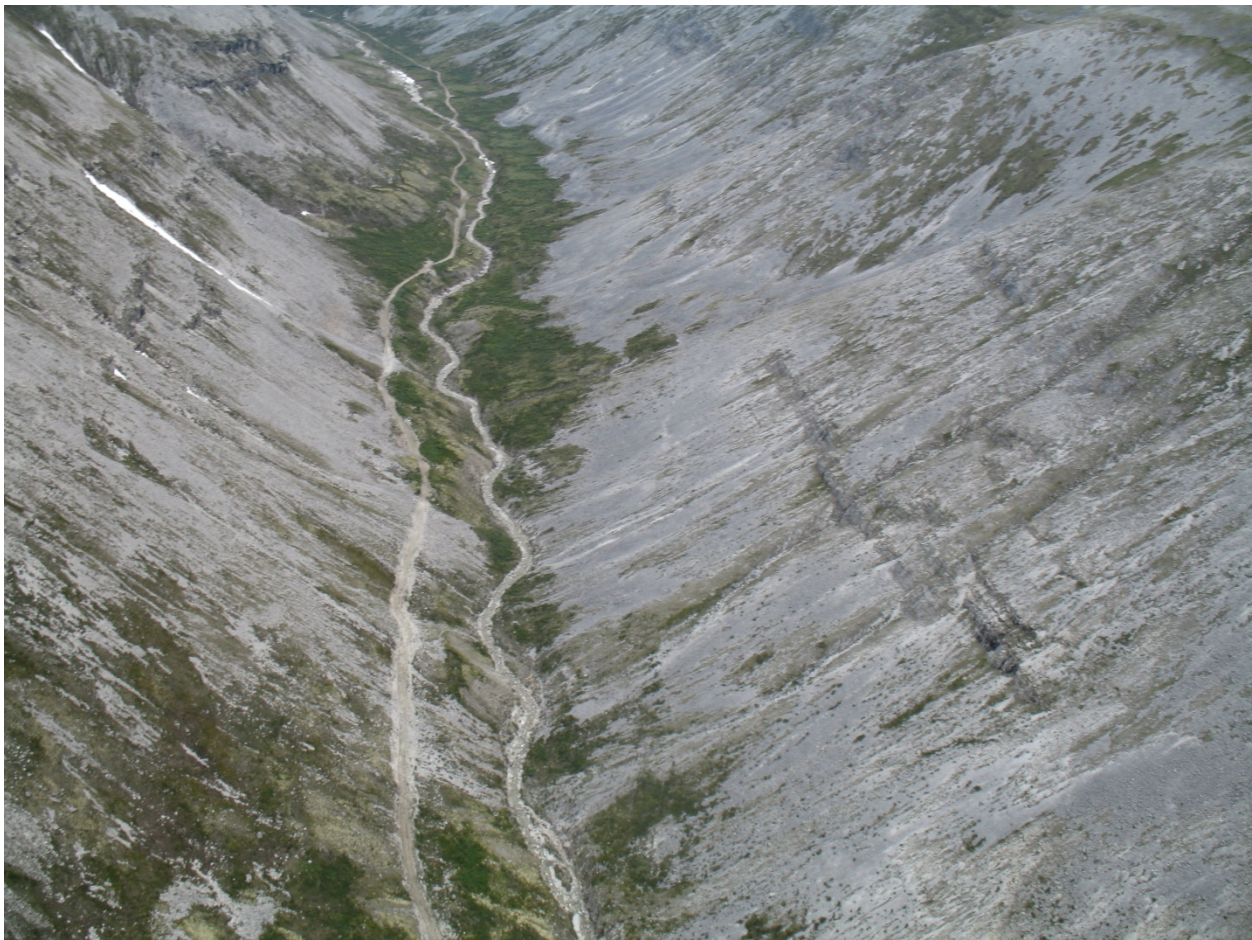
Alpine terrain over this section is sparsely vegetated. The photo below shows the road crossing rocky slopes and some vegetated patches. Note, this section of the road to Km 26 was the subject of road maintenance several years ago, so was disturbed quite recently. Revegetation where the road crosses the patches will take many years because of the short growing season, but will occur eventually. In the meantime, the road footprint is not dissimilar to the adjacent slopes.

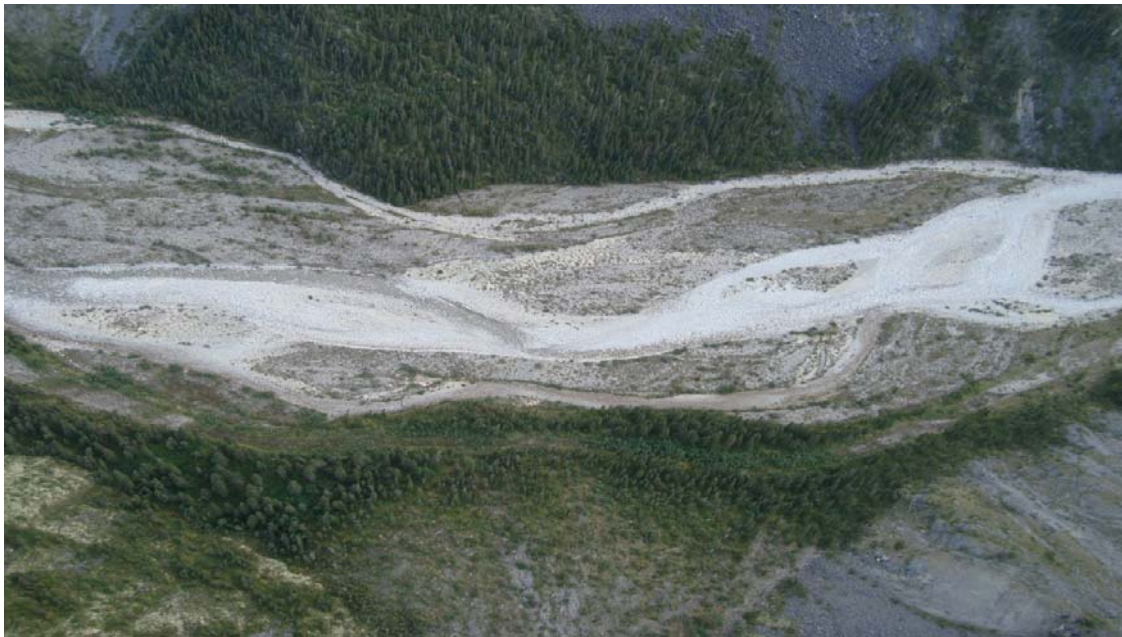
Km 29-40, Lower Sundog

The road crosses the old floodplain section of Sundog Creek. Again, there are gravel sections and vegetated sections. The photo below shows the road which has not been disturbed since 1981. Note, the alignment is still clearly visible, but revegetation is progressing well in more densely wooded areas.

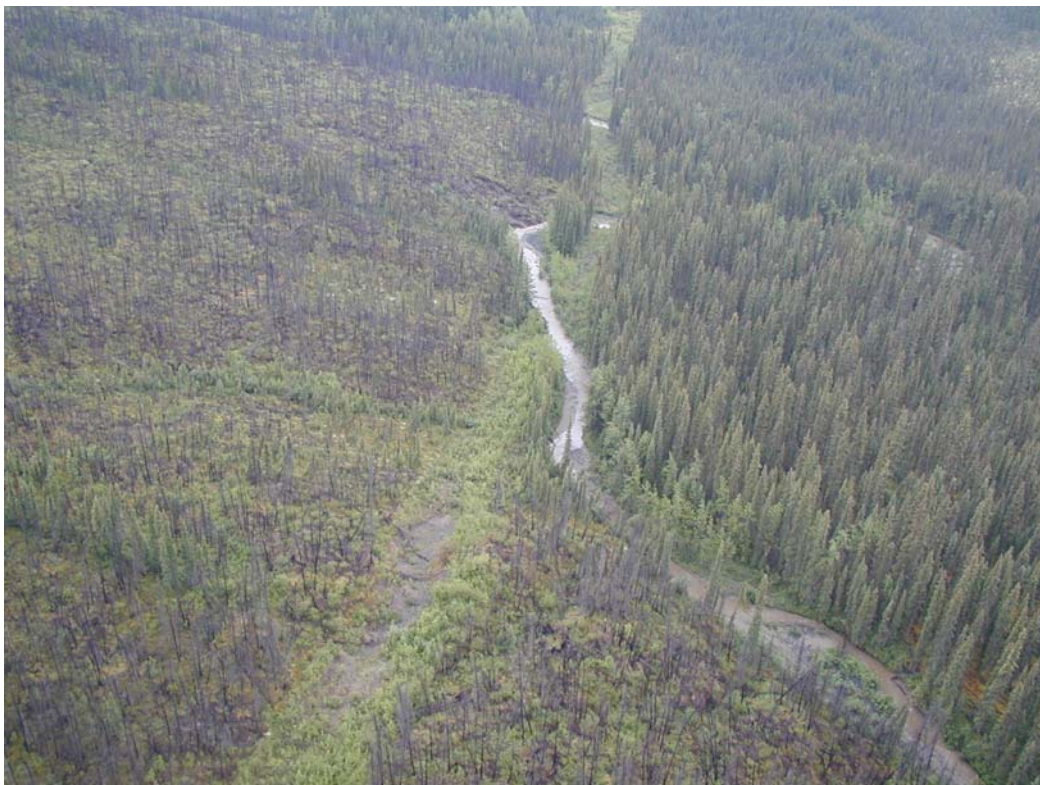
Km 40-54, Polje Creek

This section of the road crosses more wooded, lowland terrain in the catchment of Polje Creek. The western part is well vegetated, but the eastern part is more sparsely vegetated due to relatively recent extensive burns. The photo below is typical of the western section. Under-story vegetation was redeveloped in the road alignment, although tree cover has yet to re-establish. Discontinuous permafrost is likely to be present in places, however as shown in the photo, has not altered drainage or inhibited revegetation significantly. The photo after is another from this area, but more to the east. Scrub bush has re-established comparable to adjacent areas, and tree growth has started but is in the early stages.

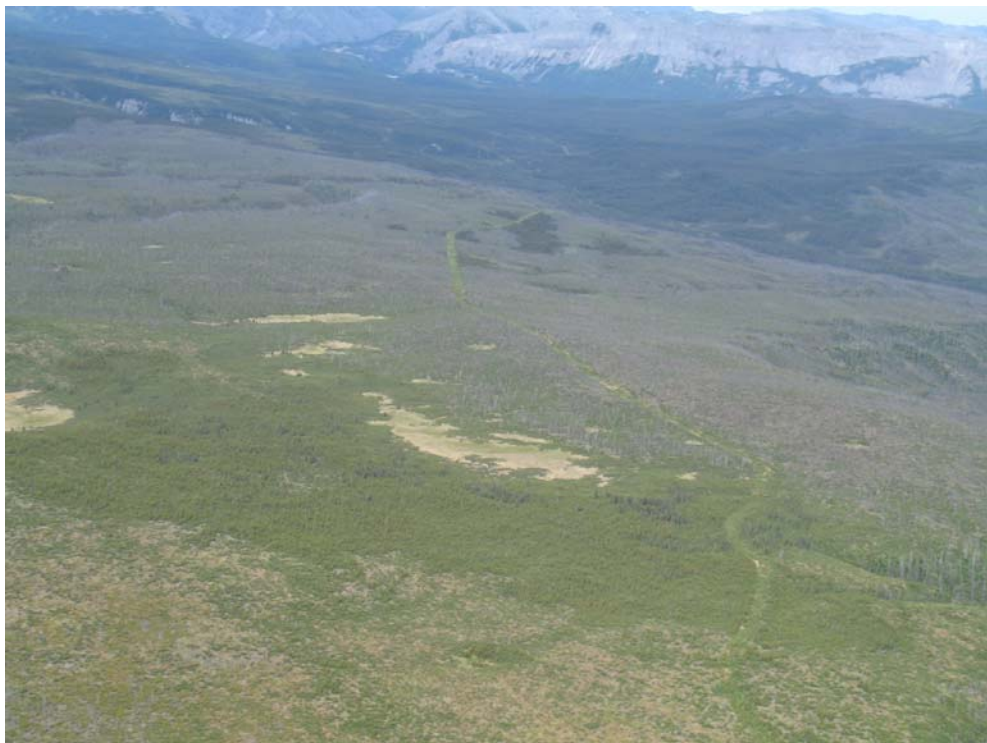
Km 54-84, Ram Plateau

Soil cover on the plateau is mostly thin, and therefore the vegetation is generally sparse with some wooded sections. As for other areas, the photo below shows that vegetation has re-established in the alignment, but its composition is not yet as dense or the same as adjacent areas. However, in places, the alignment is not discernible, as in the foreground of the photo.

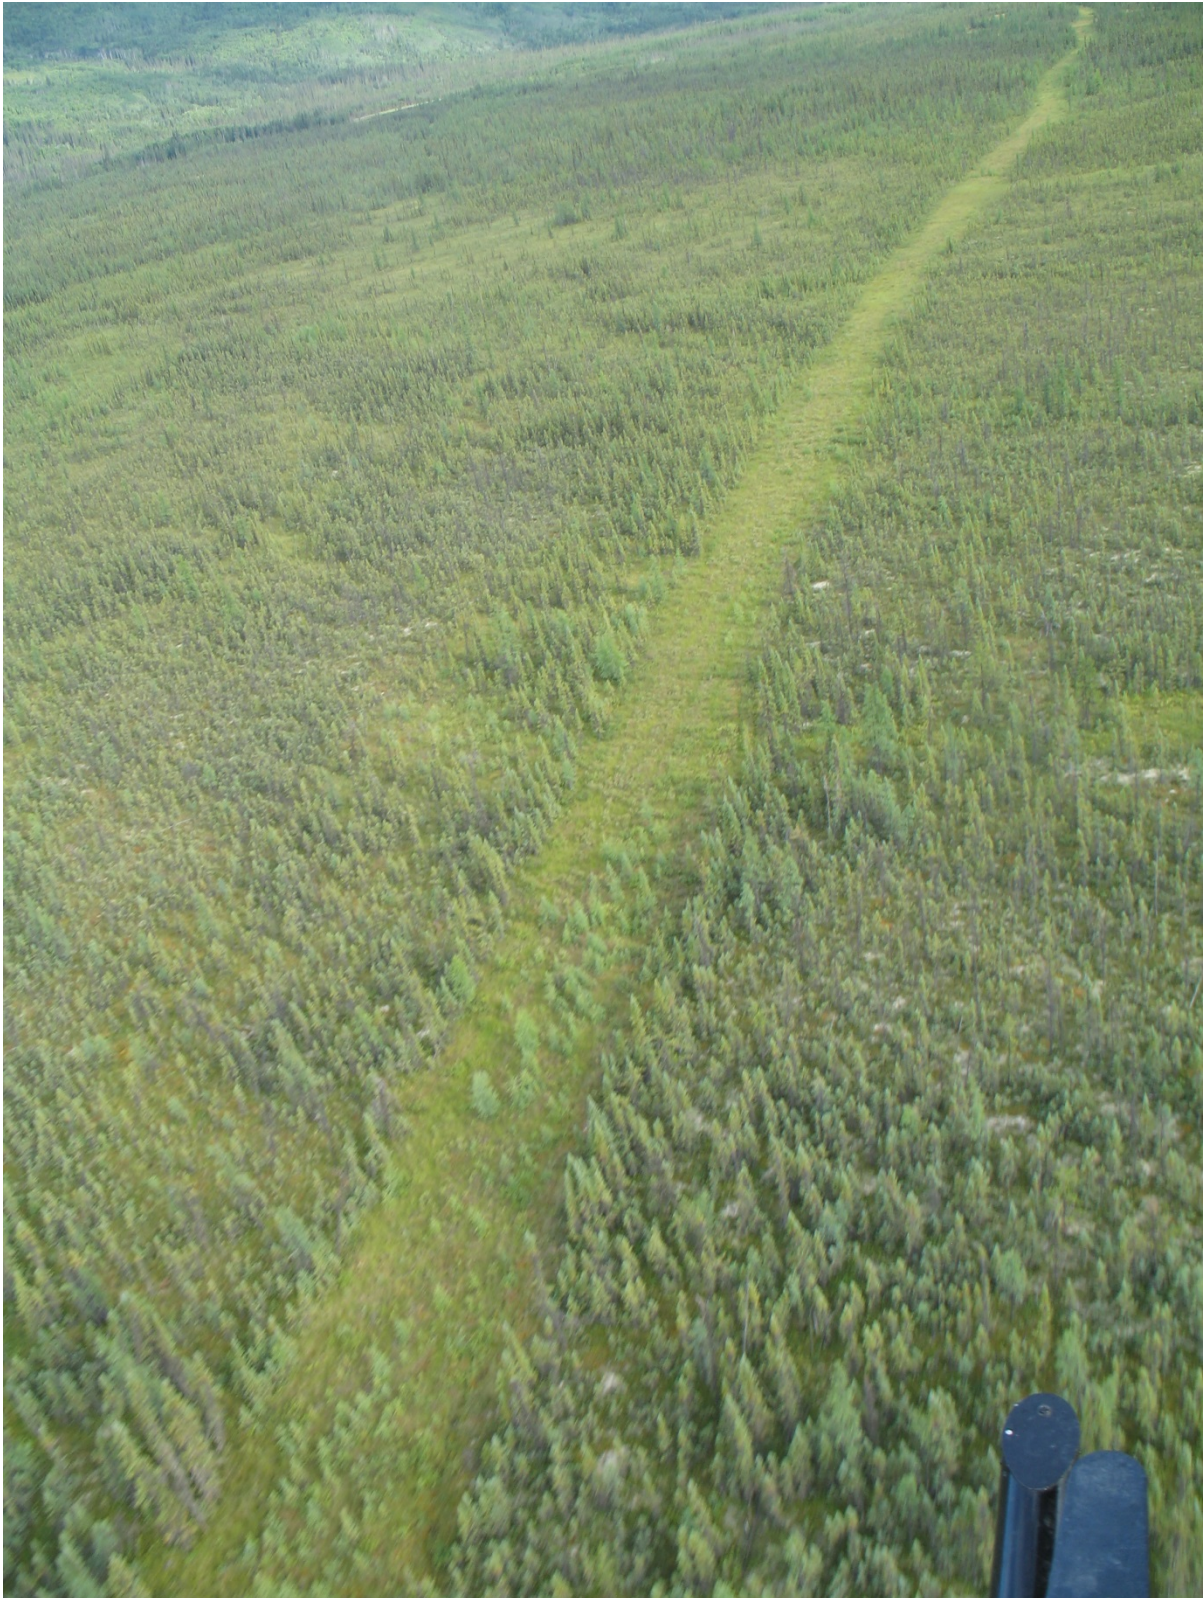
Further east as the plateau descends to the Tetcela valley, vegetation is more developed. The photo below shows that grasses and low bush dominate in the alignment, but in the foreground tree cover is re-establishing, and in the longer term we would expect the pre-disturbance assemblage to completely return.

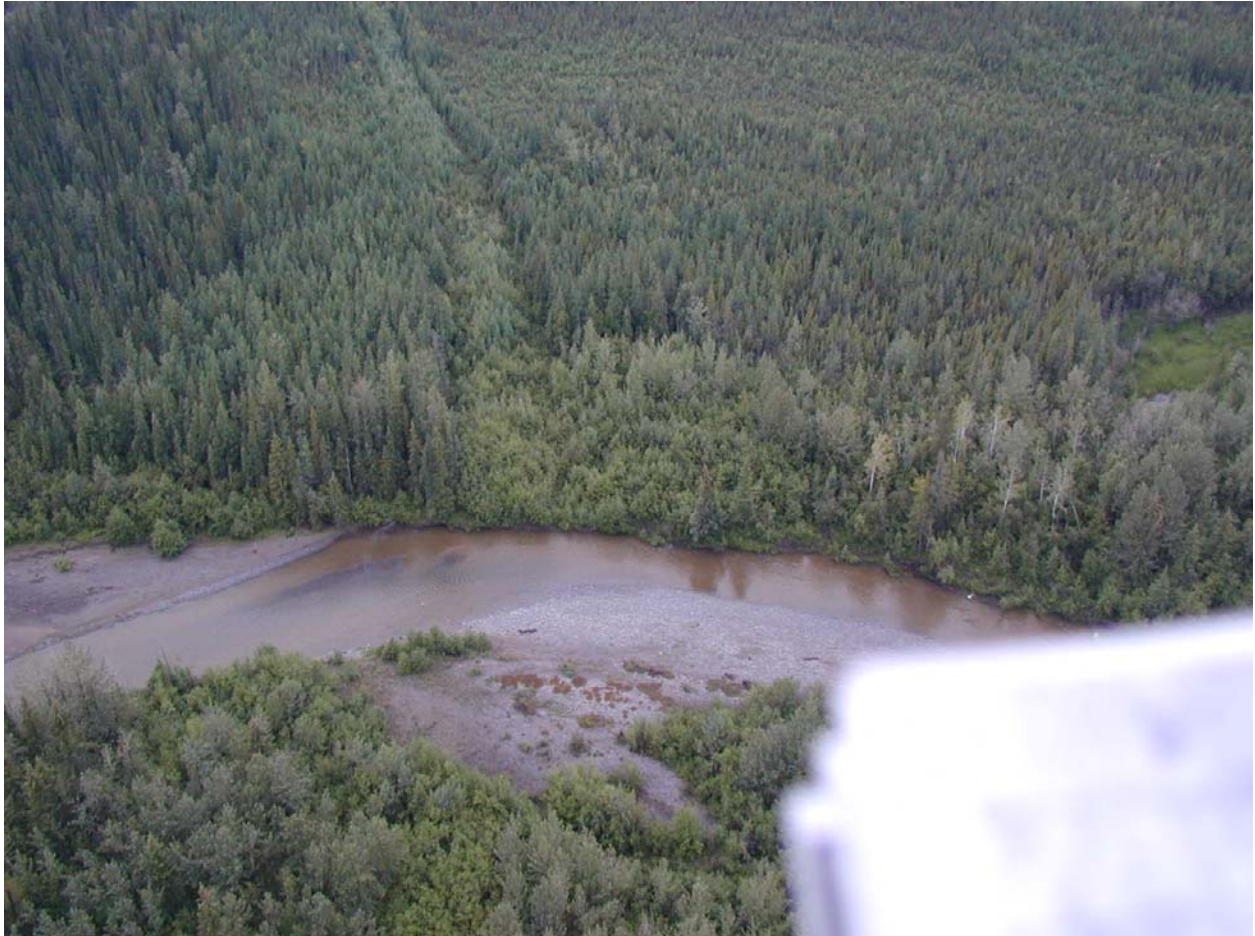
Km 84-90, Tetcela valley

The Tetcela valley is densely wooded. The photo below and one of the stream crossings shows that the alignment has revegetated significantly, and that the tree cover is approaching the same density and height as adjacent areas.

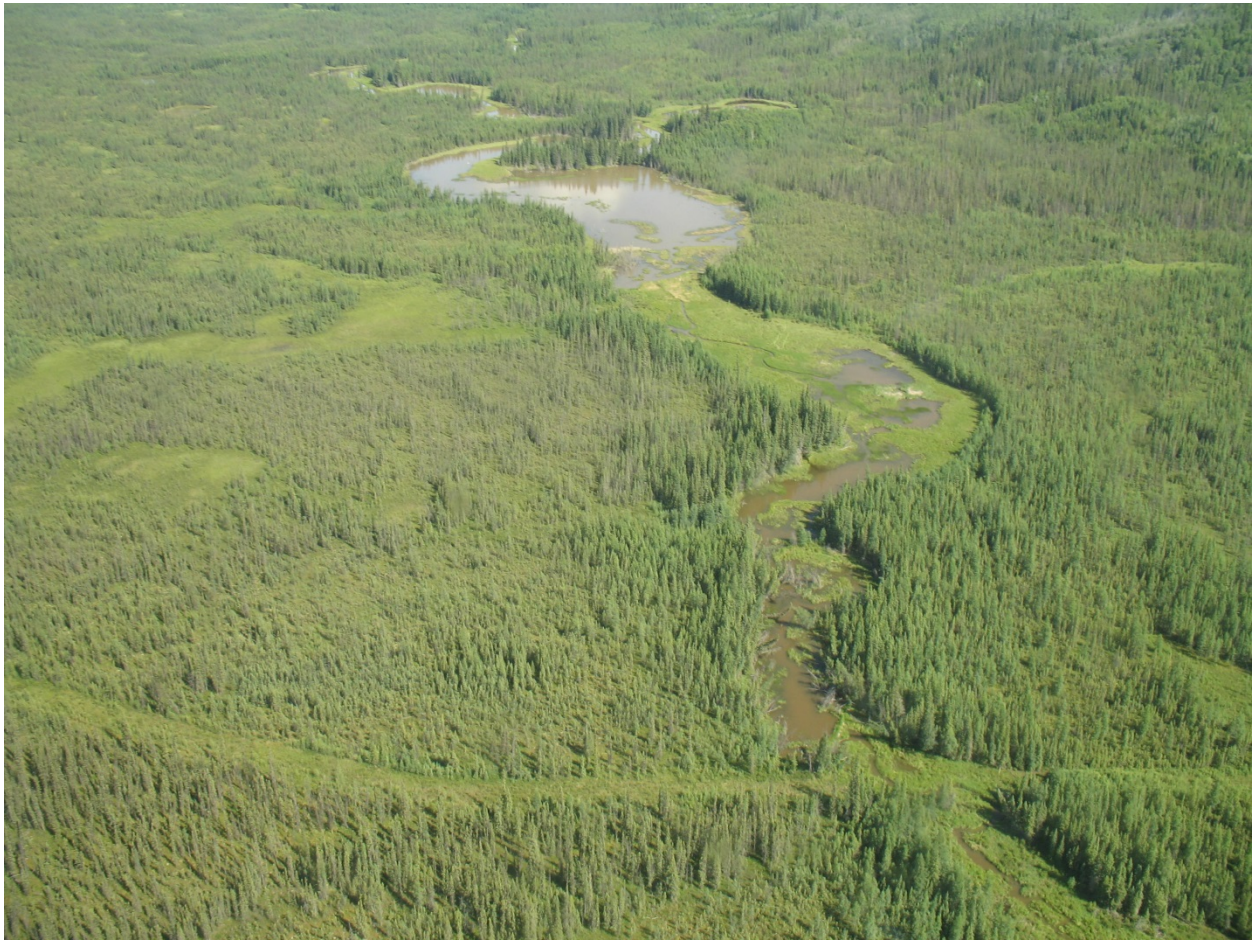
Km 90-96, Fishtrap Creek

The road crosses marshy terrain either side of the Fishtrap Creek wetlands. The photo below shows that ground cover has re-established in the alignment, but like other areas, re-developed of tree cover, while it has started, will take longer.

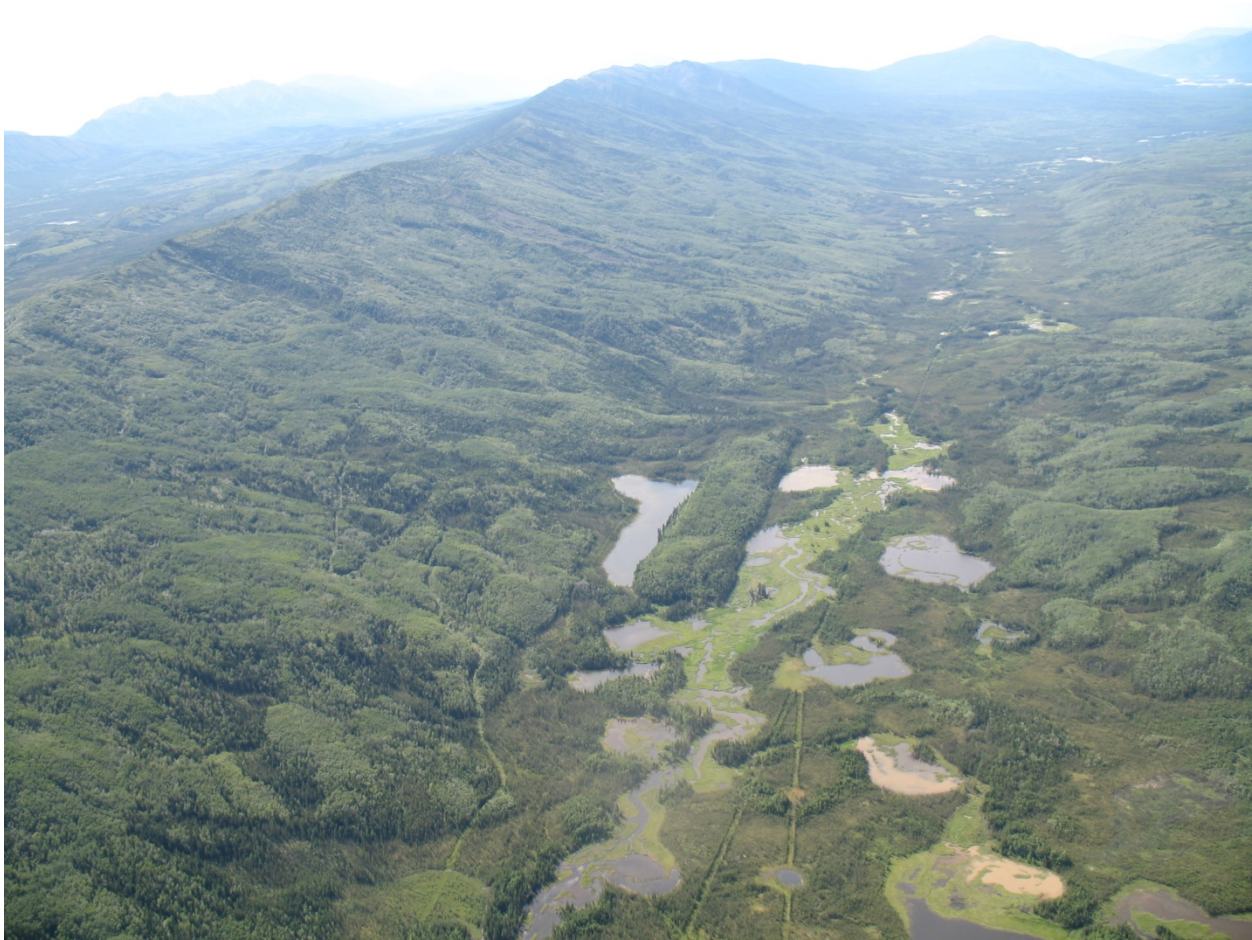
Km 96-102, Silent Hills

The Silent Hills have densely wooded slopes. The photo below from 2009 shows the alignment and switch-backs ascending the slope. Tree regrowth in the alignment is well advanced in places.
