NEB Files: 3400-P097-1 & 2620-D-4-7

Re: Cameron Hills Gas Pipeline approved under National Energy Board Order XO-P097-02-2002 as amended

**Environmental Assessment and Remediation Plan
For the Erosion Issues at the Paramount Resources Ltd.
Cameron Hills Gathering System and Transborder Pipeline**

August 7, 2002

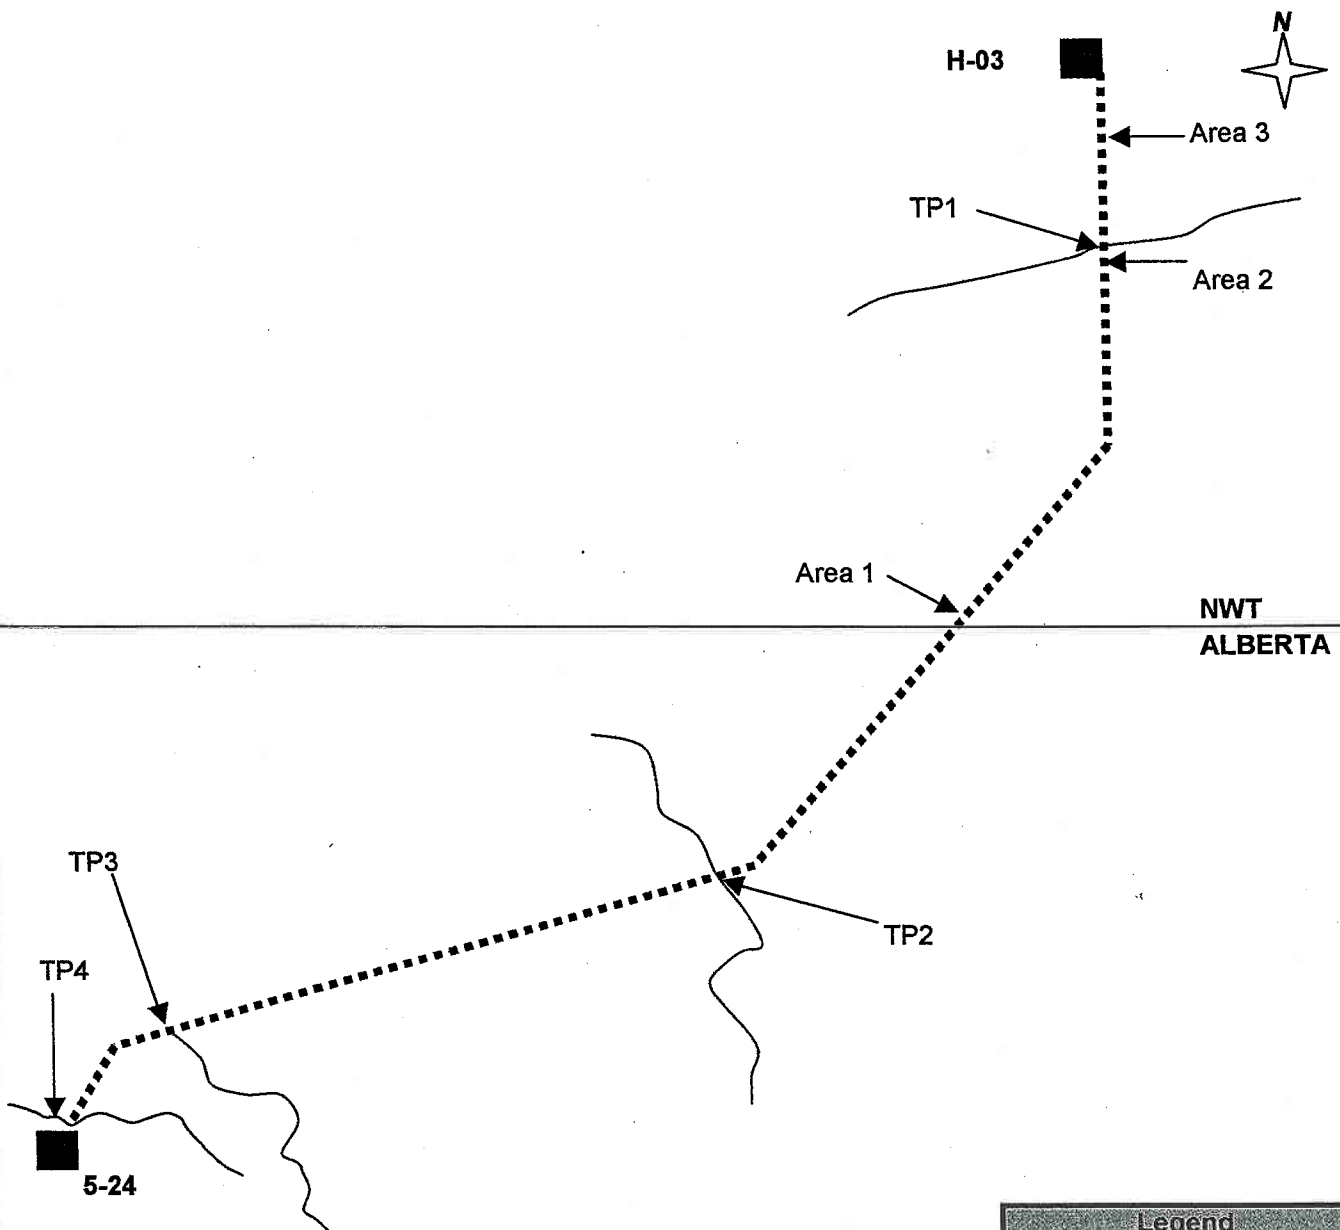
Location: Area 1 is located directly north of the Alberta/NWT border, GPS: 60° 00' 15"N; 117° 31' 29"W (Figure 1).

Location: Area 2 is located approximately 300 metres south of TP1 creek at GPS: 60° 01' 24"N, 117° 30' 00"W (Figure 1).
