DATE February 1, 2012**PROJECT No.** 09-1427-0006/20000/20100**TO** Dave Colbourne
DXB Projects / PWGSC**AECOM DOC. No.** 000-GEN-0-MEM-0006-Rev2_20120201**CC** Rudy Schmidtke, AECOM**GAL DOC. No.** 154**FROM** Darren Kennard**EMAIL** dkennard@golder.com**PUBLIC ACCESS CONTROLS ABOVE ARSENIC STOPE B2-08, GIANT MINE REMEDIATION PROJECT****1.0 B2-08 CROWN PILLAR STABILITY ASSESSMENT**

Project title/Titre du projet
**GIANT MINE
REMEDATION PROJECT
YELLOWKNIFE, N.W.T.**

POTENTIAL SURFACE SUBSIDENCE
ARSENIC STOPE B2-08,
RECOMMENDATION FOR FENCE
TO ADDRESS PUBLIC HAZARD

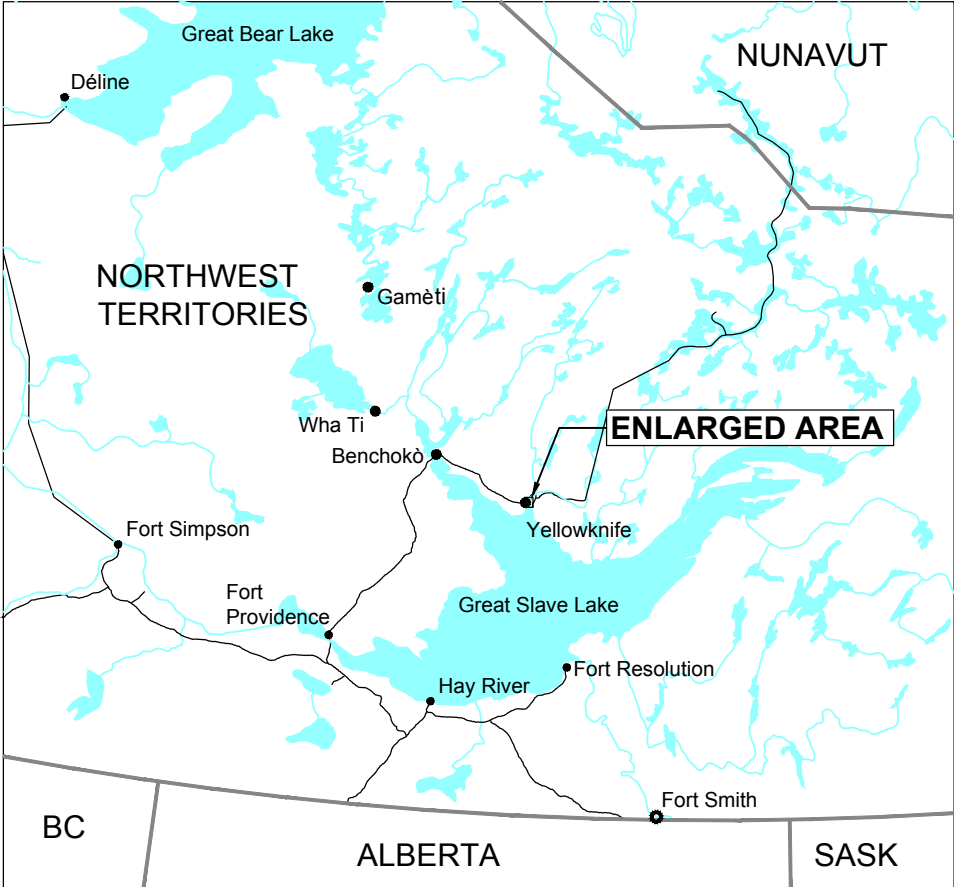
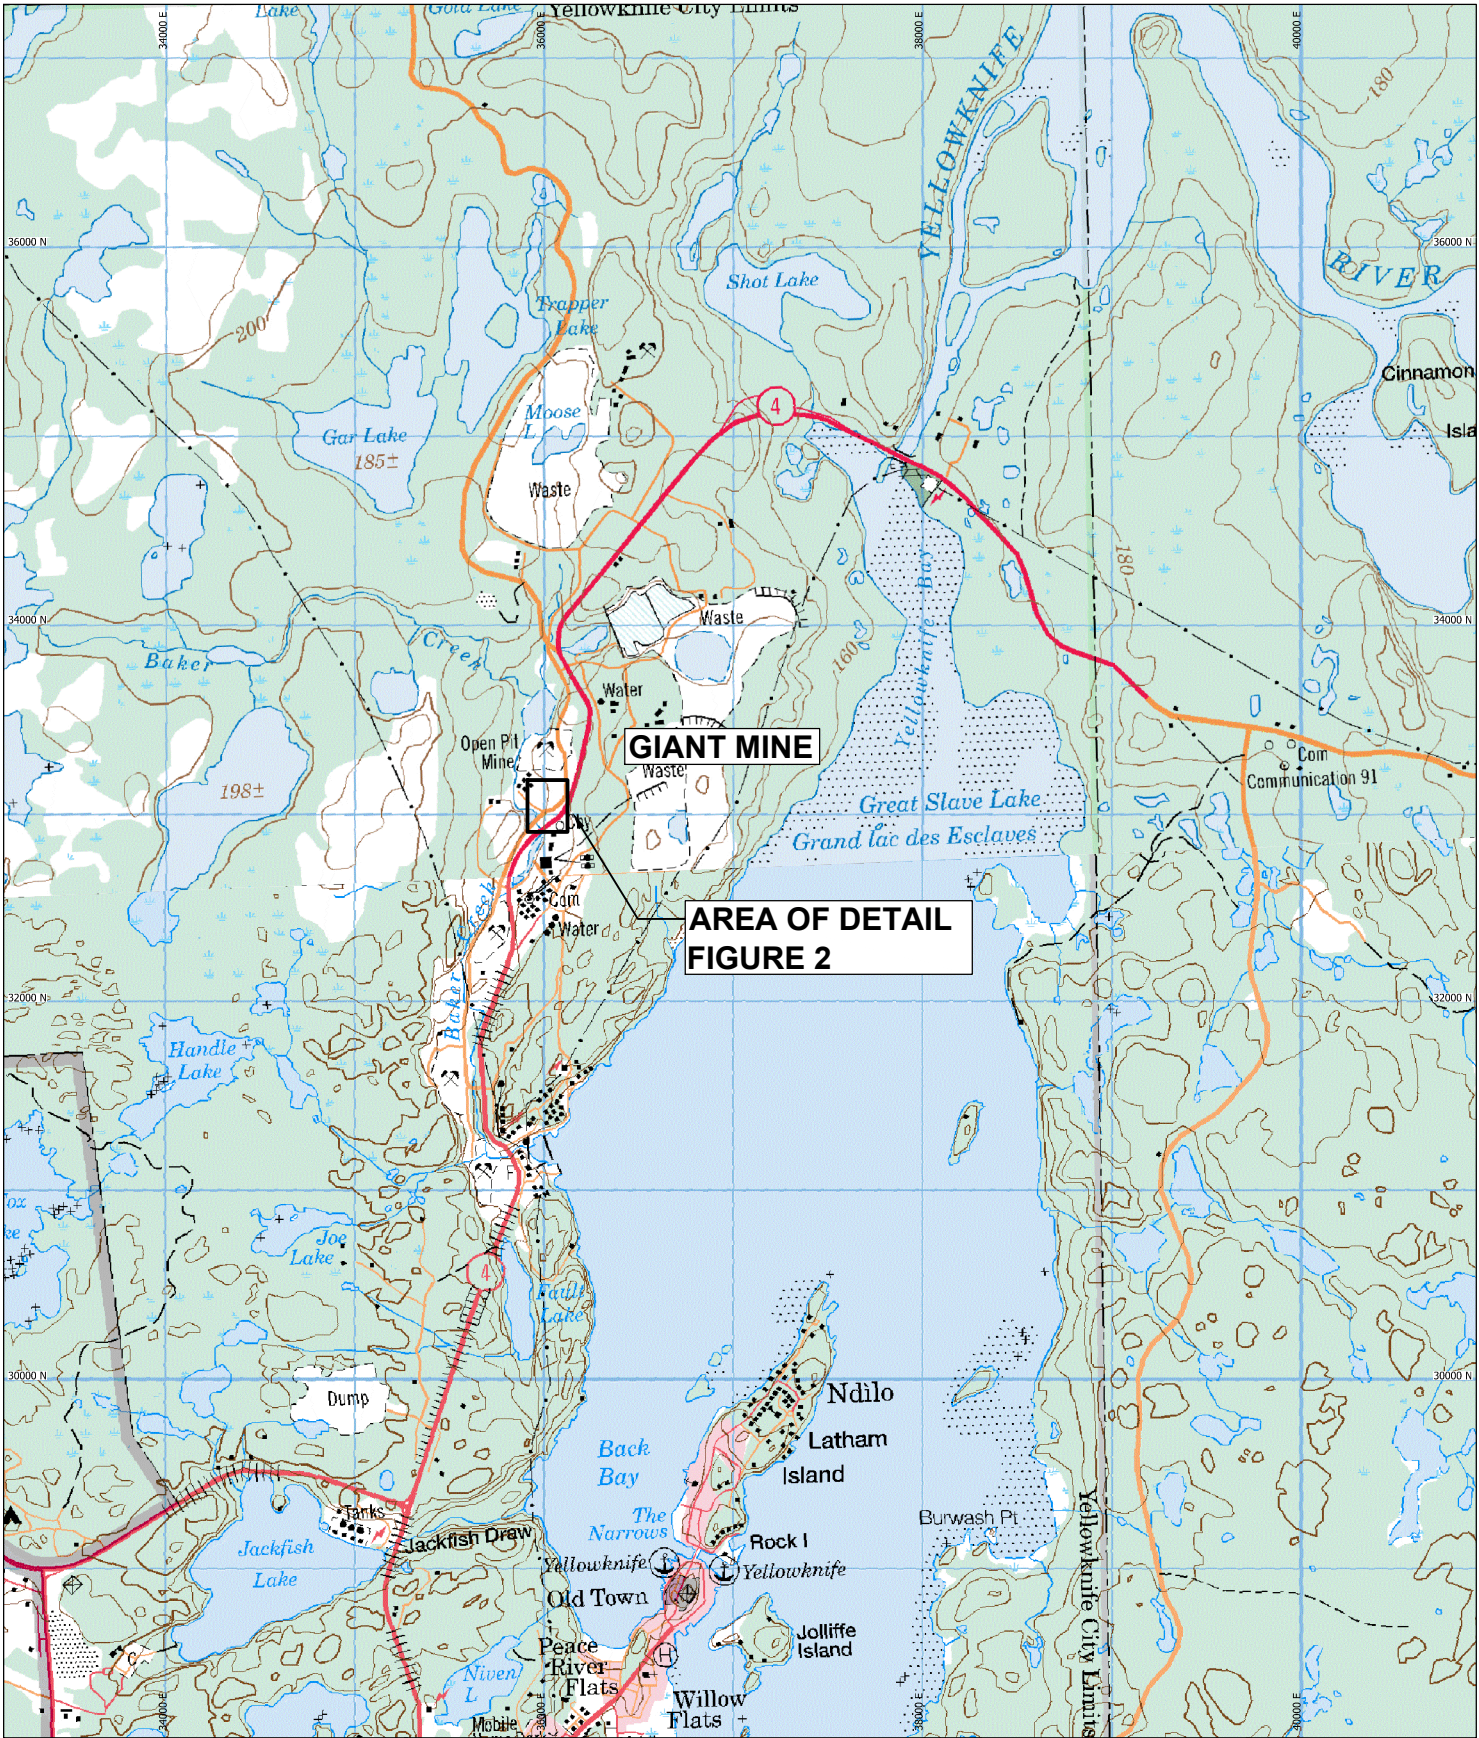
KEY PLAN
SCALE: N.T.S.

Golder's work included an assessment of the probability of failure of the crown pillar above arsenic Stope B-208 which is located on the eastern side of the B1 open pit mine and west of and immediately adjacent to public Highway 4 (see key plan shown in Figure 1 and detail in Figure 2).
