Board Decision – Geotechnical Assessment of the Polishing Pond

TECHNICAL MEMORANDUM

TO: Alan Taylor, P.Geo. **DATE:** May 30, 2006
 Dave Harpley, P.Geo.
FROM: Dave Caughill, John Hull **JOB NO:** 06-1413-024.6000
EMAIL: Dave.caughill@golder.com
RE: **QUALITY CONTROL FOR CONSTRUCTION OF POLISHING
 POND, 2006 CONSTRUCTION SEASON**

Activity Report Relating to the
Construction of a Polishing Pond at the
Prairie Creek Minesite, Northwest Territories

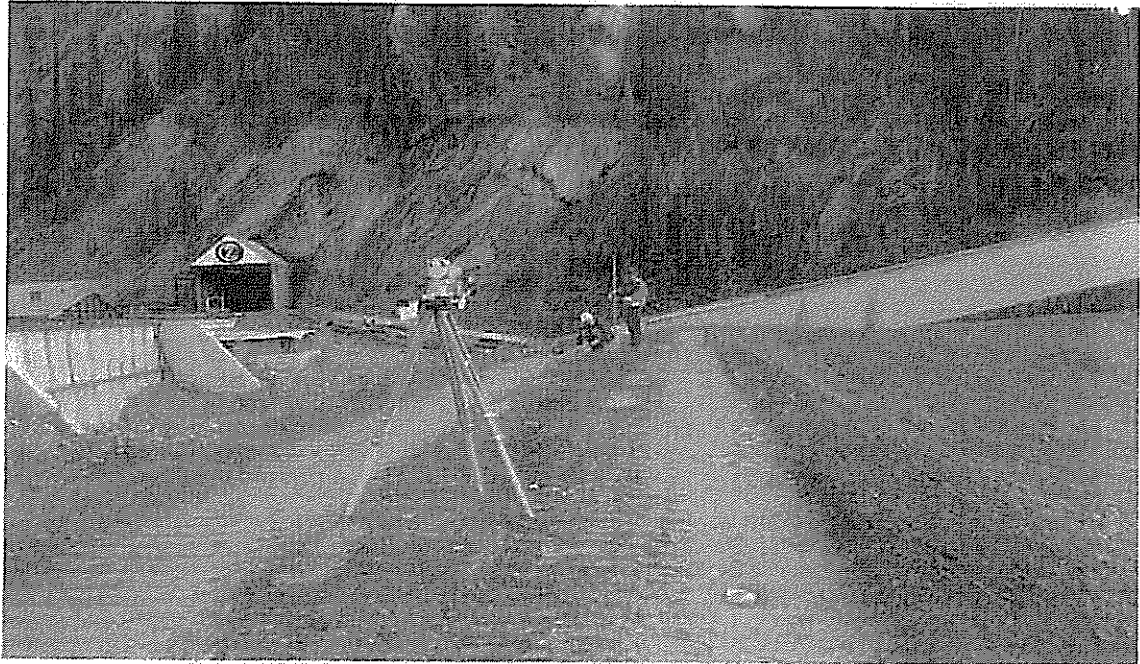
September 7

(below photo) Install steel shield around outlet drain pipe. Install a 24 inch culvert under the road on the south side of dike to channel water both from drain outlet and overflow from pond into main site drainage ditch. Cutting interior walls down towards 2.5:1.0 slope 4 hours Cat work.

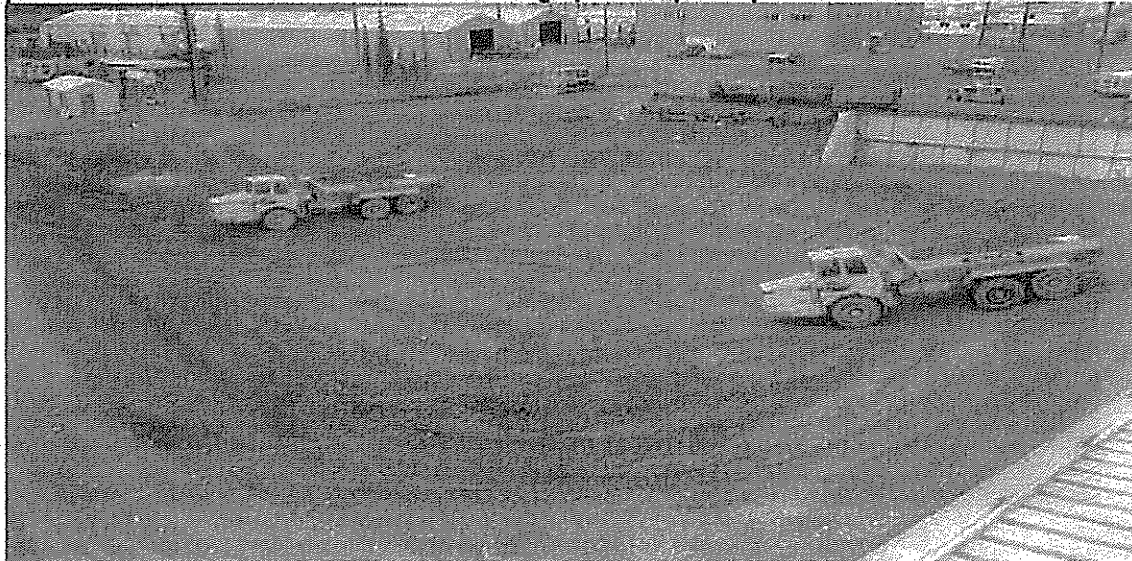
September 11

(below photo) Moved 14 truck loads of sand onto the 3 interior walls, blade with Cat. Truck 11 loads of fill onto the west wall, blade and pack.

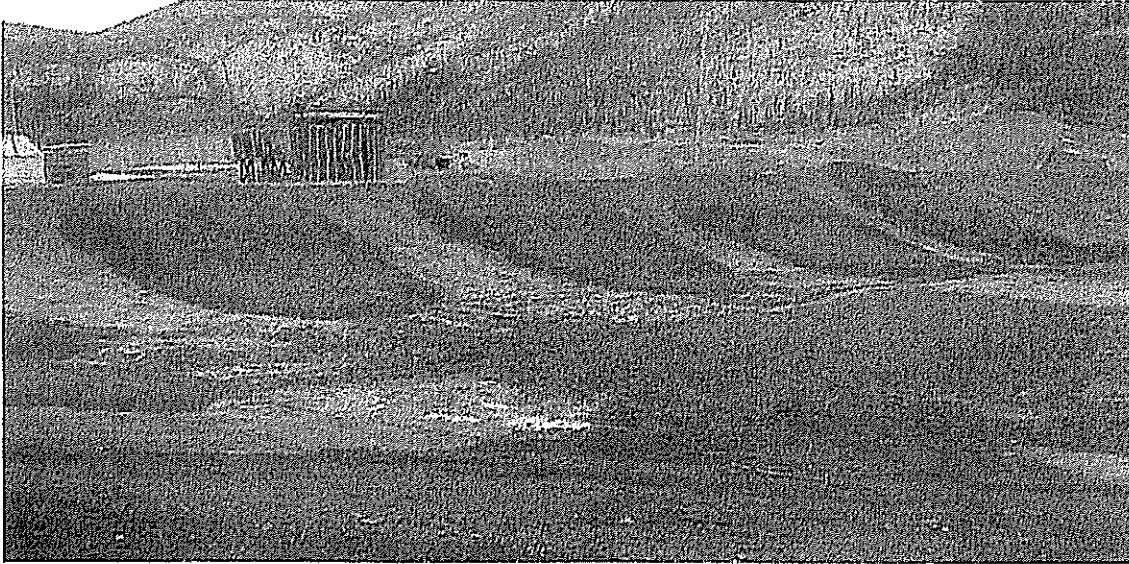
(above photo) Weld mounting plate and install knife valve on outlet pipe, new 24 inch drainage culvert under road.

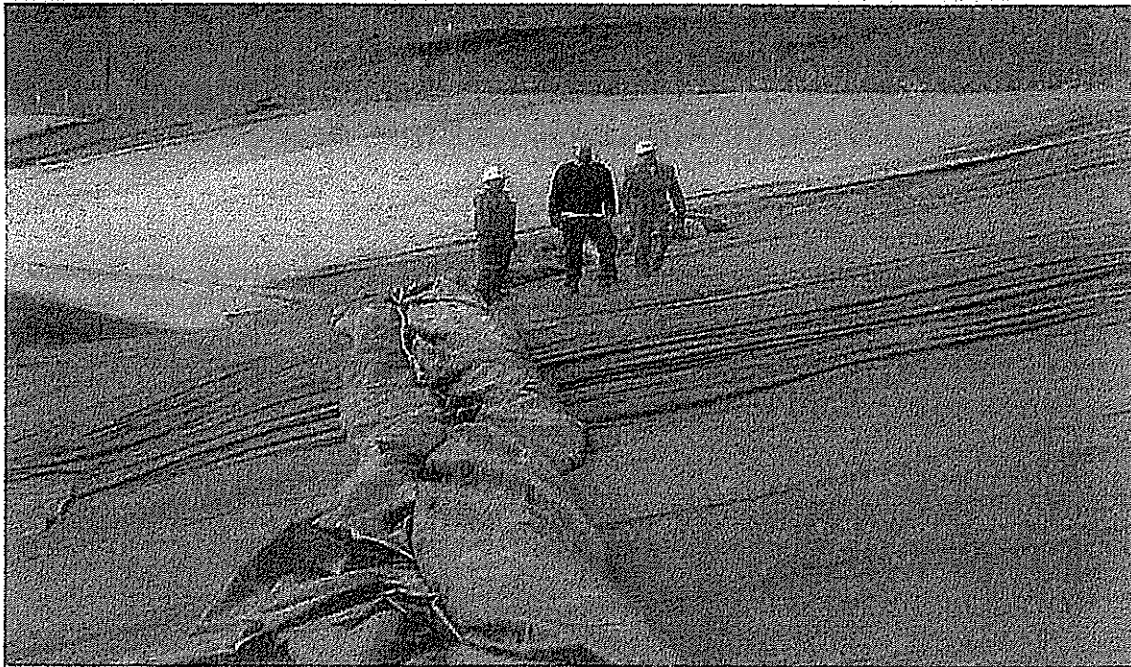
September 26

Strip of 2 sections of hypolon liner from the south and east walls of tailings pond (above photo). Roll up and drag out by CAT into yard.
