January 7, 2009

File No.: P09363B01

**Taltson Expansion Project**  
**Trudel Creek Erosion Assessment**

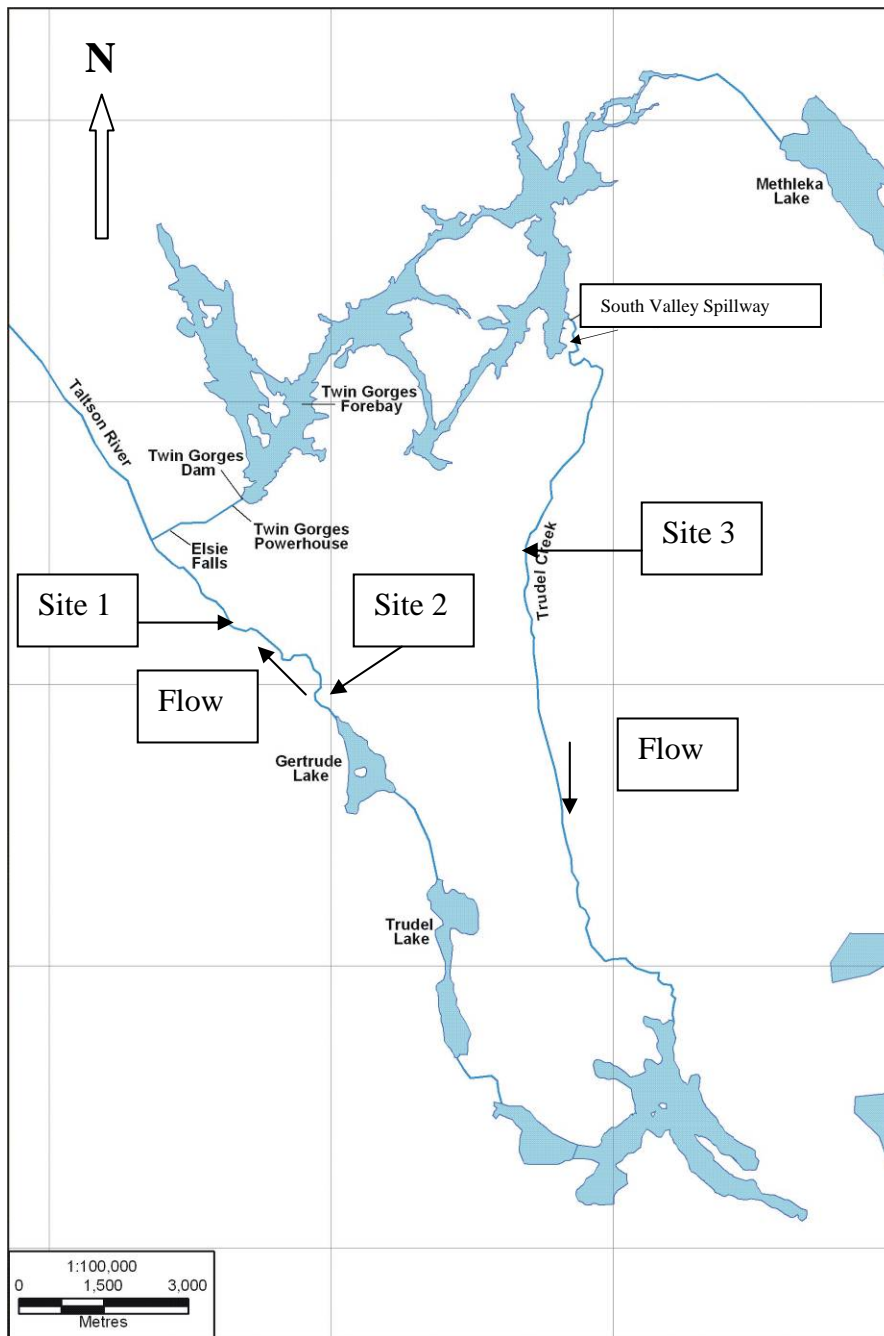
**Figure 2-1 Location of Trudel Erosion Monitoring Sites.**

A site visit was carried out by our Mr. Rick Rodman, P.Eng. (BC) who joined others from KCBL on July 8, 2008 and left the site on July 10, 2008. The length of Trudel Creek was flown by helicopter during the morning of July 9 and then three previously identified erosion sites were visited. The sites, shown on Figure 2-1 were selected as they were representative erosion sites. These three locations were also selected as erosion monitoring sites, as described in Section 3. Soil samples were collected at each site to assist in characterizing the erosion. Each site is described in the following sections. GPS points for soil samples and erosion monitoring sites are provided in Table 2-1. General and detailed photomosaics of each site are contained in Appendix I. At the time of the site visit the flow in Trudel Creek was approximately 175 m<sup>3</sup>/s (personal communication from Tom Vernon).

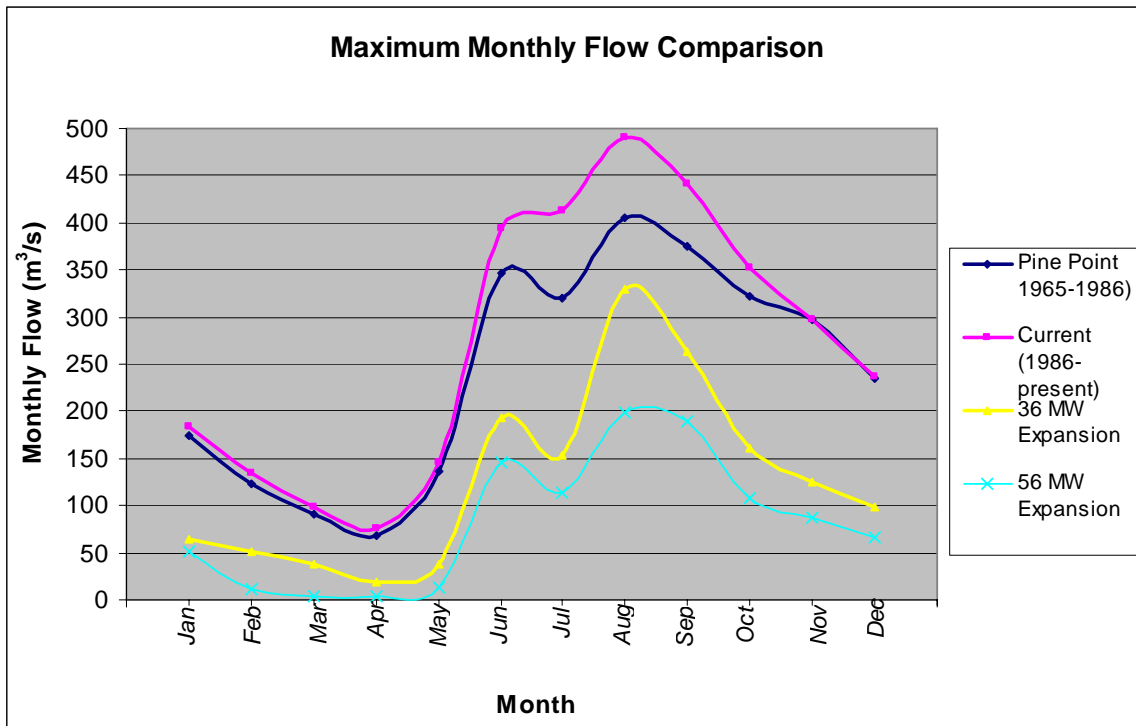
**Figure 4-5 Maximum Monthly Flow Comparison**

KCBL has processed the predicted daily flow data to obtain the maximum monthly flows, (see Table 4-1) and maximum annual daily flows (see Table 4-2). These tables also show the expected percentage reduction in flow for the 36 MW and 56 MW Expansion Eras compared to the two previous flow eras. The flow regime for the future 36 MW Expansion Era is predicted to have, on average, monthly flows that are 68% to 74% less than previous monthly flow regimes. Similarly, the predicted maximum daily flows will be reduced 63% to 69% from previous flow regimes. These results are shown graphically in Figure 4-5 and Figure 4-6.

Similarly, the flow regime for the future 56 MW Expansion Era is predicted to have, on average, monthly flows that are 79% to 83% less than previous monthly flow regimes. Similarly, the predicted maximum daily flows will be reduced 73% to 77% from previous flow regimes. These results are shown graphically in Figure 4-5 and Figure 4-6.

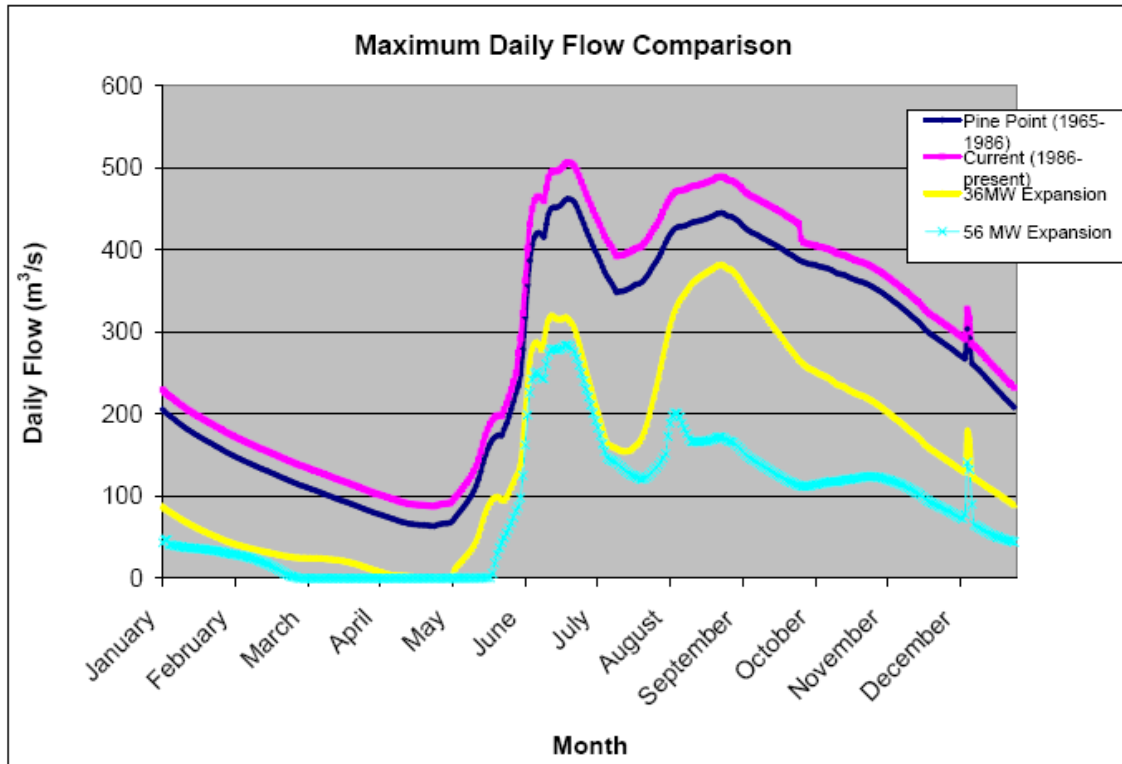
**Figure 4-6 Maximum Daily Flow Comparison**

The spike in maximum daily flows in December is the result of a high flow event in December 1990. This event is supported by data from the Environment Canada station on the Thoa River (Rescan, 2008a).

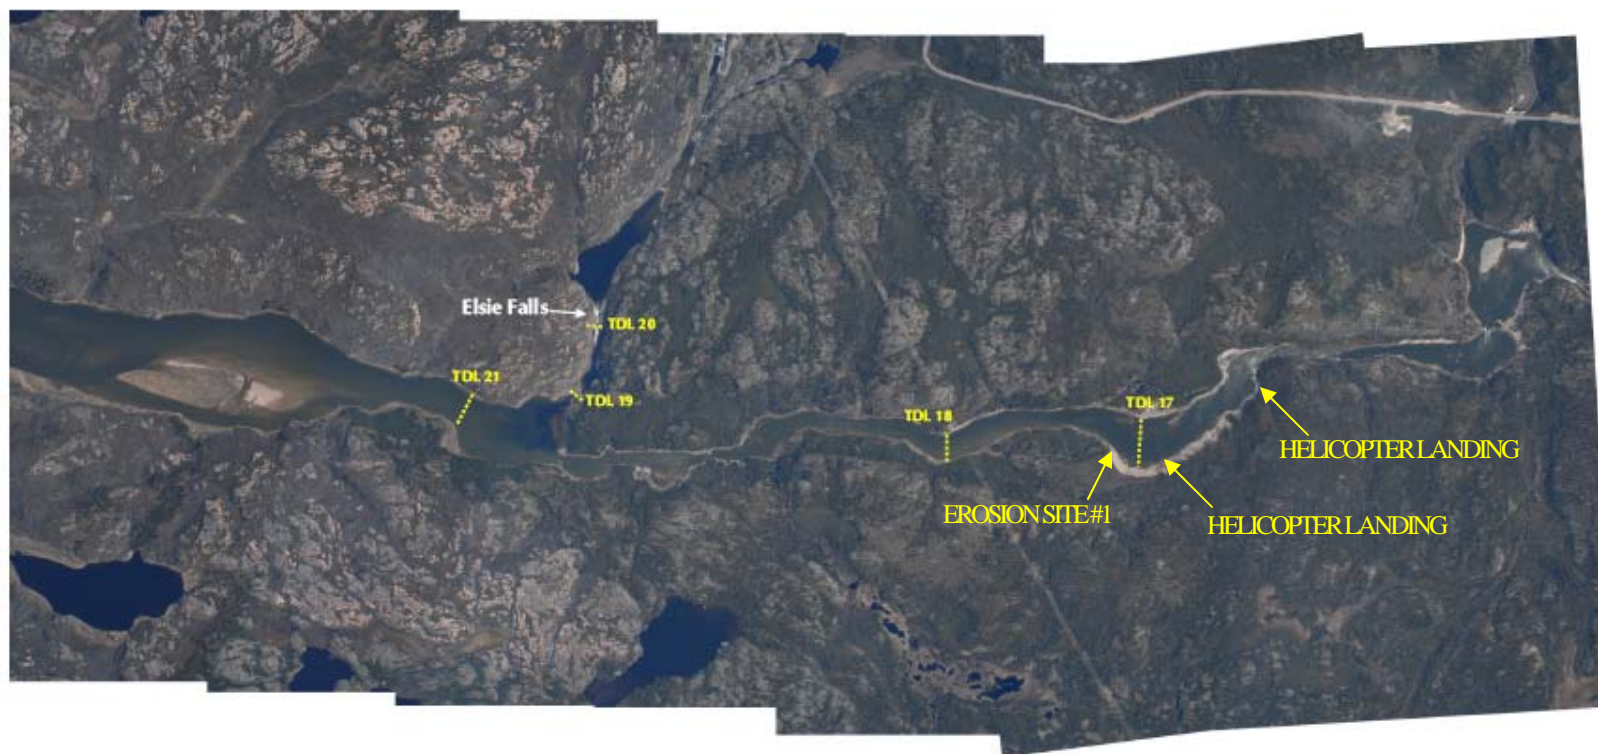
Figure I-1 Site 1 General

This site is located on a bend on the left bank of Trudel Creek, looking downstream, see Photo 2.1 and Figures I-1 and I-2 in Appendix I. It consists of a high bank composed of sandy, silt and clay. There are fingers of bedrock outcrops at several locations along the toe of Site 1 that reduce erosion, see Photo 2.2. The upstream portion of Site 1 has toe armouring by cobbles and boulders, see Photo 2.3. The downstream end of Site 1 has high steep sand banks with no toe armouring, see Photo 2.4. There are areas of erodible clay that are being undercut and eroded by surface runoff coming down the slope. There are several mud slide areas that are delivering trees and sediment to the river, see Photo 2.5. These mud slides, created by water draining off the upper slopes, tend to destabilize the banks.

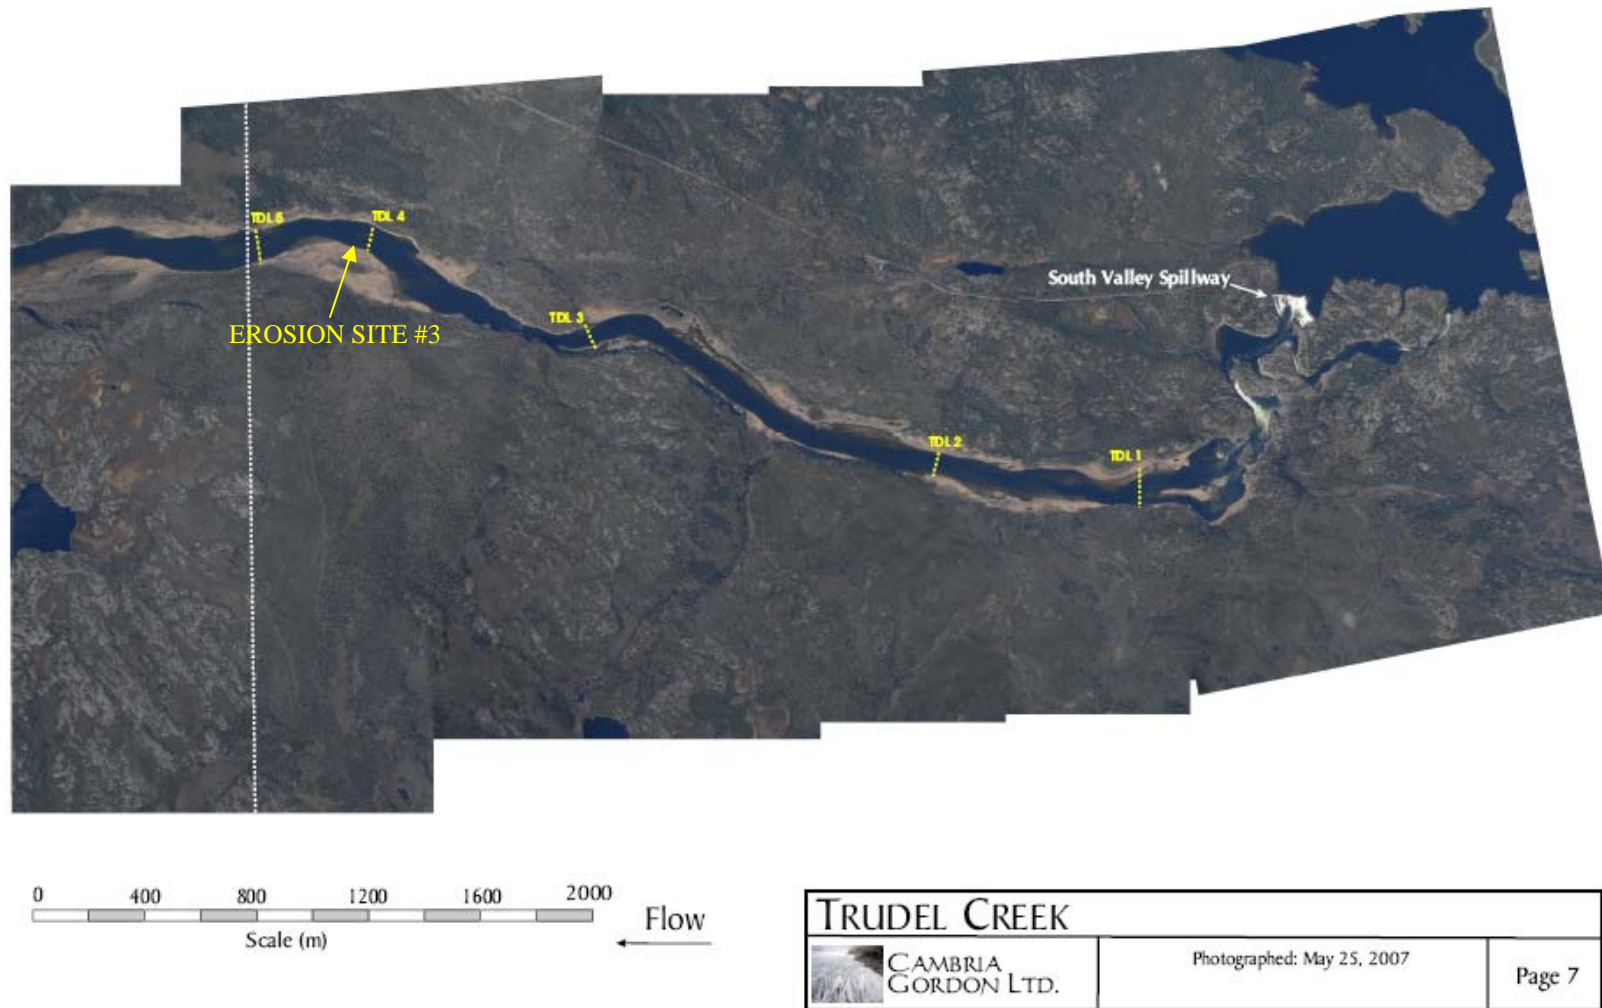
Figure I-5 Site 3 General

Site 3 is a low bar on the left bank of Trudel Creek, located approximately 4 km downstream from the South Valley Spillway (SVS), see Photo 2.8 and Figures I-5 and I-6. The bar had not yet been flooded this year and had long grass growing on it. Large pieces of the bank had fallen into the creek and large tension cracks were evident, see Photo 2.9 and Photo 2.10. Soil Sample RR-4 was taken from this bank. This sample has 68% sand and 32% fines, providing some cohesion, as can be seen in Photo 2.10.

This site is located at the same location as the previously described Site 3, see Figure 2-1 and Appendix I, Figures I-5 and I-6. Five 1.2 m long reinforcing rods were driven into the ground at 1 m spacing, see Photo 3.3. These markers may need to be lengthened so that they can be seen through the tall grass. Also, 2 m to 2.5 m long rods may be necessary should high flows submerge the area and cause the existing rods to vibrate looser be disturbed by floating debris. The ground appears to be soft enough for the longer rods to be installed.
