**Thor Lake Project – 2010 Phase I Site Investigation Results and Recommendations.
Report NB10-00556**

To:	David Swisher	Date:	January 25, 2011
Copy To:	Bill Mercer	File No.:	NB101-390/2-A.01
From:	Cara Stapley	Cont. No.:	NB10-00556
Re:	Thor Lake Project - 2010 Phase I Site Investigation Results and Recommendations

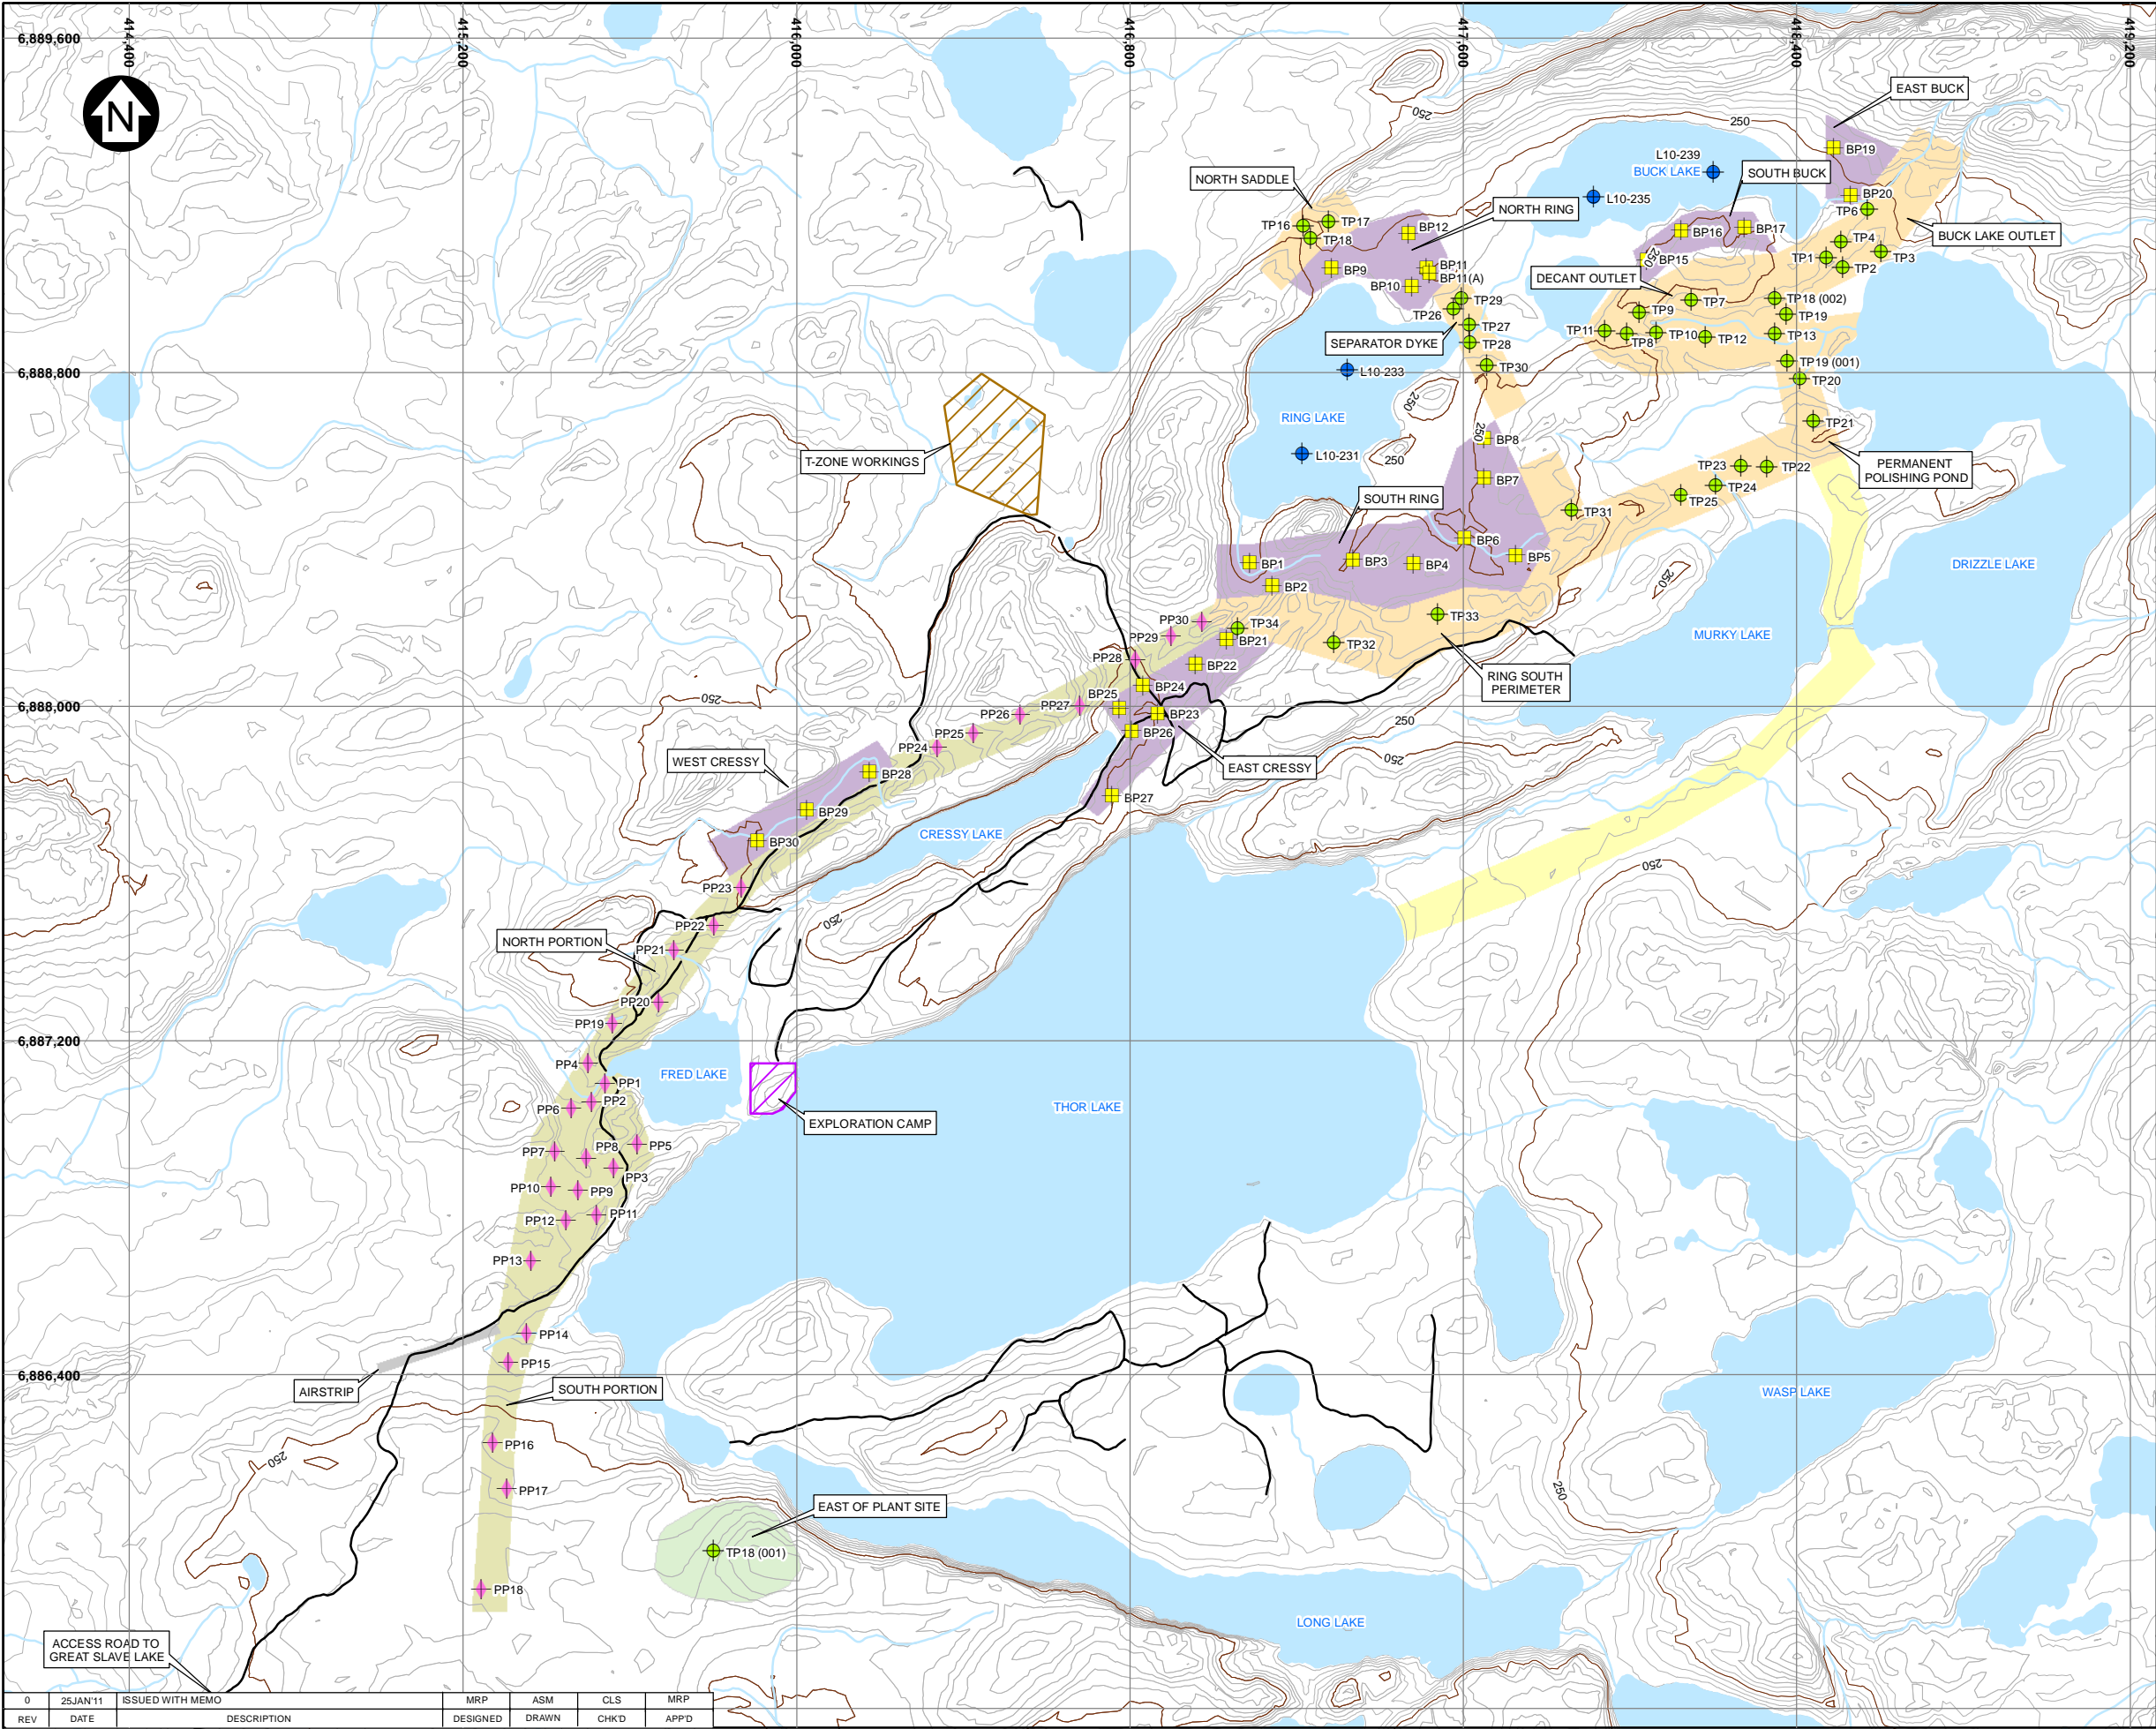
P/A NO.	REF. NO.
NB101-390/2	NB10-00556
FIGURE 1	
REV 0

During the Phase I site investigation conducted by KPL, a total of 92 sub-surface probes were completed and their locations are shown on Figure 1. A shovel and hand-auger were used to probe the surficial soil conditions at each of the investigation sites. KPL conducted logging of the soil conditions in accordance with the Universal Soil Classification System (USCS). The presence of ground water, permafrost or bedrock was also reported if encountered. Details of the test probes for each general area are provided on Tables 1 to 3. Select photos taken during the completion of the test probes are provided in Appendix B.

The following provides a summary of the sub-surface probe results by project area, as shown on Figure 1.

During the winter of 2009/2010, Avalon completed condemnation drillholes within the Ring and Buck Lake basin (L10-231, L10-233, L10-235 and L10-239 as per information provided in email from David Swisher on September 9, 2010). Two drillholes were completed at Ring Lake where 1 to 3.5 m of water/ice was encountered followed by 4.8 to 6 m of overburden. Two drillholes were completed at Buck Lake where 1 to 1.5 m of water/ice was found, followed by 4.9 to 8 m of overburden. The locations of these drillholes are shown on Figure 1.
