## **Mapping Summary Report Proposed Prairie Creek Mine All-Season Road Northwest Territories**

PRESENTED TO  
**Canadian Zinc Corporation**

DECEMBER 3, 2015  
ISSUED FOR USE  
FILE: Y14103320-01.003

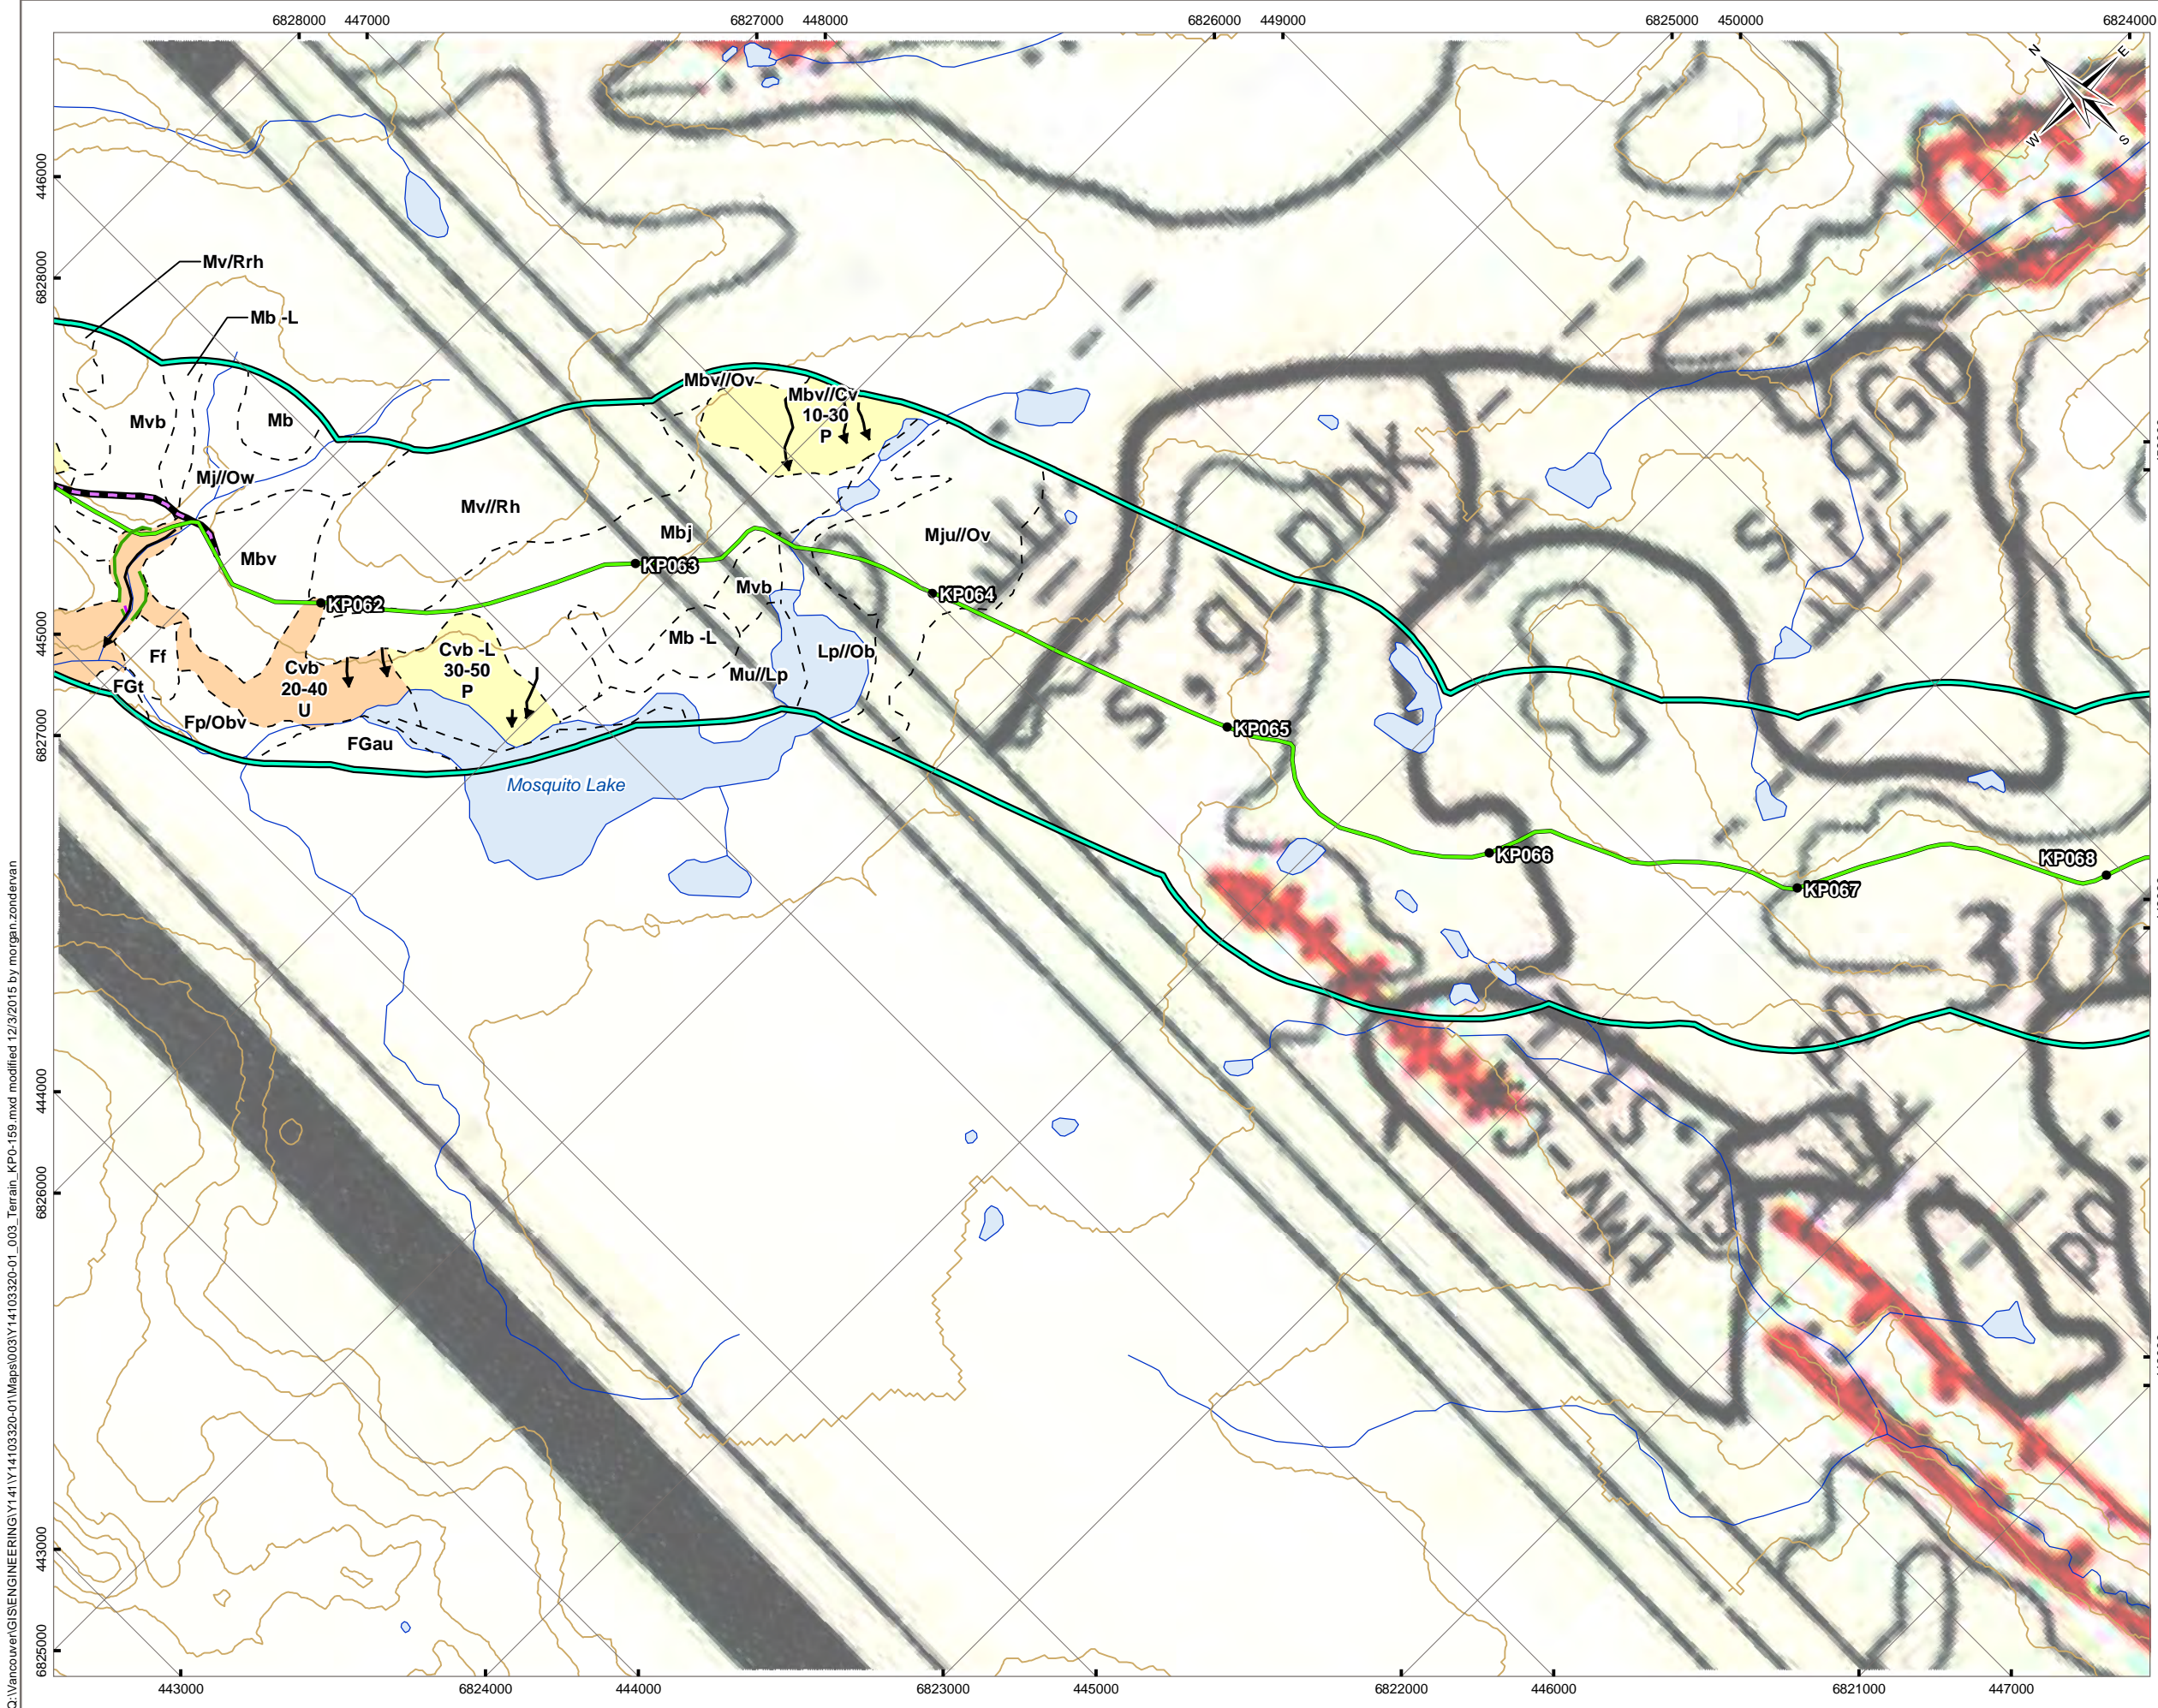
Several small debris slides, including the active one south of TFSA Site 29, have formed by riverbank erosion near KP050. A few small debris slides are new features on the 1994 photos (Figure A08). Two of these are caused by river bank erosion. The slide at KP050.5 is fresh looking in both sets of air photos, but it had widened slightly by 1994. The small slide feature adjacent to the newer head scarp (south of KP050.7) is an old slide that is covered with vegetation in both the 1949 and the 1994 photos. The proposed road's closest points to the debris slide head scarps are 9 m and 17 m from the scarp edges. Moving the proposed alignment further northwest as shown in Figure A08 will allow the road to avoid this area. Grades do not allow the road to avoid an old debris slide at KP049.8, so debris slide mitigation will be required across the slide area. A slope stability evaluation will be needed

A post-1994 slide south of KP49 visible on the 2012 LiDAR image was confirmed by fieldwork in 2014 (Figure A08). This slide was initiated by toe removal in two locations caused by creek flow. It is a translational slide in glaciofluvial sand and its toe extends across the former river location. Tension cracks visible above the slide indicate that it will continue to fail in the future, which is consistent with ongoing removal of the sandy toe deposits by the creek. The proposed road is not affected by this slide.

At the slide locations, the outer bends have eroded 8 to 26 m further into the banks. This has initiated the post-1994 slide south of KP49 and the slide at KP49.9, and has expanded the slide at KP50.5. The 1983 photos show that the expansion of the latter slide occurred sometime before 1983. The position of the creek in 1983 has been added at this location on Figure A08. Outer bank erosion is evidently the cause of the debris slide at this location. If the maximum erosion of 26 m over the time interval of 45 years is selected, then bank erosion is occurring at a rate of approximately 58 cm per year. This rate is not linear, but episodic, with expansion occurring mainly in flood years. This means that the amount of erosion could be much larger than 58 cm in flood years, with little or no erosion occurring in other years.

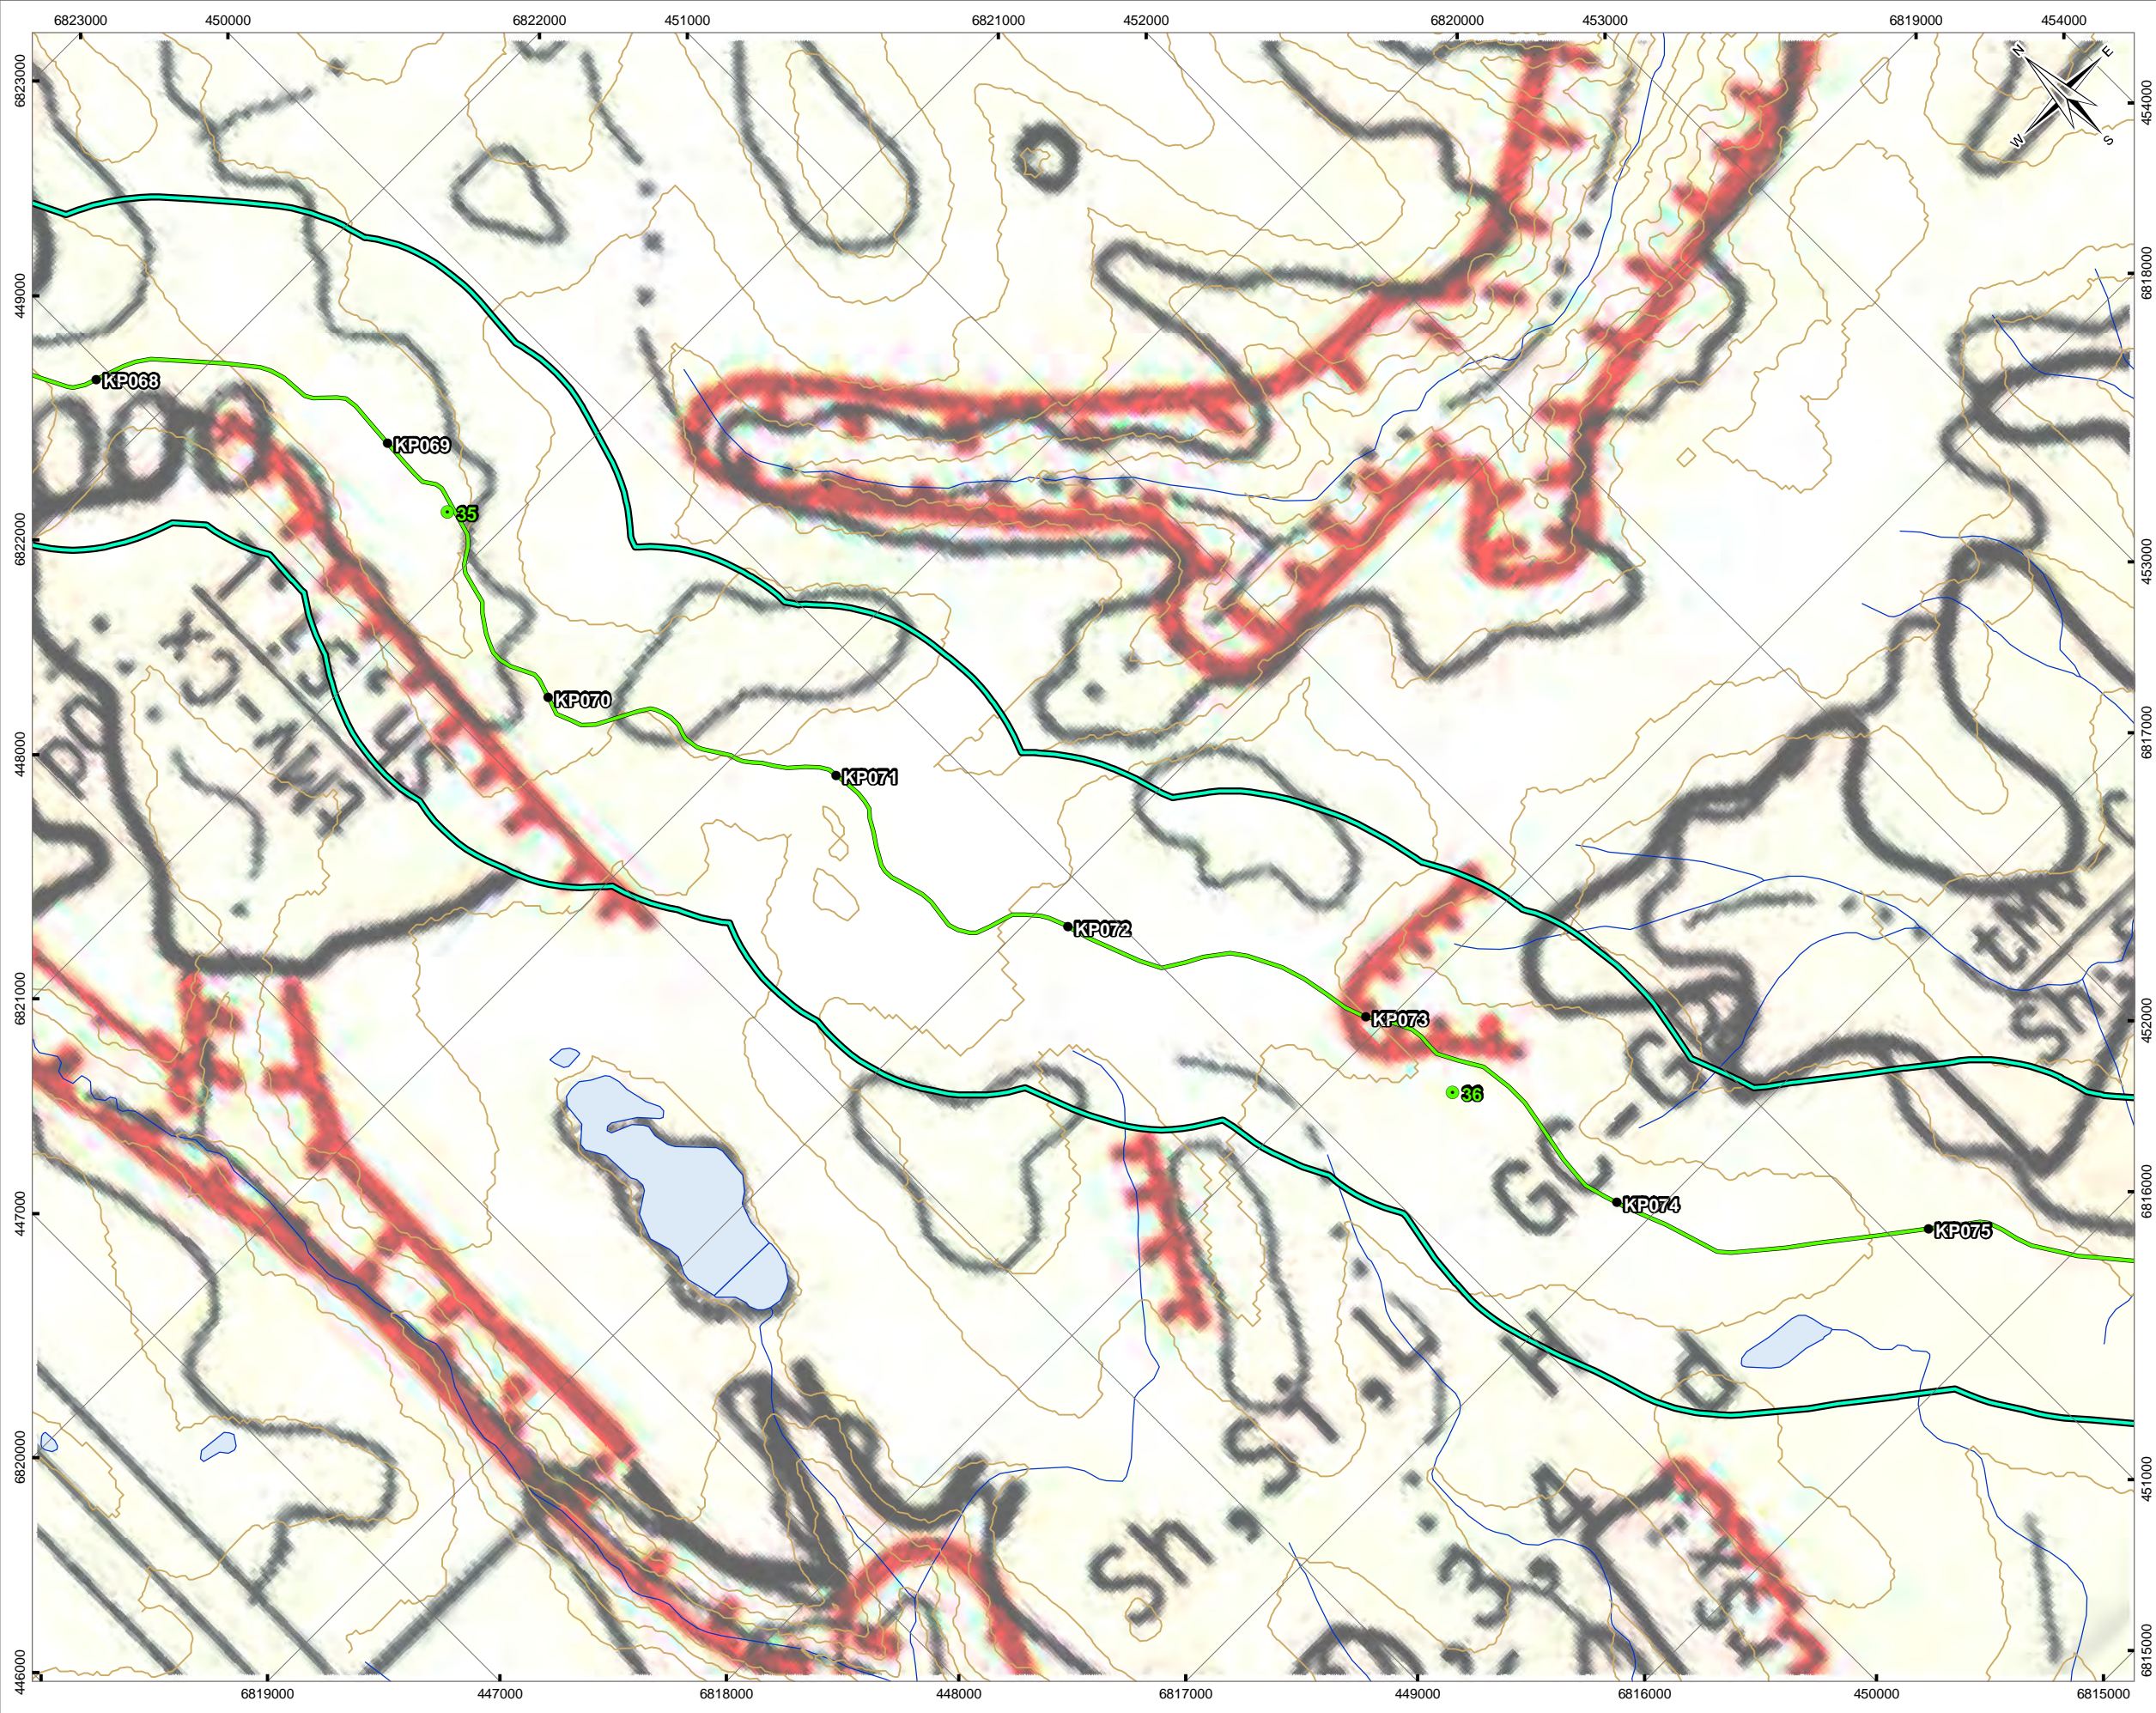
From KP053.7 to KP054.2, permafrost processes are evident near the road alignment (Figure A09). A thaw slump/flow on a northwest-facing slope that was identified in the field is also evident on the LiDAR bare-earth image, but is not present on the 1994 air photos (Figure A09). Such slides generally retrogress (expand upslope) as freshly-exposed ice-rich permafrost thaws. However, the adjacent mapped polygon does not appear to have permafrost near the surface as tree growth is quite consistent there (and there is no seepage, which may be an indication of permafrost presence). If that is the case, then the slide could grow no more than about 50 m upslope and would not affect the proposed route alignment. However, this area should be probed for permafrost presence/depth to confirm.

At KP054.6 to KP054.9 and between KP055.6 and KP055.9, debris slides are present above the proposed alignment. One such slide crosses the route at KP054.7 to KP054.8. Slide mitigation measures (engineering and/or administrative controls) may be required in these locations. Administrative controls could include signage, personnel procedures and training, inspection and maintenance schedules, and notification and reporting protocols. If administrative controls are used, road repairs may be more likely to be required after possible slide events. Moving the alignment westward at the slide crossing location may be advisable as well (location suggested in Figure A09). An alignment shift is suggested for KP055.6 and KP055.9 (Figure A09); however, this puts the road on the fluvial fan, which is not ideal. Engineering or administrative controls may be preferred at this location. A large alluvial fan is present south of the alignment between approximately KP055 and KP056.5. A possible karst depression or sinkhole near KP056, containing a pond, could be a thermokarst depression, but as there is no other evidence of permafrost on this south-facing slope, it is more likely a karst feature (Allnorth Photos SAM\_6375 and 6376, Tetra Tech EBA Photos IMG\_2010, 2014, and 2016). In its lower reaches, the alluvial fan is affected by karst processes occurring in the bedrock beneath it. These karst depressions are located about 230 m southwest of KP055.3 and 275 m south of KP055.7.
