**Dezé Energy Corporation Ltd.  
Taltson River Hydroelectric Expansion Project**

**July 2008 Habitat Assessment for Instream Works  
Locations: Nonacho Lake and North Gorge**

**January 2009**

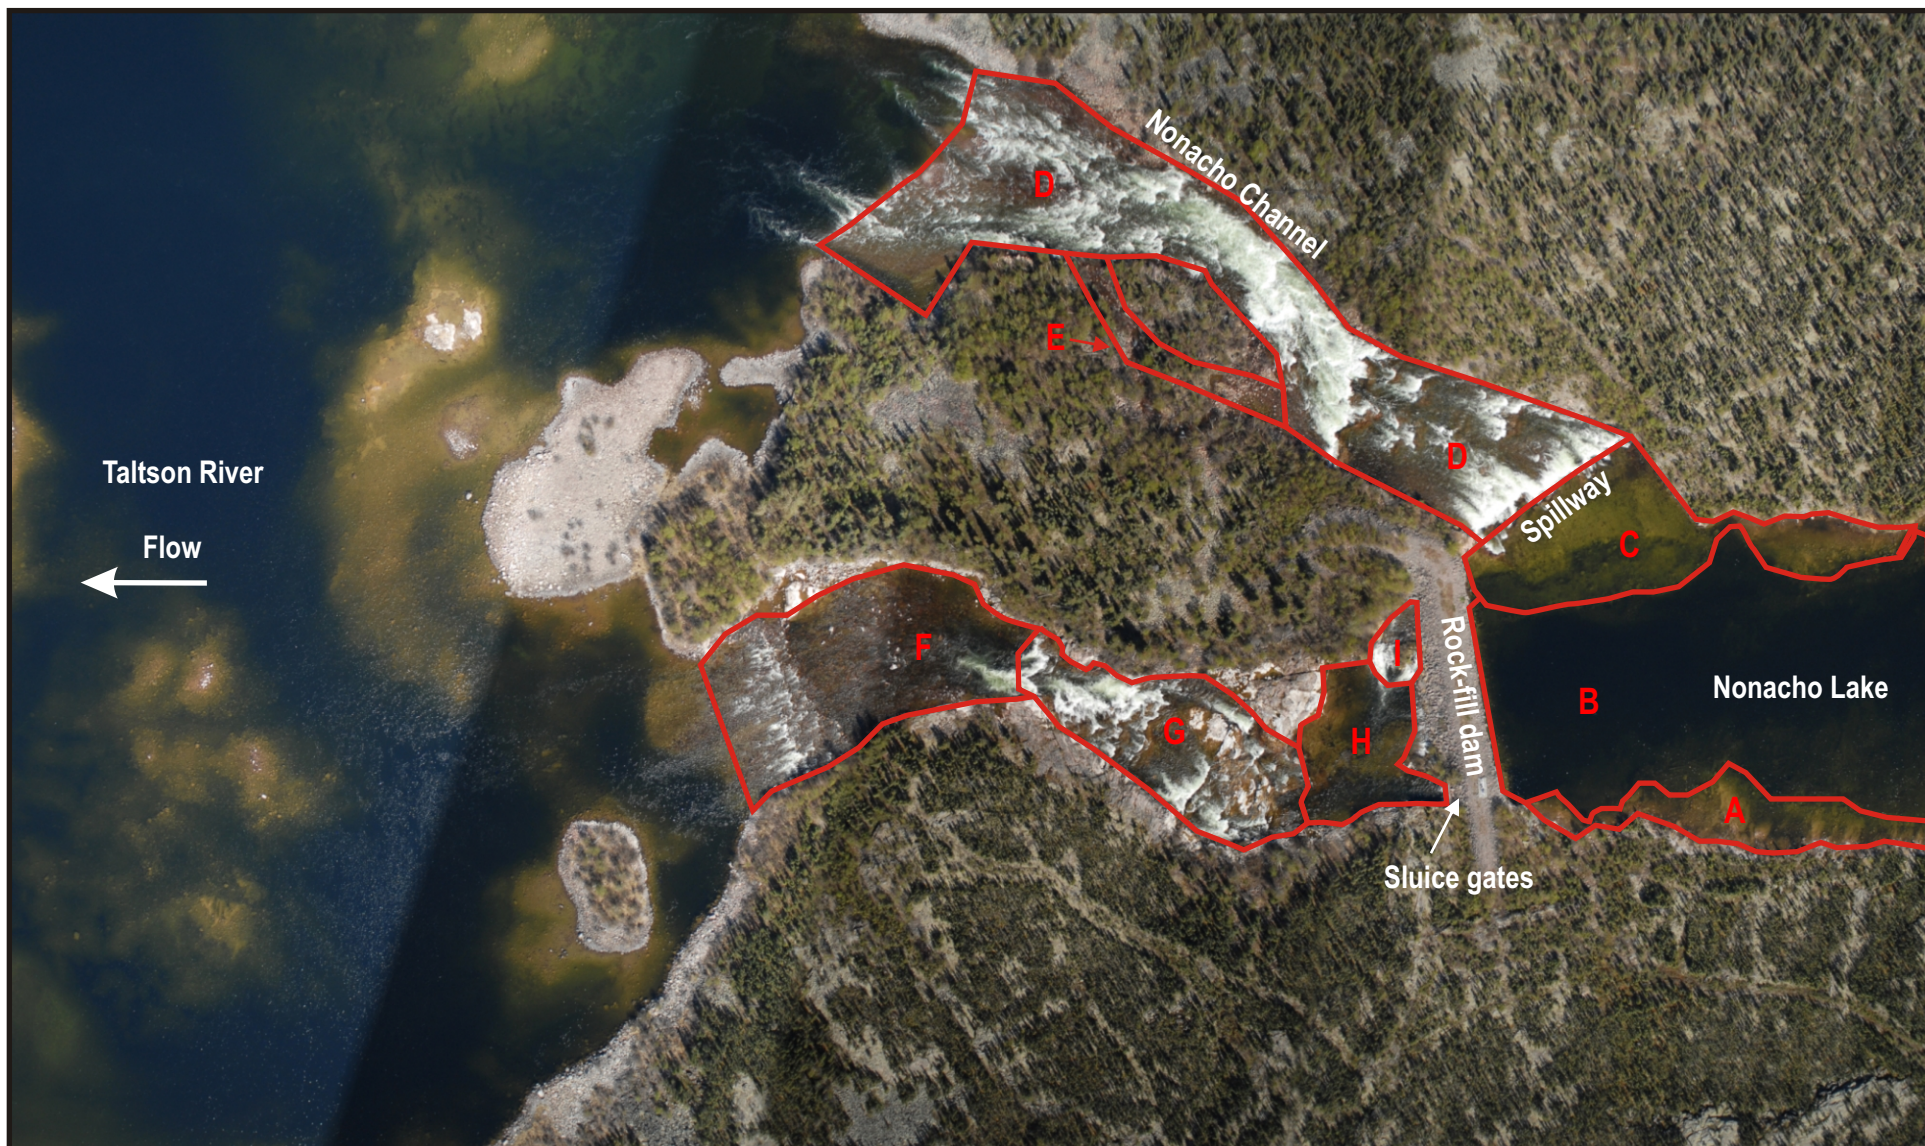
Habitat typing was conducted at the Nonacho control structure and adjacent area, as part of the desktop review. The initial step of this review was to identify habitat polygons where the physical habitat conditions within each polygon were anticipated to be homogenous. In total, nine distinct habitat polygons were identified at or adjacent to the Nonacho control structures (Figure 2).

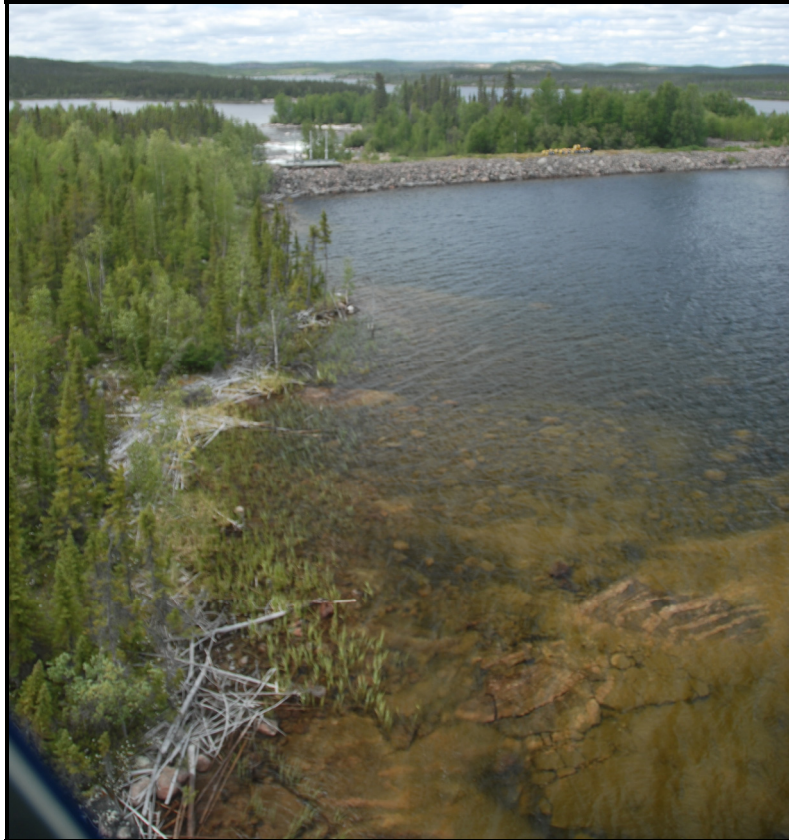
**Figure 3. Polygon A, Habitat above the Nonacho Dam.**

Polygon A is located immediately upstream of the rock-fill dam and within Nonacho Lake. This polygon is defined by a shoreline lacustrine habitat and is characterized by a small bedrock bench along the lake margin ranging in depths from 0 to 0.5 m. The bedrock bench drops off steeply to depths of 4 m and greater at approximately 10 to 15 m from the wetted edge. Along the lake margin, water velocities were slow; however, an undercurrent was observed 10 m from the shoreline. The observed undercurrent is likely associated with the three timber sluice gates located downstream at the rock-fill dam.

The substrate was primarily composed of gravel and cobbles near the lake margin with finer substrates infilling much of the interstitial spaces. Further offshore, substrate conditions shifted primarily to bedrock with boulders frequently interspersed throughout. Along the shallow bench and where the substrates were suitable, sparse submergent and emergent vegetation was present. Immediately adjacent to the inlet location of the intake canal, a sparse 200 m<sup>2</sup> submergent and emergent vegetation community had established. In addition to the vegetation communities, small woody debris (SWD) was observed to be evenly and frequently distributed throughout the polygon and could provide ample cover for juvenile fish. Figure 3 illustrates the habitat associated with Polygon A.

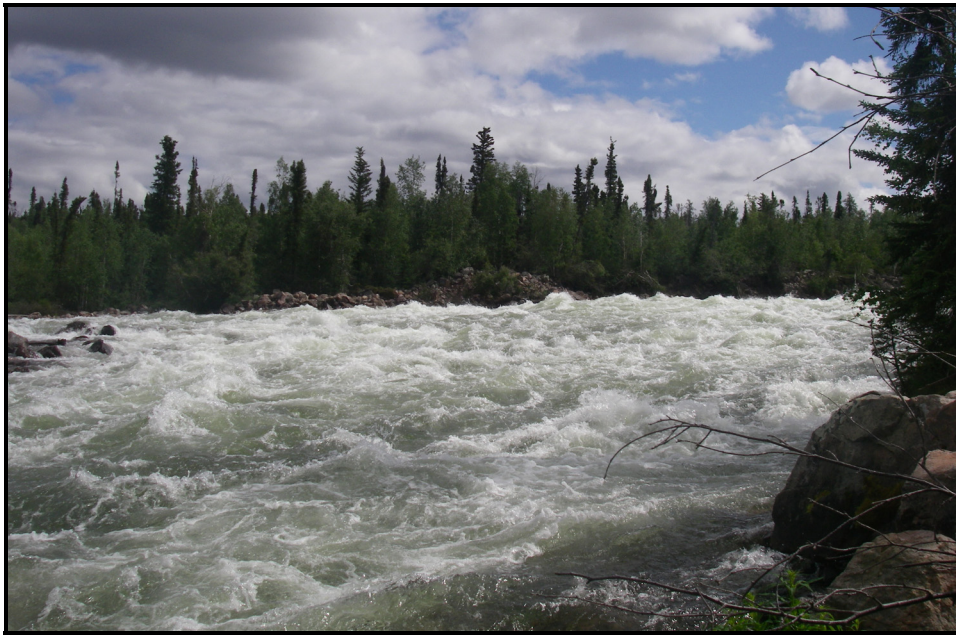
**Figure 4. Habitat present in polygon D.**

Polygon D includes in-stream habitats downstream from existing spillway. This polygon is defined by cascade pool morphology and is characterized by fast flowing waters. The spillway channel is approximately 350 m in length and ranged in width from 60 m at the inlet to 115 m at the outlet. Water velocity conditions within the channel were very fast, which likely limits the presence of boulders and aquatic vegetation cover. Depth measurements within the channel could not be collected due to safety concerns; however, the channel is estimated to be greater than 2 m in depth in most sections. This is likely due to the amount of scour experienced within this channel. At the time of assessment flow conditions were

at the seasonal high and were likely acting as a velocity barrier to fish. Figure 4 illustrates the habitat associated with Polygon D.

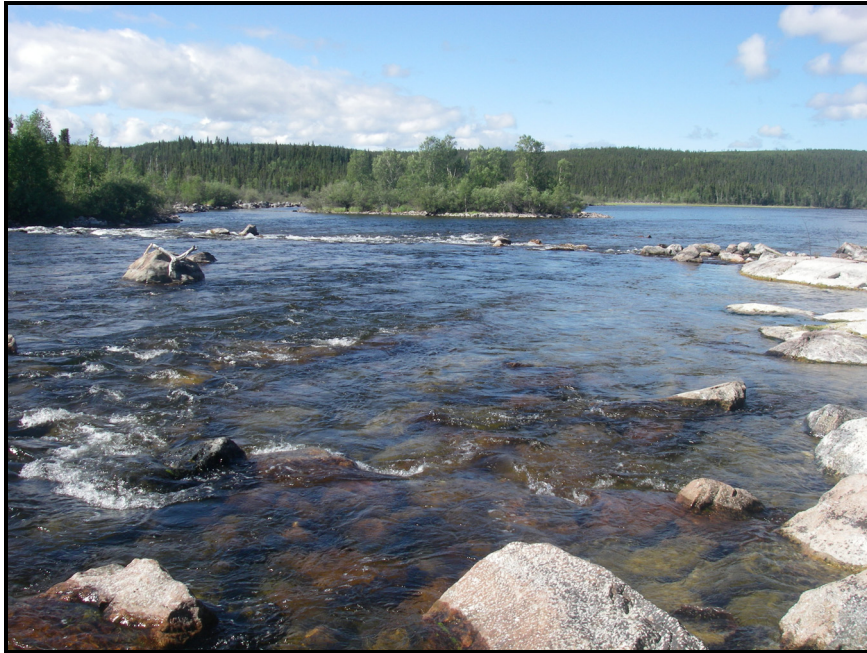
**Figure 5. Habitat present in polygon F.**

Polygon F is located at the downstream from the Nonacho dam and proposed control structure and discharges flow back into the Taltson River. This polygon is defined by riffle pool morphology. Channel depths within this polygon range between 0.5 m to 3 m. Substrate conditions are primarily bedrock with the occasional boulder. No in-stream submergent or emergent vegetation communities have established within the Polygon, again likely due to the water velocities and bedrock substrate. Figure 5 illustrates the habitat found within Polygon F.

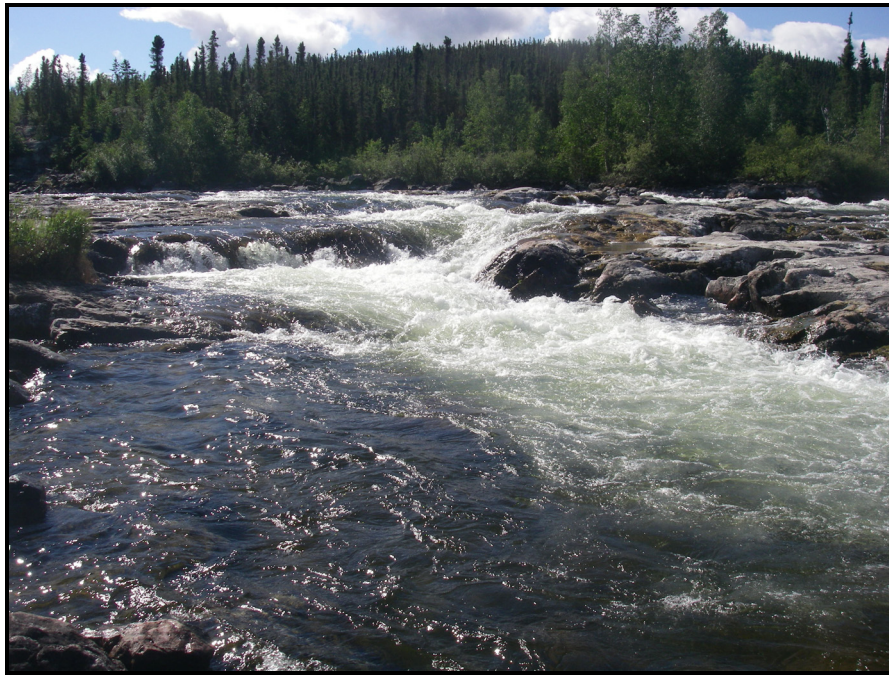
**Figure 6. Habitat present in Polygon G.**

The outlet of the canal and the proposed control structure would be located approximately 50 m downstream of the rock-fill dam and in the Taltson River on river left, which is at the upstream end of polygon G. At this location, the mainstem channel is characterized by cascade-pool morphology with fast flowing water conditions. Depths at this location could not be determined with typical sampling techniques due to the swift water velocities and could not be approximated, as the channel bottom was not visible. No vegetation was present at or adjacent to the proposed outlet location and substrates consisted mainly of bedrock with

boulders scattered along the stream margin. Figure 6 illustrates the habitat at the outlet of the proposed control structure.

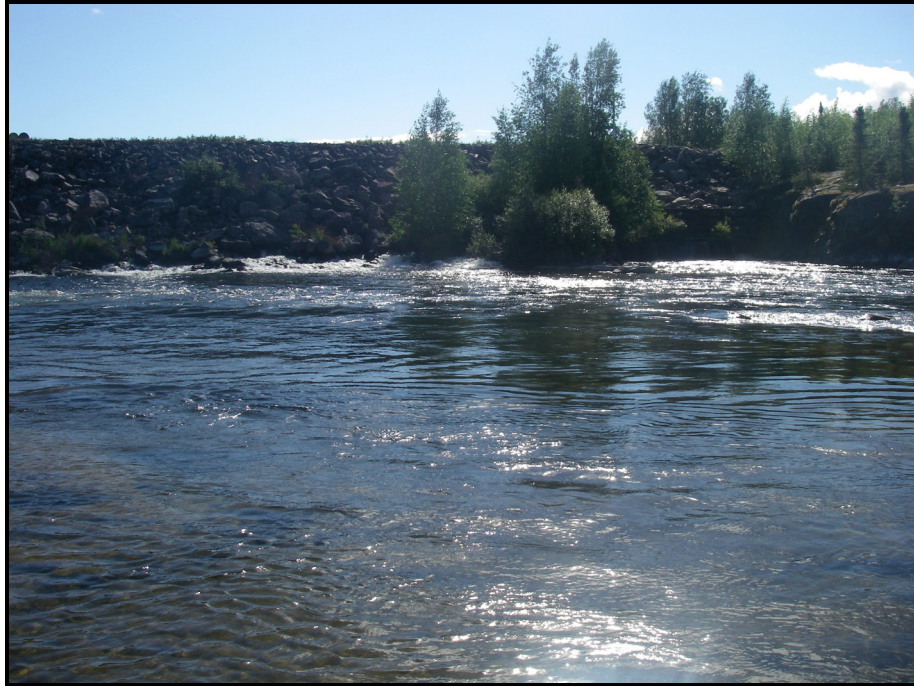
**Figure 7. Habitat present within polygon H.**

The rehabilitation of the rock-fill dam and the permanent closure of the sluice gates have the potential to interact with the aquatic habitat from the downstream side of the dam extending to the outlet of the proposed control structure. Water within this small stretch of habitat is sourced from the sluice gates and the dam leakage. Figure 7 illustrates the habitat present within polygon H.

Habitat within this section of the channel is characterized by pool habitat and is dominated by bedrock and sporadic boulders. Water velocity within these pools was moderate and no submergent or emergent vegetation or woody debris was found within this section of river. On the day of observation approximately six adult lake trout were observed holding in a large pool approximately 3-4 m in depth, immediately downstream from the sluice gates. It is not anticipated that lake trout can migrate through the sluice gates, as velocity conditions likely exceed the swimming capabilities of the fish. Although lake trout were present in the deep pool, it is not likely that lake trout or any of the other fish species present within the area are utilizing this habitat for spawning or juvenile rearing critical life stages.

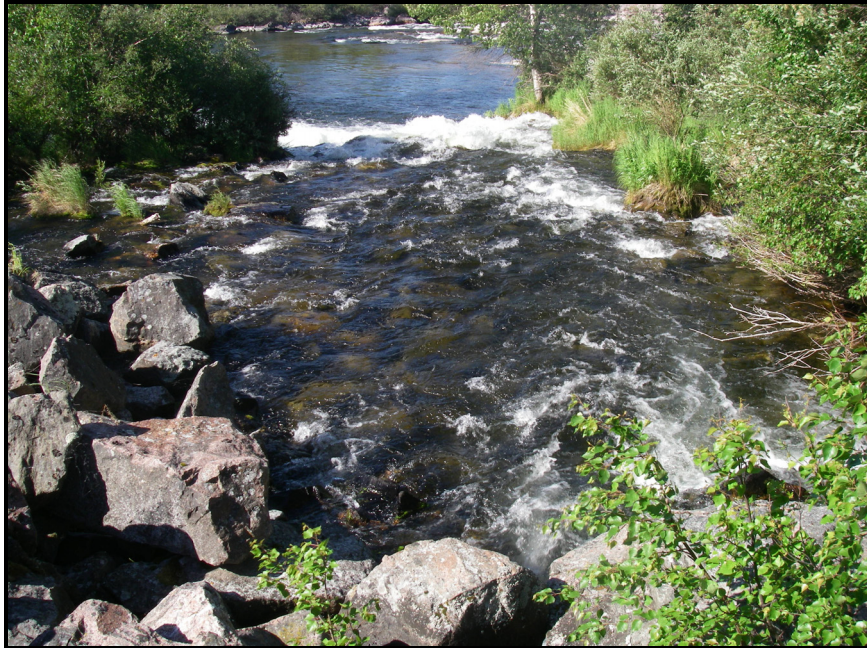
**Figure 8 . Habitat present in Polygon I.**

Habitat within this small area is characterized by boulders and moderate velocities. The water in polygon I is sourced solely from leakage through the rock fill dam. No submergent or emergent vegetation is present in this polygon, likely due to the water velocities. Some clumps of grasses and shrubs were present in the water along the margins of this area. This is likely because the flow was at the seasonal high at the time of assessment, and vegetation that was typically terrestrial had been inundated. This was not noted in any other polygons. Figure 8 illustrates the habitat present in this area.

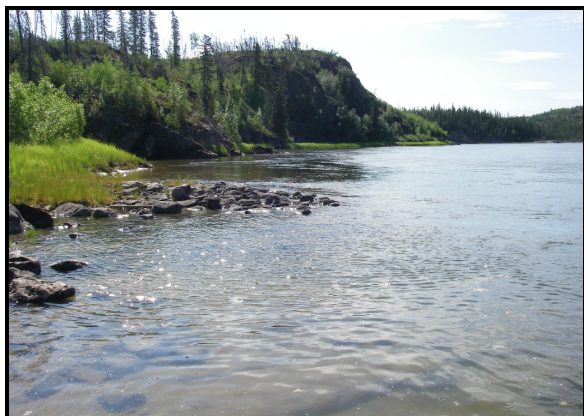
**Figure 9. Shoreline habitat at the proposed canal outlet location.**

The tailrace at the downstream end of the proposed North Gorge canal would enter the Taltson River approximately 400 m downstream from the confluence of Trudel Creek and Elsie Falls in the Taltson River. The shoreline habitat in this area is dominated by steep bedrock banks, intermixed with patches of emergent vegetation. The substrate along the shoreline is generally bedrock and boulders with a layer of fine sediment on top. Sparse terrestrial vegetation or woody debris was present along the shore to provide cover. The river is shallow in this area and was no deeper than 2.5 m in the thalweg. Figure 9 and Figure 10 illustrate the habitat present at the proposed tailrace location.
