### Giant Mine Remediation Project Closure Design Considerations

#### Key Concerns

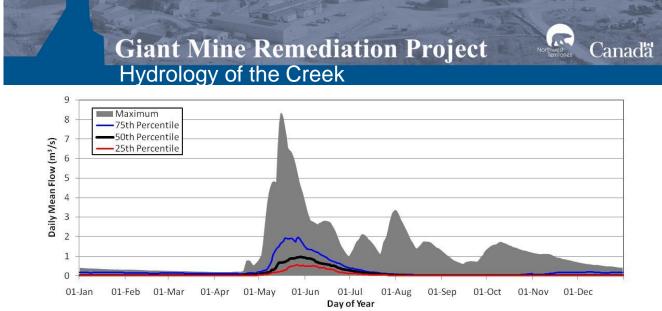
Baker	Creek	Flood	Regime
-------	-------	-------	--------

Return Period (years)	Estimated Flood Discharge (m <sup>3</sup> /s)	
2	1.7	
10	5.4	
50	10.8	
100	13.8	
200	17.3	
500	25.0	
Probable Maximum Flood	~200

- The greatest recorded flow (since 1968) on the creek was in the spring of 1991, at 8.45 m<sup>3</sup>/s.
- The mean annual flow is approximately 6.8 million m<sup>3</sup>
- Aufeis formation observed in recent years, and particularly in the winter of 2010-11, was considered in the design.

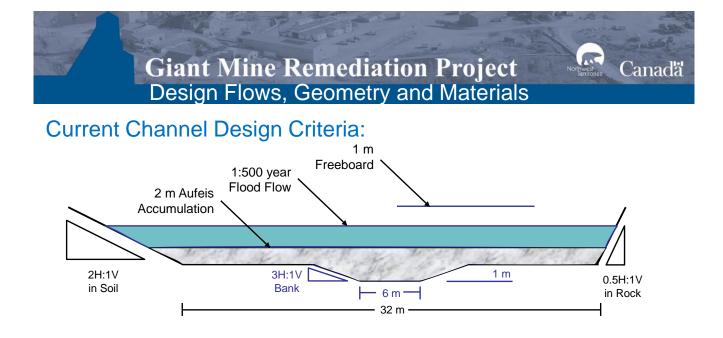
- Channel geometry and materials are based on local geomorphology investigation
- □ Active channel material will be graded with D50 = 120 mm
- □ Floodplain material will be graded with D50 = 120 to 250 mm
- Compacted till will be provided below the channel and floodplain, with a bituminous liner above shallow underground features
