**AVALON**  
RARE METALS INC.  
*MATERIALS FOR CLEAN TECHNOLOGY*

# Technical Session Presentation August 14-17, 2012

**Day 3 (Aug 16)**  
**NECHALACHO, THOR LAKE**  
*Wildlife Review*

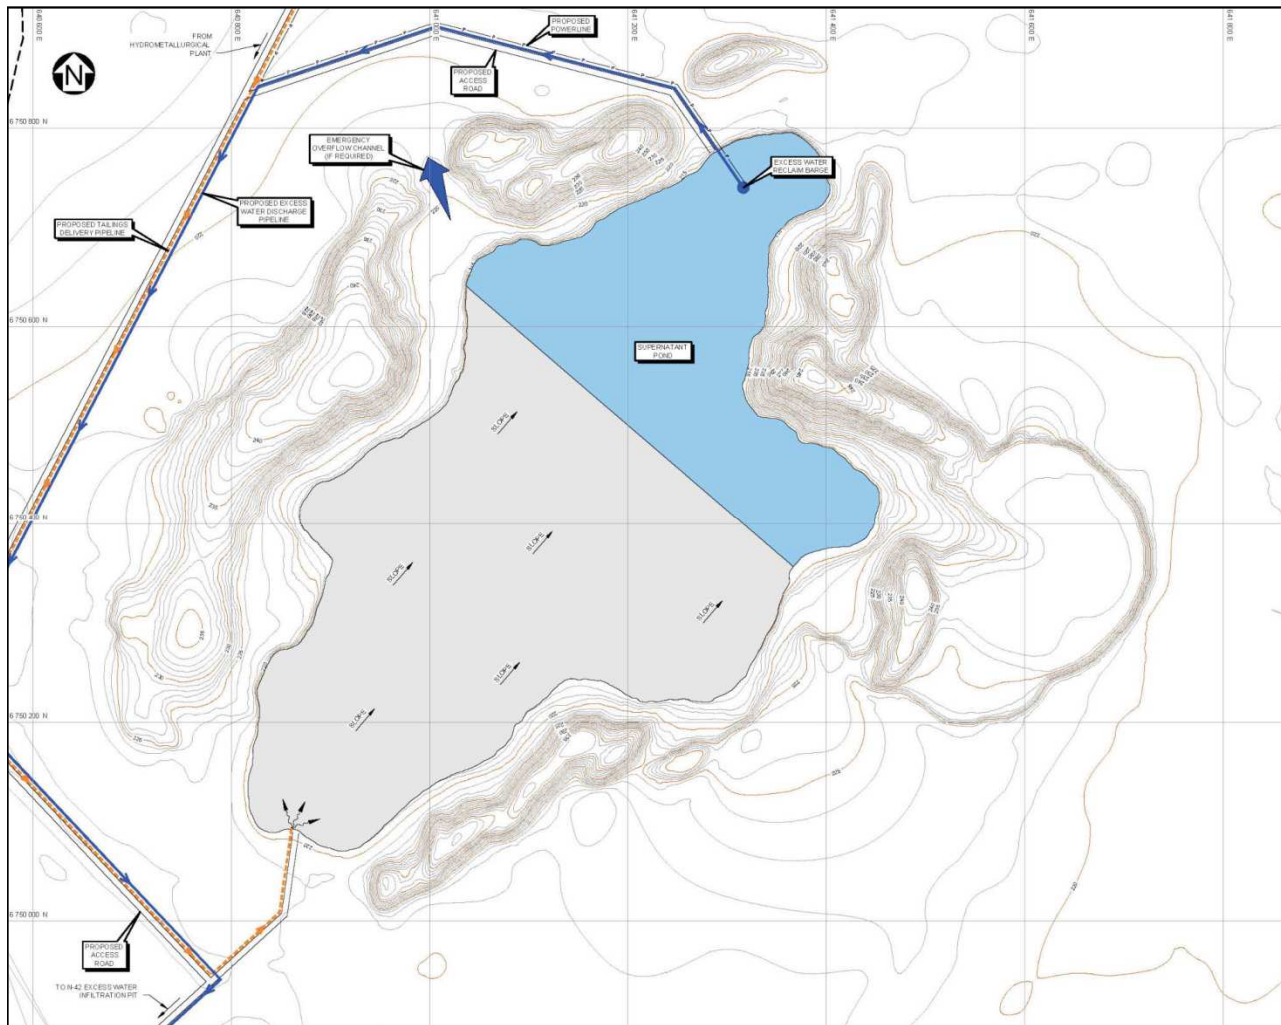
# HTF – Phase 1 (Years 2 – 20)

- Volume Tailings to TMF: 3.78 Mm<sup>3</sup> - Life of Mine
- Slurry Consistency: 40% solids
- Settled Dry Density: 0.9 t/m<sup>3</sup>
- Pit floor prepared by grading of existing of existing waste rock and till materials
- End of pipe discharge from southwest side of pit
- Temporary Separator dyke to form pond at north east portion
- Supernatant and runoff expected to infiltrate into groundwater aquifer
- Any excess water will be transferred to N-42 pit via floating pump barge and pipeline for infiltration into aquifer

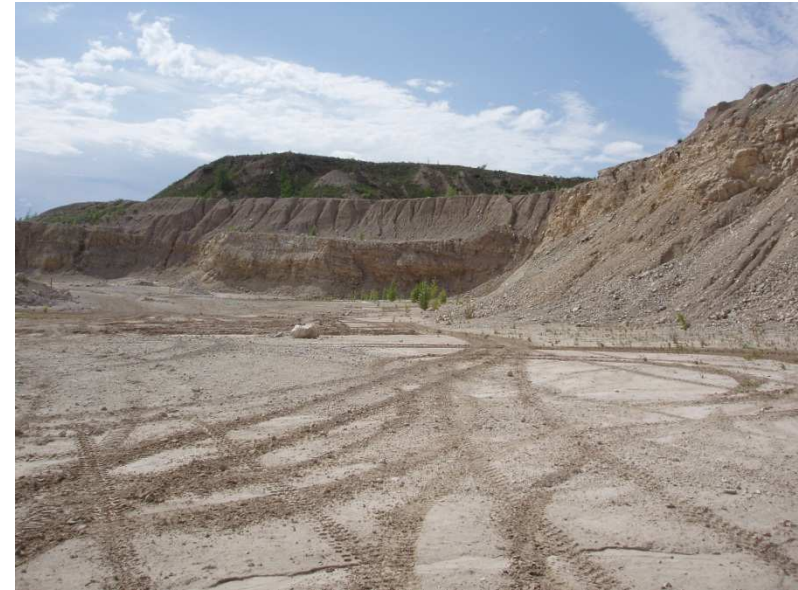
# Pine Point Metallurgical Tailing

- This tailing will be placed in an abandoned open pit
- On closure, the tailing will be covered with overburden and re-vegetated, rehabilitating an previously damaged site
- Re-vegetation testing will occur during operations
- Post closure monitoring will include water quality, physical stability, erosion protection, re-vegetation success, and key environmental quality indicators
