Appendix D Evaluation of Potential Borrow Pits

1 EVALUATION OF POTENTIAL BORROW PITS

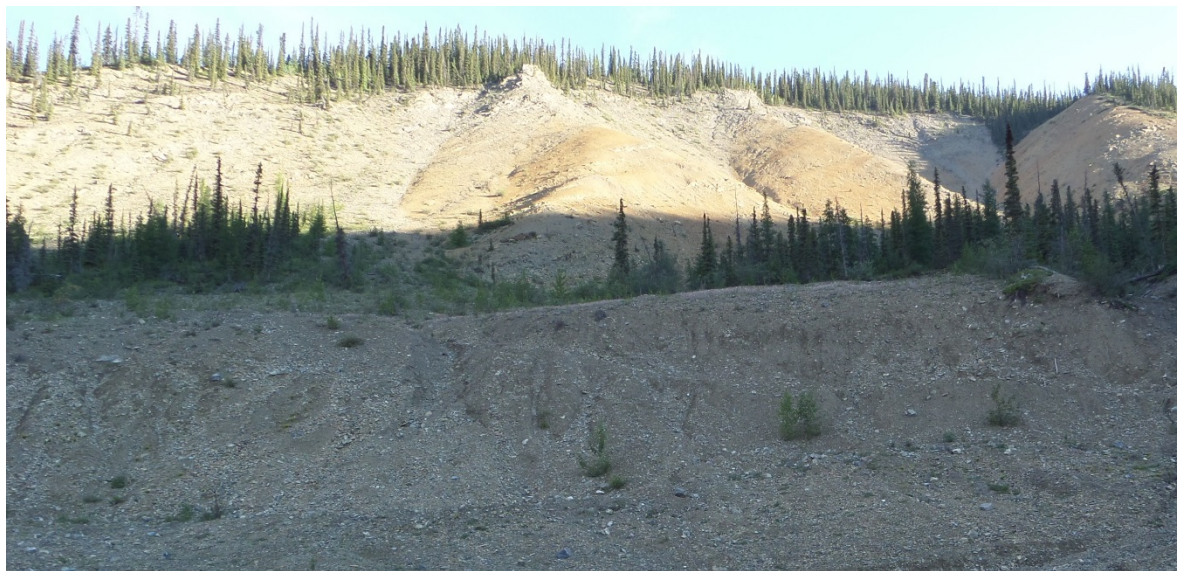
Figure 1: BP1 colluvium source material

This potential borrow source has already been developed in past and has been partially depleted in the building of the water storage pond adjacent to the mine site. The material is loose colluvium siltstone from an exposed slope along the east side of the roadway. The material is fairly fissile and the exposed debris slope consists of relatively fine fragments of broken material. This material appears suitable for subgrade construction, but is not likely suitable for road surfacing material as it appears to have little strength and would probably break down quickly under wheel loads. The previously excavated areas of this material are currently being used for mine site monitoring wells, so future development of this source would have to avoid those areas. While this is a readily available and easily developed source, the materials appear to be of fairly poor quality and the next potential source down the road at KP 2.7 is likely a better option for long-term development in this area.

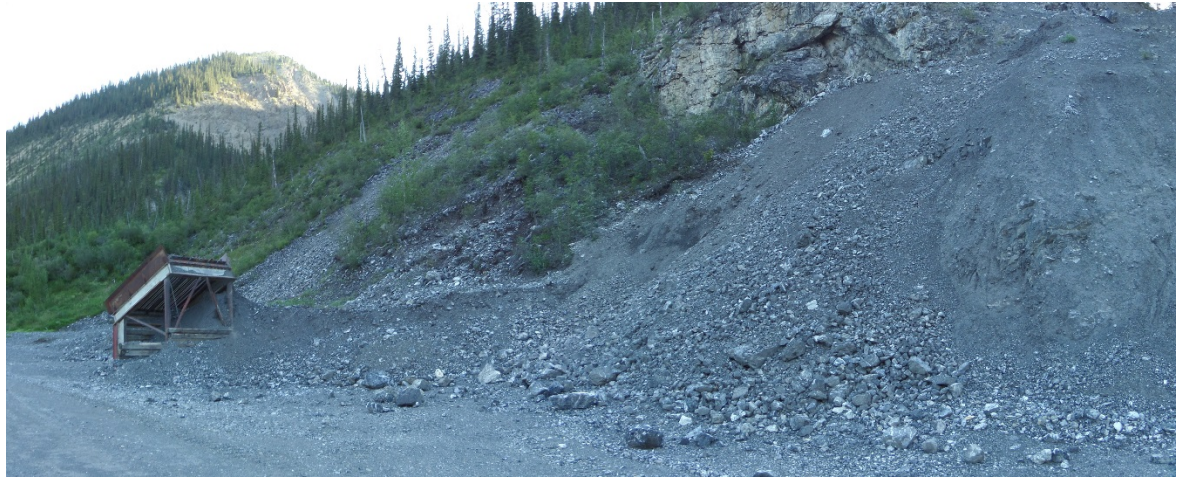
Figure 2: BP2 materials pushed from a higher rock face for screening with a grizzly.

The potential borrow source at BP 2 consists of crumbling bedrock that has been used in past by Canadian Zinc for miscellaneous roadway improvements. This source is identified as a calcareous mudstone that appears very competent in comparison to the previous siltstone source at 0.55 km. Based on the materials developed here to date, it appears that this rock source readily fragments under the blade of a bulldozer, although this favourable trait may decrease with bedrock depth. In past, the use of a grizzly screening unit at the site removed any oversized materials prior to loading the materials into trucks for movement. The apparent hardness and blocky fracture properties of this material may make it suitable for

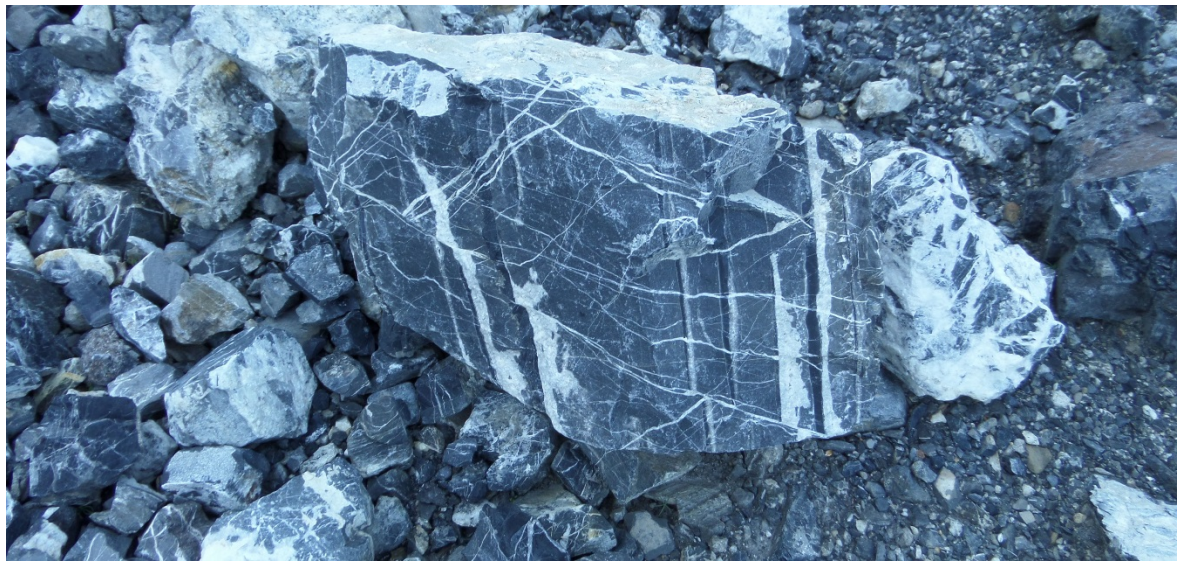
Figure 3: Close up of the BP2 mudstone with sparry calcite cementing.

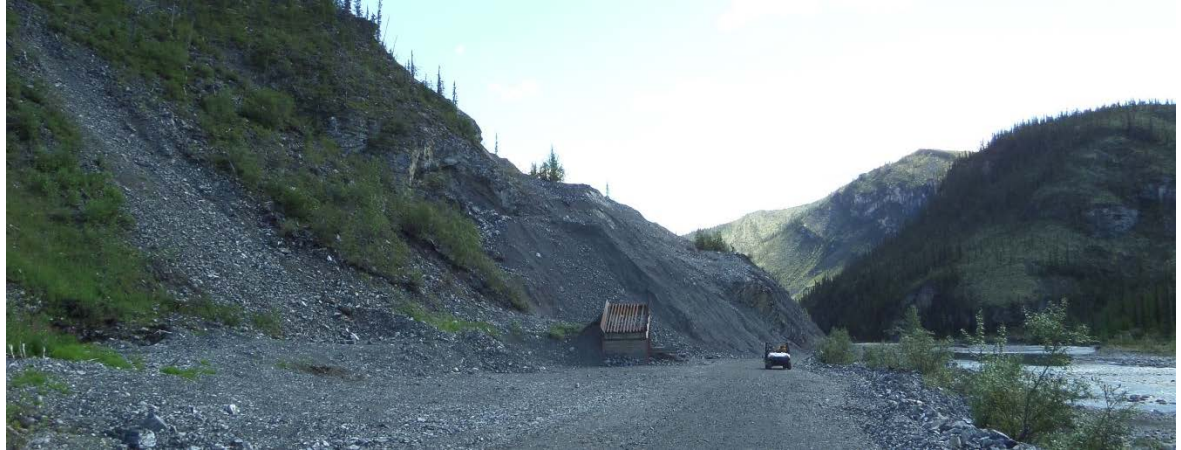
Figure 4: BP2 viewed from the north and showing the limited processing area available.

crushing for surfacing material, and it seems to pack into a very dense state. One limitation for a crushing operation is the proximity to Prairie Creek would constrain the amount of area for the crushing and stockpiling of any large amounts of materials.

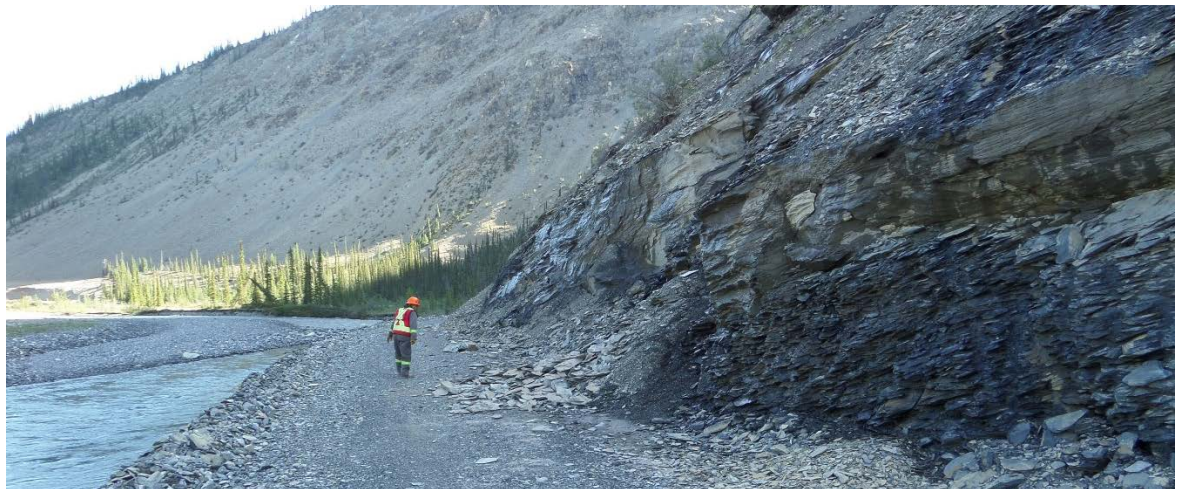
Figure 5: The rockfall hazard at 4.01 km may generate a large quantity of waste rock that could be used to supply subgrade borrow needs elsewhere nearby.

While the rock source at 4.01 km is not a preferred material source, there may be a large quantity of this material removed as waste rock in the building of the final road along this section. The material consists of a tall face of limestone/mudstone that may present a rockfall hazard to the present road location. In the event that this rock face has to be excavated back further, large amounts of waste rock will be generated and this material could be used to supply any anticipated borrow needs in the general area. It is anticipated that this material is more suited for subgrade construction than for surfacing material as it fractures quite easily and doesn't appear to be very durable in nature. Again, the close proximity of Prairie Creek will be a constraint to any processing or load out operations proposed here.

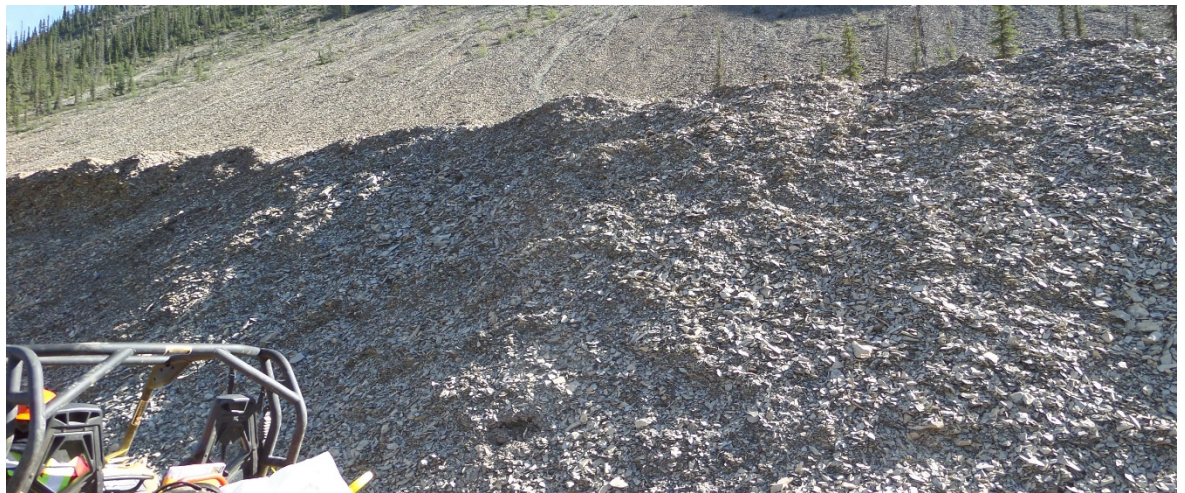
Figure 6: The currently developed face of the colluvium talus slope at BP4B.

Slightly further up the road route from the BP4A location is the site of a developed colluvial limestone/mudstone source that has been designated BP4B. This is basically a large talus slope that abuts to the current roadway, presenting a perfect natural source of shattered rock materials. It appears to result from the same parent rock as in BP4A, but the fragment sizes are much smaller in the colluvial slope. Again, this material seems more appropriate for subgrade construction material than for surfacing material due to its weak plane structure. In terms of ease of development for a talus source in the general area, the BP4B source is very straight forward operation – basically it appears ready to load out as it currently sits. However, if the slopes in the area of BP4A need to be trimmed back due to rockfall issues, then it makes sense to use the BP4A material for borrow instead since it will already be loaded into trucks for removal.

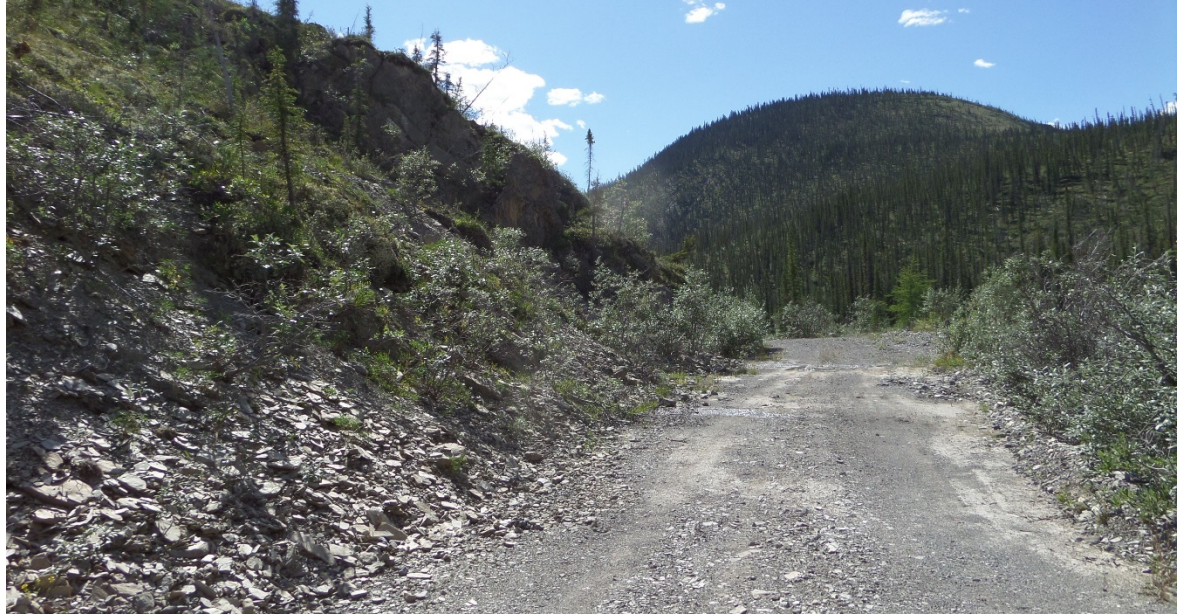
Figure 7: View from the north of the rock face (BP6) at 6.78 km

BP 6 is another case where rock face crowding the current road corridor presents an opportunity for a borrow pit due to economics. Any excavated material here will likely have to be hauled out for disposal. Once loaded into a truck it could be used to supply borrow needs elsewhere in the general area. This material appears to consist of mudstone and as such would be more suited for subgrade construction material than for surfacing material.

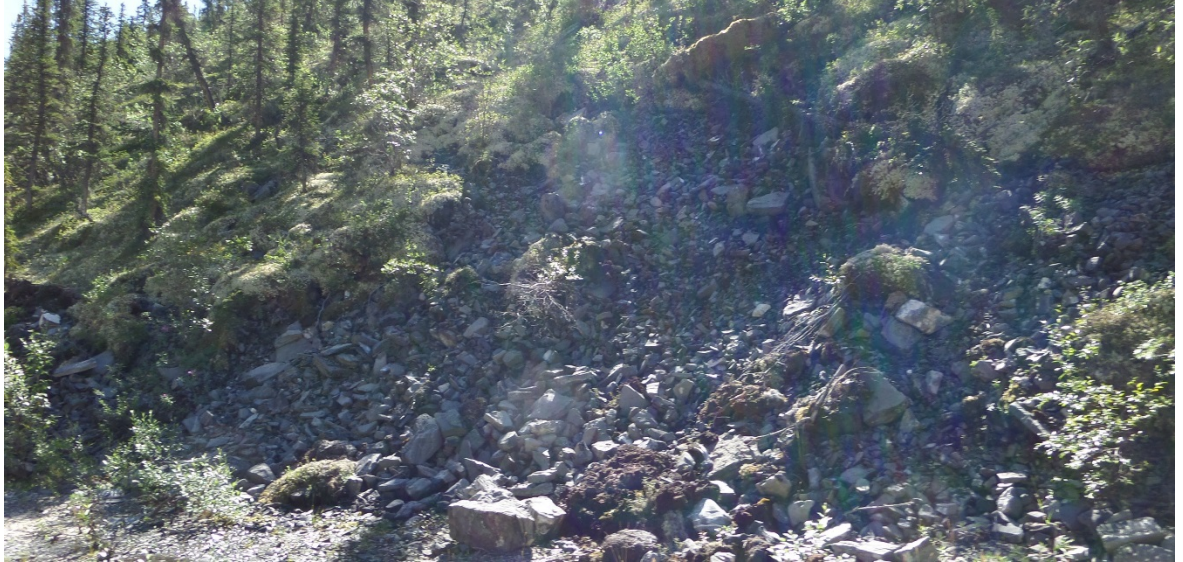
Figure 8: BP10 material showing a wide size gradation. Also note some evidence of creep along the slope – this is assumed to be related to permafrost.

Bp10 is a potential source of black argillite colluvium exposed in a slope alongside the roadway at 10.02 km. This material evidently extends for several hundred meters along the road here, but permafrost might be a strong possibility in the slopes as they are located on a northern aspect. Based on the material evident in the surface exposure, any permafrost in this slope may be ice poor, but it may still be a stability factor due to slow creep within the steep slope. The material in the slope does contain some competent looking large fragments that may serve as light to medium sized riprap. Riprap will be needed in this section of the road route, and along adjacent sections as well, to help manage stream flow adjacent to the roadway. This source contains some of the largest and most competent fragments noted on the western end of the road route. Planning for permafrost prior to any development is recommended.

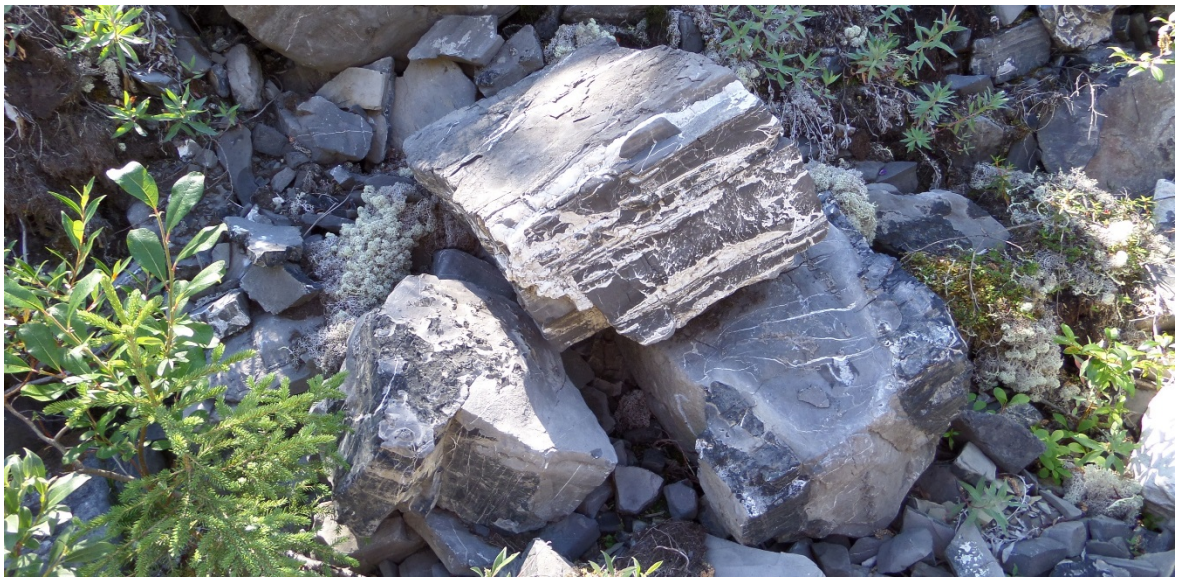
Figure 9: Some of the potential light riprap material noted in the BP10 slope.

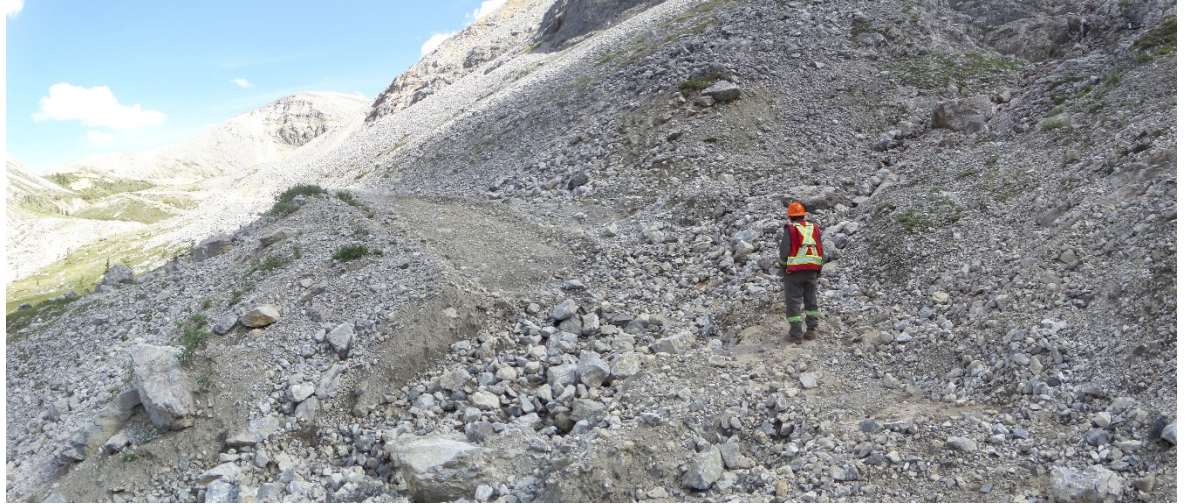
Figure 10: The limestone talus slope at 14.88 km (BP14).

Bp14 appears to consist primarily of a limestone talus slope along the road corridor in a high mountain pass at 14.88 km. The gradation of the material is generally toward fragments of less than 0.3m, but some occasional embedded boulders within the matrix could be used for medium to large sized riprap. This talus slope is derived from limestone bedrock, making it an ideal construction material as it poses no risk of acid drainage – it is actually an acid neutralizing material. At this location, the potential borrow pit material is best suited for either subgrade fill or riprap, as the ground is too steep to accommodate a crushing

operation for road surfacing material. BP 16 may offer better opportunities for setting up a crushing plant if required. This rock would likely create a superior surfacing material for the new road as it should be quite durable in nature and pack extremely well. The light color of this rock helps reduce solar heat absorption as well, making it a preferred choice if there is a need for filling over permafrost areas to help keep the ground insulated.

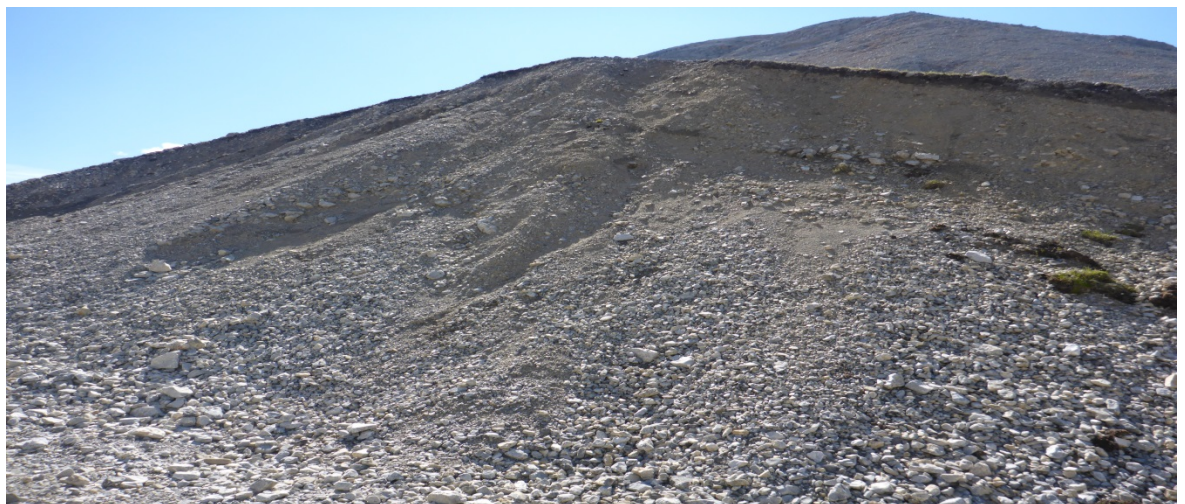
Figure 11: Large esker like deposit of glacial-fluvial gravel at 15.8 km.

A large esker like deposit of limestone gravel left behind from the glaciers. Appears to be a large quantity and quality should provide enough room to accommodate a crush plant but it may be tight.

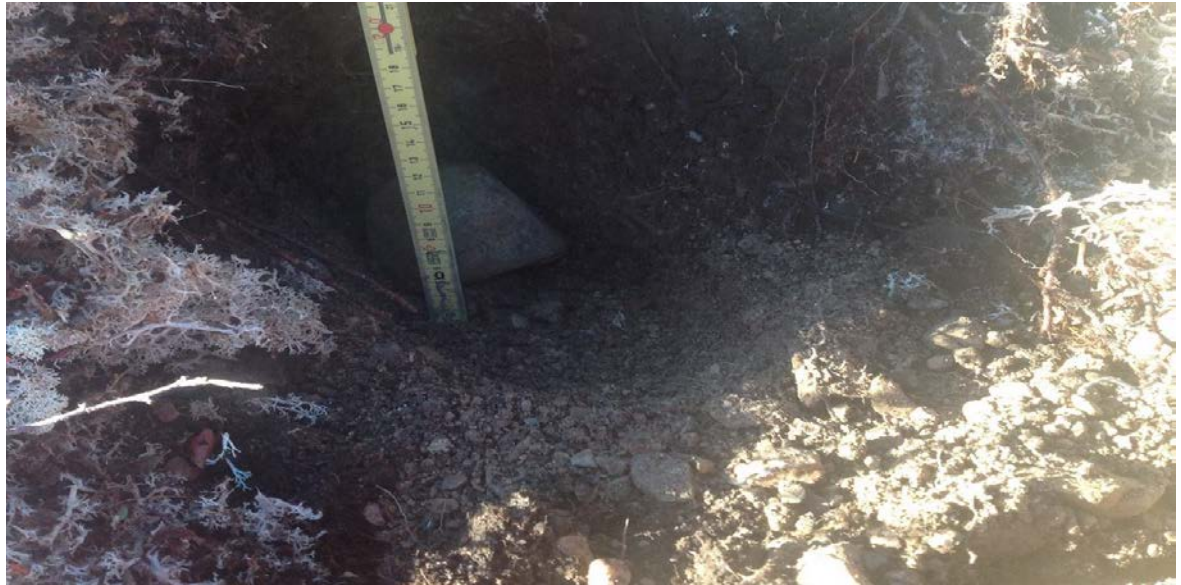
Figure 12: Large esker like deposit of glacial-fluvial gravel at 15.8 km.

A large esker like deposit of limestone gravel left behind from the glaciers. Appears to be a large quantity and quality. If required, should have adequate room for a crush plant.

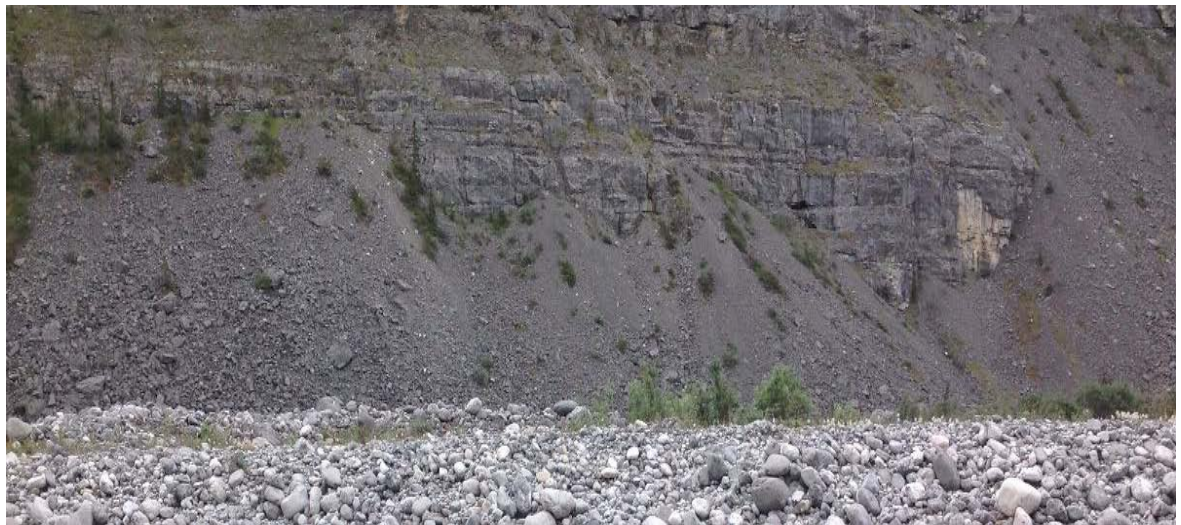
Figure 13: Large talus rock deposits along a number of locations of the lower Sundog Creek between Km 33 to 39.

All similar large fragmented talus rock deposit found along the lower Sundog Creek parallel to the proposed road location. Will work well for the proposed road construction approach along the lower sections of lower sundog.

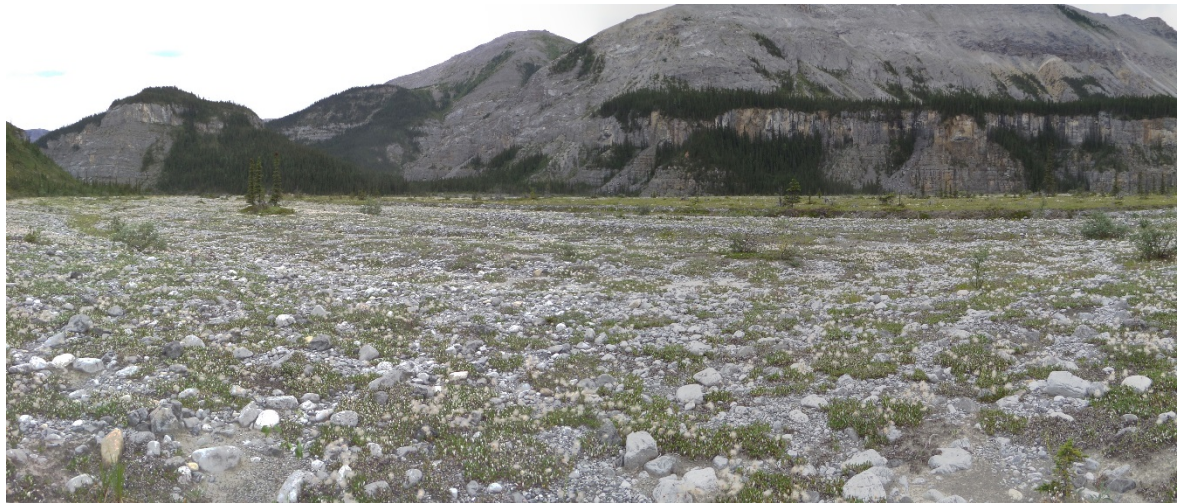
Figure 14: This dry alluvial flood plain at 39.20 km will become isolated from the main stem of Sundog Creek during road construction, providing opportunity to develop it as a crushed gravel source – BP39.

Bp39 lies on a meander along the southern margin an old alluvial floodplain along Sundog Creek. This section of the alluvial plain will become isolated from the main stem of the creek when the permanent access road is constructed. Once the road is constructed, this fringe margin of the old floodplain will no longer be subjected to the spring floods that have overtopped the dry gravel bar here infrequently in past. With the removal of the risk of flooding on this area, the deposited gravel materials here could potentially be extracted for road construction because it is located outside the active high water levels. This area could be one of the most important potential borrow sites along the planned roadway, as it contains washed carbonate materials (limestone/limy siltstone) that make for a preferable construction material. This light colored, durable, and non-acidic cobble and gravel would be a preferred material for use at many places within the project area because of it properties. It could be processed by crushing and screening into a highly durable, long-term road surfacing material for construction and maintenance purposes. The material is extremely free draining and its light color would not absorb much solar heating so it would assist in insulating fill material over permafrost zones (if required). Because it is situated on the fringe of an old alluvial wash channel, there is a good likelihood that this material is free of permafrost as well. The large flat here is also advantageous for operating a crushing plant and for stockpiling crushed materials until they can be applied to the road. Since the area may be subject to a fluctuating water table (as controlled by seepage from nearby Sundog Creek), any gravel excavation would need to be carried out during periods with a low water table.

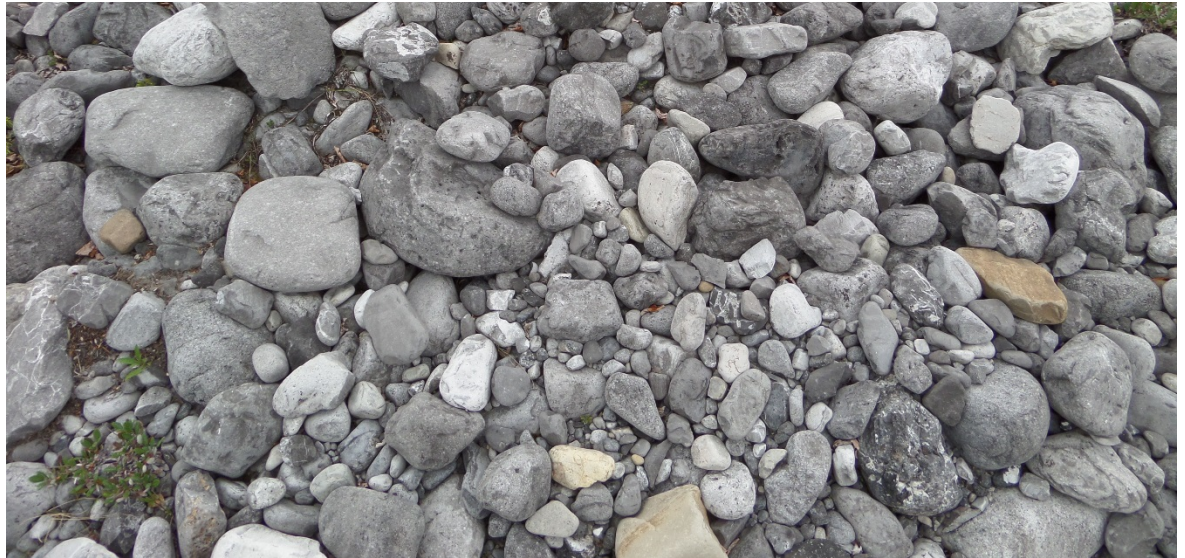
Figure 15: Typical gravel and cobble material available at BP39. This material consists primarily of Paleozoic carbonate rocks as evidenced by the abundance of fossilized coral fragments throughout the aggregates.

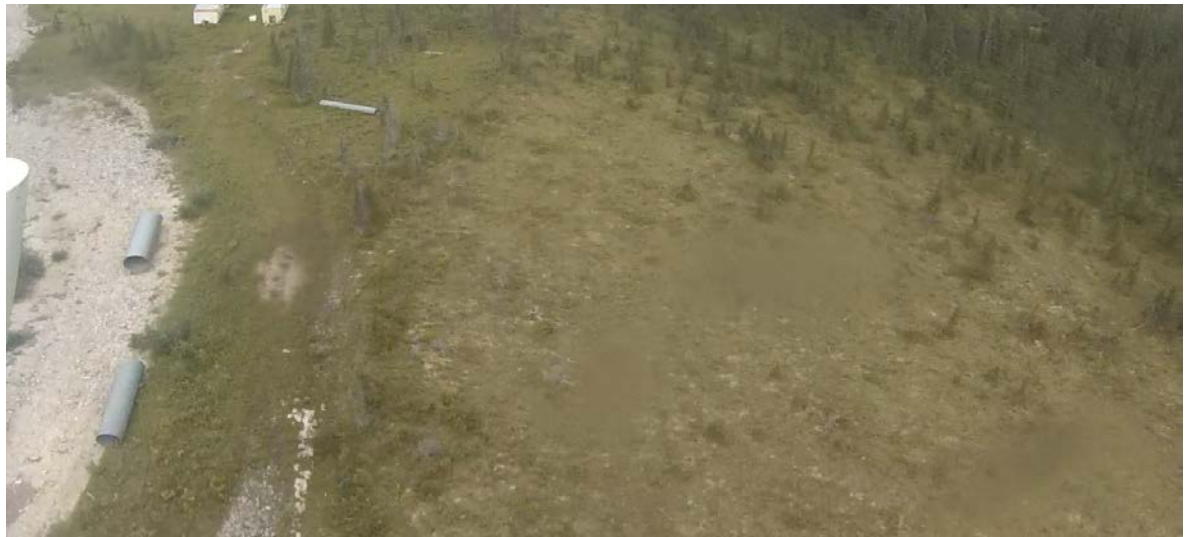
Figure 16: Old flood plain of Sundog Creek utilized as a camp/laydown area (Cat Camp) from the 1980 winter road construction.

Similar deposit as identified at BP 39, an old floodplain of Sundog Creek. Perhaps more attractive than BP 39 because closer proximity (1 km) to the intended destination. Expect it to be a shallow depth as to not compromise the water table. If required, ample room for crushing plant.

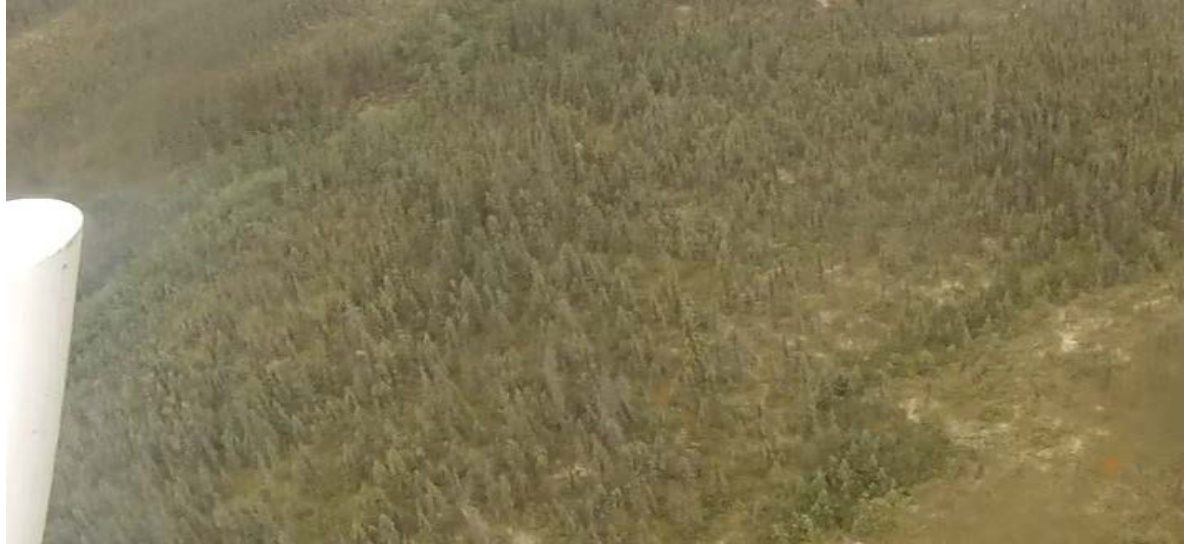
Figure 17: An aerial view of an elevated “hump” of expected silty sand which should provide adequate base material to support overland sections.

Not field confirmed but expecting similar material type that was consistently observed in the surrounding area. Should provide adequate base material for subgrade material for expected localized overland sections. Expect shallow pit depths of 2 m.

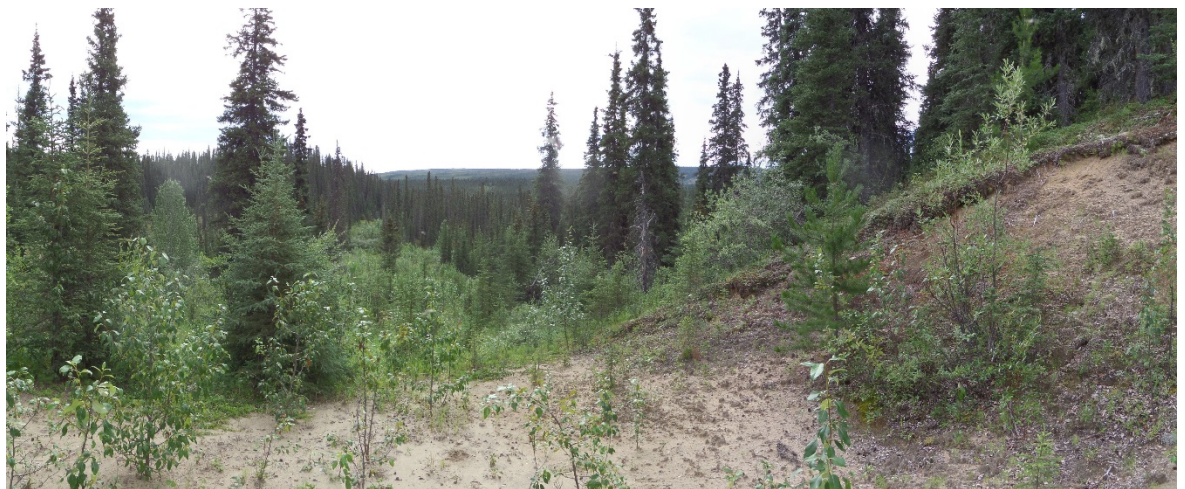
Figure 18: View of the existing cut for the past winter road across the end of the esker at 43.15 km.

At 43.15 km a small esker of fine sand (BP43A) is crossed by the road route. This esker runs in a westerly direction from roadway, and could be developed as a long-term source of sand for winter road sanding and for pipe bedding material during construction. During construction, this sand deposit could also be used for free draining road fill across lowlands.

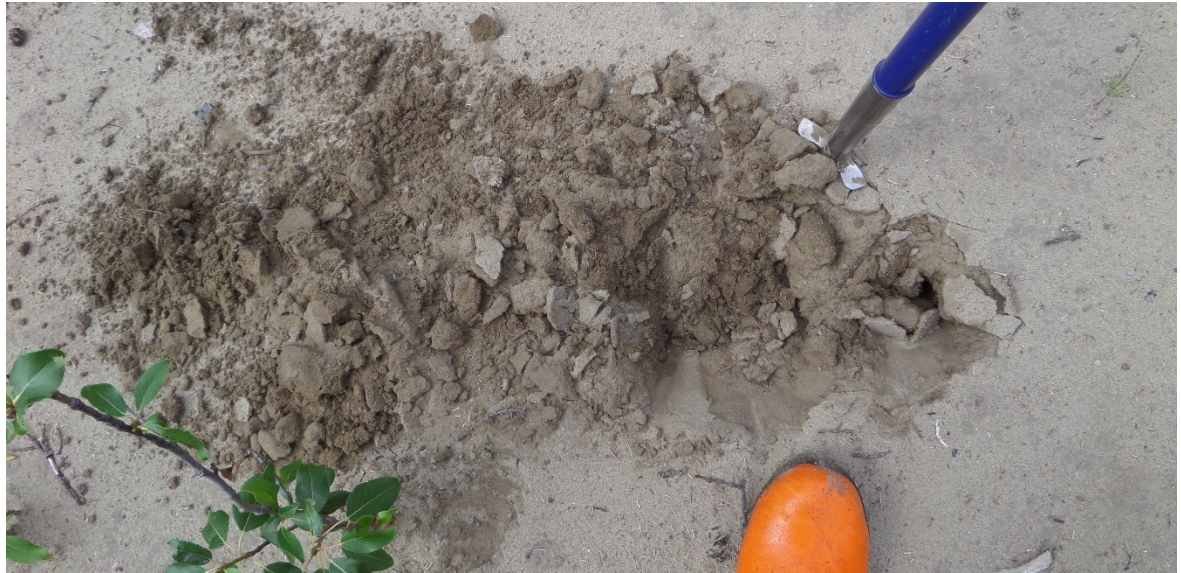
Figure 19: Example of the fine sand in the esker source designated as BP43.

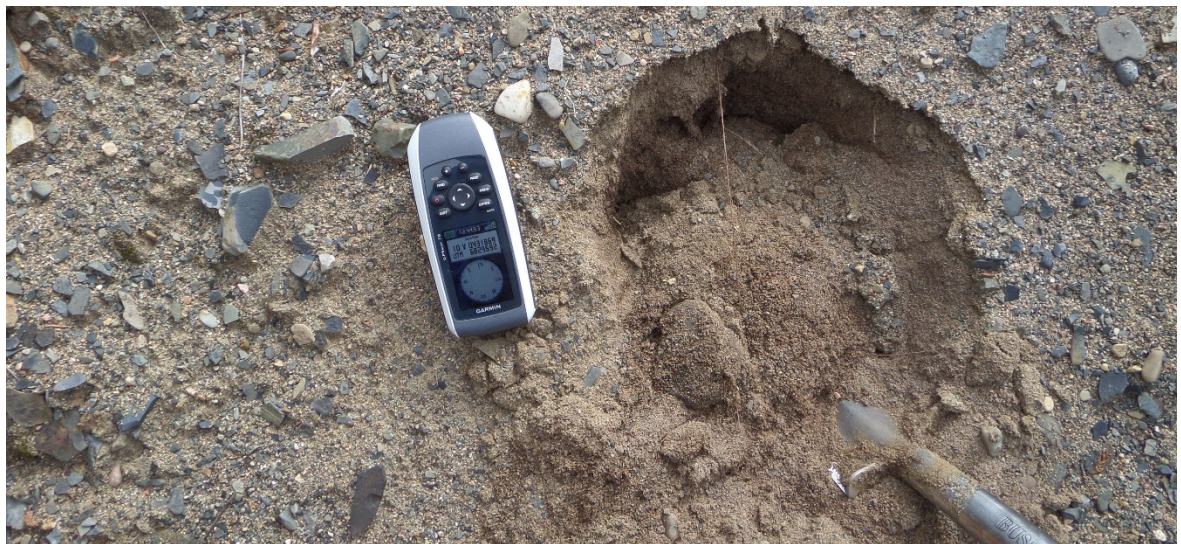
Figure 20: View of the sand material in the original construction borrow at 43.65 km.

BP43B is situated at 43.65 km and covers an area containing an existing borrow pit of medium sand from the original winter road construction era. While this particular area has been designated as the borrow site, the sand deposit itself runs from approximately 43.5 km to 45.75 km. As with the BP43A site, this sand has potential for pipe bedding, winter road sanding, and for subgrade fill across lowland areas. The material in BP43B grades a little coarser than the material in BP43A, so it may be a bit more appropriate for lowland fills where the pumping of groundwater into the subgrade may be a concern.

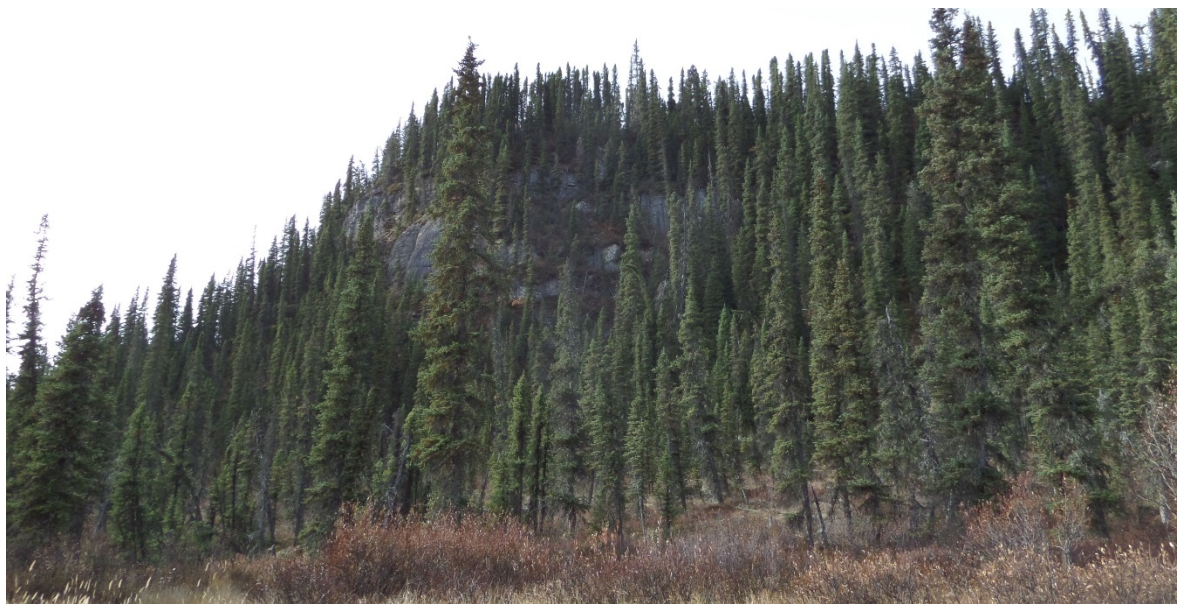
Figure 21: View of BP47A limestone bedrock face.

BP47A is situated about 300 m south of 47 km, and consists of a large rock face along a seasonal side drainage that enters from the south and parallels the route to the east. While this side valley is off the planned corridor construction footprint, it does contain two potential sources of important construction materials, and could be readily accessed with a short access road and crossing over a small stream. This rock face, and the scree slope situated below it, offers a source of both colluvium and solid rock limestone for road development needs. These raw materials could be used to generate construction materials ranging from crushed surfacing materials and subgrade rock fill, to riprap for armouring. Geologically, this area consists extensively of carbonate based bedrock so all the materials available for borrow here should be acid neutralizing materials.

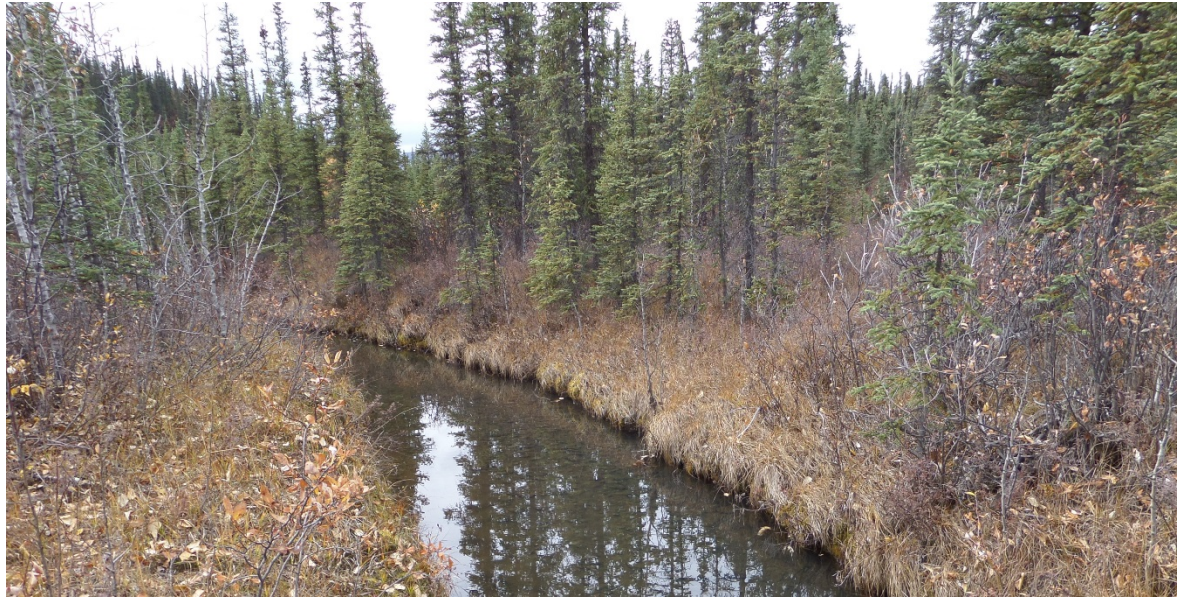
Figure 22: The small stream that would need to be crossed to access BP47A and BP47B.

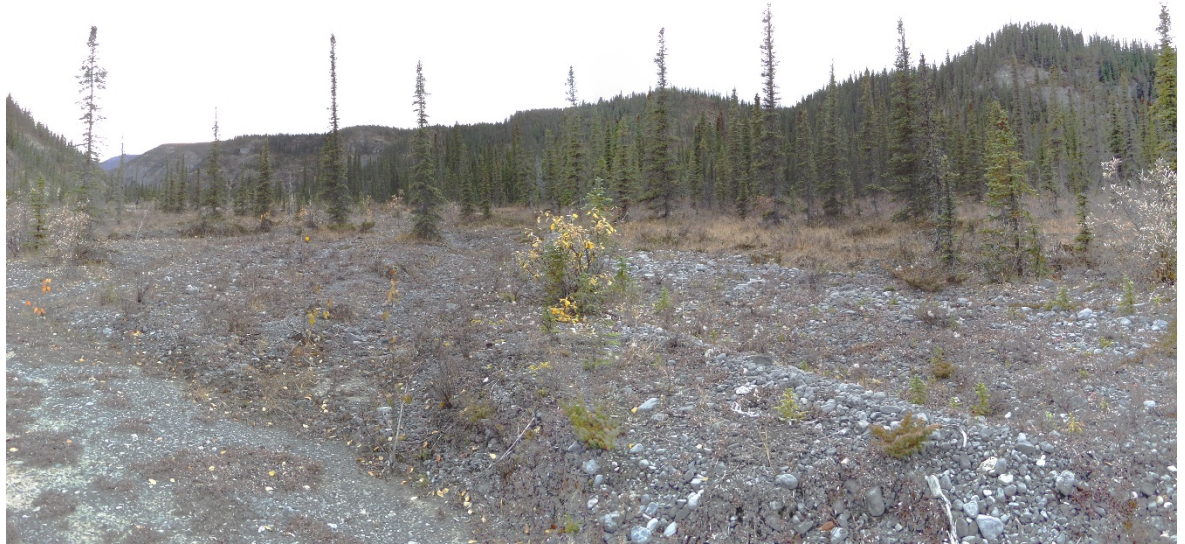
Figure 23: View of BP47B alluvial deposit area.

BP47B is also situated to the south of 47 km and requires the same short access road and creek crossing as BP47A would in order to develop it. This potential borrow source consists of alluvial gravel deposits (carbonate based) situated along the west side of a valley entering from the south. The stream within the valley is seasonal and appears to be dry except for during the higher spring runoff periods when it briefly avulses and deposits gravels across the broader floodplain. As such, this deposit is similar to that of BP39, in that material excavation would likely be possible during the drier summer, fall, and winter months, and the depth of excavation could be controlled by a fluctuating water table. There is also a possibility that the low level water flows are carried underground in subterranean channels within the limestone bedrock. Shallow gravel excavations carried out further back from the seasonal channel would be practical, but would require additional planning.

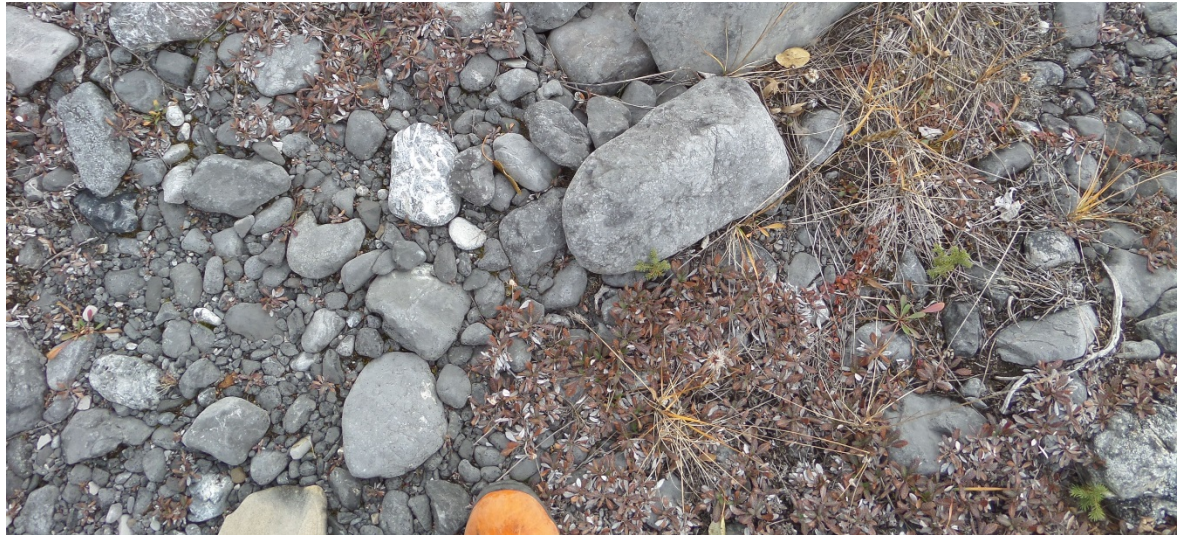
Figure 24: Typical BP47B alluvial deposit materials derived from carbonate parent rock.

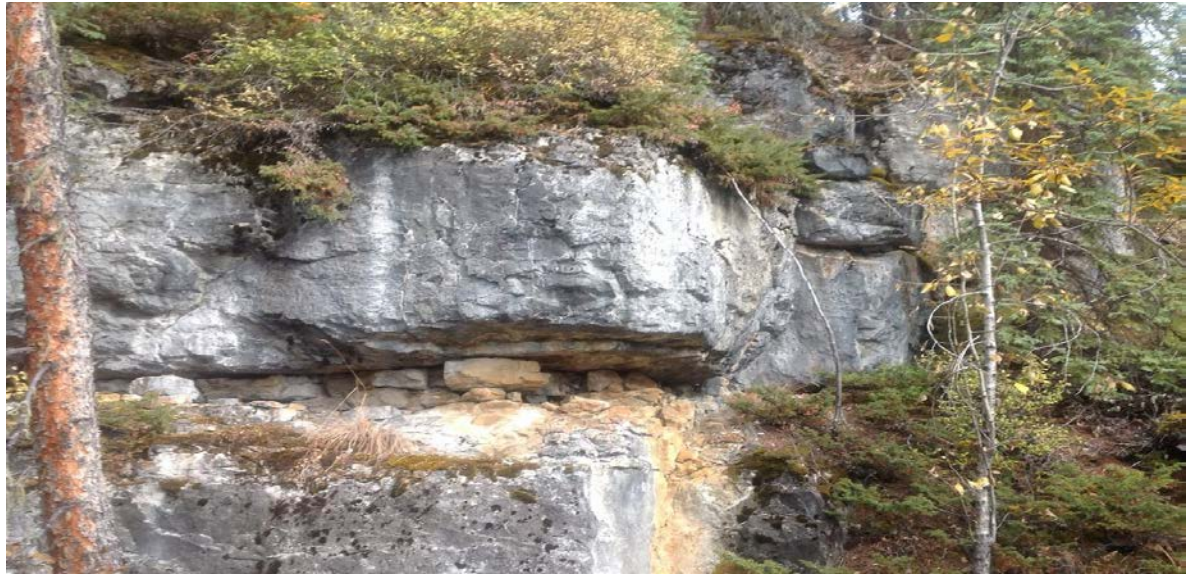
Figure 25: Exposed rock face adjacent to the proposed road at KM 47.7.

Assumed a similar rock formation as identified in BP 47A however is adjacent to the proposed road location so more accessible.

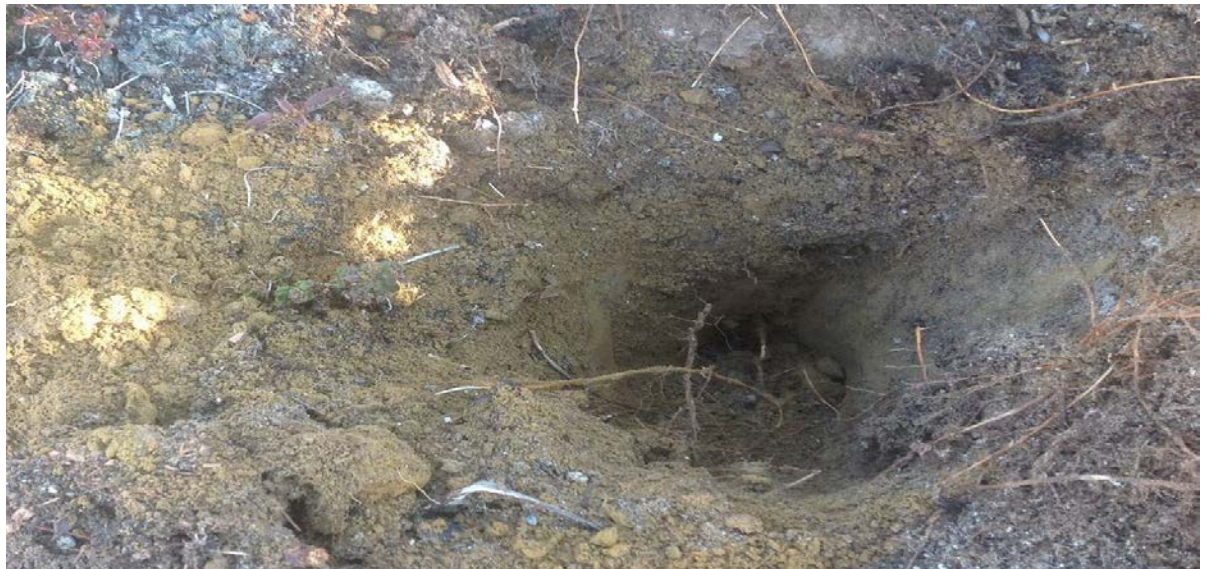
Figure 26: An example of the fine sand material found near BP 50B.

Could be easily expanded and would provide adequate material for localized overland sections.

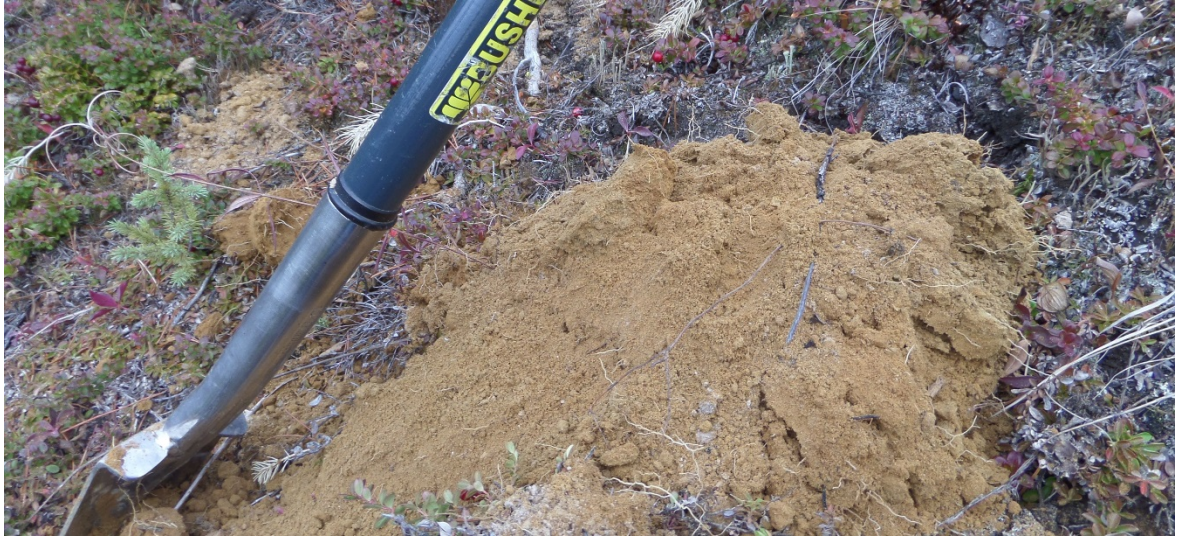
Figure 27: The fine sand in BP50 is potential fill for crossing over nearby lowlands.

BP50 is part of a broad area of fine sand found between 50.88 and 51.75 km that could be used for subgrade fill over the wetter lowlands in the area. These lowlands present relatively deep organics and potentially permafrost at depth. This material provides free draining borrow, but it is also quite fine and it would have to be capped with coarser materials to protect it from potential surface erosion after construction.

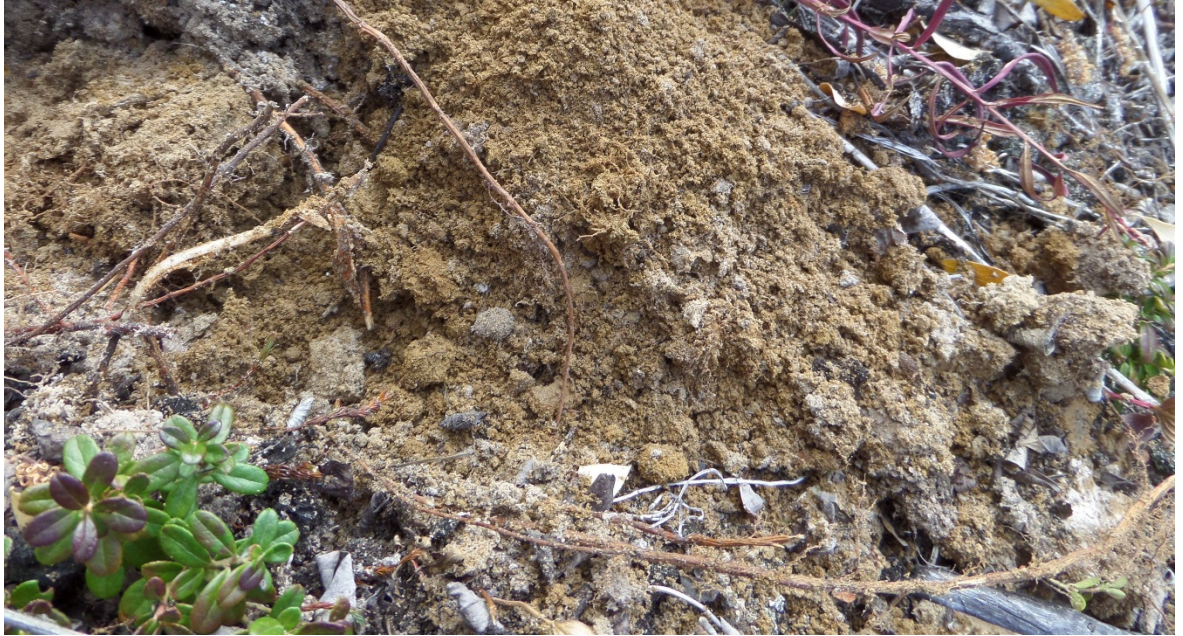
Figure 28: The fine sand in BP51 is a potential overland subgrade borrow source on the west side of a section of deep organic lowland running from 51.75 km to 52.95 km.

BP51 is part of the same broad sand deposit that BP50 is situated on, but BP51 is located strategically on the west end of a wide lowland with deep organics that the road must cross. This lowland area, possibly with permafrost under it at depth, must be crossed using overland construction techniques to build the subgrade. Overland construction involves “floating” a roadway across areas with deep organics by leaving the organics undisturbed and covering them with a thick layer of imported free-draining material taken from suitable borrow sources. BP51 would provide a suitable borrow source on the western end of the long overland section running from about 51.75 km to 52.95 km. As with BP50, this sand is quite fine and would have to be capped with coarser material to control the potential for surface erosion.
