Appendix D Evaluation of Potential Borrow Pits

1 EVALUATION OF POTENTIAL BORROW PITS

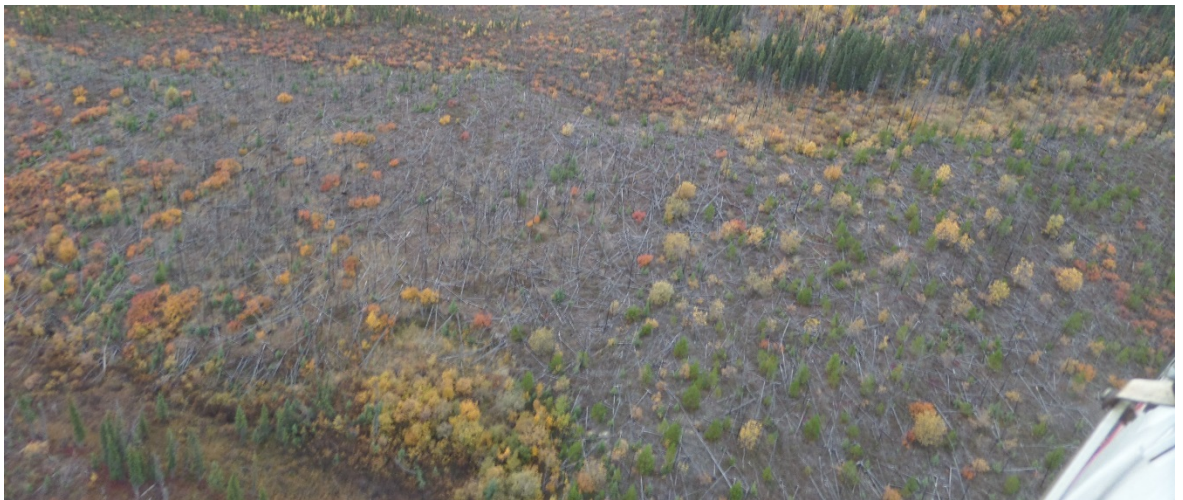
Figure 29: Aerial view of the BP51 source area – burned area (grey) indicates the sand.

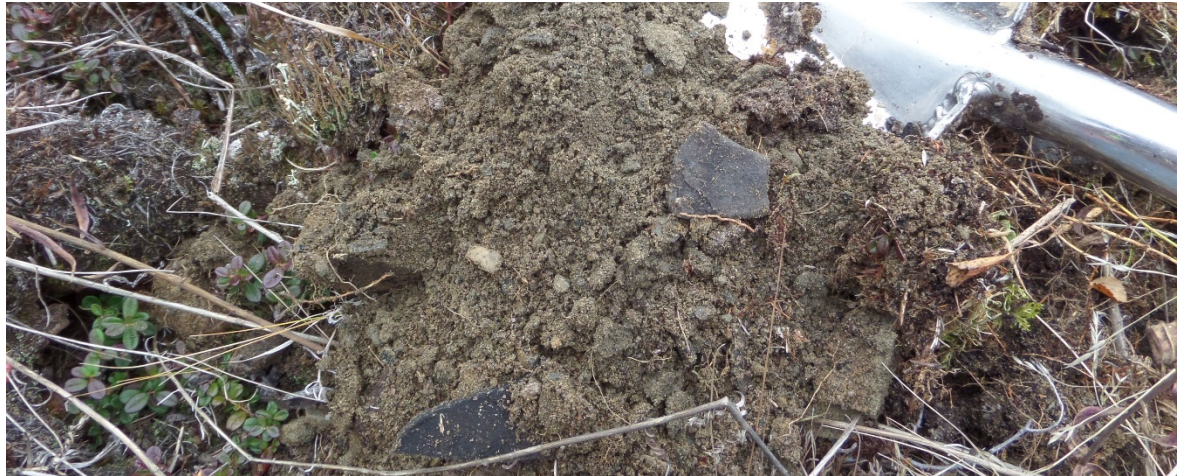
Figure 30: Fine sand with minor gravel and shale showings in the lower bench of BP53.

BP53 is located at 53.4 km, slightly beyond the eastern end of the wide lowland area that the road must cross between 51.75 km to 52.95 km with overland construction. BP53 is located on the nose of some benched terrain that juts out on its east side toward Poljie Creek and is bordered by an ancient paleo-channel of Poljie Creek on the north. The upper bench level consists primarily of the same fine sand as was noted in BP50 and BP51, while the lower bench has some slightly coarser sand with some minor gravel and shale fragments. All this material is free-draining and suitable for the overland fill required between 51.75 km to 52.95

km. As with the previous borrow sites in this area, this sand is quite fine and would have to be capped with coarser material to control the potential for surface erosion. Previous subsurface geotechnical drilling at nearby Poljie Creek also indicated some gravel deposition at depth in this general area, so the lower levels of this borrow area have some limited potential for glaciofluvial gravel deposits as well.

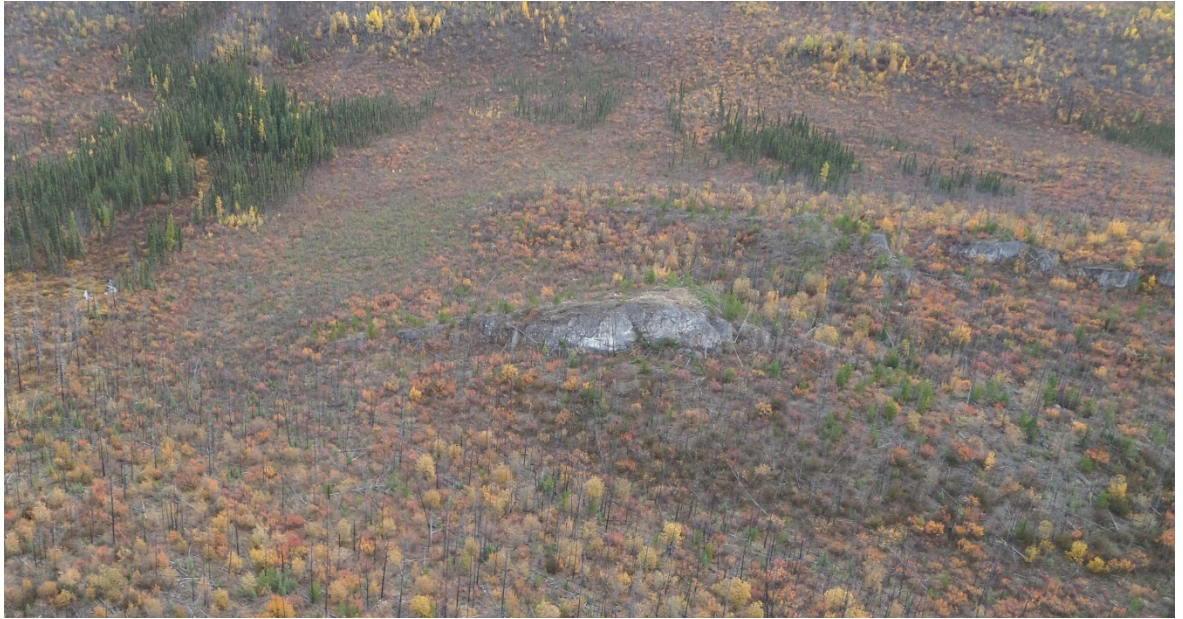
Figure 31: Aerial view (looking east) of the carbonate rock exposures proposed for BP54.

At 54.60 km the road route passes in close proximity to the northern end of a chain of carbonate rock protrusions along the east side of Poljie Creek. The protrusions forming BP54 consist of two low, timbered, rock outcrops on the north end of a chain of carbonate exposures that become visually impressive further south where they form karst cliffs and pinnacles overlooking Poljie Creek. While physically connected to this same chain of karst exposures, the BP54 outcrop knobs are very subdued outlying outcrops, with very little aesthetic value evident. They do however provide a good potential source of carbonate rock that could be developed into a needed source of riprap and ballast for construction within the general area. Depending on the depth of the material that can be developed here, there may be enough volume in these exposures to justify a small rock crushing operation to develop superior surfacing for the road and for the proposed airstrip nearby. This rock would also form an excellent capping material for the sand fill proposed for overland construction in the section from 51.75 km to 52.95 km to the west. It would armour the sand fill from erosion and provide a light colored reflective surface to prevent solar heat absorption into the fill should permafrost be present at depth.

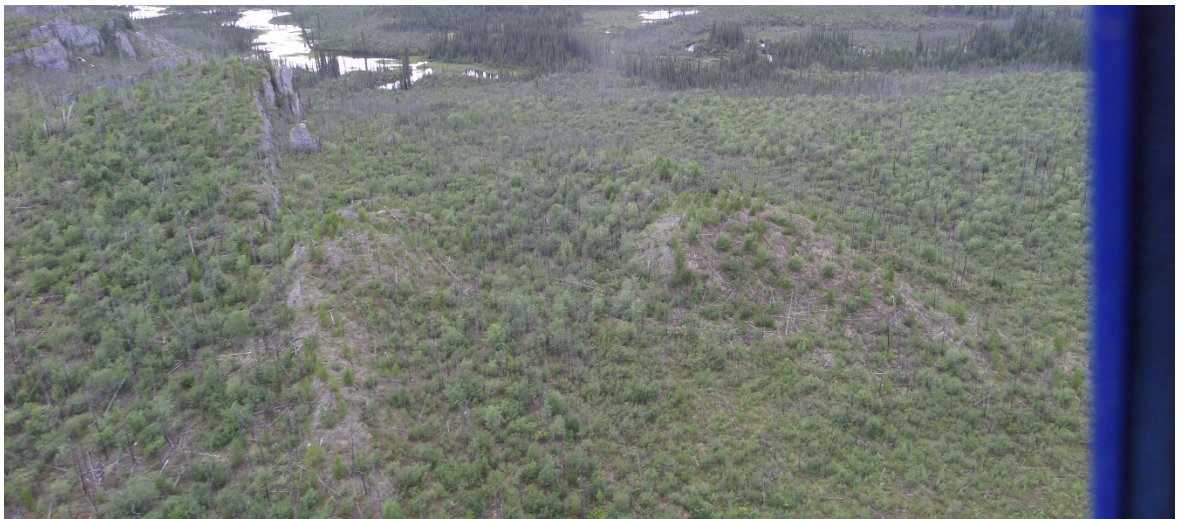
Figure 32: Aerial view (looking southwest) of the timbered carbonate rock knobs (lower center) proposed for BP54. The more exotic karst formations (upper left) that start further south along Poljie Creek, are not part of the proposed BP54 borrow area.

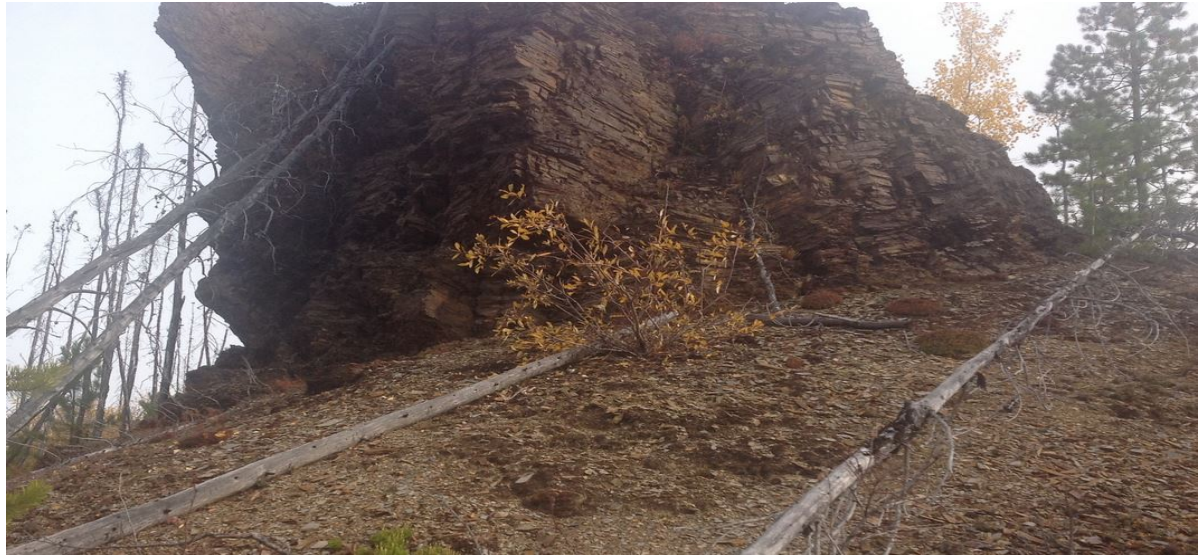
Figure 33: The fragmented shale rock knob the road passes thru at km 55.3.

Shale rock knobs comparable to BP 54 however the road passes thru them. Could be utilized for excellent subgrade base over overland sections and/or possibly surfacing.

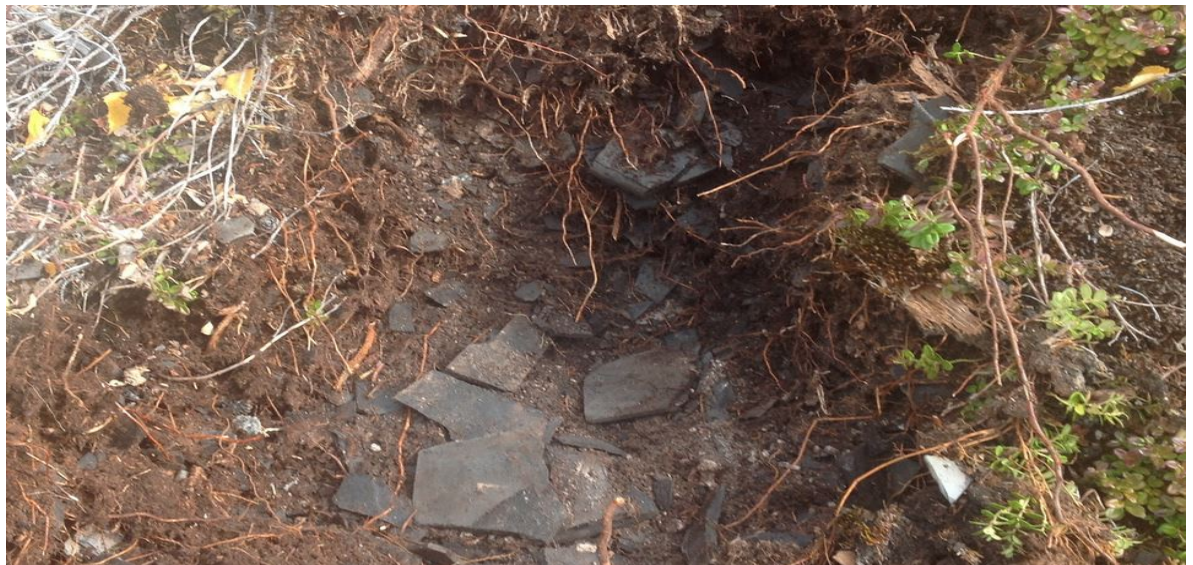
Figure 34: A large exposed shale rock sideslope near KM 55.9.

Exposed shale rock knob located along the upper cut-slope of the proposed road. Could provide excellent subgrade material and possibly for surfacing.

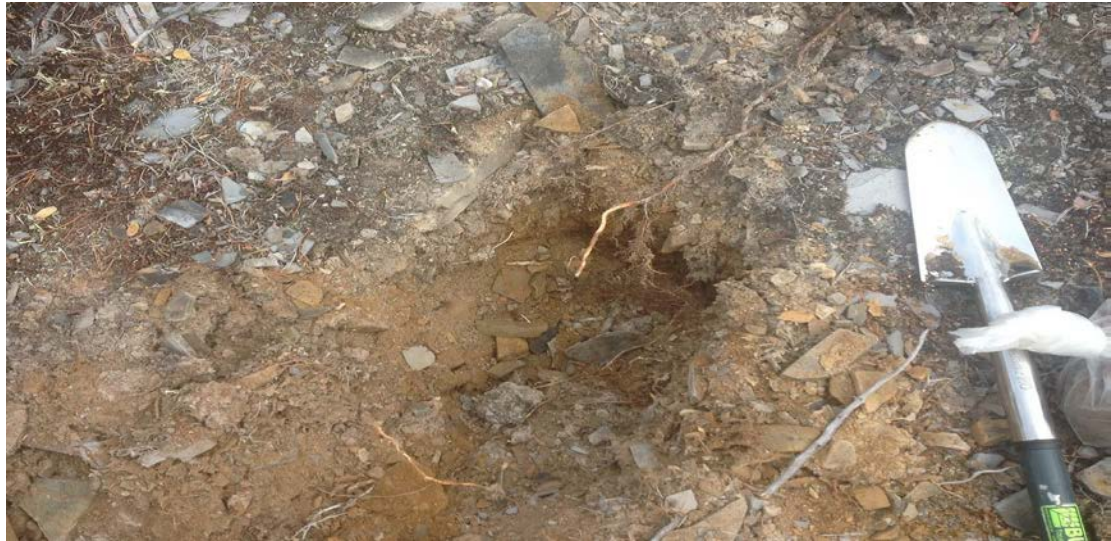
Figure 35: An example of the shale rock found at Km 56.5.

Exposed shale rock knob located in close proximity to road location. Could provide excellent subgrade material and possibly for surfacing.

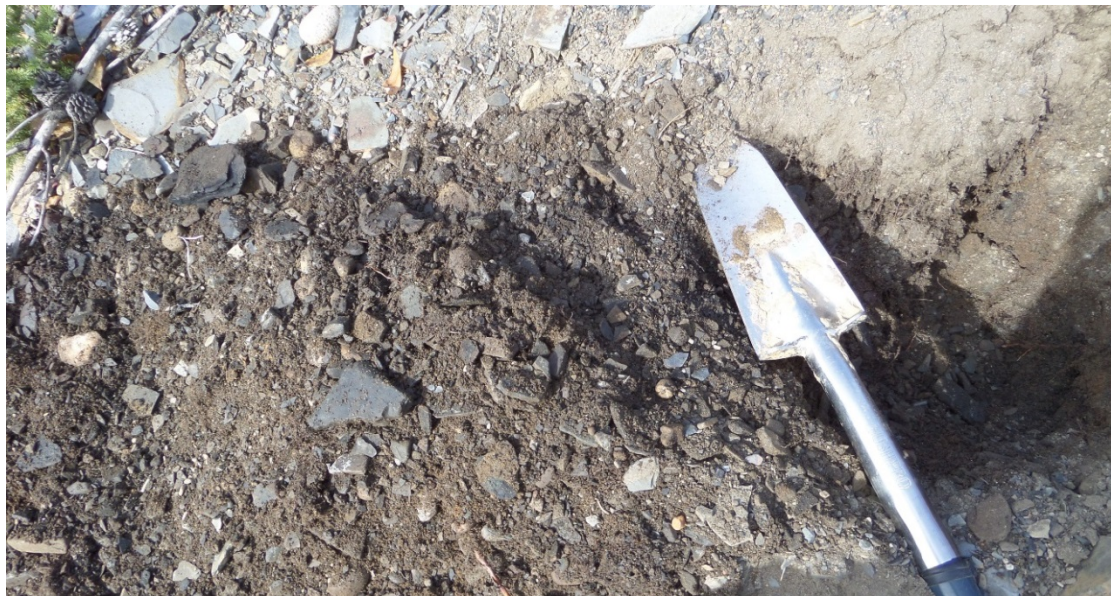
Figure 36: Shale based sandy gravel noted along the old winter road at 59.41 km (BP59)

BP59 consists of a shale based gravel deposit exposed in a constructed cut at 59.41 km along the old winter road. The material is fairly sandy but is still one of the better looking glaciofluvial gravel materials noted within the general area. It could be used as a lower durability pit-run gravel source, or for fill for the road or the nearby proposed airstrip. This gravelly material appears in exposures along the old winter road right up to about 59.90 km.

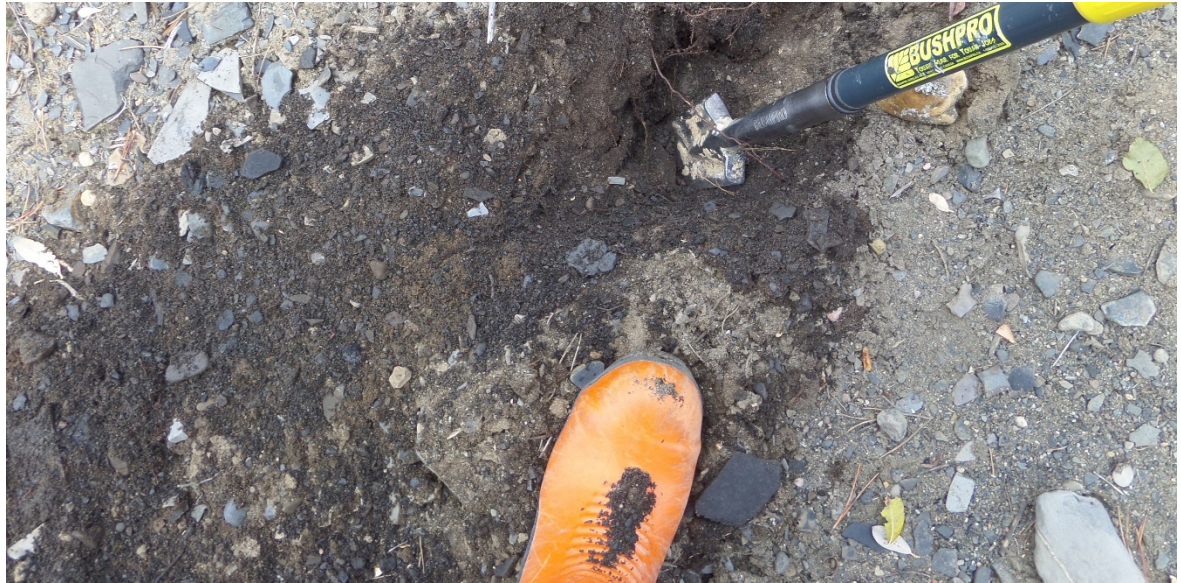
Figure 37: Similar looking material found along winter road at 59.90 km.

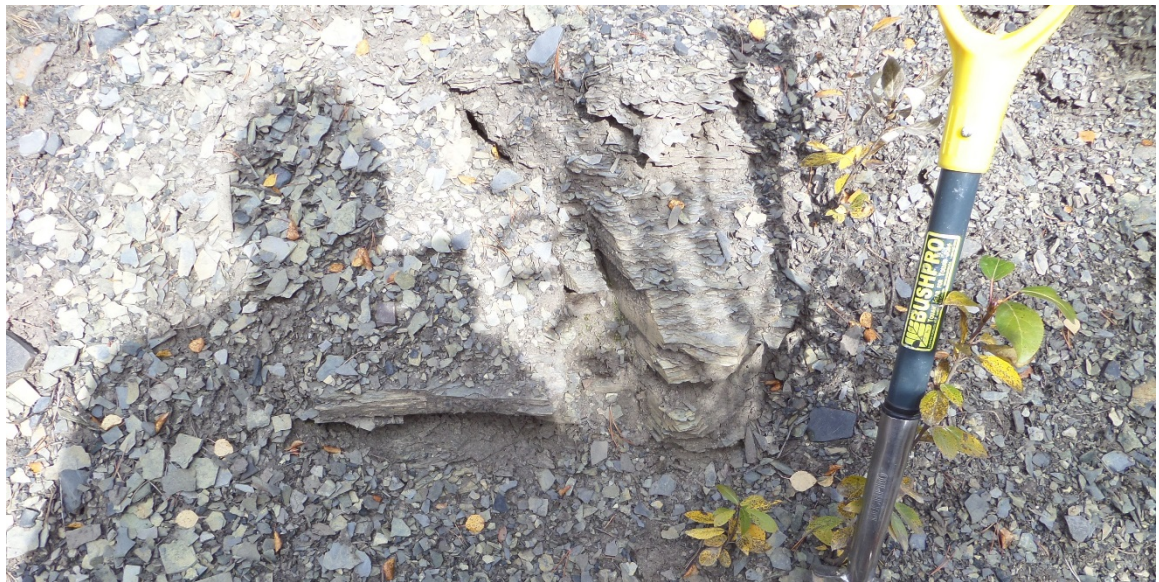
Figure 38: Fissile siltstone exposure.

BP61 consists of a siltstone outcrop exposed in a cut along the old winter road at 61.40 km. The material is quite fissile and likely of low durability, but is one of the best construction materials found in this section of finer grained moraine deposits with occasional seepage zones. This material can be used to firm up areas of soft ground and to repair some ditch and shoulder erosion that has occurred on a few steep grades along the old winter road west of this location.

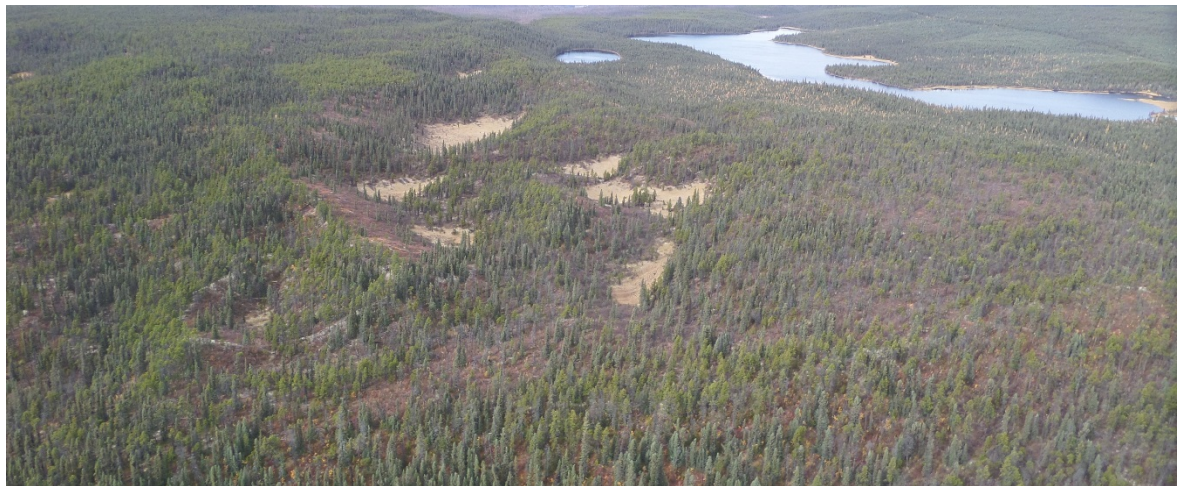
Figure 39: Overview of major glaciofluvial deposits south of Mosquito Lake (background)

BP64 constitutes but a small portion of a very large glaciofluvial kame/kettle deposit that is several kilometers in size and situated south of Mosquito Lake. The material contains sub-rounded sedimentary rock fragments in a matrix of silty sand that would pack well for road surfacing and may even have some natural dust control properties. The potential gravels here are quite deep and additional sampling at depth would be needed if it is necessary to confirm suitable gradation throughout. The BP64 location is situated about 400 m west of the planned road route, and has the best looking gravel from multiple sampling locations taken along the nearby esker chains. This area could be developed for gravel pit purposes with a short section of easily constructed access road across well drained soils. If however, the quantity of materials at BP65 is proven out by deeper test excavations, then it would be simpler to develop that material directly along the roadway.

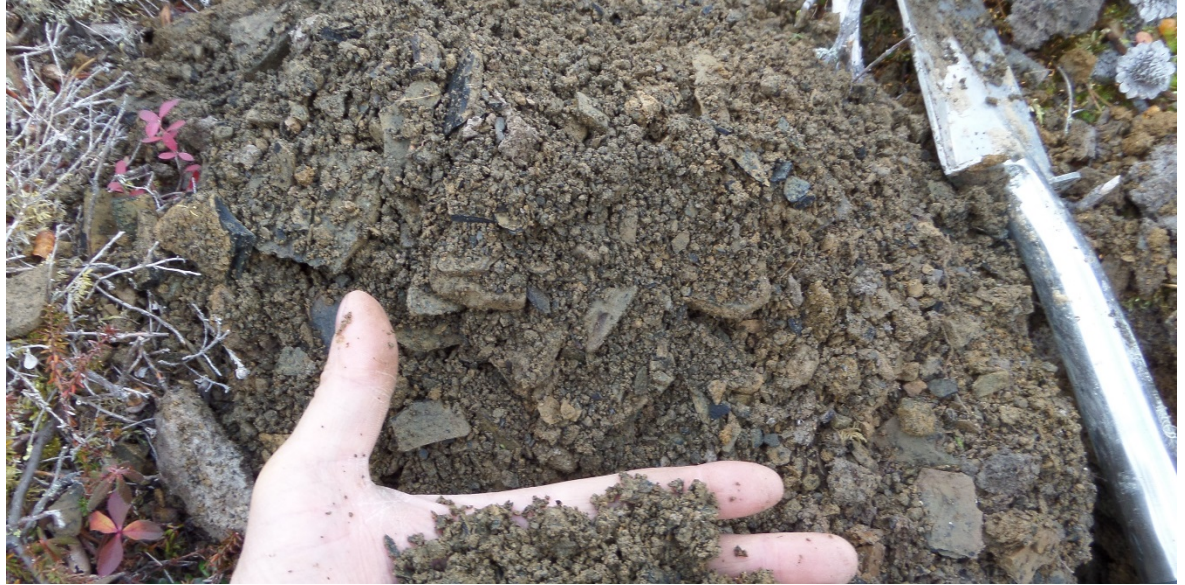
Figure 40: Sub-rounded gravel present in the BP64 sample area

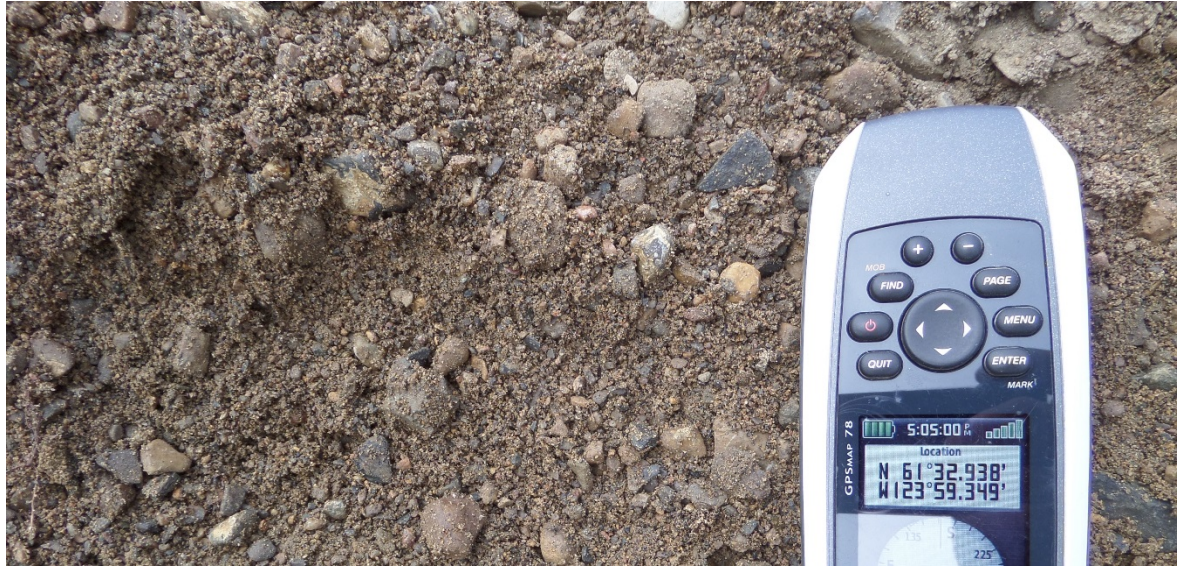
Figure 41: Test pit with well-rounded gravel at BP65. Another test nearby revealed more angular shale gravel content, so the area is somewhat variable for gravel composition.

BP65 also falls on the large glaciofluvial kame/kettle deposit previously noted for the BP64 site, but this borrow site falls along the existing roadway and doesn't require additional access road to develop it. BP65 appears to fall along the southern edge of the deposit area, and the depth of deposition will likely be substantially shallower in comparison to the esker deposit at BP64. As evidence of the potential for a shallow deposit here is the rock knob of primarily fissile shale that protrudes up through the area on the west side of the road. The base of this hill may contain more shale than gravel. This shale, in itself, is a potential borrow material for subgrade construction and the rock knob here appears to contain a substantial amount of it. The gravel materials sampled along the road here also appear fairly variable in composition over short distances. That, taken in combination with potentially shallow gravel deposition in this area, indicates a need for additional investigation to a greater depth to confirm materials prior to any large pit development. A low ridge formation (esker?) protruding out into the wetland on the southeast side also may contain gravels, but this formation wasn't sampled during the field reconnaissance. Should further testing in this area indicate a limited gravel volume, the use of BP64 would be the preferred alternative due to the volume available there.

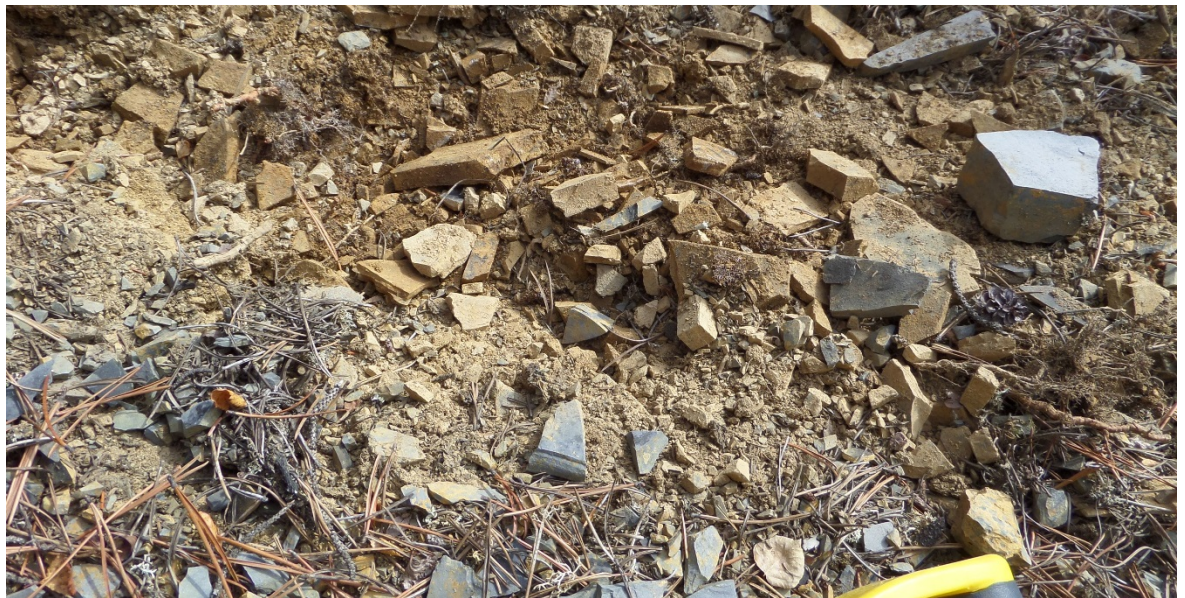
Figure 42: Exposed face with both blocky and fine fissile shale was noted in a rock knob about 200 m southwest of BP65. This material likely extends back close to the road

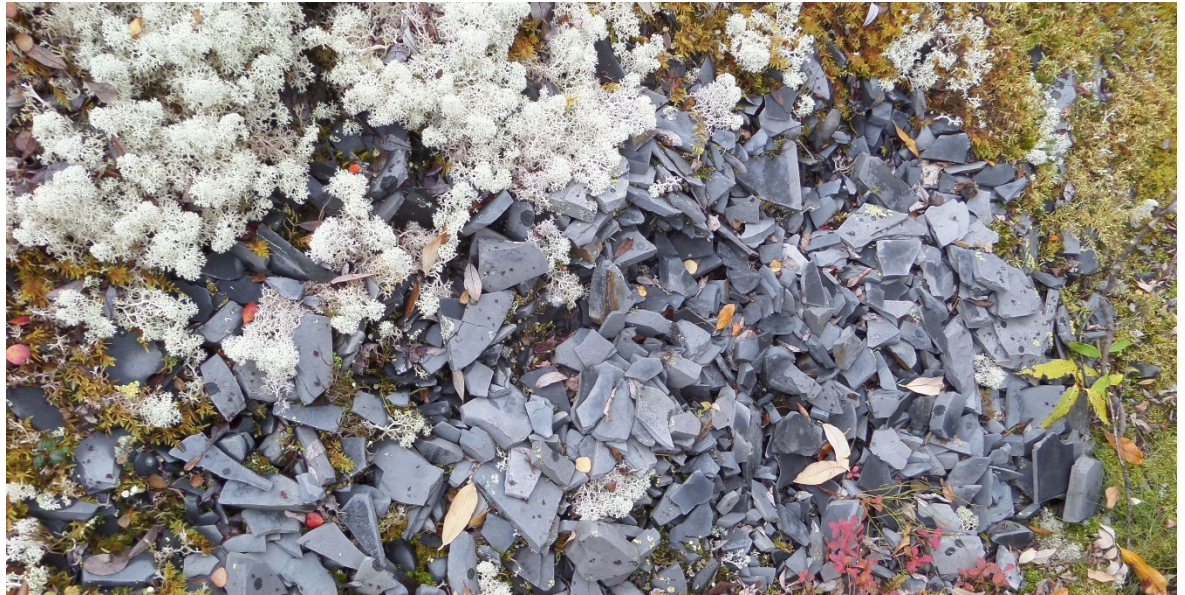
Figure 43: Surface talus exposure of fine shale at 67.52 km (BP67).

At 67.52 km the road route runs along the toe of a steep (70%) hillside that is covered in fine shale talus. Shale colluvium is apparent along the entire hillside above the road here up to about 67.8 km, but this location has the cleanest exposed talus material noted in the area. This material would be suitable for overland fills and for firming up areas of soft ground, but wouldn't be a very good surfacing material due to its fractures and sharp fragments. There is

also some potential for ice poor permafrost in this hillside, due to the northern aspect of this talus face, so additional investigation would be prudent before any development is carried out.

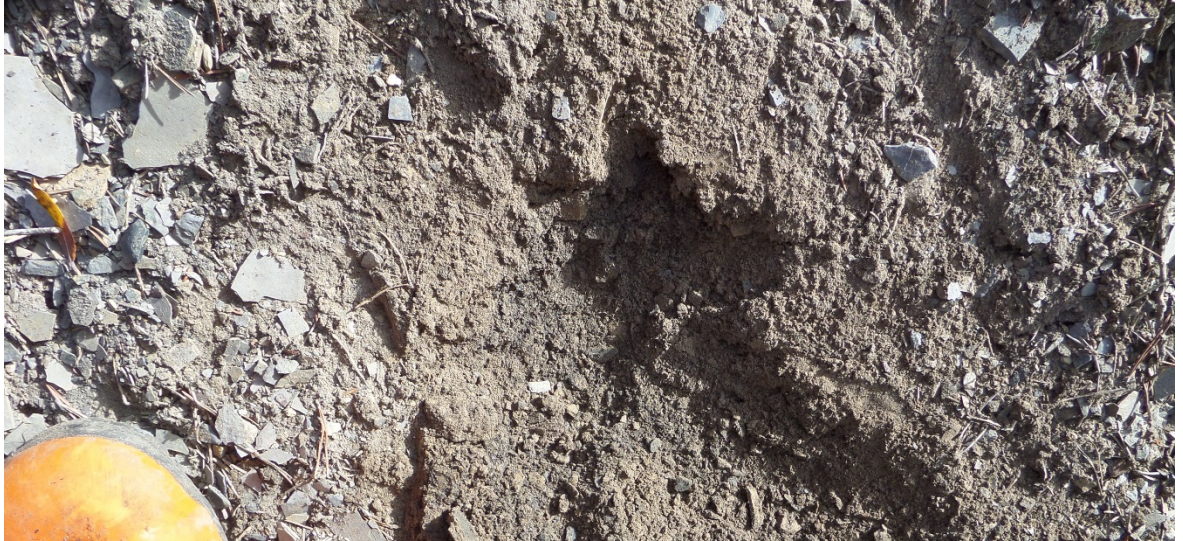
Figure 45: Fine sand material at 70.75 km (BP70)

The route crosses a sidehill with an old cut slope showing fine sand material intermixed with minor colluvium shale at about 70.75 km. This material (BP70) is free draining and good for subgrade fills in overland sections. There are several small lowland sections requiring overland fills within the general area.

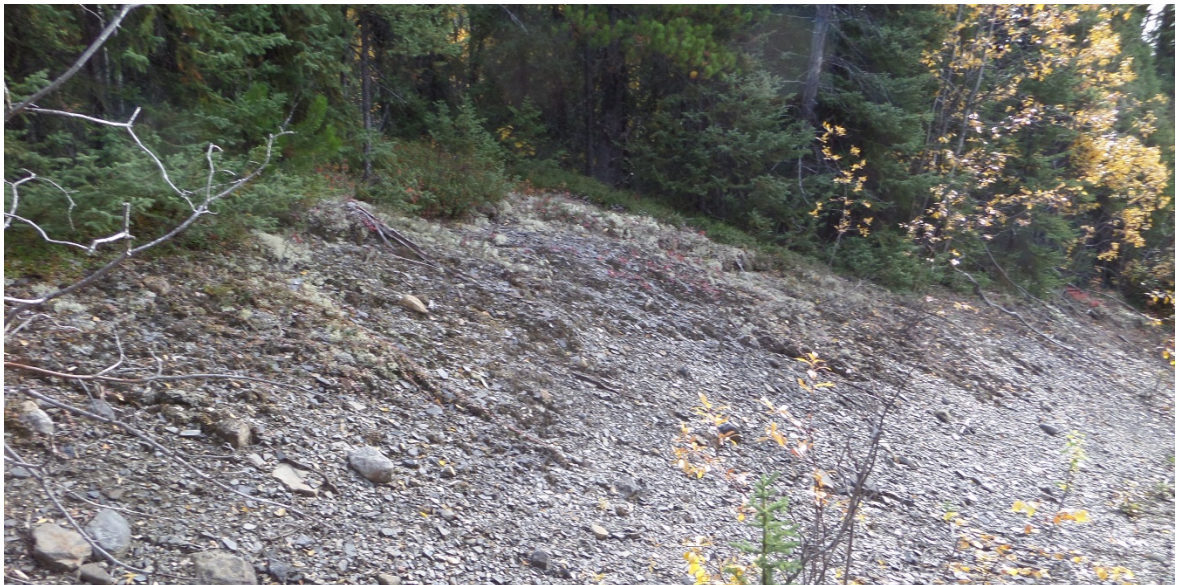
Figure 46: The existing cut slope at BP70. The weathered face appears to be colluvium shale because of the residual fragments left in place, but the slope is in sandy materials.

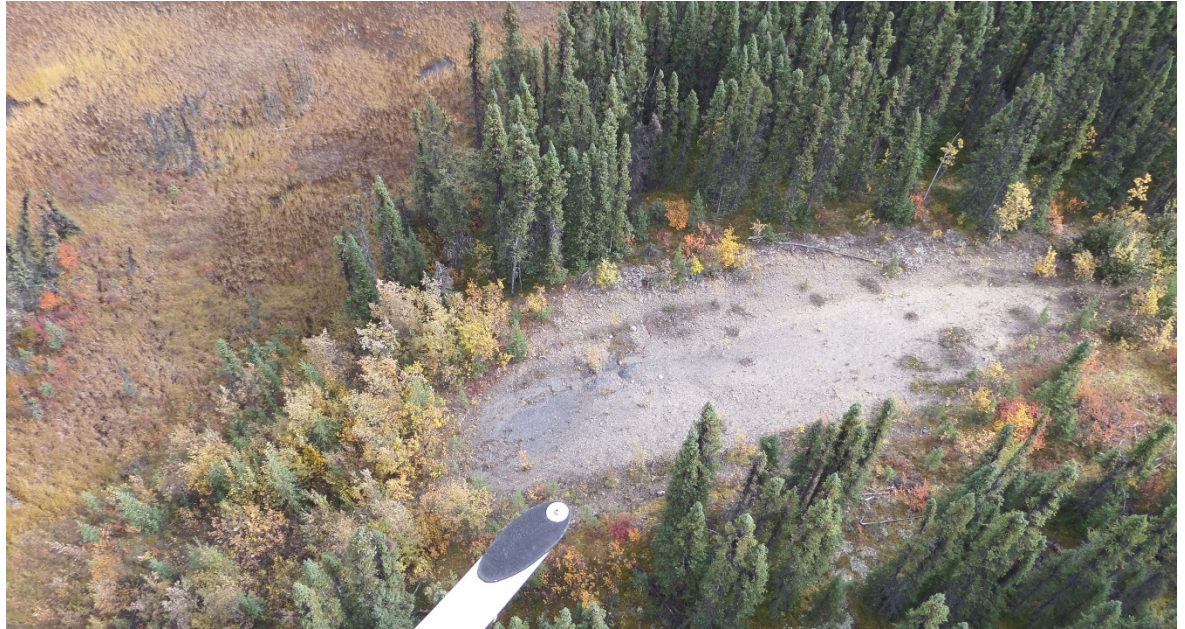
Figure 47: Sandy material in a low hump at 72.86 km (BP72) can be used in a wetland fill.

The current route cuts through a low knob of sand at 72.86 km, which is directly adjacent to a wetland crossing that requires an overland fill that was not constructed as part of the original winter road. The wetland crossing is approximately 130 m long, and it will need an appreciable volume of fill material to build a new subgrade across it. The sand knob here (BP72) is strategically located for supplying the needed subgrade fill volume for the crossing, and the existing cleared road footprint can be re-utilised to reduce new ground disturbance as well.

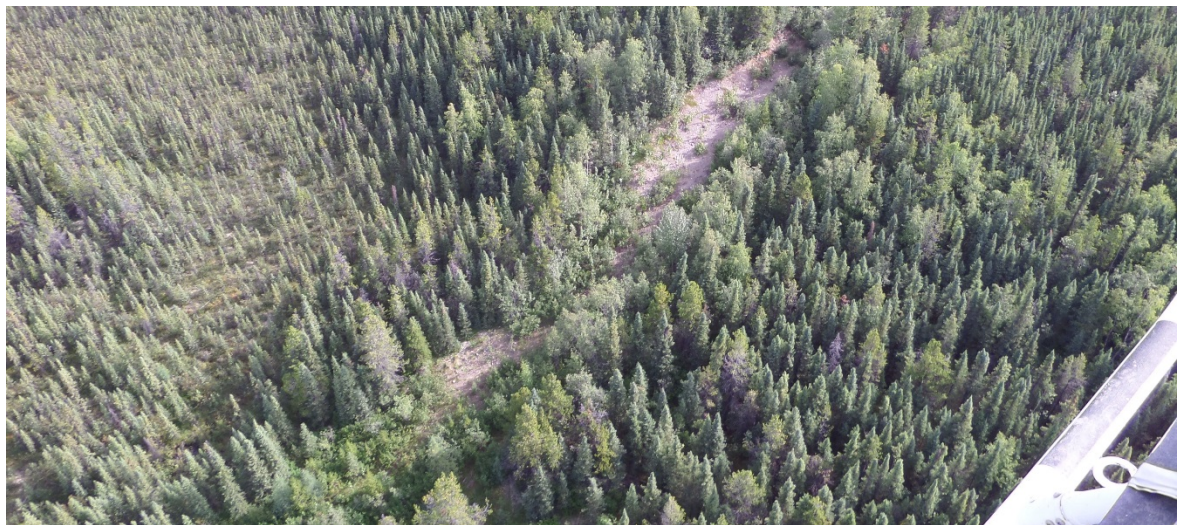
Figure 48: Another small sand hump at 76.23 km can provide fill for a wetland crossing.

In an almost mirror image of the BP72 situation, this small hump of sand at 76.23 km (BP76) is strategically located next to a wetland crossing that will need to be built up with fill as well. Again, the existing road footprint can be re-utilised to reduce new ground disturbance at the borrow site.

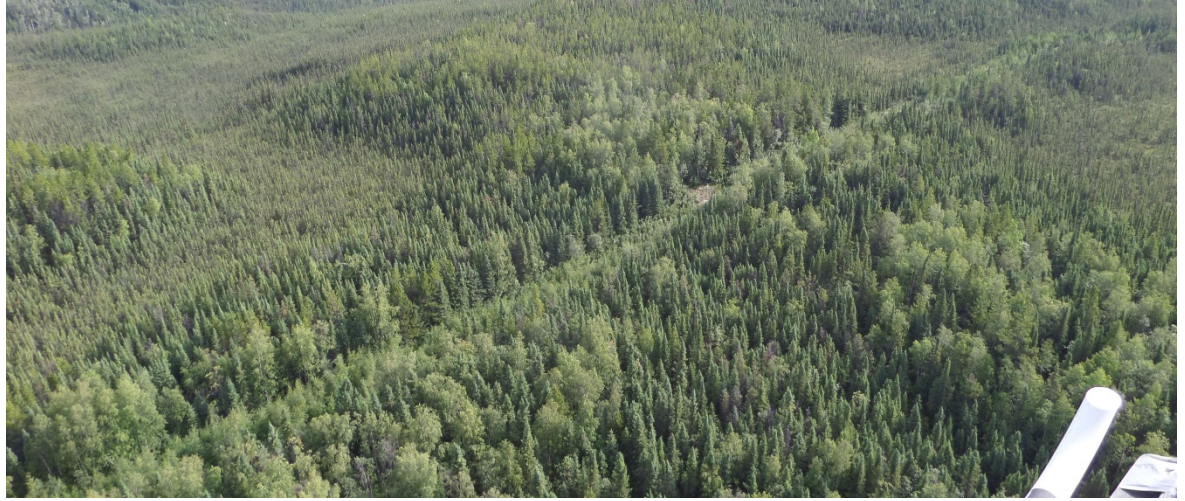
Figure 49: A low ridge of higher sandy till (BP77A) crosses over the road route laterally at 77.22 km. This source of drier material could be used to build some of the overland fills that will be required to cross the wetland.

Between 77 km and 78 km a broad lowland area must be crossed by the road, and additional borrow to build overland subgrade fills will be needed. This lowland area only presents a few opportunities for borrowing nearby material, and these areas consist of long low glacial deposition ridges left within the lowland margin area itself. As the existing winter road crosses these low ridges, it is advantageous to borrow the drier materials found in these areas for constructing the subgrade fills across the lowland. Any additional materials required to complete the fills will have to be imported from borrow sources further away.

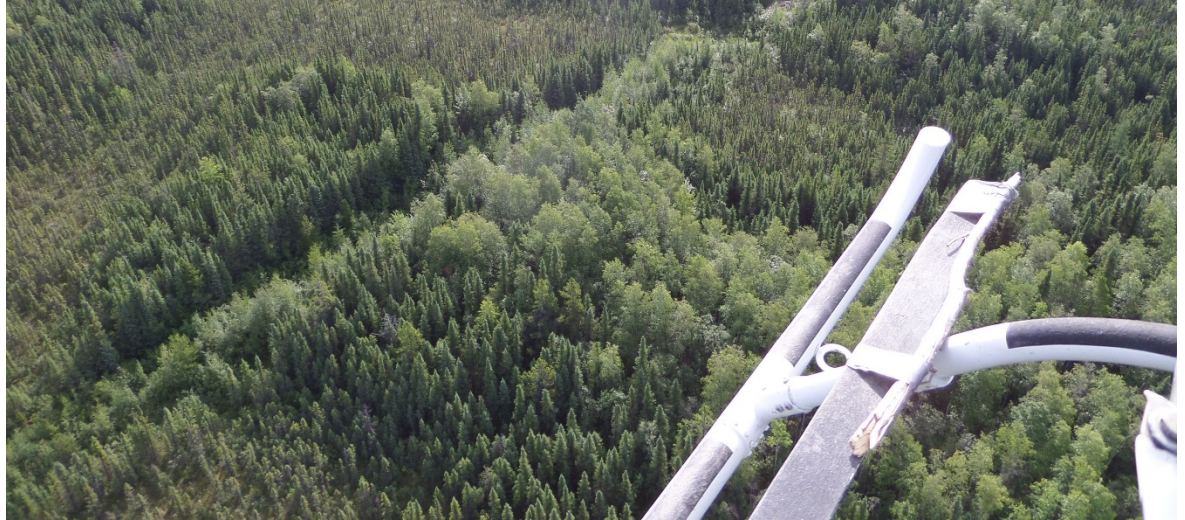
Figure 50: A small hump of higher sandy till (BP77B) lies on the southern side of the road at 77.70 km. This source of drier material could also be used to construct some of the overland fills that will be required to cross the nearby lowland area.

At 77.70 km, another low relief ridge of dry sandy till (BP77B) lies on the south side of the existing road. This source, in conjunction with BP77A, could be used to supply some fill for the overland subgrade crossing of the lowland to the west of this location.

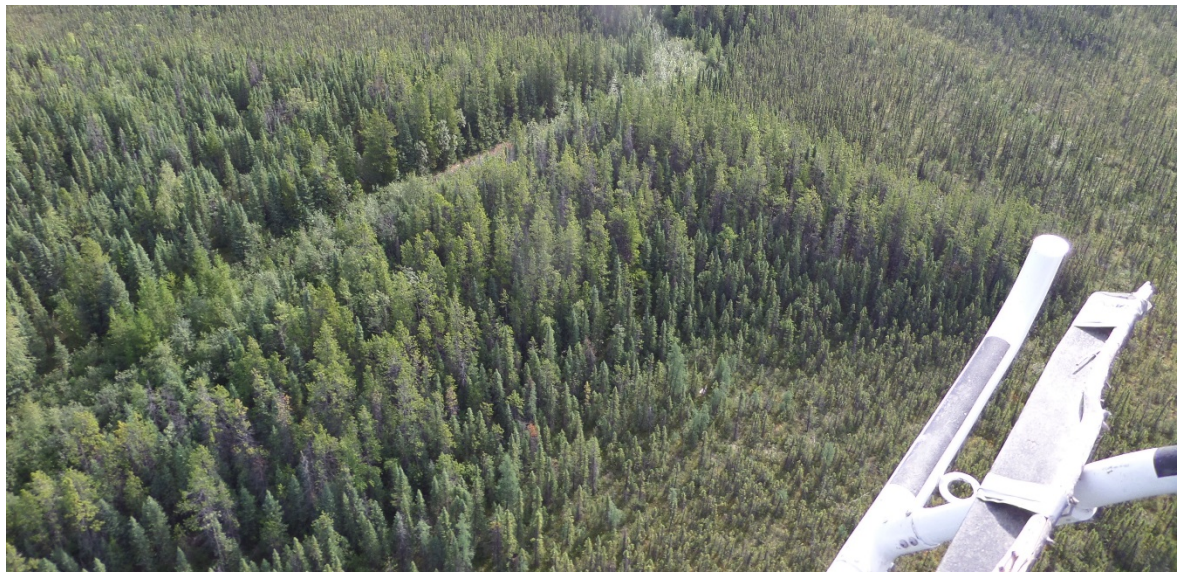
Figure 51: A small ridge of sandy till (BP78) lies under the road route at 78.52 km. The drier material here could be used to construct adjacent overland fills.

The nose of a ridge crossed at 78.52 km provides another source of dry sandy till (BP78) for constructing overland fills in this area of low ground.

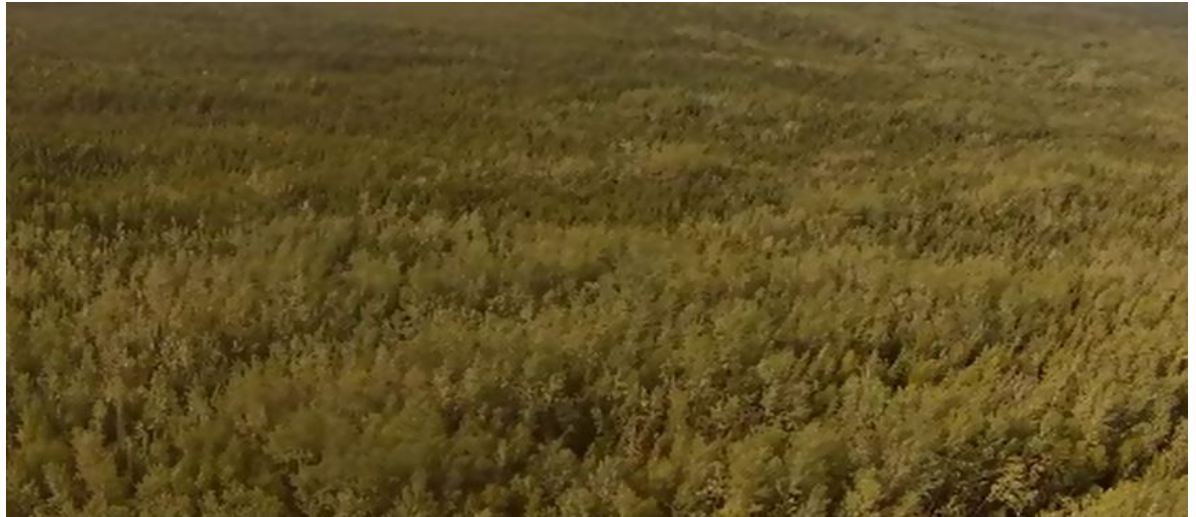
Figure 52: The road passes through the center of this aspen patch and the borrow area parallels the road.

Similar to PB 78, expected sandy till type material to be utilized for localized overland sections.

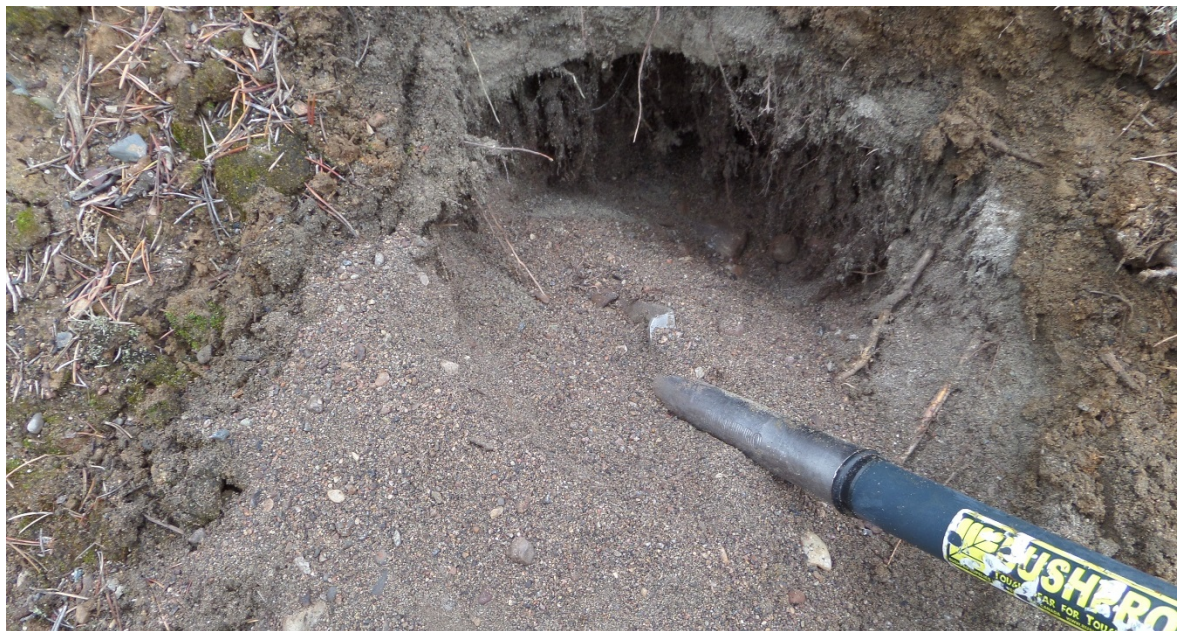
Figure 53: Sand material found in an existing cut slope at 86.35 km. This is some of the cleanest sand noted in the area and could be used for pipe bedding and overland fills.

A soil exposure on an existing cut face along the original winter road reveals a source of medium sized sand at 86.36 km (BP86A). The material appears to be very free draining and suitable for pipe bedding or overland fill material.

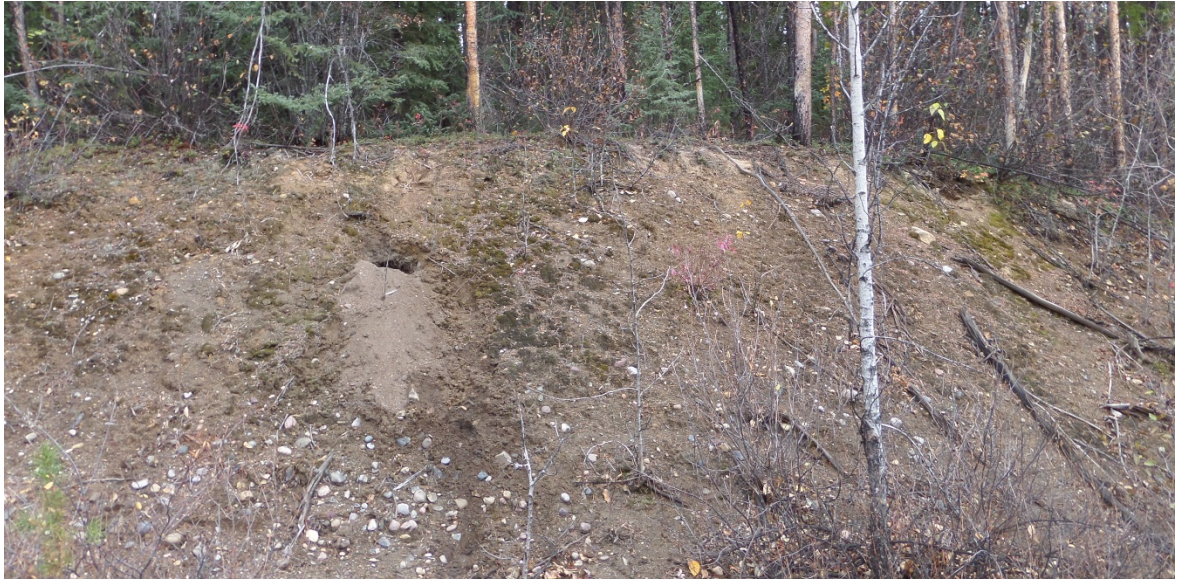
Figure 54: Existing cut slope exposing the BP86A sand material. Large timber growing on the site indicates the area is likely permafrost free.

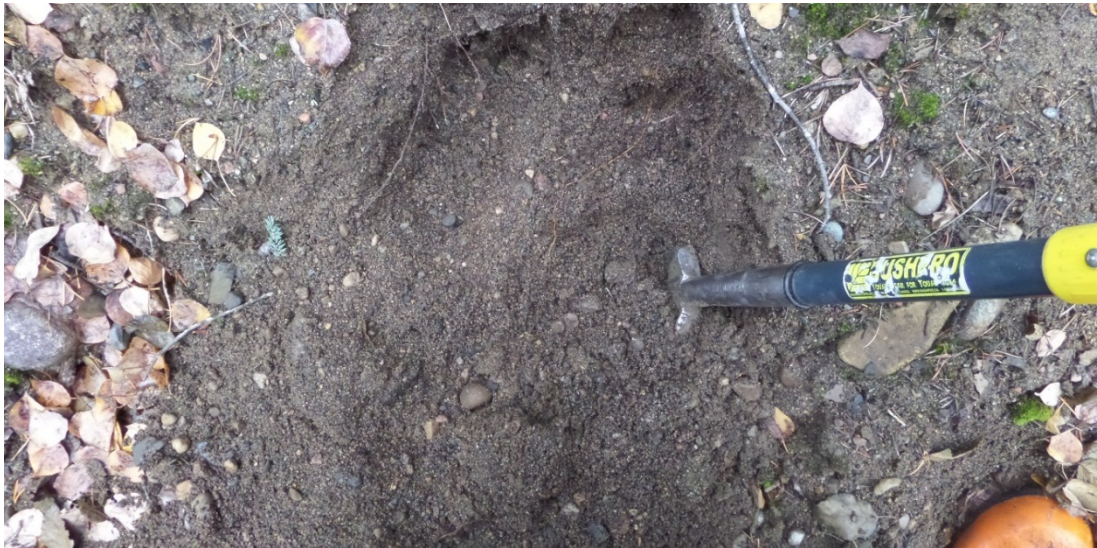
Figure 55: Medium grain sized gravelly sand material found in an existing cut slope at 86.52 km.

Another nearby soil exposure along an existing winter road cut face at 86.52 km (BP86B) reveals medium sized gravelly sand within the slope. This material could be utilized as road fill for construction over an adjacent lowland area, and for overland construction across other lowland sections to the northwest.

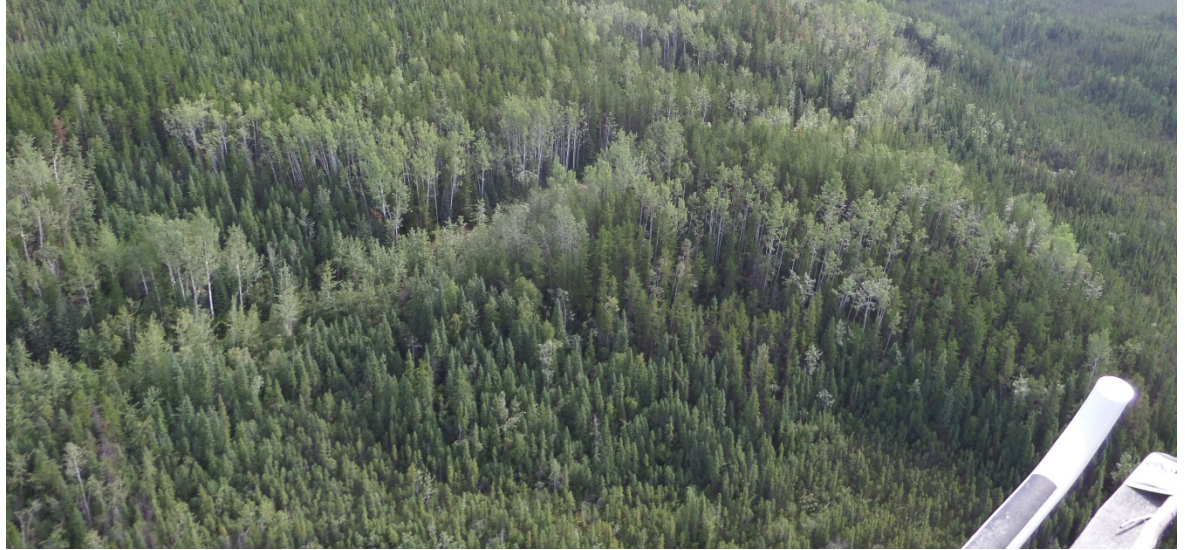
Figure 56: Aerial view of the BP86B site (right of center) showing the ridge containing gravelly sand.

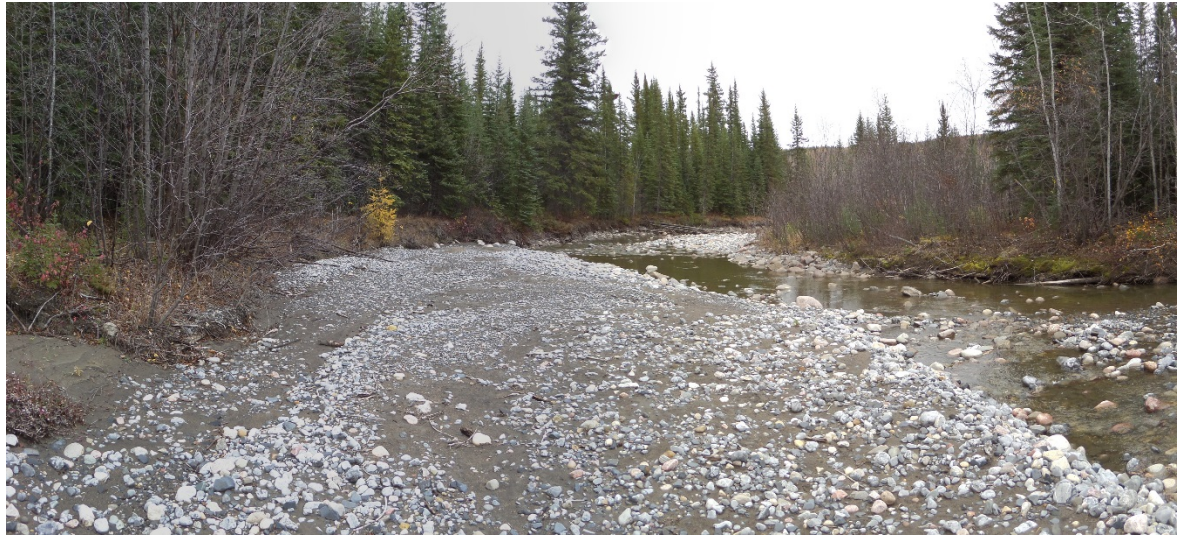
Figure 57: The bed composition of the current day Tetcela River is assumed to be indicative of the materials that should underlie the BP87 site, which is situated well back of the river here, in the timber on the left hand side.

At about 87.4 km, the Tetcela River is crossed by the route, and the planned road continues eastward across a flat plain which appears to be the site of several relict river channels from past millennia. As such, much of this area is comprised of old river beds and there is substantial subsurface gravel and cobble deposition under this currently forested plain. Hand excavated test holes were almost impossible to carry out to any depth here as the subsurface material consists of large embedded cobbles and gravels in a coarse matrix that is practicably impenetrable to shovels. The composition of the materials deposited here is assumed to be similar in texture to that of the current day active channel nearby – coarse mixtures of gravels and cobbles. This area could provide a critical supply of durable gravel aggregate that could be crushed for making superior surfacing materials. Materials of this nature could be used for road surfacing and grade construction for tens of kilometers in either direction from this site. The presence of innumerable Paleozoic coral fossils within the gravels throughout the Tetcela River system also indicate that the resulting gravels here are derived from carbonate based bedrock and are non-acidic.

Deeper investigation needs to be carried out in the coarse material here to determine the full depth and gradation of the deposited materials, and to ascertain if the water table would present a problem to development of a borrow pit. There is ample area well back of the river near the BP87 site that is suitable for the establishment of a crushing plant and for stockpiling material.
