Appendix D Evaluation of Potential Borrow Pits

1 EVALUATION OF POTENTIAL BORROW PITS

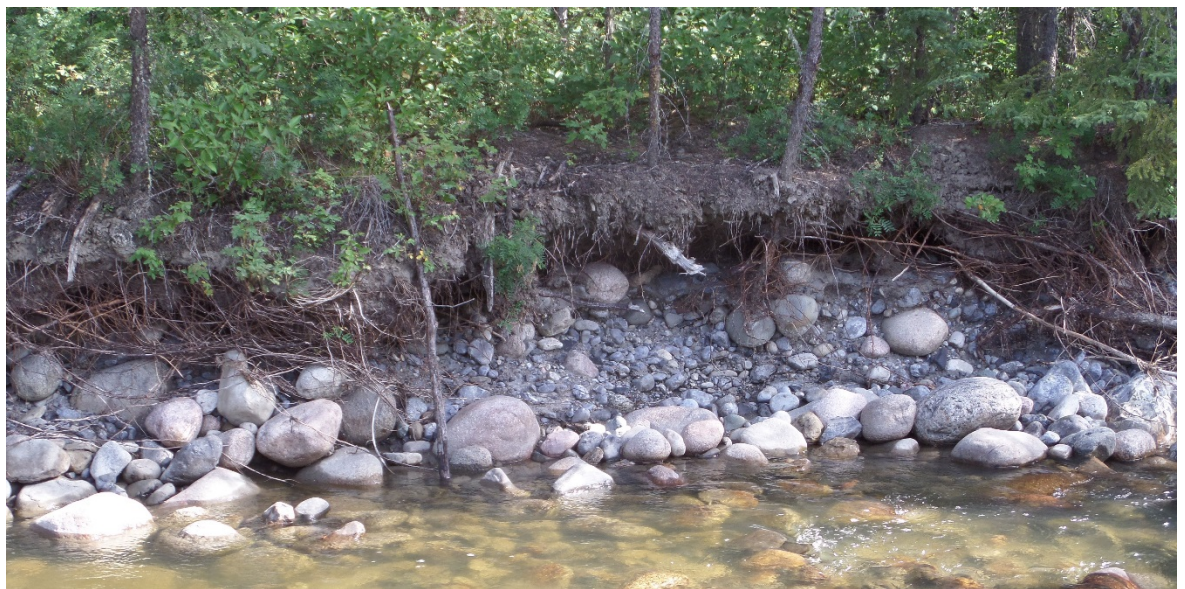
Figure 58: View of some of the material deposited within the existing river bank to the west of the proposed BP87 location. This material is assumed to be typical of the deposition in the borrow area and it would need to be crushed for road surfacing.

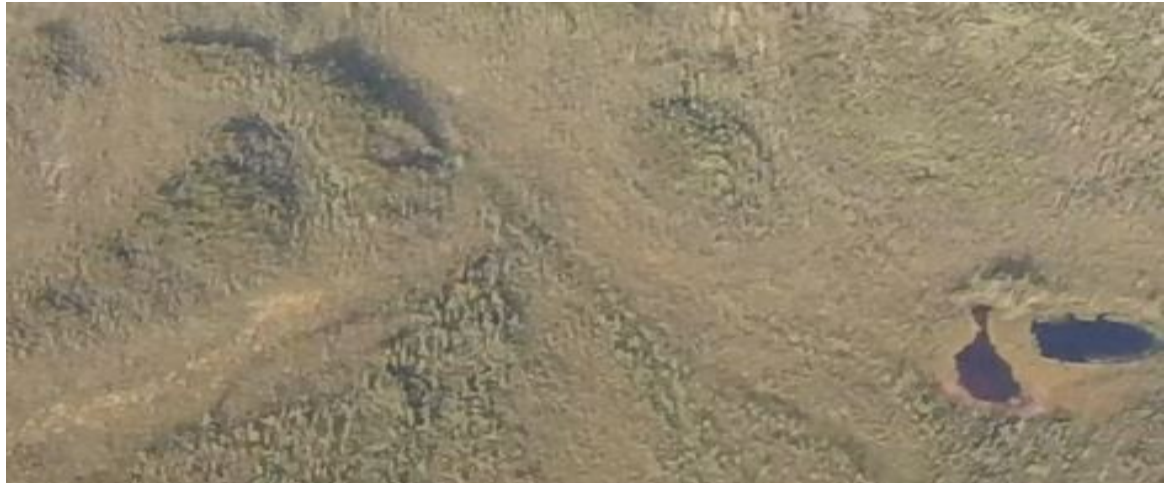
Figure 59: Aerial view of the landscape from KP 90 to 95. Patches/islands of dry, esker type terrain covered with lodgepole pine/aspen. These humps will provide borrow material to overland the lower, depressed permafrost (likely ice-rich) sections in between.

Borrow volume required for localized overland sections. Area and volume could be easily expanded. Not field verified but similar material found in the surrounding area.

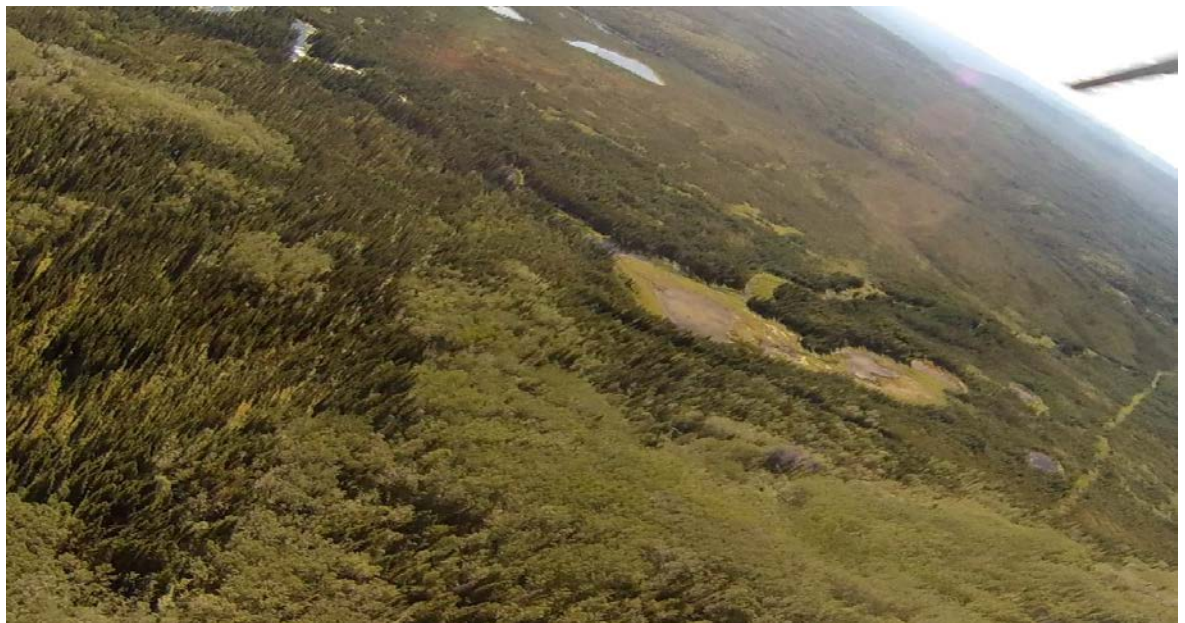
Figure 60: Aerial view of the landscape near KP 96. Borrow to be extracted from elevated dry humps covered mainly with aspen and lodgepole pine.

Borrow volume required for localized overland sections. Area and volume could be easily expanded. Not field verified but similar material found in the surrounding area.

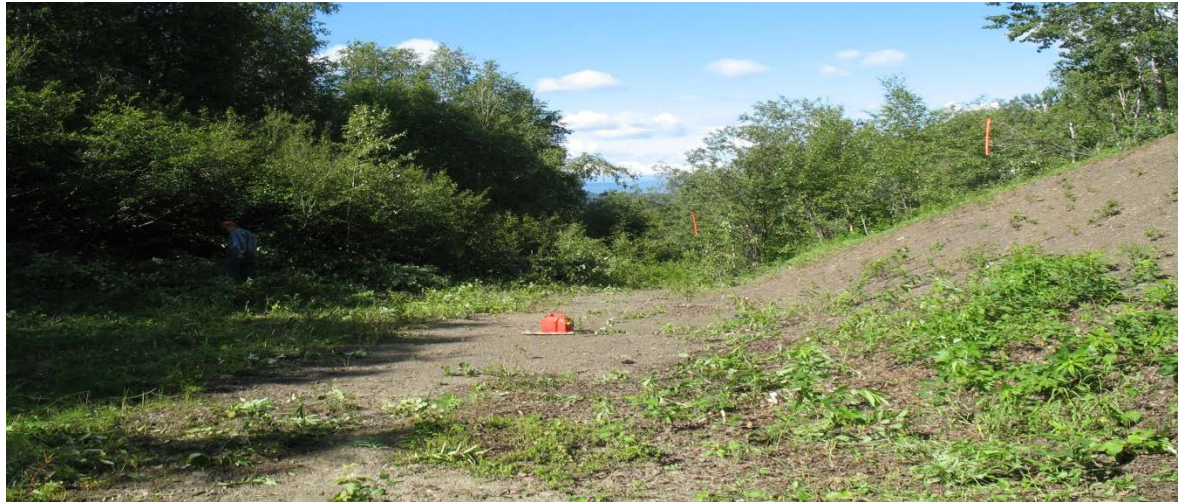
Figure 61: Dry sand type material at Wolverine Pass which should supply the large volume demands required for the overland construction approach within the switchbacks.

Borrow volume required for localized overland sections. Area and volume could be easily expanded.

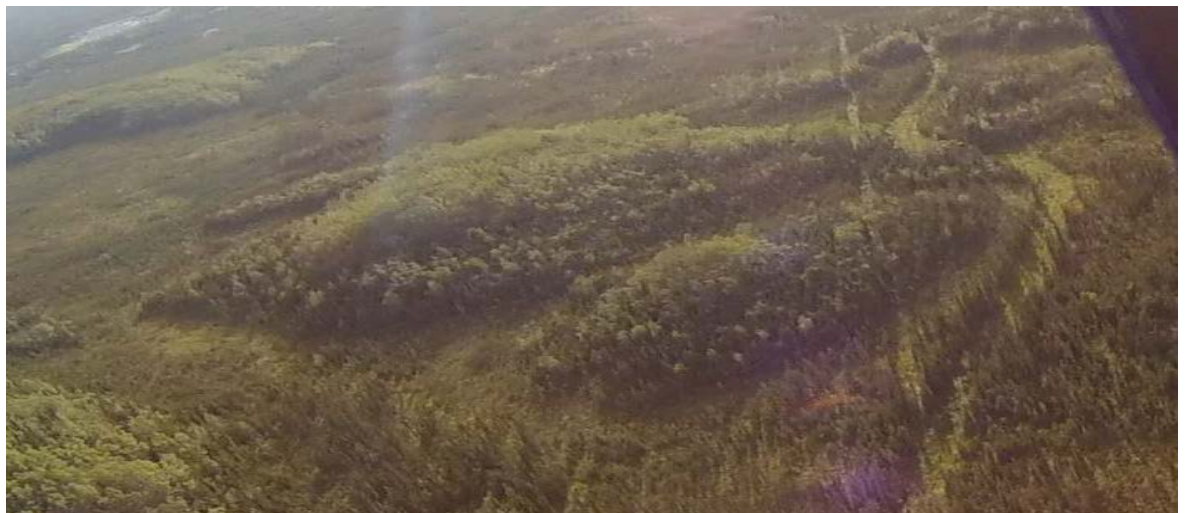
Figure 62: Dry elevated “humps” covered with lodgepole pine and aspen should provide adequate silty sand type material for overland sections, particularly in the proposed switchback section KP 97 to 102.

Borrow volume required for localized overland sections. Requires a short 175 m access road. Area and volume could be easily expanded. Not field verified but similar material found in the surrounding area.

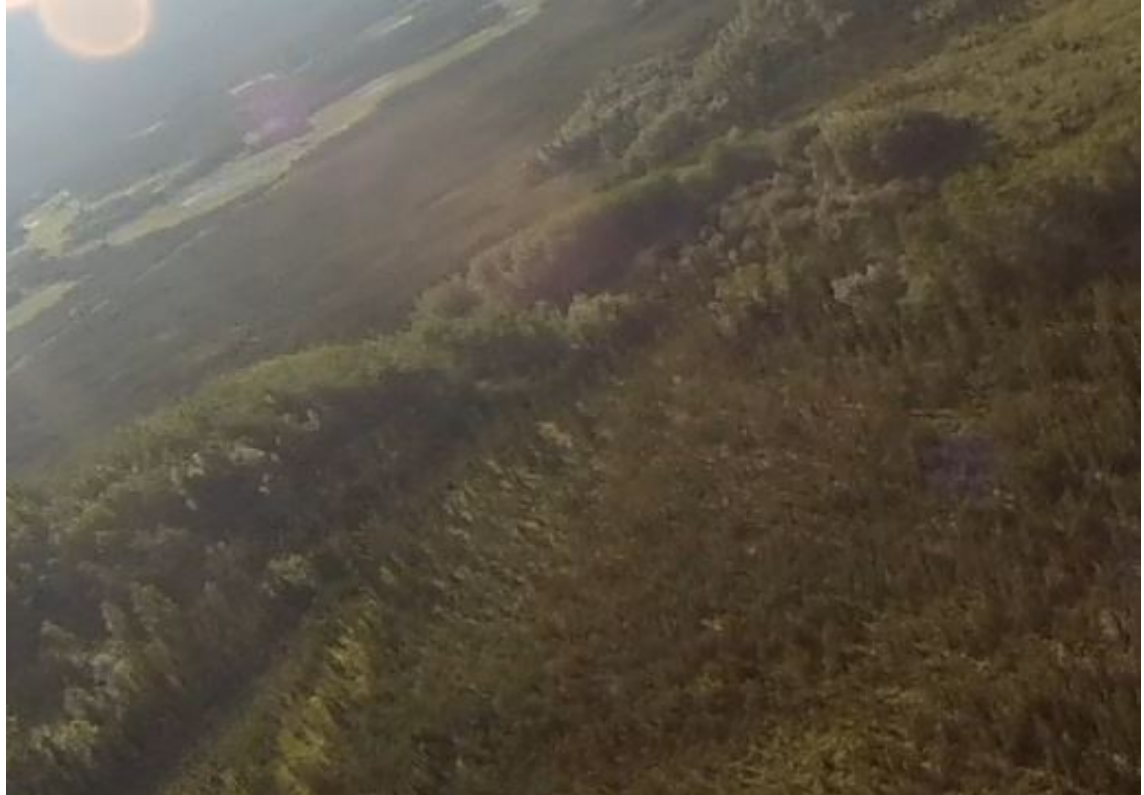
Figure 63: One of many large, elevated rock knob “humps” in a south to north linear line which the proposed road parallels. Exposed rock outcrops are common along a number of these knob features and we expect this particular one to offer the same material.

Large elevated knob with potential clay till type material overlying a carbonate rock layer underneath. The clay could be utilized for subgrade overland base material, the rock could be blasted/crushed and utilized for road surfacing.

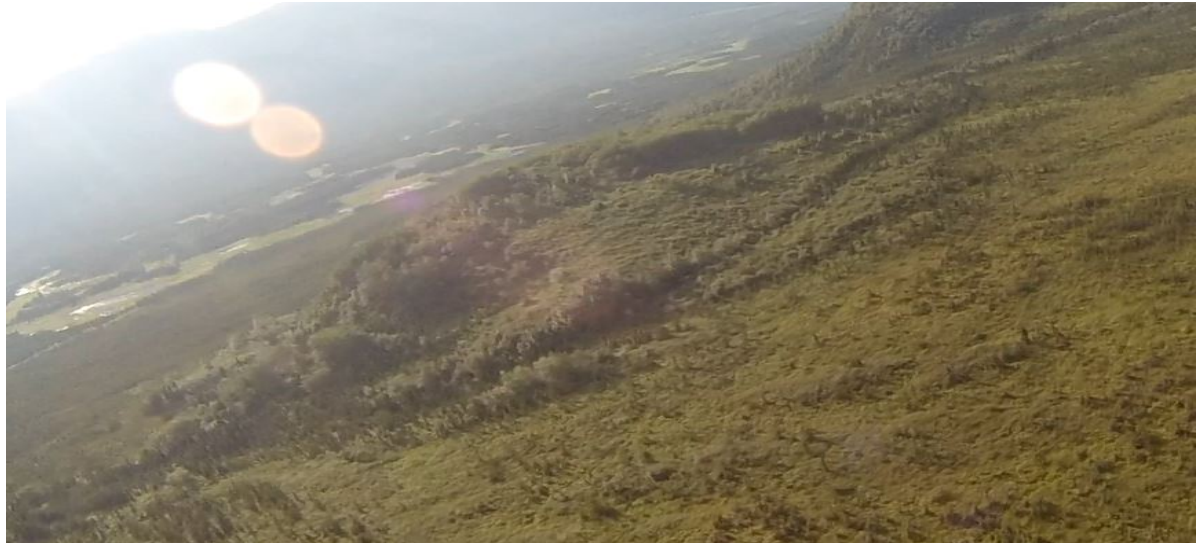
Large elevated knob with potential clay till type material overlying a carbonate layer underneath. The clay could be utilized for subgrade overland base material, the rock could be blasted/crushed and utilized for road surfacing. Future test pits will determine the precise shape and size (probably less than 2.5 ha).

Figure 64: One of many large, elevated rock knob “humps” in a south to north linear line which the proposed road parallels. Exposed rock outcrops are common along a number of these knob features. We expect this particular one to offer the same material.

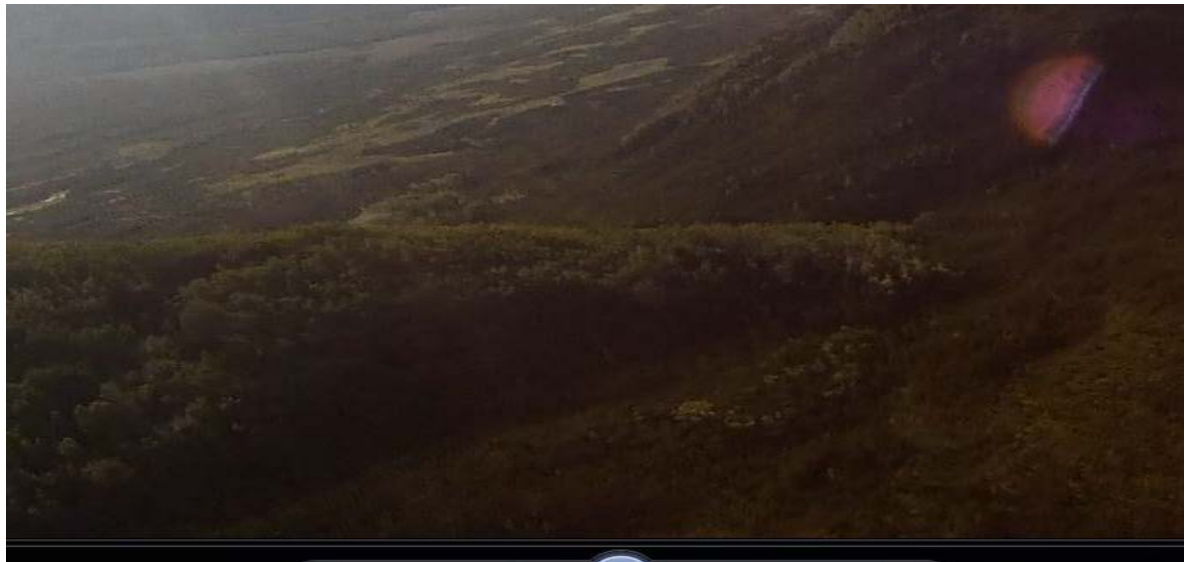
Large elevated knob with potential clay till type material overlying a carbonate layer underneath. The clay could be utilized for subgrade overland base material, the rock could be blasted/crushed and utilized for road surfacing.

Figure 65: One of many large, elevated rock knob “humps” in a south to north linear line which the proposed road parallels. Exposed rock outcrops are common along a number of these knob features. We expect this particular one to offer the same material.

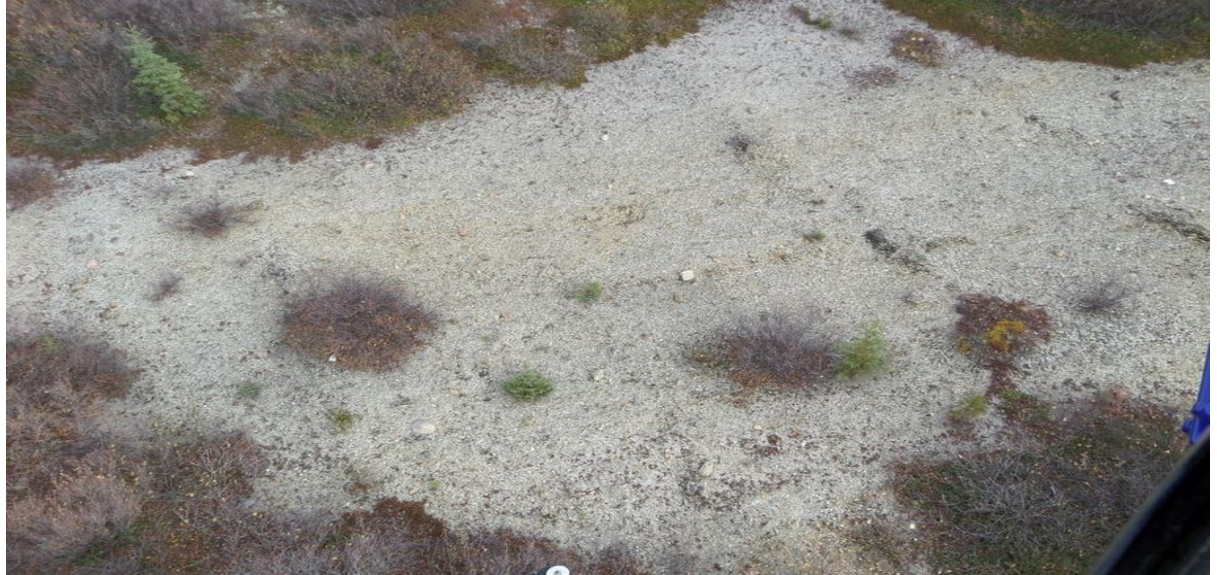
Part of the same geological formation as BP 104. Any overburden material (clay/silt/sand) Could provide borrow for overland subgrade base material and a rock quarry for crushing/surfacing.

Figure 66: Aerial view of a potential large exposed shale rock outcrop near KP 112.

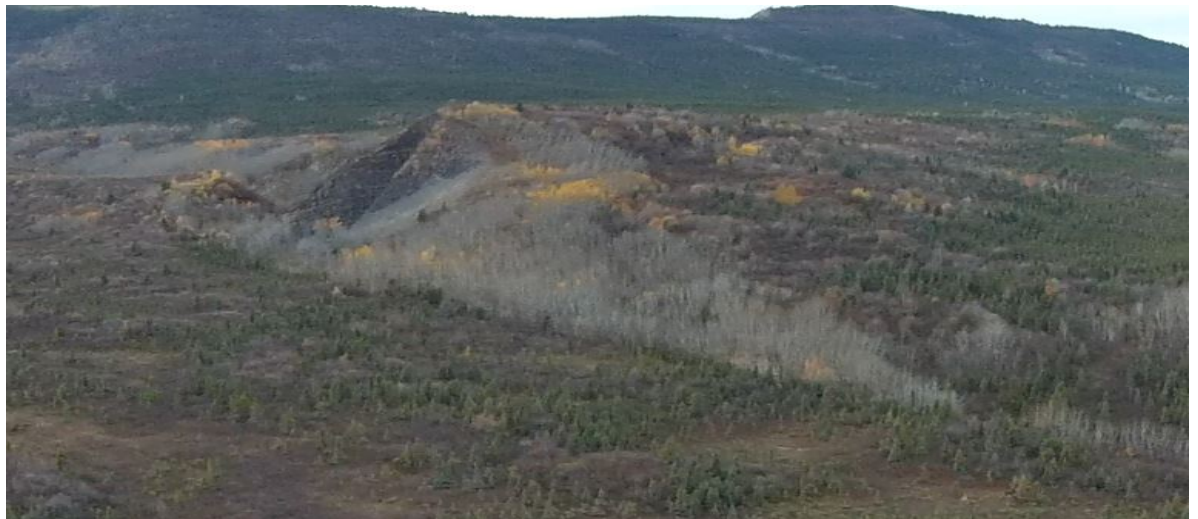
Part of the same geological formation as BP 104 and 111. Overburden material (clay/silt/sand) could serve as borrow for overland subgrade base material and a rock quarry for crushing/surfacing.

Figure 67: An aerial view of a large, exposed shale rock outcrop a few hundred meters above the proposed road location. It is assumed this rock feature extends down to the road location and could provide an excellent source of blasted/crush surfacing material.

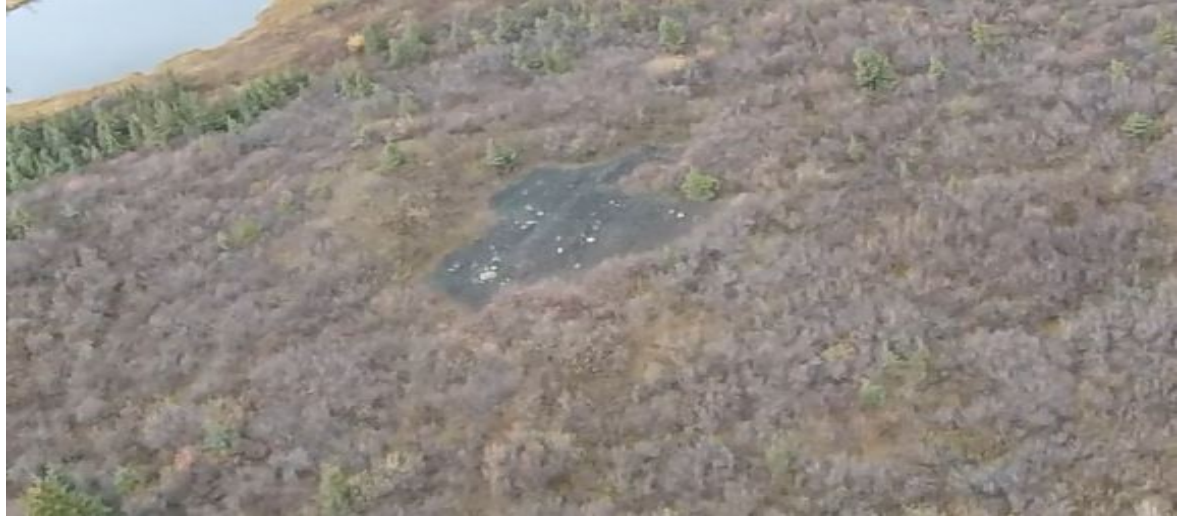
An exposed and *visible from the air* “shale rock” looking deposit the road location passes through.

Figure 68: A low level fly over identified this potential shale rock deposit. The proposed road is located through this feature.

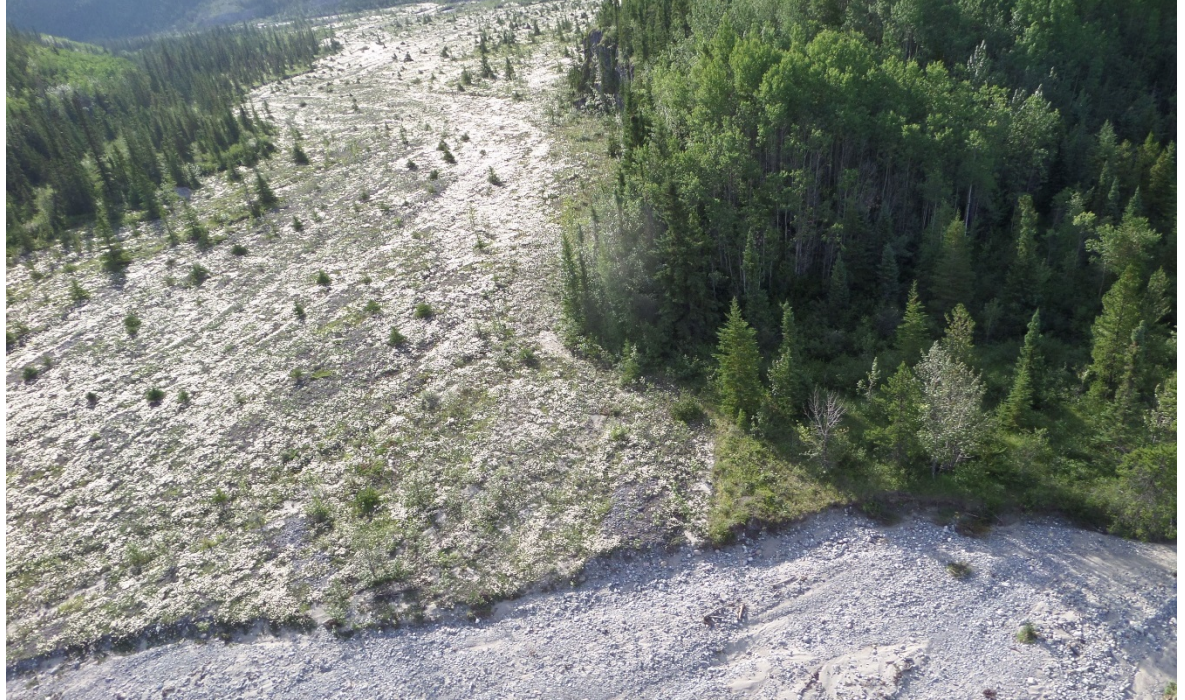
Where the route passes through the gap in the Front Range Mountains, known locally as Grainger Gap, there is a substantial potential for developing a crushed natural gravel source that can be used surfacing material over large sections of the road. In the area of 123.68 km, the Grainger River (or an unnamed major tributary of it) has changed its channel in recent decades, and has left a large deposition channel abandoned to annual runoff. The current annual runoff avulsion channel flows directly south now, leaving a 500 m section of old channel that had flowed eastward abandoned. Based on all available visual evidence in the field, this relict channel hasn't received any appreciable water flow since the time the original winter road was constructed back in the early 1980's – there isn't any evidence of flows across that roadway since then. The dry relict channel (BP123A) holds promise for supplying all the material required for a large crushing operation producing surfacing aggregate, as well as other products for road construction. As with much of the other alluvial cobble noted along the route, the Grainger Gap gravels appear to originate from competent carbonate bedrock, making them an environmentally friendly and preferred construction material.

The large relict channel provides a flat plain with ample room for setting up a crushing plant, and for holding stockpiled materials. This area has potential to be a long-term source of maintenance aggregate as well.

Figure 69: Aerial view (from west) of the dry relict channel left behind when an avulsing streambed changed course at least 35 years ago. The lower part of the photo shows the present day avulsion channel's course, while the upper left side shows the abandoned channel proposed for use by BP123A.

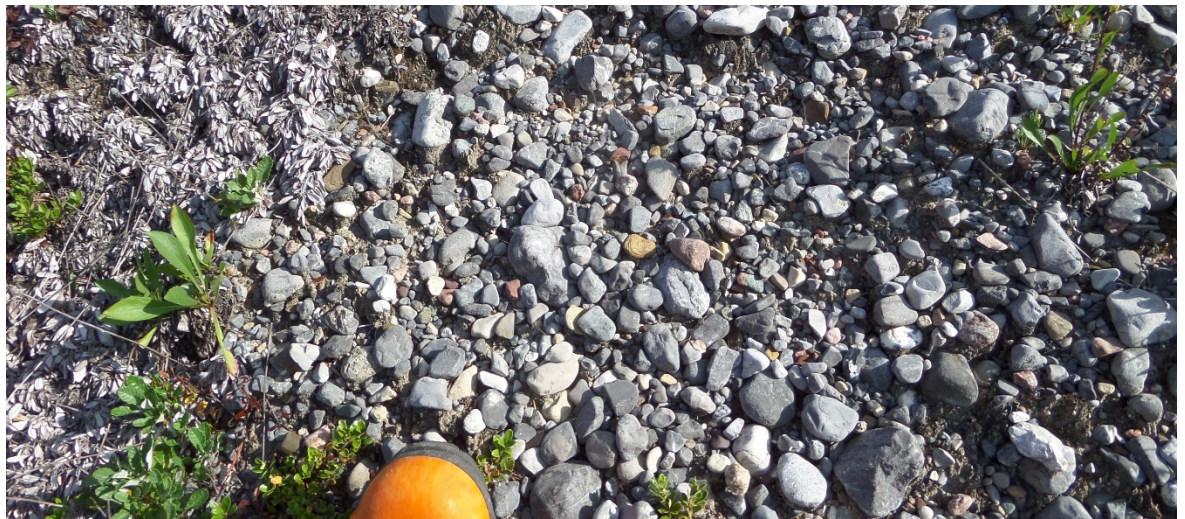
Figure 70: Typical gravel materials found in the abandoned channel at BP123A.

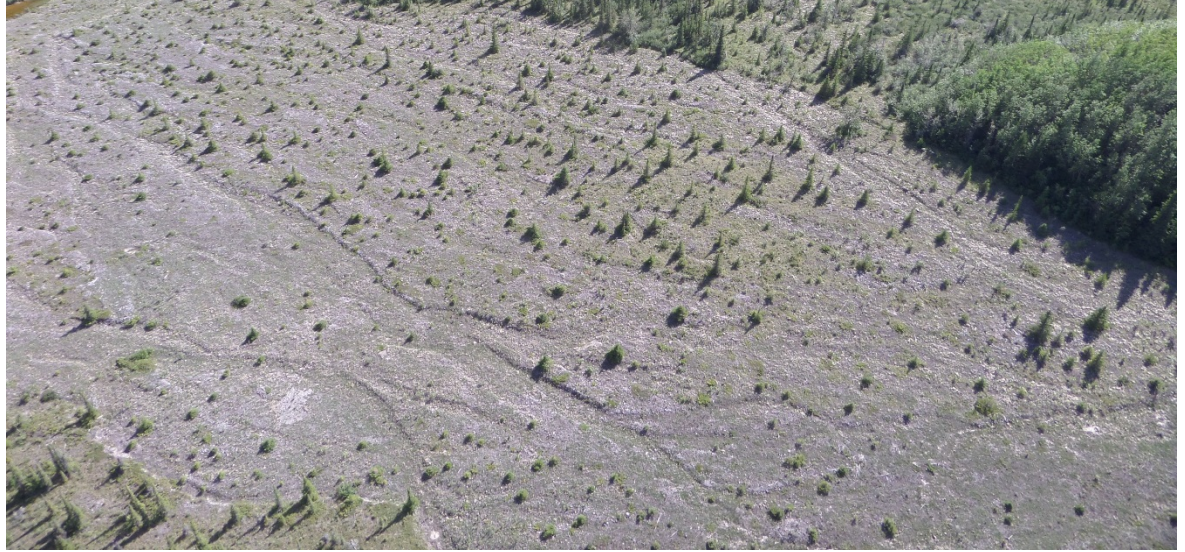
Figure 71: Aerial view of the east end of the relict channel where BP123A is proposed. The proposed road route would cross over it along the area at the bottom of the photo.

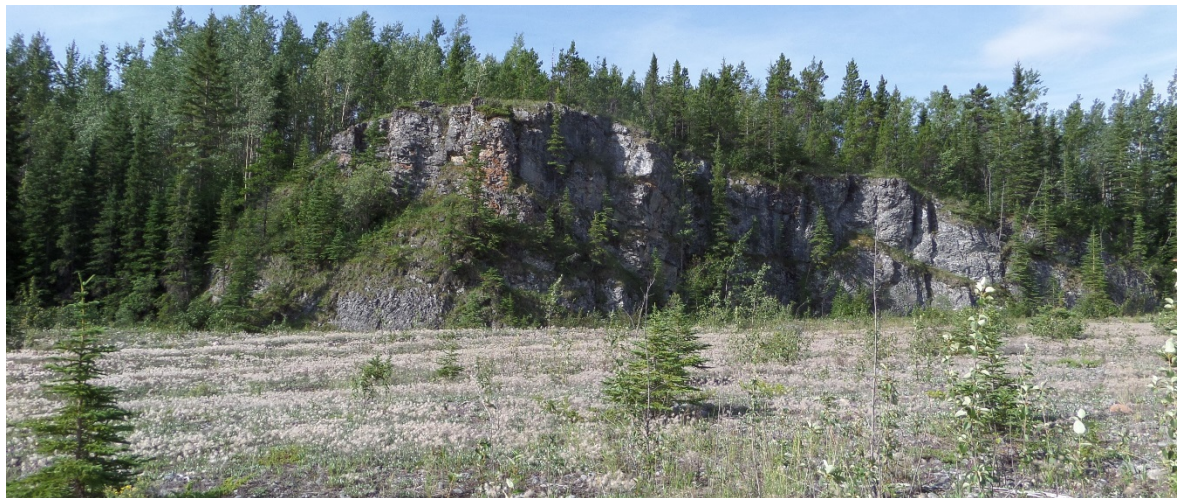
Directly adjacent to the relict avulsion channel at BP123A, is a limestone bedrock knob that juts up about 10 m in height from the alluvial plain. This rock knob is readily accessible from flat ground on all sides, making it a simple candidate for developing a blasted rock source in this area. While the eroded rock surface is fairly fractured, there is potential for producing larger shot rock and riprap from interior sections of the rock knob via controlled blasting. The limestone rock would be an environmentally friendly material for stream crossing works.

Figure 72: View of the isolated limestone rock knob (BP123B) protruding from the BP123A relict channel plain. This knob has level access on all sides of it making it a very simple location to develop for a source of blasted rock.

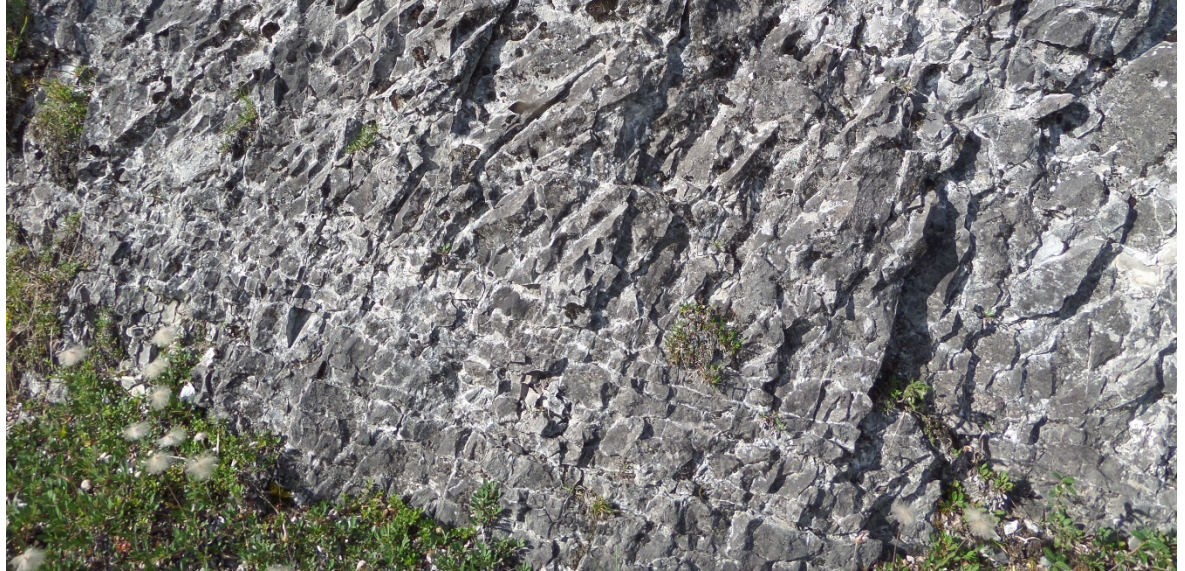
Figure 73: Closer view of the limestone bedrock available in BP123B.

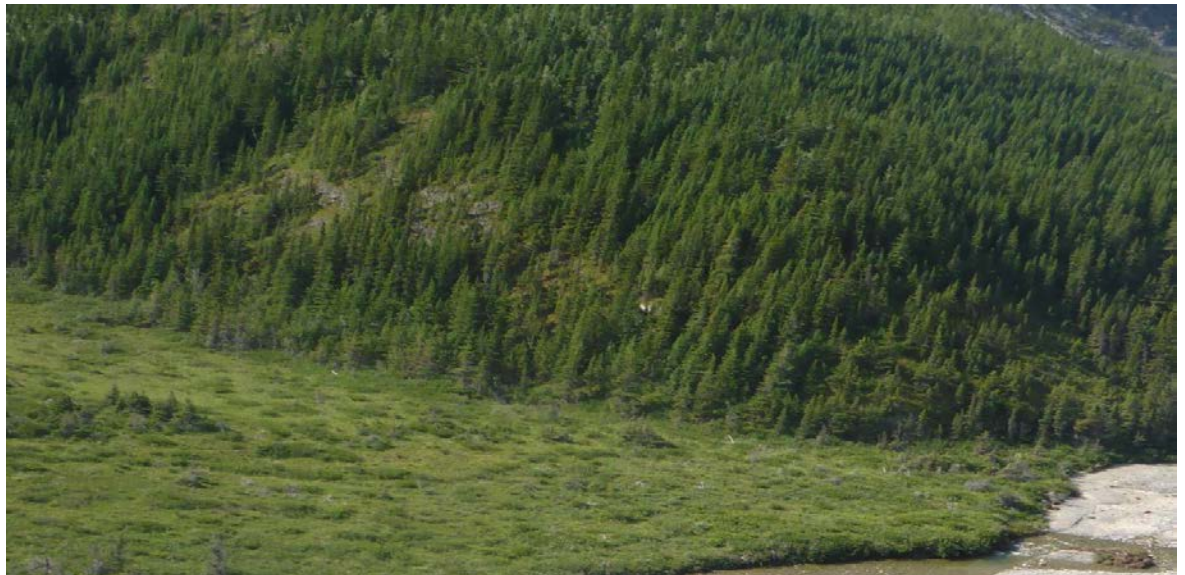
An exposed outcrop of limestone bedrock with talus at the base (125B) would make an excellent rock quarry. The northern tip of BP 125A is in close proximity to the proposed road while BP 125B requires a short 400m access road but offers loose talus rock deposit at the base of the face. Both pits would provide excellent base material for overland construction from KP 124.8 to 127.2.

Figure 74: A view of the exposed rock face of BP 125A. The proposed road is located on the right side of photo at the base of the slope on the historic flood plain of Grainger River.

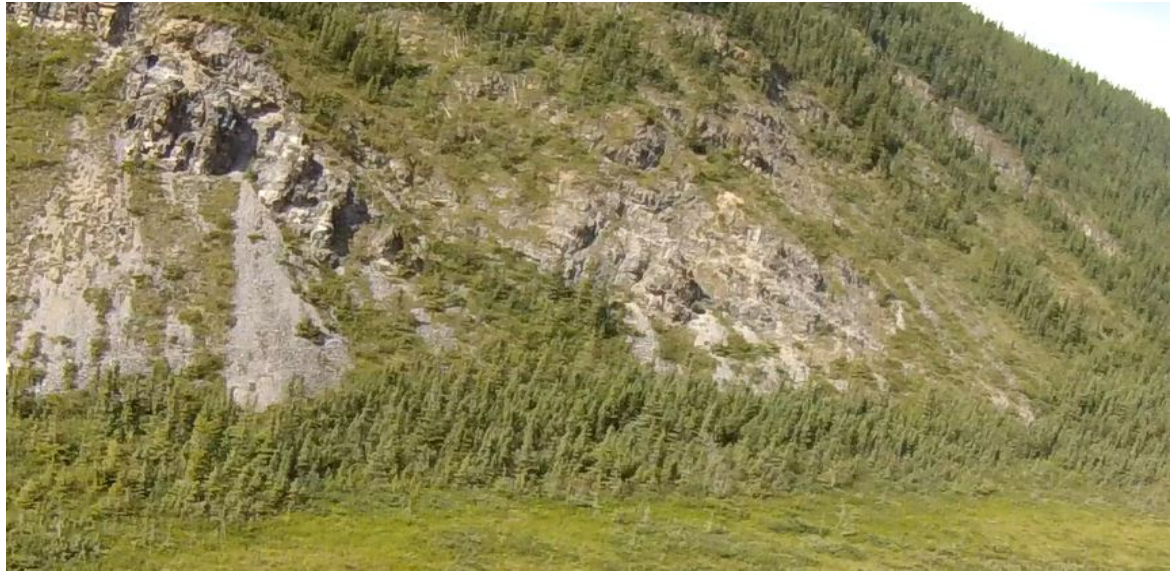
Figure 75: At view of BP 125B with exposed bedrock and talus rock deposit at the base.

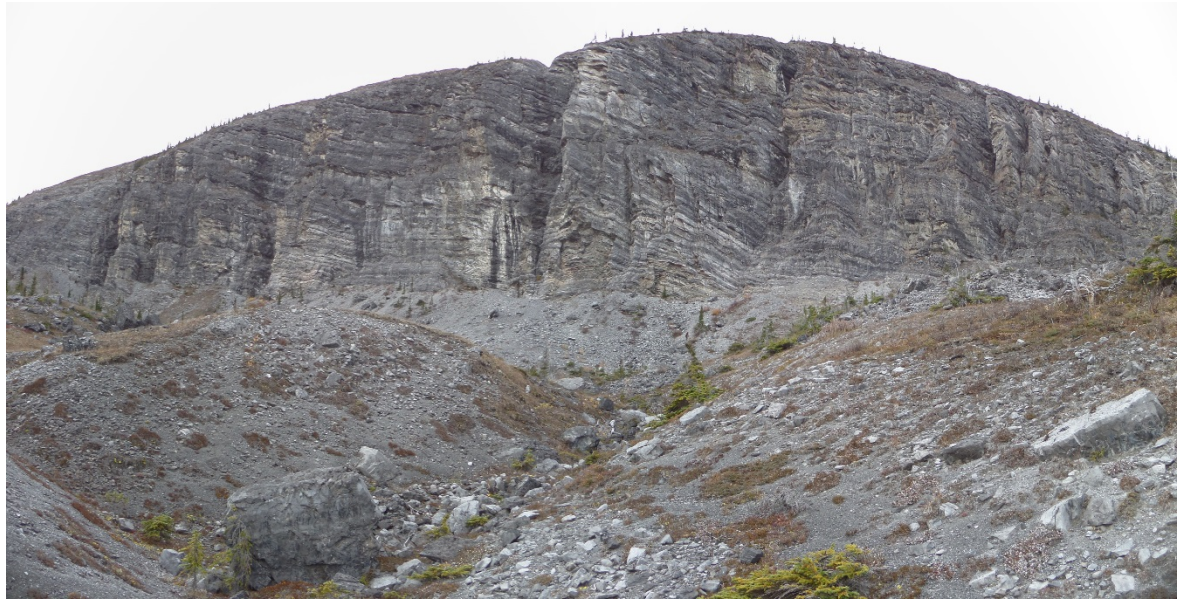
What appears to be a large limestone rockslide above the road at 126.40 km presents an opportunity to access naturally broken rock in a wide range of sizes, varying from large riprap down to fine rubble. The toe of this slide is about 250 m above the road, and it extends another 500 m uphill toward the originating bedrock cliffs. There is an extensive supply of broken rock in this formation, and it doesn't require expensive blasting to produce it – just sorting of the material and loading it out in trucks. It would require an access trail of about 550 m in length to connect this source to the proposed road route in order to utilise it.

When viewed in the field, this formation has all the appearances of a run-out zone from a large past rockslide, but when viewed on satellite photos the toe of the slide seems to have some appearance of "flowing" material. This raised the question of whether this rubble formation is actually a rockslide deposit or a rock covered glacial remnant, and a subsequent field inspection of the surface debris failed to provide a clear answer to that question. It would be necessary to conduct some subsurface excavation to determine if there is ice present in, or under the rubble. If the formation is the remnant of a glacier, the lower toe of the formation may still provide ample thawed rubble material that has resulted from past ice retreat from subsequent melting.

Figure 76: View of the top end of rubble source and the near vertical limestone cliff it originated from.

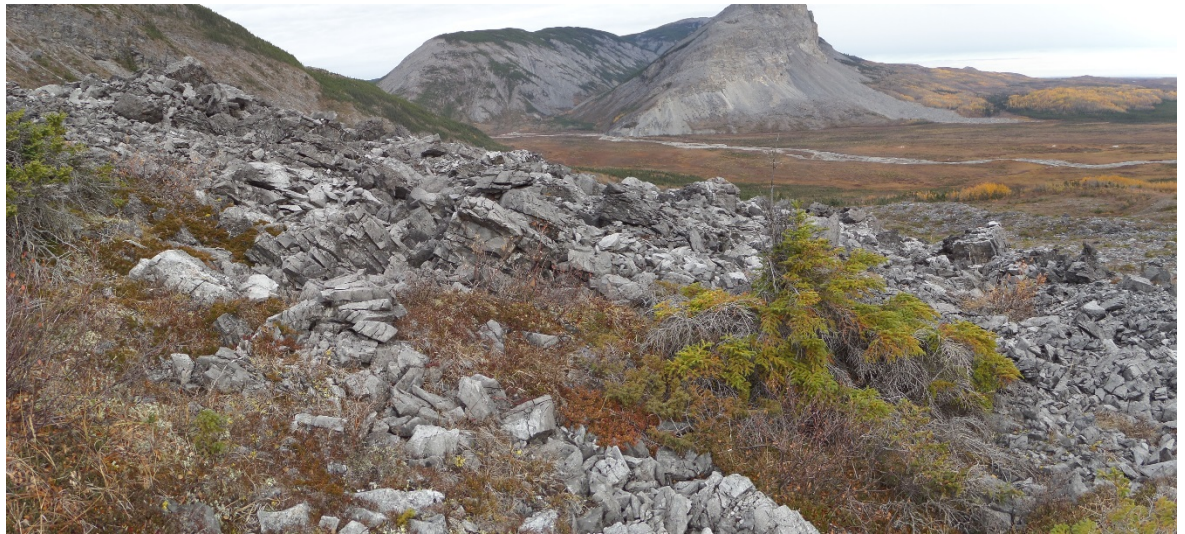
Figure 77: Limestone colluvium rock gradation available at the middle of the rubble slope.

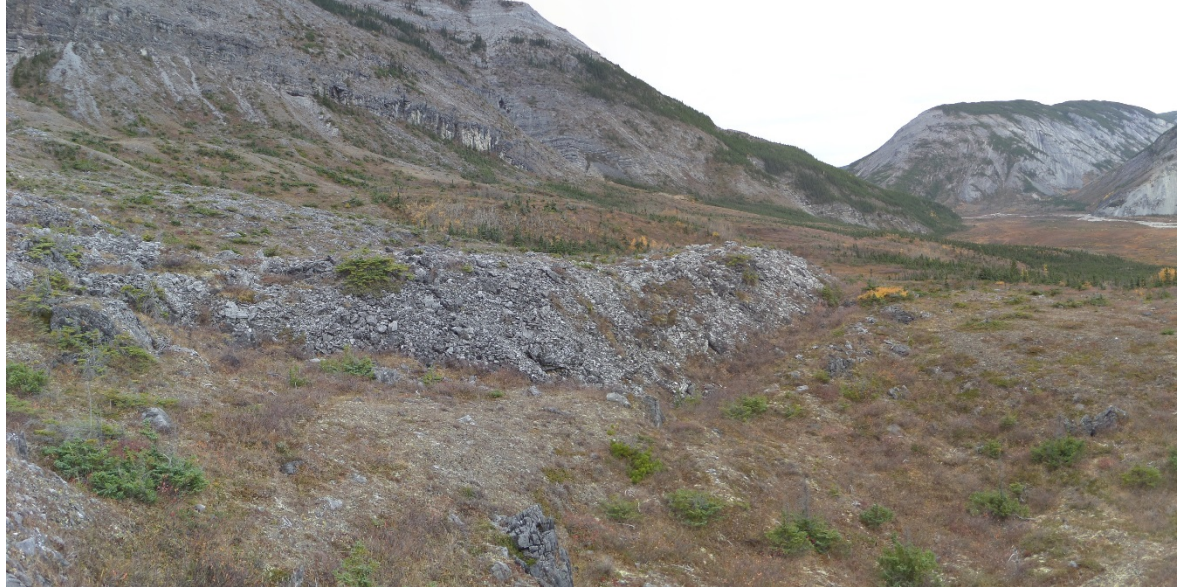
Figure 748: Finer material evident at the toe of the rubble slope. If the rubble pile is a rock glacier, this portion may be ice free now, as it is at the terminal end of the debris field.

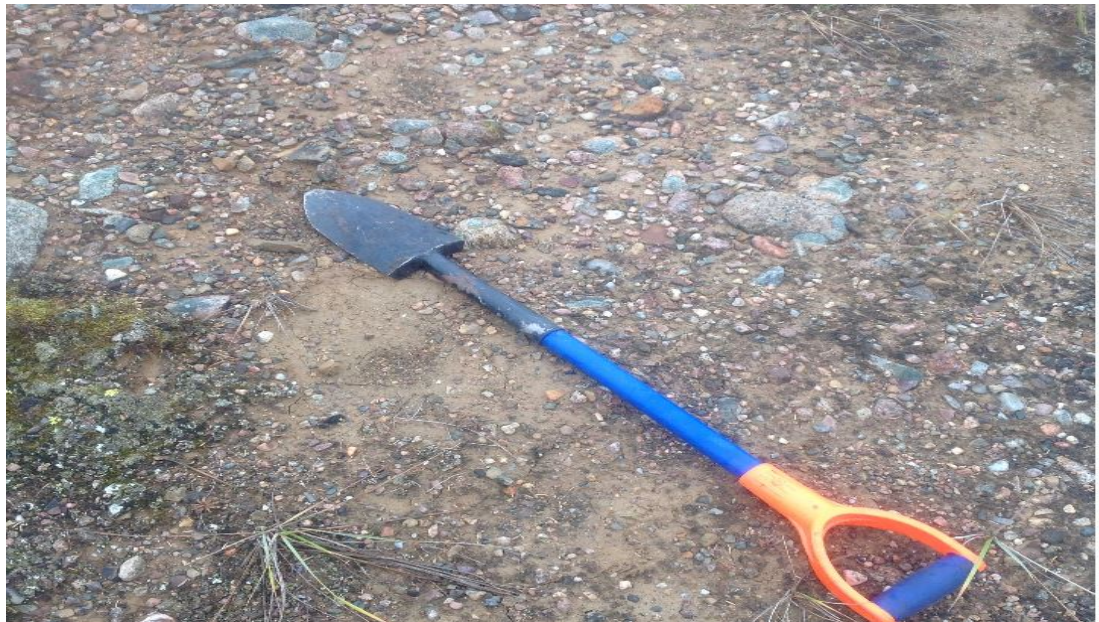
Potential good source of surfacing gravel. Close proximity to the proposed road location.

Figure79: An example of the gravels at BP 129.

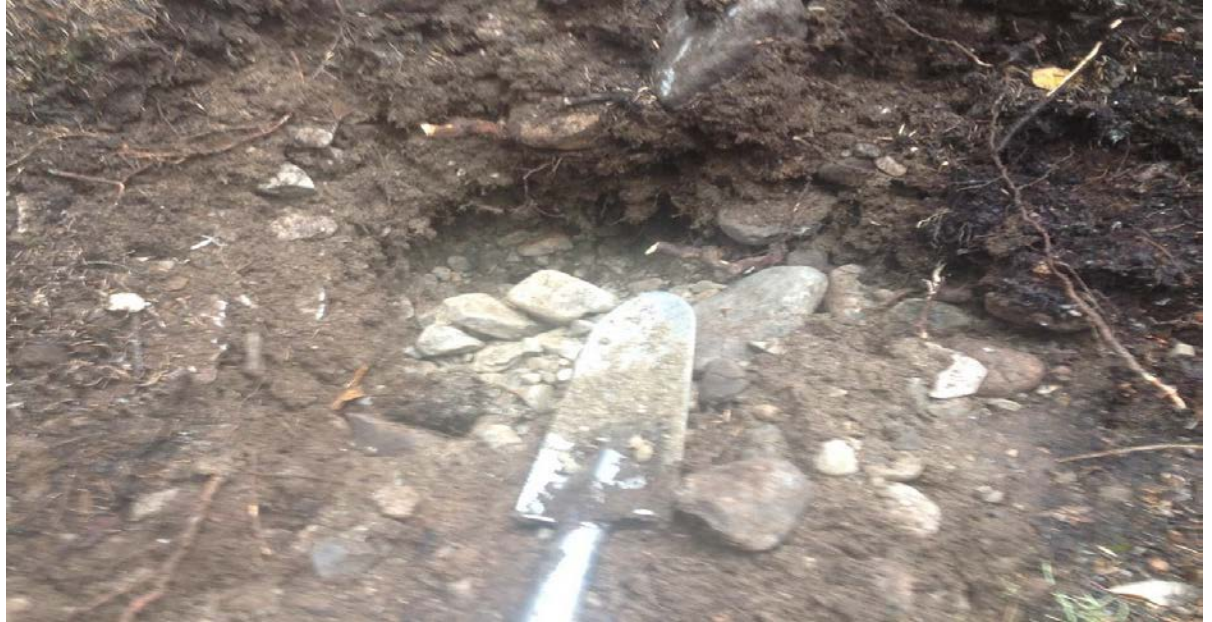
Must confirm depth and area but expect shallow source (2m deep) spread over a large fan. Some short access road(s) may be required to develop. A potential S3 seasonal stream divides the two defined patches. Probably requires crushing.

Figure 80: One example of the gravel type material at BP 151.

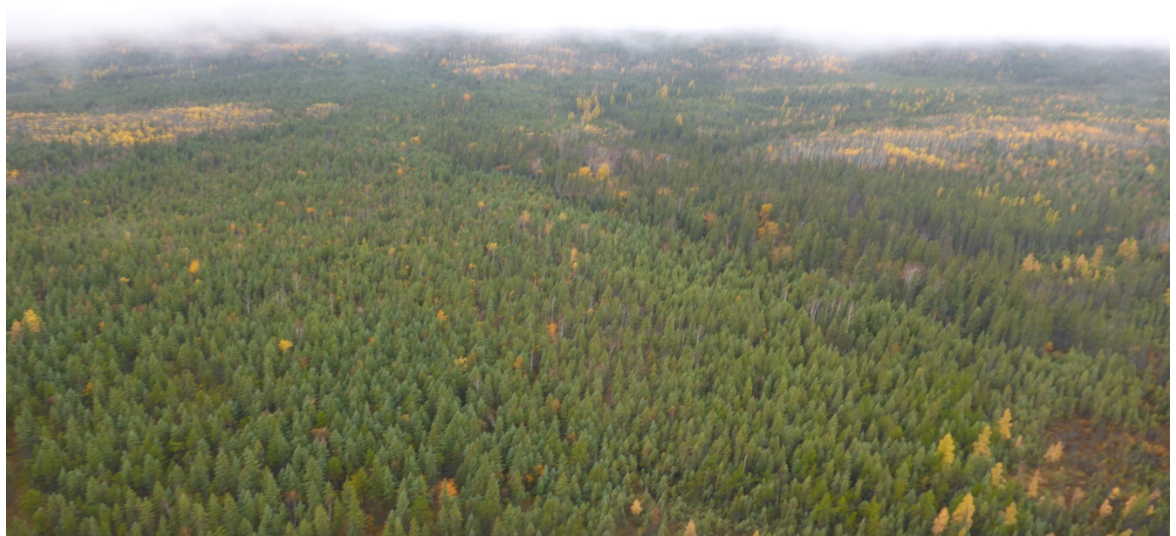
Figure 81: An aerial view of the large fan at BP 151, KP 151.5.

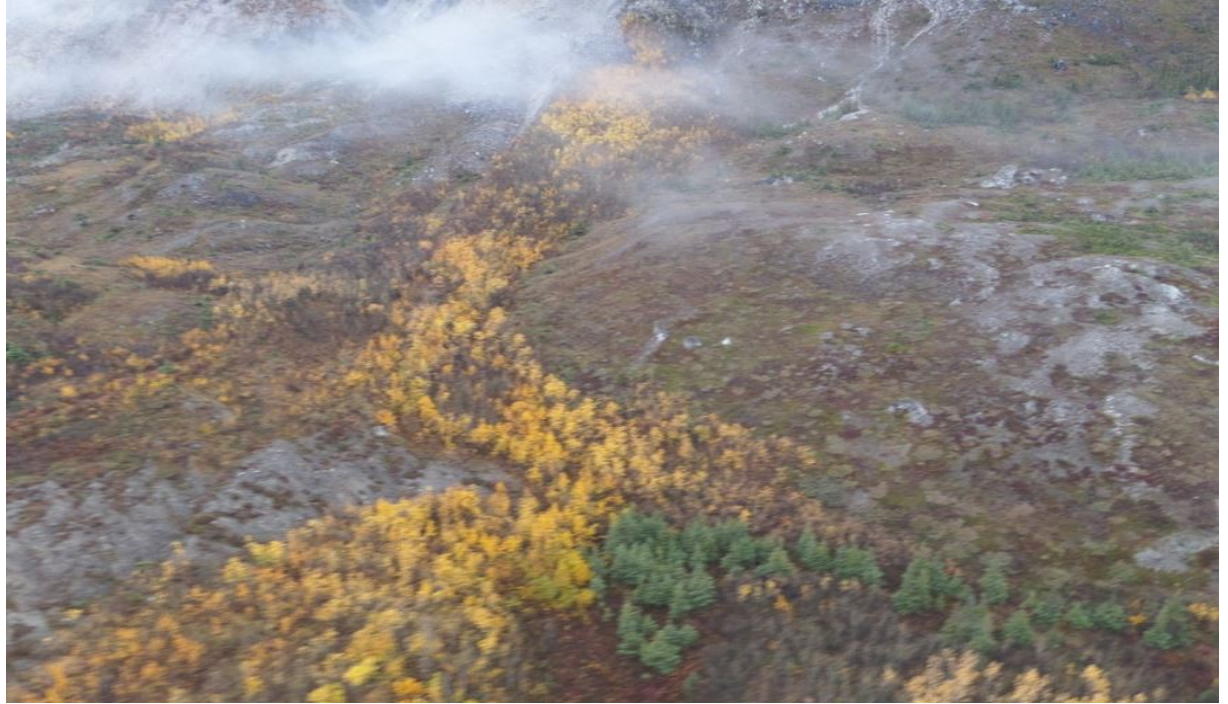
Final area must be defined and will be much smaller. Excellent source of mixed talus rubble at the base of limestone/carbonate rock face. A very strategic aggregate source to supply surfacing requirements and rip rap from KP 155 to 184. Requires a 1.5 km access road.

Figure 82: An aerial view of large deposit of talus rock at BP 158.

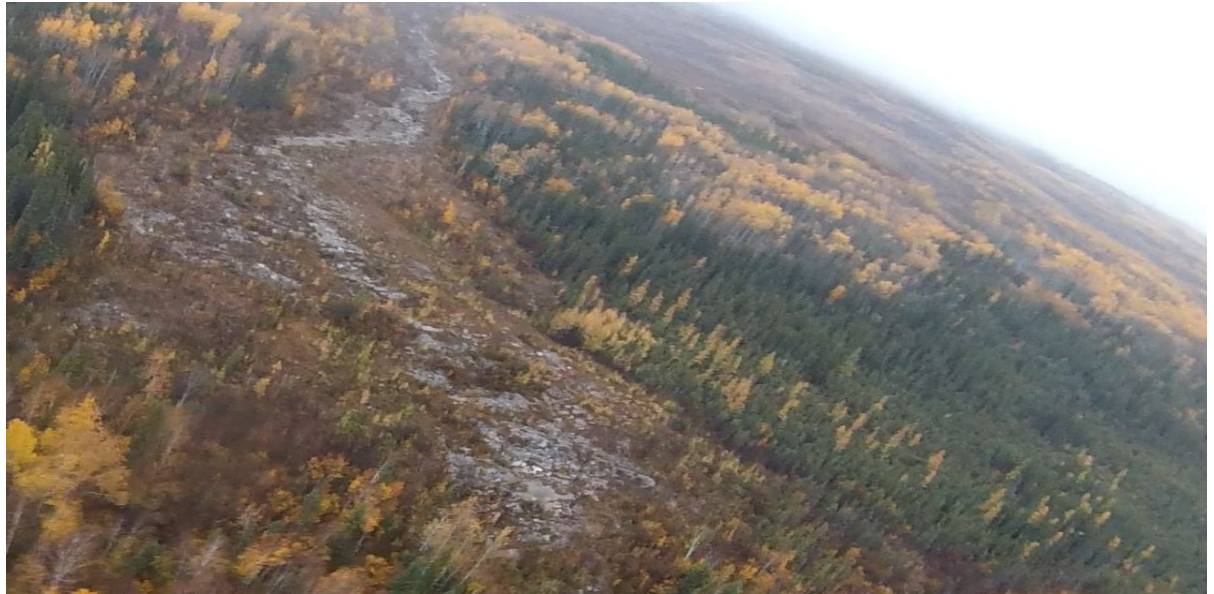
On the north side of the proposed Liard River landing/crossing exists a large debris/fan of rubble mix of limestone based rocks, gravel, mixed with clay. A detailed investigation to determine the potential and extent of the deposit must be completed. This source would be strategic location to serve aggregate requirements on both the north side and especially the south side of the Liard River where gravel sources are difficult to find.

Figure 83: An aerial view of the potential aggregate source just above the proposed north landing on the Liard River.

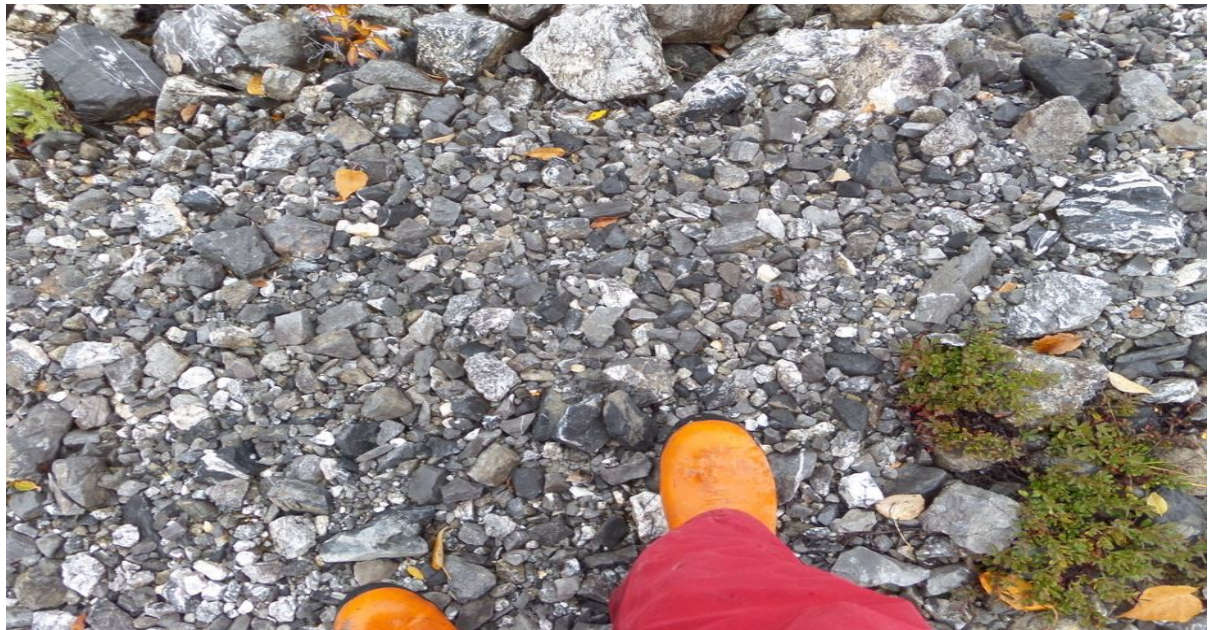
Figure 84: On the surface, the material looks attractive but only additional investigation will determine the true potential of the source.
