APPENDIX 9

Date: March 12, 2015 HCP Ref No.: CZN6788
From: John Wilcockson
To: David Harpley – Canadian Zinc Corporation
Subject: **Prairie Creek Proposed All Season Road - Stream Crossing Habitat Assessments, August and September, 2014**

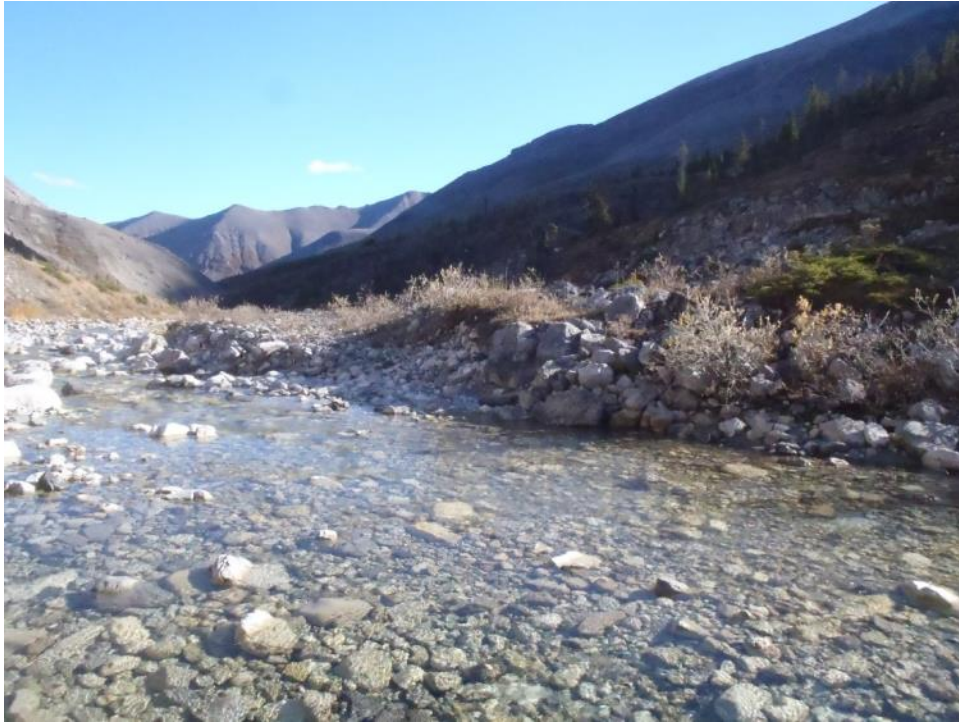
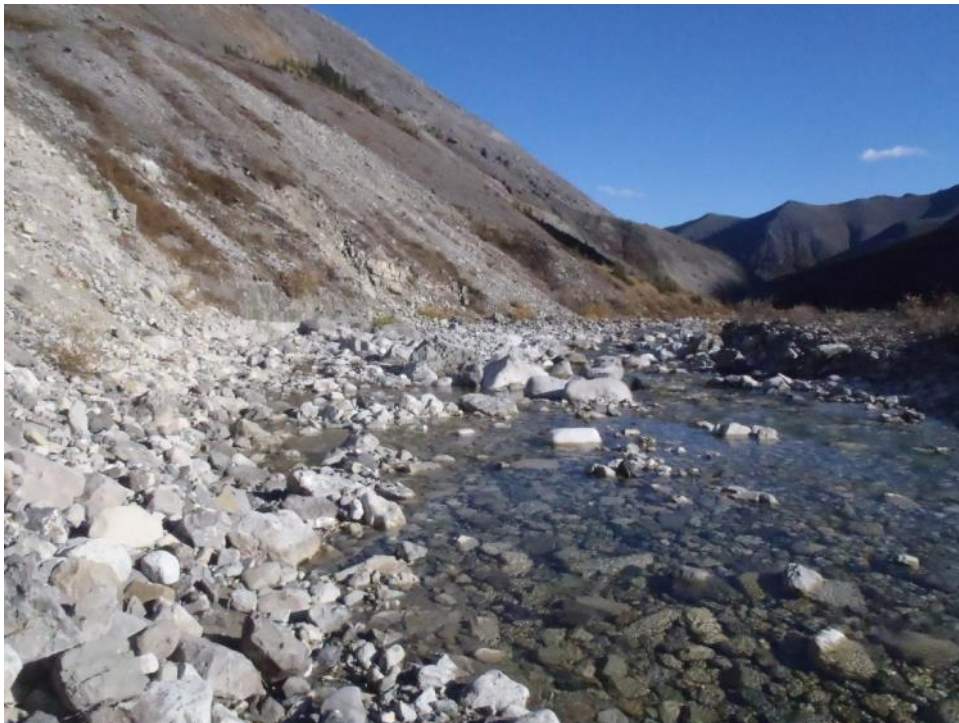
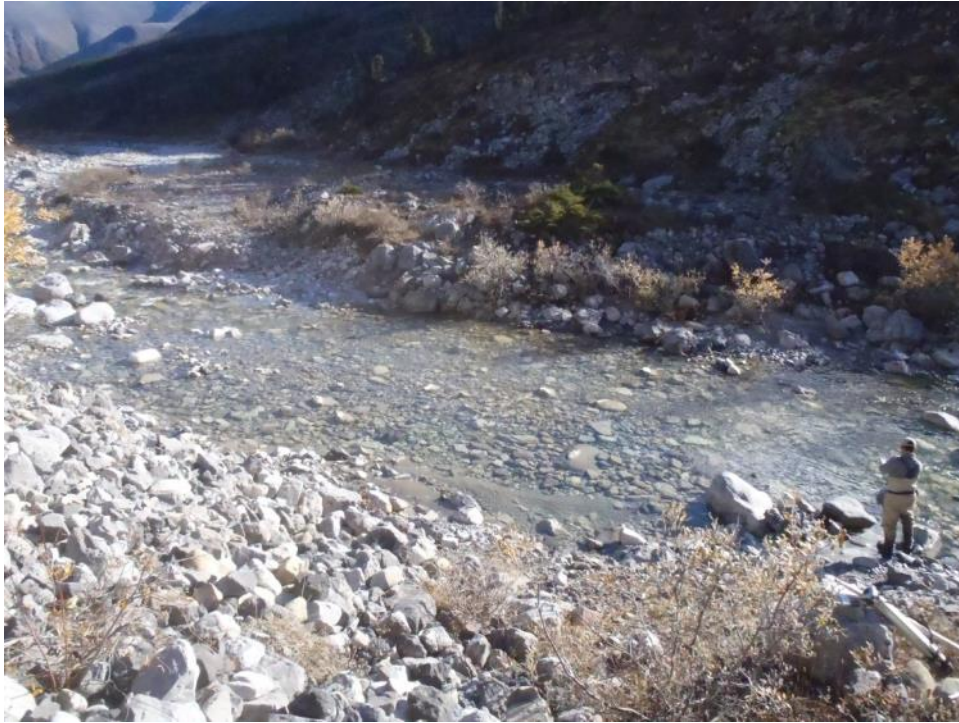
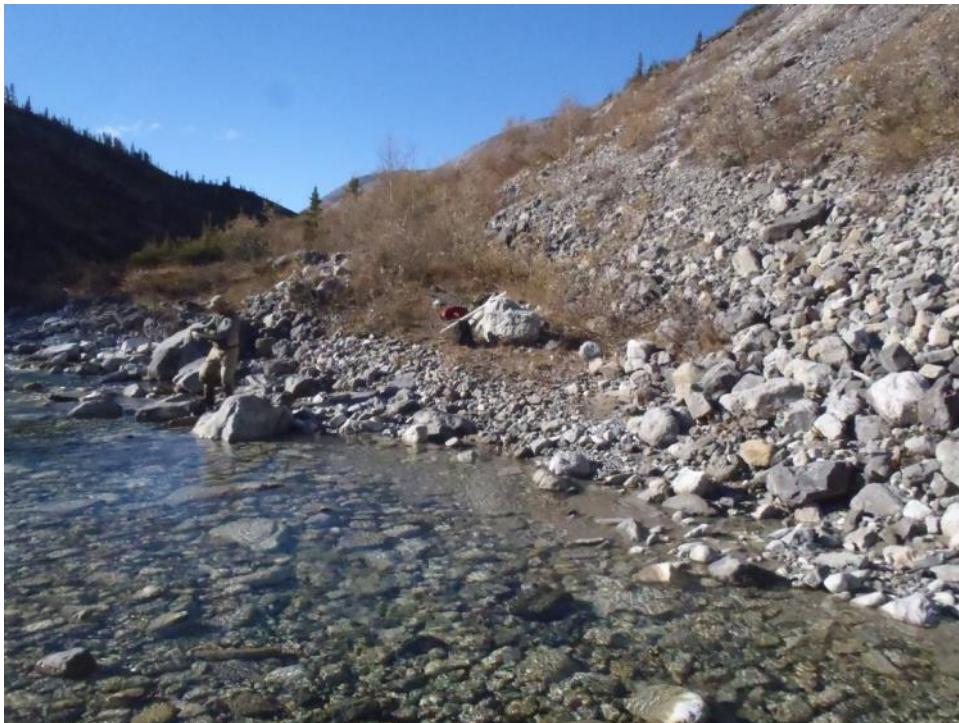
Photograph 1 Sundog Creek at Km 27.1, Prairie Creek all season road stream crossing study, September 22, 2014.

Photograph 2 Sundog Creek at Km 27.1, Prairie Creek all season road stream crossing study, September 22, 2014.

Photograph 3 Sundog Creek at Km 27.1, Prairie Creek all season road stream crossing study, September 22, 2014.

Photograph 4 Sundog Creek at Km 27.1, Prairie Creek all season road stream crossing study, September 22, 2014.

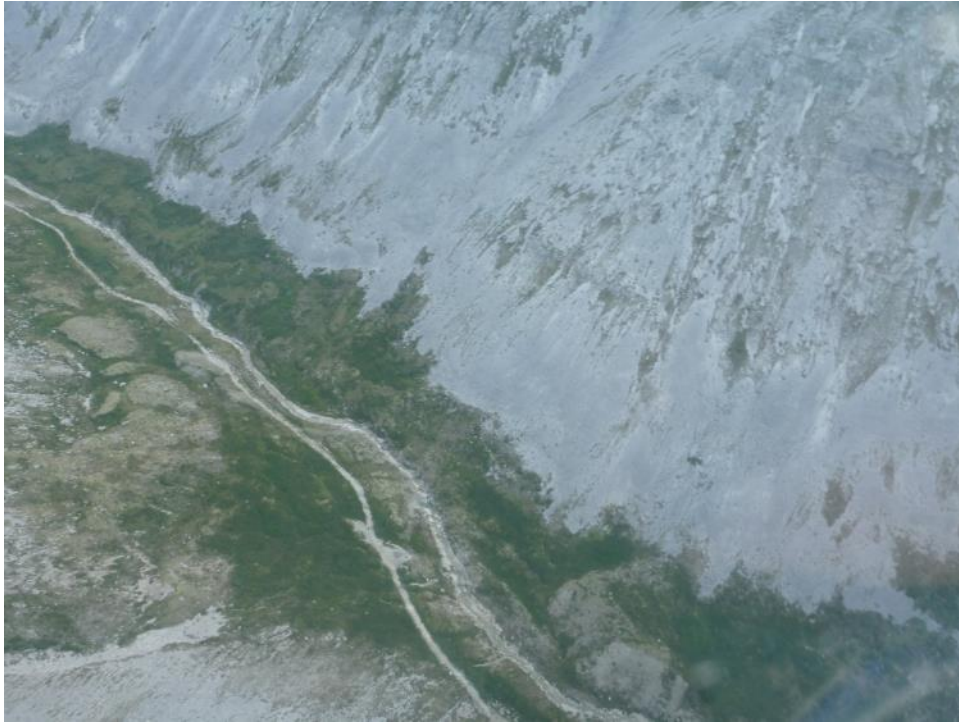
Photograph 5 Sundog Creek at KP27.2 facing north (upstream), Prairie Creek all season road stream crossing study, July 28, 2014.

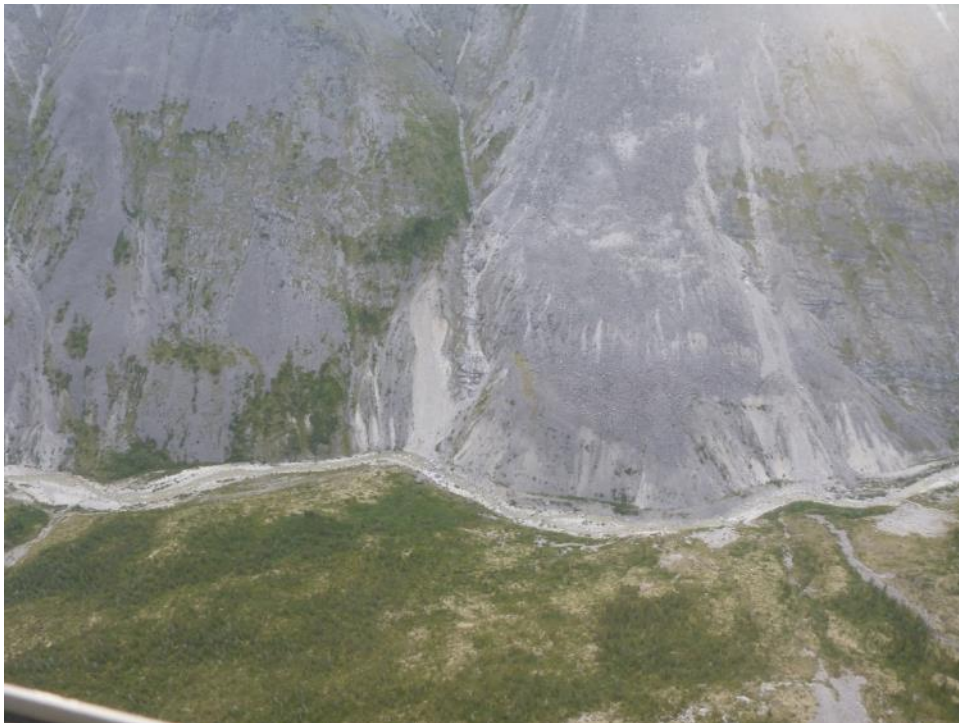
Photograph 6 Sundog Creek at KP27.4 facing north-northeast (cross-stream), Prairie Creek all season road stream crossing study, July 28, 2014.

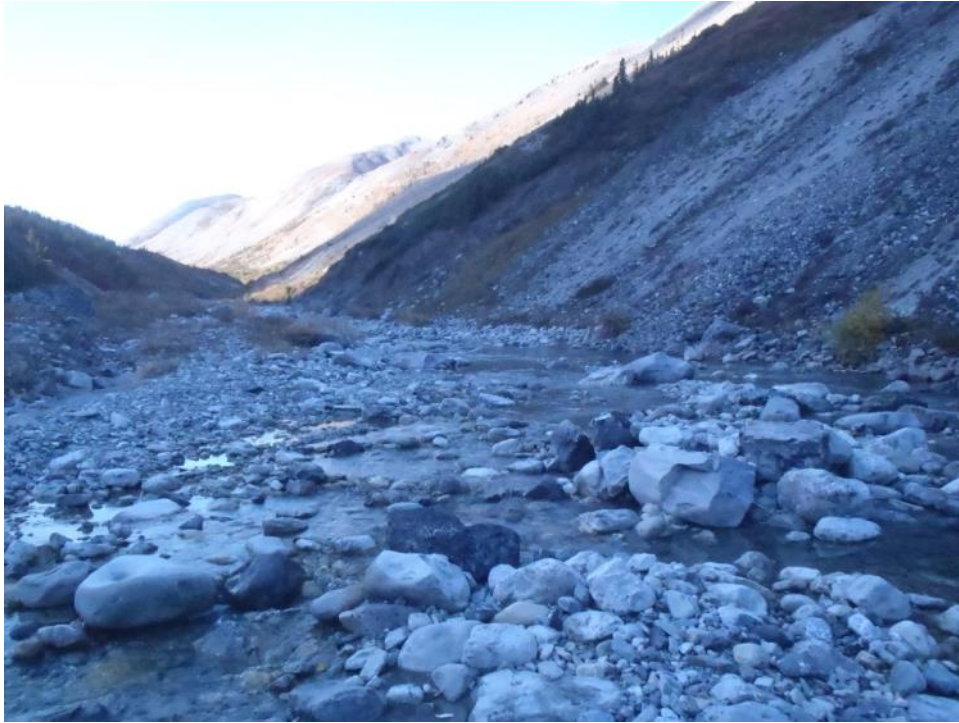
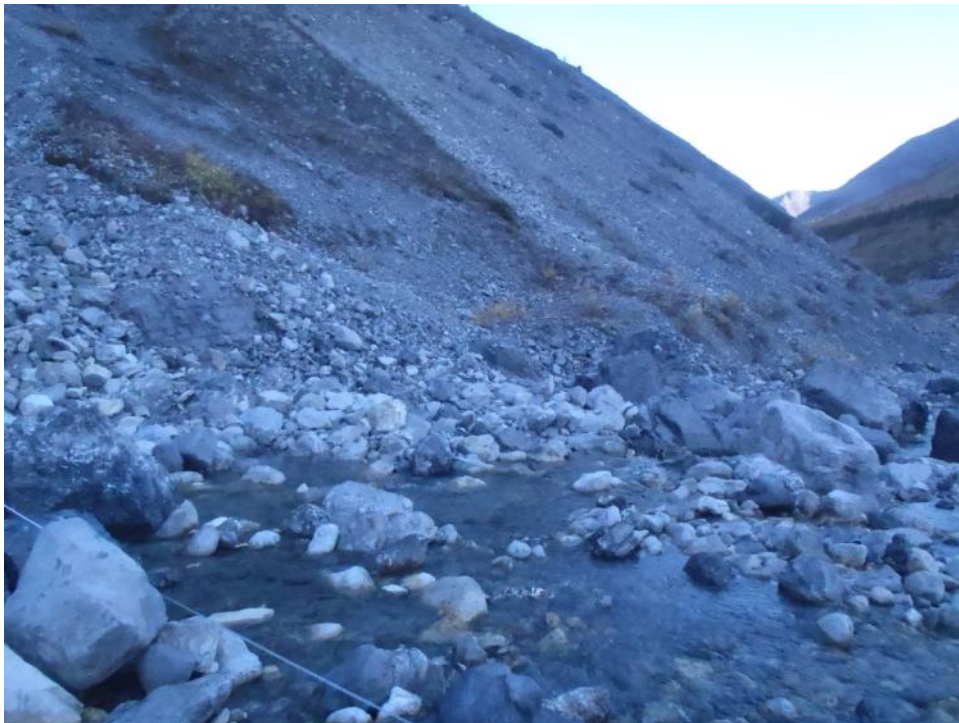
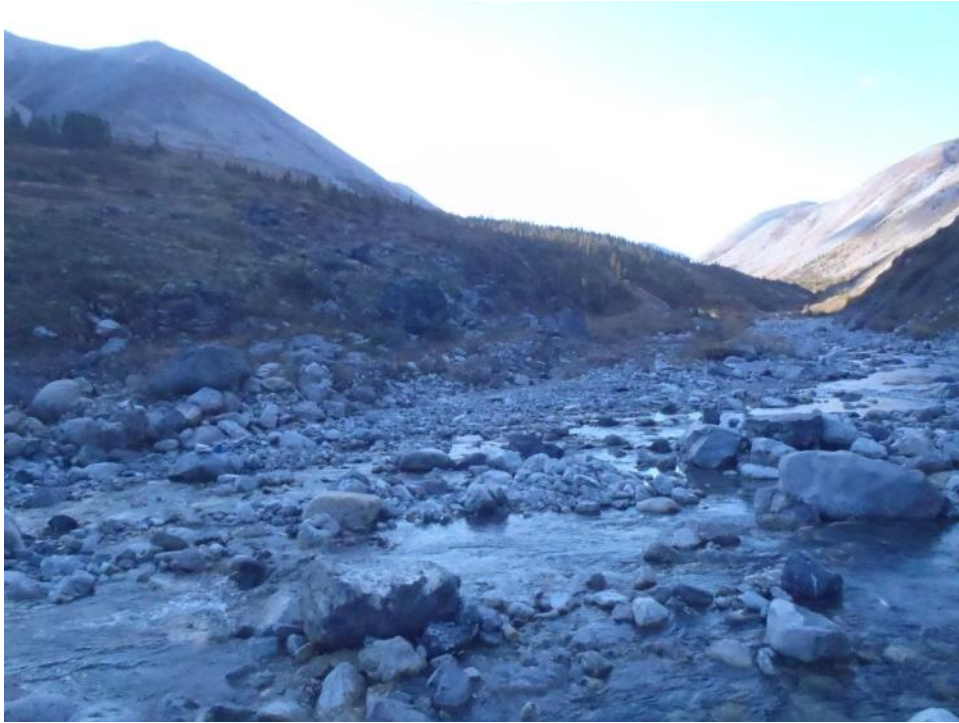
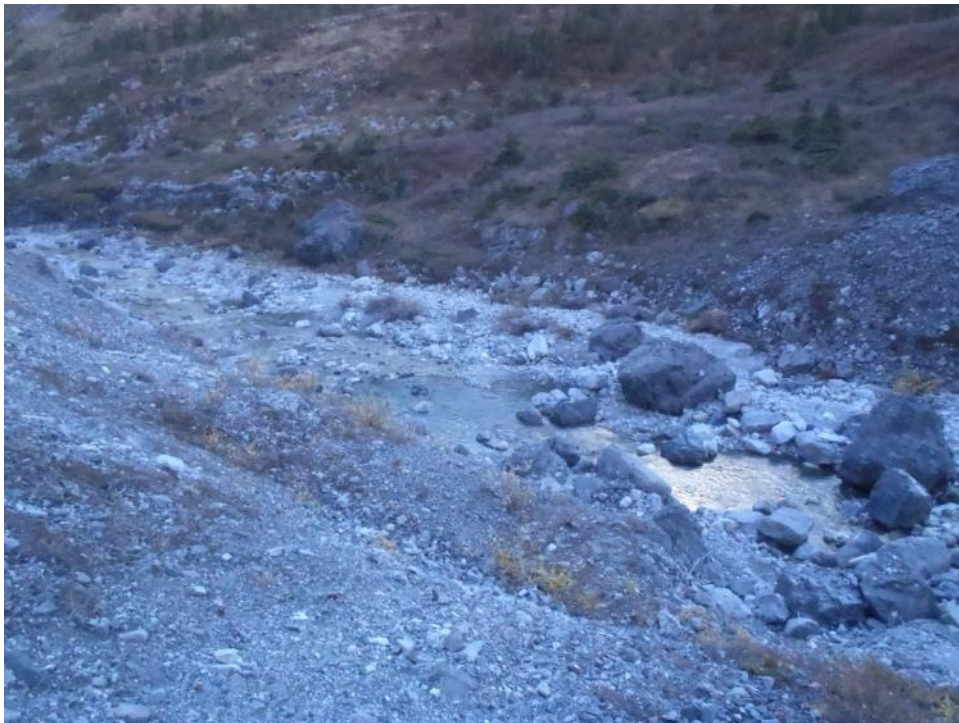
Photograph 7 Sundog Creek at Km 27.5, Prairie Creek all season road stream crossing study, September 22, 2014.

Photograph 8 Sundog Creek at Km 27.5, Prairie Creek all season road stream crossing study, September 22, 2014.

Photograph 9 Sundog Creek at Km 27.5, Prairie Creek all season road stream crossing study, September 22, 2014.

Photograph 10 Sundog Creek at Km 27.5, Prairie Creek all season road stream crossing study, September 22, 2014.

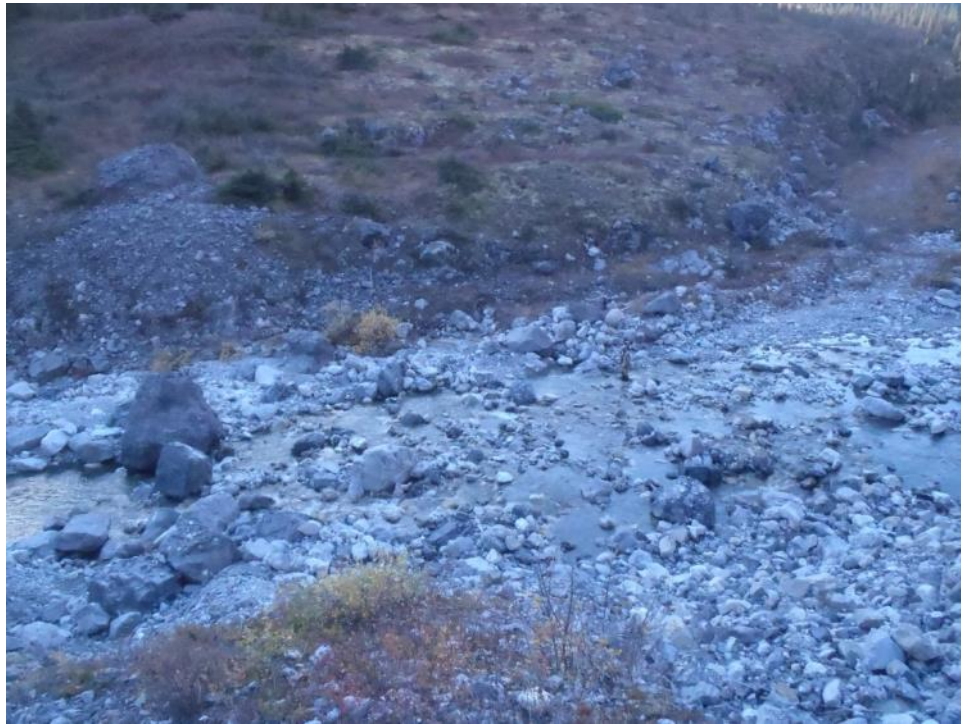
Photograph 11 Tributary to Sundog Creek at Km 27.5, Prairie Creek all season road stream crossing study, September 22, 2014.

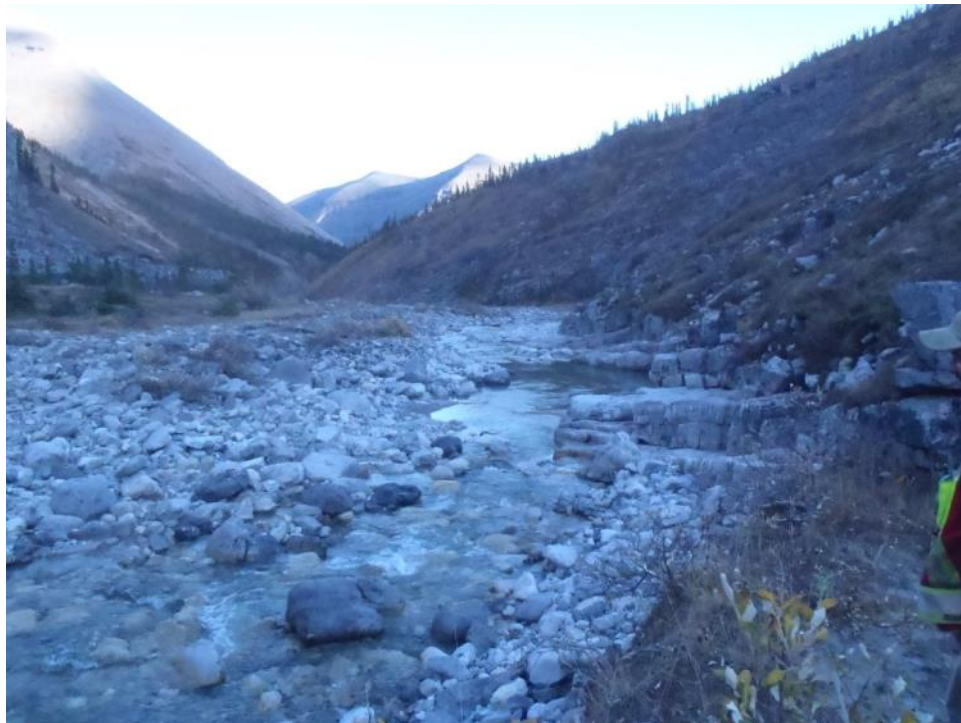
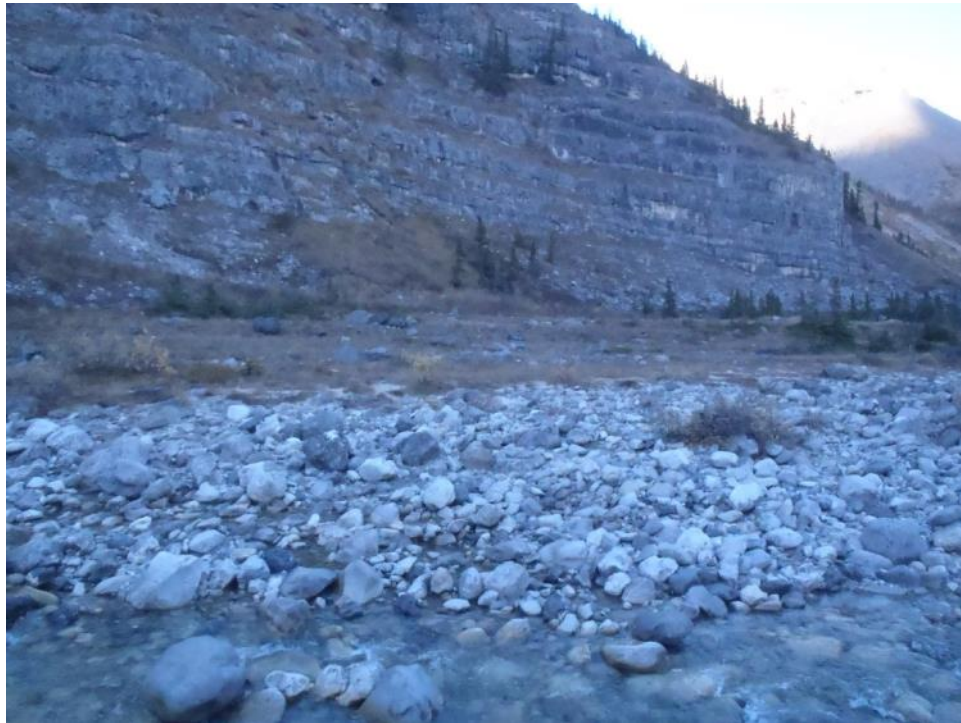
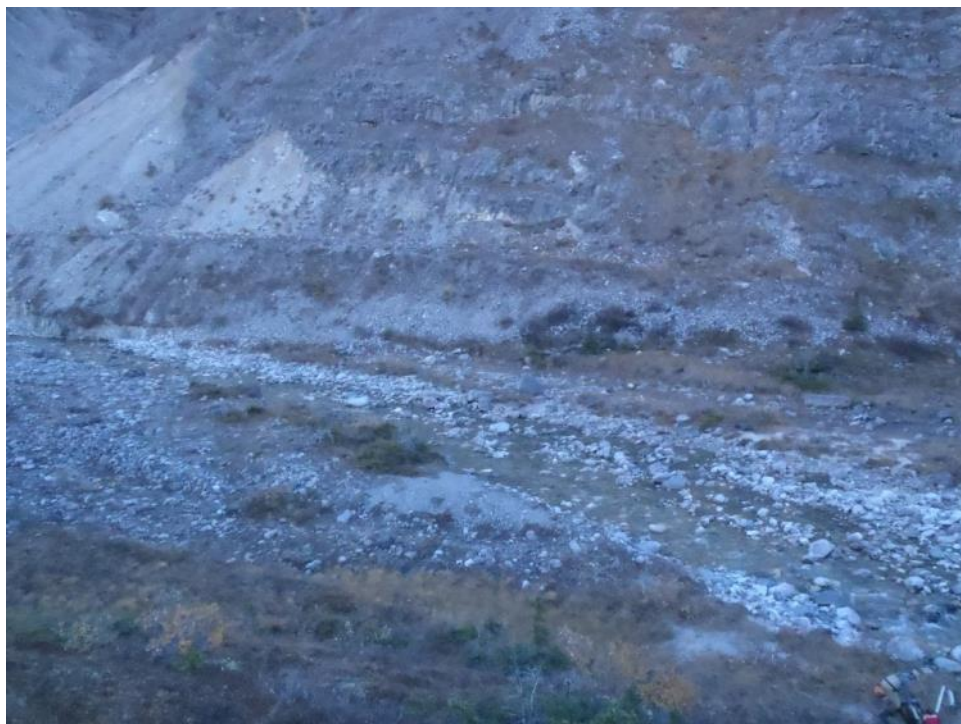
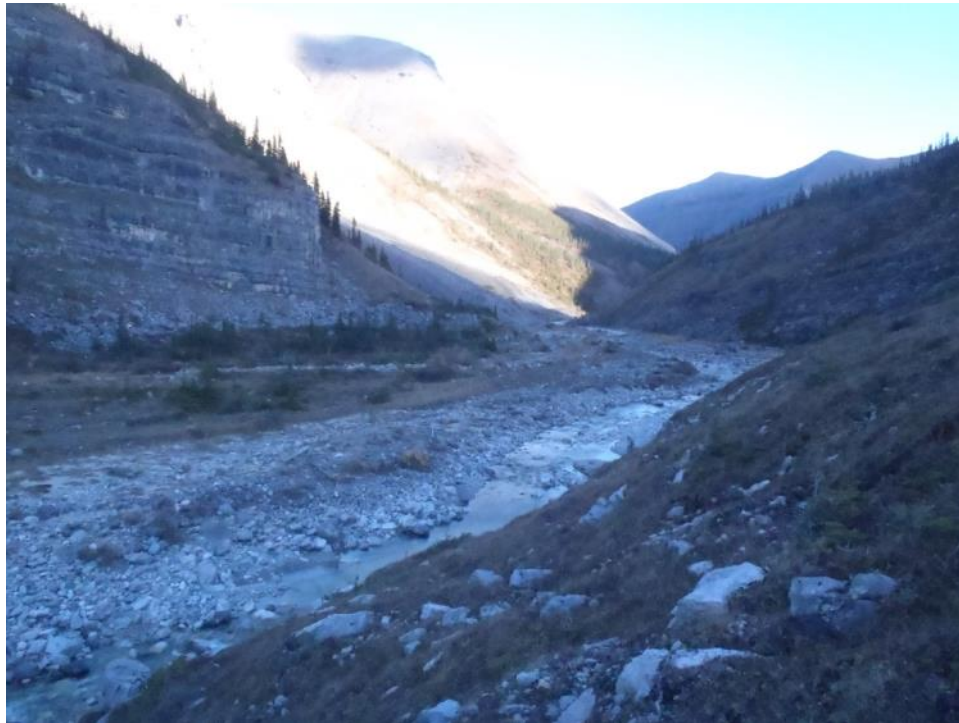
Photograph 12 Sundog Creek at Km 28.4, Prairie Creek all season road stream crossing study, September 22, 2014.

Photograph 13 Sundog Creek at Km 28.4, Prairie Creek all season road stream crossing study, September 22, 2014.

Photograph 14 Sundog Creek at Km 28.4, Prairie Creek all season road stream crossing study, September 22, 2014.

Photograph 15 Sundog Creek at Km 28.4, Prairie Creek all season road stream crossing study, September 22, 2014.

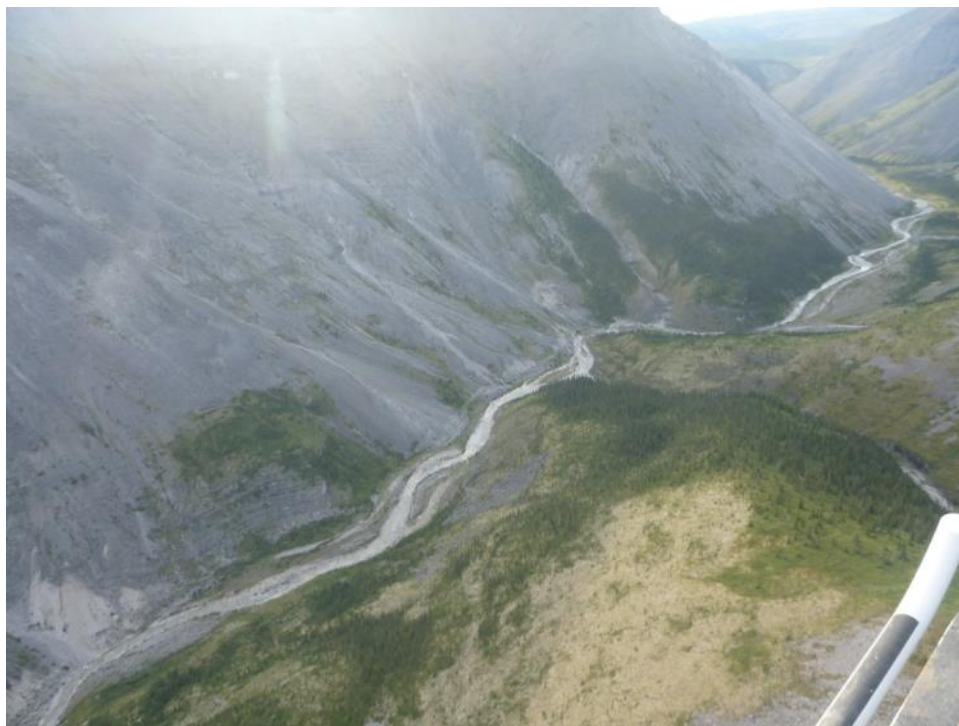
Photograph 16 Sundog Creek at KP29 facing east-southeast (downstream), Prairie Creek all season road stream crossing study, July 28, 2014.

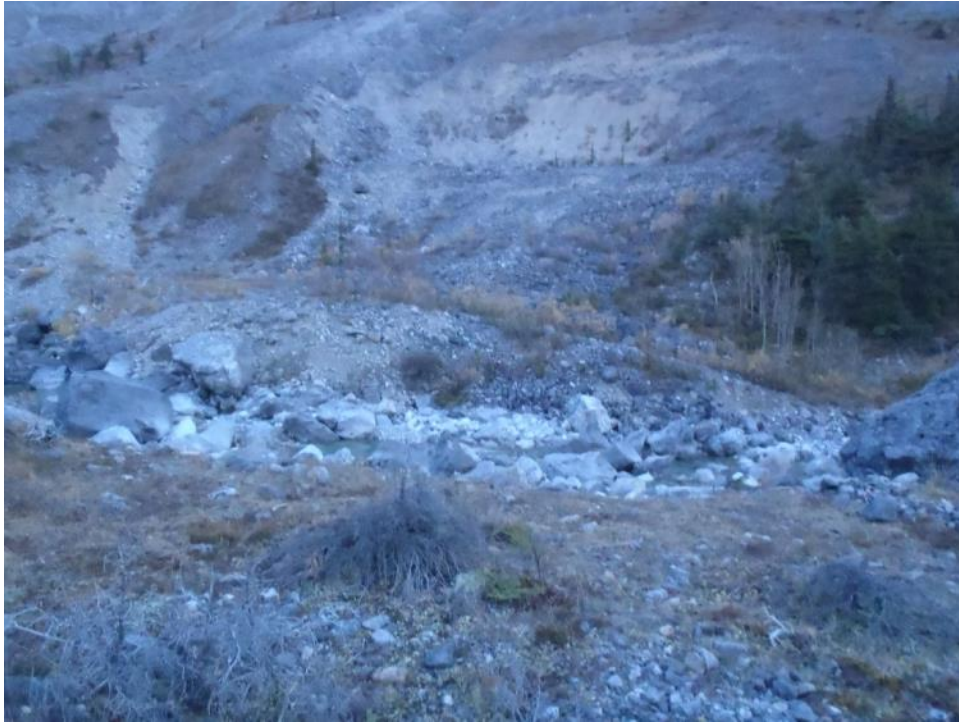
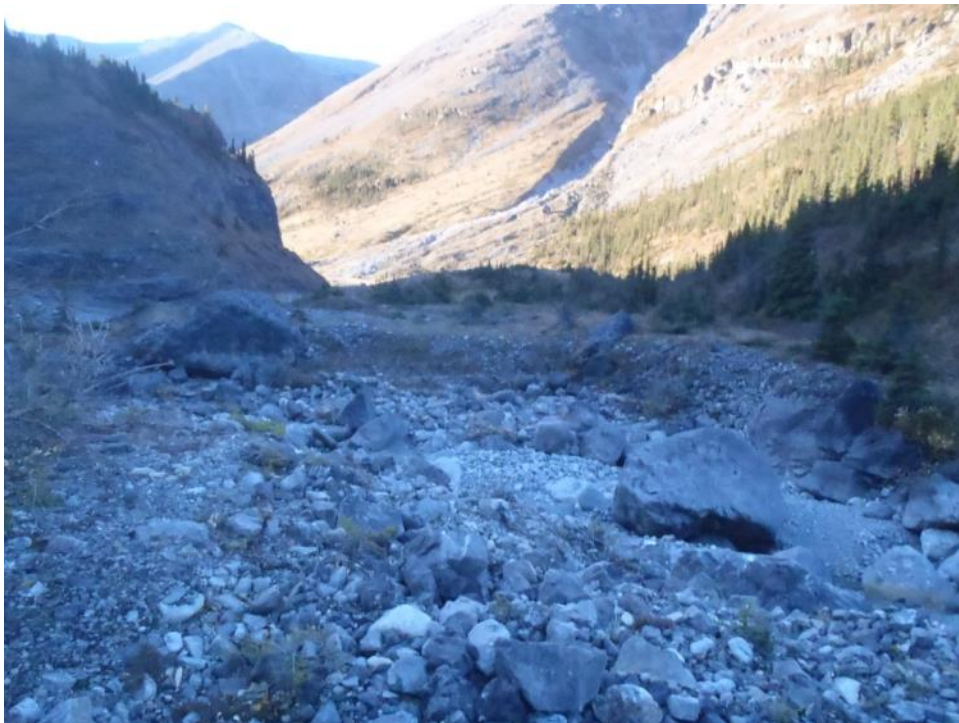
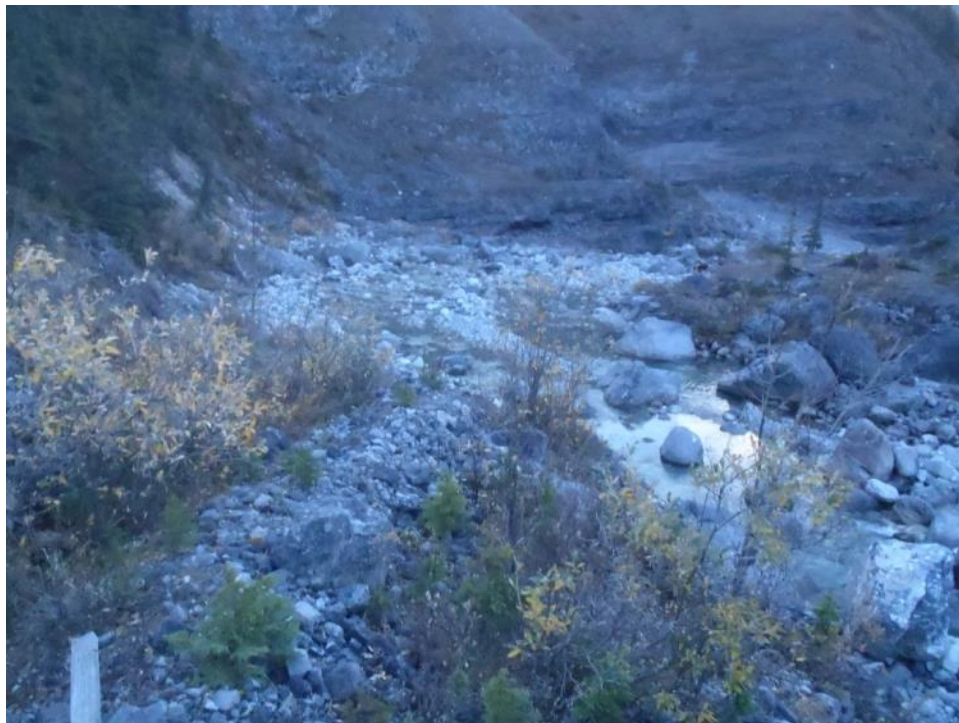
Photograph 17 Sundog Creek at Km 29.2, Prairie Creek all season road stream crossing study, September 23, 2014.

Photograph 18 Sundog Creek at Km 29.2, Prairie Creek all season road stream crossing study, September 23, 2014.

Photograph 19 Sundog Creek at Km 29.2, Prairie Creek all season road stream crossing study, September 23, 2014.

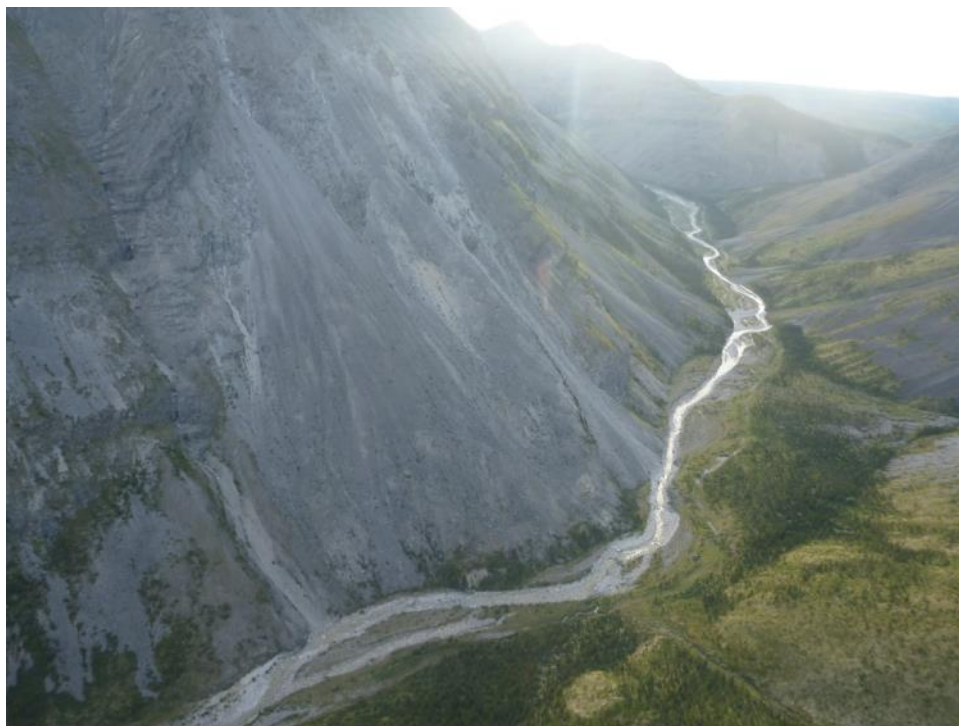
Photograph 20 Sundog Creek at KP30.5 facing east-southeast (downstream), Prairie Creek all season road stream crossing study, July 28, 2014.

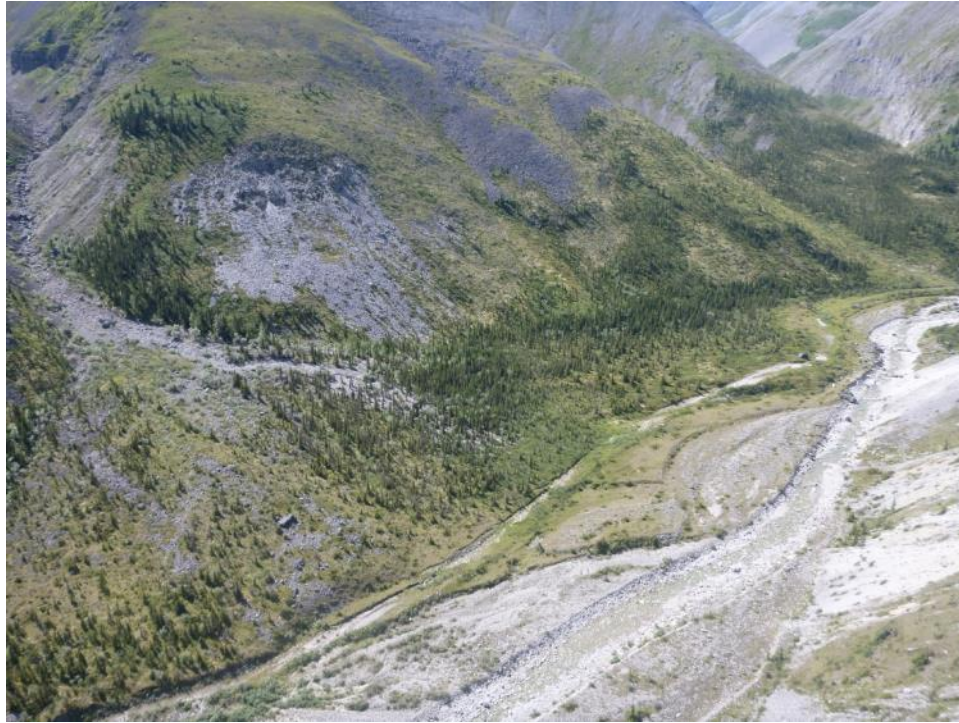
Photograph 21 Sundog Creek at KP 30.5 facing north-northwest (upstream), Prairie Creek all season road stream crossing study, July 28, 2014.

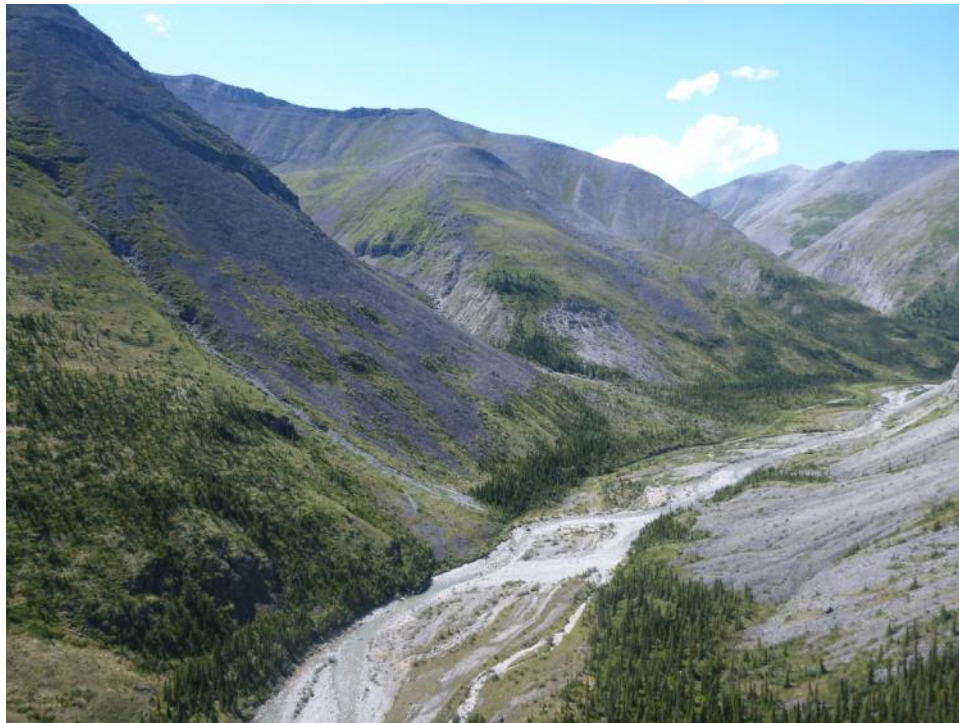
Photograph 22 Sundog Creek at KP30.7 facing west-northwest (upstream), Prairie Creek all season road stream crossing study, July 28, 2014.

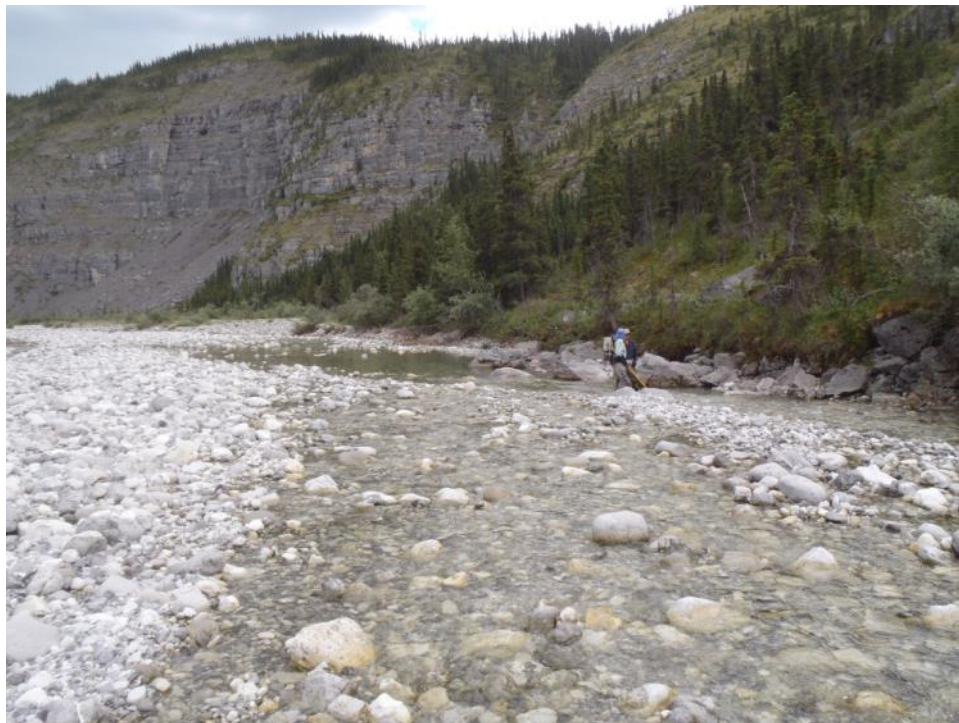
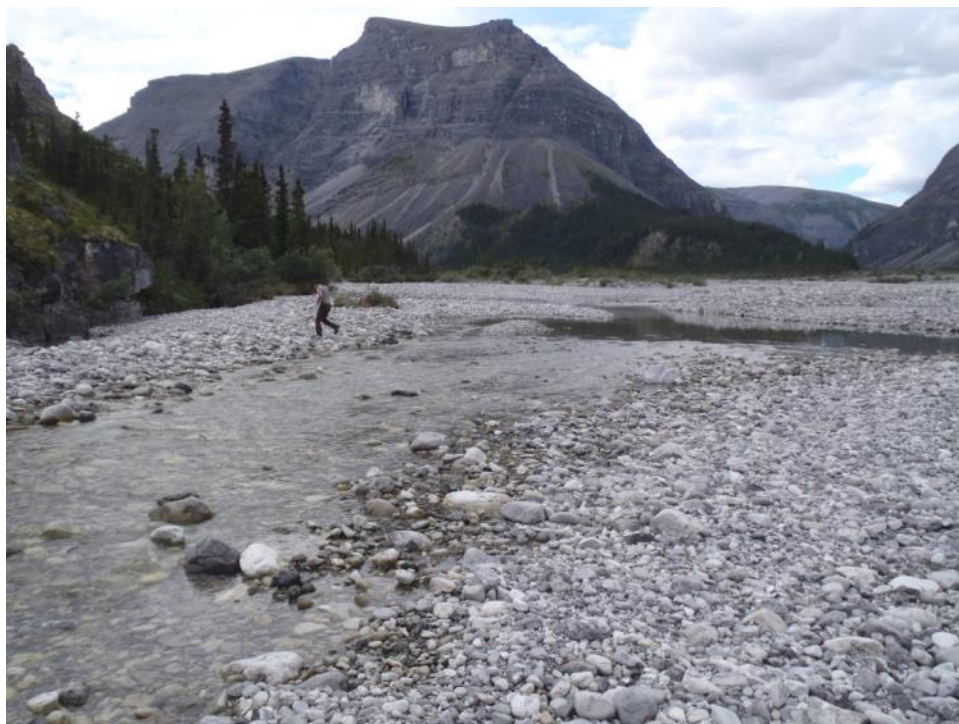
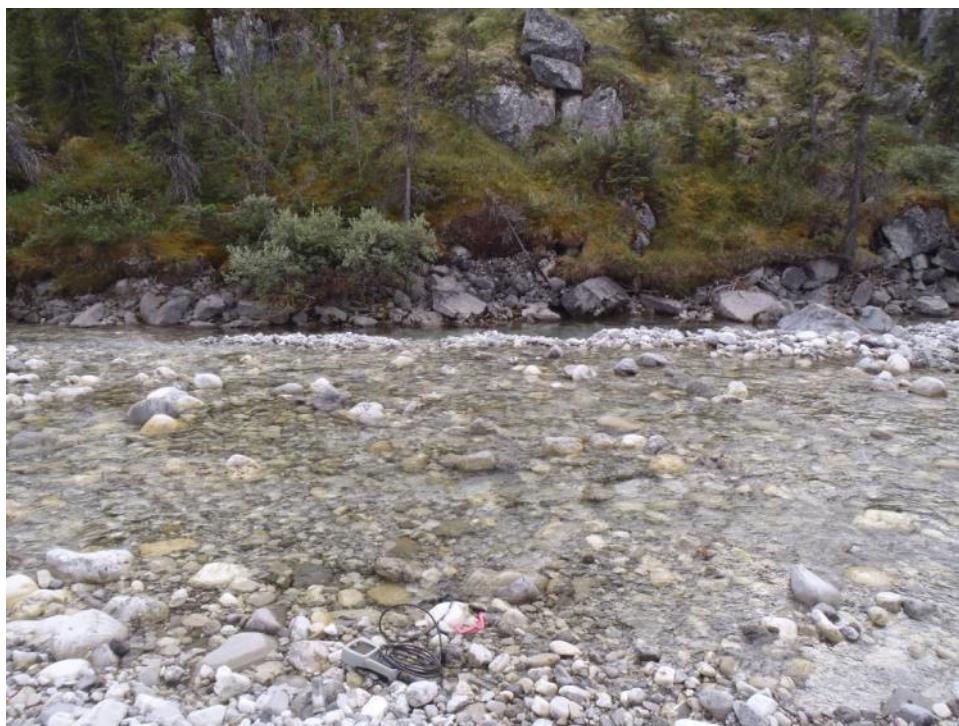
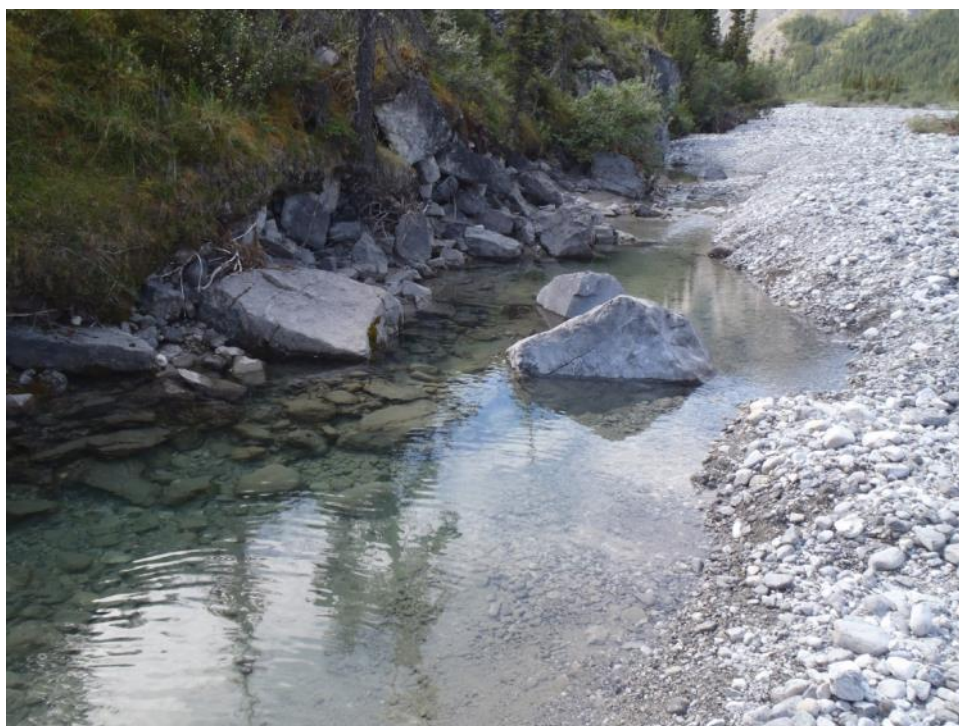
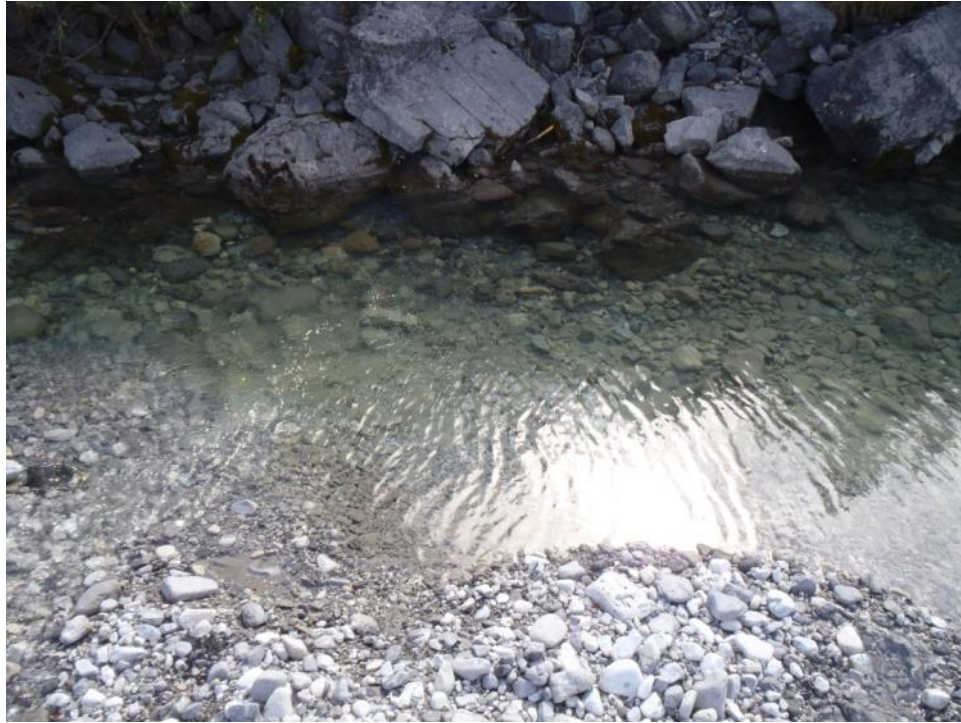
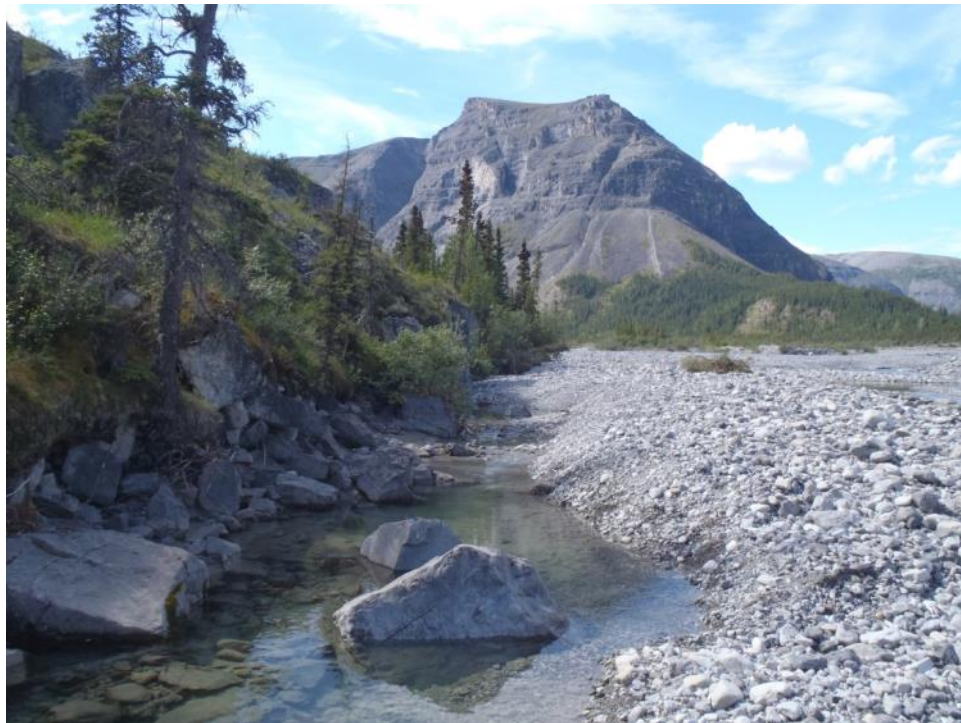
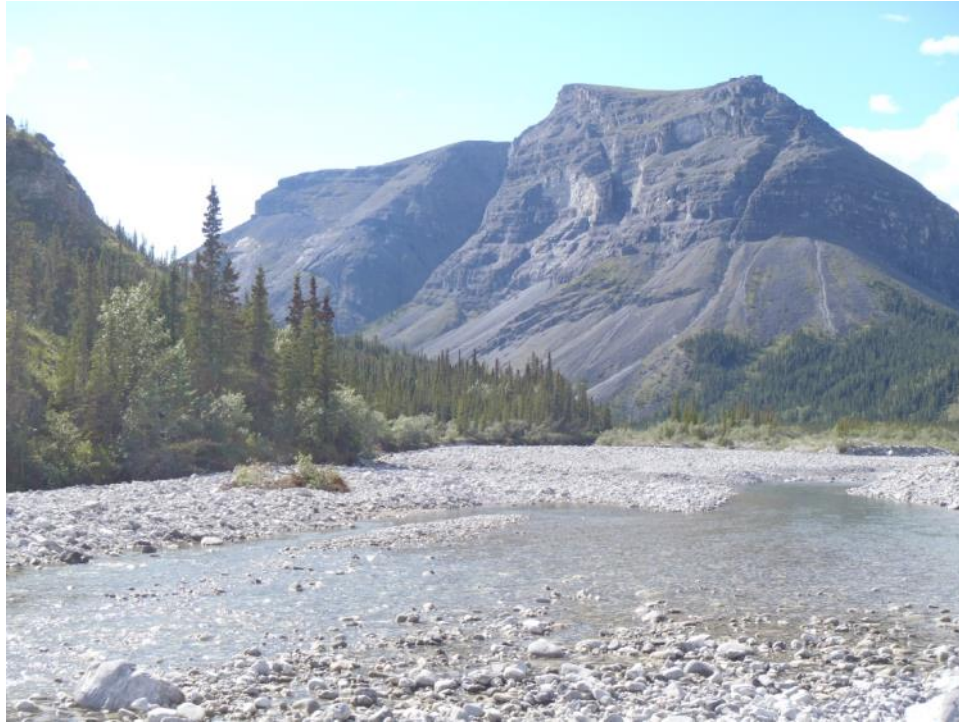
Photograph 23 Sundog Creek at Km 37.5, Prairie Creek all season road stream crossing study, July 27, 2014.

Photograph 24 Sundog Creek at Km 37.5, Prairie Creek all season road stream crossing study, July 27, 2014.

Photograph 25 Sundog Creek at Km 37.5, Prairie Creek all season road stream crossing study, July 27, 2014.

Photograph 26 Sundog Creek at Km 37.5, Prairie Creek all season road stream crossing study, July 27, 2014.

Photograph 27 Sundog Creek at Km 37.5, Prairie Creek all season road stream crossing study, July 27, 2014.

Photograph 28 Sundog Creek at Km 37.5, Prairie Creek all season road stream crossing study, July 27, 2014.

Photograph 29 Sundog Creek at Km 37.5, Prairie Creek all season road stream crossing study, July 27, 2014.

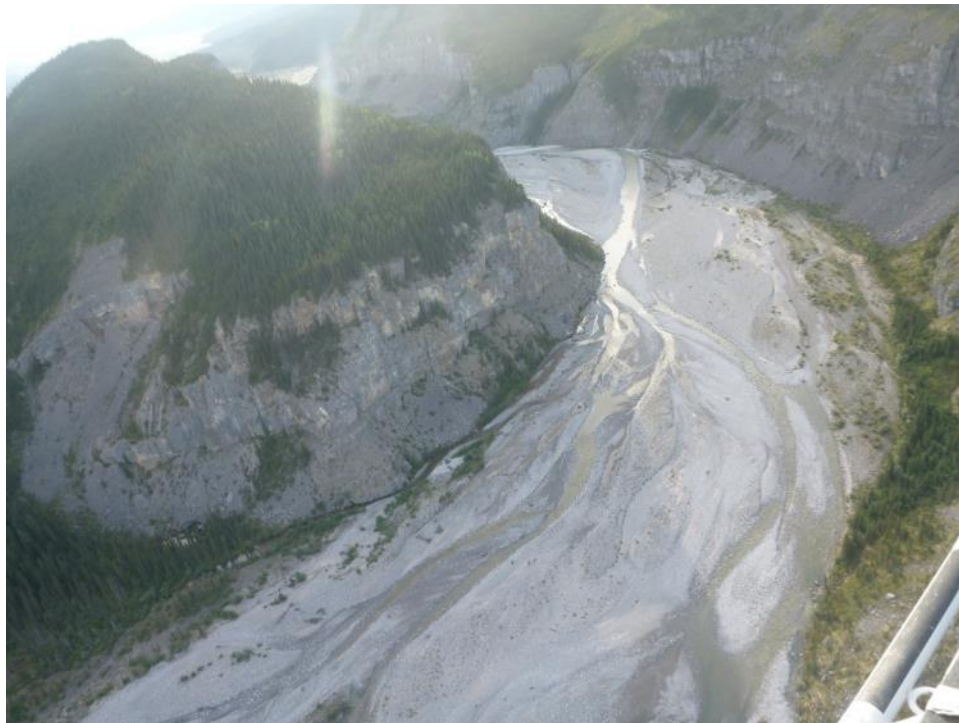
Photograph 30 Sundog Creek at KP37.8 facing east (downstream), Prairie Creek all season road stream crossing study, July 28, 2014.

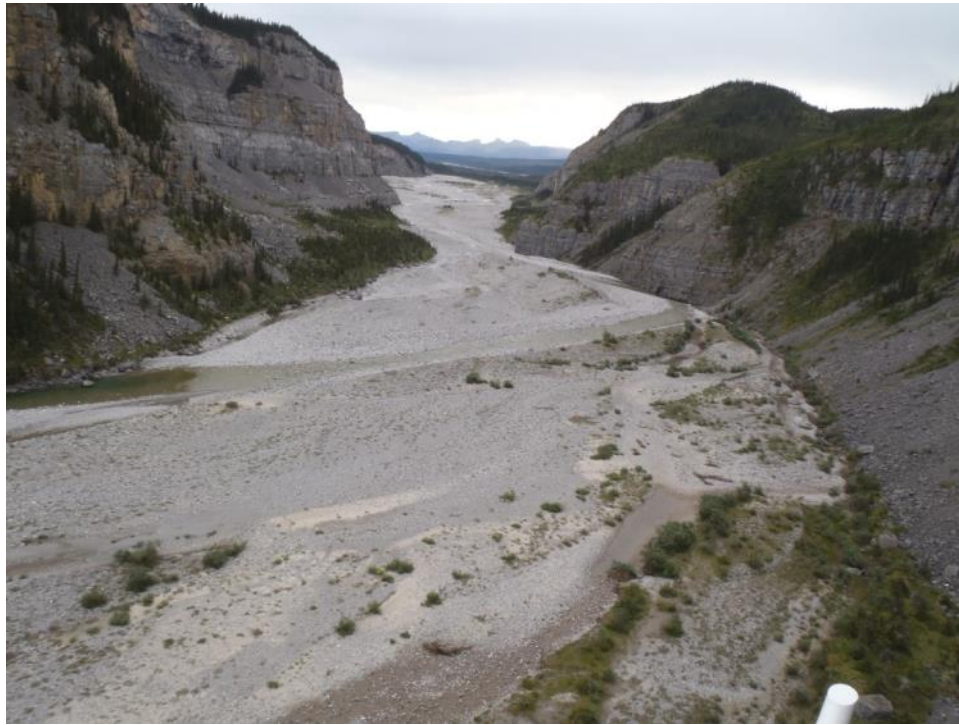
Photograph 31 Sundog Creek at Km 38 facing northeast (downstream), Prairie Creek all season road stream crossing study, July 27, 2014.
