APPENDIX 9

Date: March 12, 2015 HCP Ref No.: CZN6788
From: John Wilcockson
To: David Harpley – Canadian Zinc Corporation
Subject: **Prairie Creek Proposed All Season Road - Stream Crossing Habitat Assessments, August and September, 2014**

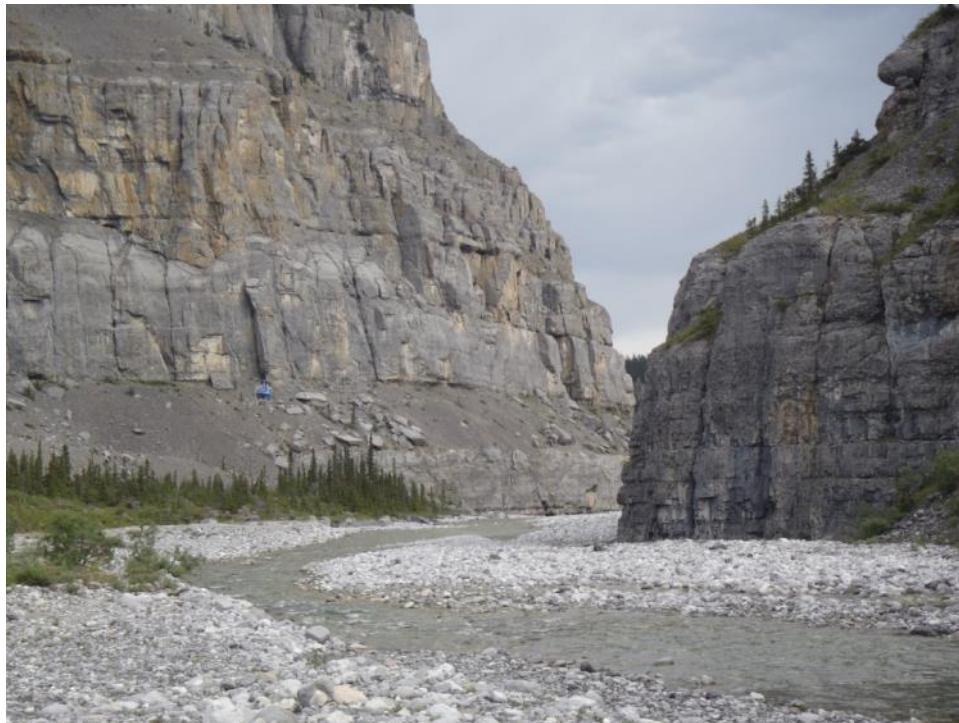
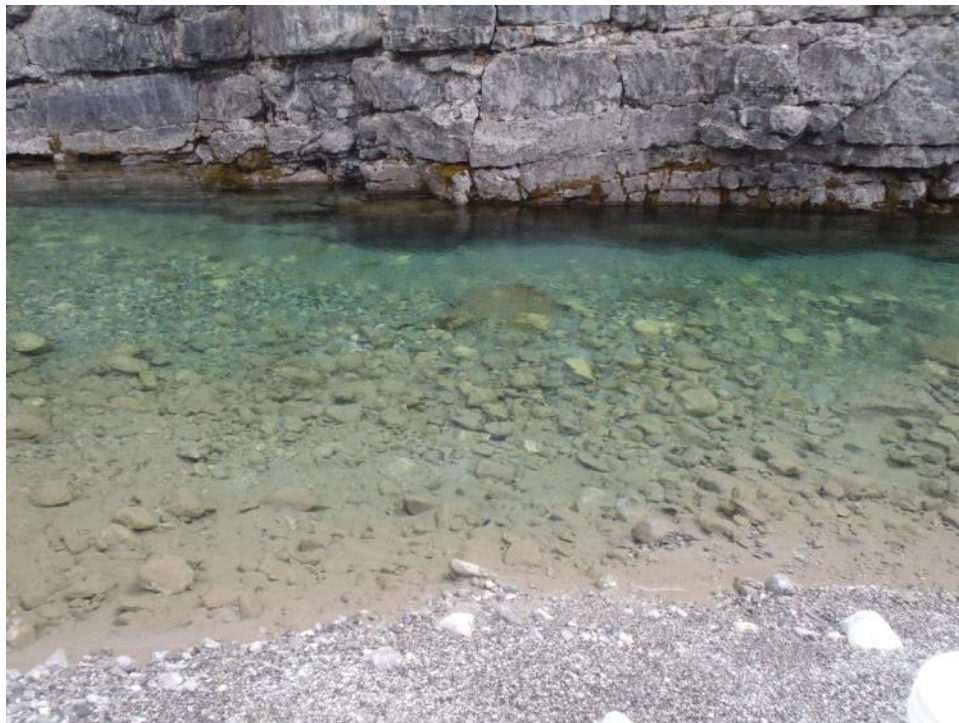
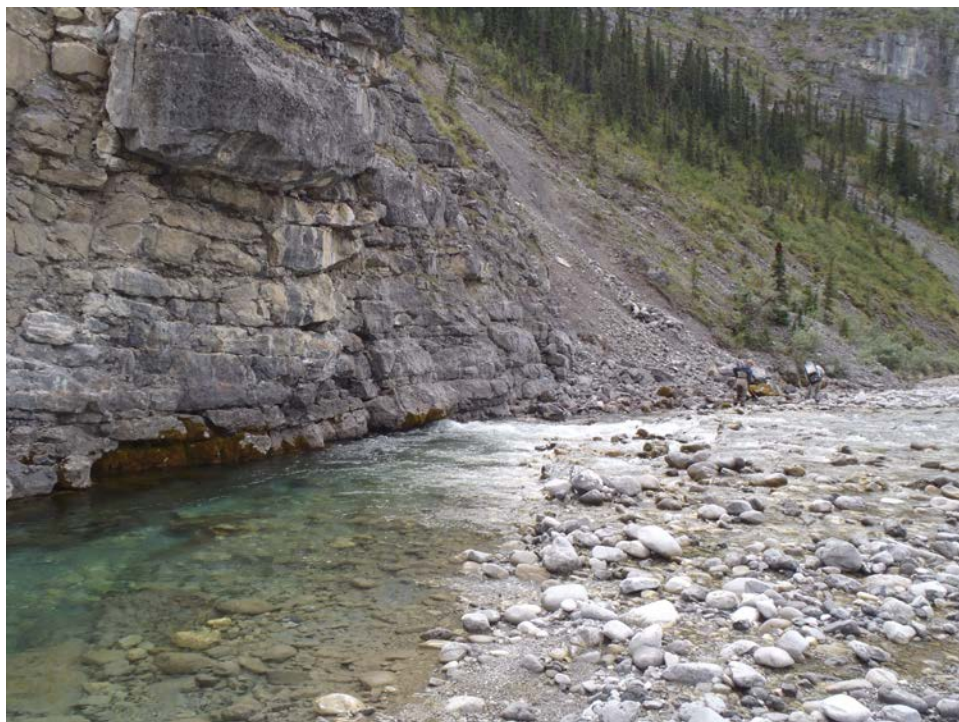
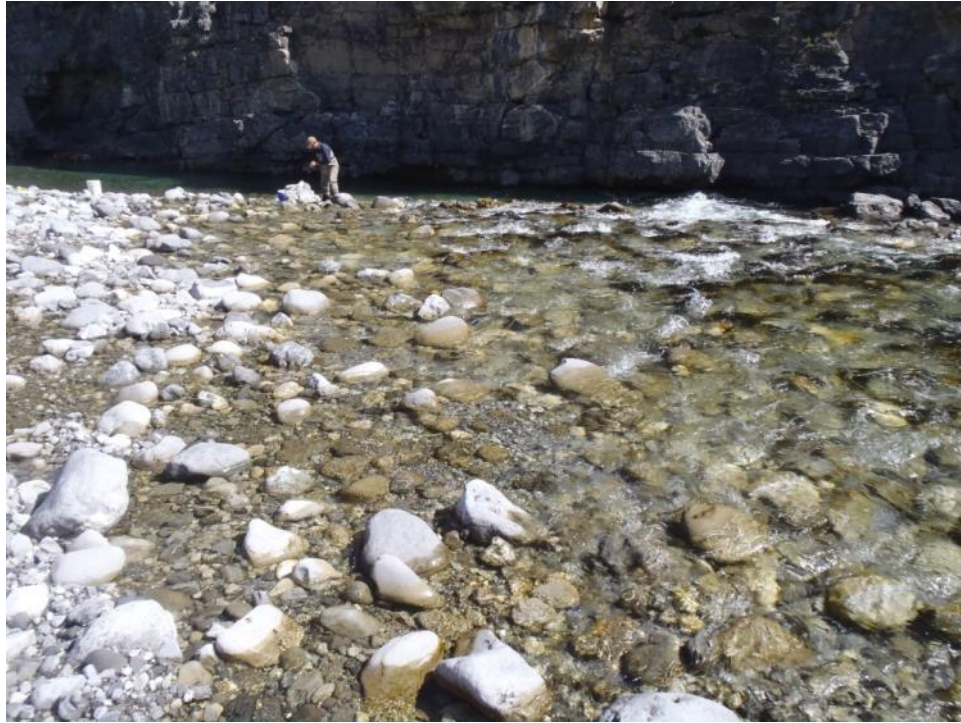
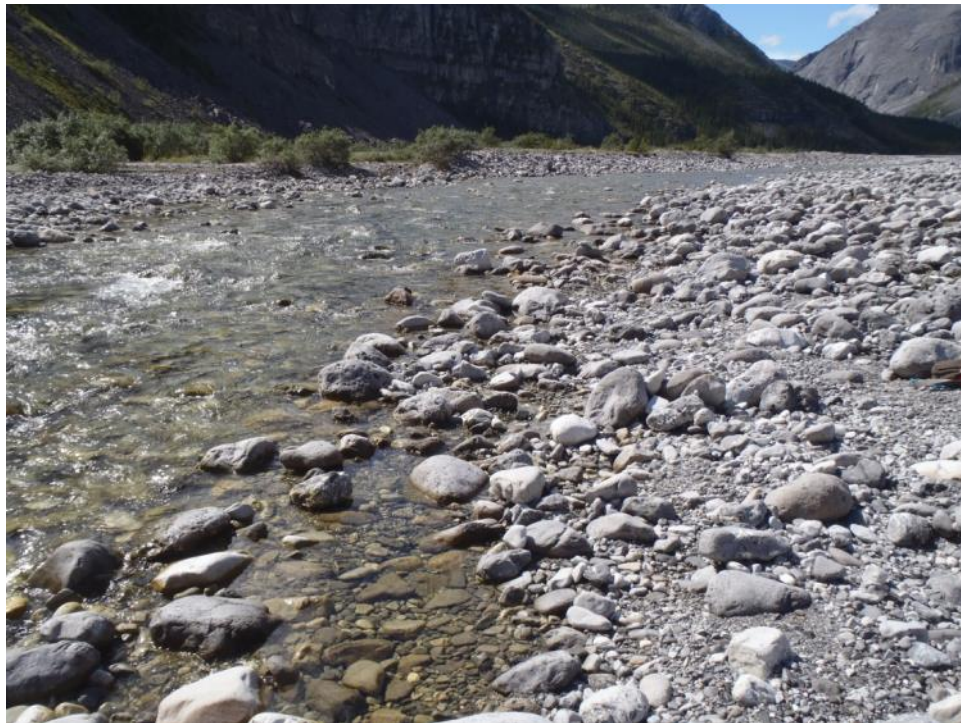
Photograph 32 Sundog Creek at Km 38.1, Prairie Creek all season road stream crossing study, July 27, 2014.

Photograph 33 Sundog Creek at Km 38.1, Prairie Creek all season road stream crossing study, July 27, 2014.

Photograph 34 Sundog Creek at Km 38.1, Prairie Creek all season road stream crossing study, July 27, 2014.

Photograph 35 Sundog Creek at Km 38.1, Prairie Creek all season road stream crossing study, July 27, 2014.

Photograph 36 Sundog Creek at Km 38.1, Prairie Creek all season road stream crossing study, July 27, 2014.

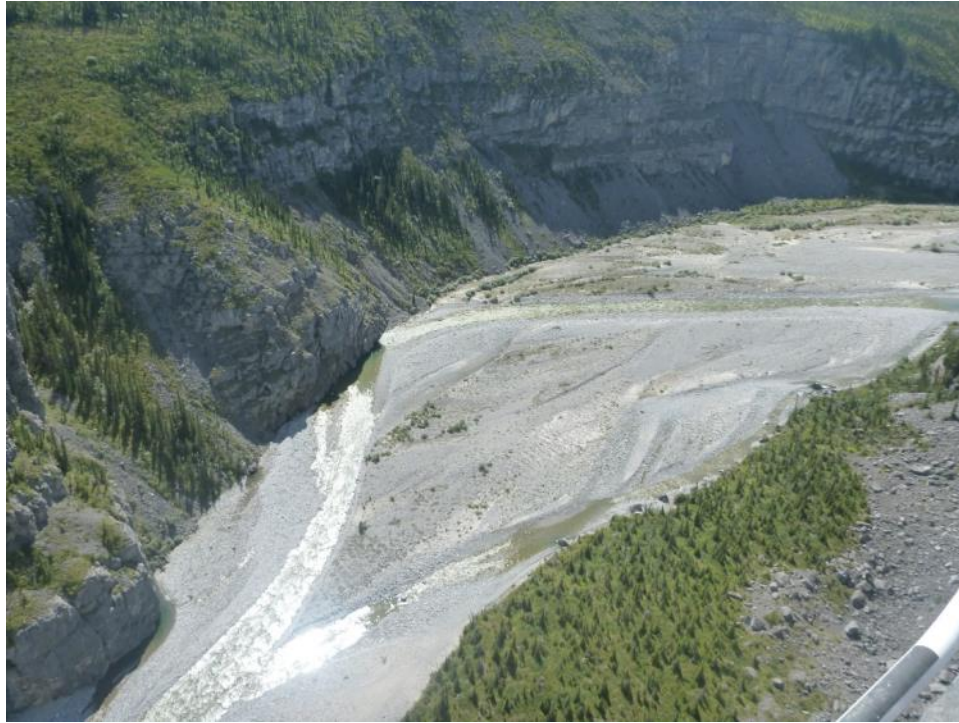
Photograph 37 Sundog Creek at KP38.2 facing southwest (upstream), Prairie Creek all season road stream crossing study, July 28, 2014.

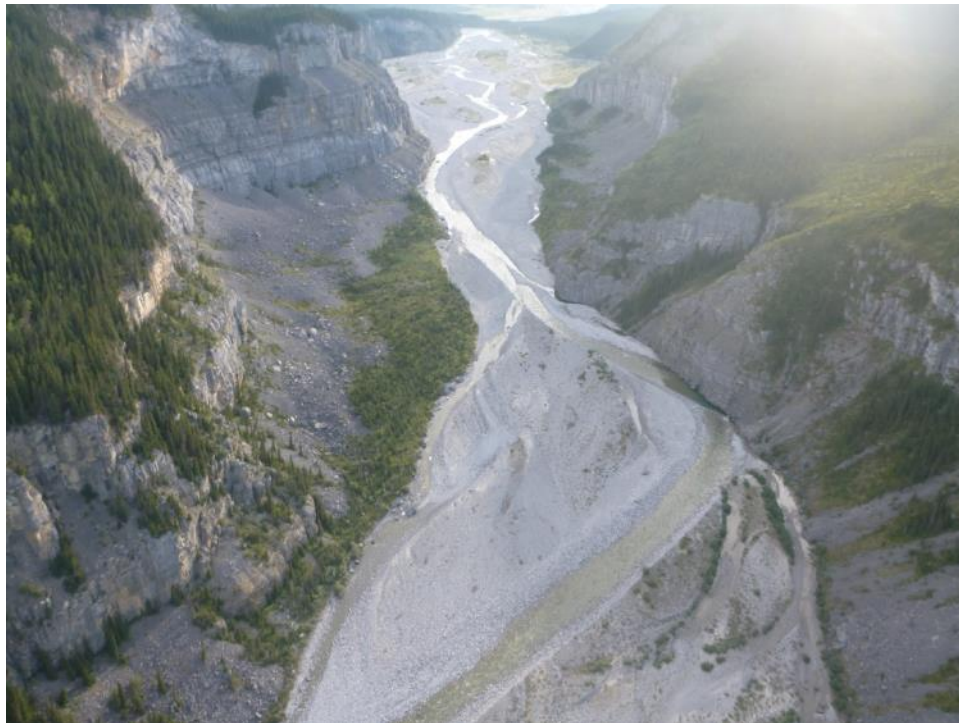
Photograph 38 Sundog Creek at KP38.2 facing northeast (downstream), Prairie Creek all season road stream crossing study, July 28, 2014.

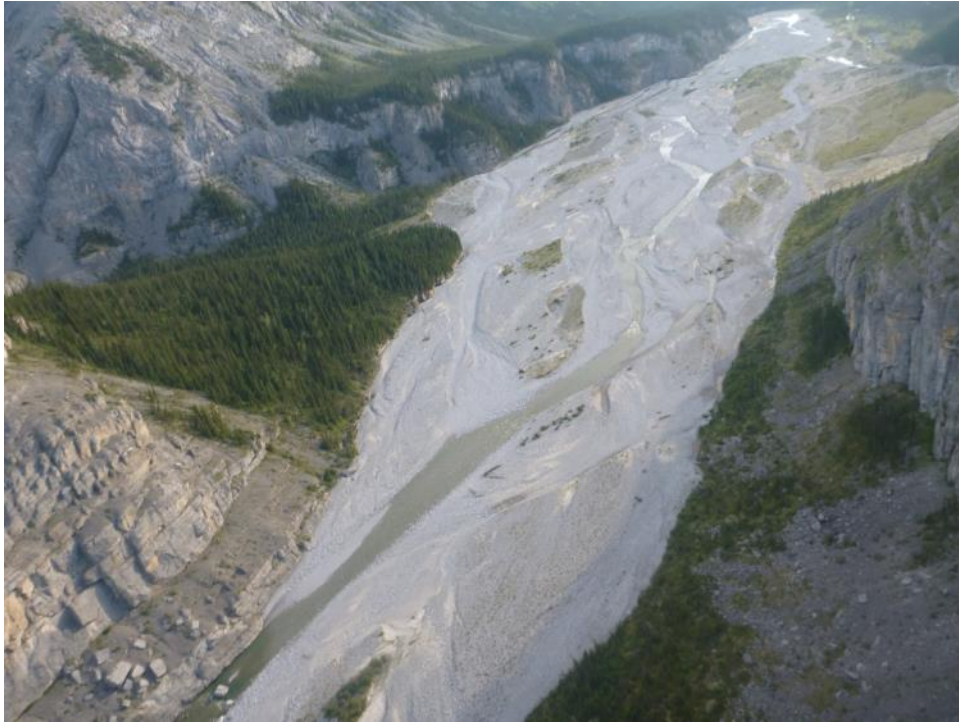
Photograph 39 Sundog Creek at KP38.8 facing northeast (downstream), Prairie Creek all season road stream crossing study, July 28, 2014.

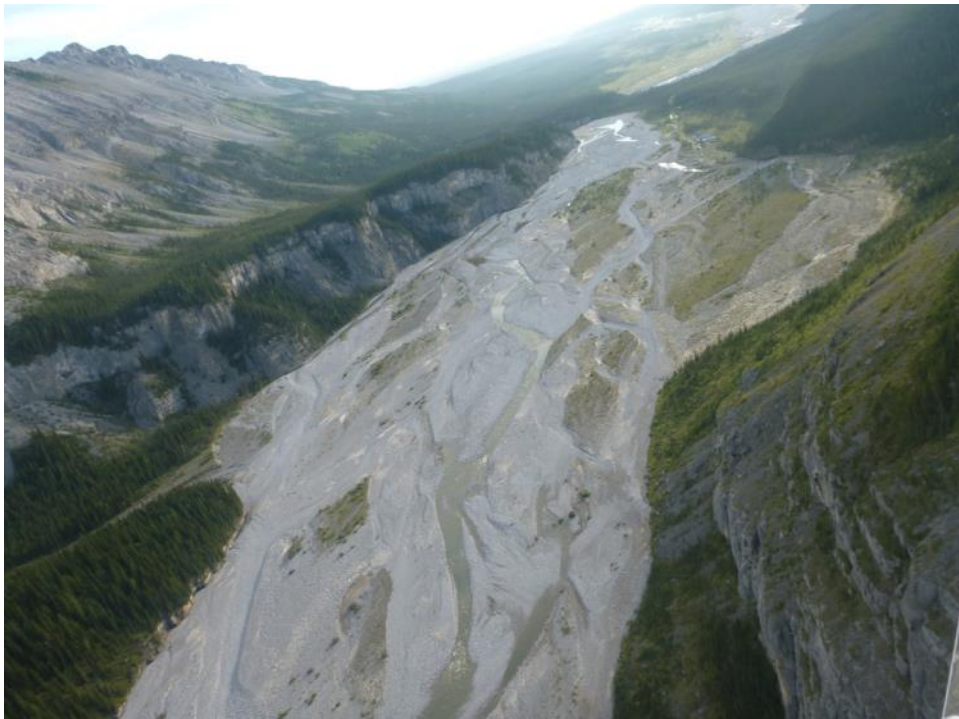
Photograph 40 Sundog Creek at KP39.3 facing northeast (downstream), Cat Camp shown in top quarter of photo, Prairie Creek all season road stream crossing study, July 28, 2014.

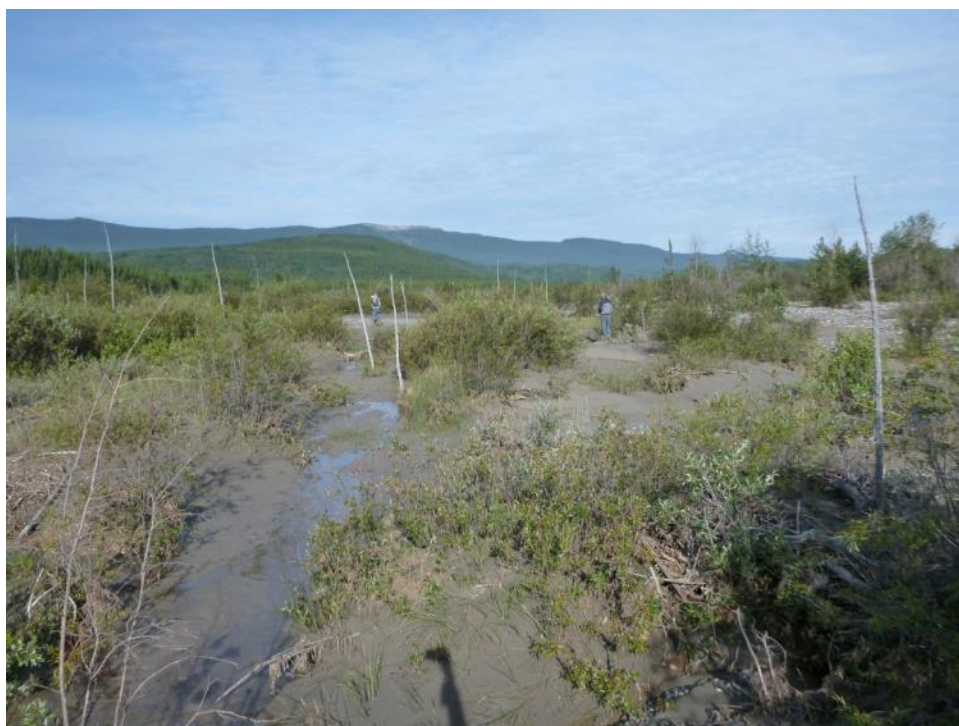
Photograph 126 Debris fan some flow to Granger River at Km 123.5, Prairie Creek all season road stream crossing study, July 29, 2014.

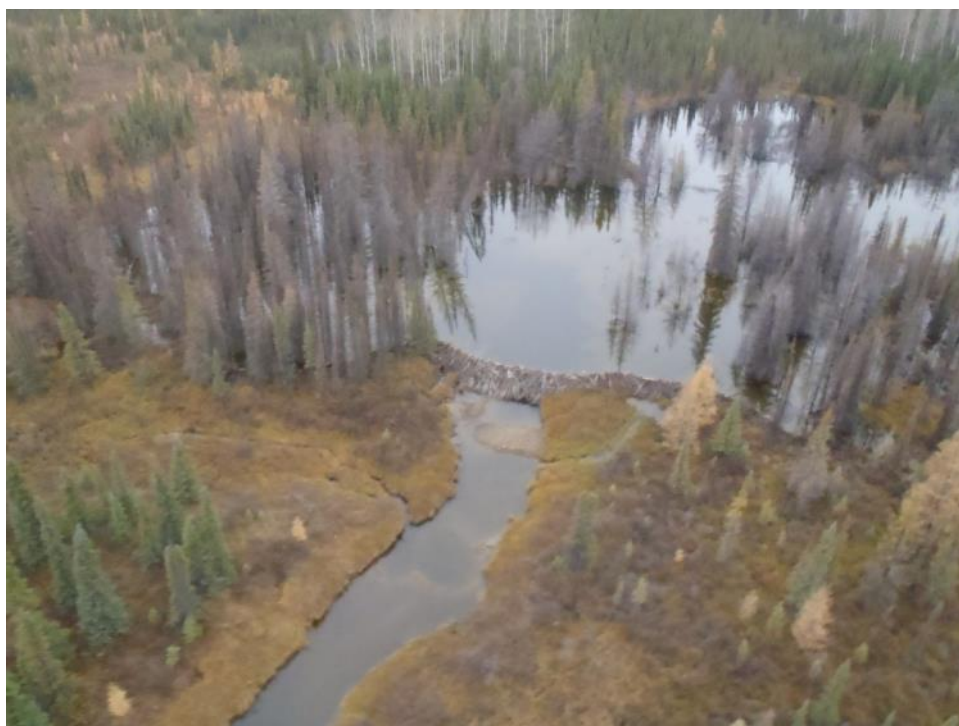
Photograph 161 Bluefish Creek (~7 km west of 146 km), Prairie Creek all season road stream crossing study, September 26, 2014.

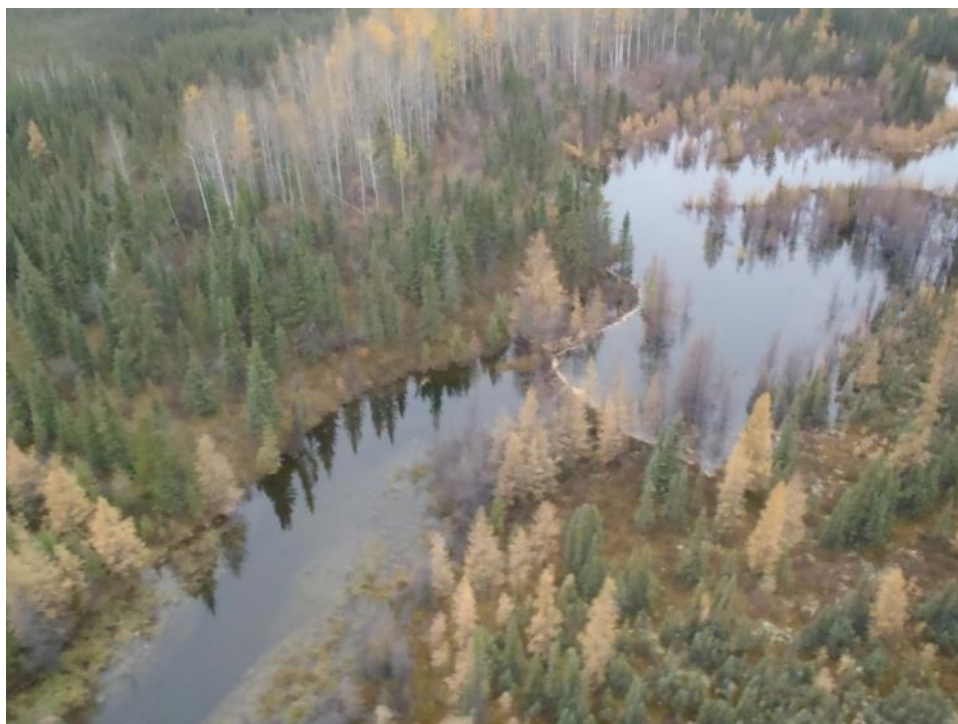
Photograph 162 Bluefish Creek (~7 km west of 146 km), Prairie Creek all season road stream crossing study, September 26, 2014.

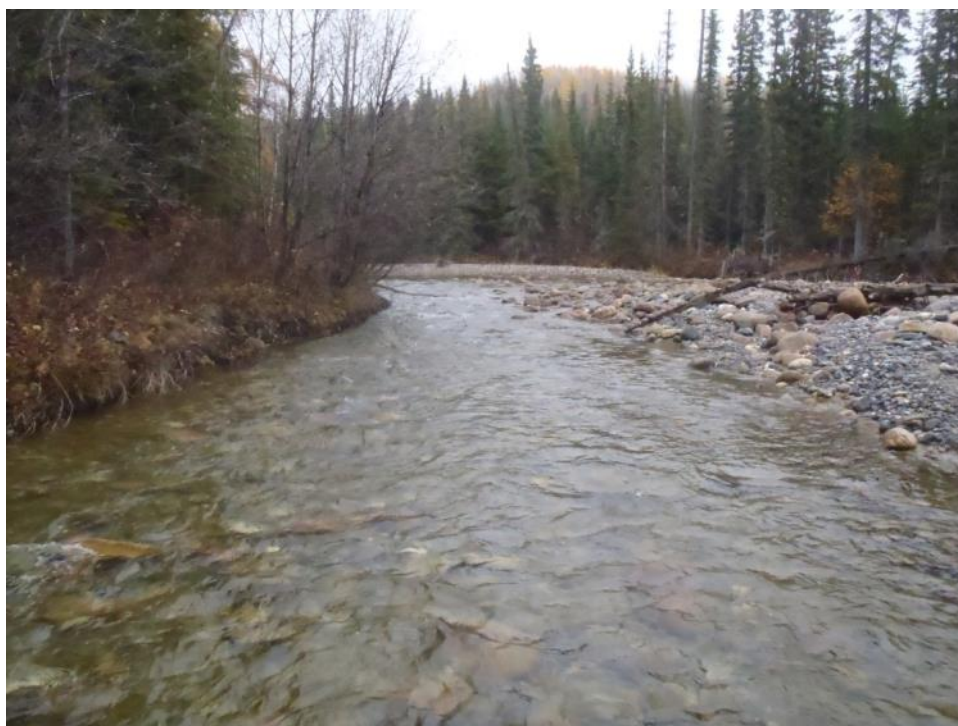
Photograph 163 Bluefish Creek (~7 km west of 146 km), Prairie Creek all season road stream crossing study, September 26, 2014.

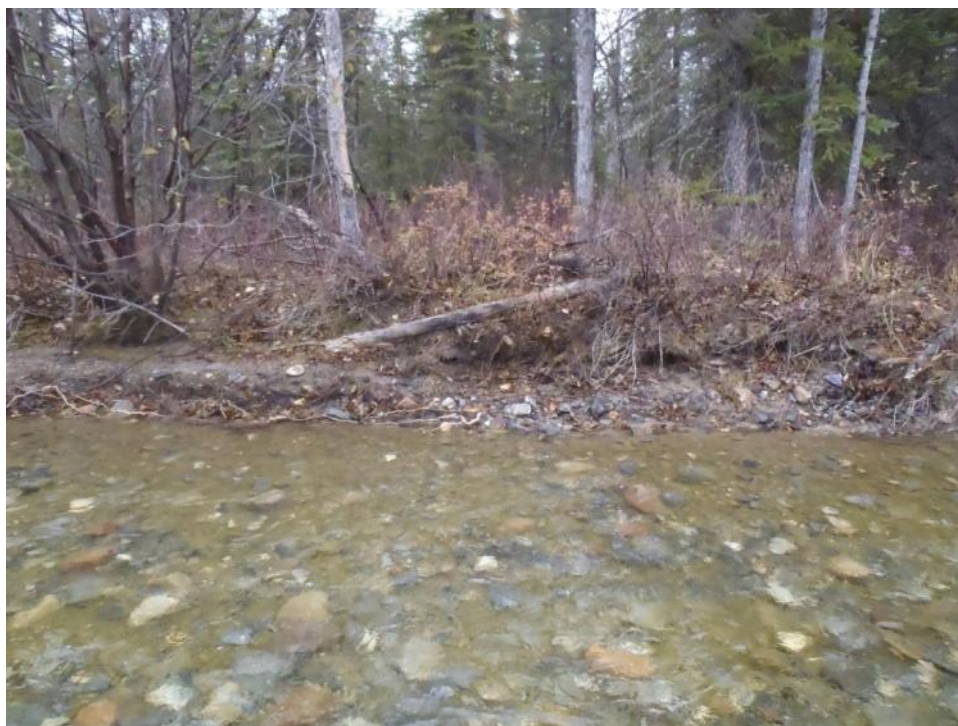
Photograph 164 Bluefish Creek (~7 km west of 146 km), Prairie Creek all season road stream crossing study, September 26, 2014.

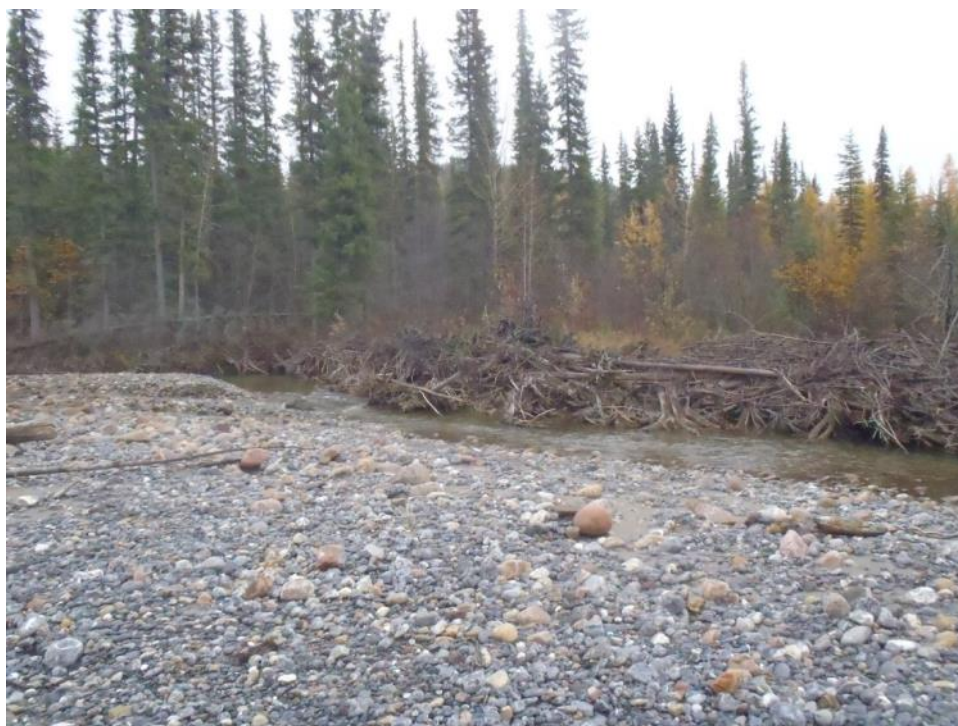
Photograph 165 Bluefish Creek (~7 km west of 146 km), Prairie Creek all season road stream crossing study, September 26, 2014.

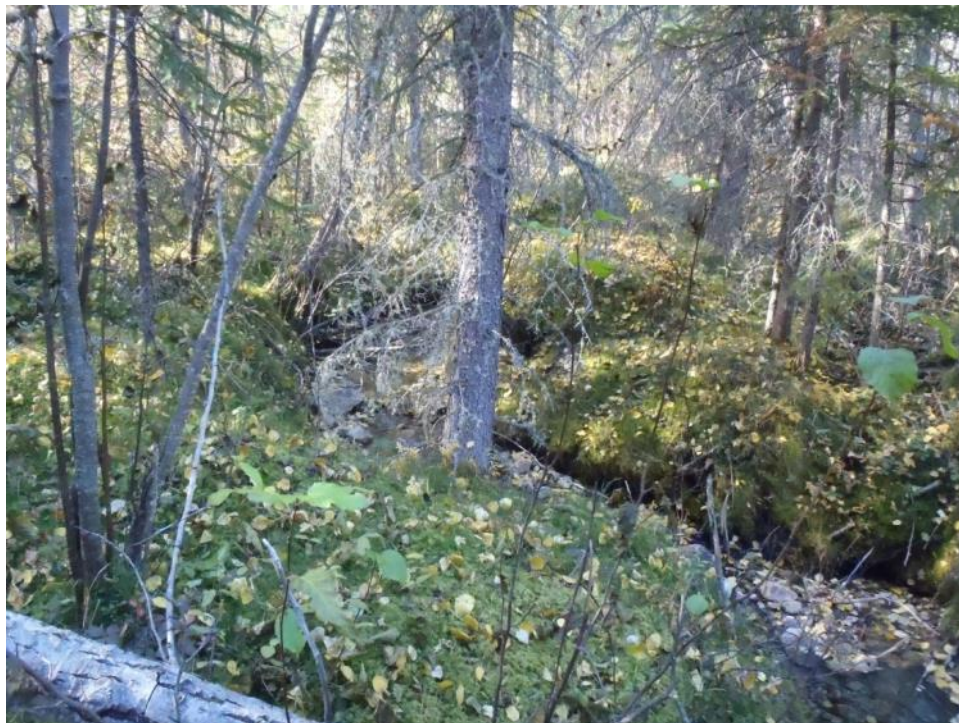
Photograph 166 Tributary to Liard River (Km 154.4), Prairie Creek all season road stream crossing study, September 23, 2014.

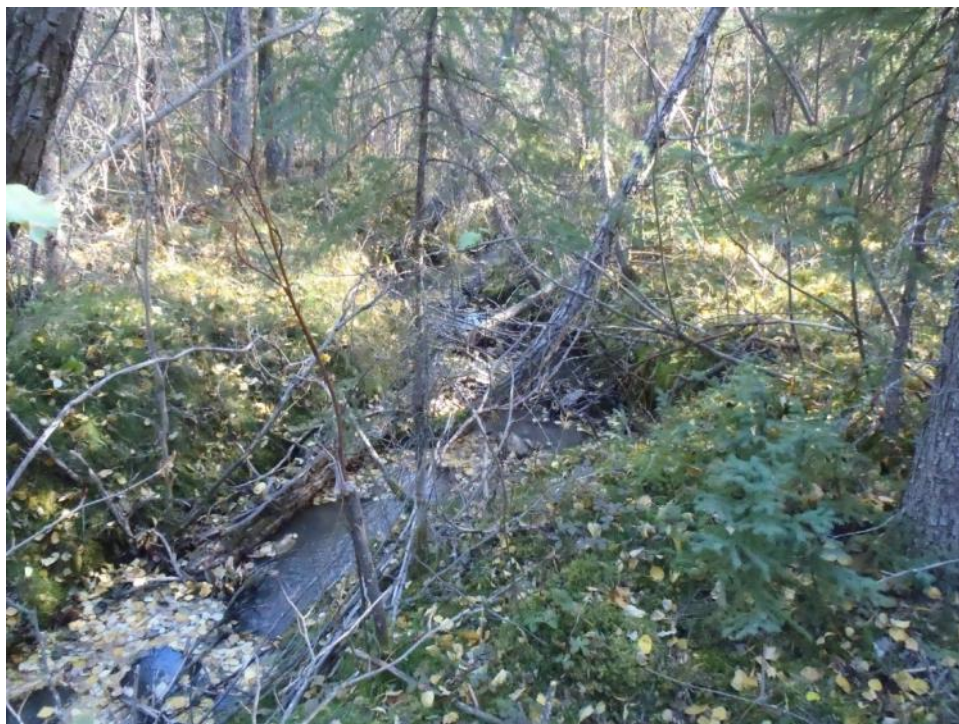
Photograph 167 Tributary to Liard River (Km 154.4), Prairie Creek all season road stream crossing study, September 23, 2014.

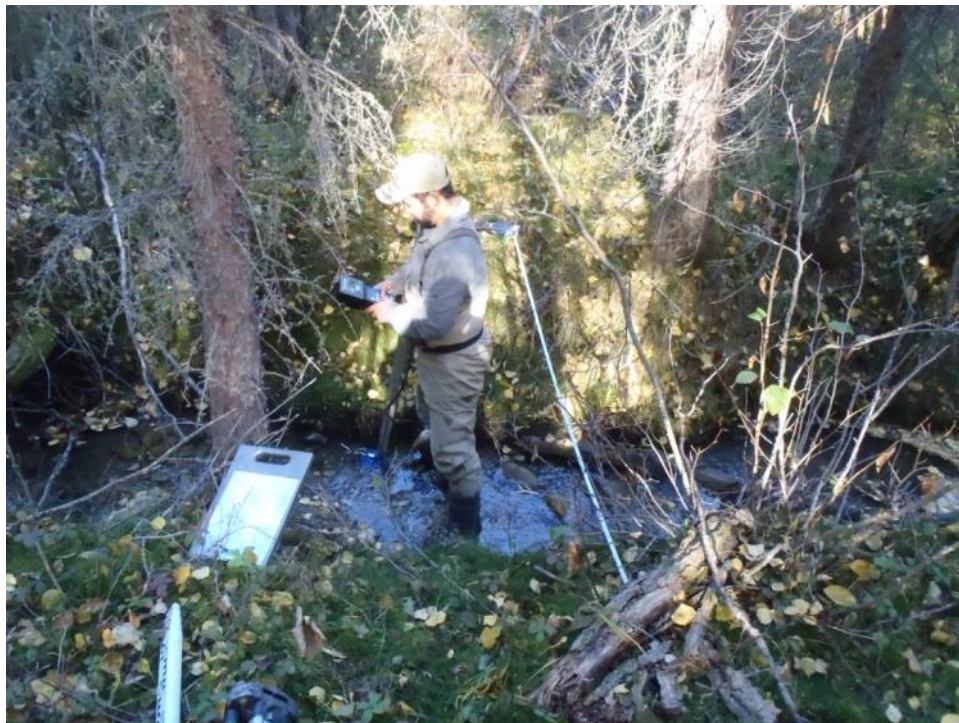
Photograph 168 Tributary to Liard River (Km 154.4), Prairie Creek all season road stream crossing study, September 23, 2014.
