GAHCHO KUÉ PROJECT

2011 Shoreline and Channel Erosion Assessment

Submitted to:
De Beers Canada Inc.

Report Number: 11-1365-0001/DCN-048

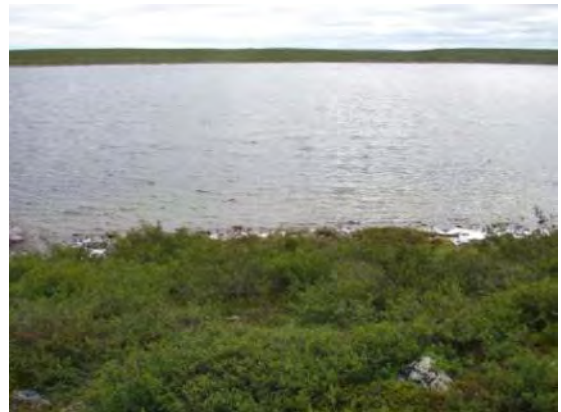
Figure 2: Lake A3 West Shoreline looking East

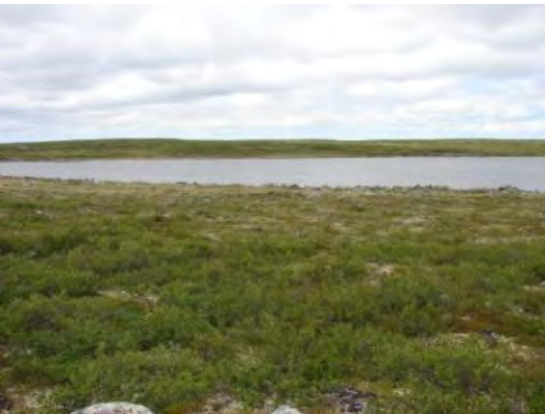
Figure 3: Lake A3 South East Shoreline looking West

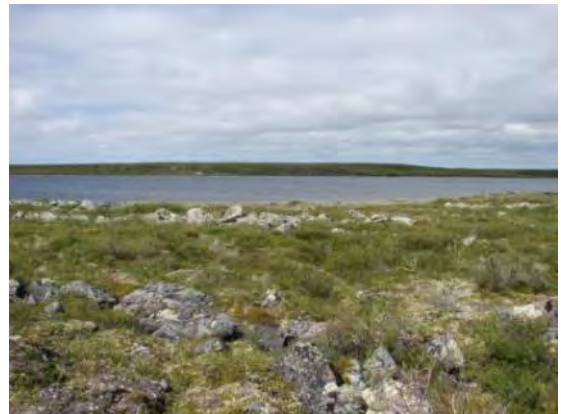
Figure 4: Lake A3 East Shoreline looking West

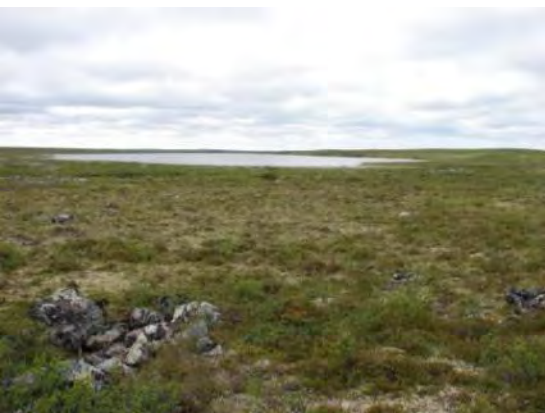
Figure 5: Lake A3 North Shoreline looking South

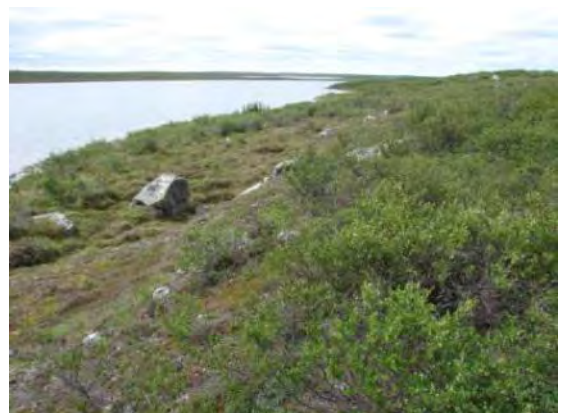
Figure 6: Lake A3 West Shoreline looking South

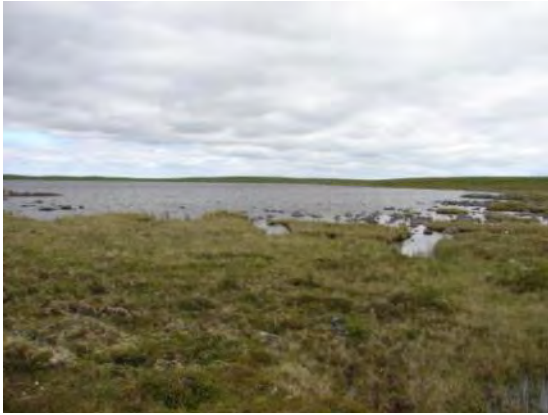
Figure 7: Lake A3 South Shoreline looking Northeast

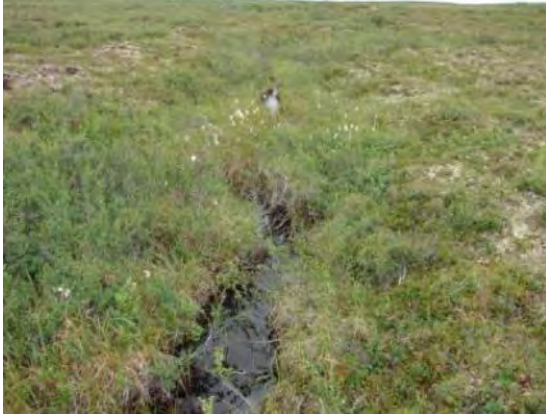
Figure 8: Outlet Channel A3 looking Upstream

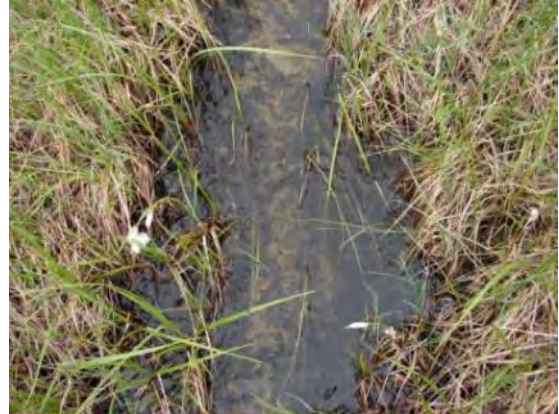
Figure 9: Outlet Channel A3 Detail

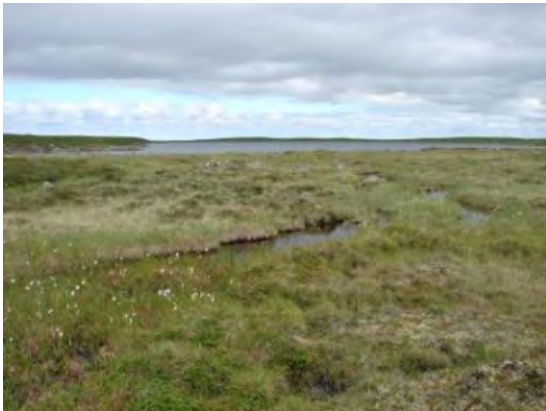
Figure 10: Outlet Channel A3 looking Upstream

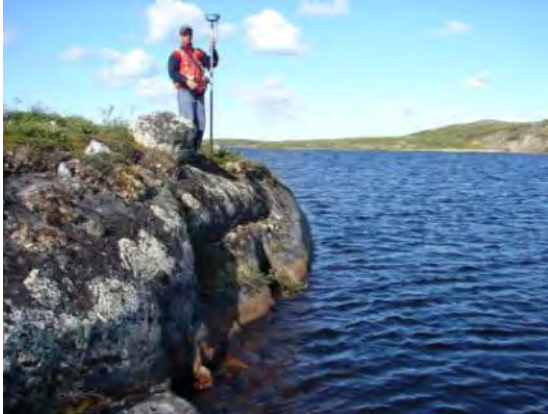
Figure 11: Lake B1 Northeast Shoreline looking Southwest

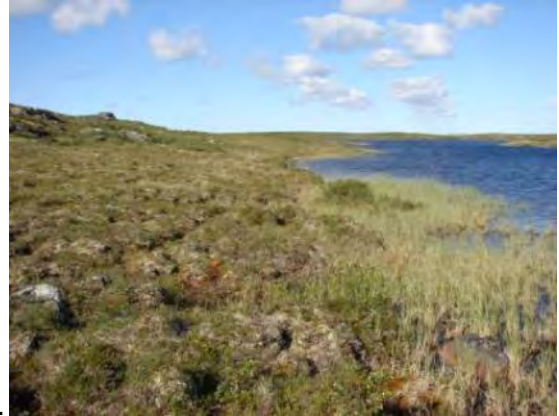
Figure 12: Lake B1 East Shoreline looking Southwest

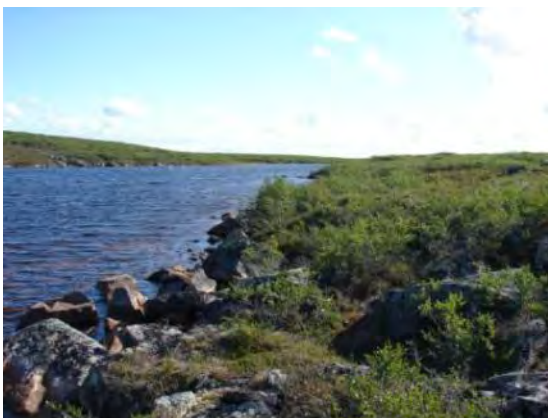
Figure 13: Lake B1 East Shoreline looking Northeast

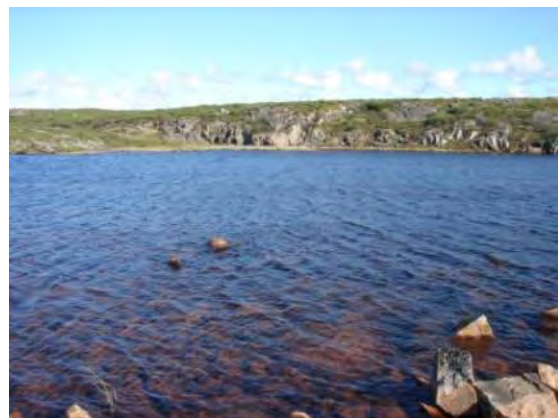
Figure 14: Lake B1 East Shoreline looking North

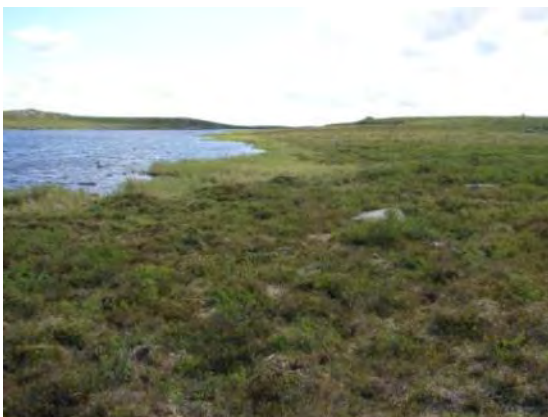
Figure 15: Lake B1 Southeast Shoreline looking Northeast

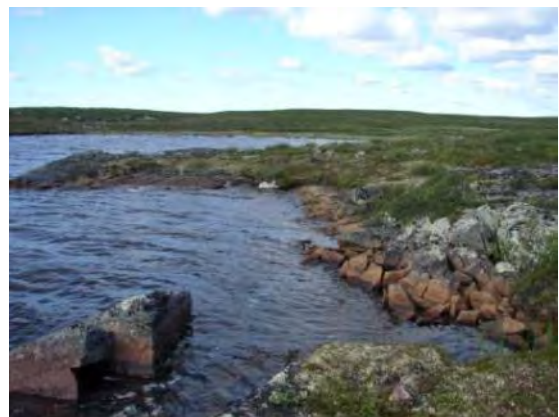
Figure 16: Lake B1 Southwest Shoreline looking South

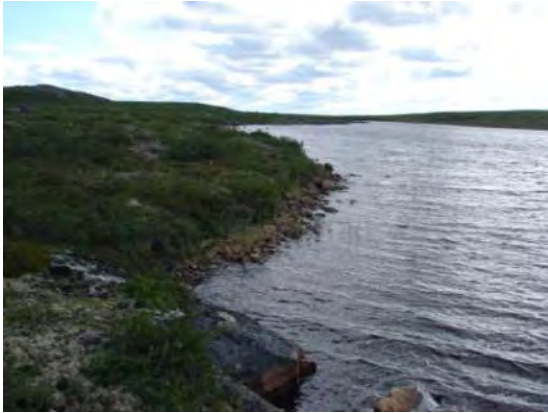
Figure 17: Lake B1 West Shoreline looking North

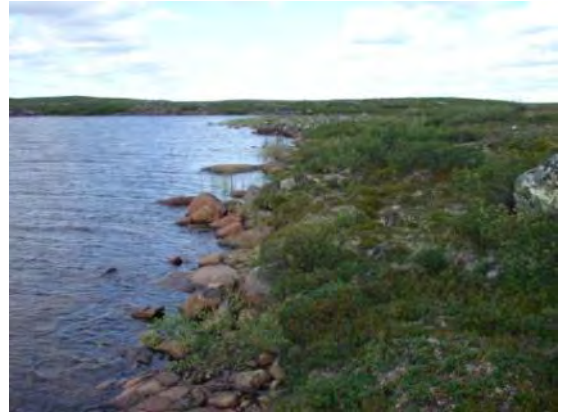
Figure 18: Lake B1 West Shoreline looking South.

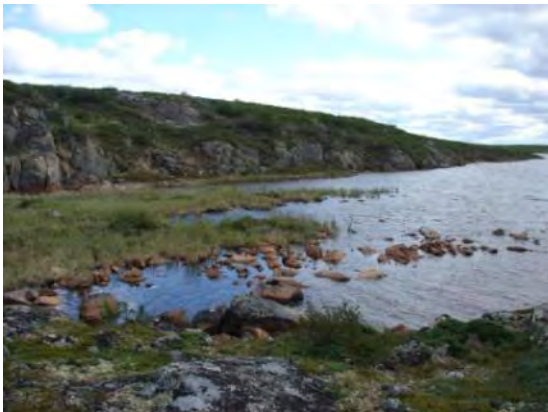
Figure 19: Lake B1 Northwest Shoreline looking Northeast

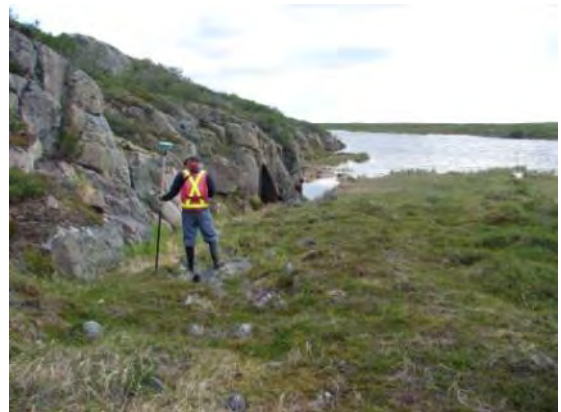
Figure 20: Lake B1 Northwest Shoreline looking East

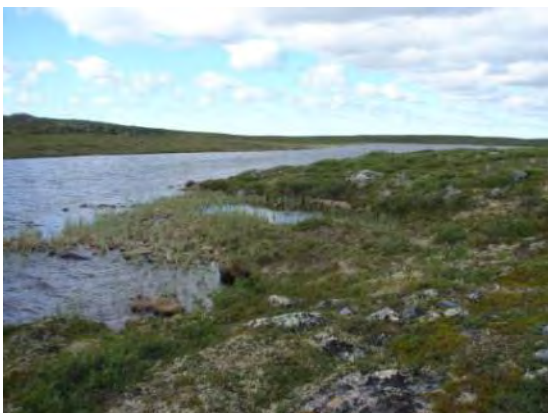
Figure 21: Lake B1 Northwest Shoreline looking South

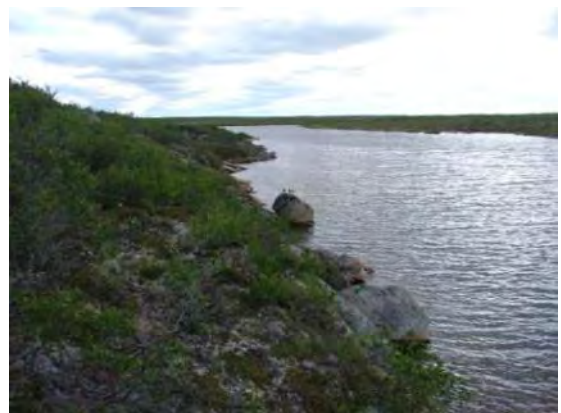
Figure 22: Lake B1 Northwest Shoreline looking East

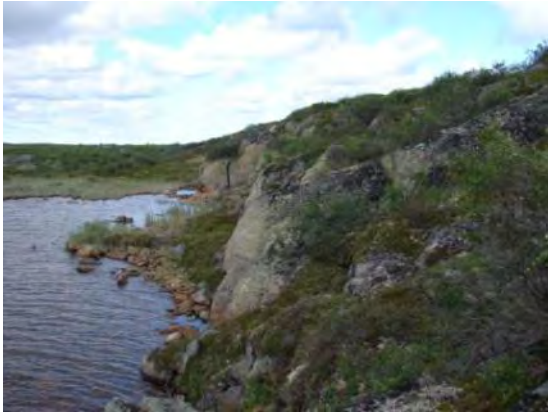
Figure 23: Lake B1 Northwest Shoreline looking West

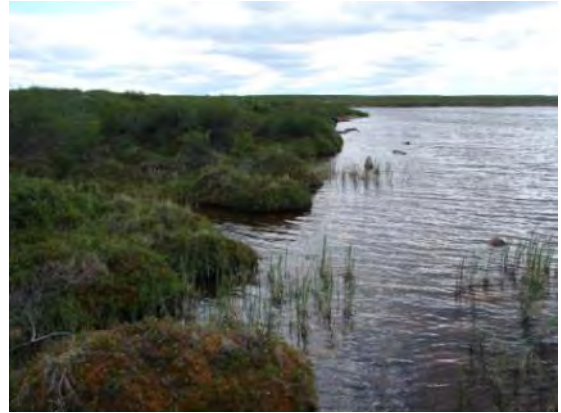
Figure 24: Lake B1 North Shoreline looking East

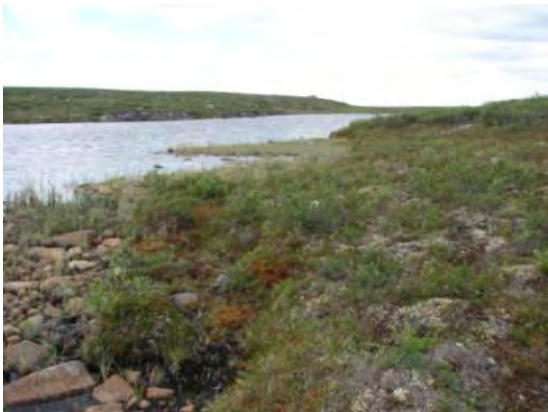
Figure 25: Lake B1 North Shoreline looking West

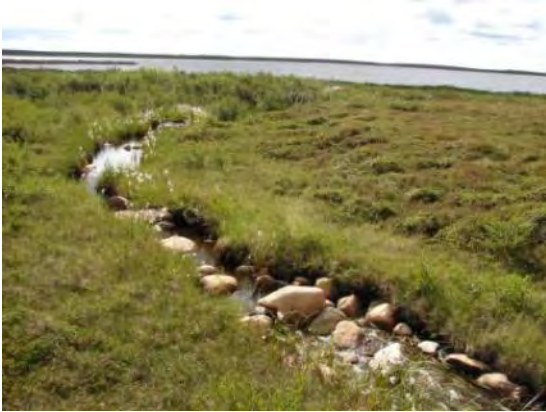
Figure 26: Outlet Channel B1 looking Downstream

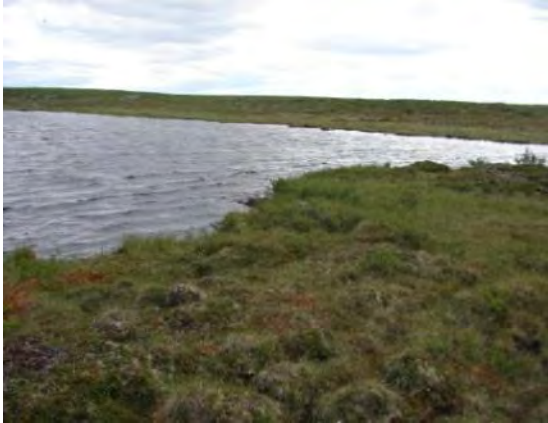
Figure 27: Lake N8 West Shoreline looking South

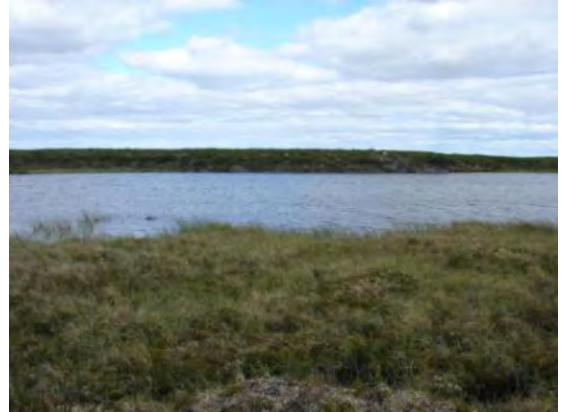
Figure 28: Lake N8 East Shoreline looking West

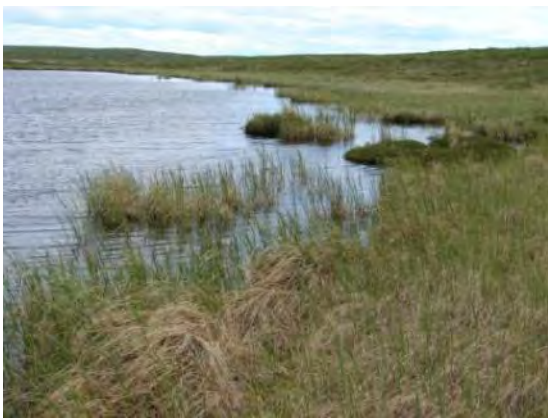
Figure 29: Lake N8 East Shoreline looking North

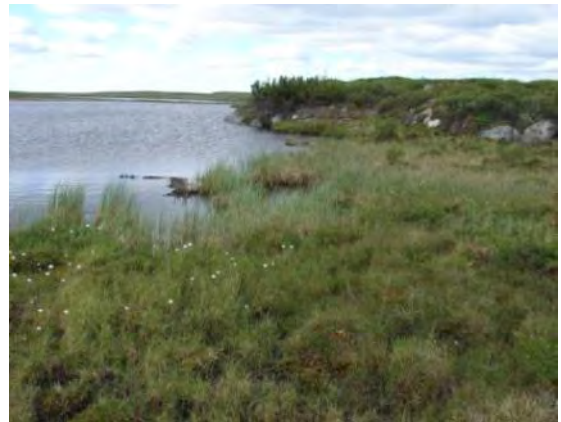
Figure 30: Lake N8 North Shoreline looking West

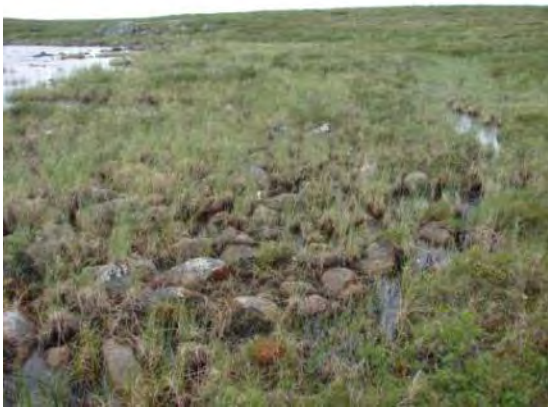
Figure 31: N8 Outlet Channel on downstream half

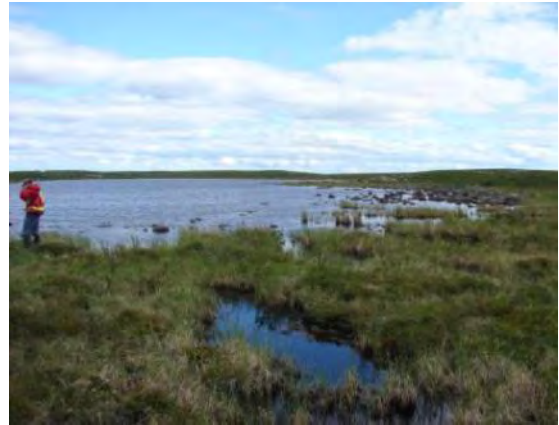
Figure 32: N8 Outlet Channel at Lake N6 inlet

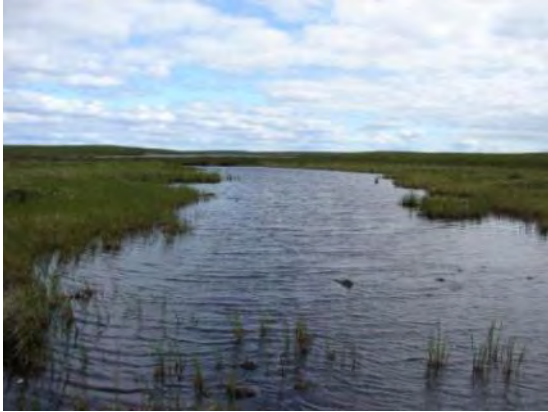
Figure 33: N6 Outlet Channel downstream view from left downstream bank (LDB)

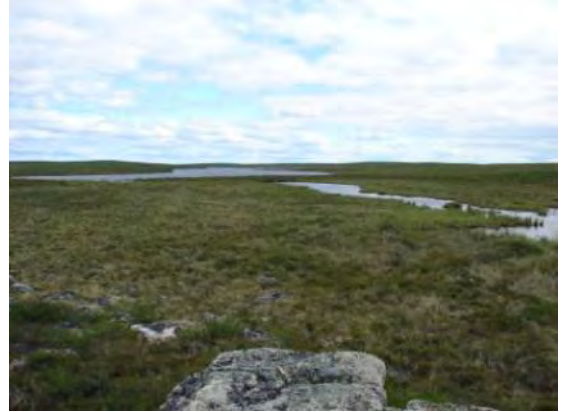
Figure 34: N6 Outlet Channel downstream panorama view from LDB

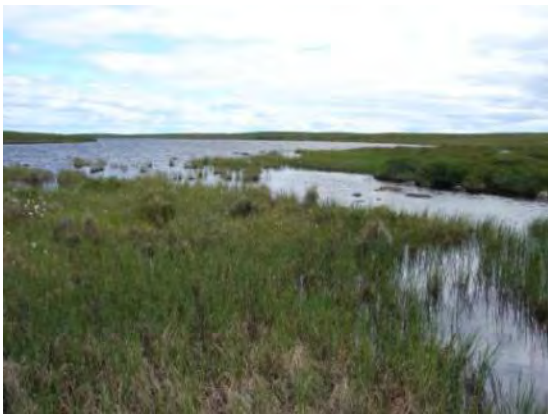
Figure 35: N6 Outlet Channel downstream view from LDB

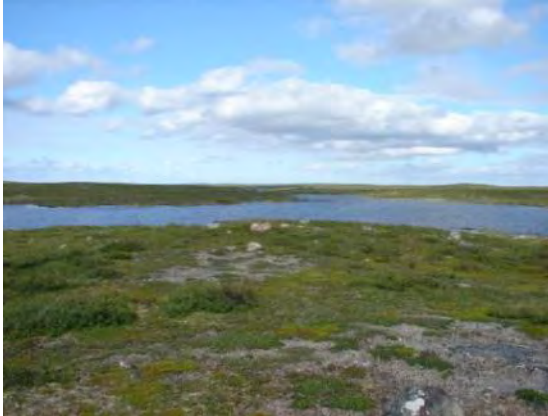
Figure 36: Lake L2 South Shoreline looking Northeast

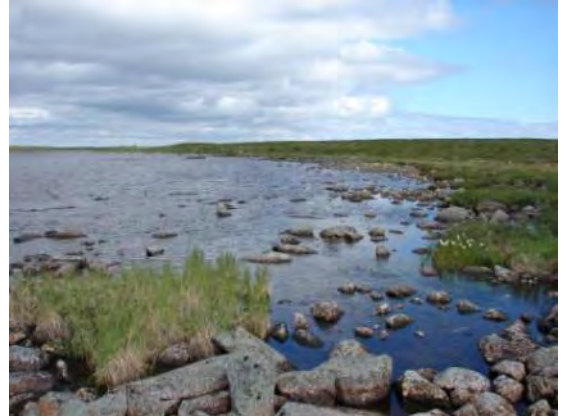
Figure 37: Lake L2 South Shoreline looking Northeast

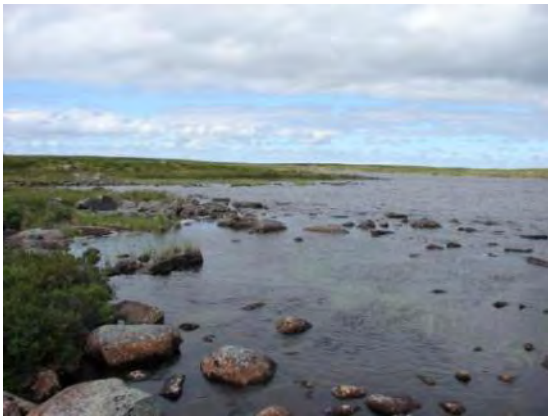
Figure 38: Lake L2 South Shoreline looking Northwest

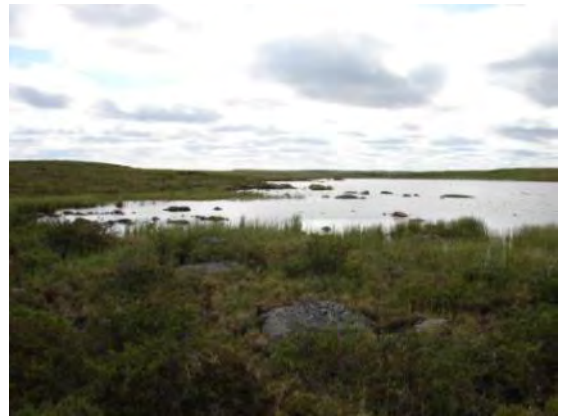
Figure 39: Lake L2 West Shoreline looking Southeast

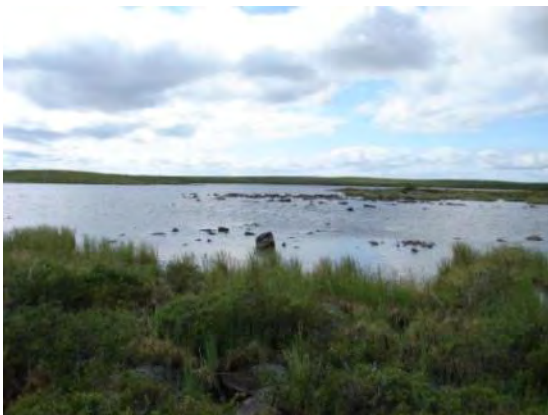
Figure 40: Lake L2 West Shoreline looking Northeast

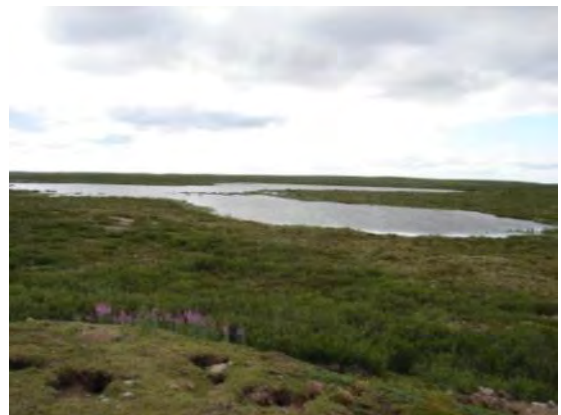
Figure 41: Lake L2 Southeast Shoreline looking West

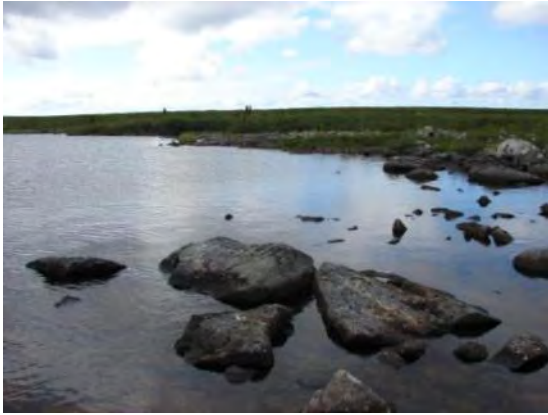
Figure 42: Lake L2 North Shoreline looking Southwest

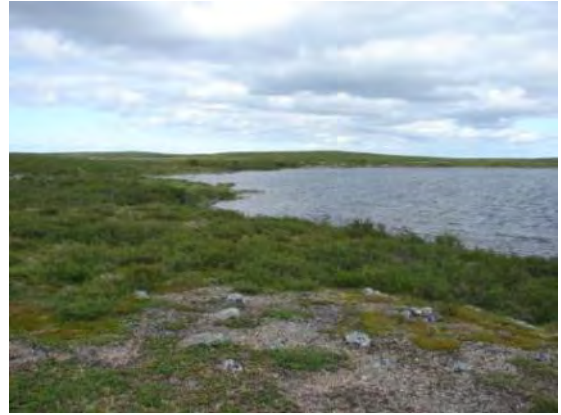
Figure 43: Lake L2 West Shoreline looking North

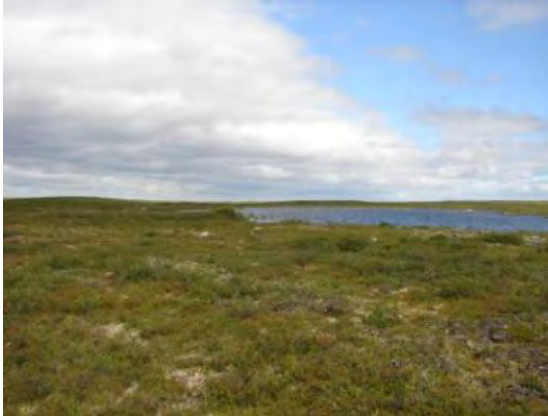
Figure 44: Lake L3 West Shoreline looking Northeast

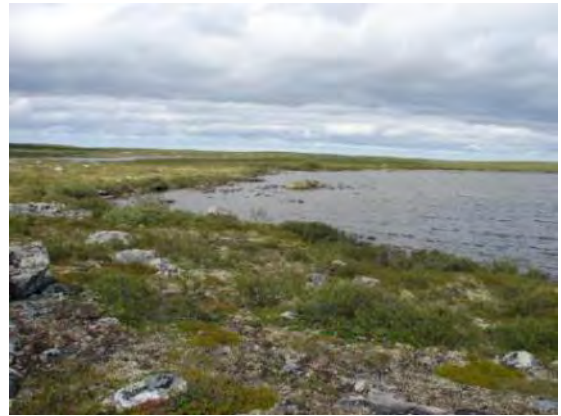
Figure 45: Lake L3 Southwest Shoreline looking North

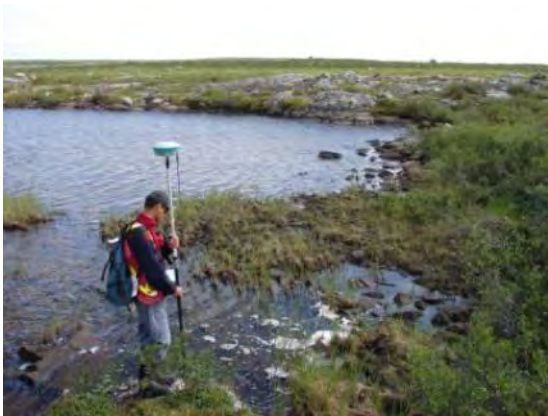
Figure 46: Lake L3 Southwest Shoreline looking South

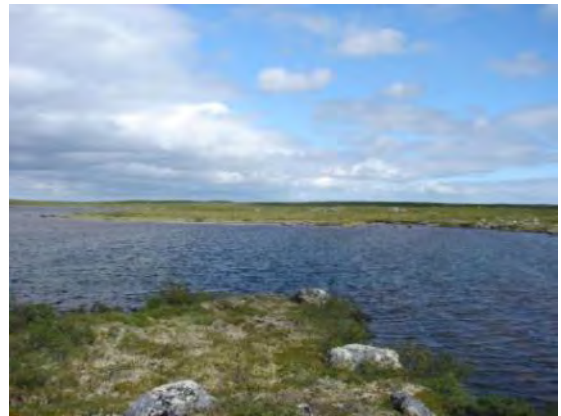
Figure 47: Lake L3 Southwest Shoreline looking Northeast

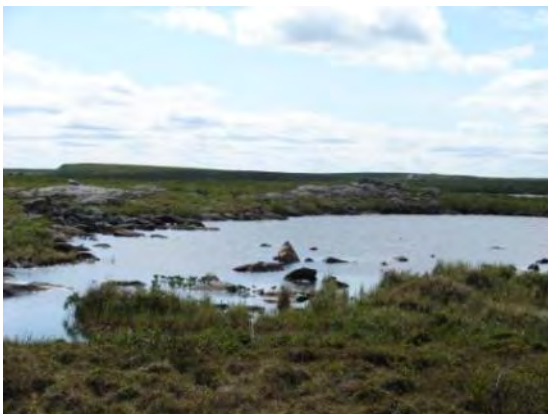
Figure 48: Lake L3 East Shoreline looking West

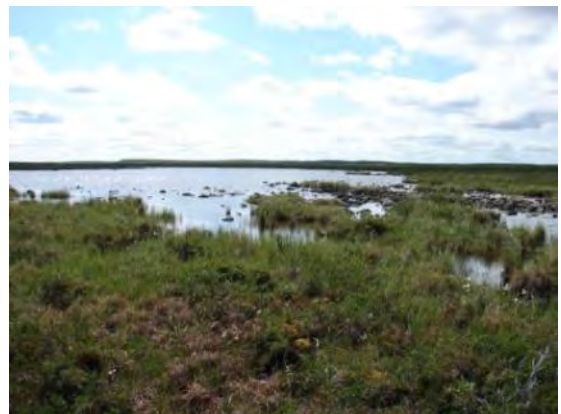
Figure 49: Lake L3 North Shoreline and Outlet looking South

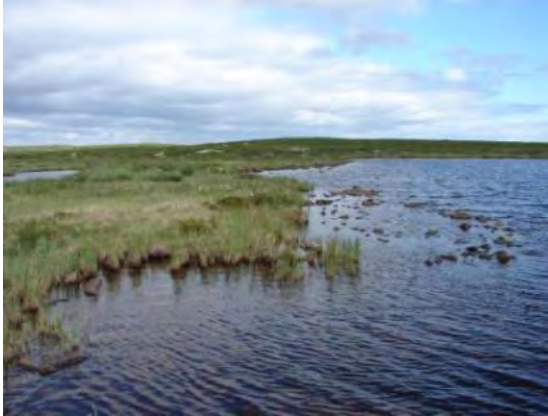
Figure 51: Lake L13 West Shoreline looking North

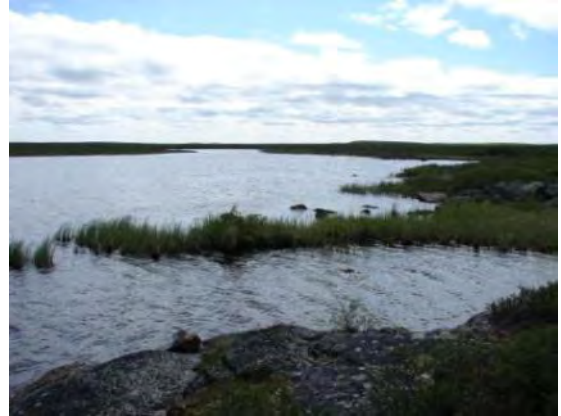
Figure 52: Lake L13 West Shoreline looking South

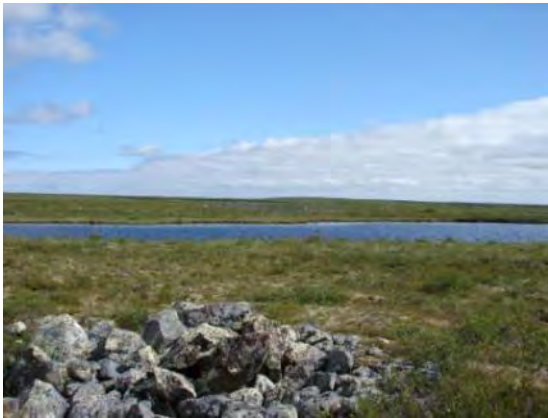
Figure 53: Lake L13 West Shoreline looking East

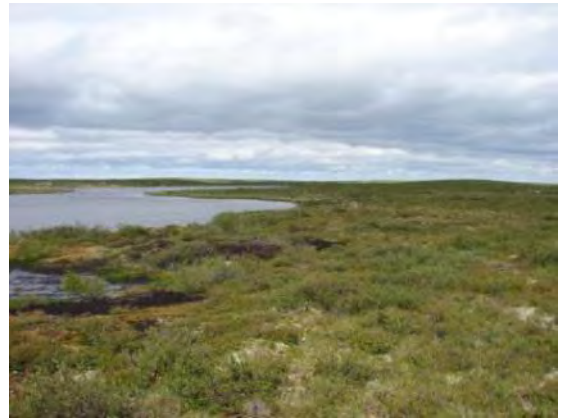
Figure 54: Lake L13 East Shoreline looking North

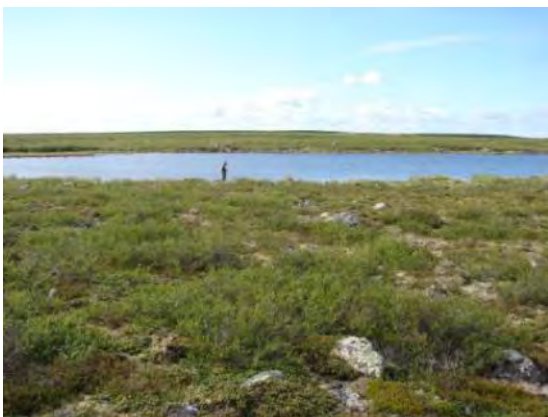
Figure 55: Lake L13 West Shoreline looking East

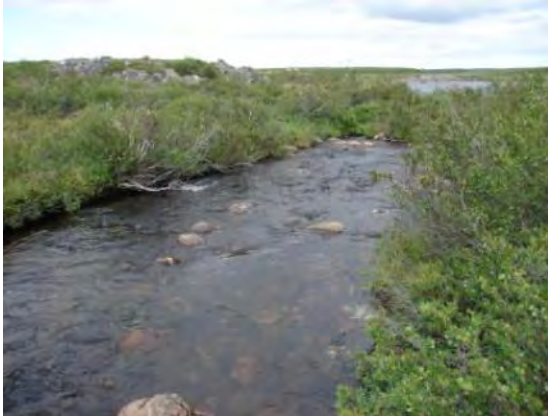
Figure 56: L2 Outlet Channel looking Downstream

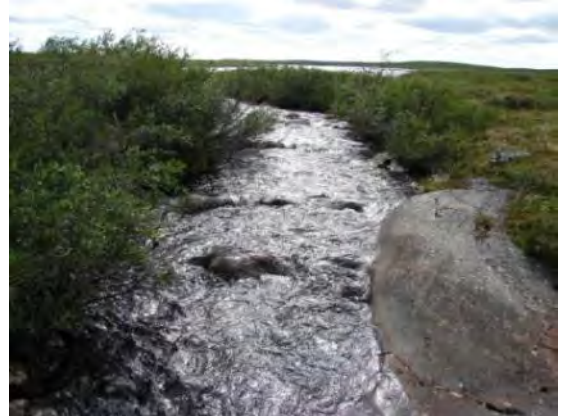
Figure 57: L2 Outlet Channel looking Upstream

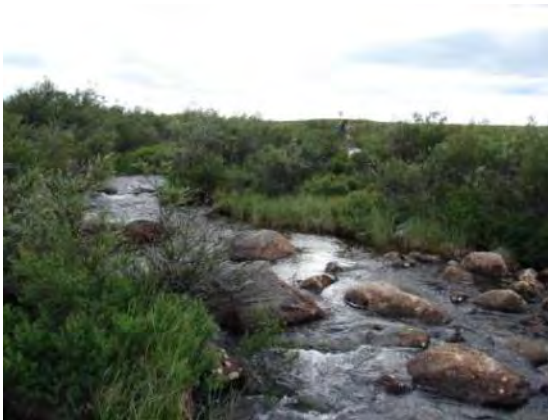
Figure 58: L2 Outlet Channel looking Upstream

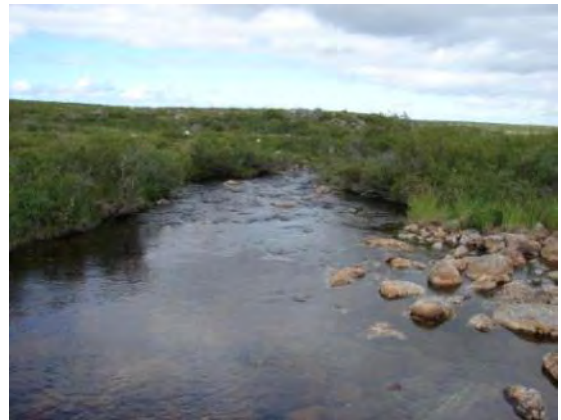
Figure 59: L2 Outlet Channel looking Downstream

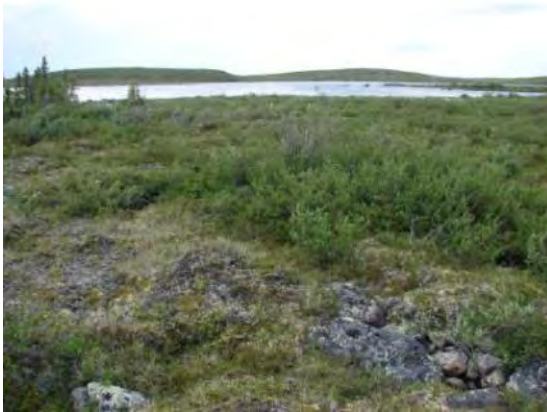
Figure 60: Lake E1 East Shoreline looking West

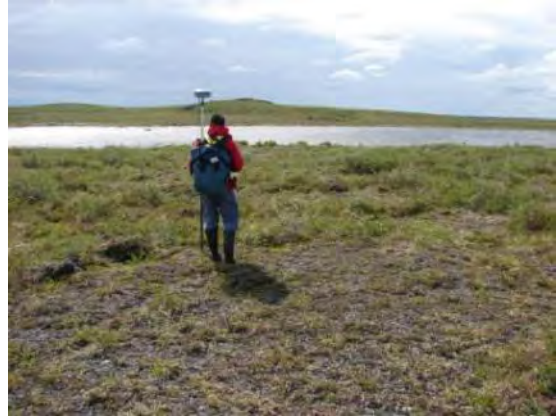
Figure 61: Lake E1 Southeast Shoreline looking Southwest

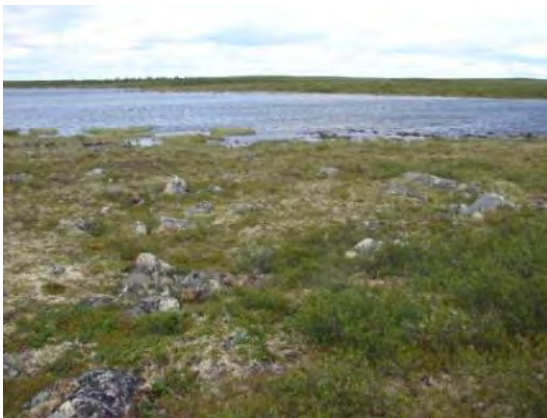
Figure 62: Lake E1 Southwest Shoreline looking Northwest

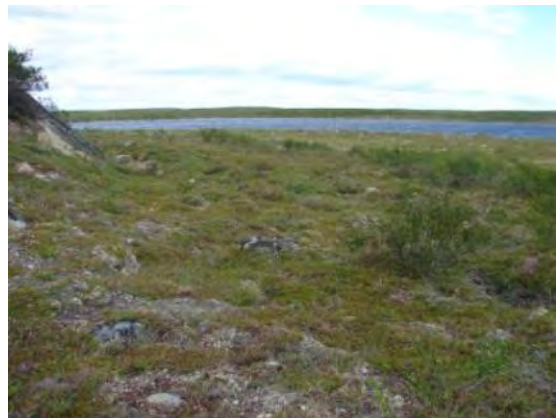
Figure 63: Lake E1 West Shoreline looking East

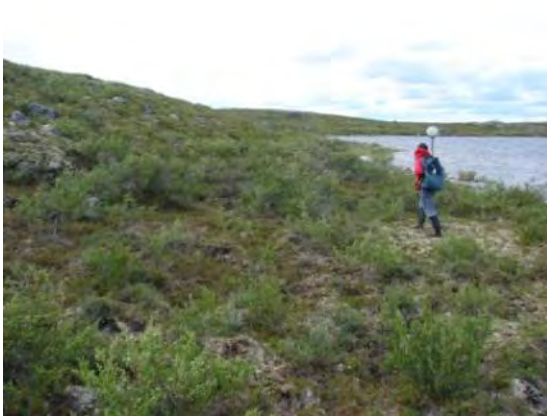
Figure 64: Lake E1 West Shoreline looking North

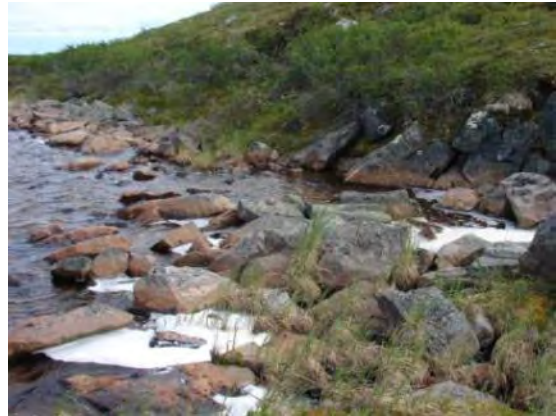
Figure 65: Lake E1 Southwest Shoreline looking Southeast

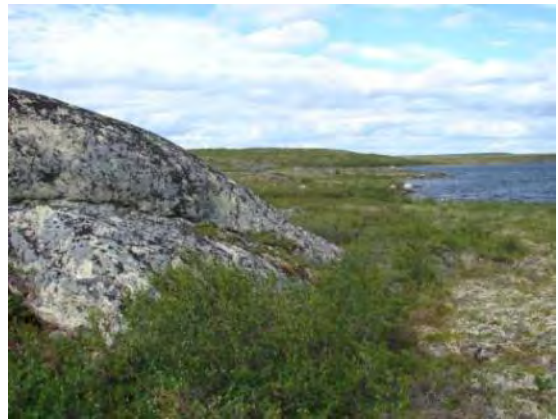
Figure 67: Lake E1 West Shoreline looking North

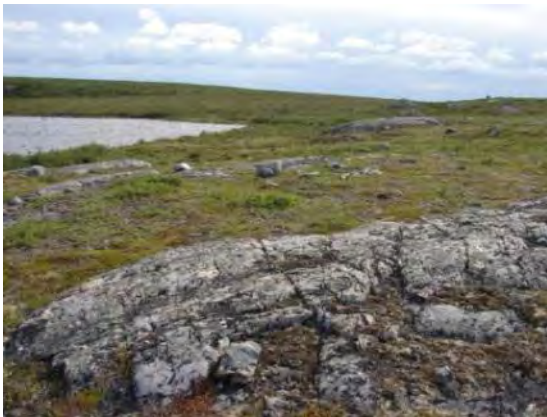
Figure 68: Lake E1 West Shoreline looking South

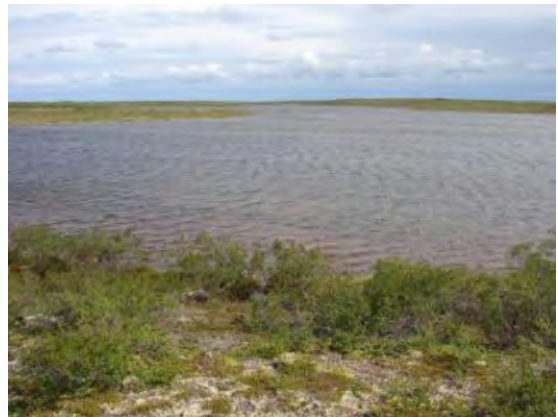
Figure 69: Lake E1 North Shoreline looking South

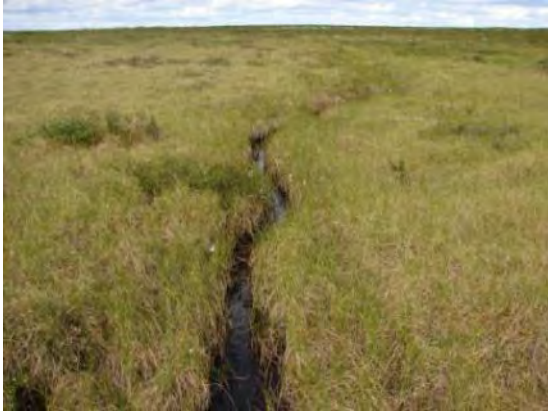
Figure 70: E1 Outlet Channel looking Downstream

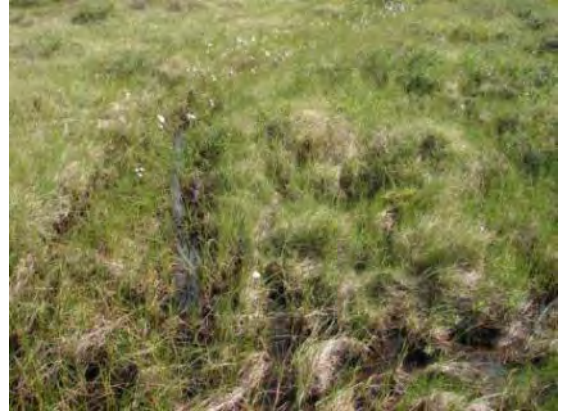
Figure 71: E1 Outlet Channel Detail

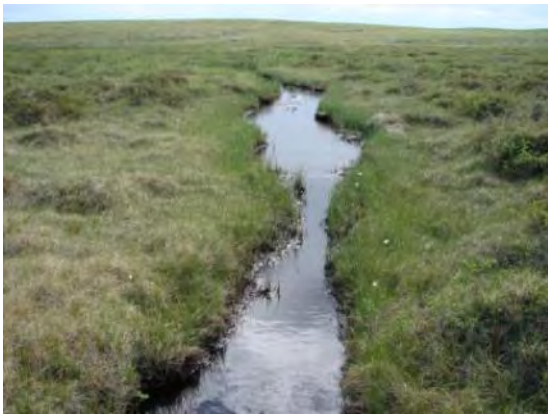
Figure 72: E1 Outlet Channel looking Downstream

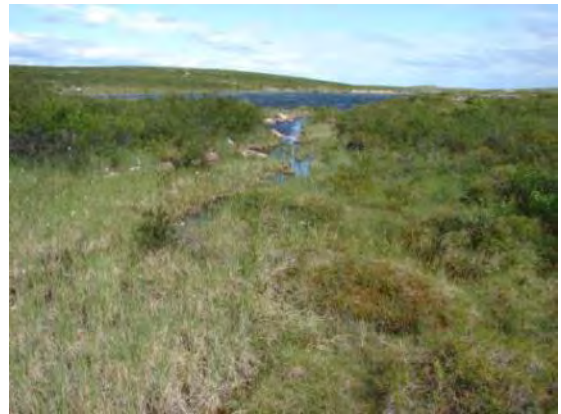
Figure 73: E1 Outlet Channel looking downstream at Kennady Lake Inlet

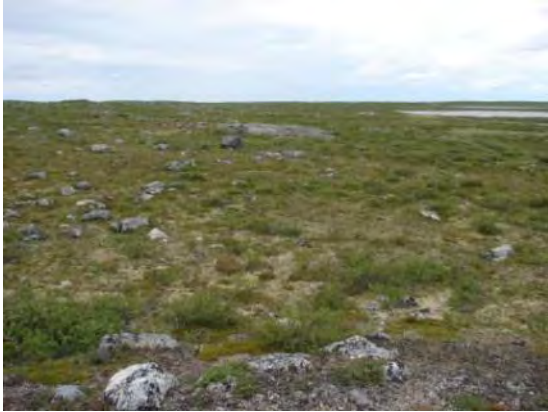
Figure 74: Lake D2 East Shoreline looking Southwest

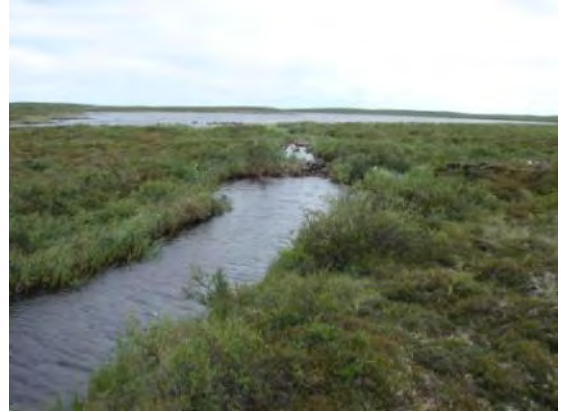
Figure 75: Lake D2 East Shoreline and Outlet looking West

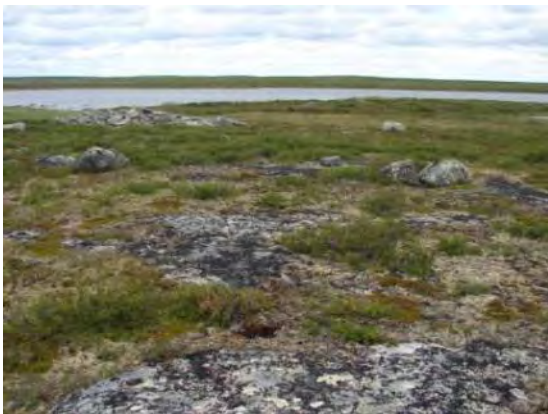
Figure 76: Lake D2 South Shoreline looking North

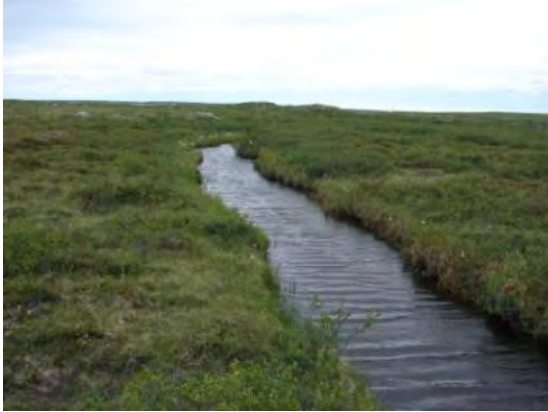
Figure 77: D2 Outlet Channel looking Downstream

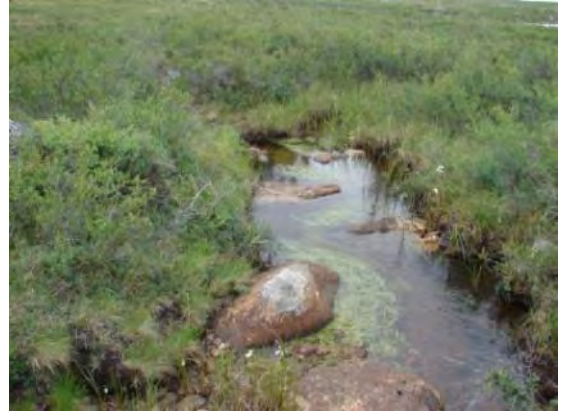
Figure 78: D2 Outlet Channel looking Downstream

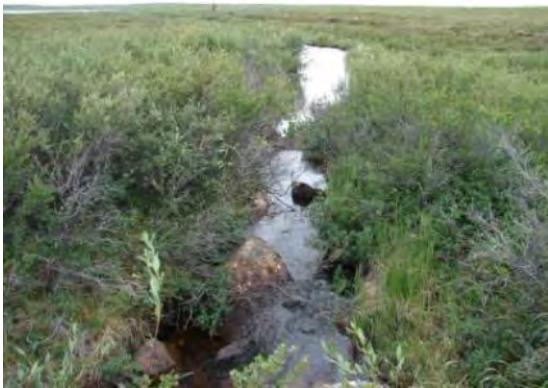
Figure 79: D2 Outlet Channel looking Upstream

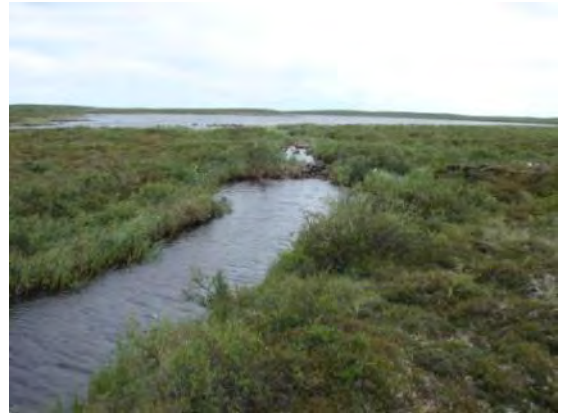
Figure 80: D2 Outlet Channel looking Upstream

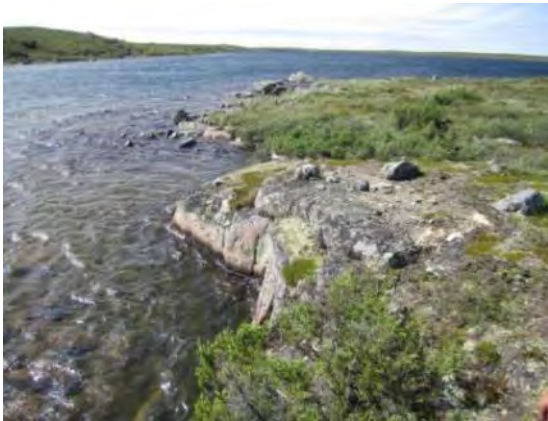
Figure 121: Lake N9 Northeast Shoreline looking West

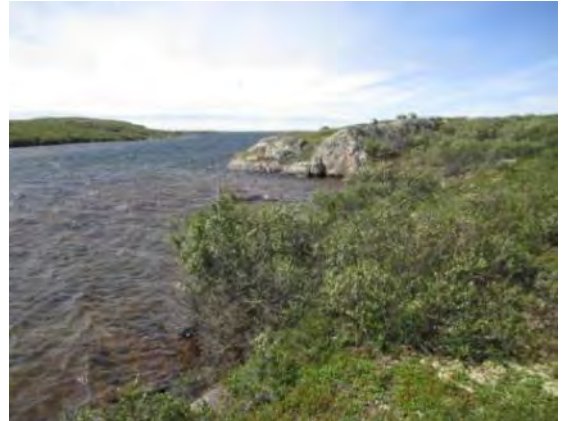
Figure 122: Lake N9 East Shoreline looking North West

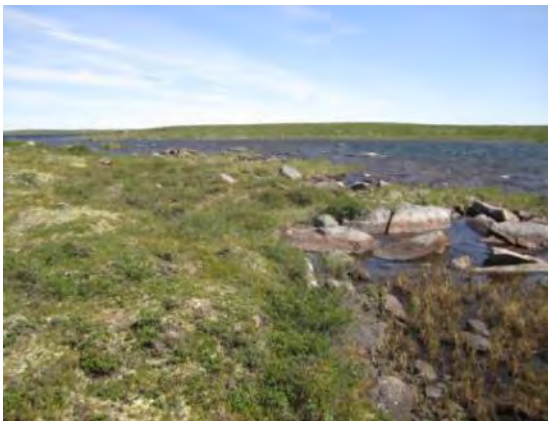
Figure 123: Lake N9 East Shoreline looking Southwest

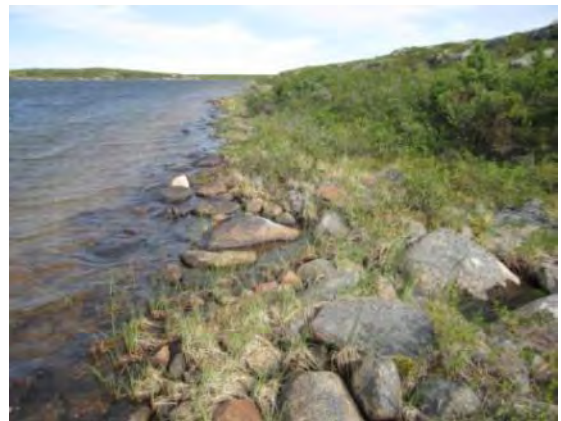
Figure 124: Lake N9 Southeast Shoreline looking Northeast

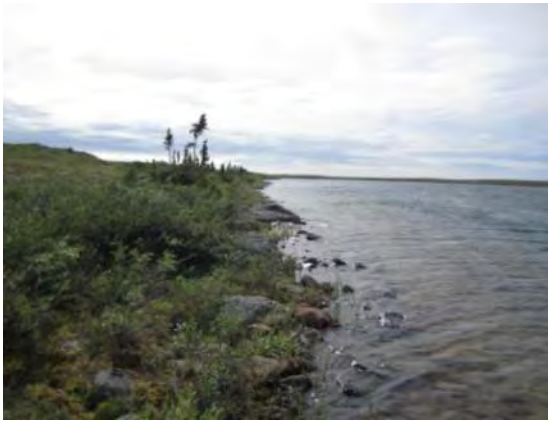
Figure 125: Lake N9 Southeast Shoreline looking West

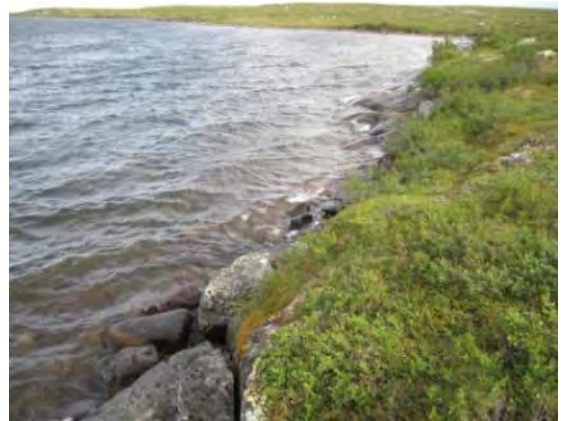
Figure 126: Lake N9 South Shoreline looking West

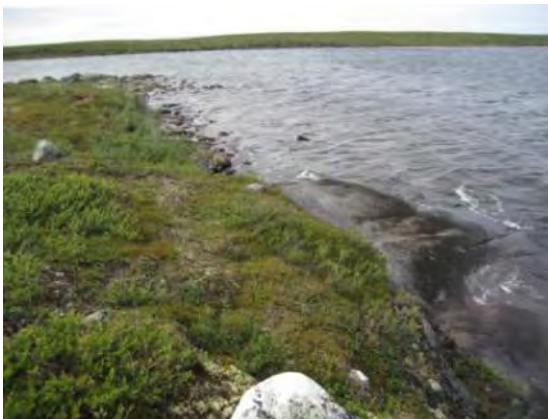
Figure 127: Lake N9 South Shoreline looking East

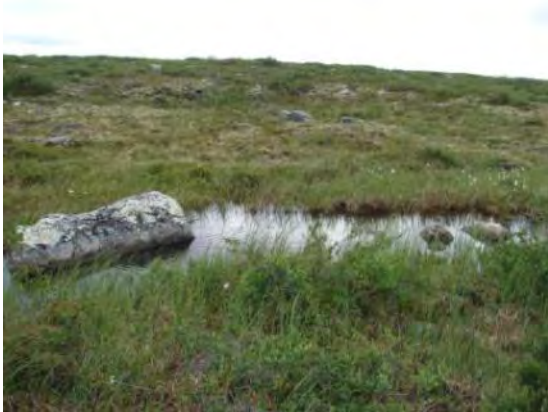
Figure 128: N9 Outlet Channel looking at Right Bank

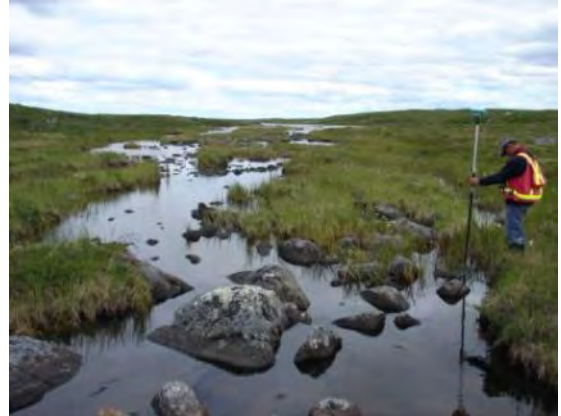
Figure 129: N9 Outlet Channel looking Upstream

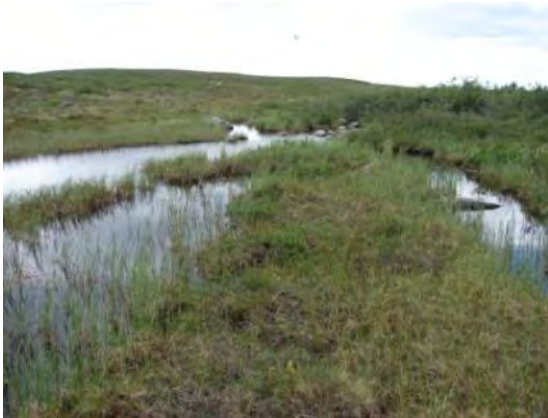
Figure 130: N9 Outlet Channel looking Downstream

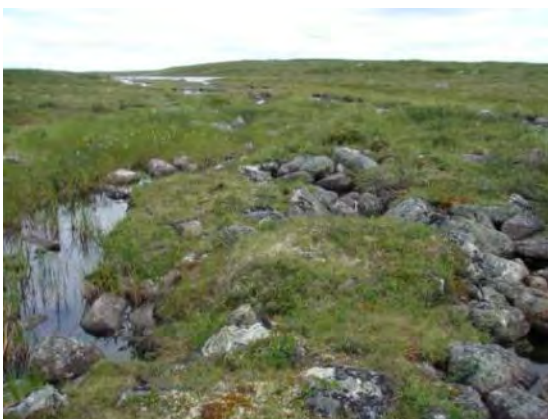
Figure 132: N9 Outlet Channel looking Upstream

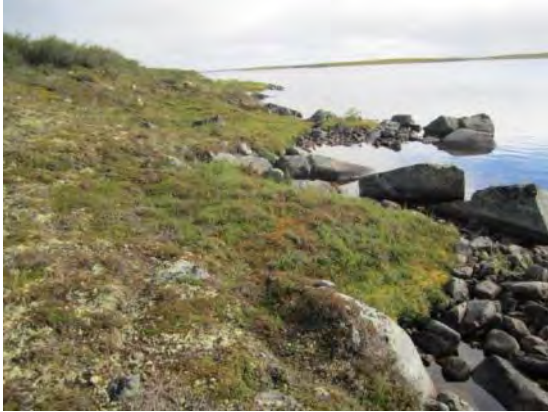
Figure 133: Area 5 West Shoreline looking North

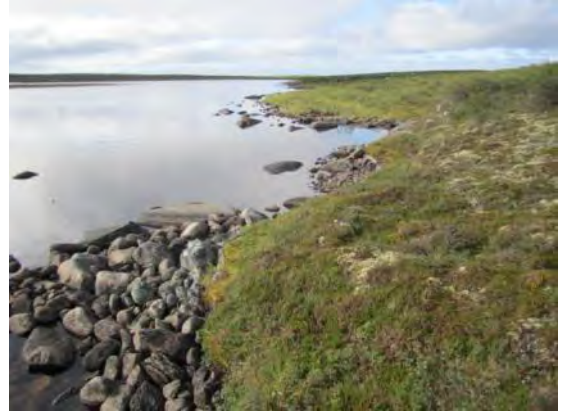
Figure 134: Area 5 West Shoreline looking South

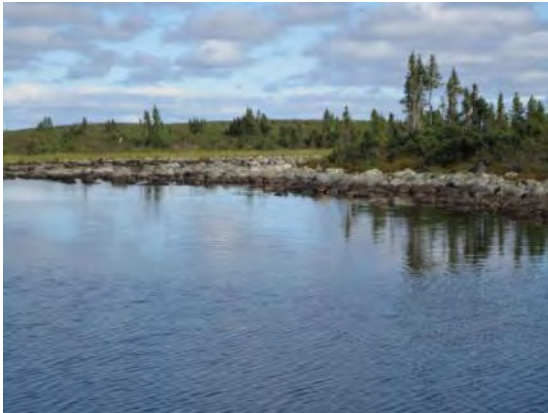
Figure 135: Area 5 East Shoreline looking East

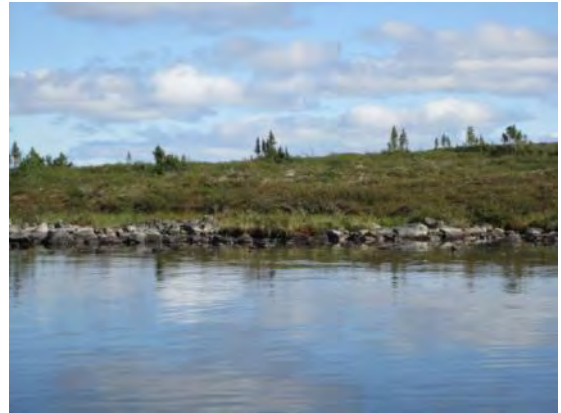
Figure 136: Area 5 East Shoreline looking East

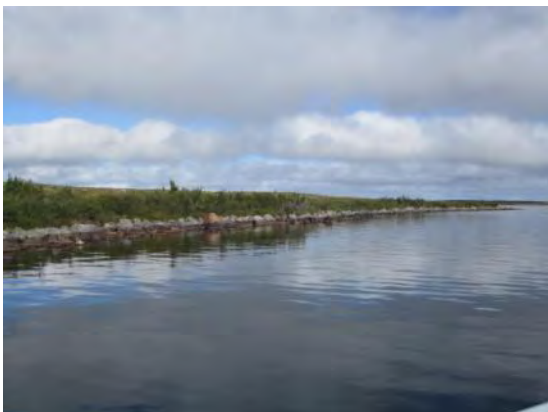
Figure 137: Area 3 West Shoreline looking North

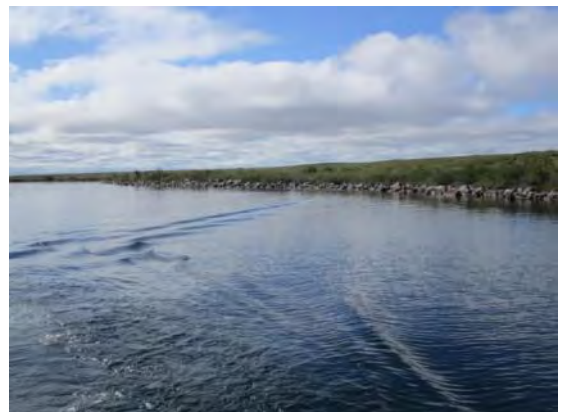
Figure 138: Area 3 West Shoreline looking South

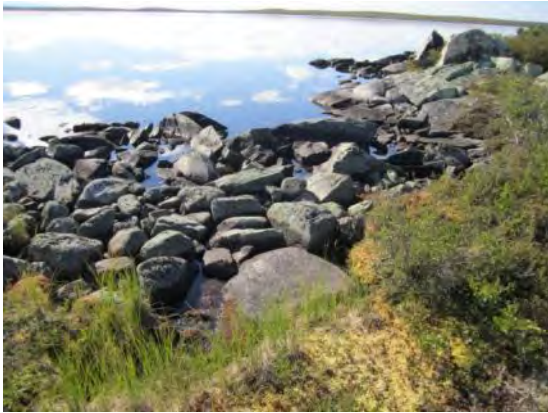
Figure 139: Area 3 East Shoreline looking North
