GAHCHO KUÉ PROJECT

2011 Shoreline and Channel Erosion Assessment

Submitted to:
De Beers Canada Inc.

Report Number: 11-1365-0001/DCN-048

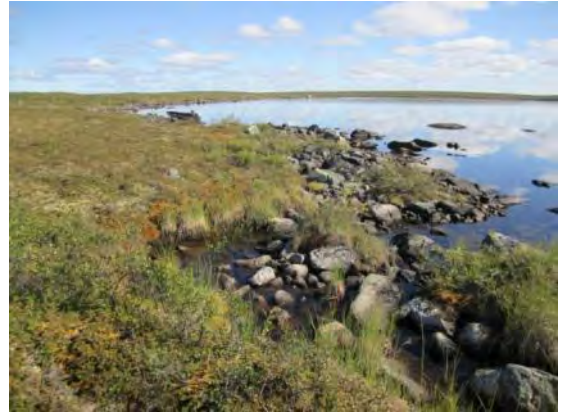
Figure 140: Area 3 East Shoreline looking South

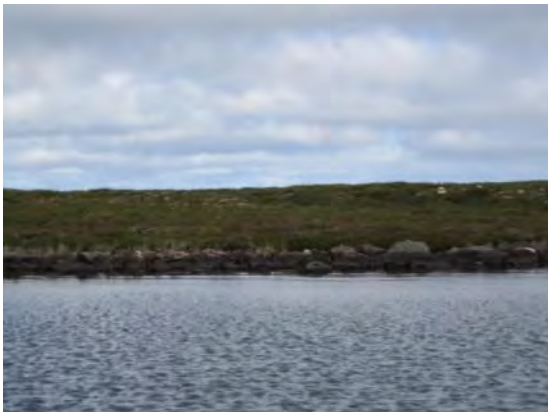
Figure 141: Area 3 North Shoreline looking North

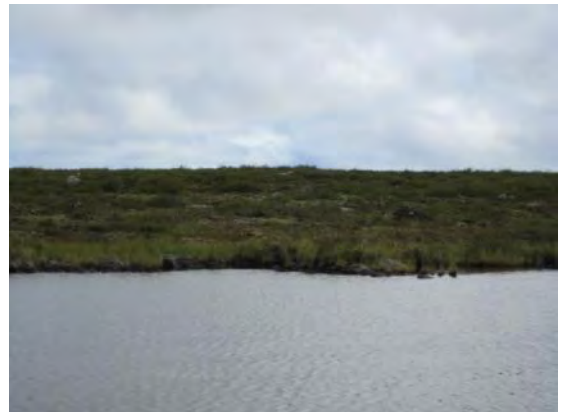
Figure 142: Area 3 North Shoreline looking North
